## Methods for Locating Pool Liner Leakage at Nuclear Power Plants

### A Review and Experimental Evaluation of Inspection Techniques for Underwater and Robotic Deployment

REPORT 2026:1156

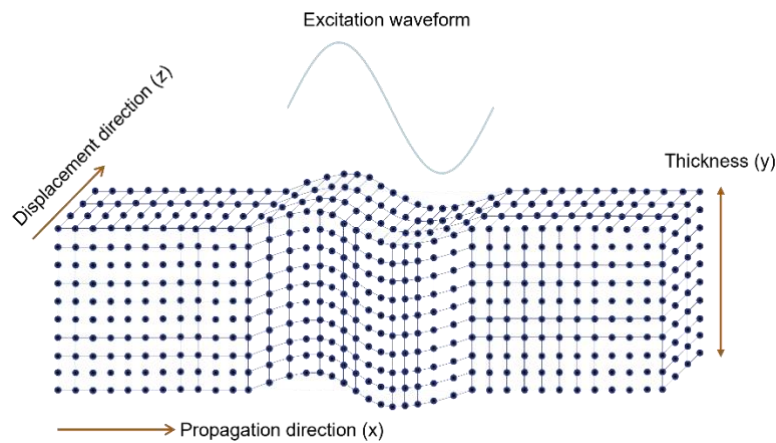
**Figure 5. Illustration of a horizontally polarized shear wave with unidirectional displacement in the z-direction and propagation in the x-direction. No excitation is applied in the y-direction. Figure reproduced from [15].**

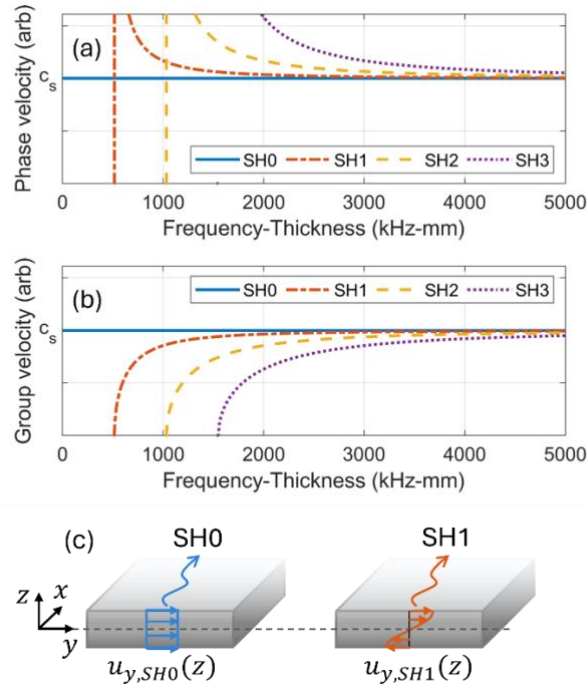
Figure 6. Dispersion curves for shear-horizontal (SH) guided waves in a 3 mm stainless-steel plate. (a) Phase velocity and (b) group velocity as functions of frequency-thickness. (c) Corresponding through-thickness displacement (mode) shapes  $u_y(z)$  for SH0 and SH1.

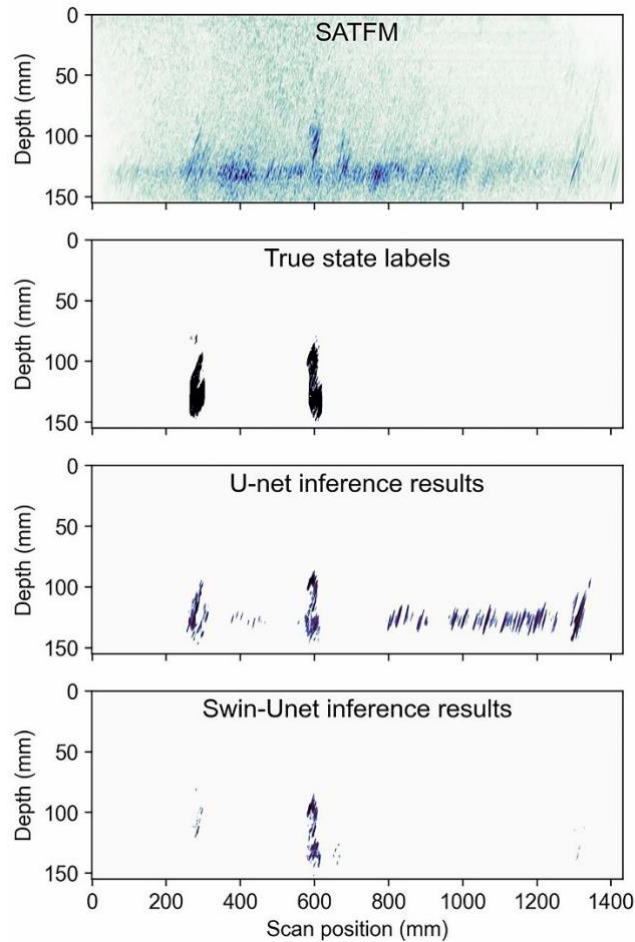
**Figure 10.** PAUT imaging using combined SAFT and TFM (SATFM). The top plot shows the reconstructed image as viewed by the inspector, while the second plot presents the ground-truth flaw positions. The two lower images show results obtained using two different neural network architectures (U-Net and Swin-U-Net), illustrating differences in predicted flaw locations. Reproduced from Sorger et al. [33], licence under CC BY 4.0.

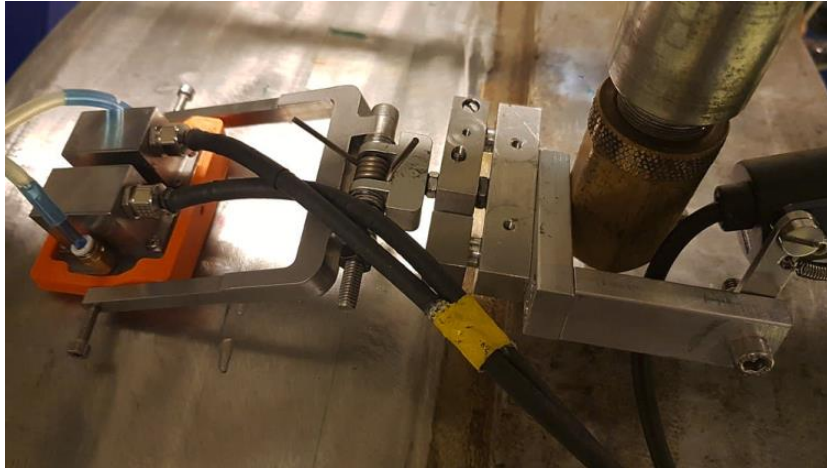
**Figure 12.** Scan setup for dissimilar weld mock-up. Adapted from Virkkunen et al. [32]. Observe the water-feed to the transducers to the left in the figure. Licensed under CC BY 4.0.

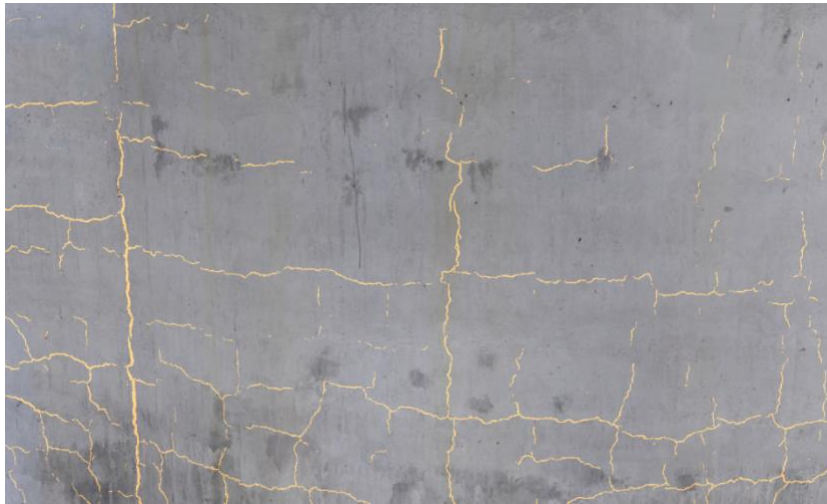
**Figure 19. AI-supported high-resolution photogrammetry using drones for remote crack mapping on concrete surfaces. Cracks are highlighted in yellow. Figure from Spotscale.**

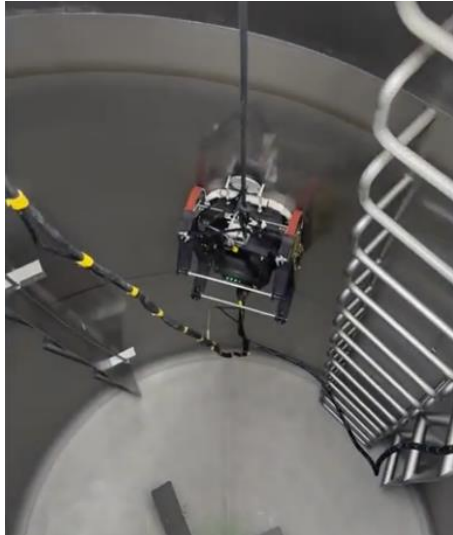
**Figure 22.** HausBots HB2 deploying UT probe inside a stainless-steel tank. Image courtesy of HausBots Ltd.

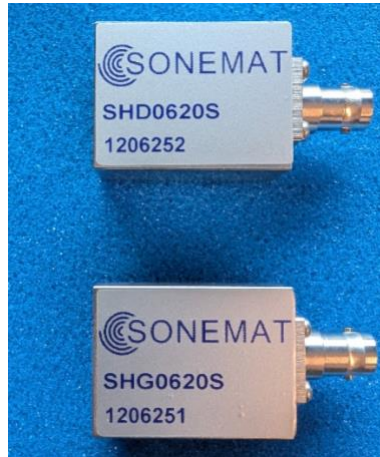
**Figure 23. SONEMAT 600 kHz SH-wave probes.**

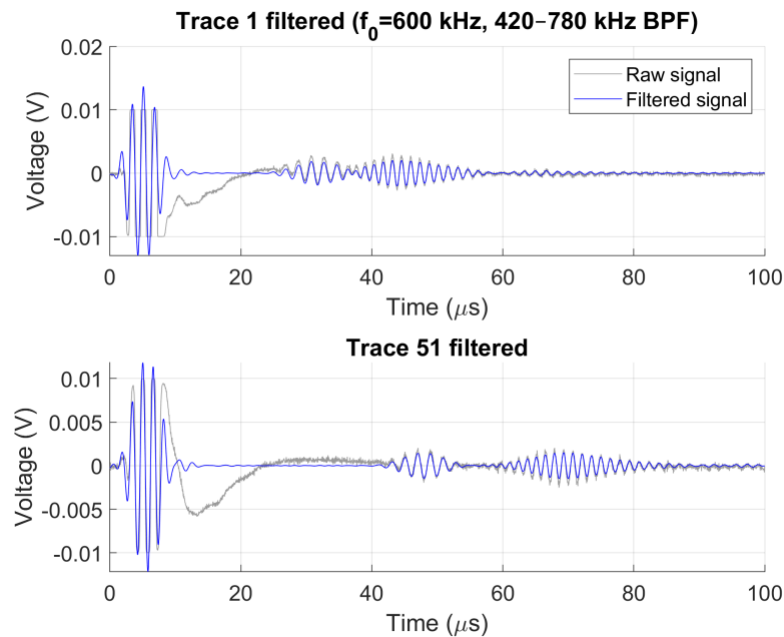
Figure 27. Received EMAT signals at 50 mm (upper plot) and 100 mm (lower plot). The grey curves are the raw signals, and the blue curve are the bandpass filtered signals.

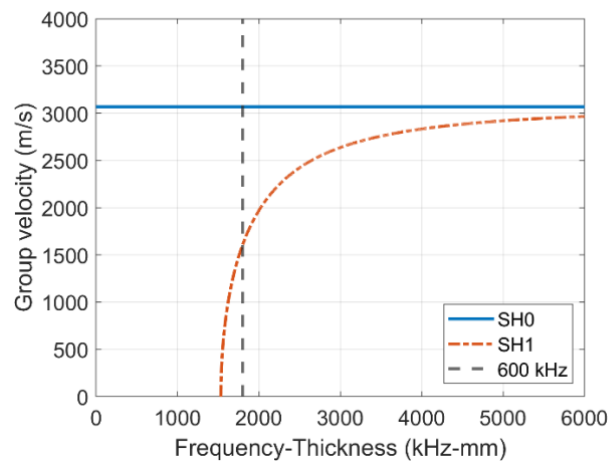
Figure 31. Analytic group velocity curves for the non-dispersive symmetric SH0 mode (blue) and the first dispersive and anti-symmetric mode SH1 (orange dash dotted). Vertical dashed line indicates the frequency-thickness product at 600 kHz and 3 mm.

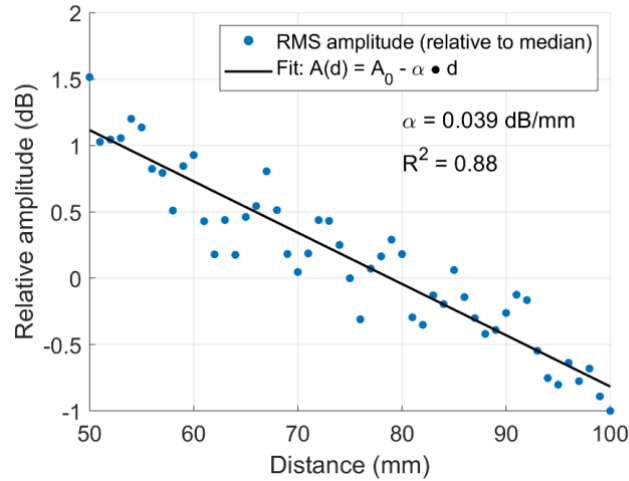
Figure 32. Relative RMS amplitude plotted against distance between probes. The slope of the fitted curve yields an estimate of the attenuation per unit length see eq. (2).
