Self-healing of cracks in concrete long-term exposed to different types of water : results after 1 year exposure

SELF-HEALING OF CRACKS IN CONCRETE LONG-TERM EXPOSED TO DIFFERENT TYPES OF WATER

Results after 1 year exposure

ISRN LUTVDG/TVBM--09/3156--SE(1-58)
ISSN 0348-7911 TVBM

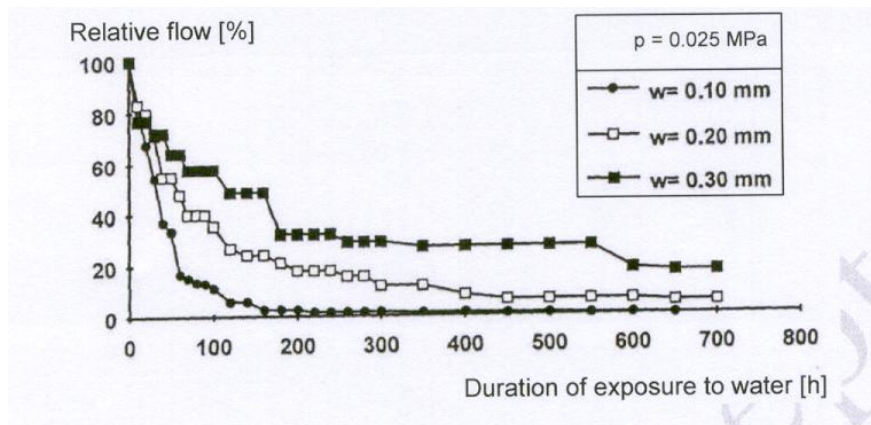
Figure 1.1: Influence of crack width and time on water flow under pressure; Edvardsen (1996).

The fact that *through cracks* in structures exposed to one-sided water pressure can heal has been known for long time. A well-established repair technique is to dry the downstream face so that lime precipitates in the crack opening thereby stopping the water flow. Extensive experimental work on healing of cracks with regard to permeability has been performed by Edvardsen (1996, 1999). An example from her work is shown in Figure 1.1. It shows flow through specimens with one single crack parallel to water flow at the water pressure 0.025 MPa (2.5 m hydraulic head). Complete healing is obtained after about 200 hours for the crack width 0.10 mm. Also cracks with 0.20 and 0.30 mm width heal almost completely within about 30 days.

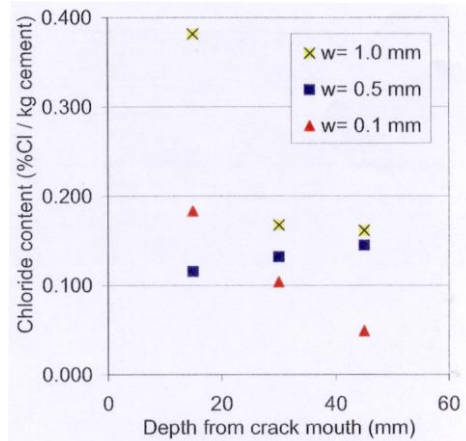
Figure 1.2: Chloride content in the crack wall after 5 winter exposure to salt spray from a Swedish highway. Effect of the crack width. Nordström (2005).

Reports on the effect of healing of cracks with regard to chloride diffusion are scarce. Nordström (2005) exposed pre-cracked steel fibre reinforced concrete to salt spray from a Swedish highway. The exposure time was 5 years (5 winters) and the crack width was 0.1, 0.5 and 1 mm. Some results from measurements of the total chloride content on depths 2 mm to 4 mm from the crack wall, on different depths from the crack mouth, are shown in Figure 1.2. There is no clear certain tendency of reduced chloride content with increased depth in the crack. The chloride content on 45 mm depth varies between about 0.05 and 0.15 % of the cement weight. This can be compared with the chloride content on the same depth in un-cracked concrete, which is less than 0.02 % of the cement weight. Thus, chloride penetration in the crack is considerably higher. It must be noted that the specimens were exposed to seasonal variations in chloride and moisture exposure. Therefore, chloride can diffuse both inwards and outwards within the crack.

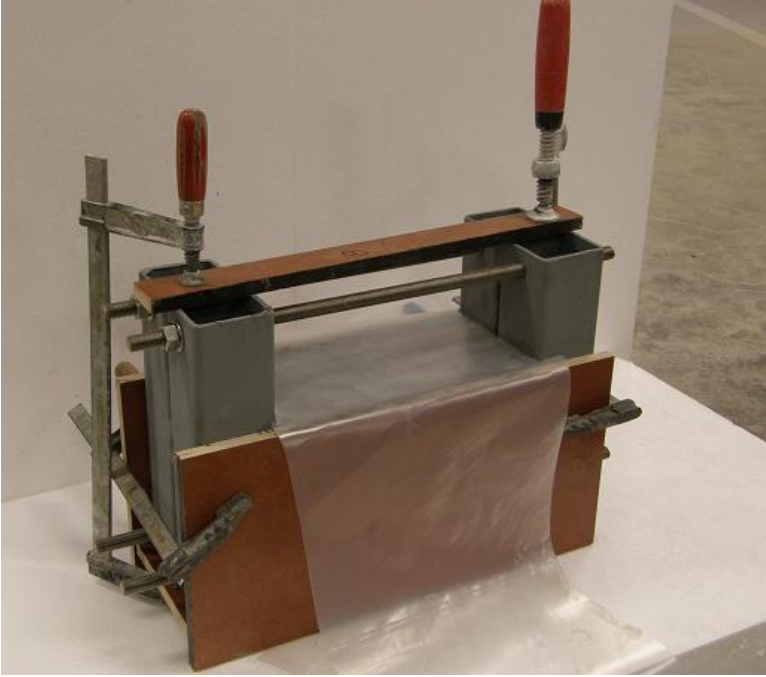
Figure 4.2: Specimen directly after casting.

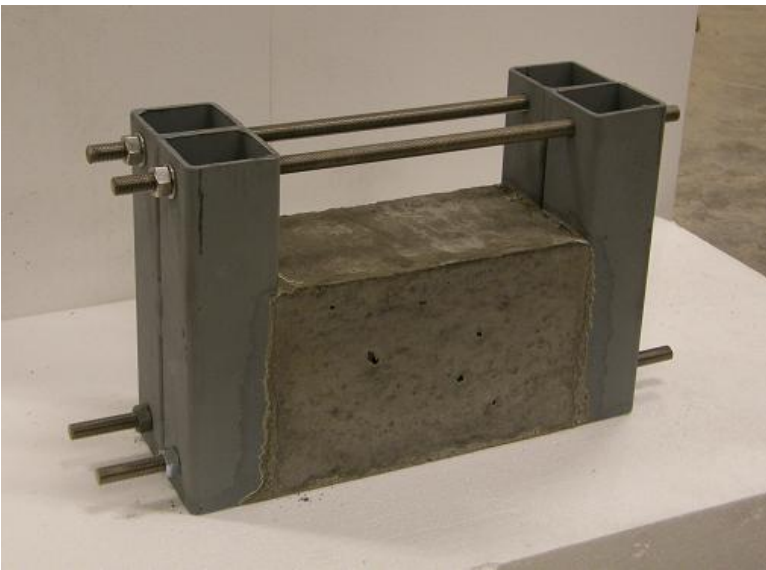
Figure 4.3: Specimen after de-moulding.

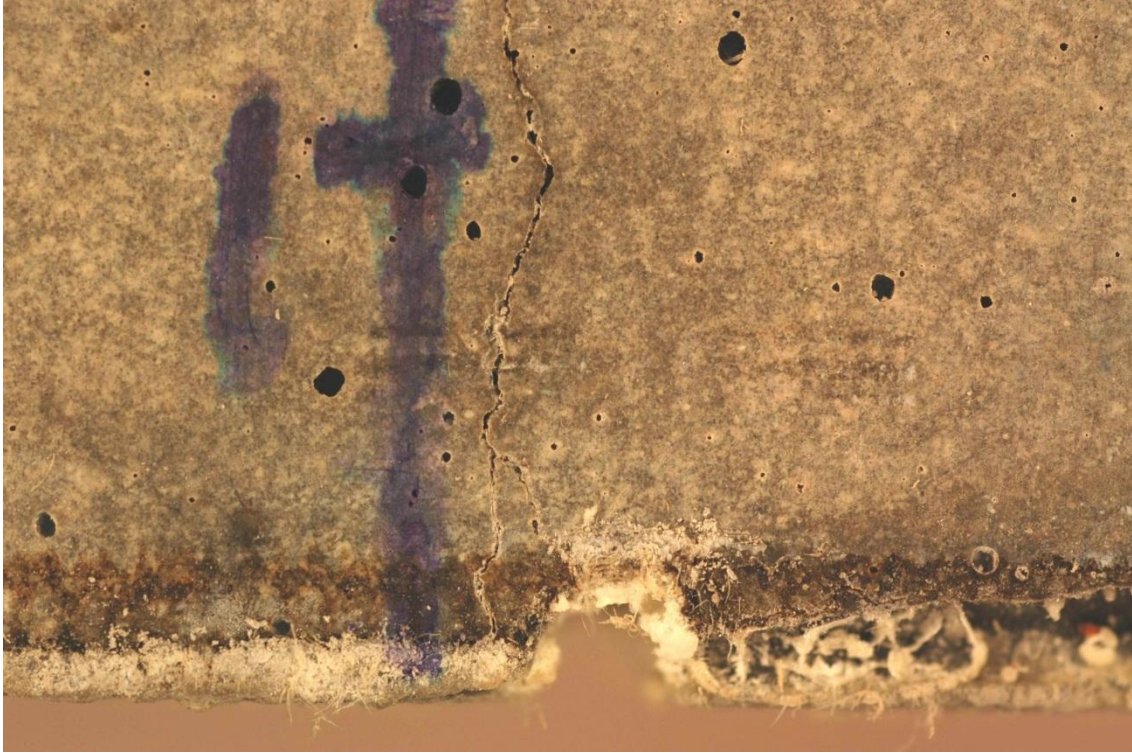
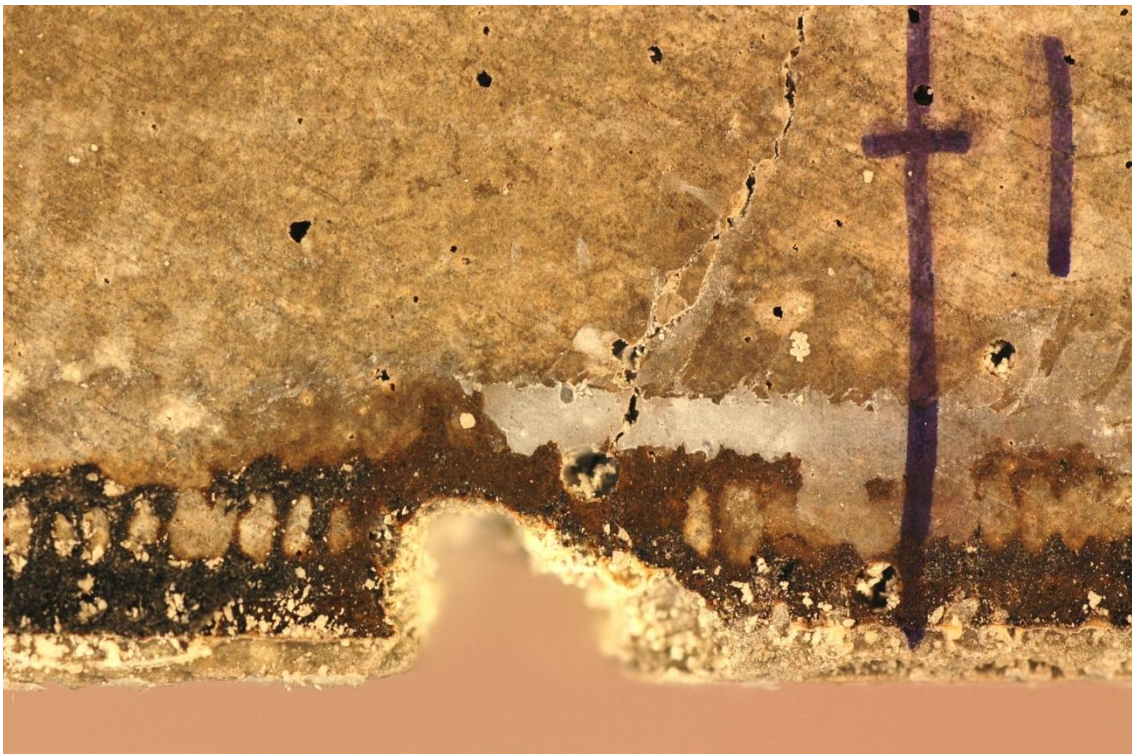
*Figure 12.6: 0.4 mm relaxed crack after 1 year permanent immersion in sea water.
Test series 1, specimen H55-4R-1-1.*

*Figure 12.7: 0.4 mm relaxed crack after 1 year cyclic immersion in sea water and drying.
Test series 1, specimen H55-4R-2-1.*

- Figure 12.2-12.3: At *permanent immersion* in sea water there are clear visual indications of a certain healing at the bottom of the crack, also for the crack width 0.4 mm.
- Figure 12.4-12.5: At *cyclic immersion and drying* the healing seems to be smaller than at permanent immersion, especially for the crack width 0.4 mm.
- Figure 12.6-12.7: There seems to be no bigger healing for *relaxed cracks* compared to the non-relaxed 0.4 mm cracks, cf. figure 12.2-12.3.
- Figure 12.8-12.9: There are no signs of self-healing of 0.4 mm cracks at storage in *tap water* but small signs of healing at storage in *brackish water*.
- Figure 12.10-12.11: When the crack mouth is *sealed* there are no visual signs of self-healing.

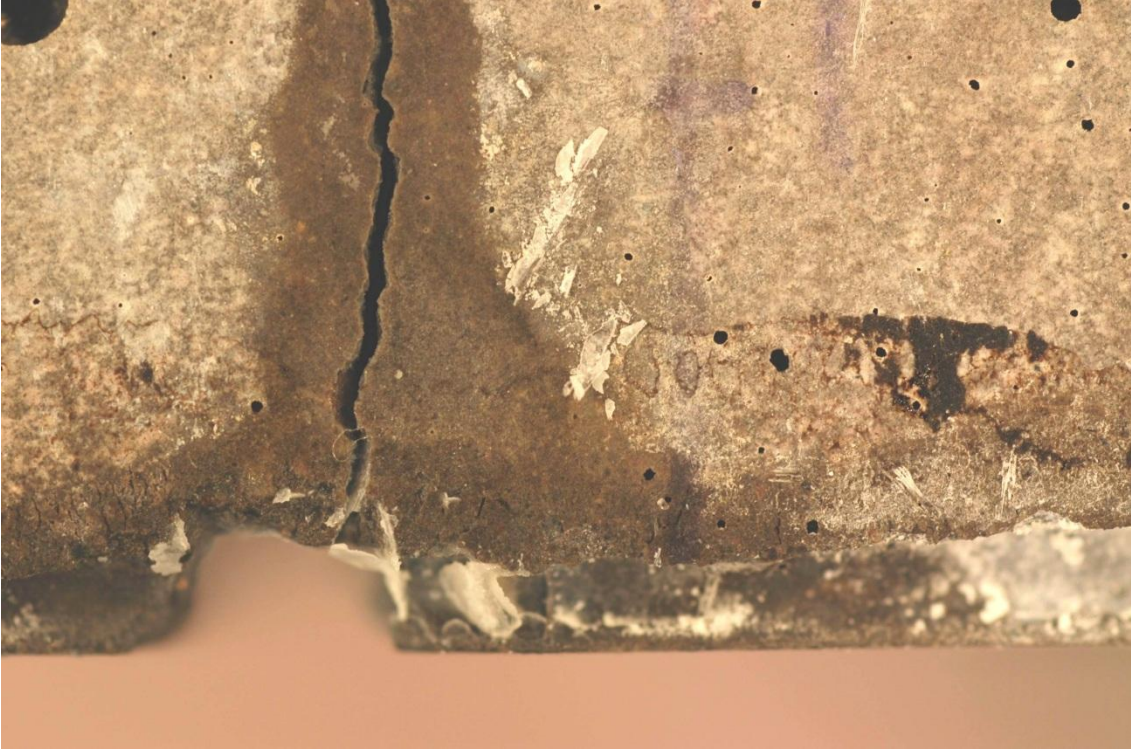
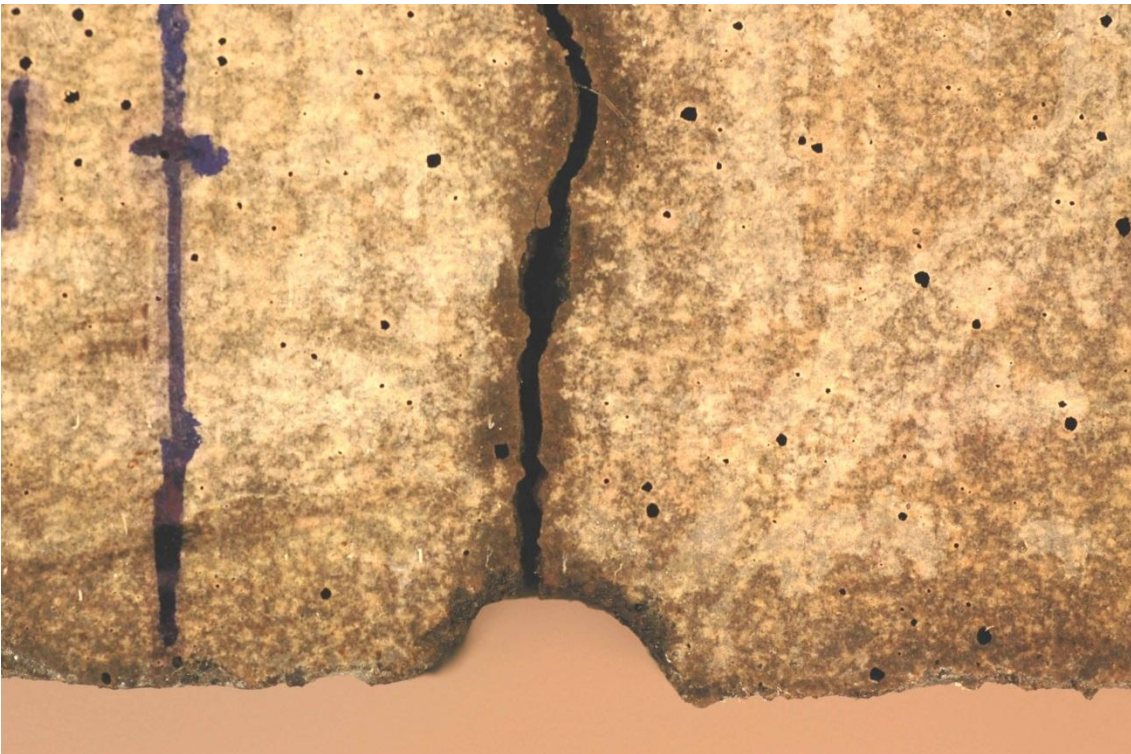
*Figure 12.10: 0.4 mm sealed crack after 1 year permanent immersion in sea water.
Test series 5, specimen S275-4-1-1.*

*Figure 12.11: 0.4 mm sealed crack after 1 year cyclic immersion in sea water and drying.
Test series 5, specimen S275-4-2-1.*

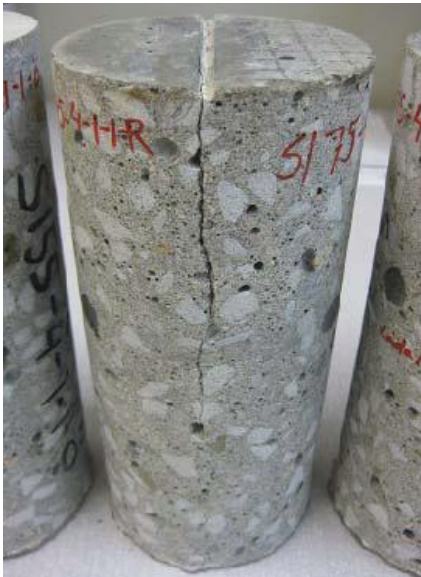
Figure 13.2: Example: core drilled out from specimen S1-75-4-1-1-R (75 mm cover, crack width 0.4 mm, permanently exposed to pure water).

After terminated exposure a 10 cm core was drilled centrally in the specimen from its bottom side along the crack. Drilling was made with water-cooled drill. An example of the specimen after drilling is shown in figure 13.1. An example of a drilled-out core is shown in figure 13.2.

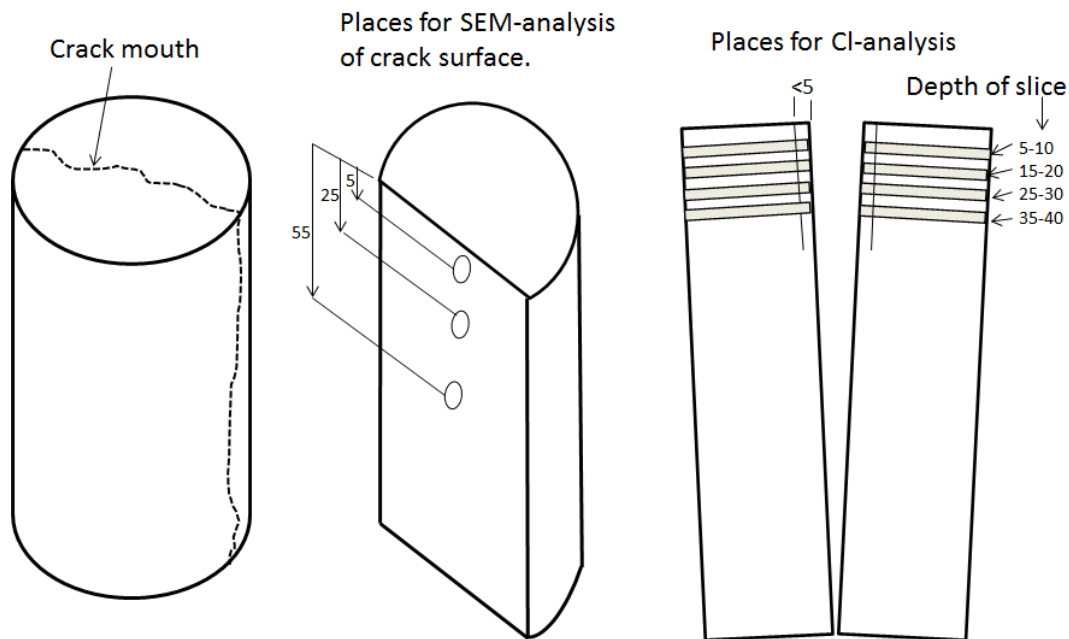
Figure 14.1: Core and places where samples were taken from the crack walls.

Location of the test areas are shown in figure 14.1.

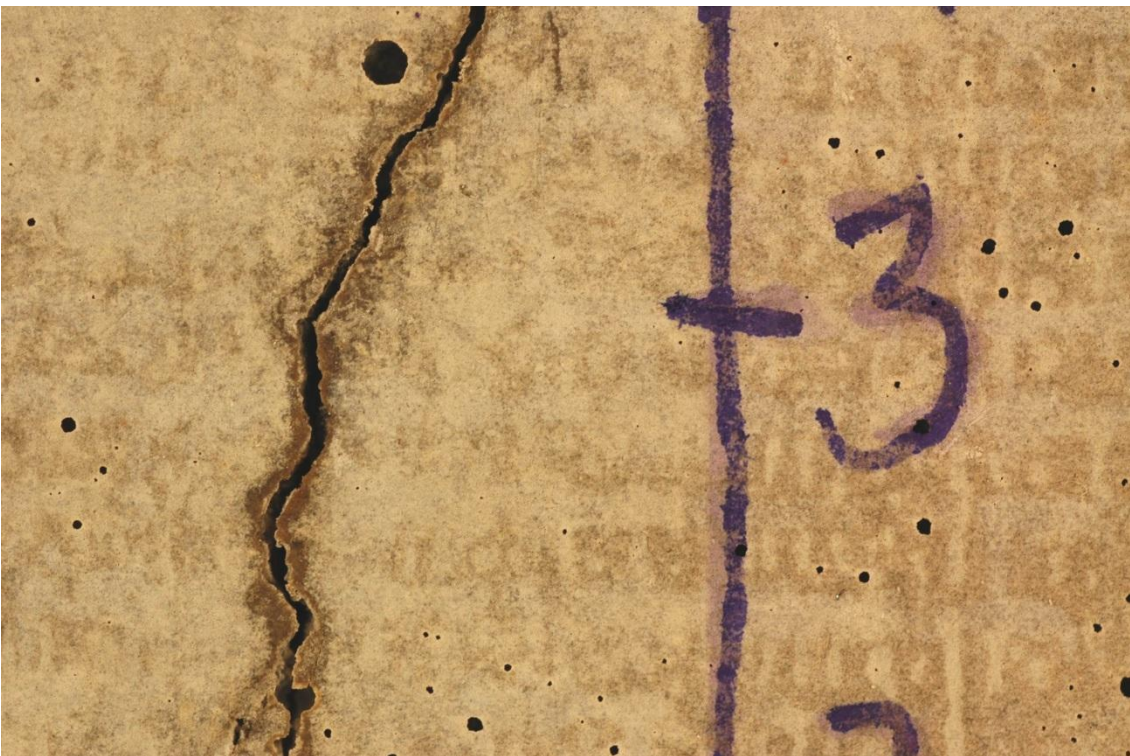
*Figure A2.1: 0.2 mm crack after 1 year permanent immersion in sea water.
Test series 1, specimen H75-2-1-1.*

*Figure A2.2: 0.4 mm crack after 1 year permanent immersion in sea water.
Test series 1, specimen H75-4-1-1.*

- Figure A2.1-A2.2: *Permanent immersion*: Visually, certain healing of 0.2 mm crack. No healing of 0.4 mm crack.
- Figure A2.3-A2.4: *Cyclic immersion and drying*: No healing of cracks visible.
- Figure A2.5-A2.6: *Relaxed 0.4 mm cracks*: Certain healing observable both for permanent immersion and cyclic immersion and drying.
- Figure A2.7-A2.8: *Brackish water and tap water*: No signs of healing of 0.4 mm cracks in tap water but slight indication of healing in brackish water.
- Figure A2.9-A2.10: *Sealed crack mouth*: No signs of healing at permanent immersion but indications of certain healing at cyclic immersion and drying.

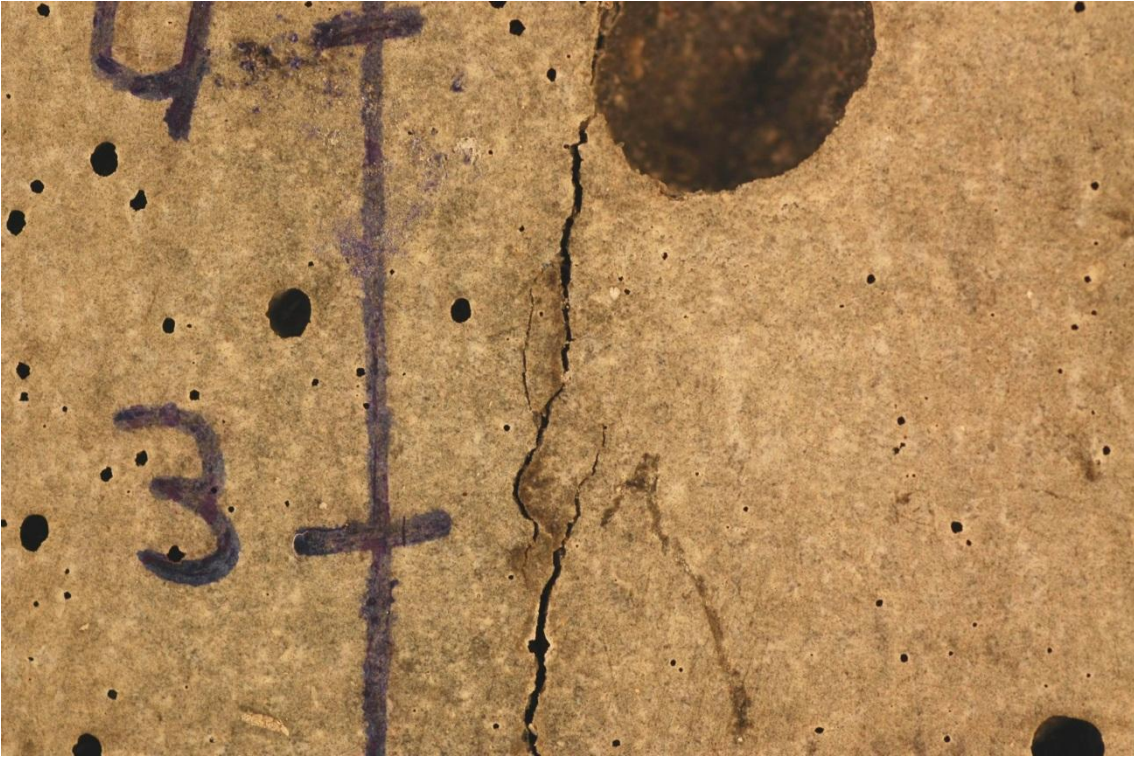
*Figure A2.3: 0.2 mm crack after 1 year cyclic immersion in sea water and drying.
Test series 1, specimen H75-2-2-1.*

*Figure A2.4: 0.4 mm crack after 1 year cyclic immersion in sea water and drying.
Test series 1, specimen H75-4-2-1.*

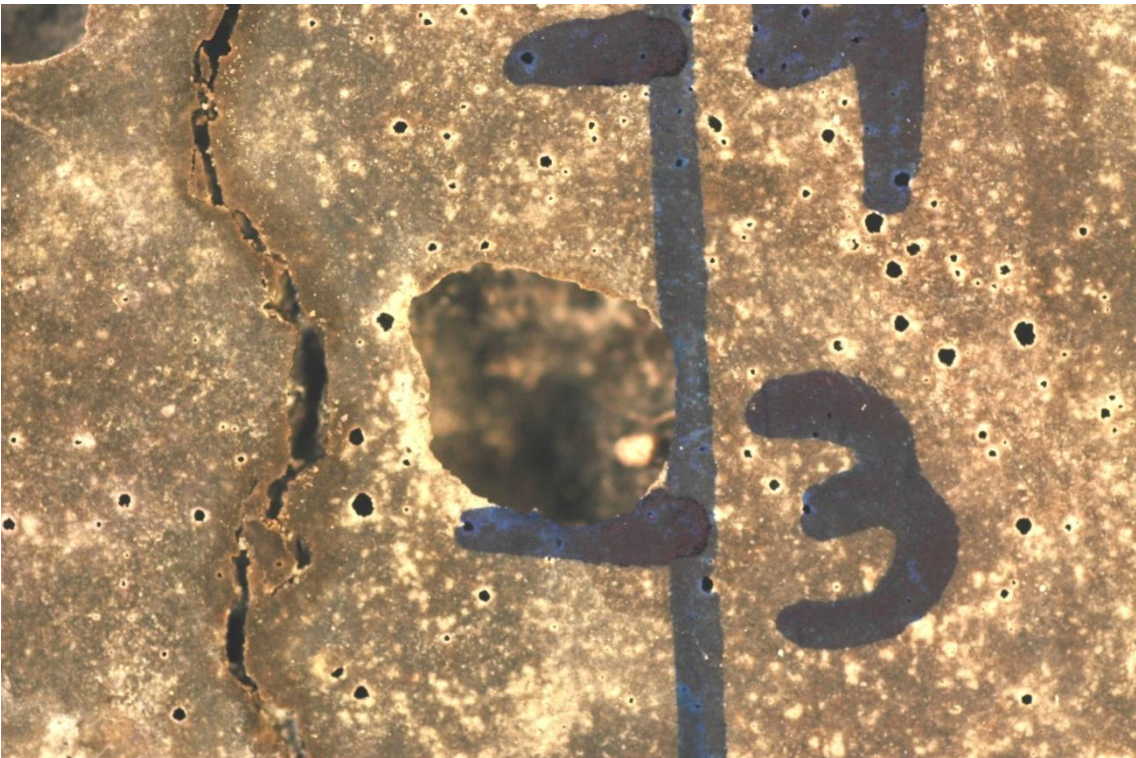
*Figure A2.7: 0.4 mm crack after 1 year permanent immersion in pure water.
Test series 3, specimen S175-4-1-1-R.*

*Figure A2.8: 0.4 mm crack after 1 year permanent immersion in brackish water.
Test series 2, specimen S175-4-1-1-Ö.*

*Figure A2.9: 0.4 mm sealed crack after 1 year permanent immersion in sea water.
Test series 5, specimen S275-4-1-1.*

*Figure A2.10: 0.4 mm sealed crack after 1 year cyclic immersion in sea water and drying.
Test series 5, specimen S275-4-2-1.*
