Soil and Water Conservation in Thika-Chania catchment, Kenya

International Journal of Sustainable Water and Environmental Systems

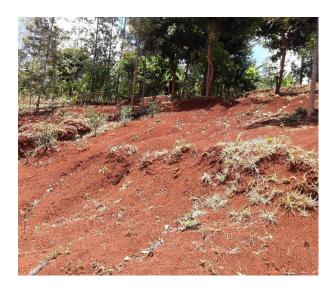
Figure 6. Collapsed terraces in Gatura village.

Terraces were commonly found in the coffee growing zones. The terraces are however not managed properly leading to their collapse and the soils washed away by surface runoff as shown in Figures 6 and 7.

For their optimal operation, terraces need to rehabilitated and encourage construction of new ones in areas where none exists. Based on a study done in Ethiopia, the lack of short term benefits from conservation measures could be attributed to the lack of maintenance of terraces [11]. This is evident in areas where grass strips are well maintained because they are a source of fodder for livestock.

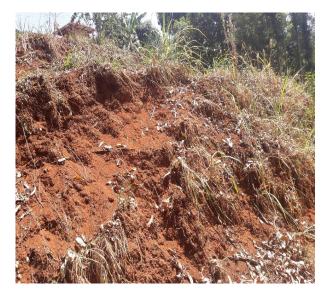
Figure 7. Degraded grass terrace in Gatura village.

Research shows that when soil and water conservation measures are improved, they can reduce moisture stress and improve crop yields associated with rain-fed agriculture [17]. Surface erosion was evident in sloping areas where gullies have already developed Figure & 7. From the baseline survey, it was observed that more than half of the respondents (51%) had less than a quarter of their lands with soil conservation measures.
