## Carbonation of indoor concrete : measurements of depths and degrees of carbonation

# Carbonation of indoor concrete

## Measurements of depths and degrees of carbonation

## 2 Office building in Limhamn constructed in 1967

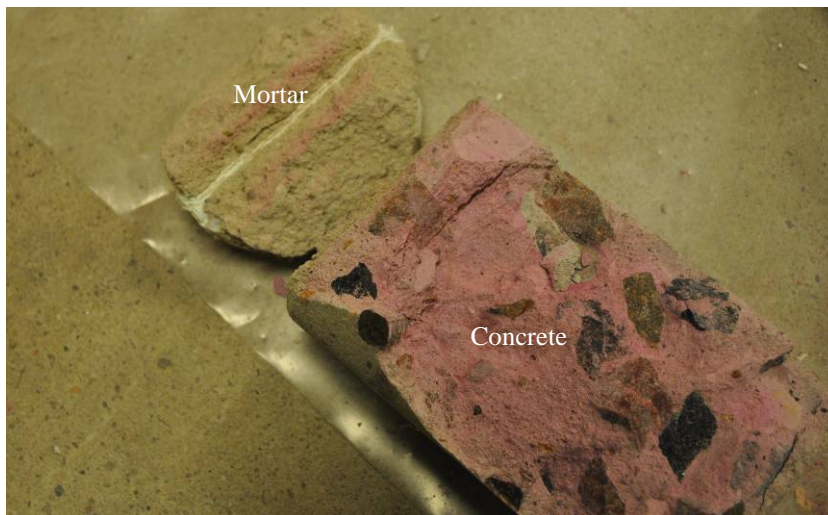
Wall thickness 180 mm. Concrete with binder of probably CEM I. There was 7-8 mm of mortar on the concrete surface and a painted plastic weave on surface of the mortar. A more porous layer could be found between the outer mortar and the concrete, figure 2.1.

*Figure 2.1.Split Core from inner wall.*

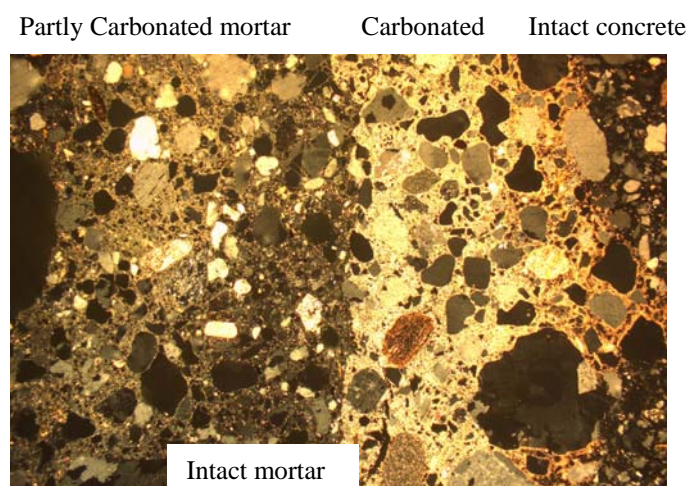
The thin section reveals carbonation of most of the mortar, figure 2.2. At the contact to the concrete the mortar is only partially carbonated. The concrete is then carbonated to a depth of between 1 and 5 mm.

Remaining cement grains can be observed in the carbonated part of the concrete. This suggests that the concrete was allowed to carbonate before the mortar was applied. The low depth of carbonation of the concrete (1-5 mm) in part explains the low degree of carbonation. Moreover the concrete contains grains of limestone aggregates. This probably explains why the slice that according to thin section is uncarbonated between 16 and 27 show carbonation.

*Figure 2.2. Thin section of interfacial zone between cover mortar and concrete. The inner part of the mortar is uncarbonated while the outer part of the concrete is carbonated. This indicated that the mortar was applied after a while when the concrete was partly carbonated.*

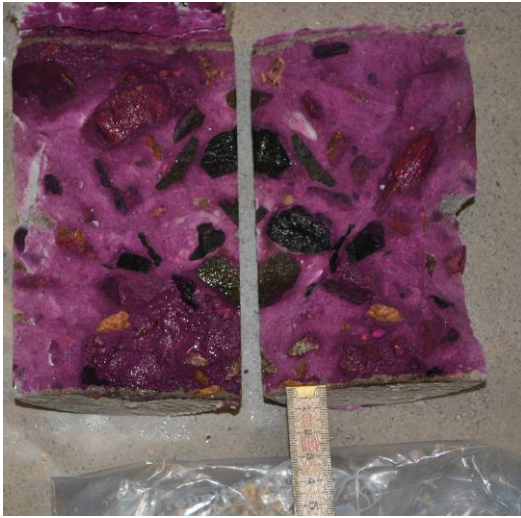
Wall thickness and the drill core was 190 mm. Concrete was made from Portland cement, probably CEM I. On one side the concrete was covered by a mortar with a thickness of 7-8 mm. The mortar was covered with a painted plastic weave (same as for core 1). On the other side of the wall was the concrete painted and covered by glazed tile plates, figure 2.3.

*Figure 2.2. Core 2: Inner wall.*

The core was split just before applying the phenolphthalein. The depth of carbonation of the concrete was 3-4 mm. The concrete covered with paint and glazed tile plates was uncarbonated.

The thin section was taken from concrete beneath the mortar. The depth of carbonation was between 3 to 4 mm. This carbonation is probably due to carbonation before the concrete was covered. The w/c equivalent is about 0.6.

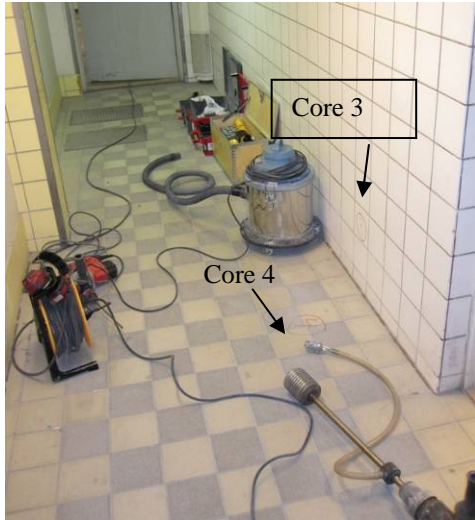
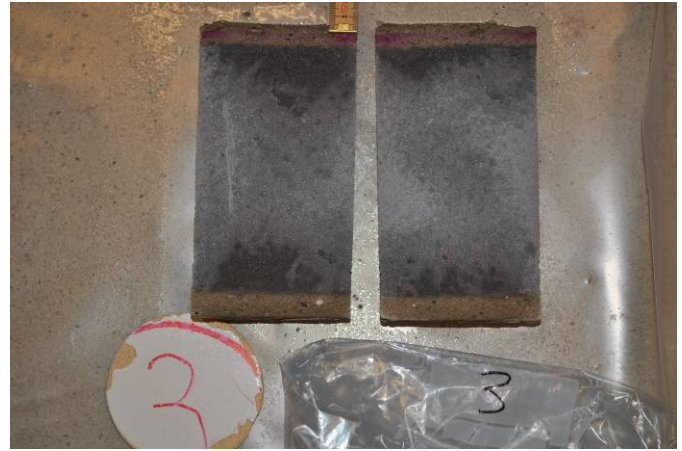
The wall thickness is 100 mm. This wall turned out to be of aerated concrete with mortar on the surface. The mortar was painted on one side and ceramic tiles were the surface material on the other side, figure 2.4.

*Figure 2.3. Core 3: Inner wall.*

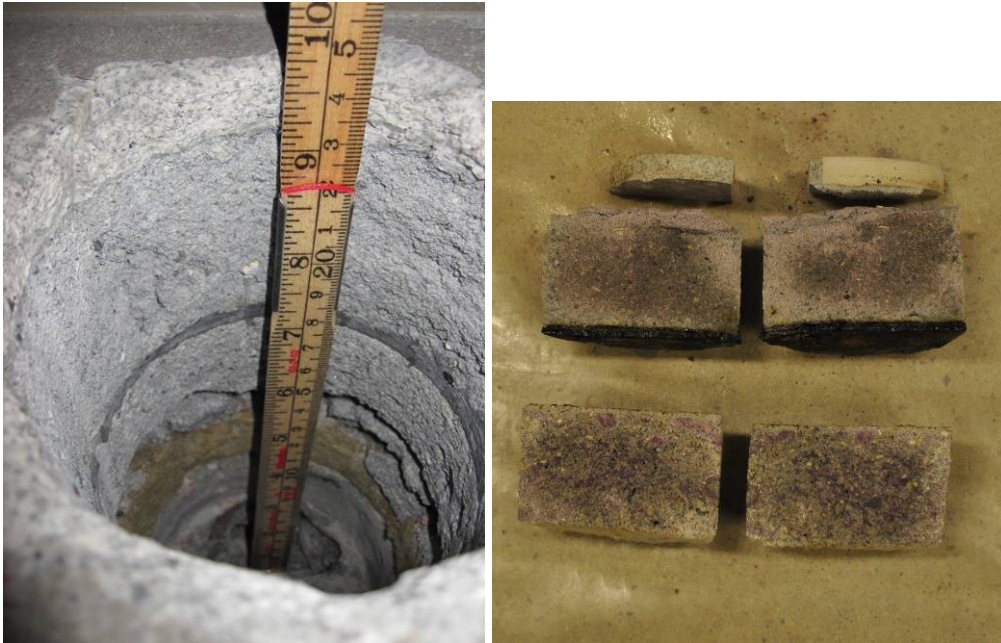
This floor was a construction component including many different materials. The surface material was ceramic tiles on mortar and that was followed by mortars of different kind separated by a capillary breaking layer. The second mortar layer was followed by an insulating material and an additional concrete layer which was placed on macadam, figure 2.5. The total thickness was 250 mm.

*Figure 2.4. Core 4: Ground floor.*

The core was split just before applying the phenolphthalein. The upper two layers of mortar are partial carbonated. Spots of dark pink are found in both layers, with larger areas in the lower part. The tiles have probably been applied long after the floor was constructed or that carbon dioxide from the ground wanders through the construction component and carbonates the porous part of the construction. The lower part of the core was partially carbonated.

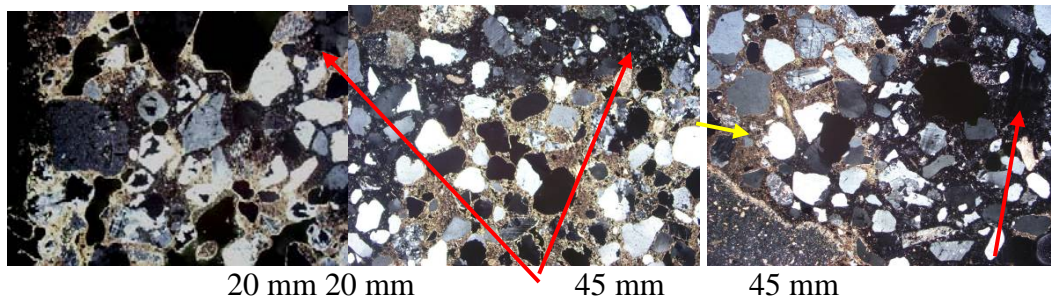
The bottom of the core showed a patchy carbonation (see figure 2.6) to at least 45 mm (the length of the thin section). The patchy texture is in part due to bad mixing that gives an uneven porosity and thus a patchy appearance. The w/c equivalent of the dense parts is around 0.55 while that of the porous parts is above 0.7. The dense parts are mainly uncarbonated while the porous are carbonated.

Figure 2.6. Thin sections in polarized light. The light colour shows carbonation. It shows the patchy carbonation where carbonation follows porous parts. Yellow arrows shows carbonated patched while red arrows shows uncarbonated patches. The depth is from concrete at the bottom of the drillcore.

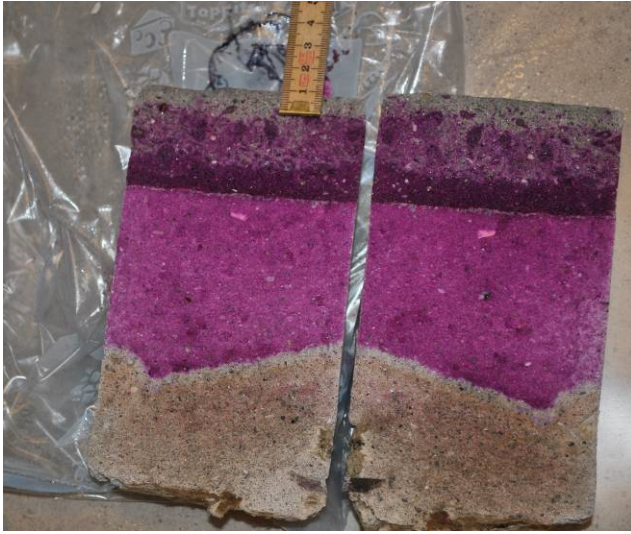
Though this core was taken in the same floor as core 4 in an adjacent room weren't the materials the same. The building component consisted of three to the eye different mortar layers which were separated by thin well defined layers. The mortar layers where followed by insulation, concrete layer and macadam, figure 2.7. The total thickness was 250 mm.

*Figure 2.7. Core 5: Ground floor, painted surface.*

The top mortar layer showed complete carbonation in 9 mm and thereafter partial carbonation 3-5 mm. The bottom of the concrete part of the core was found to be completely carbonated in 22 mm with a distinct front. This was followed by a partial carbonation for an additional 3 mm. The w/c equivalent of the concrete was about 0.65. Signs of alkali silika reaction (ASR) were found. ASR is an indication of reactive aggregates and a high humidity.

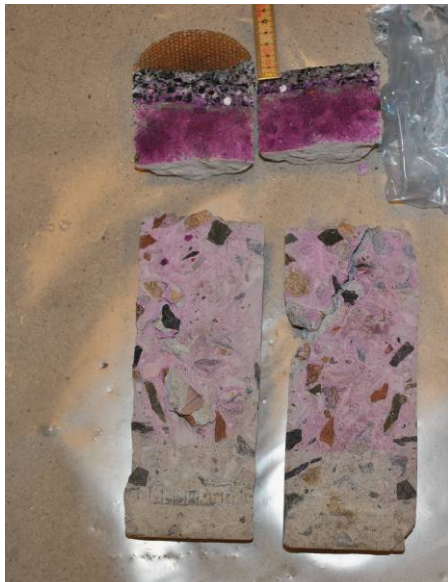
The construction component was 200 mm thick. The different layers were linoleum carpet, a concrete layer with smaller aggregates, and a layer with even smaller aggregates followed by more regular concrete and paint on the roof side, figure 2.8.

Figure 2.8. Core 6: Intermediate floor.

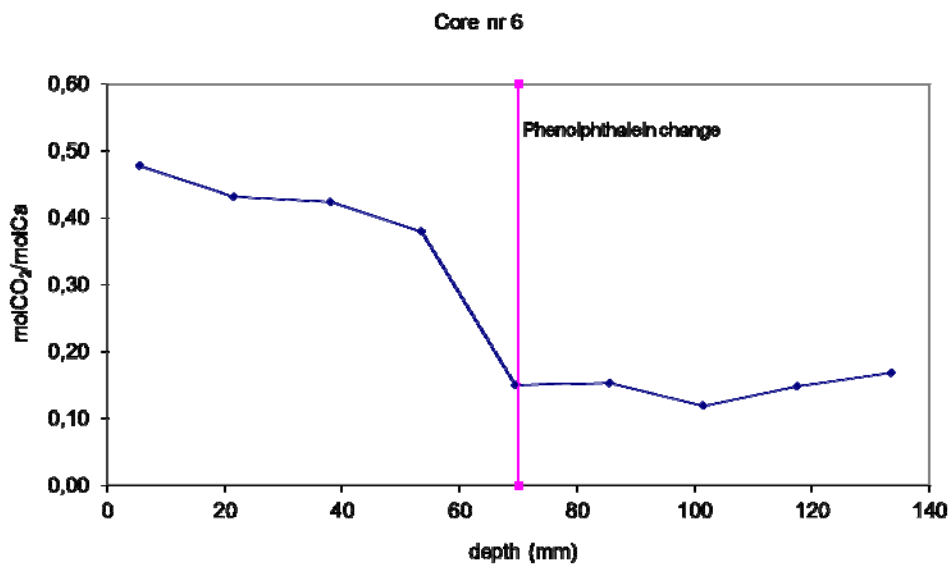
To investigate the degree of carbonation nine slices (11 mm each) were sawed from the concrete covered by paint on the roof side, figure 2.9.

Figure 2.9. Core 6: Degree of carbonation at different depths. Depth defined as the centre of each slice. From the painted surface and upwards towards the floor. The concrete contains some carbonate aggregate particles giving an apparent higher degree of carbonation.

The pH-change coincide with the drop in degree of carbonation just as (Möller, 1994) also found. For the first 60 mm is the degree of carbonation decreasing slowly from 0.49 to 0.40 and thereafter drop to 0.15 in just 11 mm. The degree of carbonation is fairly constant after that. One must however consider that the concrete contain some small carbonate aggregates and that this gives a higher degree of carbonation. Presumably the degree of carbonation in the interior of the concrete is close to 0 %. Thus the degree of carbonation at the surface is closer to 40 than 50 %.

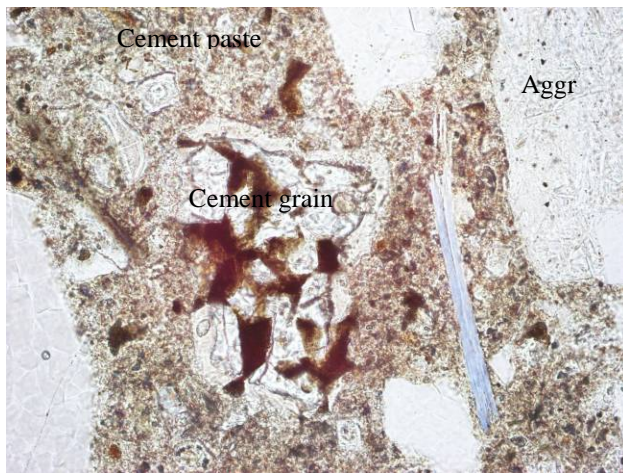
For the thin section taken from the painted roof side the first 3 mm completely carbonated, followed by 15 mm that was partly carbonated and the remain of the thin section (20-45 mm) was vaguely carbonated, figure 2.10. This measurement agrees with the other measurements on this core but show with a greater detail how the carbonation proceeds. In the thin section it is possible to observe unhydrated cement grains in a carbonated matrix.

*Figure 2.10. Unhydrated cement grains in a carbonated matrix (the carbonated roof side of the drill core).*

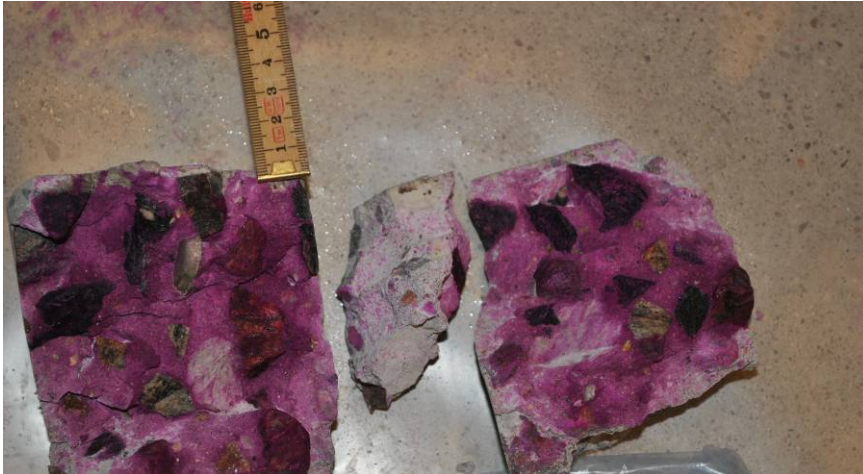
This core was taken from an external wall, figure 2.11, to be able to compare the different measurements from internal concrete with concrete exposed to outdoor climate. The core was 100 mm long and had no surface cover.

*Figure 2.11. Core 7: External wall*

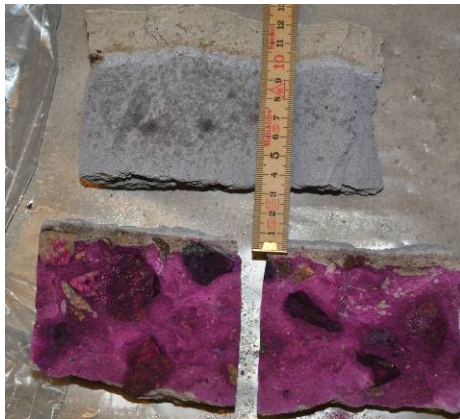
The inside part of the external wall was also investigated, figure 2.12. The concrete had two layers of different paste/mortar and the outer layer was painted.

*Figure 2.12. Core 8: Inside of external wall.*

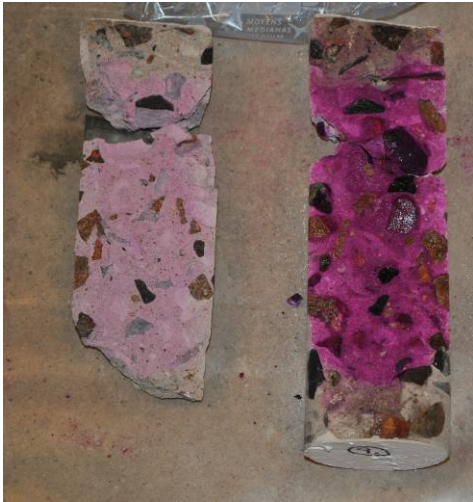
A beam subjected to same indoor climate at both sides was tested, figure 2.13. The beam was 250 mm thick and painted on the three exposed sides.

*Figure 2.13 Core 9: Concrete beam.*

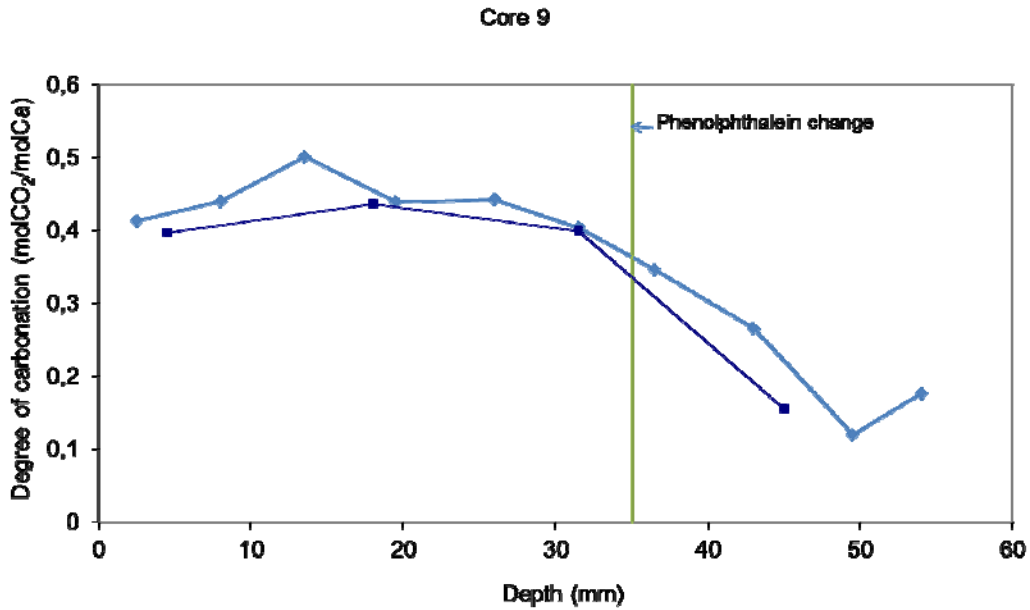
To investigate the degree of carbonation four slices (11 mm each) were sawed from one end of the core and ten slices (5 mm each) from the other end was investigated, figure 2.14.

Figure 2.14. Core 9: Degree of carbonation at different depths. Depth is centre of each slice and the figure shows two different measurements from opposite sides of the core.

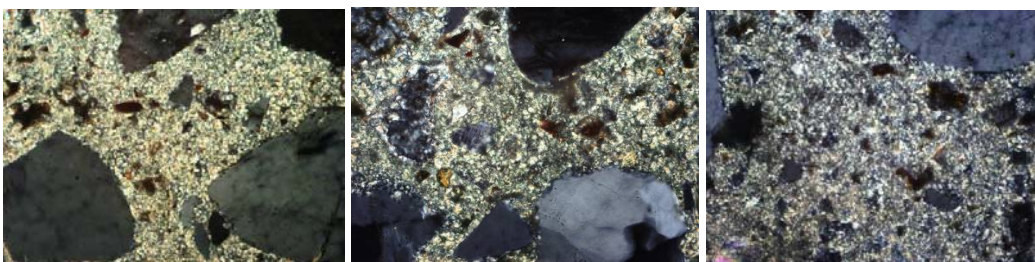
The concrete was completely carbonated about 30 mm, partly carbonated 15 mm and vaguely carbonated for the rest of the thin section (see figure 2.15) and the w/c equivalent was 0.60-0.65. Un-reacted cement grains are found in the entire sample. The fine aggregate contains some limestone particles.

Figure 2.15. Thin section pictures. Crossed polarizers. From the surface (left side) to a depth of 35 mm (right side). Pictures 0.3 mm. Carbonatisation can be observed by a lighter more yellow colour. From this it is possible to observe that the cement paste at the surface layer is much more carbonated than the interior.

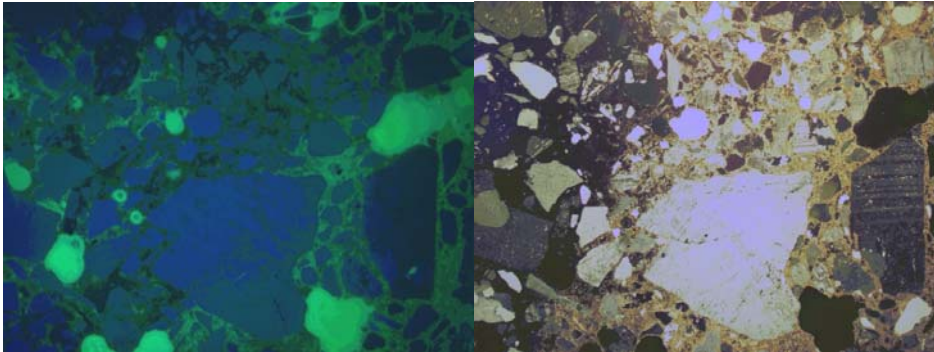
There is a thick layer of paint on the concrete. The concrete is rather porous and badly compacted. The carbonated cement paste has a more homogeneous paste than the uncarbonated. This can be seen in the thin sections when analysed in UV-light, figure 3.1. The lighter colour shows a larger amount of absorbed fluorescent dye and shows that the carbonated paste is more porous. The depth of carbonation

is 20 mm and the carbonated paste contains large amounts of remaining unhydrated cement grains.

*Figure 3.1. Thin section pictures. On the left side with UV-light and on the right side with crossed polarisers. Carbonated paste on the right side. Picture is 5 mm.*

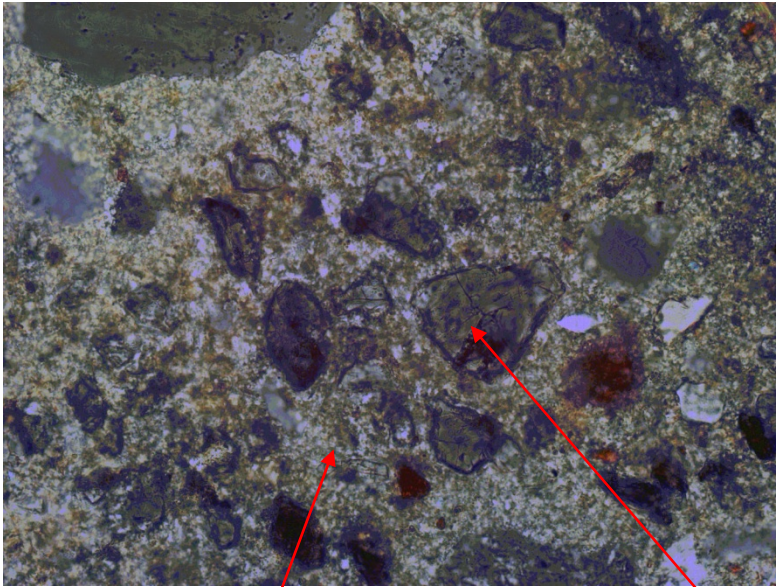
The depth of carbonation varies between 10 and 14 mm. The carbonated paste is more inhomogeneous than uncarbonated. The carbonated cement paste contains remaining cement grains, figure 3.2.

Figure 3.2. Carbonated cement paste with remaining unhydrated cement grains.

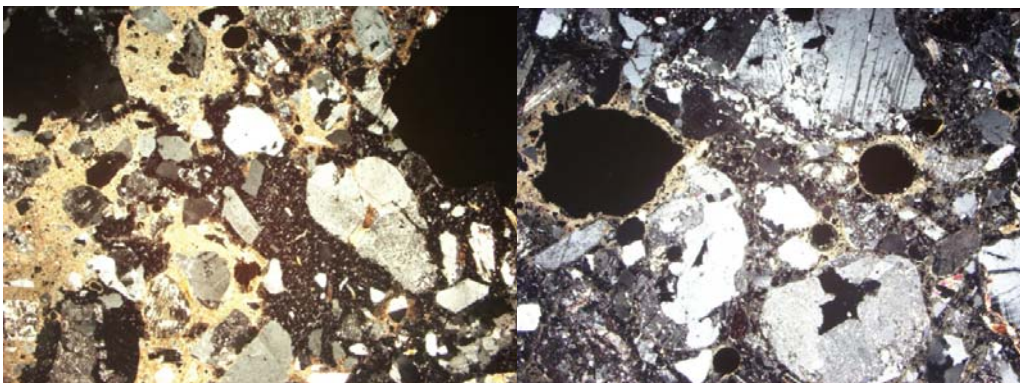
Thin section shows that the w/c equivalent in is 0.55-0.60, figure 4.1. No carbonation below the linoleum carpet. From below, above the capillarity breaking layer, the concrete is carbonated for 5 mm and partly carbonated another 5 mm. It is also possible to observe carbonation at the rim of air bubbles.

*Figure 4.1. Thin section photos. Crossed polarisers. To the left, patchy carbonation front. To the right carbonation at air bubbles.*

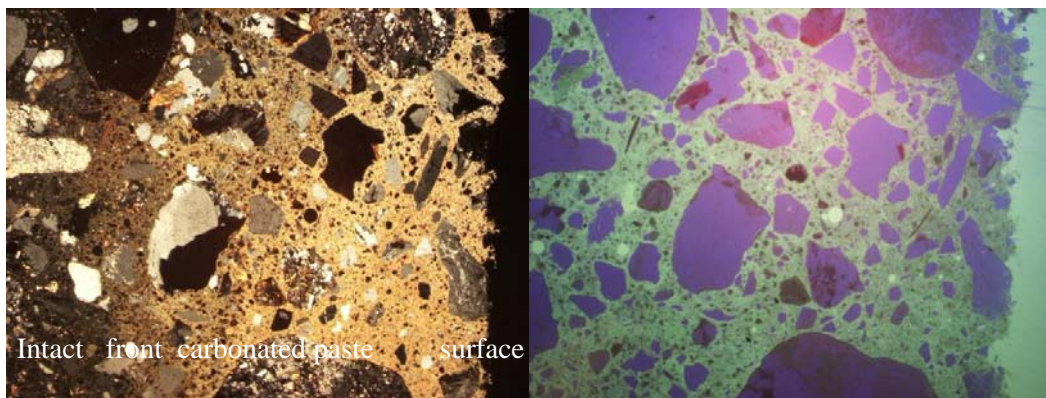
The depth of carbonation is 5-8 mm, figure 5.1. Unhydrated cement grains remains. The concrete contain natural mainly granitic aggregate. The w/c equivalent is around 0.60-0.65. Rather homogeneous.

*Figure 5.1. The picture to the left is with crossed polarizers and show the carbonation front. The picture to the right show the same area is uv-light and indicates a homogeneous paste with no porosity difference over the carbonation front. The pictures are 4.8 mm.*

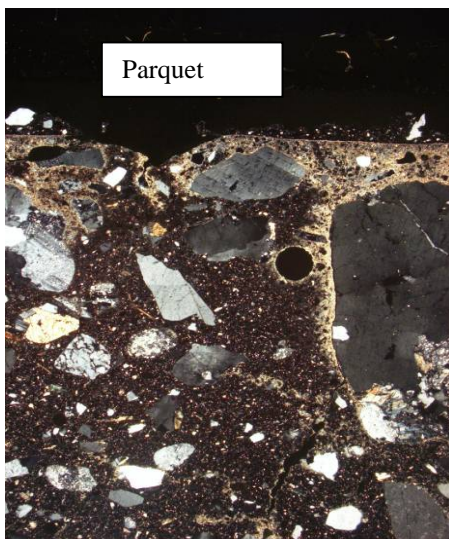
The thin section showed a depth of carbonation of 1-2 mm, figure 5.3. The carbonation is somewhat deeper at cracks and in the interfacial zone between paste and stones.

*Figure 5.3. Concrete under parquet. Crossed polarisers. The lighter colour is carbonation.*
