Self-healing of cracks in concrete exposed to different types of water : effect on chloride penetration

**SELF-HEALING OF CRACKS IN CONCRETE
EXPOSED TO DIFFERENT TYPES OF WATER**

Effect on chloride penetration

ISRN LUTVDG/TVBM--11/3161--SE(1-75)
ISSN 0348-7911 TVBM

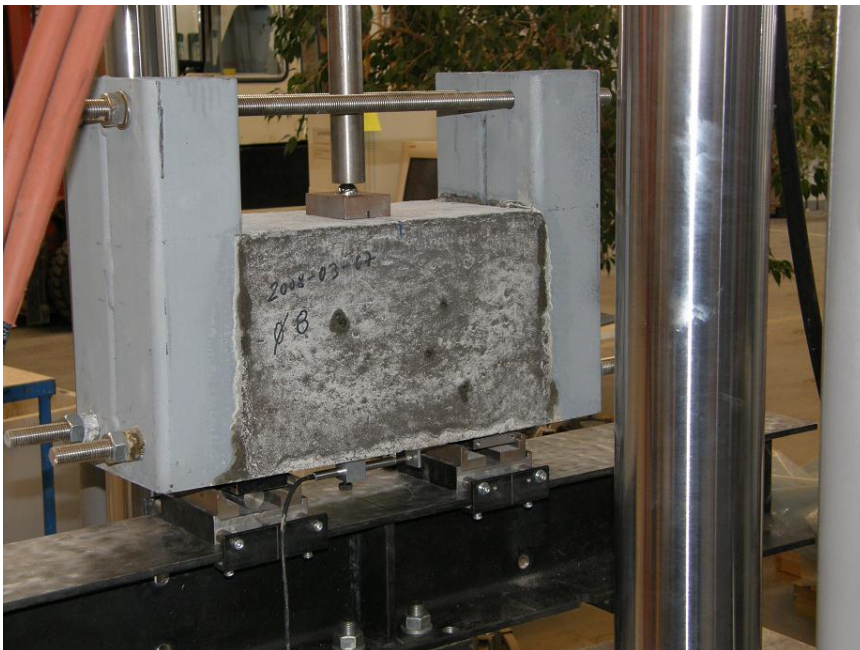
Figure 5.2: Test assembly for creating a crack in the specimen.

Pressure was applied on the upper surface of the specimen at its mid-section. A crack was induced at the notch. Pressure was increased until the extensometers indicated that the crack mouth opening aimed at was reached (0,2 or 0,4 mm). Then, the nuts on the upper threaded bars was tightened and locked by another nut so that the crack was locked. When the pressure was released it was controlled that the crack maintained its initial width and that no relaxation of the crack occurred.

The test arrangement is shown in figure 5.2.

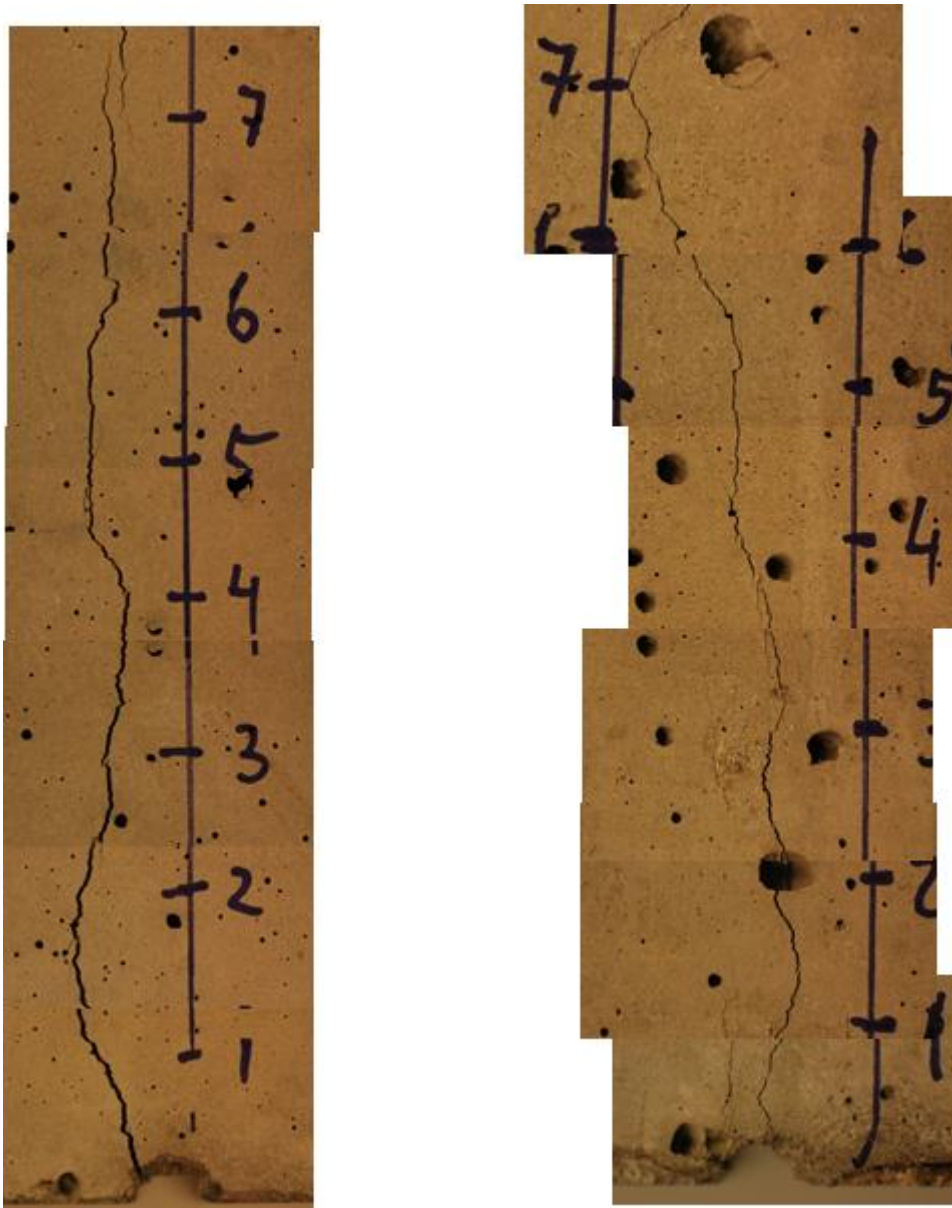
Figure 7.1: Photography of cracks before exposure. 75 mm cover. cm-scale indicated.

Left: Crack width 0.4 mm (specimen H75-4-1-2 left side).

Right: Crack width 0.2 mm (specimen H75-2-1-2 left side).

Photos were taken of the crack before it was sealed, i.e. before the concrete placed in the bath. 5 to 8 photos were taken along the crack on each side of this. Each photo covered about 12 mm of the crack length. Examples of photos of two cracks are shown in figure 7.1.

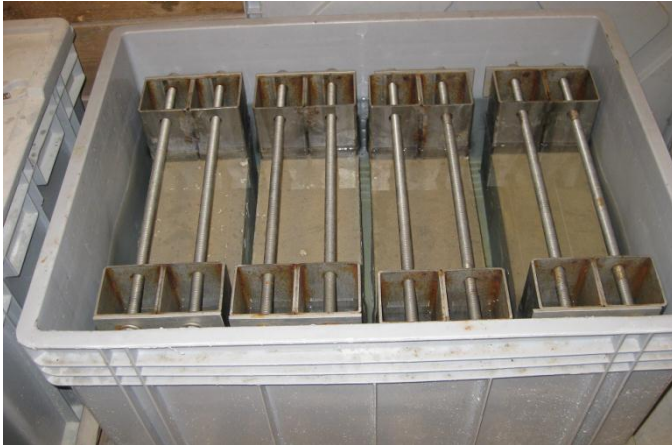
Figure 10.1: Water exposure type 1; permanently under water.

- Type 1: Permanently stored under water. The specimens were completely covered by water during 28 months. A basin with specimens is shown in figure 10.1.
- Type 2: Cyclic. 1 week immersed in water followed by 1 week in lab air. In total 55 cycles.
- Type 3: Water suction from the un-cracked side. The specimens were turned upside down and the un-cracked upper surface was immersed some millimetres in water. Drying in lab-air occurred from the cracked side. The specimens were stored in this way during 28 months. A basin with specimens is shown in figure 10.2.

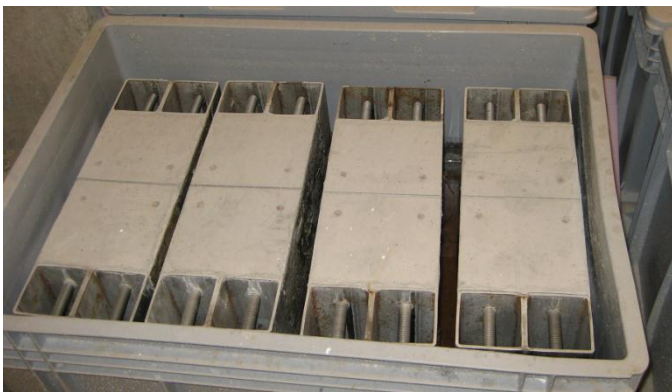
Figure 10.2: Water exposure type 3: Capillary suction from the un-cracked top side.

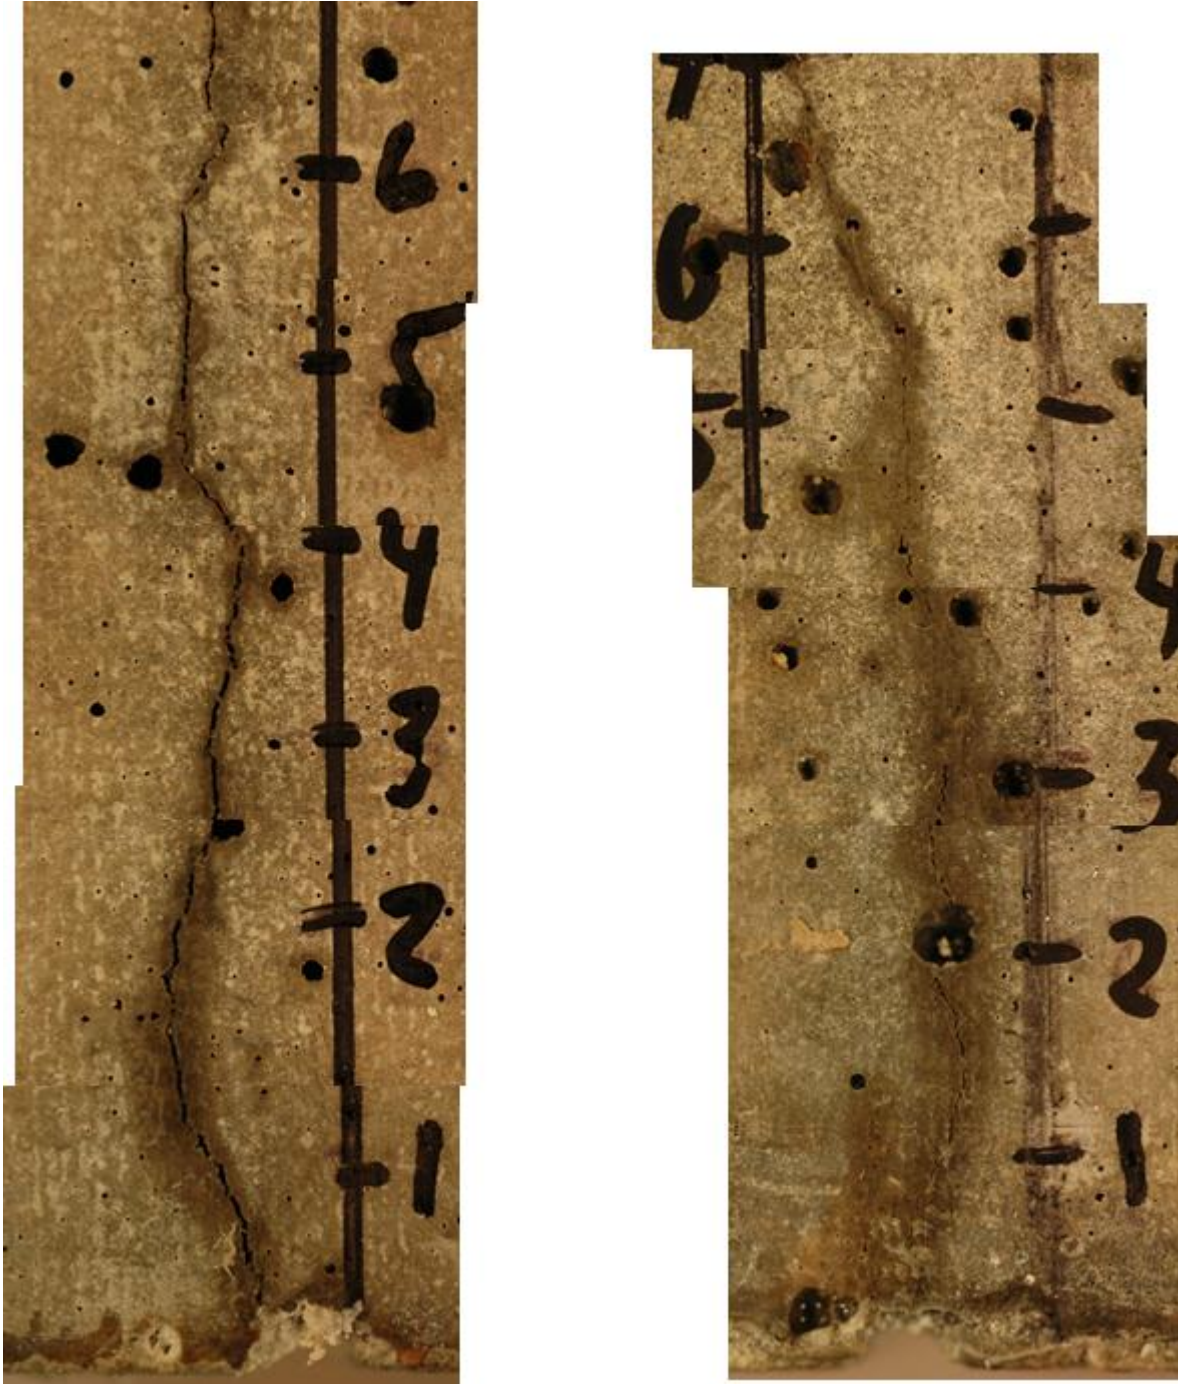
Figure 12.1: Photographs of cracks after exposure. The same specimens as in figure 7.1.

Left: Crack width 0.4 mm (specimen H75-4-1-2 left side).

After about one year exposure the crack seal was removed. Thereafter photos of the cracks were taken in the same manner as before exposure. Examples of photos are given in figure 12.1 which shows the same cracks as are shown in figure 7.1 before exposure. There is a clear indication of healing, particularly for the thinner crack, which seems to be almost completely healed on 2 cm from the crack tip.

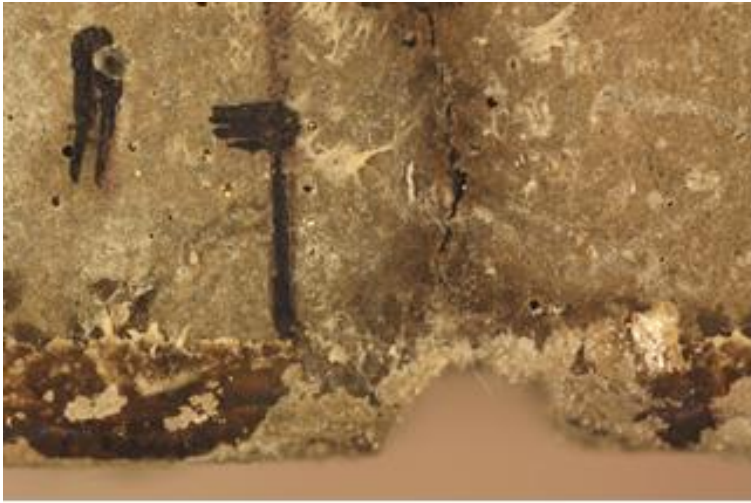
Permanent immersion
H75-2-1-2

Water suction from the
un-cracked side
H75-2-3-2

Figure 12.2: 0.2 mm crack after 28 month exposure to sea water. Concrete cover 75 mm.

Magnifications of photos of the lowest part of the crack after 28 month exposure for all 16 specimens are shown in figure 12.2-12.7. Only one side of the specimens is shown. The other side is similar to the side shown.

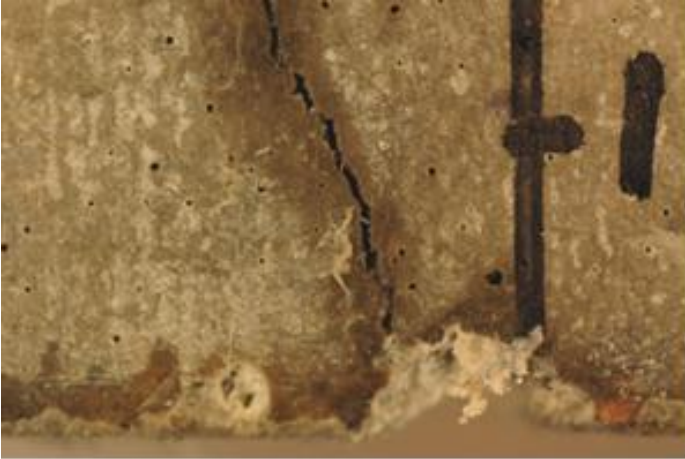
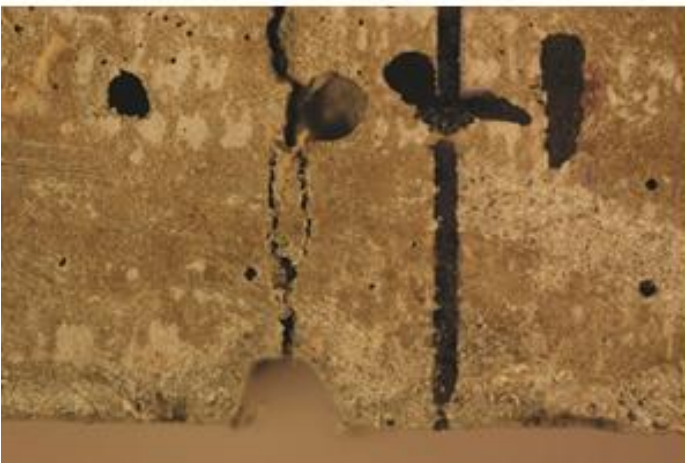
Permanent immersion
H75-4-1-2

Water suction from the
Un-cracked side
H75-4-3-2

Figure 12.3: 0.4 mm crack after 28 month exposure to sea water. Concrete cover 75 mm.

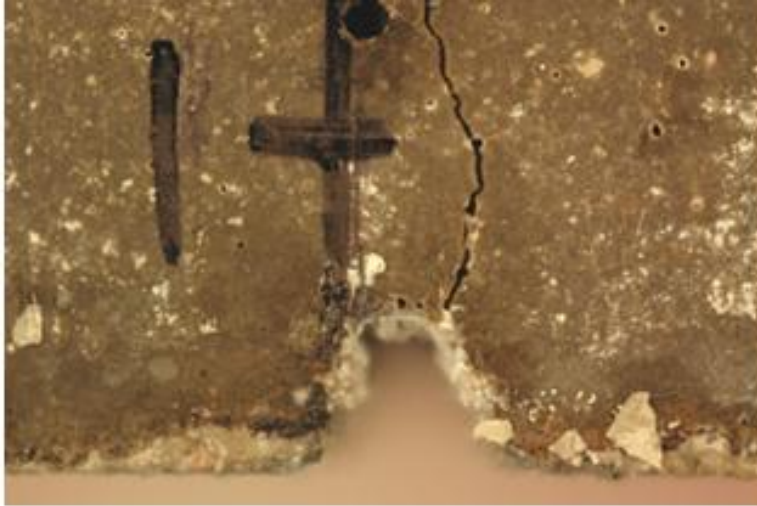
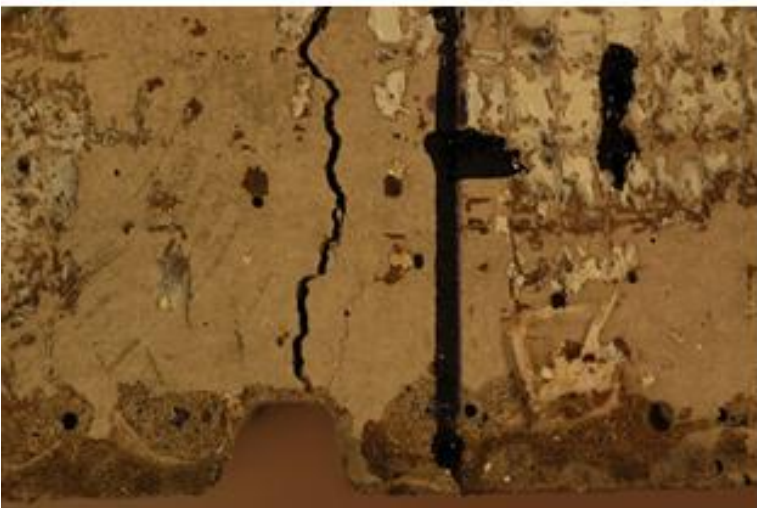
Permanent immersion
H55-2-1-2

Water suction from
the un-cracked side
H55-2-3-2

Figure 12.4: 0.2 mm crack after 28 month exposure to sea water. Concrete cover 55 mm.

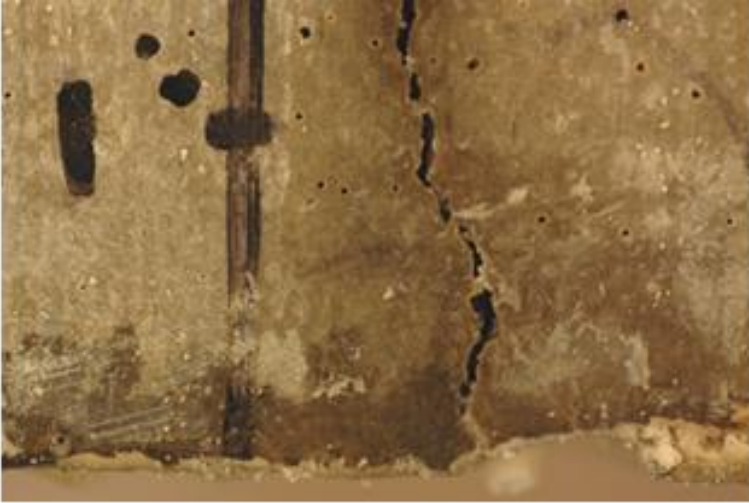
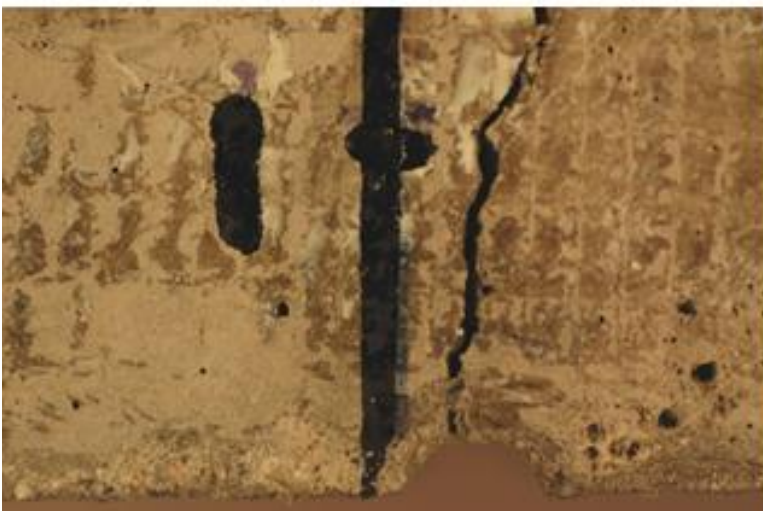
Permanent immersion
H55-4-1-2

Water suction from the
un-cracked side
H55-4-3-2

Figure 12.5: 0.4 mm crack after 28 month exposure to sea water. Concrete cover 55 mm.

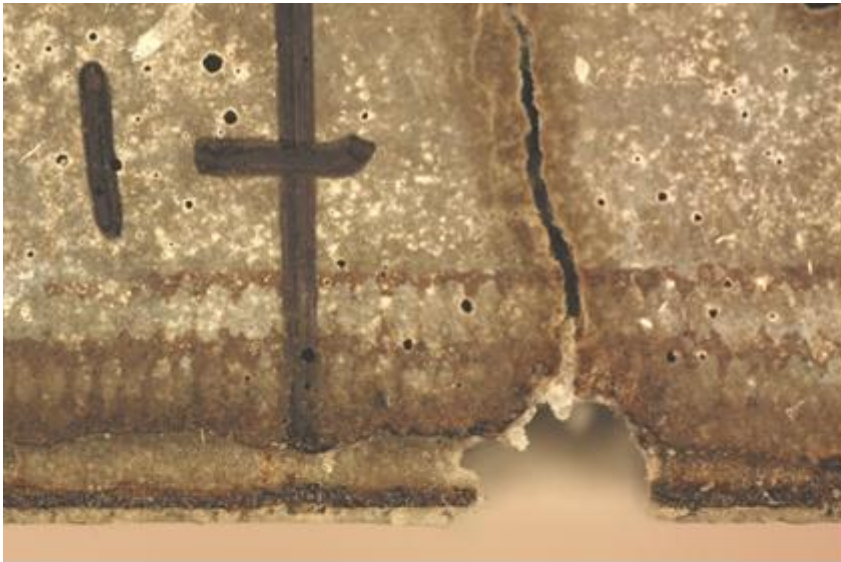
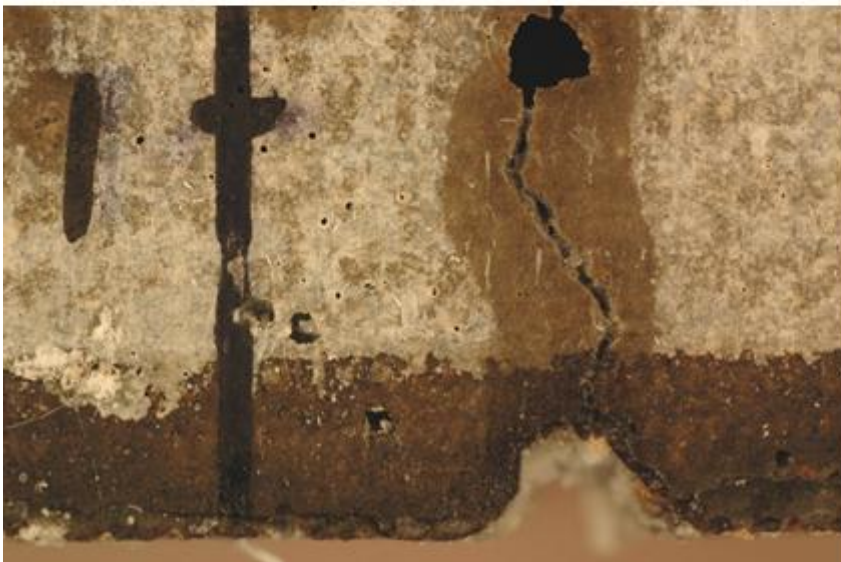
Permanent immersion
S175-4-1-2-Ö

Permanent immersion
S155-4-1-2-Ö

*Figure 12.6: 0.4 mm crack after 28 month permanent exposure to brackish water.
Upper: 75 mm cover. Lower: 55 mm cover*

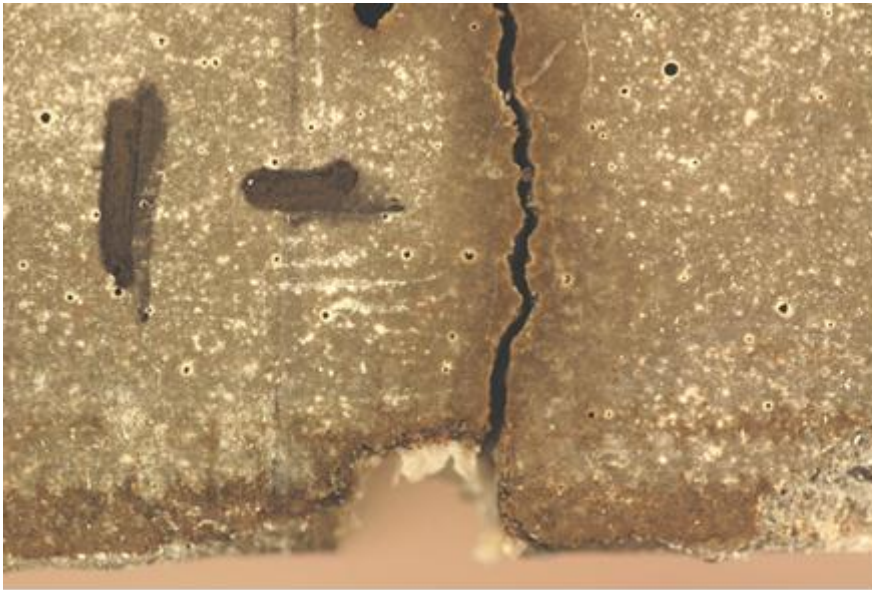
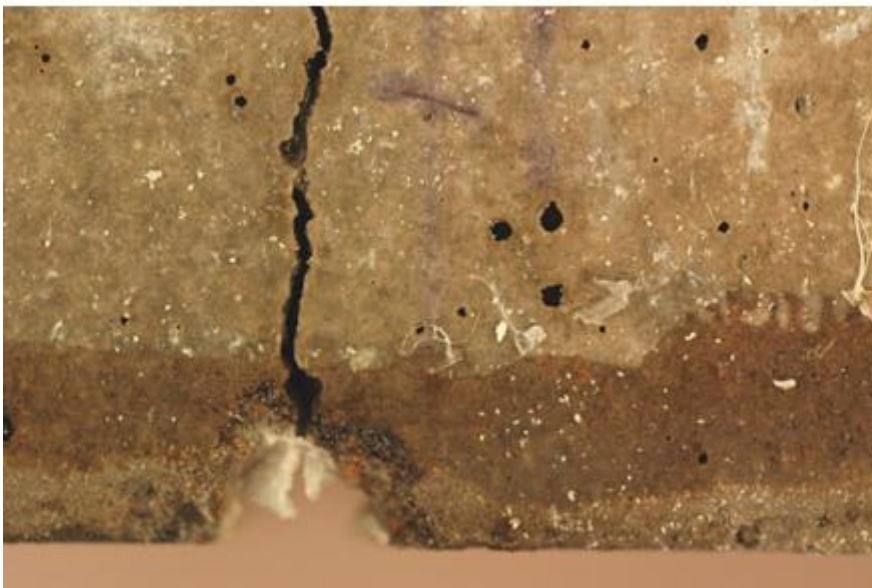
Permanent immersion
S175-4-1-2-R

Permanent immersion
S155-4-1-2-R

*Figure 12.7: 0.4 mm crack after 28 month permanent exposure to pure water.
Upper: 75 mm cover. Lower 55 mm cover.*

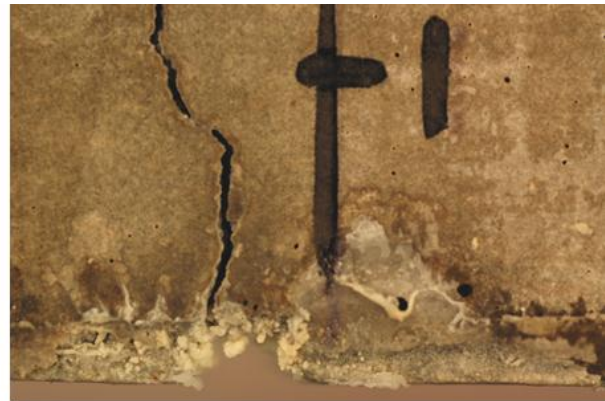
28 month exposure
Specimen H75-4-2-2

Figure 13.6: Crack width 0.4 mm. Cover 75 mm. Cyclic immersion in sea water for 12 and 28 months.

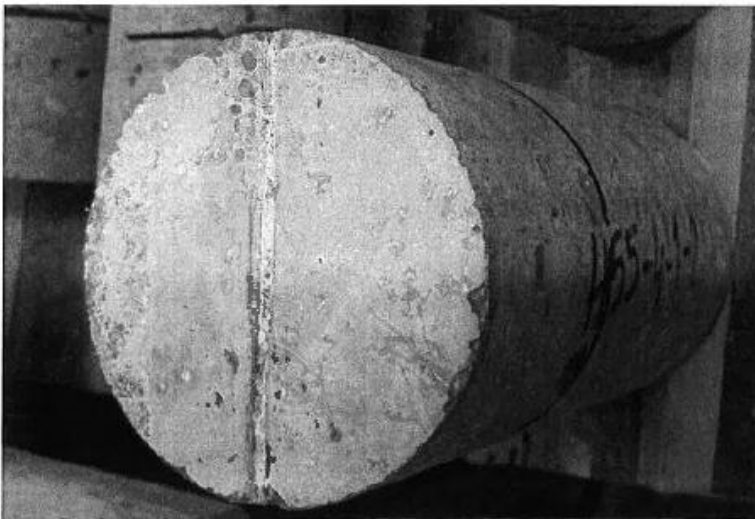
Figure 14.2: Example: core drilled out from specimen H55-4-1-2 (55 mm cover, crack width 0.4 mm, permanently exposed to pure water).

After terminated exposure a 10 cm core was drilled centrally in the specimen from its bottom side along the crack. Drilling was made with water-cooled drill. An example of the specimen after drilling is shown in figure 14.1. An example of a drilled-out core is shown in figure 14.2.

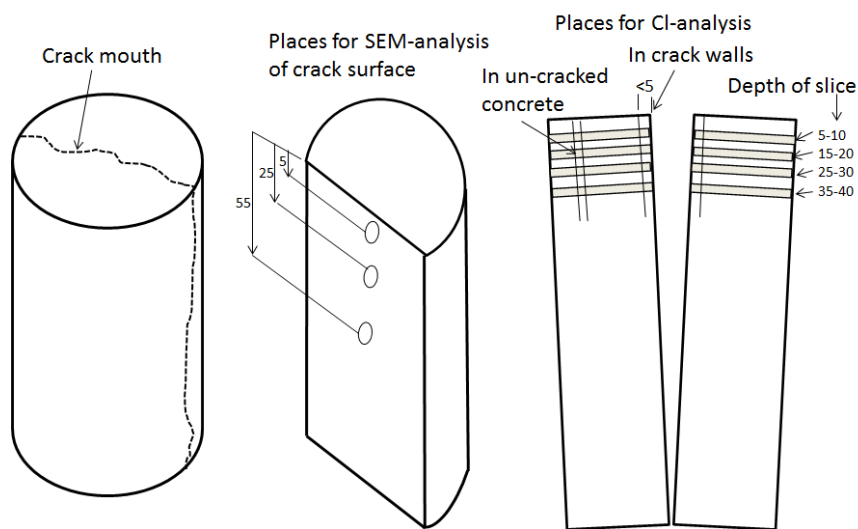
Figure 15.1: Core and places where samples were taken from the crack walls.

Location of the test areas are shown in figure 15.1.

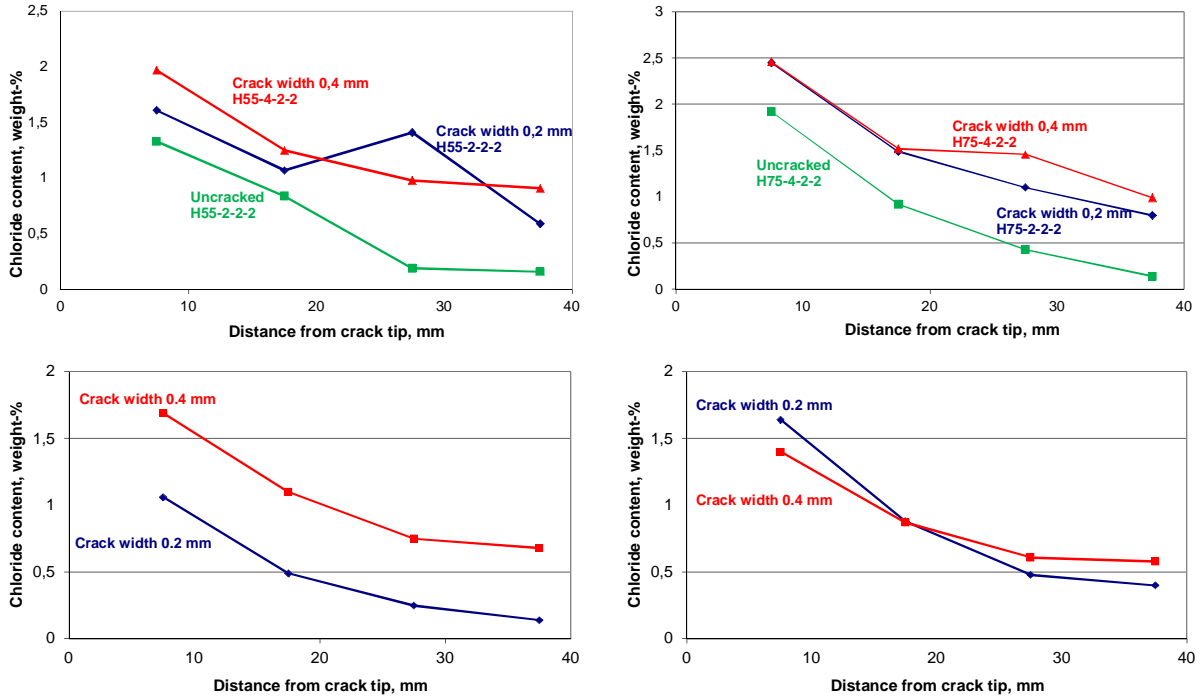
Figure 15.8: Chloride content in crack wall. Cyclic immersion and drying in sea-water. Upper row: 28 months exposure. Lower row: 1 year exposure. Left column: 55 mm cover. Right column: 75 mm cover.

The results for exposure types 1 and 2 are shown in figure 15.7-15.10. In these figures comparisons are also made with the chloride profiles observed after 1 year exposure copied from report (1).

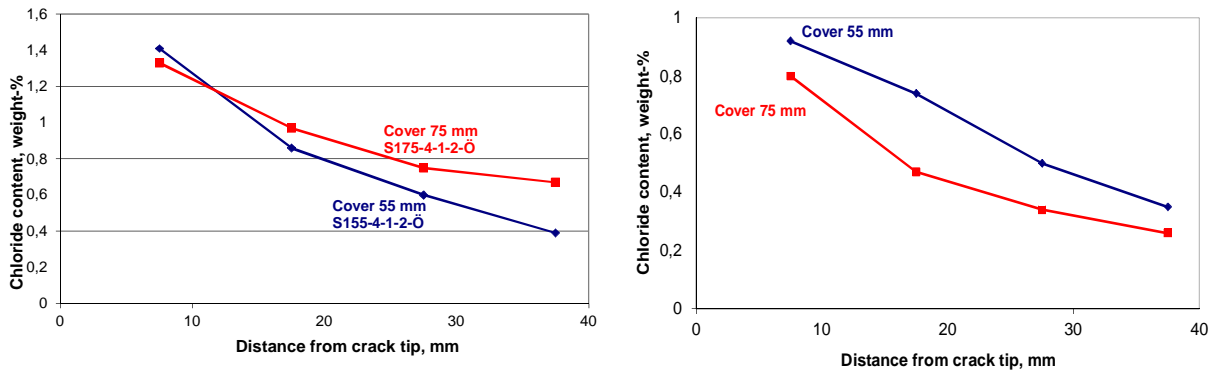
Figure 15.9: Chloride content in crack wall. Permanently immersed in brackish water. Effect of cover. Crack width 0,4 mm. Left: 28 month exposure. Right: 1 year exposure.

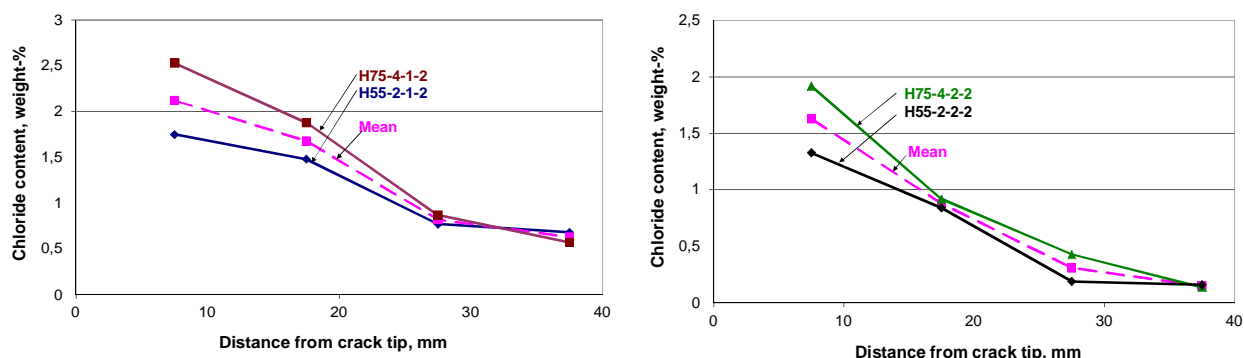
Figure 15.10: Chloride content in un-cracked concrete. 28 month exposure.
Left: Permanent in sea-water. Right: Cyclic in sea-water and drying.

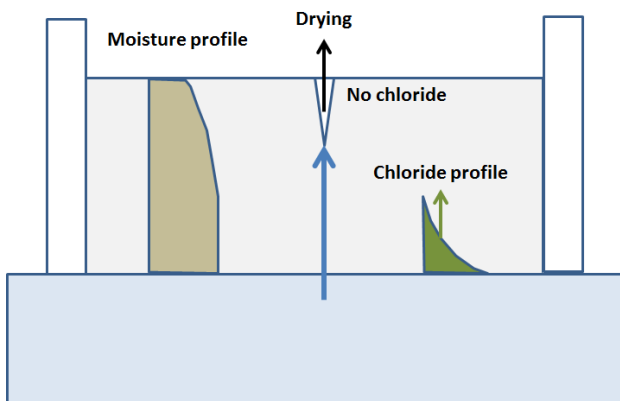
Figure 15.11: Exposure type 3. Moisture and chloride distribution, principally.

6. *Specimens exposed to water suction from the un-cracked side*
 No chloride (<0,03%) could be detected in the crack which shows that the upper part of the concrete specimen had been so dry that chloride transport could not take place. This is illustrated by Figure 15.11.

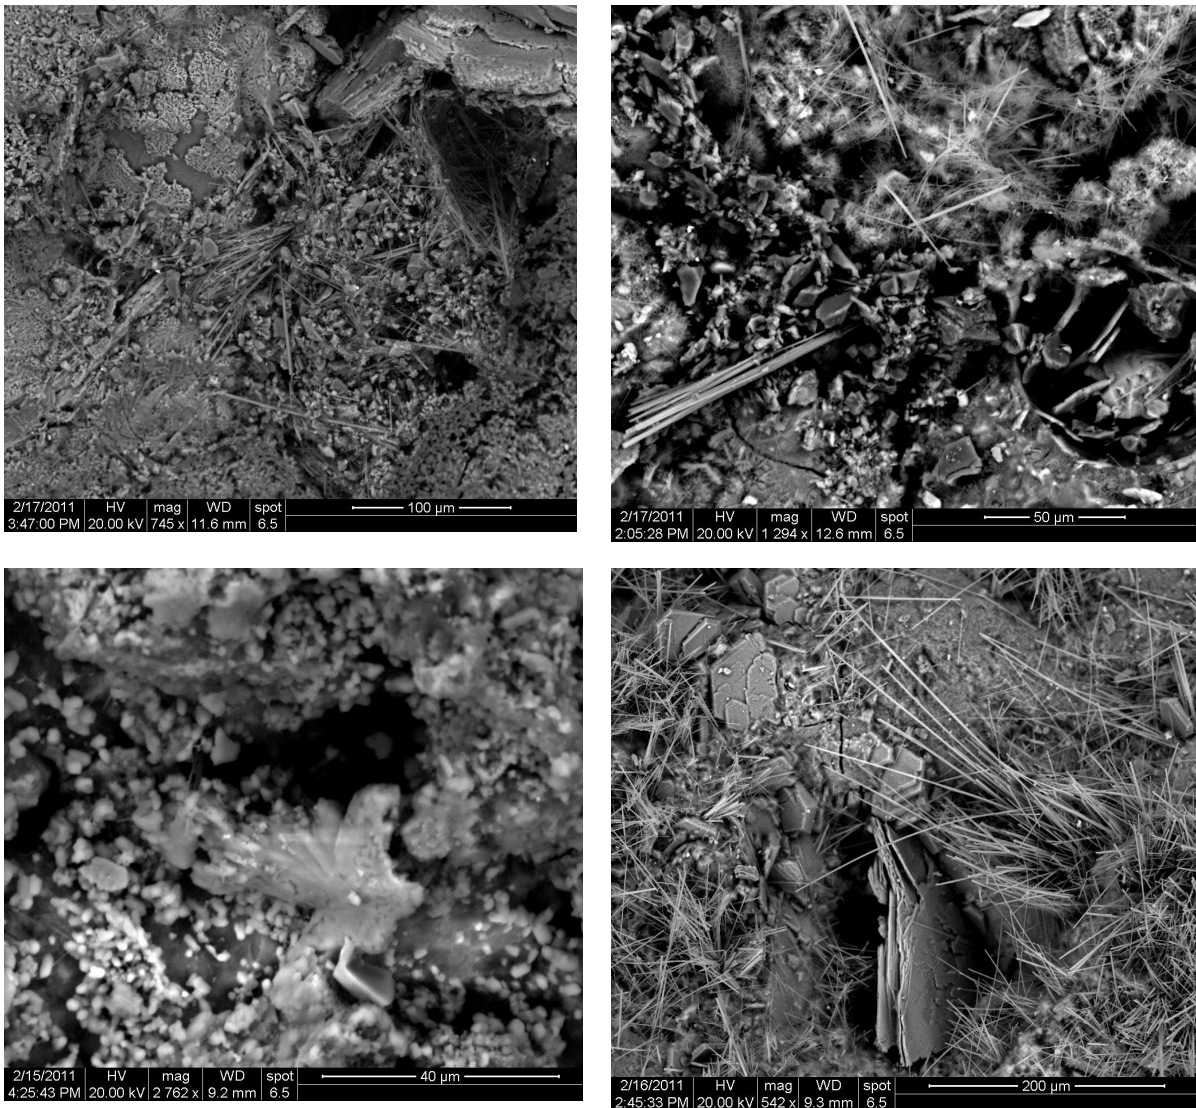
Figure A3.1: Specimens stored permanently in sea water. Cover 55 mm.

Left column: 5 mm from crack mouth.

Lower row: Crack width 0.4 mm; Specimen H55-4-1-2.

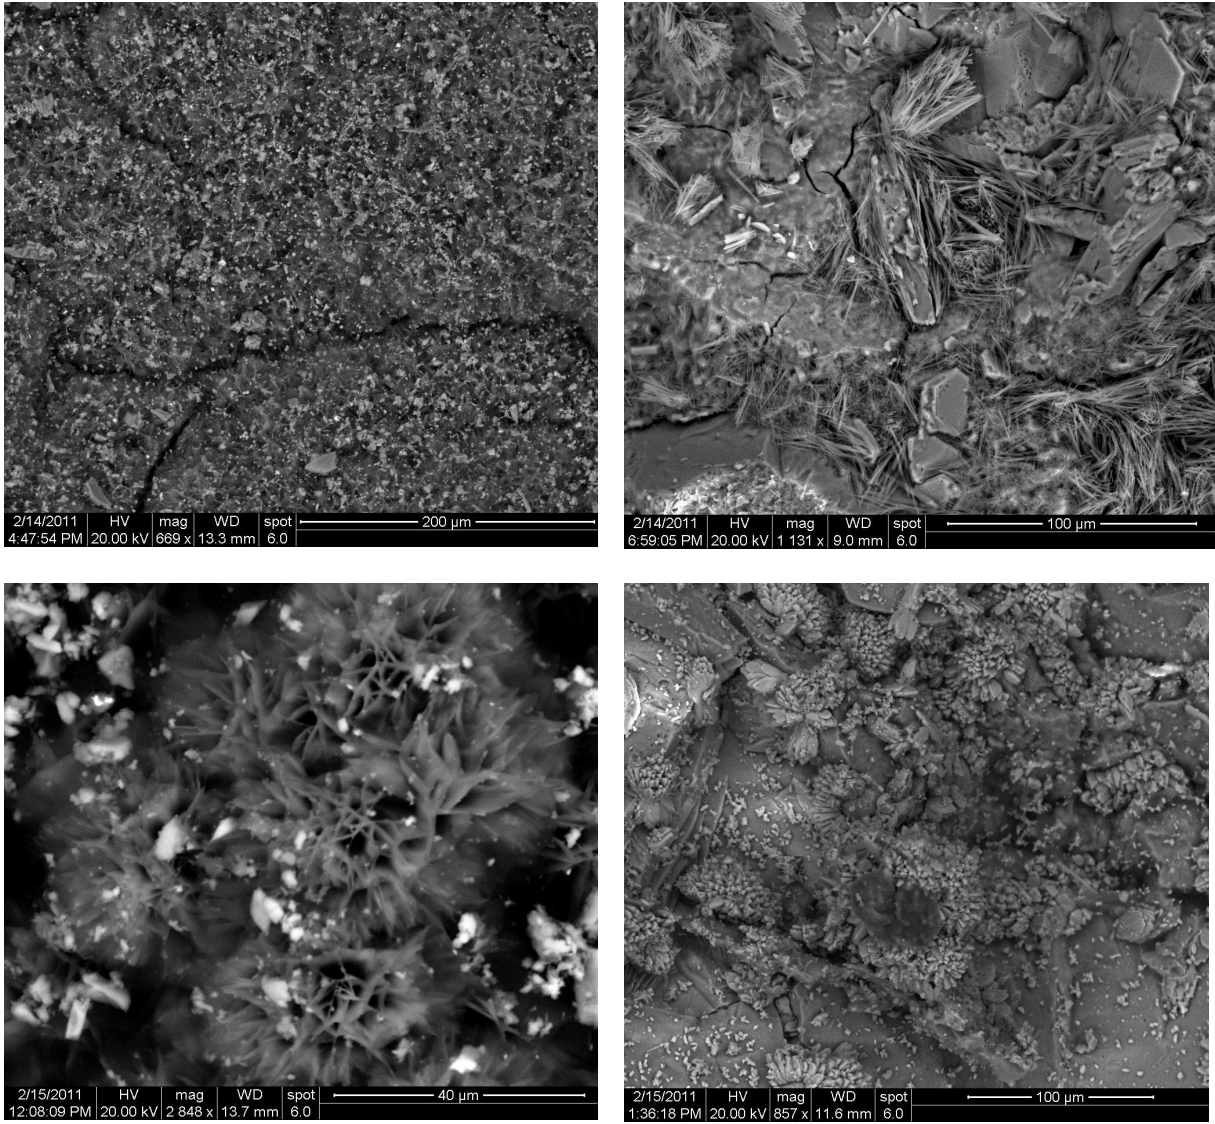
Figure A3.2: Specimens cyclically exposed to sea water and drying. Cover 55 mm.

Left column: 5 mm from crack mouth.

Lower row: Crack width 0.4 mm; Specimen H55-4-2-2.

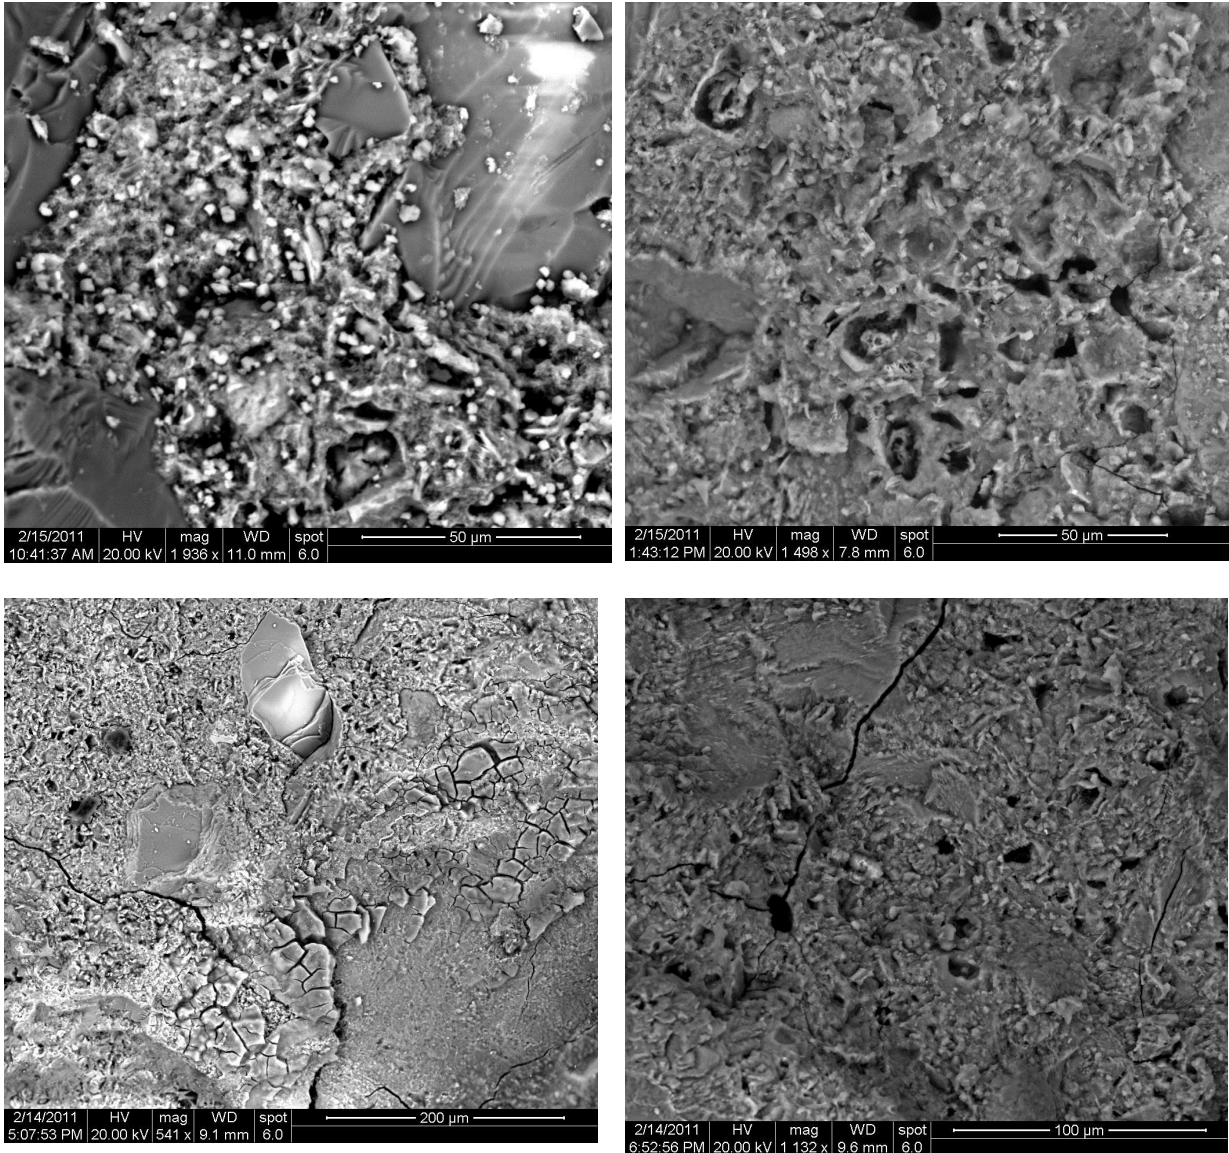
*Figure A3.3: Specimens exposed to water suction from the un-cracked side. Cover 55 mm.
 Left column: 5 mm from crack mouth.
 Right column: 50 mm from crack mouth.
 Upper row: Crack width 0.2 mm; Specimen H55-2-3-2.
 Lower row: Crack width 0.4 mm; Specimen H55-4-3-2.*

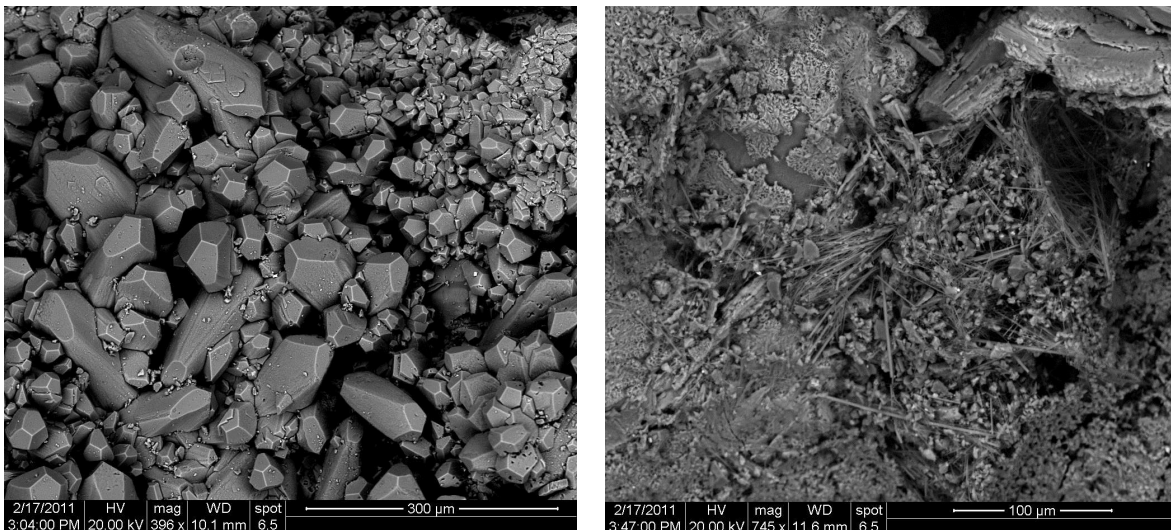
*Figure A3.5: Specimens stored permanently in pure water. Cover 55 mm.
 Left column: 5 mm from crack mouth.
 Right column: 50 mm from crack mouth.
 Crack width 0.4 mm; Specimen S155-4-1-2-R.*
