Self-healing of cracks in concrete exposed to different types of water : effect on chloride penetration

**SELF-HEALING OF CRACKS IN CONCRETE
EXPOSED TO DIFFERENT TYPES OF WATER**

Effect on chloride penetration

ISRN LUTVDG/TVBM--11/3161--SE(1-75)
ISSN 0348-7911 TVBM

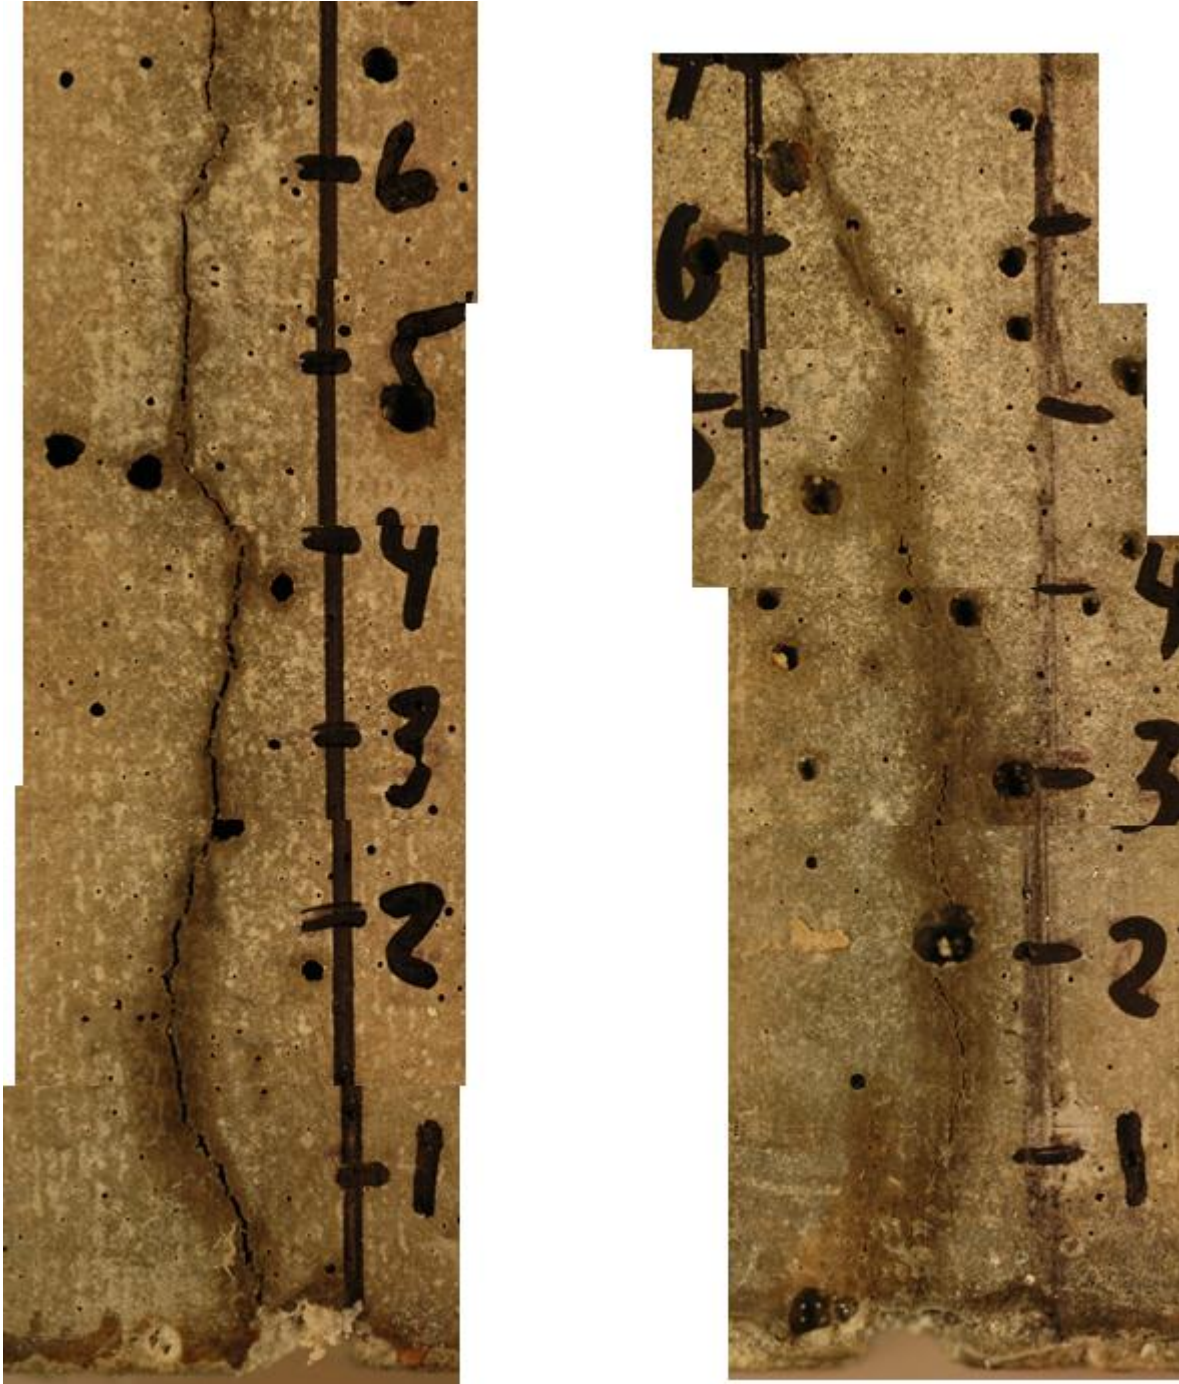
Figure 12.1: Photographs of cracks after exposure. The same specimens as in figure 7.1.

Left: Crack width 0.4 mm (specimen H75-4-1-2 left side).

Right: Crack width 0.2 mm (specimen H75-2-1-2 left side).

After about one year exposure the crack seal was removed. Thereafter photos of the cracks were taken in the same manner as before exposure. Examples of photos are given in figure 12.1 which shows the same cracks as are shown in figure 7.1 before exposure. There is a clear indication of healing, particularly for the thinner crack, which seems to be almost completely healed on 2 cm from the crack tip.

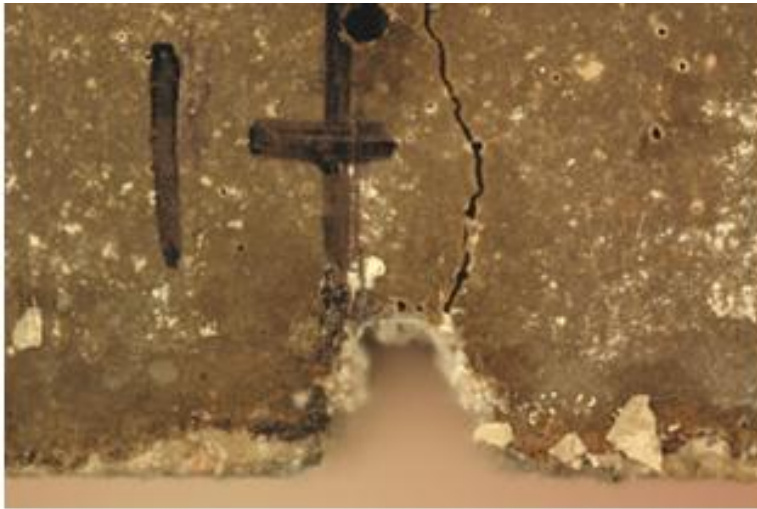
Permanent immersion
H55-2-1-2

Water suction from
the un-cracked side
H55-2-3-2

Figure 12.4: 0.2 mm crack after 28 month exposure to sea water. Concrete cover 55 mm.

Magnifications of photos of the lowest part of the crack after 28 month exposure for all 16 specimens are shown in figure 12.2-12.7. Only one side of the specimens is shown. The other side is similar to the side shown.

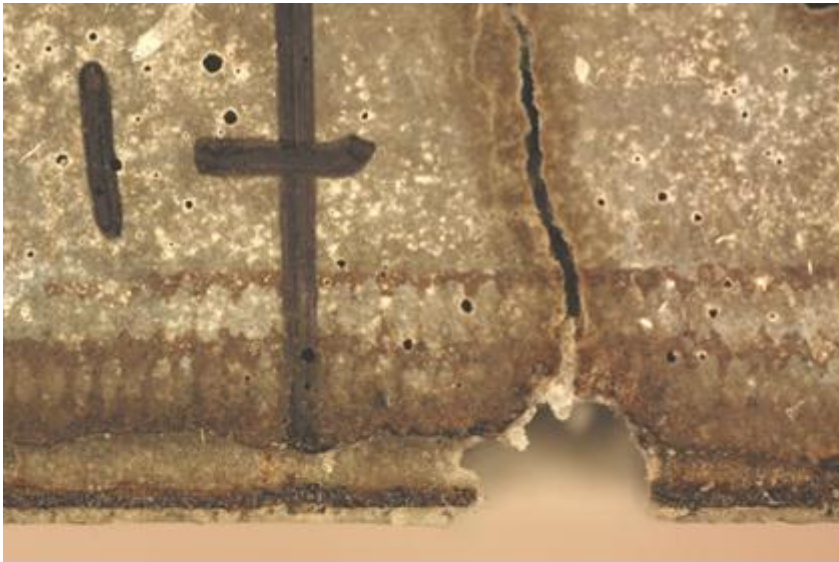
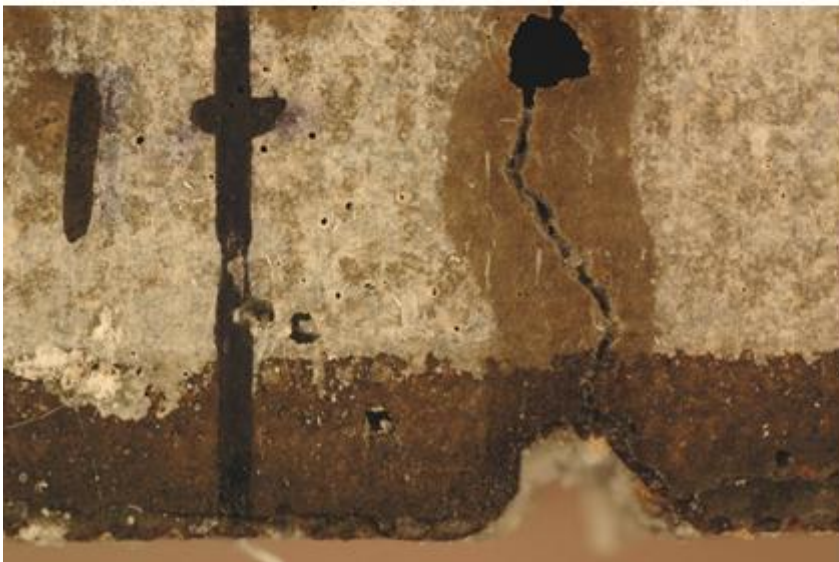
Permanent immersion
S175-4-1-2-Ö

Permanent immersion
S155-4-1-2-Ö

*Figure 12.6: 0.4 mm crack after 28 month permanent exposure to brackish water.
Upper: 75 mm cover. Lower: 55 mm cover*

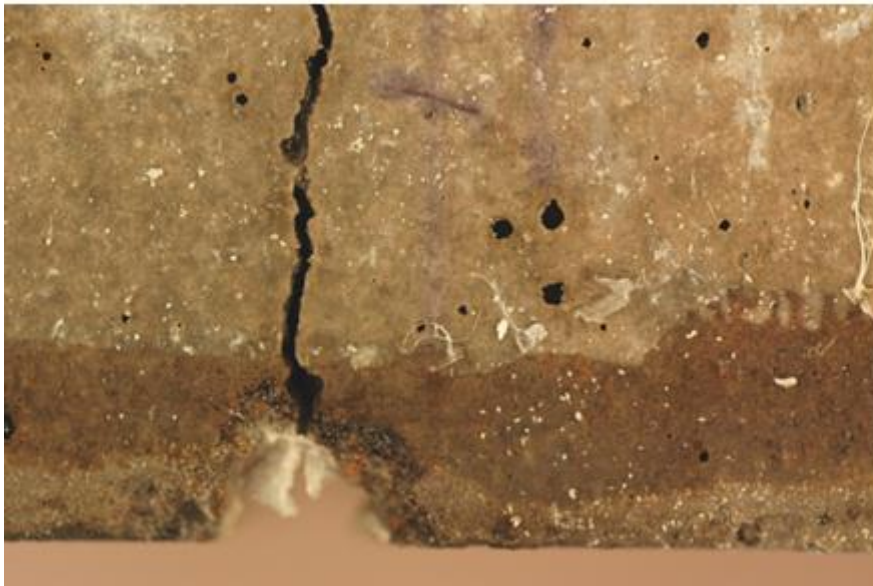
Permanent immersion
S175-4-1-2-R

Permanent immersion
S155-4-1-2-R

*Figure 12.7: 0.4 mm crack after 28 month permanent exposure to pure water.
Upper: 75 mm cover. Lower 55 mm cover.*
