The effect of defects at the steel - concrete interface, exposure regime and cement type on pitting corrosion in concrete

Sandberg, Paul

1998

ISRN LUTVDG/TVBM--98/3081--SE(1-18)
ISSN 0348-7911 TVBM

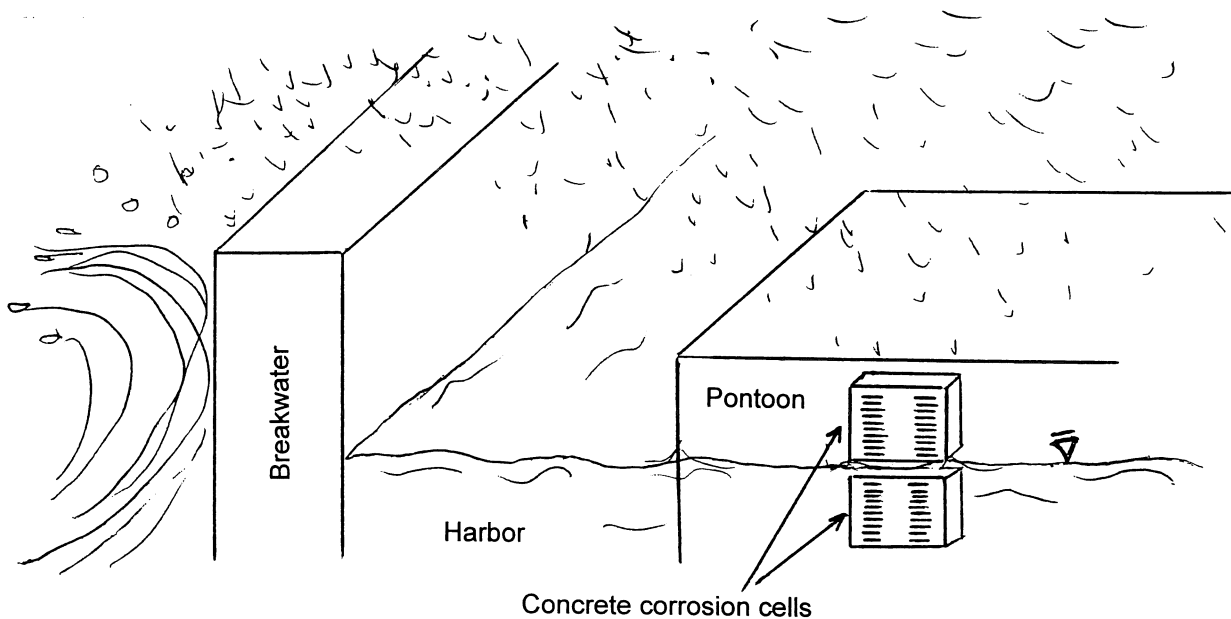
Figure 3. Exposure conditions for corrosion cells at the Träslövsläge Marine Field Station.

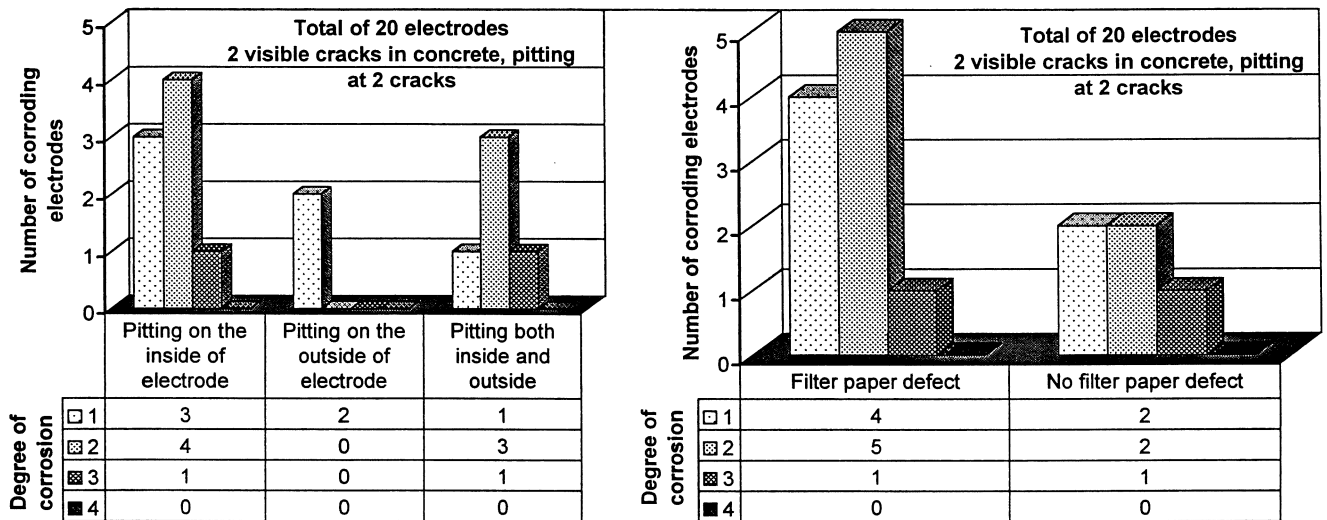
Figure 4. Presentation of results on the effect of defects on the location and size of corrosion pits.

The effect of defects was evaluated from the following indications:

- B) The presence of corrosion pits in electrodes with artificial filter paper defects at the steel - concrete interface, relative to the presence of pits in electrodes without filter paper defects.
- C) The presence of visible compaction voids or cracks at the steel - concrete interface.

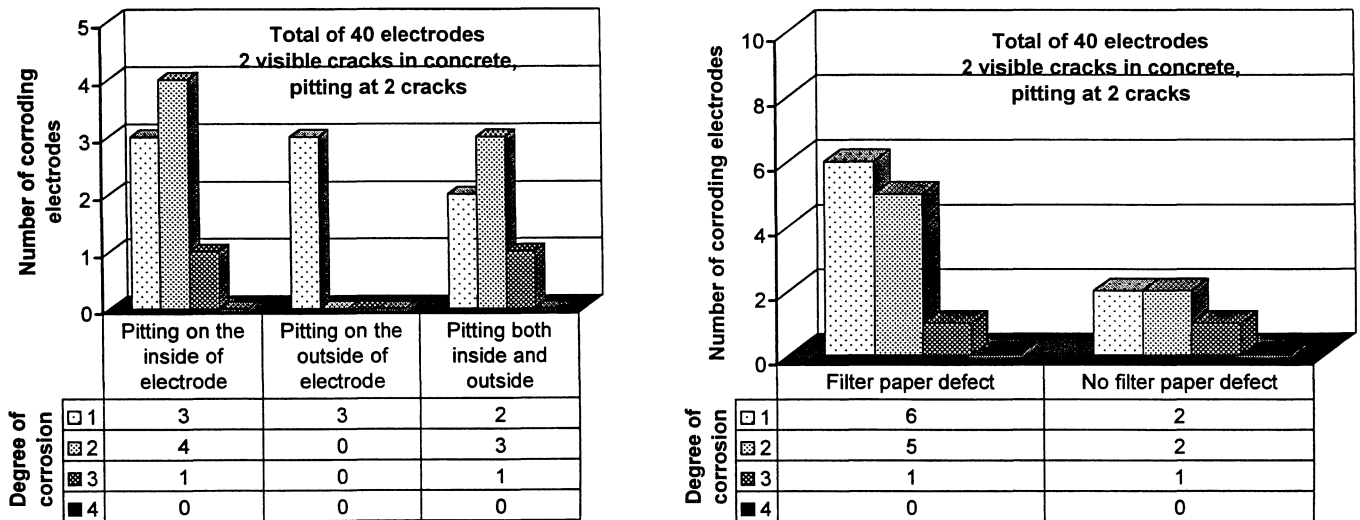
Figure 7. Evaluation of the location of corrosion pits in concrete w/c 0.4 exposed for 2 years in the splash zone at the Träslövsläge Marine Field Station.

17 of 40 electrodes started to corrode in the splash zone within 2 years of field exposure, Figure 7. 15 of the 17 corroding electrodes were found in slag cement concrete, with active corrosion in all electrodes with filter paper defects and / or compaction voids close to the steel surface. 5 of 10 electrodes in slag cement concrete without filter paper defects, voids or cracks were also corroding.

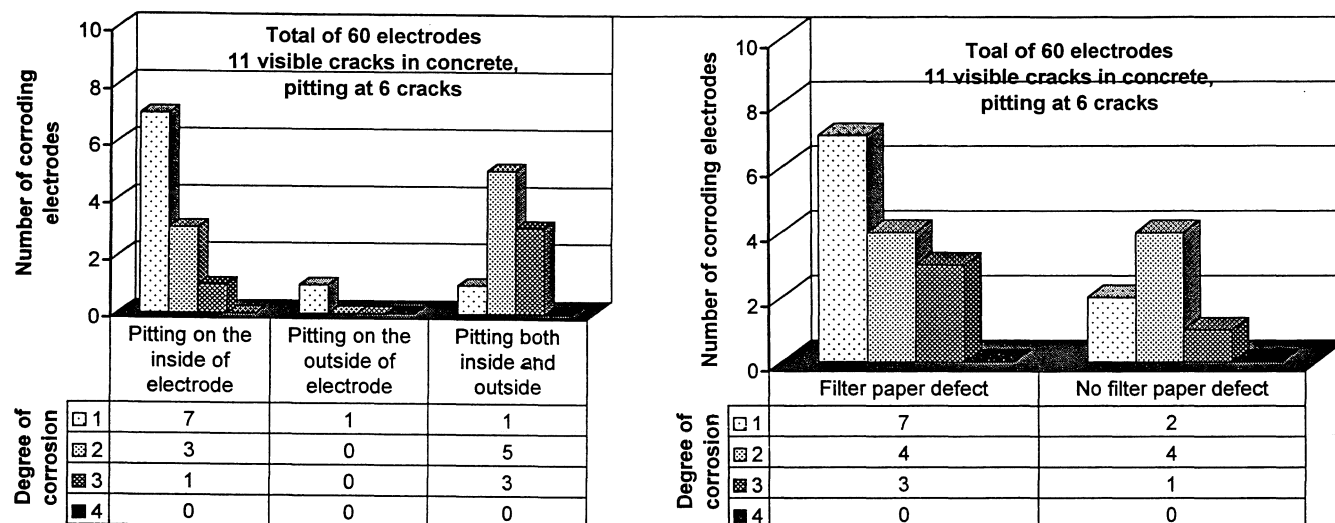
Figure 8. Evaluation of the location of corrosion pits in concrete w/c 0.4 exposed for 2 years in the submerged zone at the Träslövsläge Marine Field Station.

11 of 60 electrodes started to corrode in the submerged zone within 2 years of field exposure, Figure 8. 8 of the 11 corroding electrodes were found in slag cement concrete, with active corrosion in 7 of 12 electrodes with filter paper defects and / or compaction voids close to the steel surface. 1 of 8 electrodes in slag cement concrete without filter paper defects, voids or cracks was also corroding.

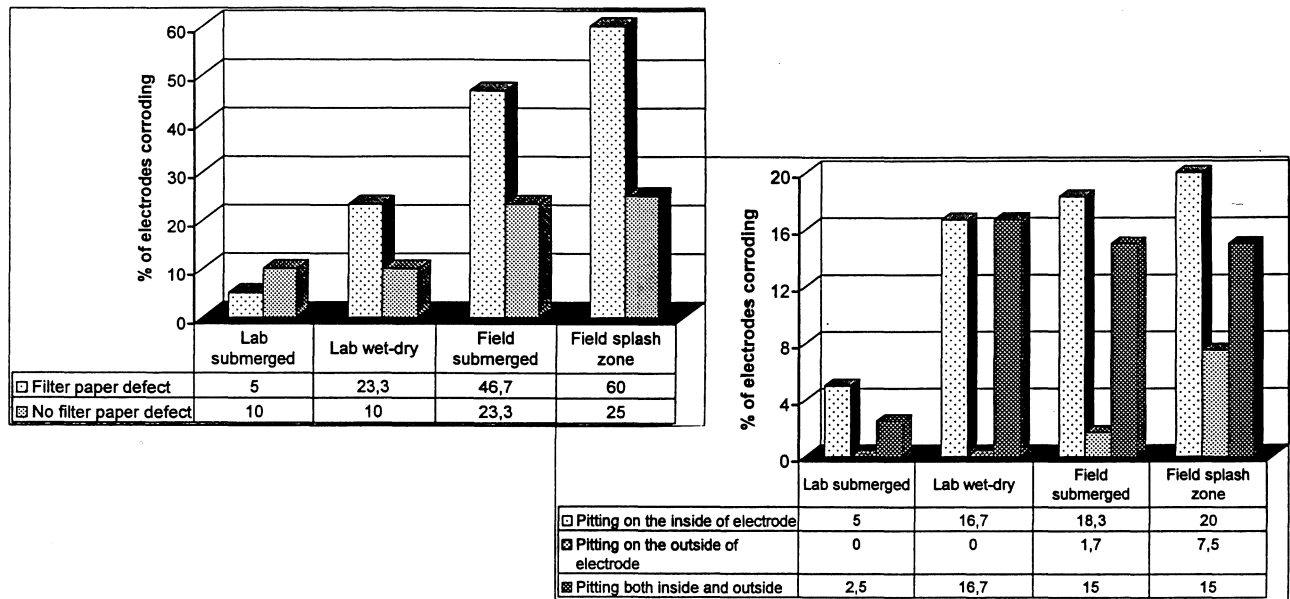
Figure 9. The effect of exposure regime on the corrosion activity for all concrete with w/c 0.40.

An evaluation of the effect of the exposure regime is presented in Figure 9. Concrete w/c 0.40 with plain sulfate resisting portland cement, sulfate resisting portland cement and 5 % silica fume, or slag cement were exposed to all exposure regimes. Figure 9 shows the percentage of electrodes corroding with pitting on the inside of electrodes, on the outside of electrodes, or with pitting on both the inside and the outside of electrodes.

As indicated in Figure 9, the corrosion activity was generally found to be very low in concrete exposed submerged in the laboratory at +5 °C or at room temperature, as compared to concrete exposed in all other exposure regimes. The results from wetting and drying in the laboratory at room temperature seems to be more representative for the field performance as compared to concrete exposed submerged in the laboratory at +5 °C or at room temperature.

The incorporation of artificial filter paper defects at the steel – concrete interface had a strong negative effect on the resistance to corrosion. except for electrodes in concrete exposed submerged in the laboratory, as shown in Figure 9.

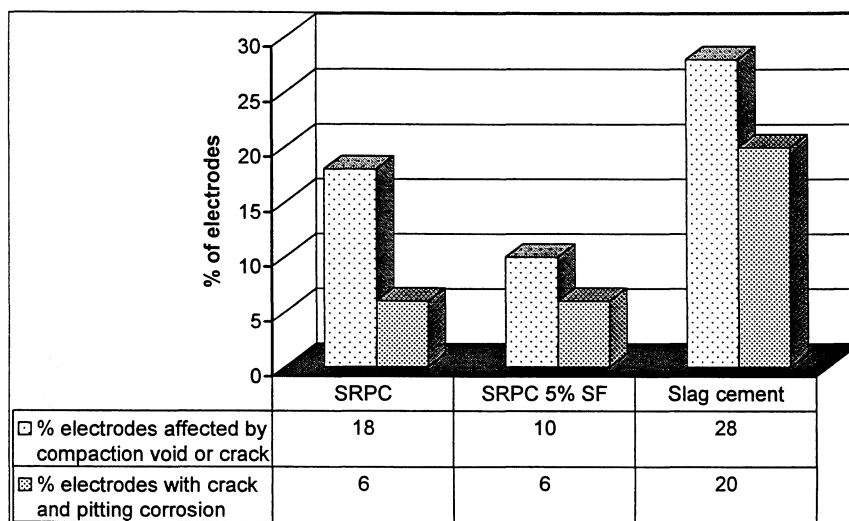
Figure 11. The effect of binder composition and compaction voids or cracks at the steel – concrete interface on the resistance to pitting corrosion

34 of a total of 210 examined electrodes in all concrete exposed exhibited evidence on visible compaction voids or cracks at the steel surface. 16 electrodes or approximately 50 % of the electrodes with visible compaction voids or cracks at the steel surface also experienced pitting corrosion. However, only approximately 25 % of the electrodes with visible compaction voids or cracks at the steel surface corroded in concrete exposed submerged in the laboratory.

The effect of microstructural defects in the concrete seems to be far more important in concrete exposed to moisture- and temperature variations, as compared to concrete submerged at a constant temperature in the laboratory. The visible compaction voids or cracks and the artificially produced filter paper defects at the steel surface had relatively little effect on the resistance to corrosion initiation in concrete submerged at a constant temperature in the laboratory. These findings support the idea that it is not the defects, but the effects of the defects on the moisture variations at the depth of the reinforcement, and the temperature variations, which control the chloride threshold. The positive effect of introducing silica fume seems to be related to the improvement of the homogeneity and the reduced permeability of the cover, which in turn reduces the moisture variations at the depth of the reinforcement. This effect can of course also be achieved by increasing the cover thickness or by lowering the w/c ratio.
