The effect of defects at the steel - concrete interface, exposure regime and cement type on pitting corrosion in concrete

Sandberg, Paul

1998

ISRN LUTVDG/TVBM--98/3081--SE(1-18)
ISSN 0348-7911 TVBM

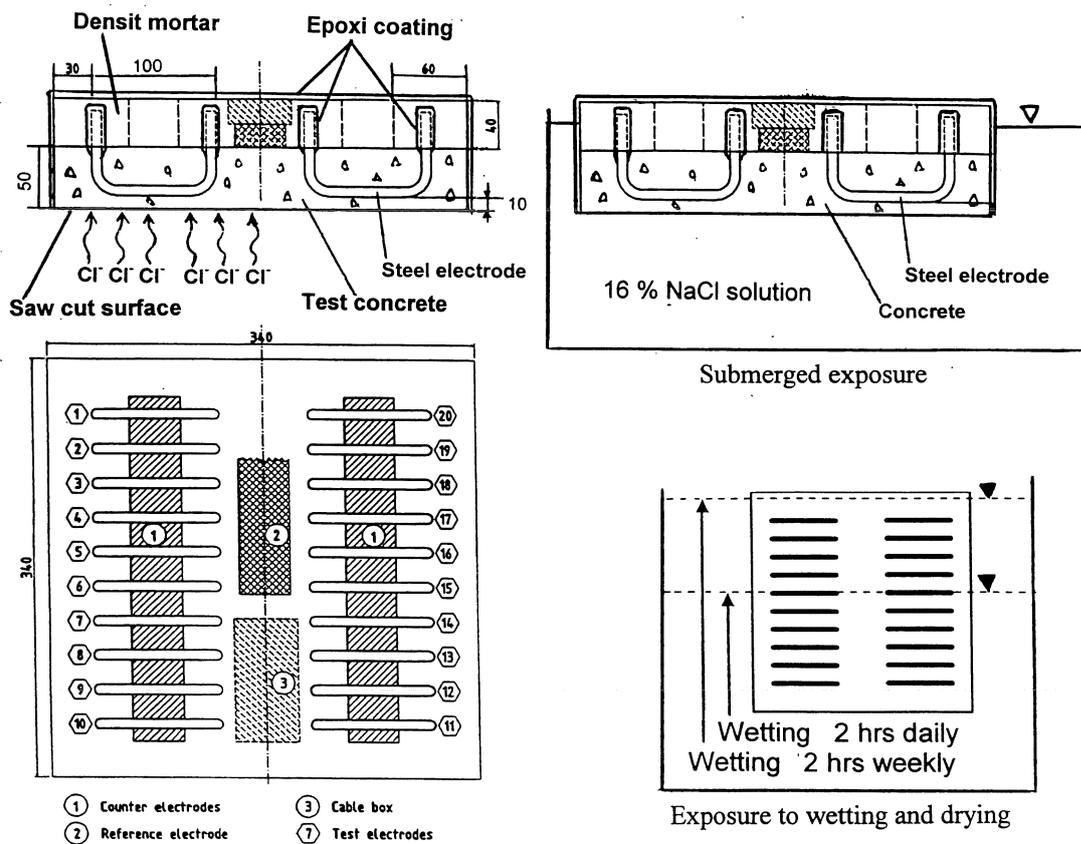
Figure 1. Standard corrosion cell. All measures are given in millimetres [11].

The U-shaped steel electrodes have epoxy coated legs facing away from the exposed surface in order to prevent corrosion initiation on the legs. The MnO_2 reference electrode and the titanium mesh counter electrode were cast into mortar bars before assembling the standard unit. The design minimises errors due to IR-drops in the test concrete.

A standard corrosion cell for testing of chloride thresholds in concrete /11/ was developed by Hans Arup, formerly at the Danish Corrosion Centre, in co-operation with Henrik Sørensen at AEC, Denmark and the present author at Cementa, Sweden. The test unit consists of 20 U-shaped smooth Ø 8 mm mild steel electrodes, 2 titanium mesh counter electrodes and a MnO₂ reference electrode which were very accurately positioned into a cement based precast specimen holder as shown in Figure 1. The MnO₂ reference electrode reads + 142 mV SCE. Some of the electrodes were connected to a potentiostat and kept under potentiostatic control according to Table 3-5.

The steel electrodes were embedded into the concrete or mortar to be tested. The placing and compacting of concrete were carried out carefully as described in [12]. After demoulding and moist curing for 14 days the concrete surface to be exposed was cut open using a large water-cooled diamond saw to obtain a cover to the steel electrodes of nominally 10 mm. A chloride proof coating was applied to the test unit on all sides except the saw-cut face to be exposed.

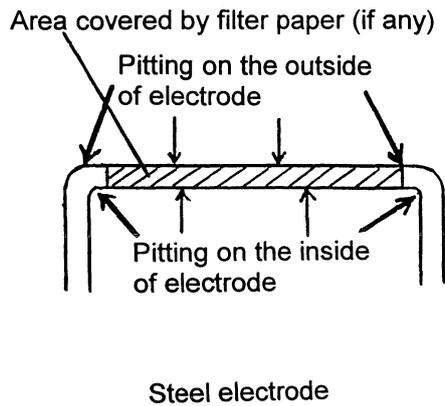
At the end of exposure of a test cell, electrodes were removed from the cell and carefully examined visually in order to confirm the position and the approximate size of the corrosion pit. The evaluation was carried out as indicated in Figure 2.

Figure 2. Evaluation of location and size of corrosion pits

- A) The location of the corrosion pit, Figure 2. Bending of hot rolled black steel causes deformation and possibly cracking of the scale in deformed zones, especially at the inside of a bend.

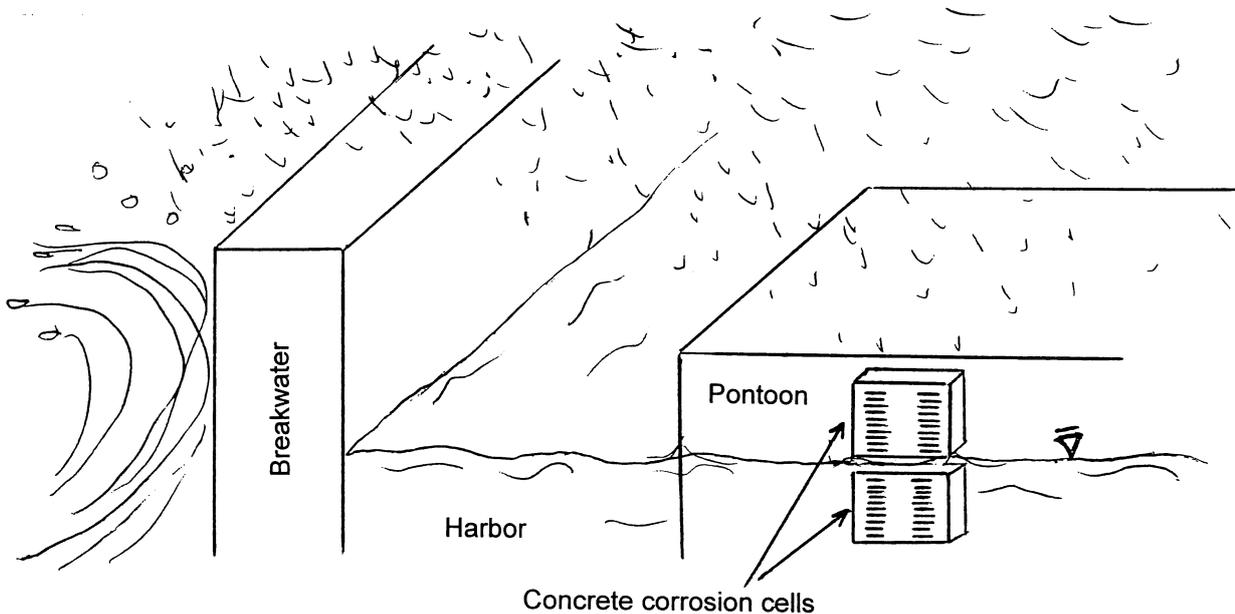
Figure 3. Exposure conditions for corrosion cells at the Träslövsläge Marine Field Station.

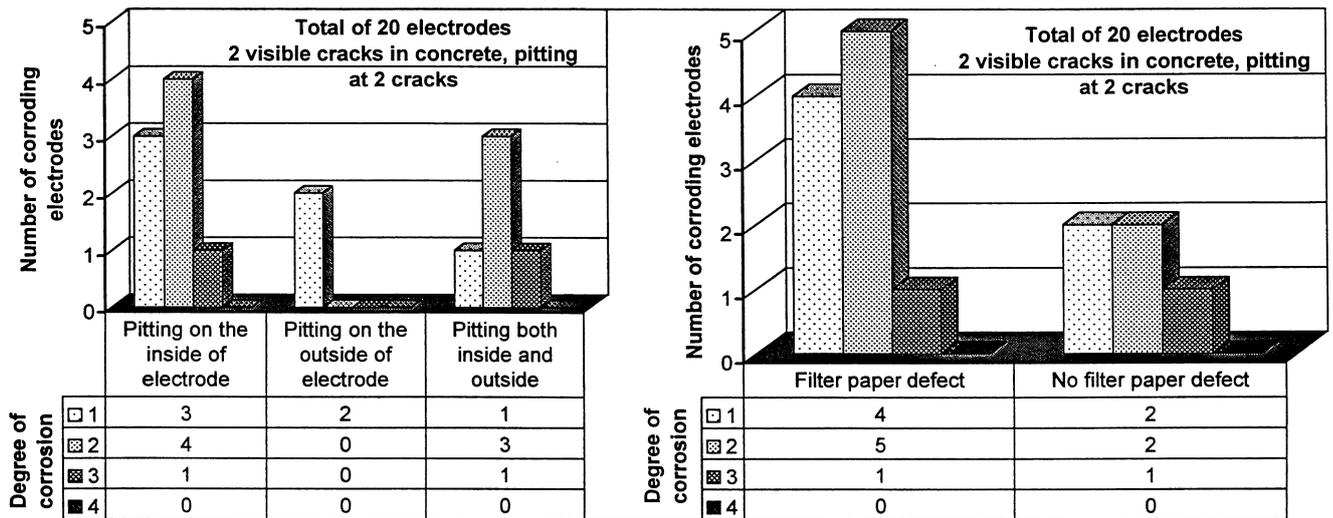
Figure 4. Presentation of results on the effect of defects on the location and size of corrosion pits.

The effect of defects was evaluated from the following indications:

- B) The presence of corrosion pits in electrodes with artificial filter paper defects at the steel - concrete interface, relative to the presence of pits in electrodes without filter paper defects.
- C) The presence of visible compaction voids or cracks at the steel - concrete interface.

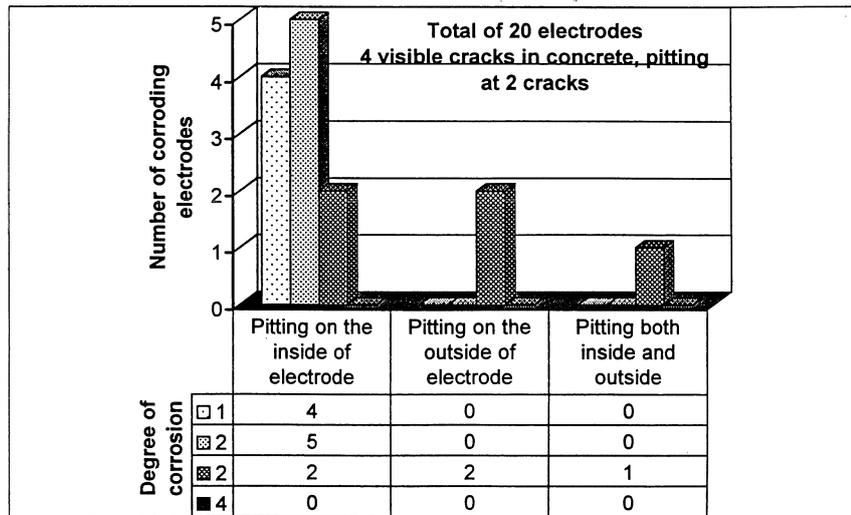
14 U-bend steel electrodes of a total of 20 started to corrode within 4 years of laboratory exposure of SRPC concrete w/c 0.50, submerged at room temperature in 16 % NaCl solution. The total chloride concentration at the depth of the corrosion pits were 2.5 to 3.0 % Cl by weight of binder after 4 years of exposure depending on the position of the corrosion pit. The visual examination revealed corrosion initiation in deformed parts of electrodes, Figure 5, at the inside of the U-shaped electrodes in 11 electrodes of 14, or in 75 % of the corroding electrodes.

Figure 5. Evaluation of the location of corrosion pits in plain SRPC concrete exposed 4 years submerged in a 16 % NaCl solution at room temperature in the laboratory. No filter paper defects applied.

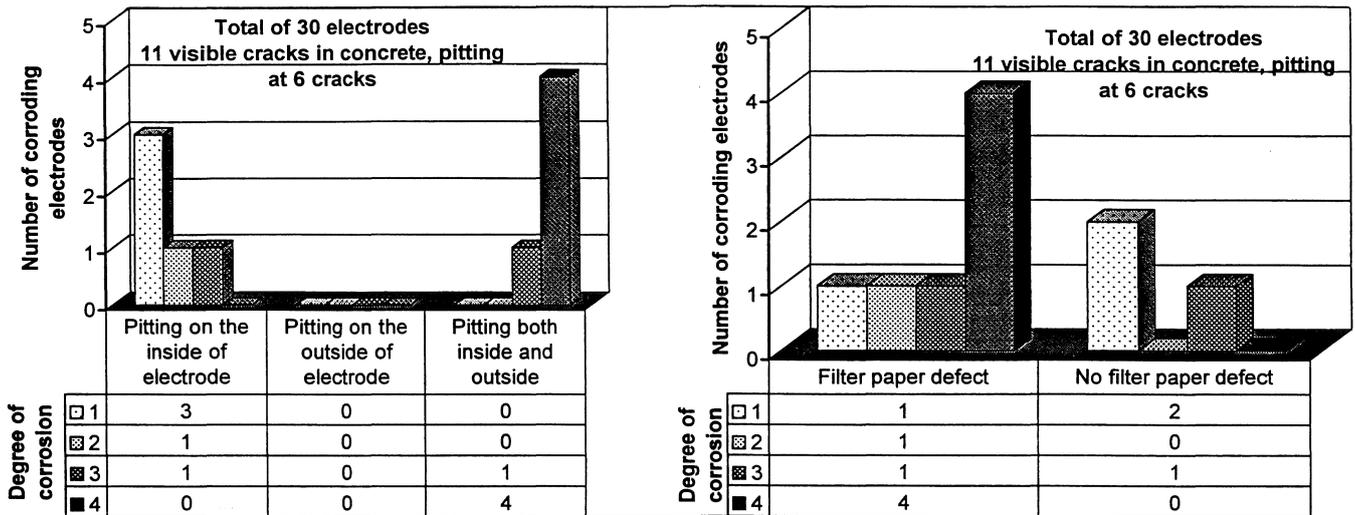
8 months of wetting and drying exposure (at room temperature) resulted in a substantial increase in the corrosion activity as compared to the 2 years submerged laboratory exposure tests (at room temperature or at + 5 °C). 6 of 8 electrodes with filter paper defects and / or compaction voids close to the steel surface started to corrode in the slag cement concrete already after a few months of exposure. On the other hand 2 of 11 electrodes with filter paper defects and / or compaction voids close to the steel surface started to corrode in SRPC concrete with 0 or 5 % silica fume in the binder. The results for all electrodes in concrete w/c 0.4 exposed for wetting and drying in the laboratory are summarised in Figure 6.

Figure 6. Evaluation of the location of corrosion pits in concrete w/c 0.4 exposed for wetting and drying for 8 months in a 16 % NaCl solution at room temperature in the laboratory.

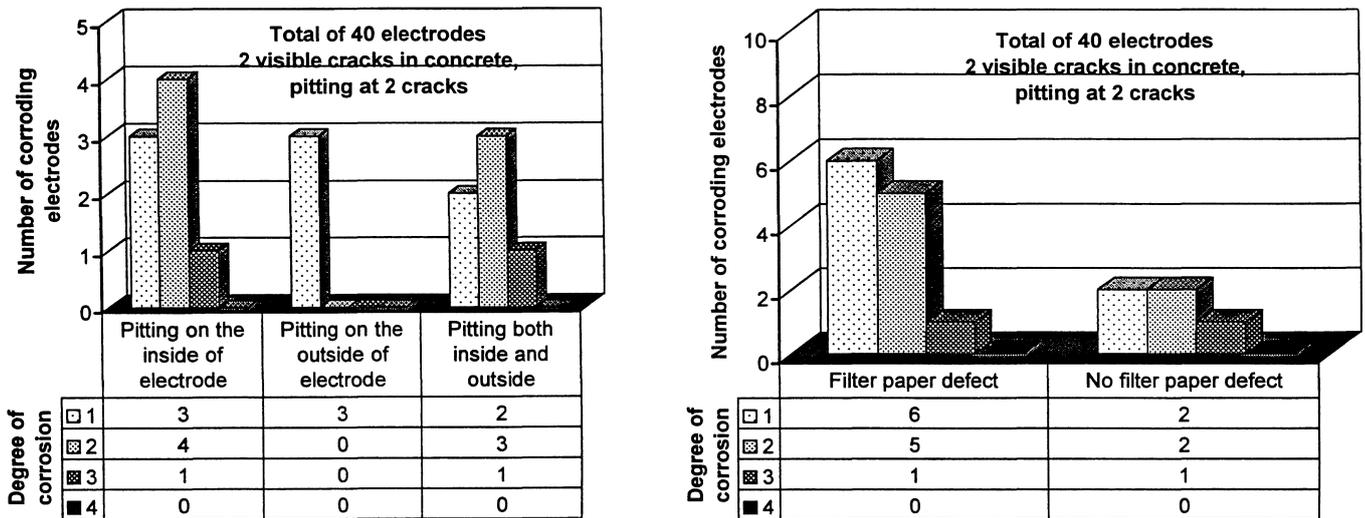
17 of 40 electrodes started to corrode in the splash zone within 2 years of field exposure, Figure 7. 15 of the 17 corroding electrodes were found in slag cement concrete, with active corrosion in all electrodes with filter paper defects and / or compaction voids close to the steel surface. 5 of 10 electrodes in slag cement concrete without filter paper defects, voids or cracks were also corroding.

Figure 7. Evaluation of the location of corrosion pits in concrete w/c 0.4 exposed for 2 years in the splash zone at the Träslövsläge Marine Field Station.

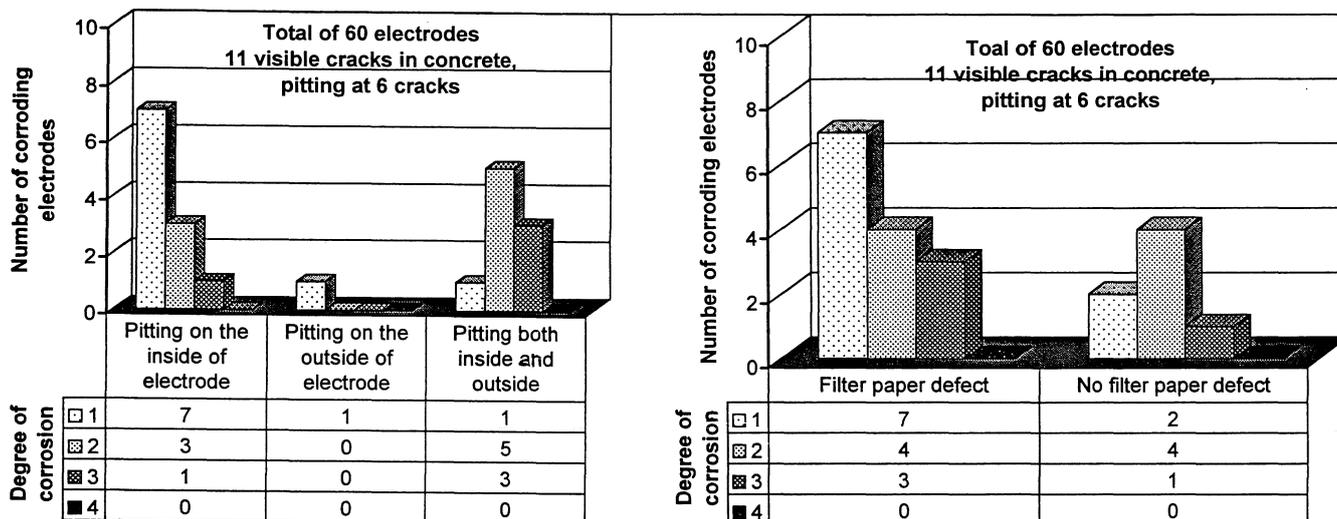
11 of 60 electrodes started to corrode in the submerged zone within 2 years of field exposure, Figure 8. 8 of the 11 corroding electrodes were found in slag cement concrete, with active corrosion in 7 of 12 electrodes with filter paper defects and / or compaction voids close to the steel surface. 1 of 8 electrodes in slag cement concrete without filter paper defects, voids or cracks was also corroding.

Figure 8. Evaluation of the location of corrosion pits in concrete w/c 0.4 exposed for 2 years in the submerged zone at the Träslövsläge Marine Field Station.

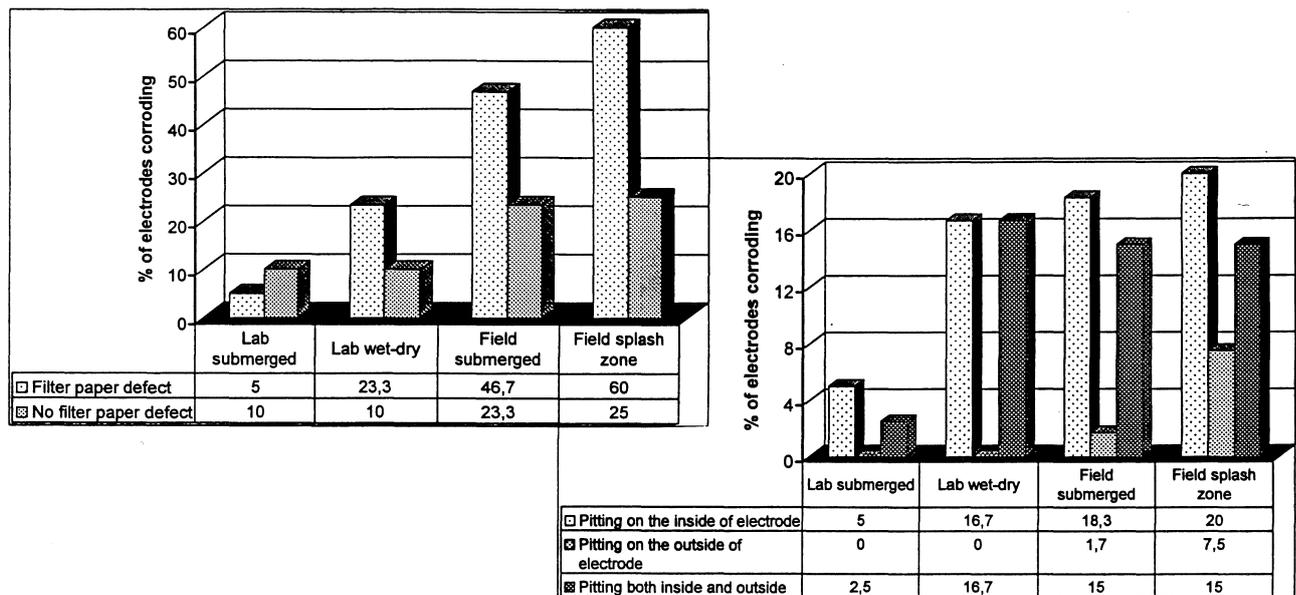
An evaluation of the effect of the exposure regime is presented in Figure 9. Concrete w/c 0.40 with plain sulfate resisting portland cement, sulfate resisting portland cement and 5 % silica fume, or slag cement were exposed to all exposure regimes. Figure 9 shows the percentage of electrodes corroding with pitting on the inside of electrodes, on the outside of electrodes, or with pitting on both the inside and the outside of electrodes.

As indicated in Figure 9, the corrosion activity was generally found to be very low in concrete exposed submerged in the laboratory at +5 °C or at room temperature, as compared to concrete exposed in all other exposure regimes. The results from wetting and drying in the laboratory at room temperature seems to be more representative for the field performance as compared to concrete exposed submerged in the laboratory at +5 °C or at room temperature.

Figure 9. The effect of exposure regime on the corrosion activity for all concrete with w/c 0.40.

The incorporation of artificial filter paper defects at the steel – concrete interface had a strong negative effect on the resistance to corrosion. except for electrodes in concrete exposed submerged in the laboratory, as shown in Figure 9.

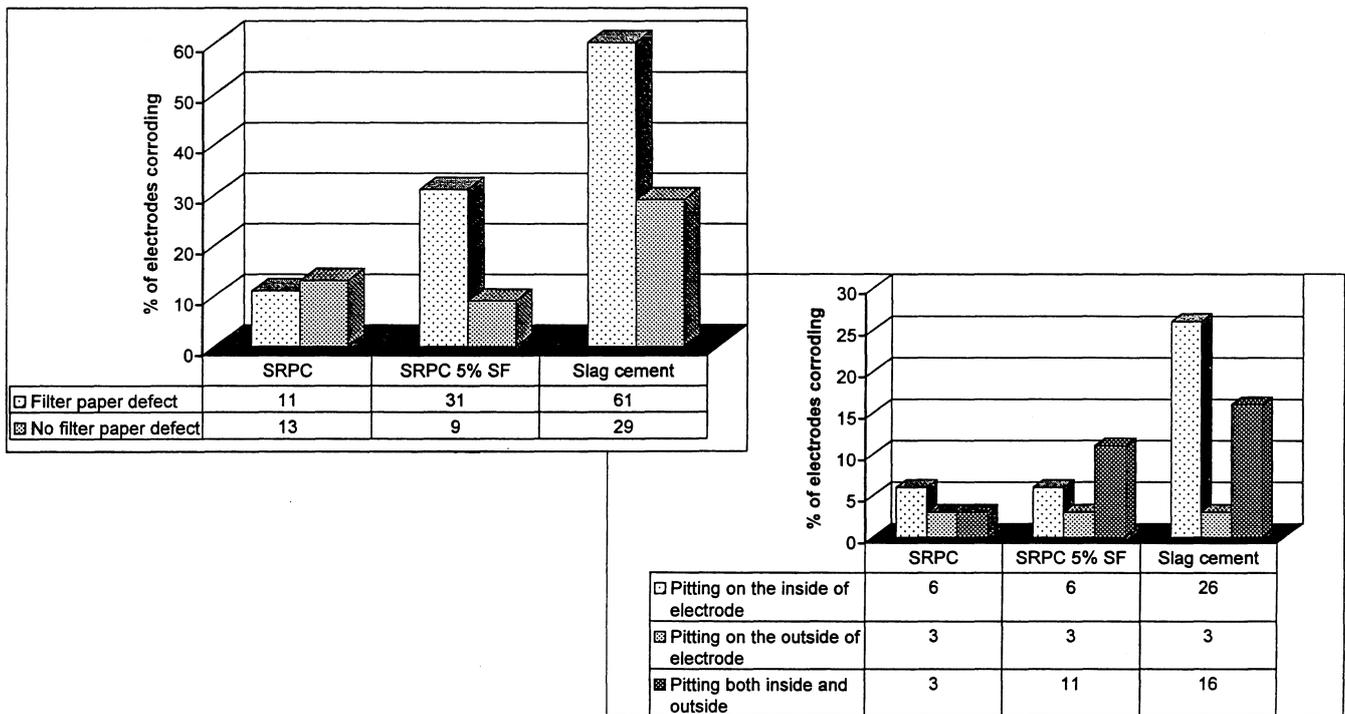
The use of slag cement had a strong negative effect on the resistance to pitting corrosion, except for slag cement concrete exposed submerged in the laboratory at + 5 °C, as compared to the use of SRPC with 0 or 5 % silica fume in the binder. The net effect considering all exposure regimes is illustrated in Figure 10. However, it should be noted that the slag cement concrete also exhibited more visible cracks or voids at the steel – concrete interface, as illustrated in Figure 11. The results nevertheless indicate that slag is more sensitive to the formation of cracks, and that the effect of cracks on the resistance to pitting corrosion is more negative for slag cement as compared to SRPC with 0 or 5 % silica fume in the binder.

Figure 10. The effect of binder composition on the resistance to pitting corrosion

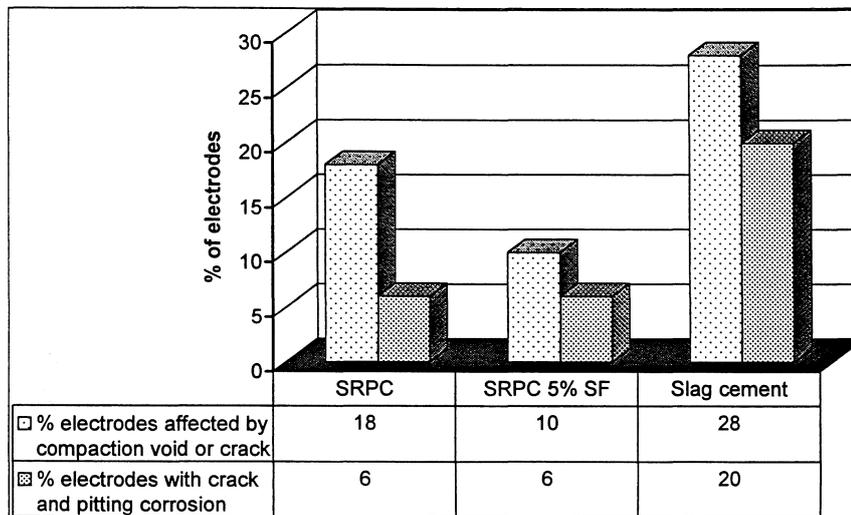
Figure 11. The effect of binder composition and compaction voids or cracks at the steel – concrete interface on the resistance to pitting corrosion

34 of a total of 210 examined electrodes in all concrete exposed exhibited evidence on visible compaction voids or cracks at the steel surface. 16 electrodes or approximately 50 % of the electrodes with visible compaction voids or cracks at the steel surface also experienced pitting corrosion. However, only approximately 25 % of the electrodes with visible compaction voids or cracks at the steel surface corroded in concrete exposed submerged in the laboratory.

The effect of microstructural defects in the concrete seems to be far more important in concrete exposed to moisture- and temperature variations, as compared to concrete submerged at a constant temperature in the laboratory. The visible compaction voids or cracks and the artificially produced filter paper defects at the steel surface had relatively little effect on the resistance to corrosion initiation in concrete submerged at a constant temperature in the laboratory. These findings support the idea that it is not the defects, but the effects of the defects on the moisture variations at the depth of the reinforcement, and the temperature variations, which control the chloride threshold. The positive effect of introducing silica fume seems to be related to the improvement of the homogeneity and the reduced permeability of the cover, which in turn reduces the moisture variations at the depth of the reinforcement. This effect can of course also be achieved by increasing the cover thickness or by lowering the w/c ratio.
