## The effect of defects at the steel - concrete interface, exposure regime and cement type on pitting corrosion in concrete

Sandberg, Paul

1998

Sandberg, P. (1998). *The effect of defects at the steel - concrete interface, exposure regime and cement type on pitting corrosion in concrete*. (Report TVBM; Vol. 3081). Division of Building Materials, LTH, Lund University.

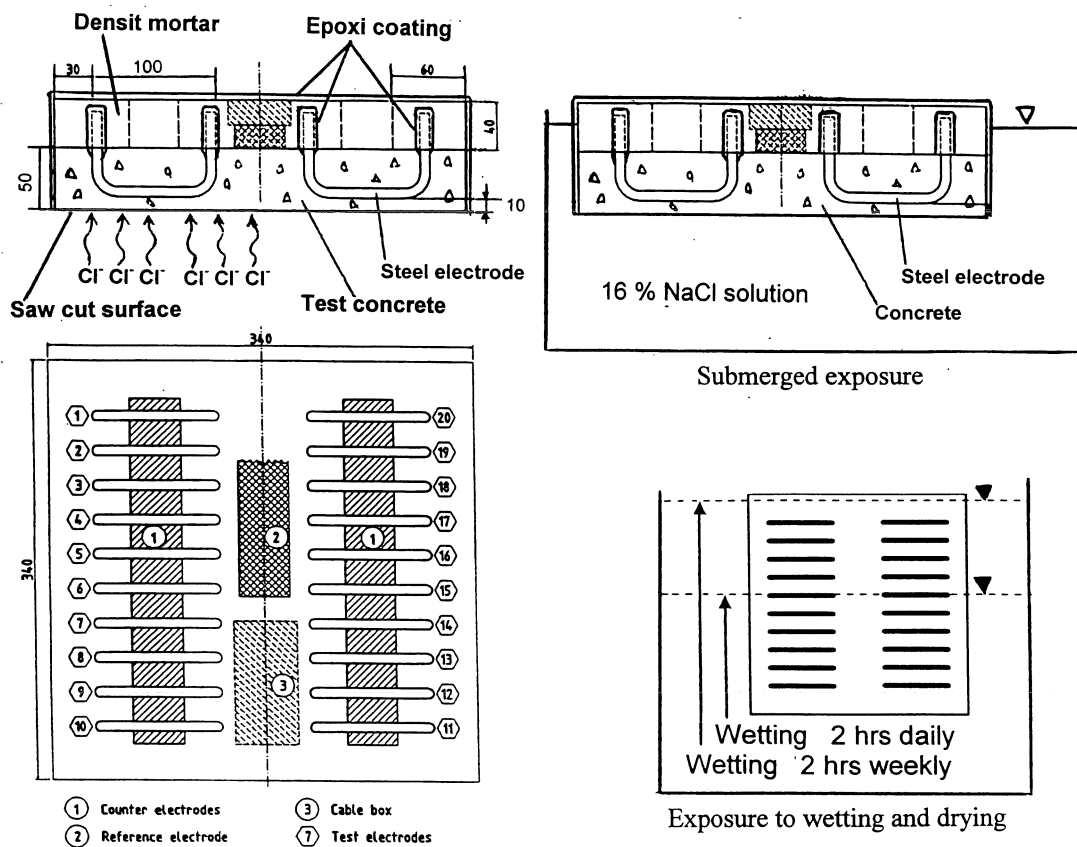
Figure 1. Standard corrosion cell. All measures are given in millimetres [11].

The U-shaped steel electrodes have epoxy coated legs facing away from the exposed surface in order to prevent corrosion initiation on the legs. The  $MnO_2$  reference electrode and the titanium mesh counter electrode were cast into mortar bars before assembling the standard unit. The design minimises errors due to IR-drops in the test concrete.

The steel electrodes were embedded into the concrete or mortar to be tested. The placing and compacting of concrete were carried out carefully as described in [12]. After demoulding and moist curing for 14 days the concrete surface to be exposed was cut open using a large water-cooled diamond saw to obtain a cover to the steel electrodes of nominally 10 mm. A chloride proof coating was applied to the test unit on all sides except the saw-cut face to be exposed.

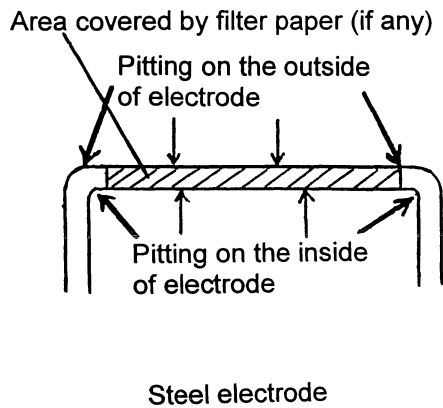
Degree of corrosion	Description of corrosion pit
0	None
1	Very small pit, 0-1 % of steel surface, only surface corrosion
2	Small pit, 1-10 % of steel surface, max 0.5 mm deep
3	Corrosion in 10-50 % of steel surface, max 1.0 mm deep
4	Corrosion in 50-100 % of steel surface, > 1.0 mm deep

Figure 2. Evaluation of location and size of corrosion pits

At the end of exposure of a test cell, electrodes were removed from the cell and carefully examined visually in order to confirm the position and the approximate size of the corrosion pit. The evaluation was carried out as indicated in Figure 2.

- A) The location of the corrosion pit, Figure 2. Bending of hot rolled black steel causes deformation and possibly cracking of the scale in deformed zones, especially at the inside of a bend.

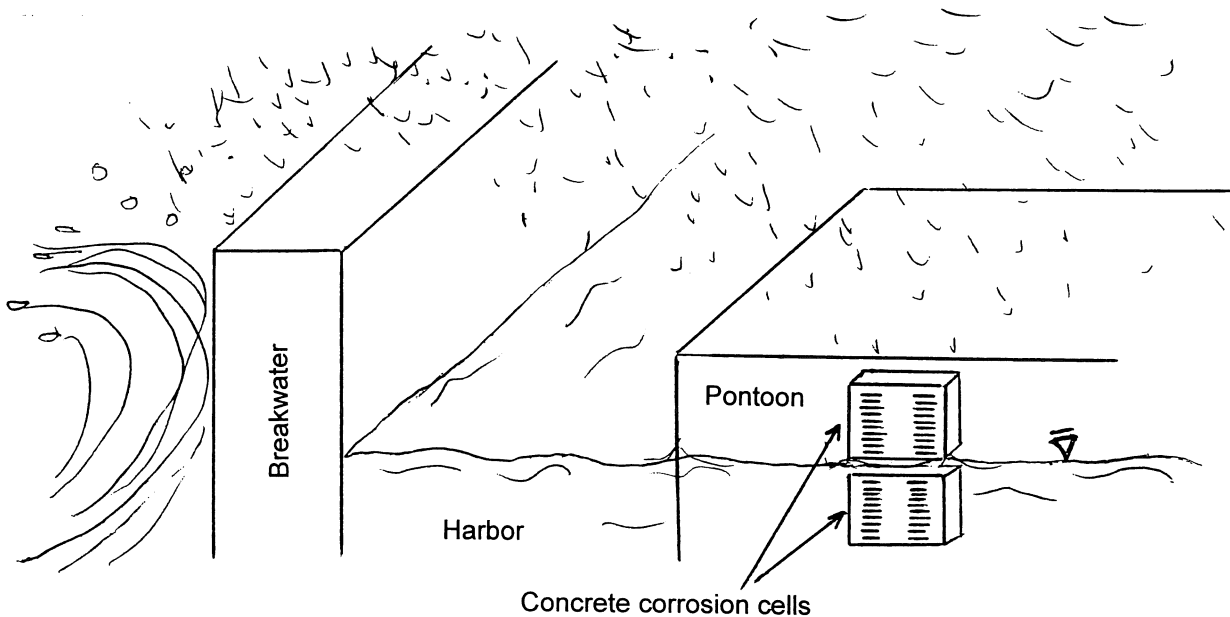
Figure 3. Exposure conditions for corrosion cells at the Träslövsläge Marine Field Station.

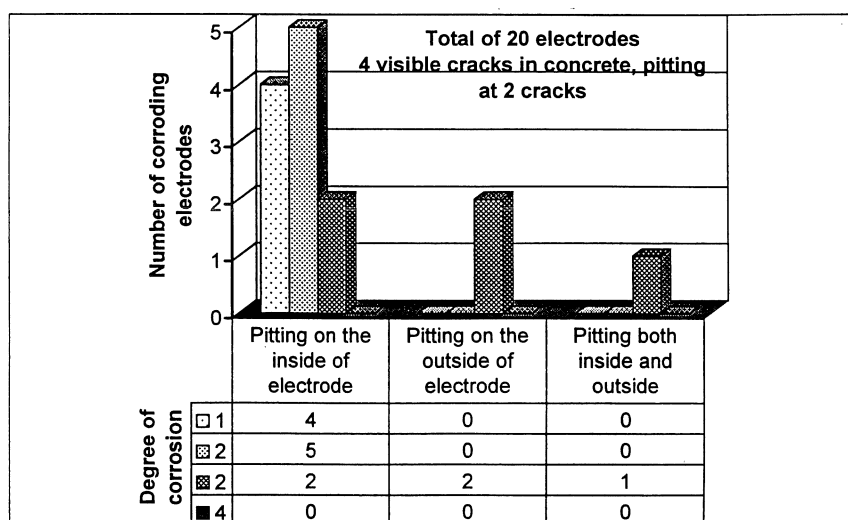
Figure 5. Evaluation of the location of corrosion pits in plain SRPC concrete exposed 4 years submerged in a 16 % NaCl solution at room temperature in the laboratory. No filter paper defects applied.

14 U-bend steel electrodes of a total of 20 started to corrode within 4 years of laboratory exposure of SRPC concrete w/c 0.50, submerged at room temperature in 16 % NaCl solution. The total chloride concentration at the depth of the corrosion pits were 2.5 to 3.0 % Cl by weight of binder after 4 years of exposure depending on the position of the corrosion pit. The visual examination revealed corrosion initiation in deformed parts of electrodes, Figure 5, at the inside of the U-shaped electrodes in 11 electrodes of 14, or in 75 % of the corroding electrodes.

A potential more negative than -100 mV SCE was necessary to prevent corrosion initiation in U-bend steel electrodes.

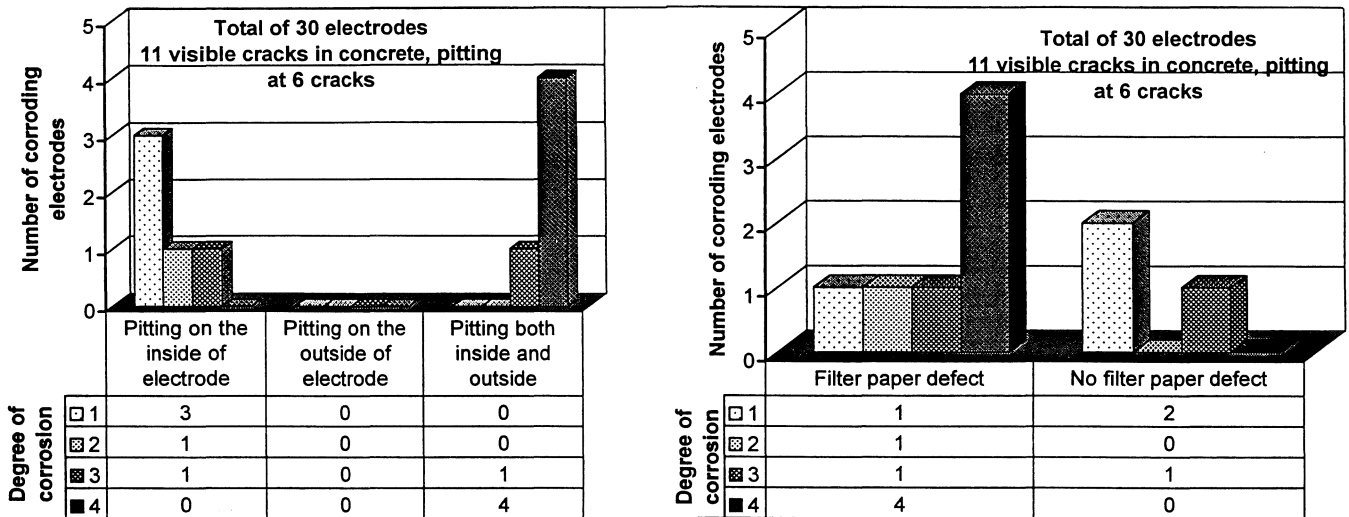
Figure 6. Evaluation of the location of corrosion pits in concrete w/c 0.4 exposed for wetting and drying for 8 months in a 16 % NaCl solution at room temperature in the laboratory.

8 months of wetting and drying exposure (at room temperature) resulted in a substantial increase in the corrosion activity as compared to the 2 years submerged laboratory exposure tests (at room temperature or at + 5 °C). 6 of 8 electrodes with filter paper defects and / or compaction voids close to the steel surface started to corrode in the slag cement concrete already after a few months of exposure. On the other hand 2 of 11 electrodes with filter paper defects and / or compaction voids close to the steel surface started to corrode in SRPC concrete with 0 or 5 % silica fume in the binder. The results for all electrodes in concrete w/c 0.4 exposed for wetting and drying in the laboratory are summarised in Figure 6.

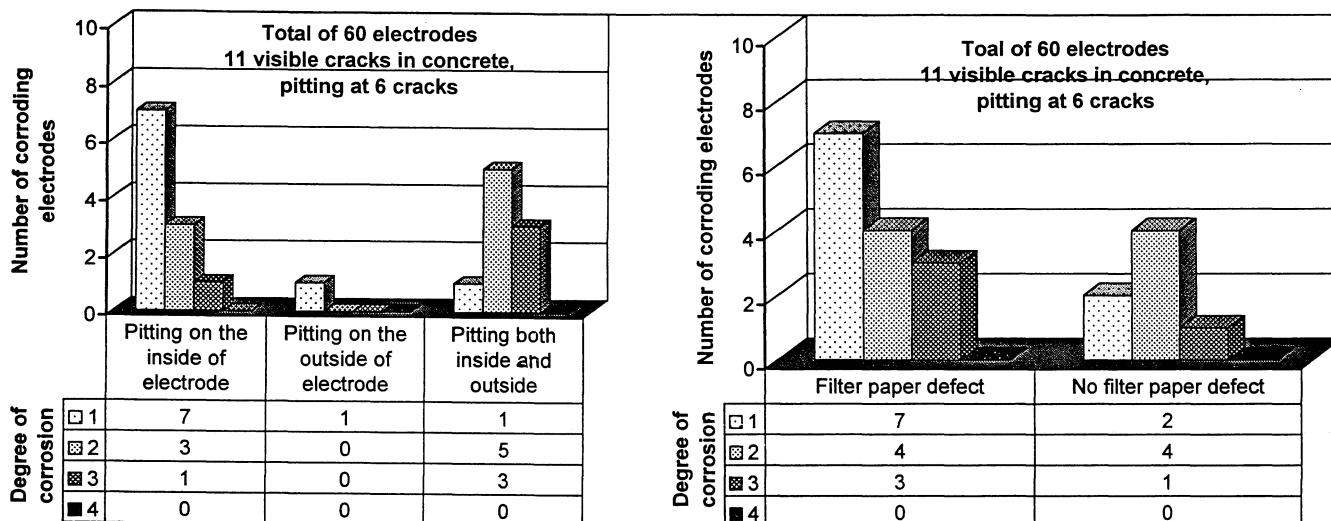
Figure 8. Evaluation of the location of corrosion pits in concrete w/c 0.4 exposed for 2 years in the submerged zone at the Träslövsläge Marine Field Station.

11 of 60 electrodes started to corrode in the submerged zone within 2 years of field exposure, Figure 8. 8 of the 11 corroding electrodes were found in slag cement concrete, with active corrosion in 7 of 12 electrodes with filter paper defects and / or compaction voids close to the steel surface. 1 of 8 electrodes in slag cement concrete without filter paper defects, voids or cracks was also corroding.

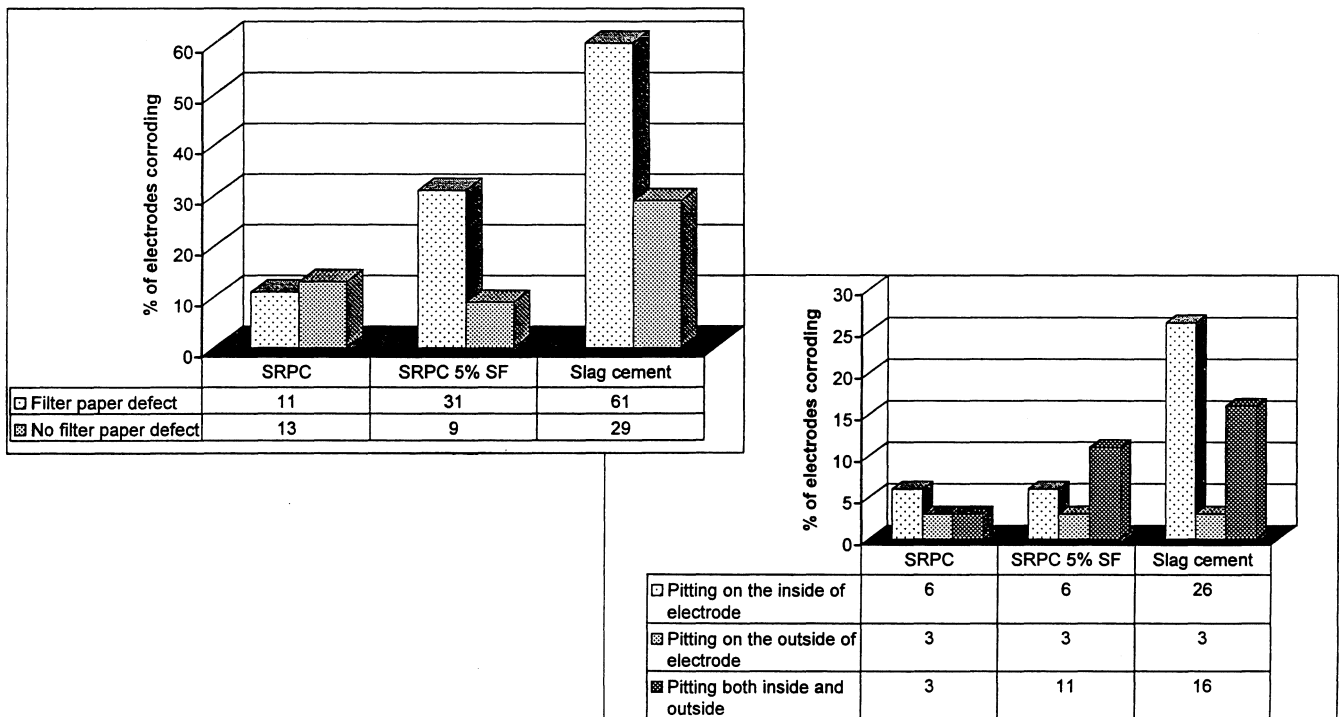
Figure 10. The effect of binder composition on the resistance to pitting corrosion

The use of slag cement had a strong negative effect on the resistance to pitting corrosion, except for slag cement concrete exposed submerged in the laboratory at + 5 °C, as compared to the use of SRPC with 0 or 5 % silica fume in the binder. The net effect considering all exposure regimes is illustrated in Figure 10. However, it should be noted that the slag cement concrete also exhibited more visible cracks or voids at the steel – concrete interface, as illustrated in Figure 11. The results nevertheless indicate that slag is more sensitive to the formation of cracks, and that the effect of cracks on the resistance to pitting corrosion is more negative for slag cement as compared to SRPC with 0 or 5 % silica fume in the binder.

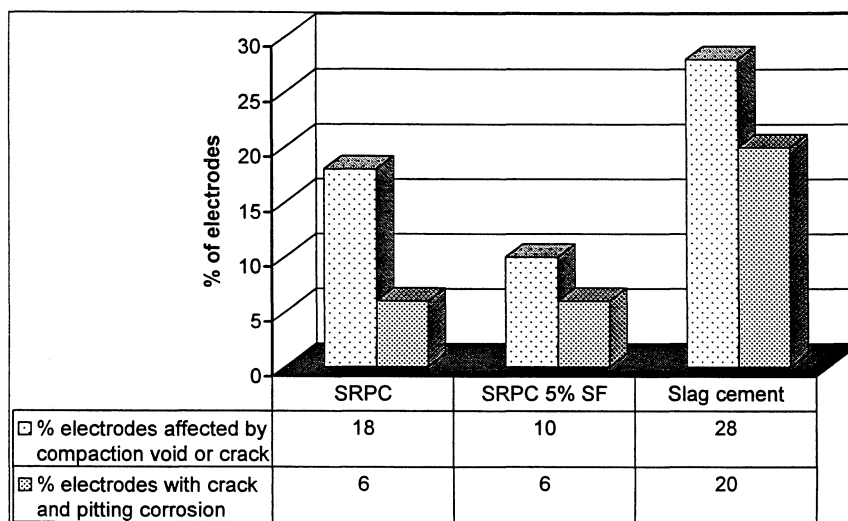
Figure 11. The effect of binder composition and compaction voids or cracks at the steel – concrete interface on the resistance to pitting corrosion
