Macroscopic ice lens growth : observations on Swedish concrete dams

Published in:
Concrete Repair, Rehabilitation and Retrofitting III

Macroscopic ice lens growth: Observations on Swedish concrete dams

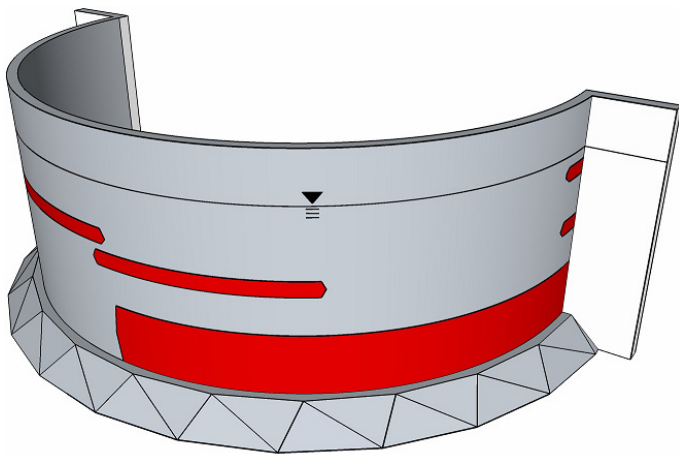
The greater part of the damage to the upstream face was located along two horizontal zones about 1.75 and 5.0 m below the full water supply level (Fig. 1). The width of the damaged zones varied between 0.5 and 2.0 m. During inspections, divers could remove concrete with their bare hands up to a depth of 150 mm. Similar damage was also found on the downstream face. When repairing the arch dam, no attempts were made to restore the damage to the upstream face. The first step in the rehabilitation process was instead to restore the downstream face. The second step involved the casting of a new arch against the existing arch on its downstream side. The new arch was also designed with a thickness of 0.35 m. To prevent further freezing and thawing of the old and new arches, the dam was equipped with an insulating wood panelling on the downstream side.

Figure 1. Areas (dark grey) with severe surface spalling on the upstream face of the arch dam at Selsforsen.

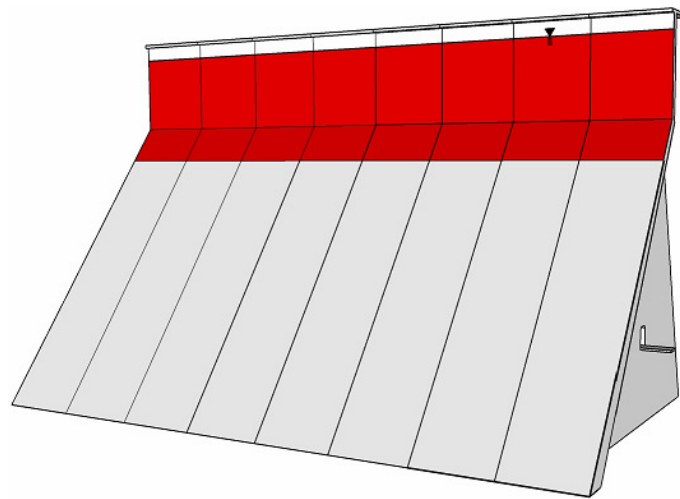
Figure 2. Zone (dark grey) with single areas of surface spalling on the upstream face of the buttress dam at Storfinnforsen.

Shortly after the commissioning a large number of cracks appeared in the deck slab. The cracking and the following leakage were documented in the early 1960s. The next large investigation took place about 30 years later. Eriksson (1994) could establish the fact that the cracks had increased in number and length. In addition to the cracking in the deck slab, severe surface spalling was found on the upstream face. The major part of the spalling was located between the full water supply level and some 10-12 m down (Fig. 2). The damaged areas varied between 0.5 and 10 m² in size and up to 200 mm in depth. On the downstream face, surface spalling concentrated to the vicinity of the dilatation joints was found. In the early 1990s the damage was repaired on upstream and downstream face. The downstream side was also equipped with an insulation wall to prevent further freezing and thawing of the buttress dam during winter time.

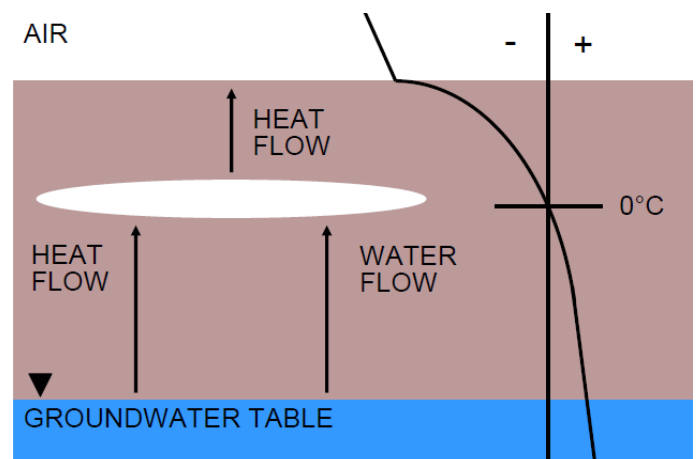
When Taber (1930) stated the conditions for ice lens growth in soil, he could thereby explain the noted frost heave in roads and pavements during winter time. In laboratory tests he showed that the formation of macroscopic ice lenses occurred perpendicular to the heat flow direction (Fig. 3). The growth of ice lenses were depending on a continuous water uptake. This was in contrast to the previous theory, where frost heave was explained by the increase in volume of the frozen water in the soil. The growth of macroscopic ice lenses continued as long as the loss of heat from the ice lens towards the soil surface was balanced by the quantity of heat brought up to the ice lens by the water uptake and later set free during phase change. If heat was conducted more rapidly towards the soil surface, the freezing zone moved downwards and the ice lens growth was ceased.

Figure 3. The three conditions for macroscopic ice lens growth in soil are; continuous water uptake, balance in heat flow, and sufficiently low external pressure on the ice lens.

- 1) Continuous access to unfrozen water underneath the ice lens.
- 2) Balance in heat supply and heat loss at the depth of the ice lens.
- 3) A sufficiently low pressure on the ice lens to allow ice formation.

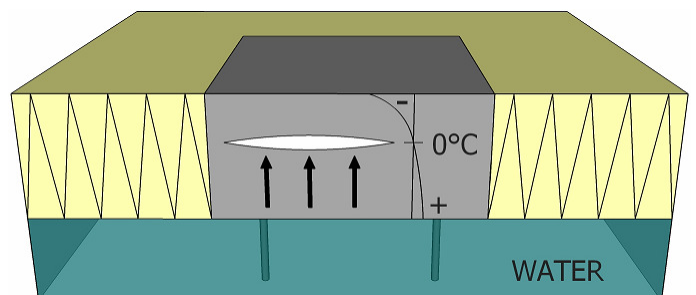
The test setup was designed to correspond to the conditions present at the two dams; one side of the concrete specimens subjected to freezing temperature and one side in contact with unfrozen water. The effect of water pressure was neglected. To ensure one dimensional heat flow, the specimens were insulated on the remaining surfaces. The specimens were then placed in a box filled with water, letting the lower surface stay in contact with water (Fig. 4).

Figure 4. The test setup used for exposing the specimen to an air temperature of -20°C and a water temperature of +4°C.

To be able to control even water temperature, a heating coil was placed on the bottom of the box. The setup was later completed with a pump to keep circulation in the water. The air temperature was set to -20°C and the water temperature to +4°C. Due to temperature fluctuations in the freezer, the air temperature actually varied between -18°C and -21°C.

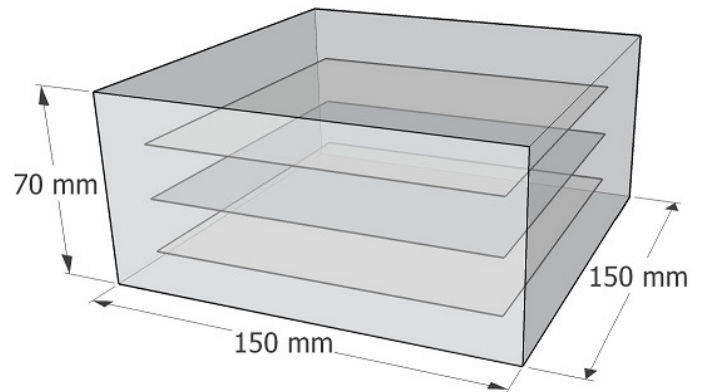
Figure 5. A specimen provided with three paper layers with the purpose of simulating internal cracks within the concrete.

Standard cubes, 150x150x150 mm³, were cast for production of specimens. Since the concrete in the Selsforsen and Storfinnforsen dams had deteriorated, some of the cubes were provided with sheets of copy paper; with the purpose of creating deteriorated concrete inside the cubes. The deterioration, in the form of internal cracks, would perhaps facilitate formation of macroscopic ice lenses. The size of the paper sheets was 130x130 mm² and they were placed two and two in horizontal layers, leaving an enclosing boundary of 10 mm of unaffected concrete along the sides of the cubes. Due to the size of the aggregates, the distance between two paper layers was set to 20 mm. This resulted in six paper layers in each cube. The fulfillment of the conditions for macroscopic ice lens growth would then hopefully coincide with one of the paper layers.

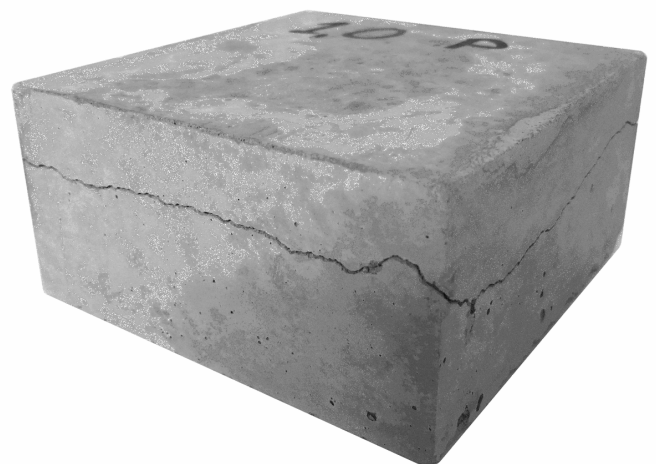
After three to four days of freezing, a crack appeared about 25 mm from the top surface of the specimen of w/c-ratio 1.0 (Fig. 6). The crack had propagated around the specimen at the level of the top paper layer. After another three to four days of freezing, the crack had widened to about 1-2 mm. An ice lens had also become visible in the crack. The specimen of w/c-ratio 0.85, provided with paper layers, showed no signs of cracking; neither did the specimens without paper layers.

Figure 6. The crack in the upper part of the specimens of w/c-ratio 1.0 appeared at the level of the top paper layer.

After one week of freezing, cracks appeared on the specimens of w/c-ratio 1.0, provided with paper layers. The course of events may be described in the following manner – the cooling slowly extended downwards in the specimens and the water in the pores began to freeze. When balance in the heat flow was reached at some level, the loss of heat from the growing ice lenses towards the surfaces was balanced by the quantity of heat brought up by the water uptake and later set free during phase change. Since the specimens were weakened by the paper layers, they could not resist the internal pressure from the growing ice lenses. Consequently, all three conditions for macroscopic ice lens growth were fulfilled.
