Macroscopic ice lens growth : observations on Swedish concrete dams

Concrete Repair, Rehabilitation and Retrofitting III

2012

Macroscopic ice lens growth: Observations on Swedish concrete dams

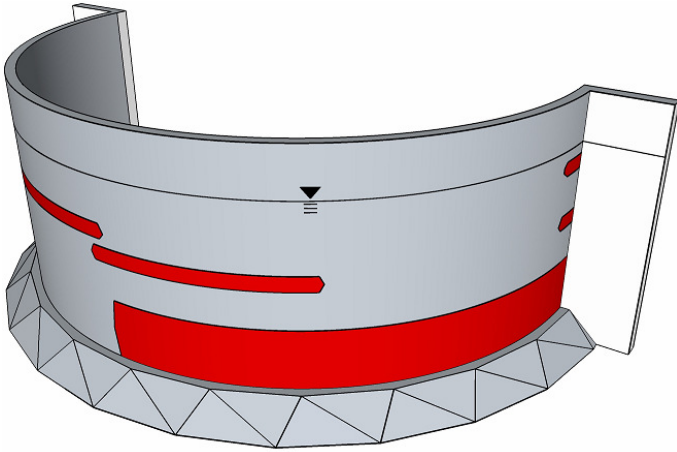
Figure 1. Areas (dark grey) with severe surface spalling on the upstream face of the arch dam at Selsforsen.

The greater part of the damage to the upstream face was located along two horizontal zones about 1.75 and 5.0 m below the full water supply level (Fig. 1). The width of the damaged zones varied between 0.5 and 2.0 m. During inspections, divers could remove concrete with their bare hands up to a depth of 150 mm. Similar damage was also found on the downstream face. When repairing the arch dam, no attempts were made to restore the damage to the upstream face. The first step in the rehabilitation process was instead to restore the downstream face. The second step involved the casting of a new arch against the existing arch on its downstream side. The new arch was also designed with a thickness of 0.35 m. To prevent further freezing and thawing of the old and new arches, the dam was equipped with an insulating wood panelling on the downstream side.

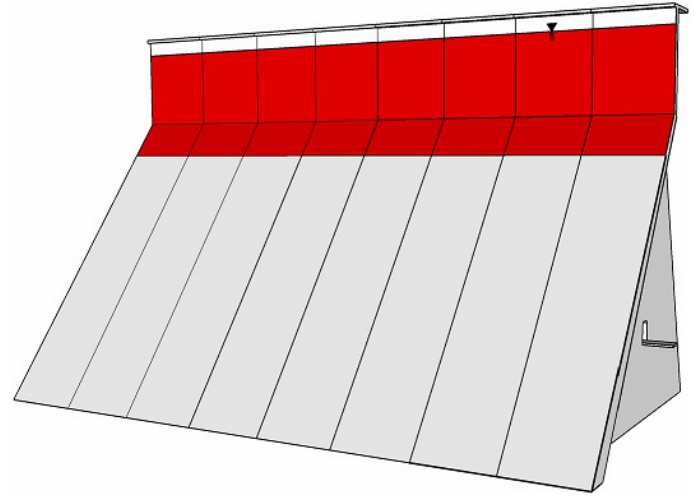
Figure 2. Zone (dark grey) with single areas of surface spalling on the upstream face of the buttress dam at Storfinnforsen.

Shortly after the commissioning a large number of cracks appeared in the deck slab. The cracking and the following leakage were documented in the early 1960s. The next large investigation took place about 30 years later. Eriksson (1994) could establish the fact that the cracks had increased in number and length. In addition to the cracking in the deck slab, severe surface spalling was found on the upstream face. The major part of the spalling was located between the full water supply level and some 10-12 m down (Fig. 2). The damaged areas varied between 0.5 and 10 m² in size and up to 200 mm in depth. On the downstream face, surface spalling concentrated to the vicinity of the dilatation joints was found. In the early 1990s the damage was repaired on upstream and downstream face. The downstream side was also equipped with an insulation wall to prevent further freezing and thawing of the buttress dam during winter time.

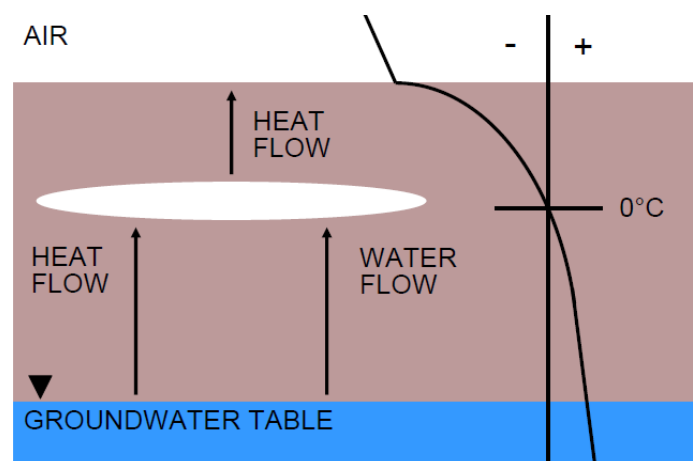
Figure 3. The three conditions for macroscopic ice lens growth in soil are; continuous water uptake, balance in heat flow, and sufficiently low external pressure on the ice lens.

When Taber (1930) stated the conditions for ice lens growth in soil, he could thereby explain the noted frost heave in roads and pavements during winter time. In laboratory tests he showed that the formation of macroscopic ice lenses occurred perpendicular to the heat flow direction (Fig. 3). The growth of ice lenses were depending on a continuous water uptake. This was in contrast to the previous theory, where frost heave was explained by the increase in volume of the frozen water in the soil. The growth of macroscopic ice lenses continued as long as the loss of heat from the ice lens towards the soil surface was balanced by the quantity of heat brought up to the ice lens by the water uptake and later set free during phase change. If heat was conducted more rapidly towards the soil surface, the freezing zone moved downwards and the ice lens growth was ceased.

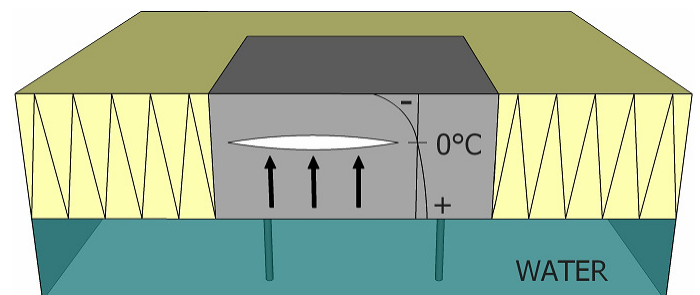
Figure 4. The test setup used for exposing the specimen to an air temperature of -20°C and a water temperature of +4°C.

The test setup was designed to correspond to the conditions present at the two dams; one side of the concrete specimens subjected to freezing temperature and one side in contact with unfrozen water. The effect of water pressure was neglected. To ensure one dimensional heat flow, the specimens were insulated on the remaining surfaces. The specimens were then placed in a box filled with water, letting the lower surface stay in contact with water (Fig. 4).

To be able to control even water temperature, a heating coil was placed on the bottom of the box. The setup was later completed with a pump to keep circulation in the water. The air temperature was set to -20°C and the water temperature to +4°C. Due to temperature fluctuations in the freezer, the air temperature actually varied between -18°C and -21°C.

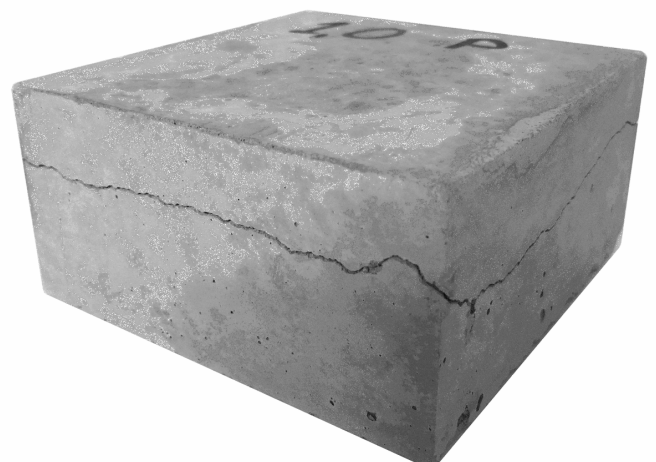
Figure 6. The crack in the upper part of the specimens of w/c-ratio 1.0 appeared at the level of the top paper layer.

After three to four days of freezing, a crack appeared about 25 mm from the top surface of the specimen of w/c-ratio 1.0 (Fig. 6). The crack had propagated around the specimen at the level of the top paper layer. After another three to four days of freezing, the crack had widened to about 1-2 mm. An ice lens had also become visible in the crack. The specimen of w/c-ratio 0.85, provided with paper layers, showed no signs of cracking; neither did the specimens without paper layers.

After one week of freezing, cracks appeared on the specimens of w/c-ratio 1.0, provided with paper layers. The course of events may be described in the following manner – the cooling slowly extended downwards in the specimens and the water in the pores began to freeze. When balance in the heat flow was reached at some level, the loss of heat from the growing ice lenses towards the surfaces was balanced by the quantity of heat brought up by the water uptake and later set free during phase change. Since the specimens were weakened by the paper layers, they could not resist the internal pressure from the growing ice lenses. Consequently, all three conditions for macroscopic ice lens growth were fulfilled.
