Published in:
Concrete Repair, Rehabilitation and Retrofitting III

Macroscopic ice lens growth: Observations on Swedish concrete dams

ABSTRACT: The arch dam at Selsforsen and the buttress dam at Storfinnforsen are two concrete dams of which both have suffered from severe surface spalling on the upstream face, far below the full water supply level. A hypothesis is that macroscopic ice lens growth, similar to frost heave in soil, could have occurred within the dam walls. After initial deterioration of the concrete dams by frost damage or cracking, the formation of macroscopic ice lenses could have been made possible. In an attempt to test the hypothesis, specimens of low strength concrete were exposed in the laboratory to climatic boundary conditions similar to those of the dams. After one week of freezing, the upper part of the concrete specimens was separated from the lower part due to cracking. The gradual propagation of the crack, which appeared about 25 mm below the top surface, was caused by macroscopic ice lens growth.

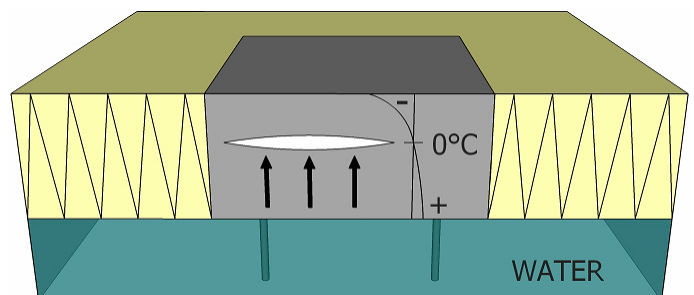
The test setup was designed to correspond to the conditions present at the two dams; one side of the concrete specimens subjected to freezing temperature and one side in contact with unfrozen water. The effect of water pressure was neglected. To ensure one dimensional heat flow, the specimens were insulated on the remaining surfaces. The specimens were then placed in a box filled with water, letting the lower surface stay in contact with water (Fig. 4).

Figure 4. The test setup used for exposing the specimen to an air temperature of -20°C and a water temperature of +4°C.

To be able to control even water temperature, a heating coil was placed on the bottom of the box. The setup was later completed with a pump to keep circulation in the water. The air temperature was set to -20°C and the water temperature to +4°C. Due to temperature fluctuations in the freezer, the air temperature actually varied between -18°C and -21°C.
