## Self-healing of concrete with various binders

Åhs, Magnus

2020

TVBM-3187

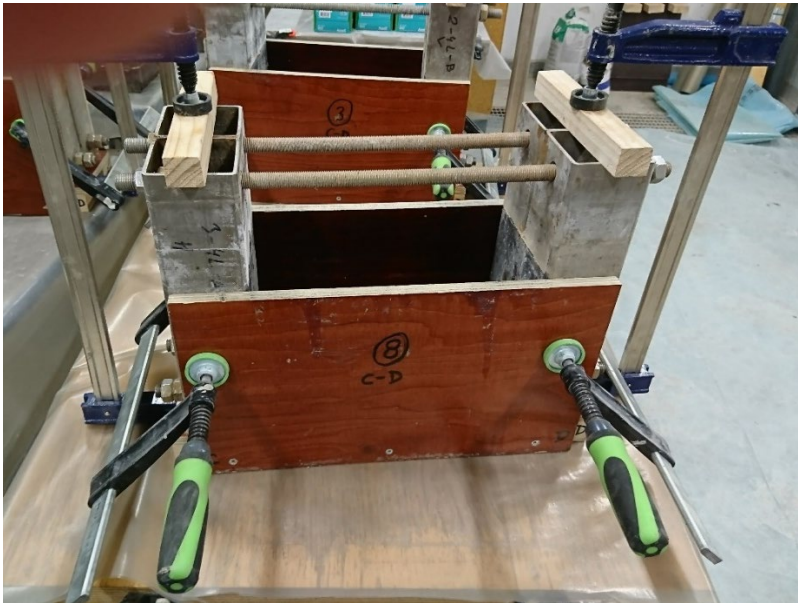
Figure 2. The formwork for the concrete beams.

The formwork of the concrete beam is shown in Figure 2.

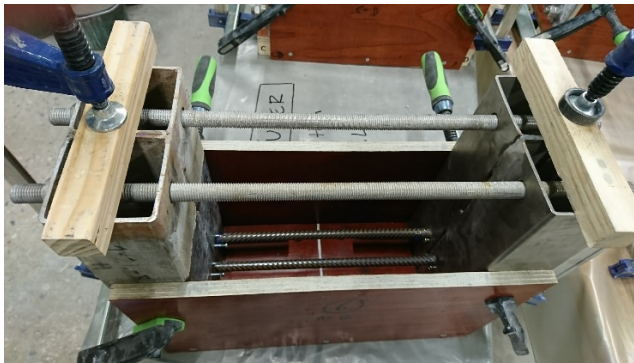
*Figure 3. Top view of the formwork used to pour the concrete beams.*

The inside of the formwork is shown in Figure 3 and Figure 4.

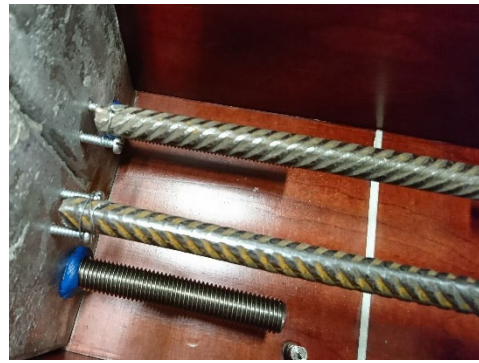
*Figure 4. Top view, close-up of the bottom of the formwork, note the white plastic ruler perpendicular to the reinforcement bars to create the notch.*

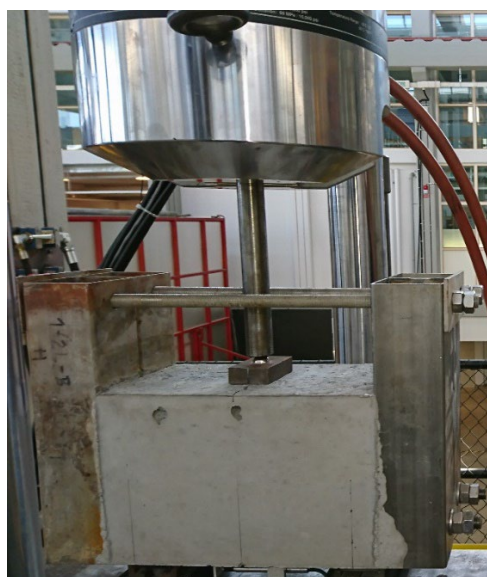
*Figure 5. Picture of a tri-axial bending test to form a crack in the notched concrete beam.*

After curing for in total 7 days the beams were subjected to a tri-axial bending test in order to form a crack at the centre of the beam. Two linear variable displacement transformers, LVDT gauges were placed over the notch in order to monitor the growth of the crack. When the crack was 0.4 mm wide, the nuts of the 16 mm steel rods at the top were firmly tightened with a wrench. This was done in order to keep the beam in a bent state and therefore keeping the crack width constant throughout the exposure procedure. After forming the crack and tightening the nuts the LVDT-gauges were removed.

In Figure 5, the tri-axial bending test setup is shown.

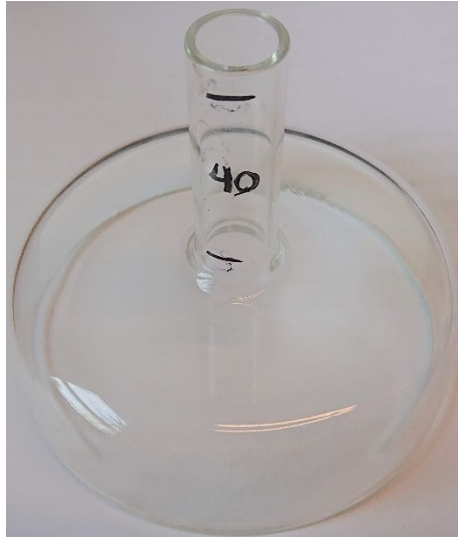
*Figure 6. Glass cup designed to be used for the permeability test.*

The permeability tests were performed 7 days after casting. A glass cup was used as a water container for the permeability test. The glass cup was made from an ordinary  $\text{Ø}100$  mm glass beaker and a  $\text{Ø}12$  mm test tube attached at the centre of the glass beaker, see Figure 6.

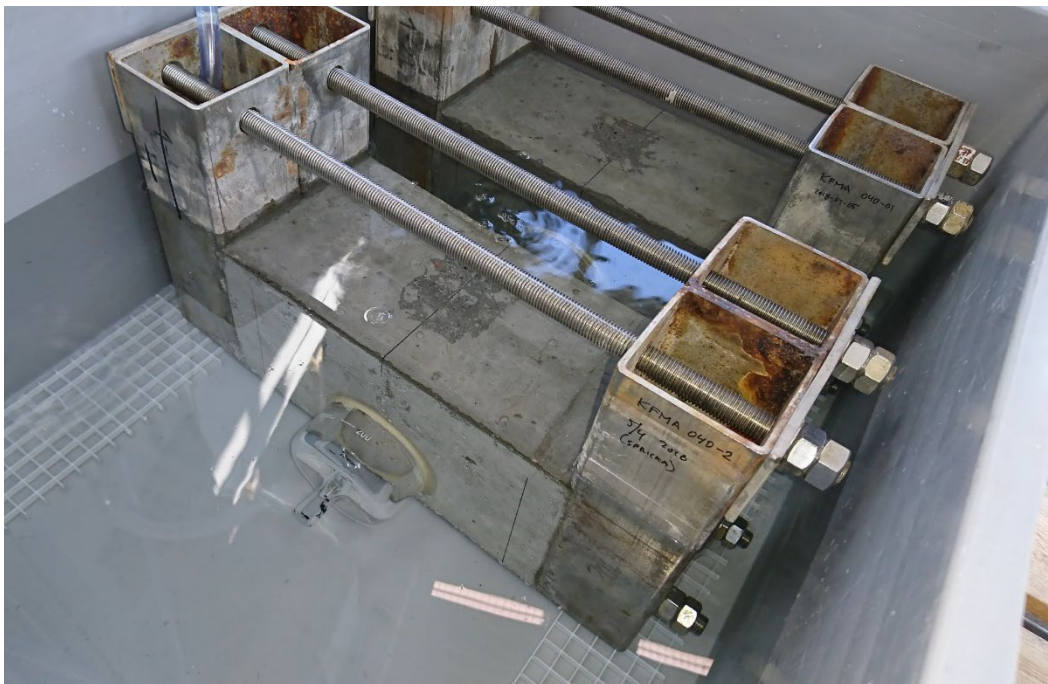
*Figure 10. Two cracked beams stored submerged in (de-ionized) water in a large polymer container.*

After performing the permeability test, the beams were submerged in de-ionized water. One beam of each pair was then kept submerged during one year, exposure climate 1, in a large polymer container, see Figure 10. The beams subjected to this exposure were labelled with a capital letter + 1, i.e. A1, B1, C1.
