## Sediment Sampling and Analysis in Rönne å at Ängelholm

Inamdeen, Fainaz; Larson, Magnus

2021

Water Resources Engineering  
Report 3243  
ISSN 1101-9824

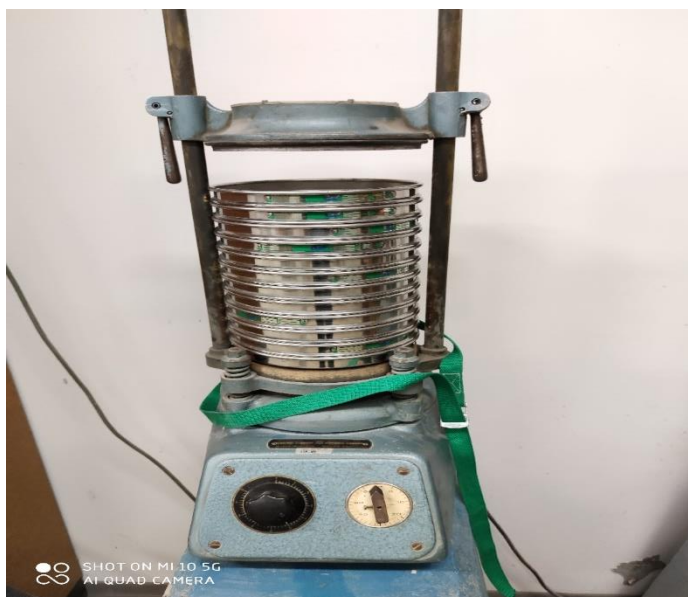
*Figure 10. Sieve set with sieve shaker*

The sampling analysis was conducted in the laboratory of Building Materials in the Department of Building and Environmental Technology at Lund University. Initially, all the samples were dried at room temperature for several days. Then the samples were qualitatively checked and clustered for visual analysis; then grain size analysis were carried out based on sample quantity and initial characteristics. This report covers the results from the particle size sieve analysis as well as the visual analysis. The finer (clay particle) sediment samples should be analyzed through sedimentation techniques, yet to be performed, see section 4. For the particle sieve analysis, ASTM standard sieves from 32 mm to 0.063 mm were used and the testing procedure was adopted with reference to ASTM D 422 standard. There were six samples subjected to particle size analysis. The particle size distribution and associated statistical analysis were performed using GRADISTAT (2021).

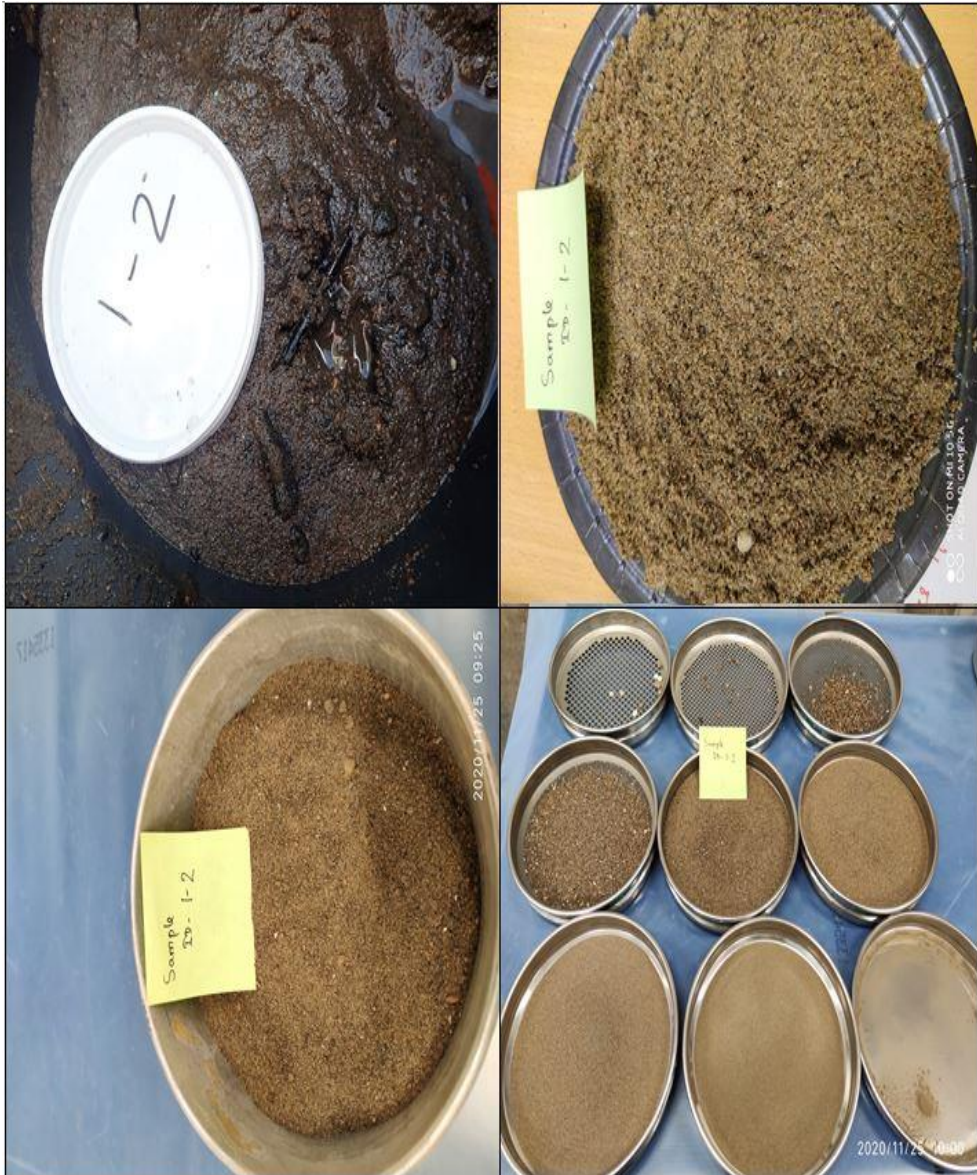
The sample 1-2 was taken adjacent to a bend scour hole (2.0 m deeper than the normal river bottom), near the river outlet to Skälderviken. This location represents an inner curve of a bend where sedimentation normally takes place (see figure 2). The sample textural group may be characterized as slightly gravelly sand.

Figure 11. Sample 1-2 during the analysis process

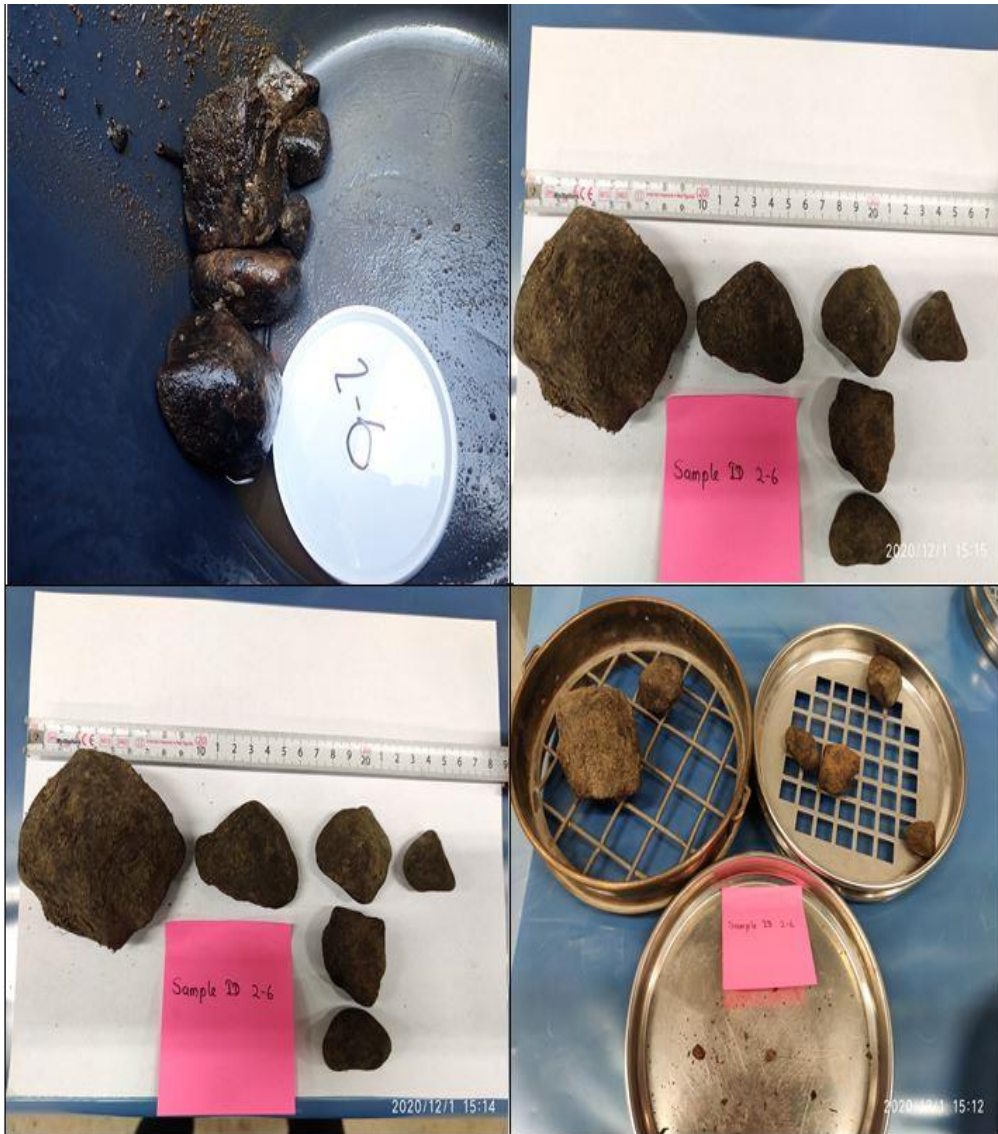
The sample 2-6 was taken from the approach section to Flygarebron (upstream) and downstream of the Skälderviken bron (see figure 3). The sample contained larger rock pieces suggesting an armored or hard bottom. The sample analysis was performed by visually means due to the sample characteristics and the quantity of material obtained.

*Figure 13. Sample 2-6 during the analysis process*

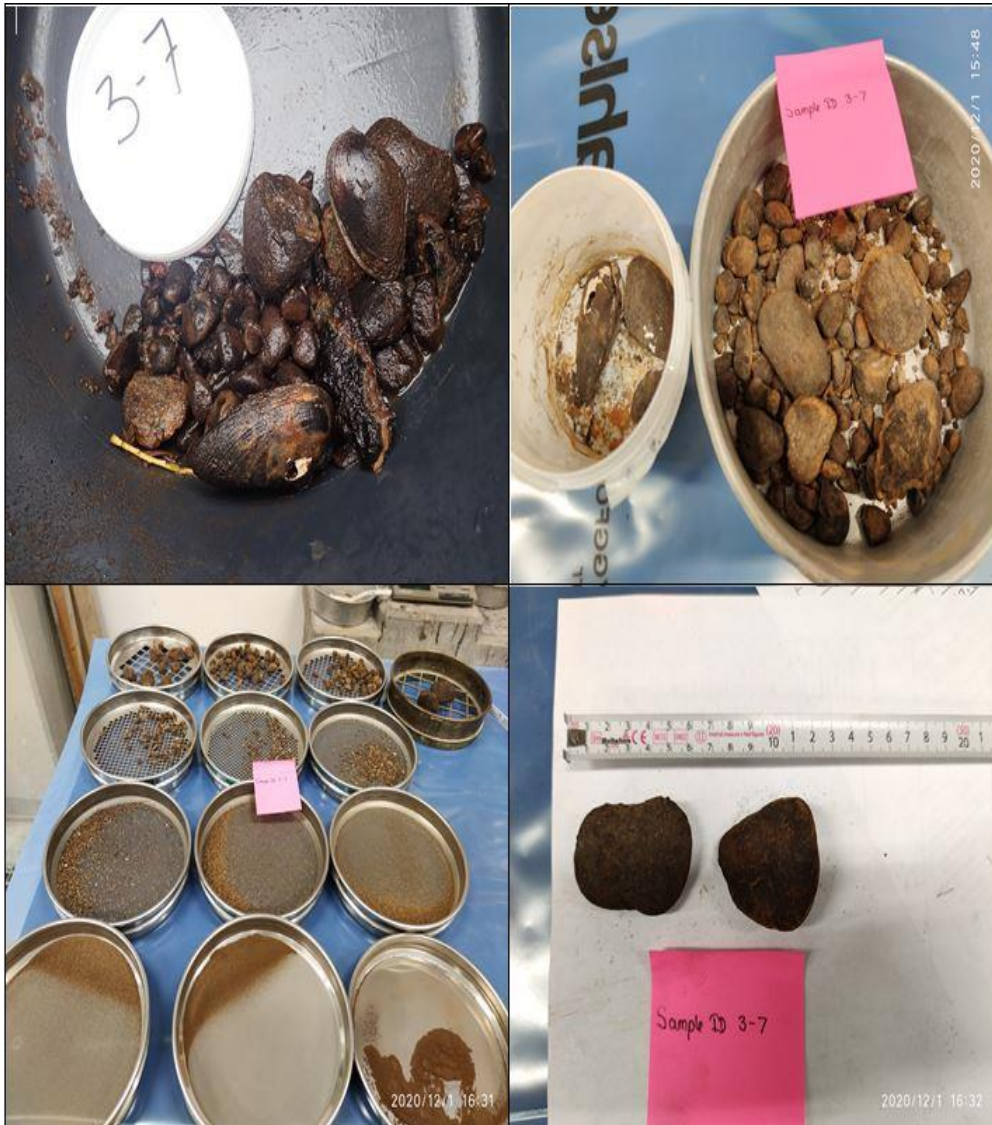
The sample 3-7 was taken from the center part of a scour hole near Järnvägsbron (see figure 4). The sample contained mussels and were not subjected to sieve analysis. The sample textural group is characterized as gravel.

Figure 14. Sample 3-7 during the analysis process

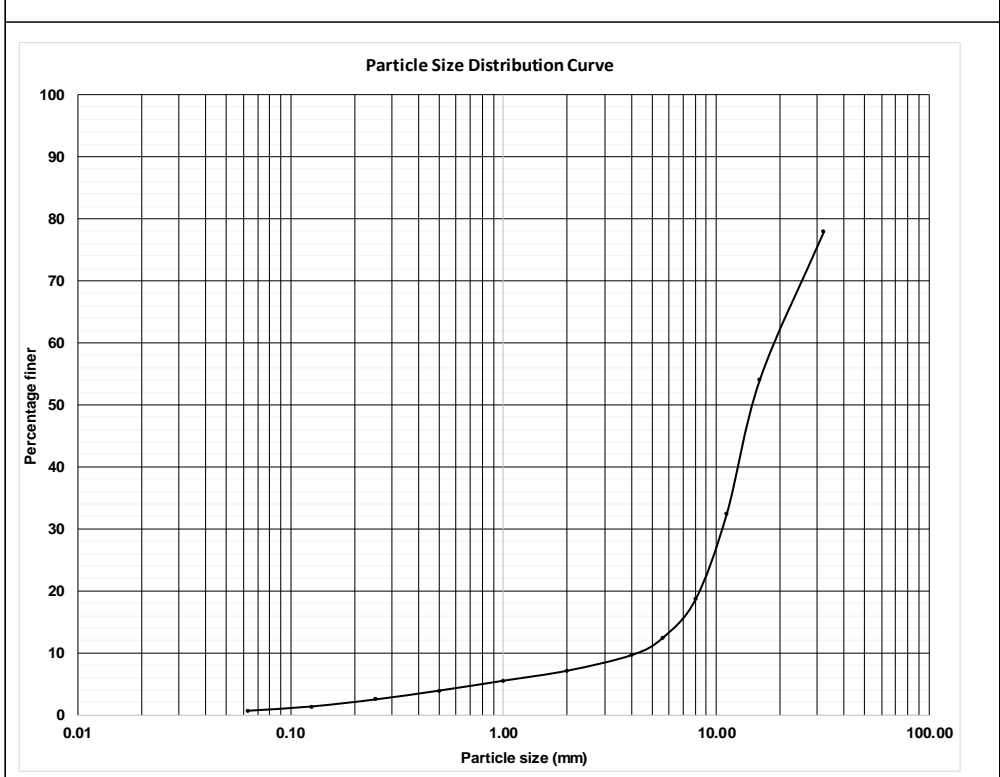
<b>SAMPLE STATISTICS</b>		
SIEVING ERROR: 0.1%		ANALYST & DATE: Fainaz Hamdeen, 1/12/2020
SAMPLE IDENTITY: <b>Sample 3-7</b>		TEXTURAL GROUP: Gravel
SAMPLE TYPE: Unimodal, Well Sorted		
SEDIMENT NAME: Coarse Gravel

mm		$\phi$		GRAIN SIZE DISTRIBUTION	
MODE 1:		13.60		-3.743		GRAVEL: 92.9%	COARSE SAND: 1.6%
MODE 2:						SAND: 6.5%	MEDIUM SAND: 1.4%
MODE 3:						MUD: 0.7%	FINE SAND: 1.1%
D <sub>10</sub> :		4.18		-5.831			V FINE SAND: 0.7%
MEDIAN or D <sub>50</sub> :		14.96		-3.904		V COARSE GRAVEL: 0.0%	V COARSE SILT: 0.1%
D <sub>90</sub> :		56.92		-2.062		COARSE GRAVEL: 45.9%	COARSE SILT: 0.1%
(D <sub>90</sub> / D <sub>10</sub> ):		13.63		0.354		MEDIUM GRAVEL: 35.4%	MEDIUM SILT: 0.1%
(D <sub>90</sub> - D <sub>10</sub> ):		52.74		3.769		FINE GRAVEL: 9.0%	FINE SILT: 0.1%
(D <sub>75</sub> / D <sub>25</sub> ):		3.15		0.661		V FINE GRAVEL: 2.5%	V FINE SILT: 0.1%
(D <sub>75</sub> - D <sub>25</sub> ):		20.03		1.653		V COARSE SAND: 1.6%	CLAY: 0.1%

Figure 15. Sample 3-7 sieve analysis results

Sample ID	$D_{50}$ (mm)	$D_{90}$ (mm)	$D_{10}$ (mm)	Textural group
1-2	0.59	1.36	0.27	Slightly gravelly sand
3-7	14.96	56.92	4.18	Gravel
4-9	0.72	2.99	0.27	Gravelly sand
4-10	0.75	10.51	0.17	Sandy gravel
6-14	1.51	3.33	0.53	Sandy gravel
7-17	0.81	1.69	0.43	Slightly gravelly sand

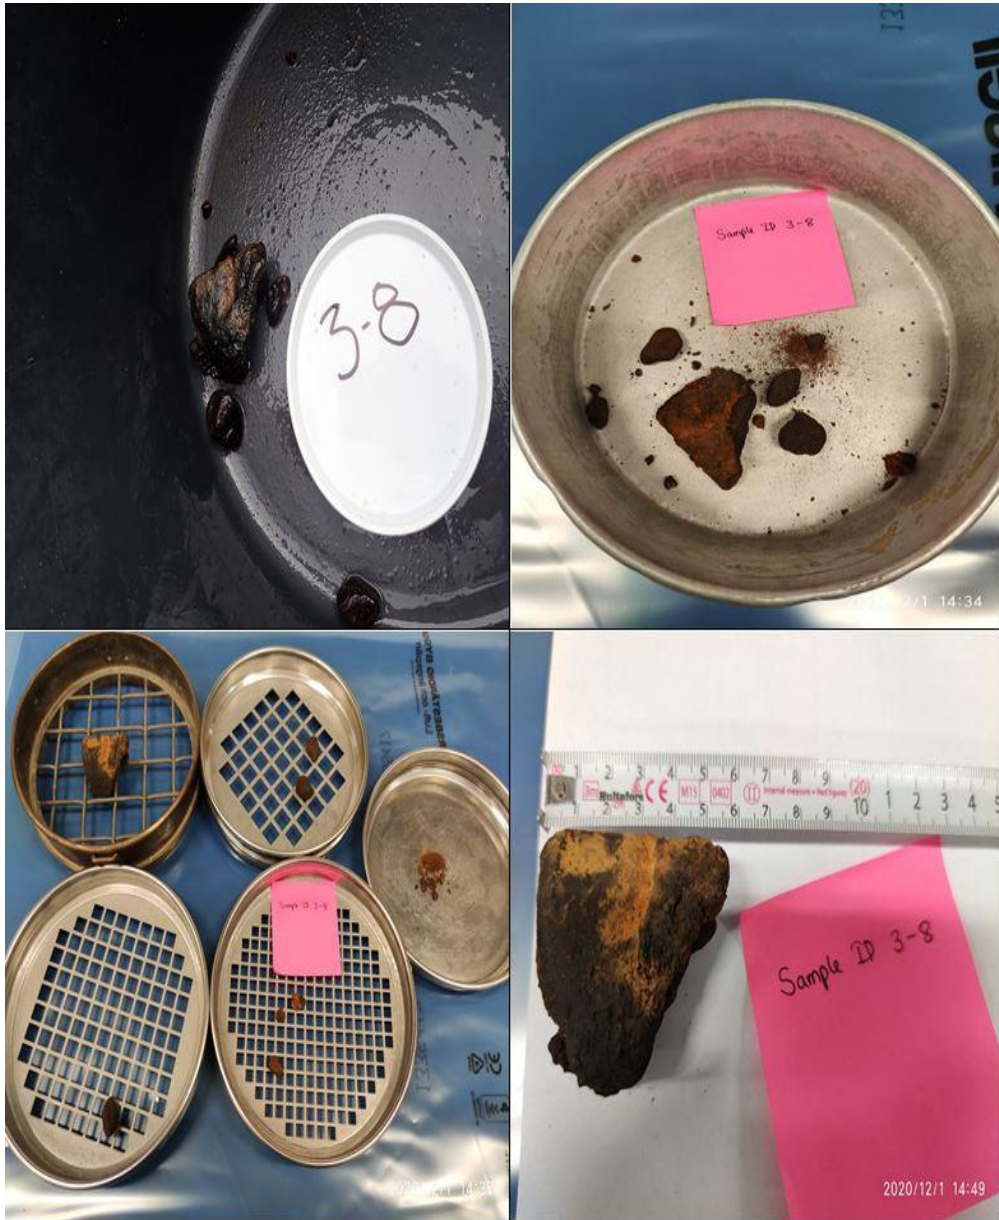
The sample 3-8 was taken upstream of a scour hole (2.0 m deeper than the normal river bottom), downstream Järnvägsbron (see figure 4). The sample contained larger rock pieces, which suggested hard bottom. The sample analysis was performed visually because of the sample characteristics and obtained quantity of material.

Figure 16. Sample 3-8 during the analysis process

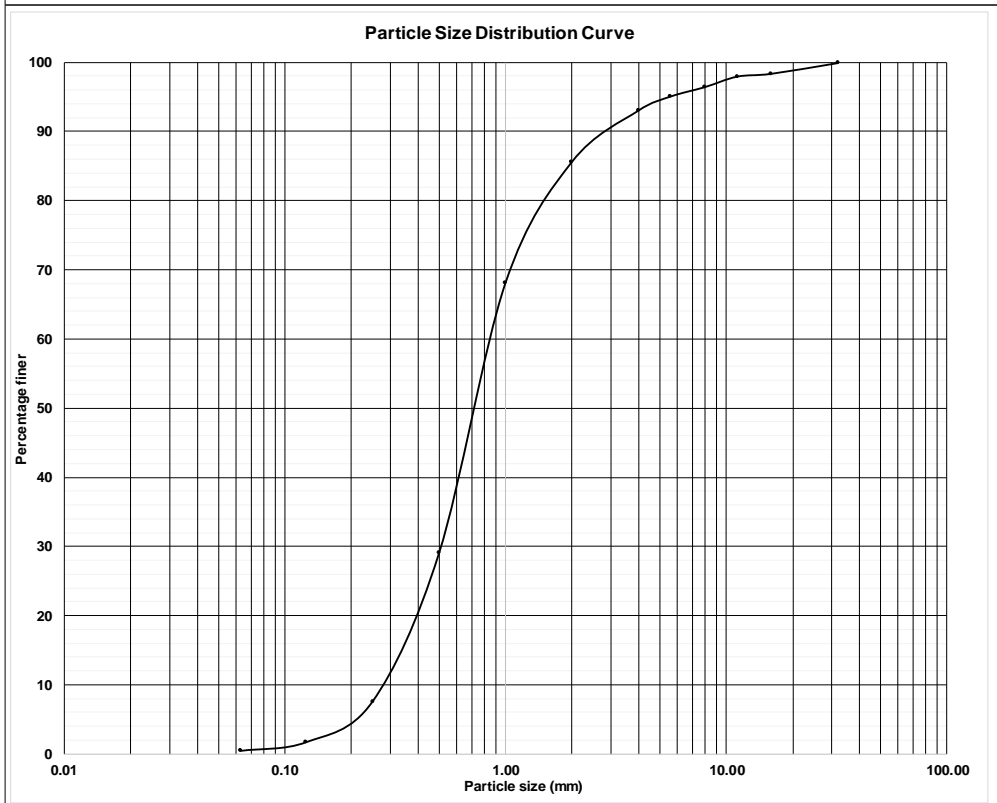
<b>SAMPLE STATISTICS</b>		
SIEVING ERROR: 0.1%		ANALYST & DATE: Fainaz Inamdeen, 23/11/2020
SAMPLE IDENTITY: <b>Sample 4-9</b>		TEXTURAL GROUP: Gravelly Sand
SAMPLE TYPE: Unimodal, Poorly Sorted		
SEDIMENT NAME: Very Fine Gravelly Coarse Sand

mm	$\phi$
MODE 1:	0.75	0.500
MODE 2:		
MODE 3:		
D <sub>10</sub> :	0.27	-1.579
MEDIAN or D <sub>50</sub> :	0.72	0.465
D <sub>90</sub> :	2.99	1.888
(D <sub>90</sub> / D <sub>10</sub> ):	11.06	-1.196
(D <sub>90</sub> - D <sub>10</sub> ):	2.72	3.468
(D <sub>75</sub> / D <sub>25</sub> ):	2.99	-3.054
(D <sub>75</sub> - D <sub>25</sub> ):	0.87	1.579

GRAIN SIZE DISTRIBUTION	
GRAVEL: 14.3%	COARSE SAND: 39.1%
SAND: 85.2%	MEDIUM SAND: 21.5%
MUD: 0.5%	FINE SAND: 5.9%
	V FINE SAND: 1.3%
V COARSE GRAVEL: 0.0%	V COARSE SILT: 0.1%
COARSE GRAVEL: 1.6%	COARSE SILT: 0.1%
MEDIUM GRAVEL: 1.9%	MEDIUM SILT: 0.1%
FINE GRAVEL: 3.4%	FINE SILT: 0.1%
V FINE GRAVEL: 7.4%	V FINE SILT: 0.1%
V COARSE SAND: 17.5%	CLAY: 0.1%

Figure 18. Sample 4-9 sieve analysis results

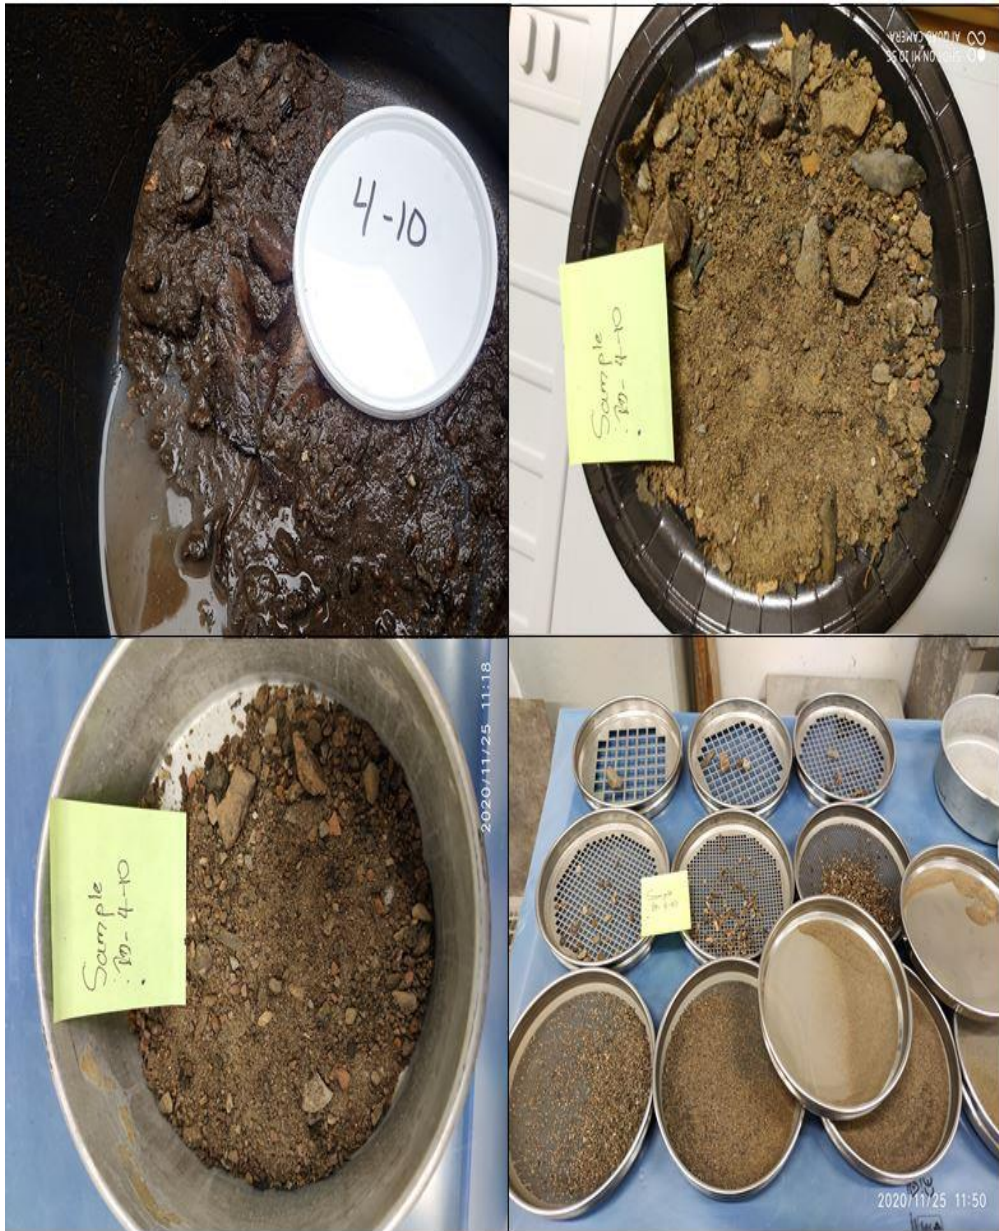
The sample 4-10 was taken from center part of a scour hole (3.5 m deeper than the normal river bottom), under Tullportsbron (see figure 5). The sample textural group is characterized as sandy gravel.

Figure 19. Sample 4-10 during the analysis process

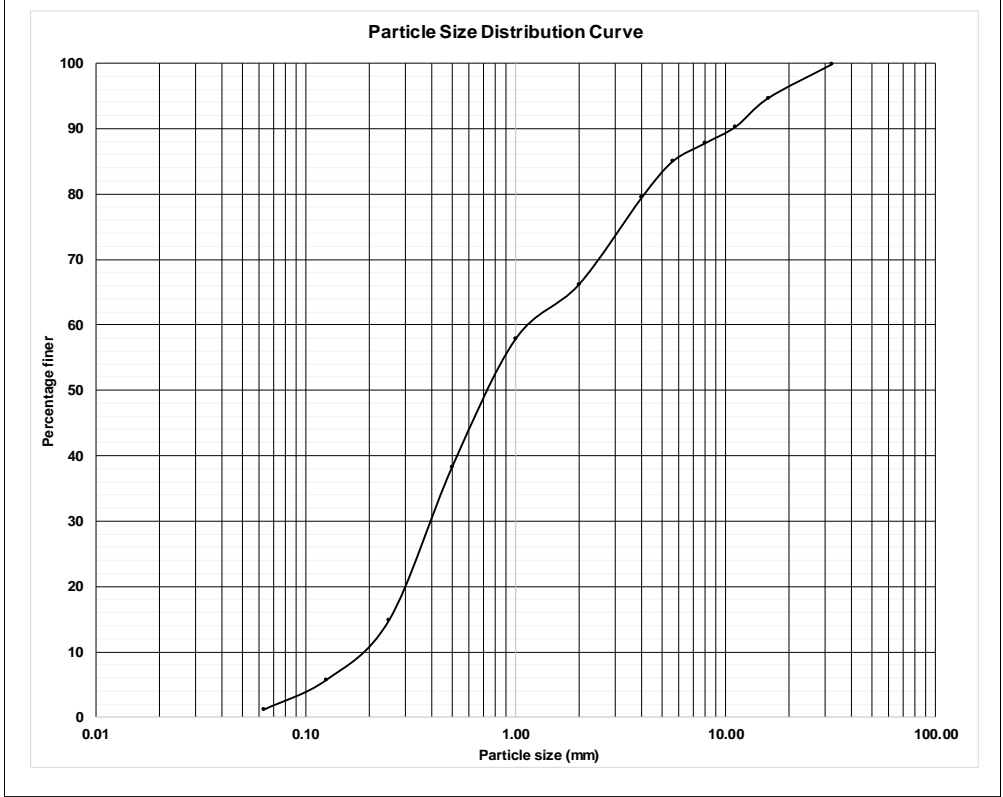
<b>SAMPLE STATISTICS</b>		
SEIVING ERROR: 0.2%		ANALYST & DATE: Fainaz Inamdeen, 25/11/2020
SAMPLE IDENTITY: <b>Sample 4-10</b>		TEXTURAL GROUP: Sandy Gravel
SAMPLE TYPE: Trimodal, Very Poorly Sorted		
SEDIMENT NAME: Sandy Very Fine Gravel

mm	$\phi$
MODE 1:	0.38	1.500
MODE 2:	3.00	-1.500
MODE 3:	13.60	-3.743
D <sub>10</sub> :	0.17	-3.394
MEDIAN or D <sub>50</sub> :	0.75	0.406
D <sub>90</sub> :	10.51	2.532
(D <sub>90</sub> / D <sub>10</sub> ):	60.79	-0.746
(D <sub>90</sub> - D <sub>10</sub> ):	10.34	5.926
(D <sub>75</sub> / D <sub>25</sub> ):	9.34	-0.950
(D <sub>75</sub> - D <sub>25</sub> ):	2.81	3.223

GRAIN SIZE DISTRIBUTION	
GRAVEL: 33.7%	COARSE SAND: 19.5%
SAND: 65.1%	MEDIUM SAND: 23.5%
MUD: 1.2%	FINE SAND: 9.2%
	V FINE SAND: 4.5%
V COARSE GRAVEL: 0.0%	V COARSE SILT: 0.2%
COARSE GRAVEL: 5.1%	COARSE SILT: 0.2%
MEDIUM GRAVEL: 6.9%	MEDIUM SILT: 0.2%
FINE GRAVEL: 8.3%	FINE SILT: 0.2%
V FINE GRAVEL: 13.4%	V FINE SILT: 0.2%
V COARSE SAND: 8.3%	CLAY: 0.2%

Figure 20. Sample 4-10 sieve analysis results

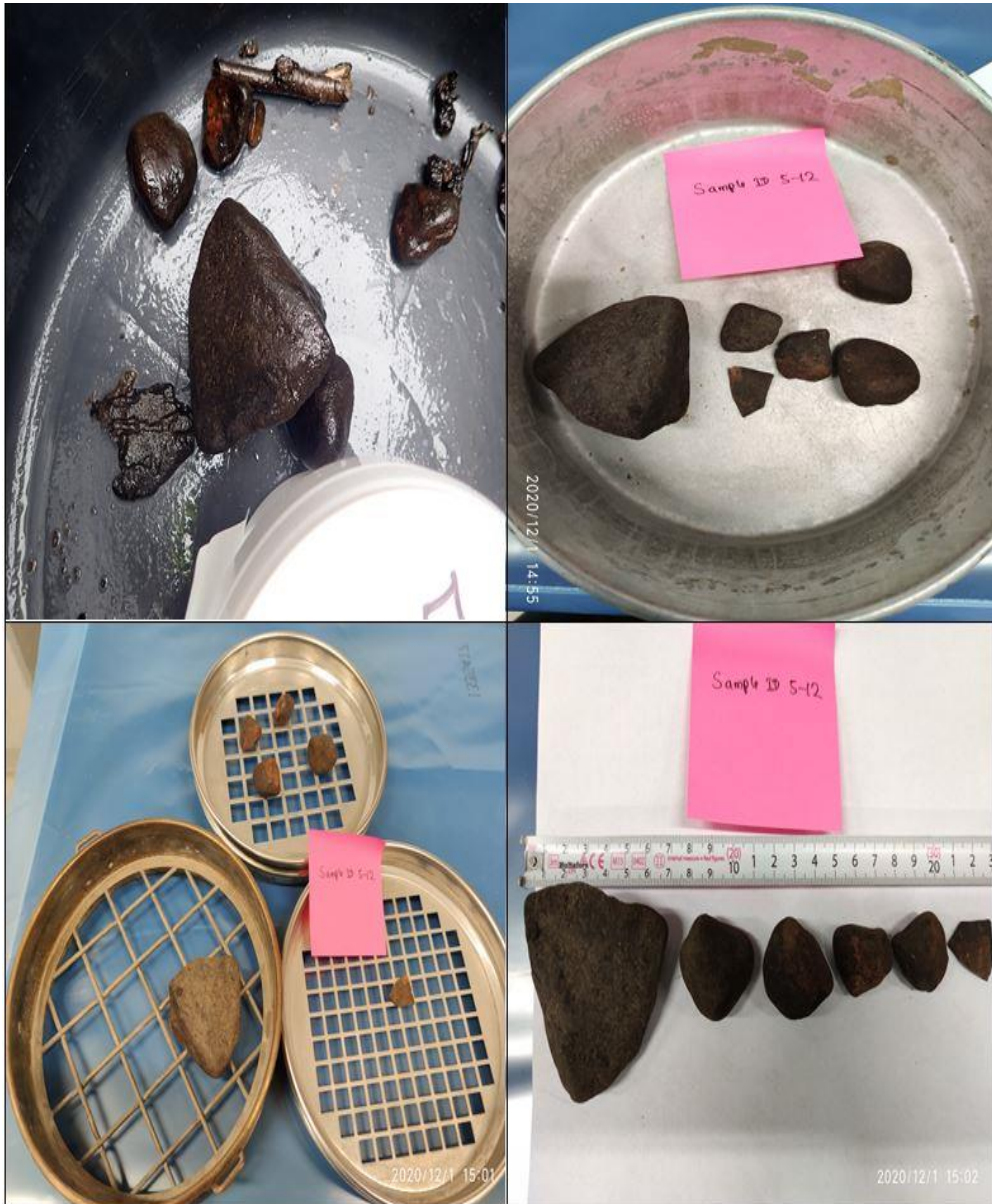
The sample 5-12 was taken from the center part of a scour hole (3.5 m deeper than the normal river bottom), near Carl XV bridge (see figure 6). The sample analysis was performed visually due to the sample characteristics and sample quantity. The sample suggests that the particular bottom is hard and contains larger rock particles.

Figure 21. Sample 5-12 during the analysis process

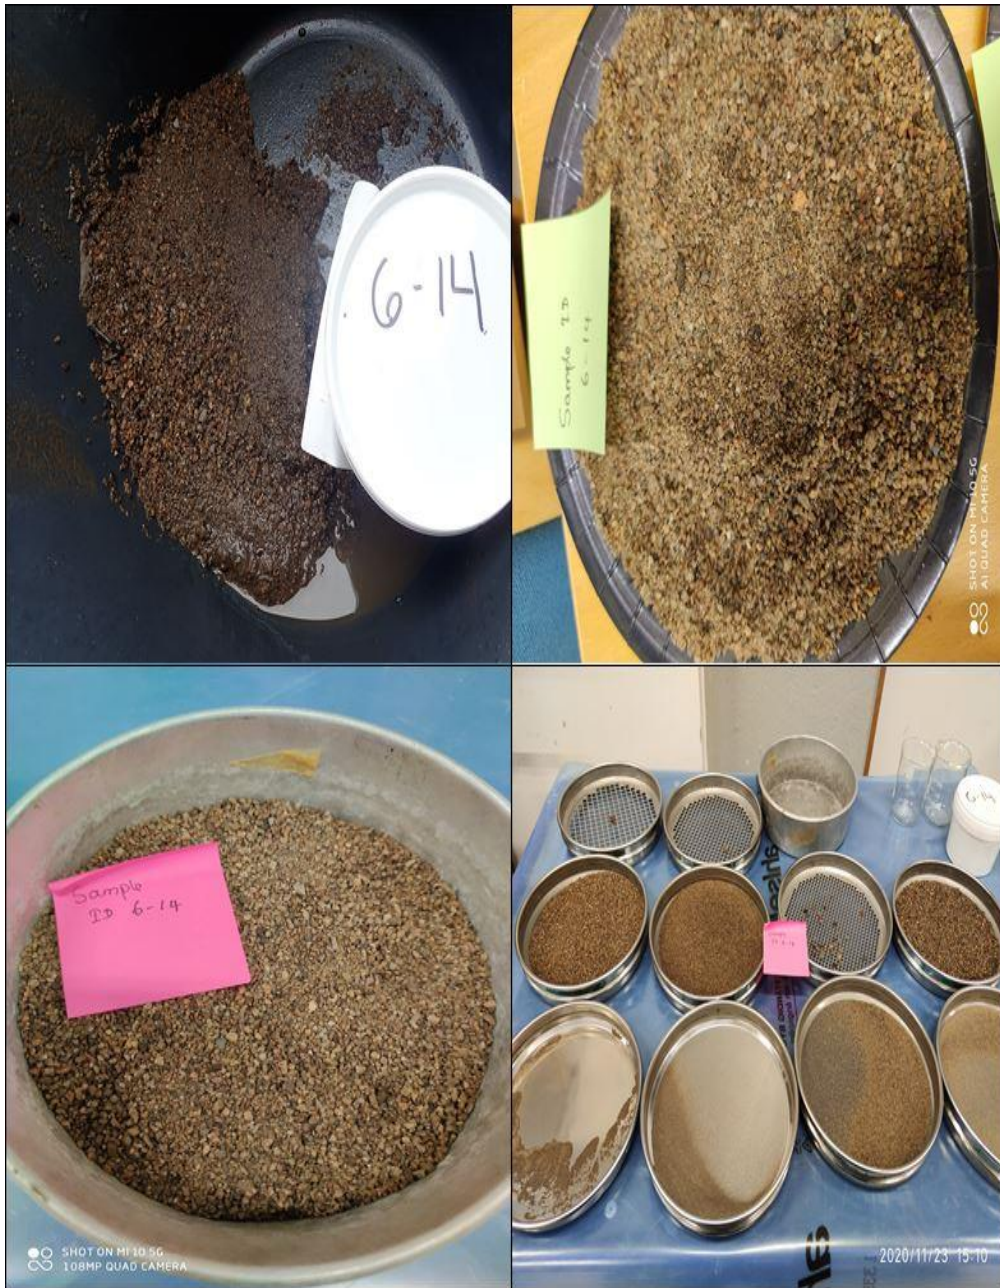
The sample 6-14 was taken from the center part of a scour hole (1.5 m deeper than the normal river bottom), downstream to Kristian II bron (see figure 7). The sample textural group is characterized as sandy gravel.

Figure 22. Sample 6-14 during the analysis process

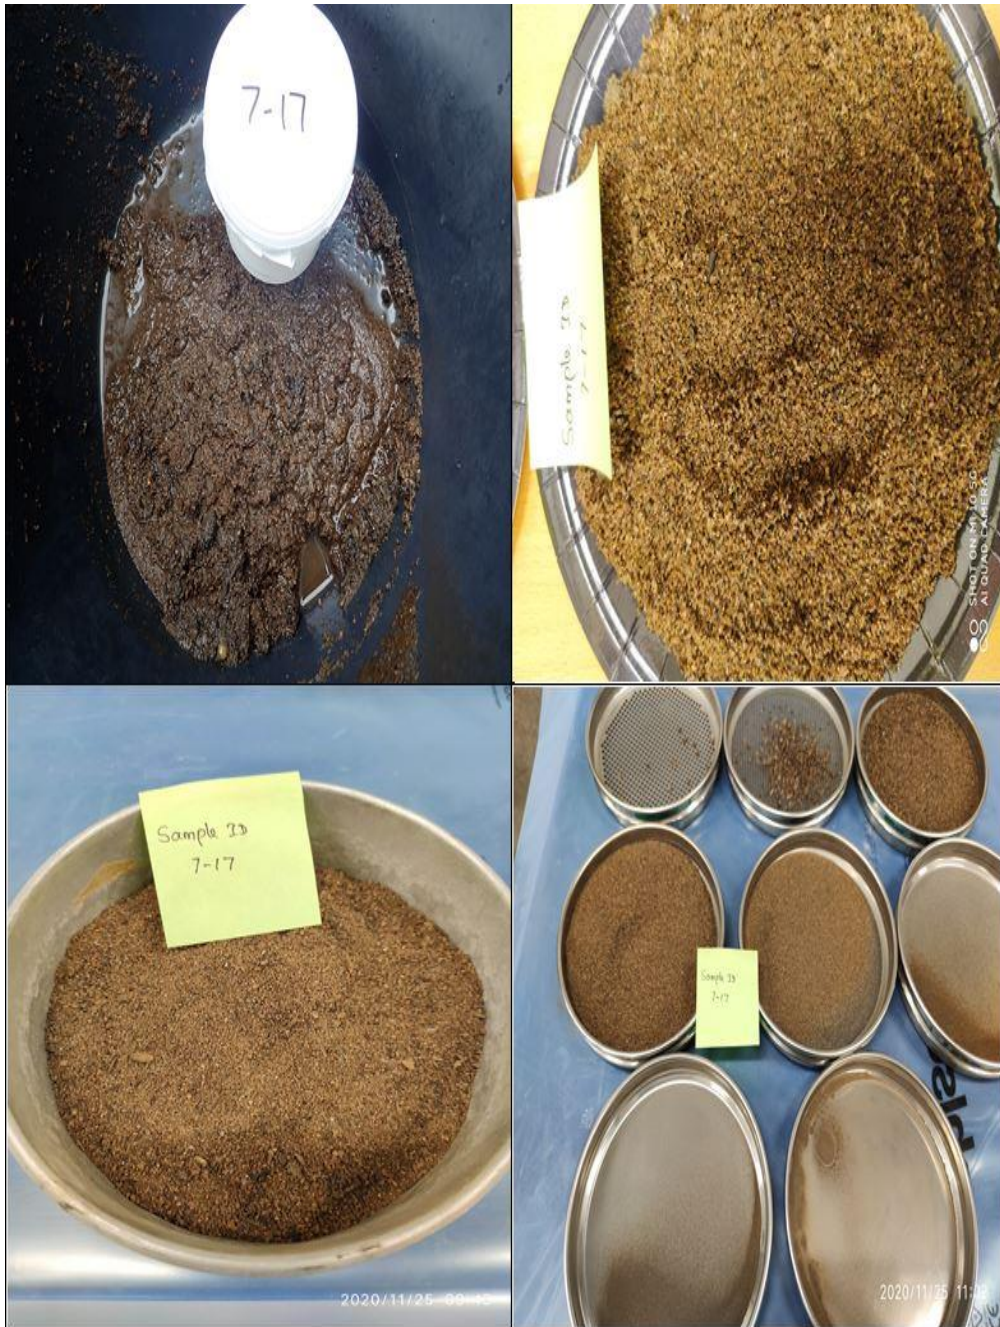
The sample 7-17 was taken from the upstream part of a scour hole and near a sharp river bend where a riffle feature can be expected (see figure 8). The sample textural group is characterized as slightly gravelly sand.

Figure 24. Sample 7-17 during the analysis process

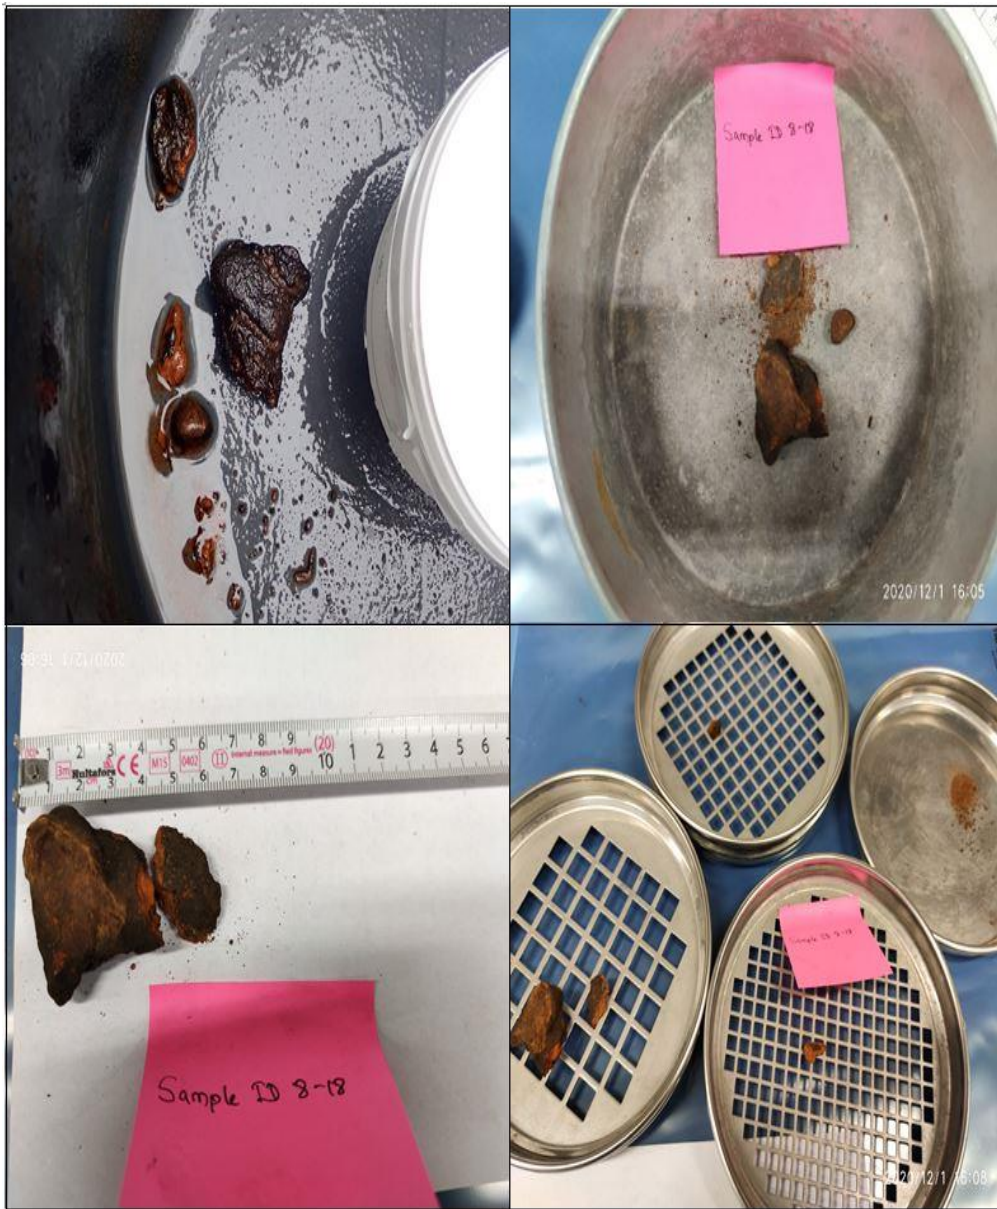
The sample 8-18 was taken from the upstream part of a scour hole and near a river bend (see figure 9). Hard bottom features were expected before the sample was taken because of the formation of surrounding scour hole and adjacent river bathymetry. The sample analysis was performed visually due to lack of a sufficient sample quantity. The sample suggests that the particular bottom is hard and formed by claystone or siltstone.

Figure 26. Sample 8-18 during the analysis process

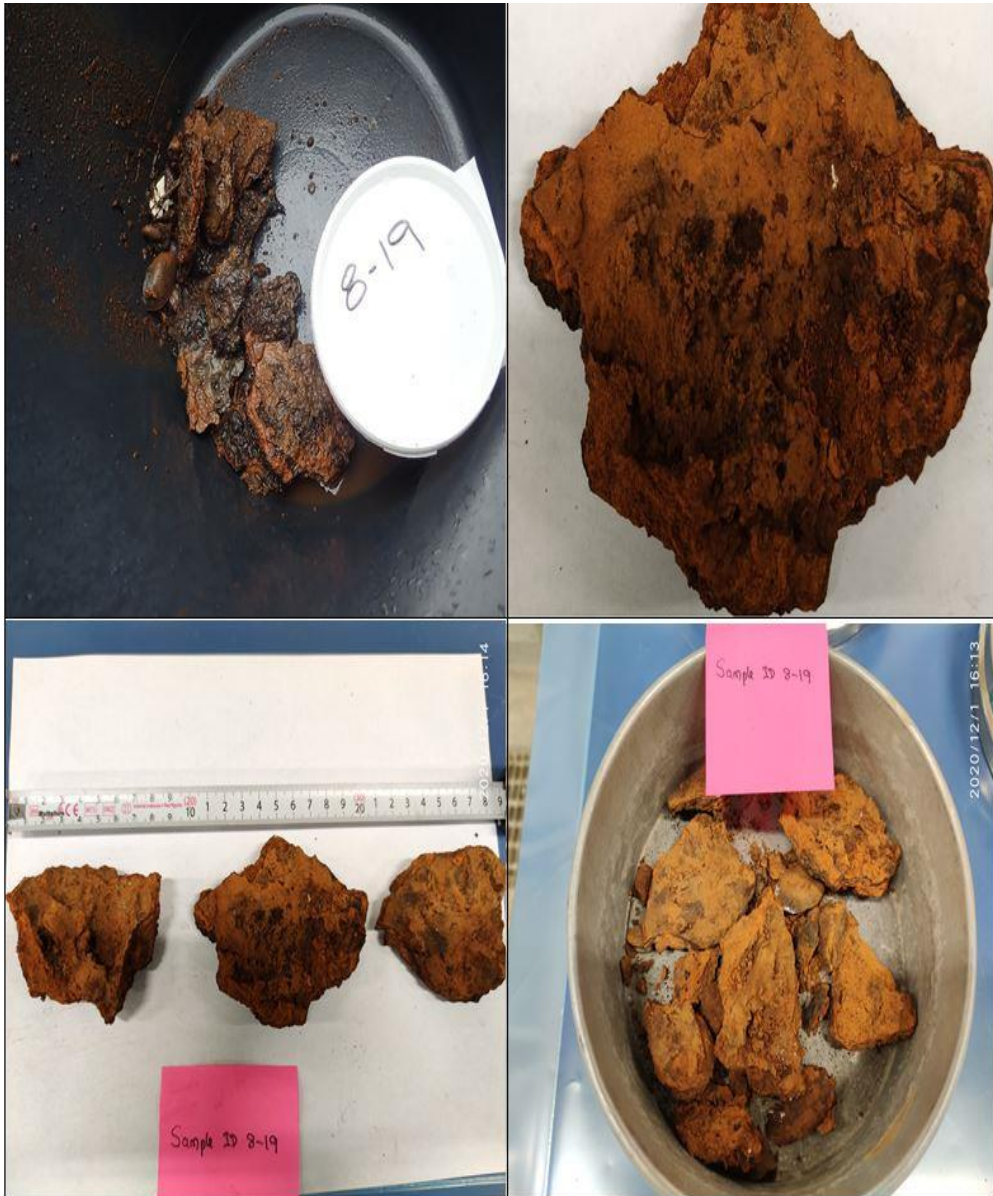
The sample 8-19 was taken from center part of a scour hole (1.3 m deeper than the normal river bottom), near a river bend (see figure 9). The sample analysis was performed visually due to the sample characteristics. The sample suggests that the particular bottom is hard and layered by claystone or siltstone. Some eroding features are indicated at the top surface of the hard bottom.

Figure 27. Sample 8-19 during the analysis process
