## Frost-induced deterioration of concrete in hydraulic structures

### Interactions between water absorption, leaching and frost action

ROSENQVIST, MARTIN

2016

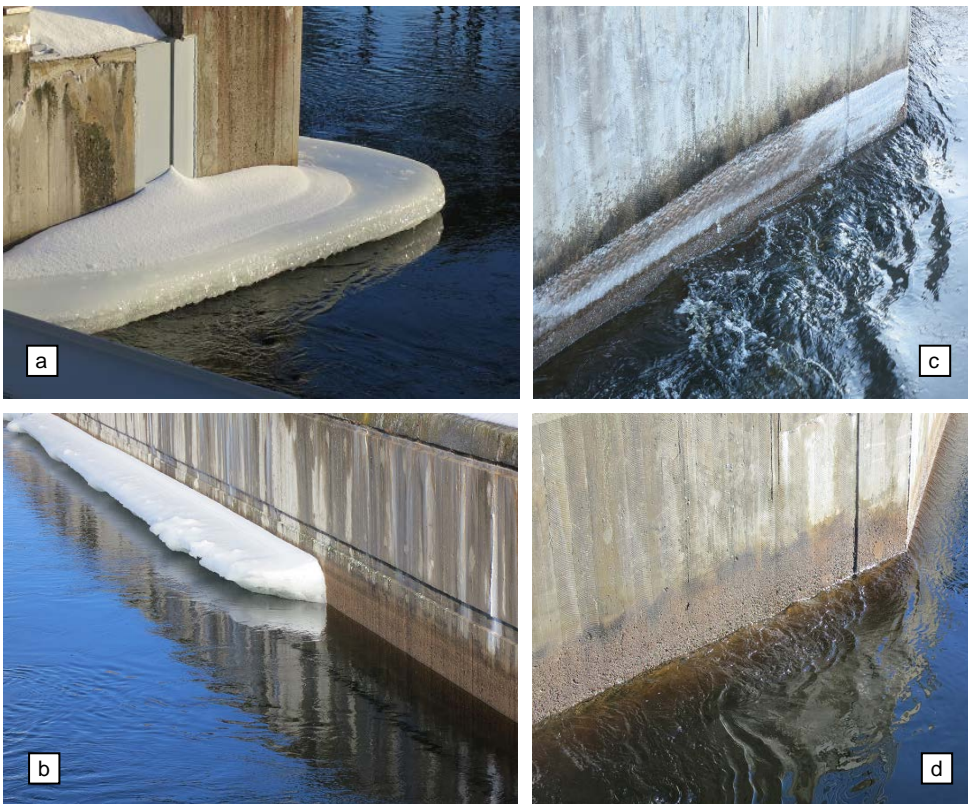
**Figure 2-3. In winter, a band of ice frozen solid to the concrete surface can be seen at the waterline of hydraulic structures (a). In spring, the band of ice falls off when the air temperature rises (b). In both spring and autumn, the air temperature frequently crosses the freezing point of water. A small band of ice can therefore be seen at the waterline in the morning (c) while it has been melted away in the evening (d).**

The band of ice falls off when the air temperature starts to rise in spring (Figure 2-3 b). However, as previously mentioned, the air temperature frequently crosses the freezing point of water in spring and autumn. Depending on the air temperatures, the band of ice can be re-formed during the nights and later melted away during the days (Figure 2-3 c-d).

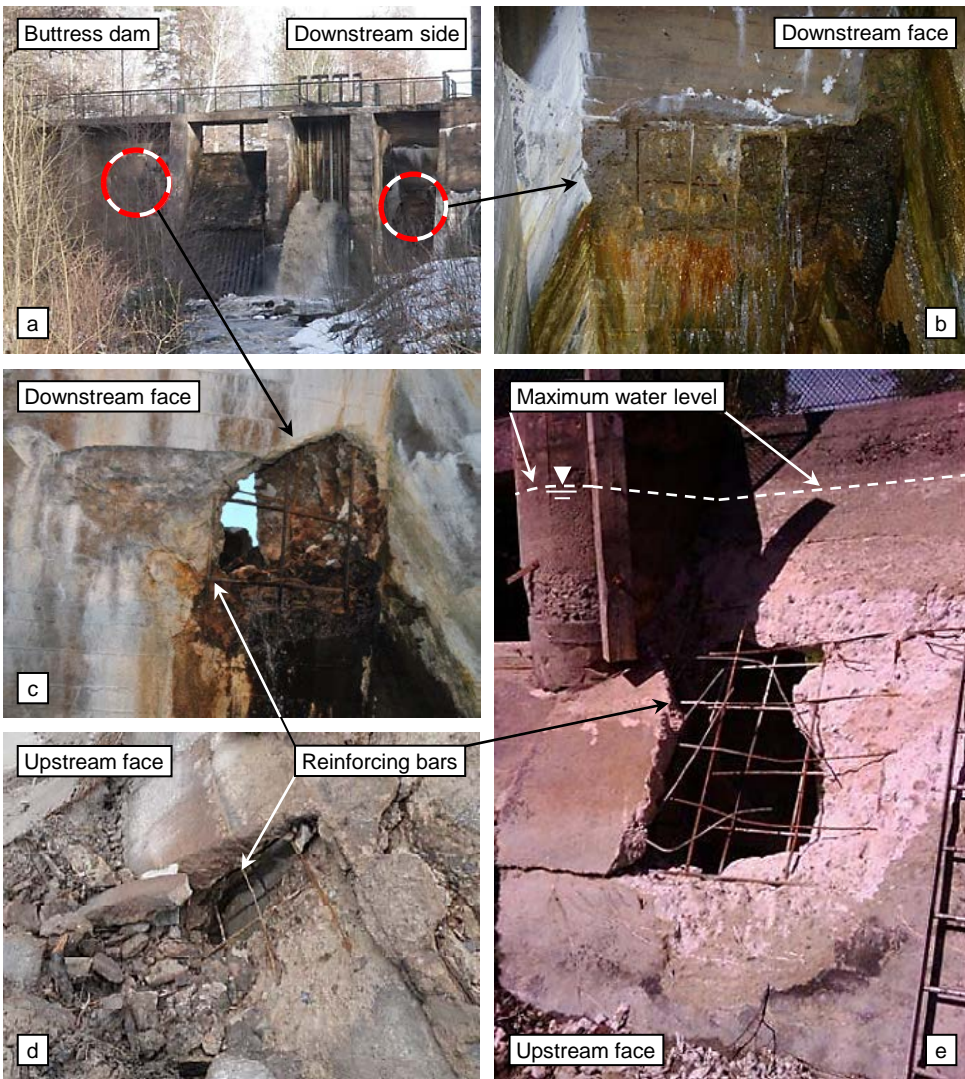
**Figure 2-11. A severely damaged buttress dam (a). Concrete cover missing in some places in the vicinity of water leakage through cracks on the downstream face (b). A hole appeared in the flat slab in another place and water escaped flushing away loose pieces of concrete (c–e). Only the reinforcing steel was left. Photos provided by Fortum AB.**

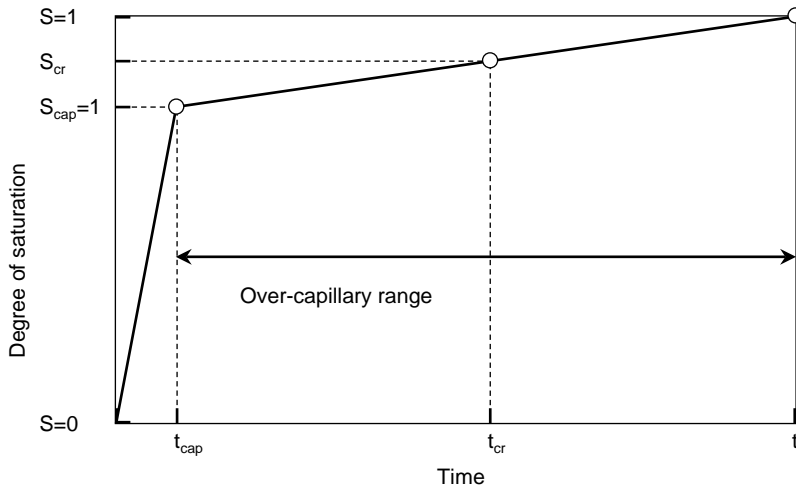
**Figure 3-4. Water absorption of concrete as a function of time. The critical degree of saturation ( $S_{cr}$ ) prevails at the critical time ( $t_{cr}$ ).**

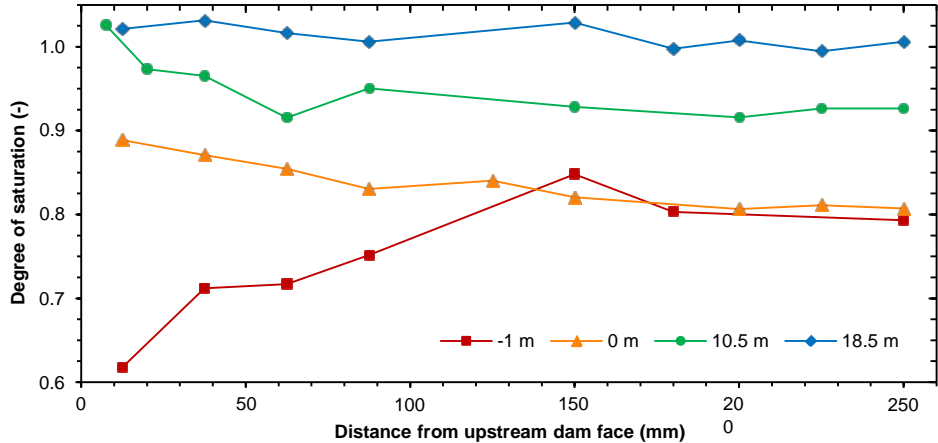
**Figure 7-3. Saturation levels in the concrete from the upstream face of the concrete dam shown in Figure 2-9 (b).**
