Service Life Assessment of Harbor Structures - Case studies of chloride ingress into concrete and sheet piling corrosion rates

Wall, H. (2013). *Service Life Assessment of Harbor Structures - Case studies of chloride ingress into concrete and sheet piling corrosion rates*. [Doctoral Thesis (compilation), Division of Building Materials]. Division of Building Materials, LTH, Lund University.

Service Life Assessment of Harbor Structures

Case studies of chloride ingress into concrete structures
and sheet piling corrosion rates

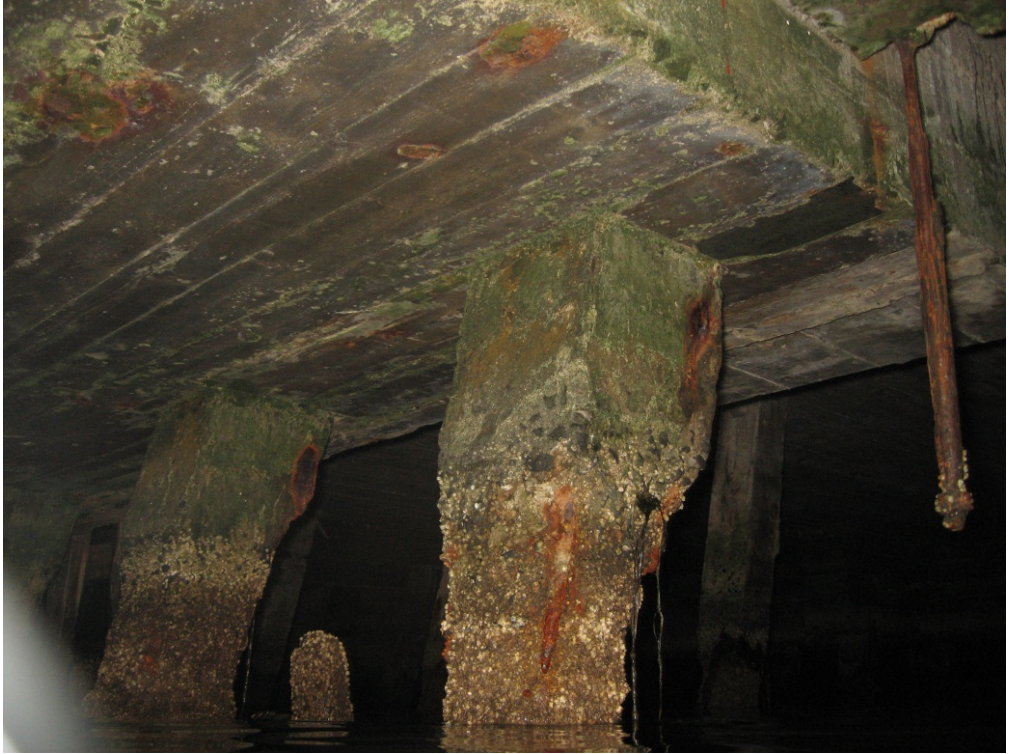
Figure 1
Damages on concrete piles on the underside of a concrete quay.

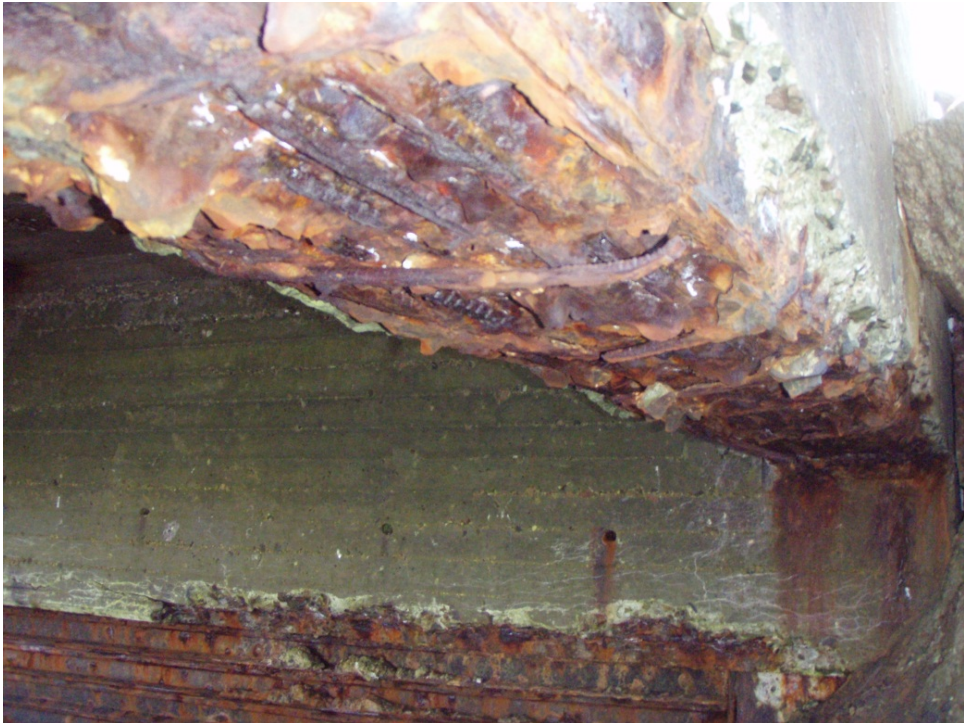
Figure 3
Corroded reinforcement bars with spalled concrete cover on a load carrying concrete beam in a quay deck.

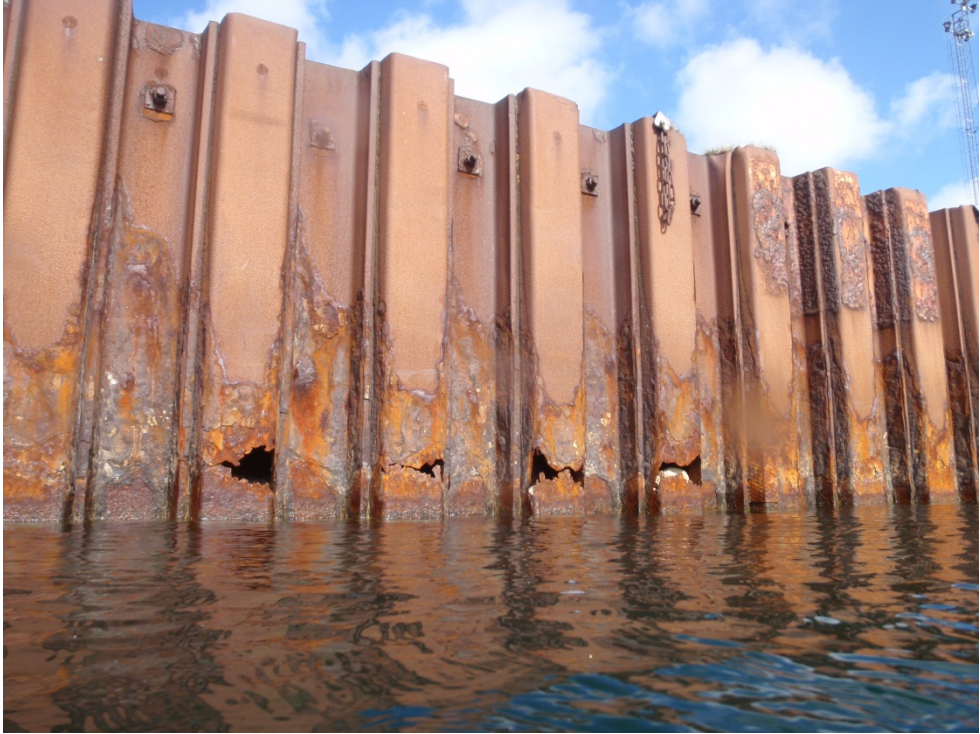
Figure 4
Typical corrosion pattern in the water line on a sheet pile wall. The backfill is visible through the holes in the piles.

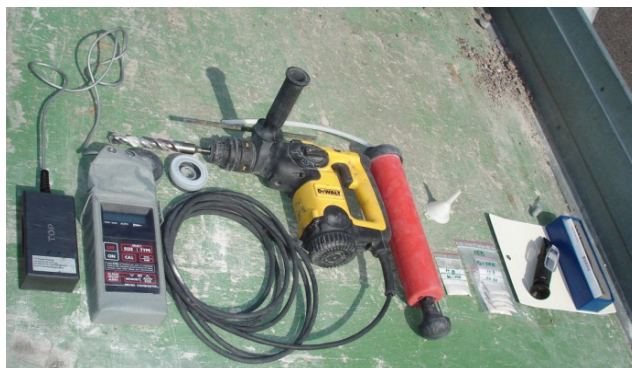
Figure 17

The dust sampling was performed with a hand held drilling machine, see Figure 17, with a 20 mm drill and the dust sampling interval was set to 20 mm with a maximum depth of 100 mm below the concrete surface. Between every interval, the holes were cleaned with a small brush and a hand held air blower. Three boreholes were drilled in every sampling point which means 15 boreholes in total. The distance between the boreholes in every sampling point was less than 200 mm, and the location was selected in homogeneous concrete without any signs of cracks or other visual damages.

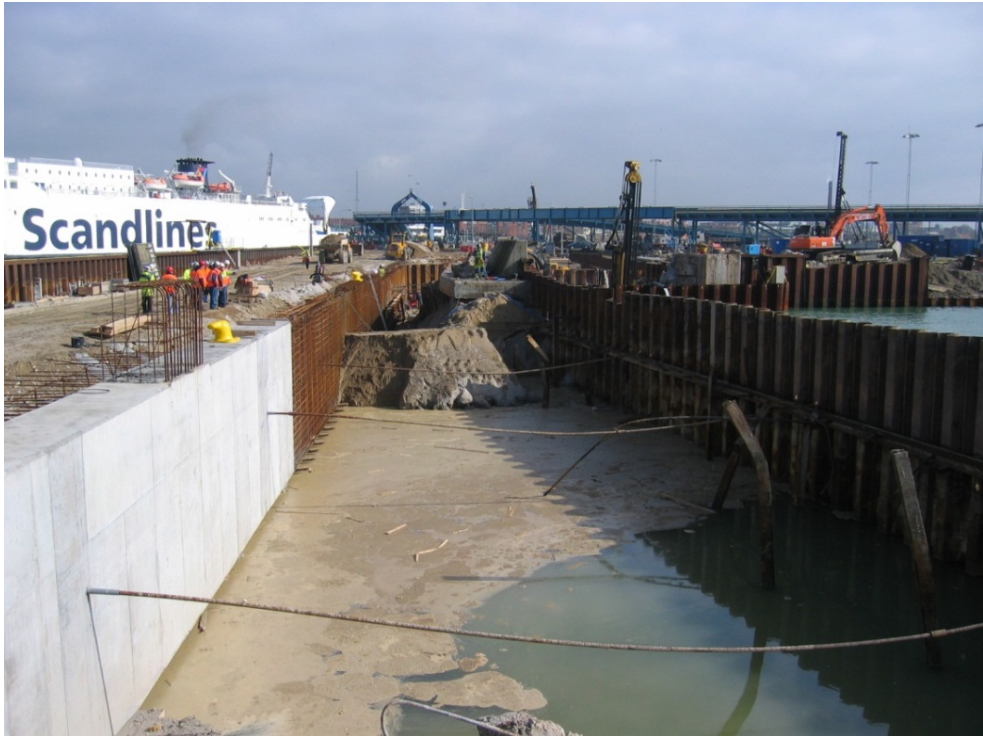
The most common quay structure today is the steel sheet pile with a cap beam of reinforced concrete (the principles of design is described in reference [6] and below), Figure 28 which shows the building of a sheet pile quay during construction behind an older existing wall.

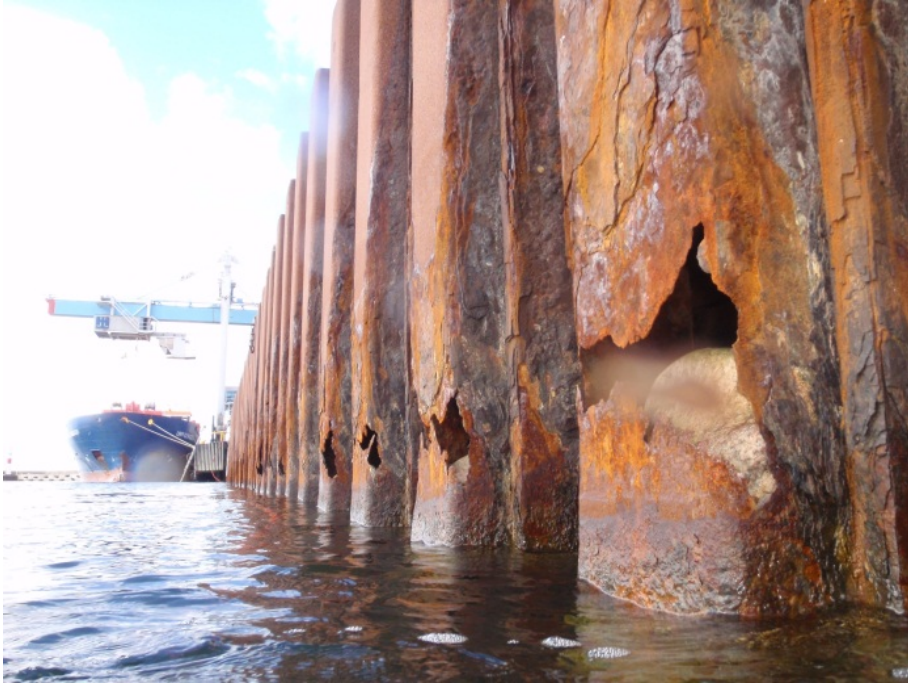
A large share of the existing quay structures in use today are steel sheet pile constructions. Many of these quays have reached an age of 60-70 years and often suffer from severe corrosion, cf. figure 29. Due to the increasing volume of transported goods in the harbors, the loads on the quay decks also tend to increase and the actual loads on old quay decks sometimes exceed the design loads, which can lead to a collapse of these structures.

Figure 29
Sheet pile wall on the Swedish west coast suffering from severe corrosion.

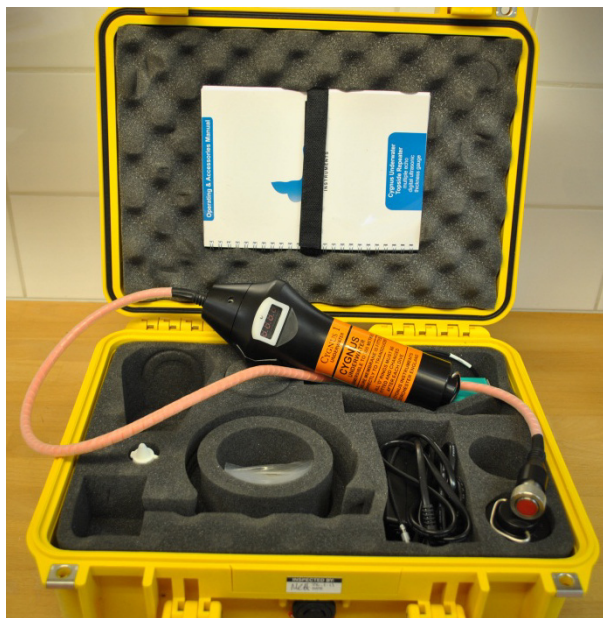
The measurements presented in this thesis have been performed with an ultrasonic thickness gauge (Cygnus Underwater, Cygnus Instruments Ltd., Dorchester, UK), Figure 33. The accuracy of the instrument is ± 0.1 mm according to the manufacturer. The device uses a triple echo verification, which means that no thickness value is displayed unless the time for three consecutive bounces of the ultrasonic signal are equal.

Figure 33
Ultra-sonic probe by Cygnus Instruments Ltd., Dorchester, UK.

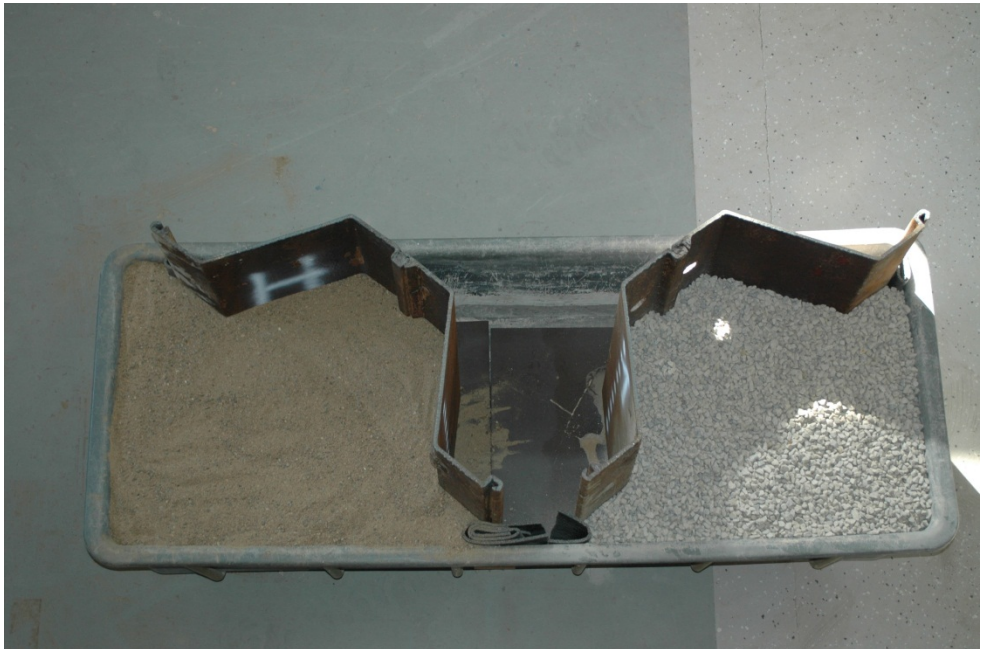
Figure 34

Arrangement for testing the ultrasonic gauge in the laboratory. Sheet pile with a fine backfill on the left and with a coarse backfill on the right.

The ultrasonic gauge was tested in the laboratory under different conditions. The test was performed with the purpose of investigating the reliability of the measuring method. The following conditions were tested (Figure 34):

- Sheet pile with no filling
- Sheet pile with coarse filling behind (12-16 mm quartzite)
- Sheet pile with fine filling behind (0-8 mm natural sand)
- Sheet pile with coarse filling behind and water on both sides
- Sheet pile with fine filling behind and water on both sides

The height of the tested sheet piles were approximately 1 m and the measurements were performed at three locations on both sets of sheet piles – on the outer web, on the flange and on the inner web. The profile tested was sheet pile AZ 18-10/10 with nominal web and flange thicknesses of 10 mm. The sheet piles were evenly corroded and had been used in a provisional retaining wall during a construction work. The remaining steel thickness was slightly less than 10 mm.

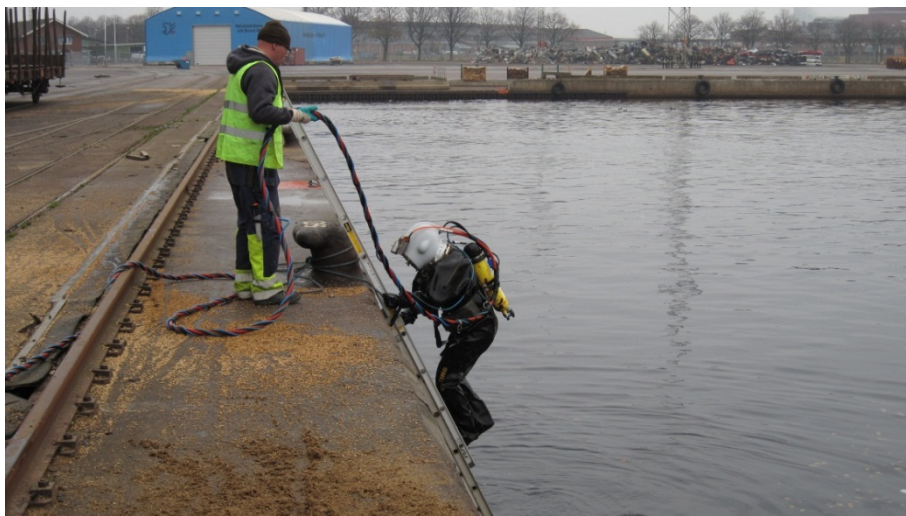
Figure 36

Picture from the investigation during October and November 2011.

In late autumn 2011 steel sheet pile wharfs located in the port of Halmstad on the Swedish west coast were inspected by ultrasonic measurements. The investigations were performed by a Swedish diving company, Marcon Teknik AB, and the diving team consisted of three members.

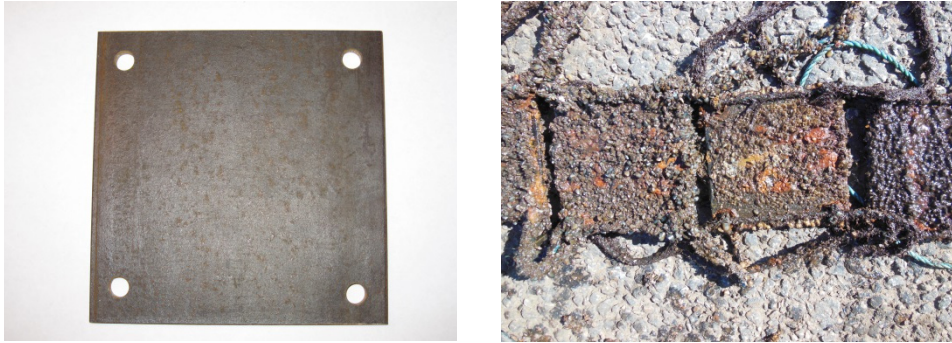
Figure 41
Steel plates before and after exposure.

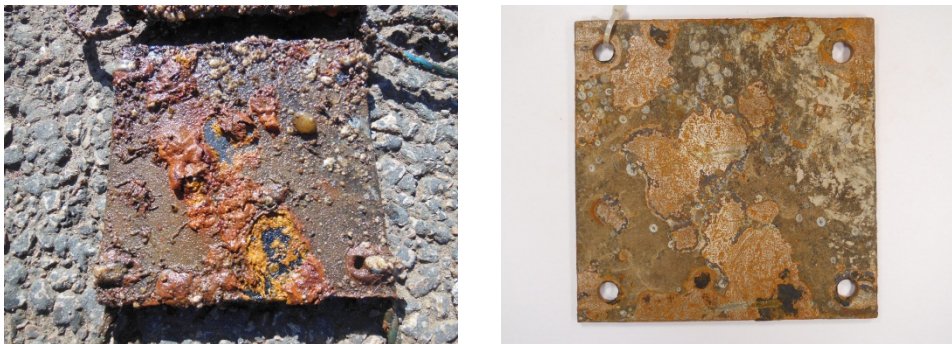
Figure 42
Steel plate before and after cleaning.
