Chloride profiling in marine concrete - methods and tools for sampling

Report TVBM-3138

Licentiate thesis

Paper I

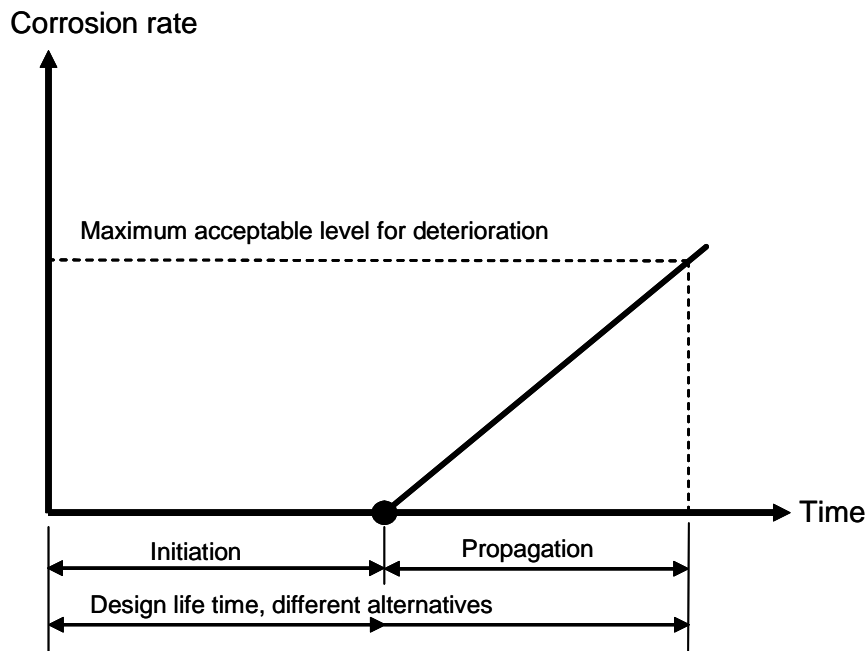
Figure 1: Initiation and propagation of reinforcement corrosion, after [4]

The service life of a reinforced concrete structure could be defined in several ways depending on what changes of the function of the structure that is accepted over the years. Schematically the changes of the work capacity of such a structure proceeds as shown in figure 1.

During the initiation phase the performance of the structure is not considerably changed. In fact, the strength of the concrete itself can actually increase due to the hardening. The surrounding climate makes it possible for carbon dioxide and chlorides from sea water or de-icing salts to penetrate into the concrete surface. The initiation phase is over when the carbonation or a critical chloride content has reached through the concrete cover resulting in initiated corrosion. After this stage the propagation phase is starting. At the end of the initiation phase and the start of the propagation phase, the cross section of the reinforcement bars starts to decrease and the developed corrosion products creates a pressure which after a certain time could result in cracking and spalling the concrete cover. This means that when the propagation stage is reached, the load-carrying capacity of the structure decreases with time.

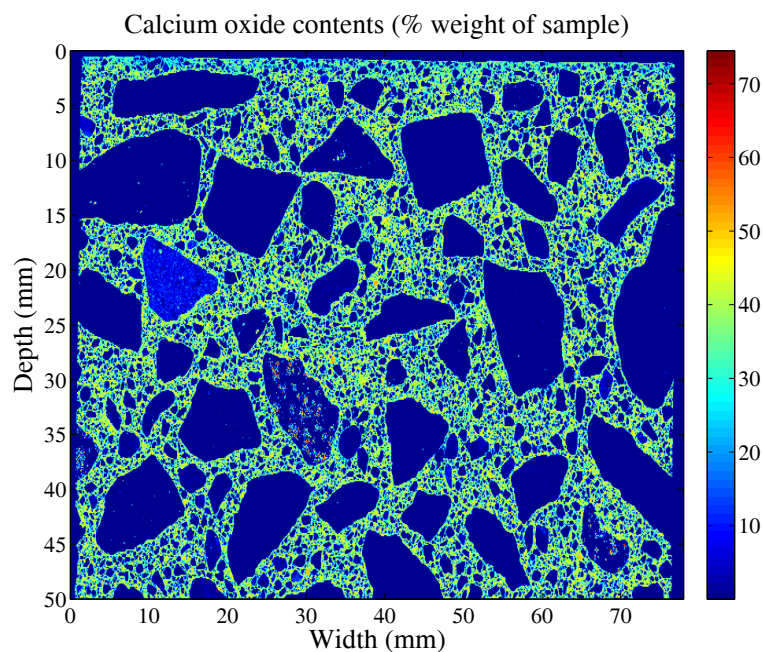
Figure 17: Calcium content in concrete specimen analyzed with EPMA

A sample from the same slab described in paper II was sent to Japan for EPMA analysis. The EPMA, or the Electron Probe Micro Analyzer, uses a focused beam of high energy electrons to non-destructively ionize a solid specimen surface for inducing emission of characteristic X-rays. The typical size of a sample to be analyzed by the EPMA is a slice with height*length*thickness = 50*75*10 mm. The analysis is two dimensional and the EPMA delivers values of the analyzed element in pixels with the size of 0.1*0.1 mm, one value for every pixel on the sample. Five different elements can be analyzed at the same time. The results from the EPMA, that is the values on the analyzed element or elements, are delivered as matrices with the dimension of 500 rows and 750 columns due to the size of the pixels. The elements analyzed in this study were chloride, calcium oxide, silica, potassium and sodium.

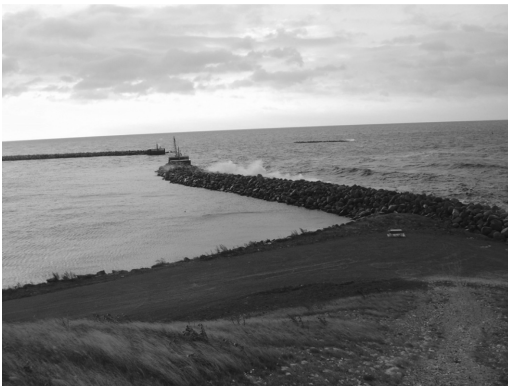
Figure 6. Wave action on breakwaters. Wind direction about 200 degrees.

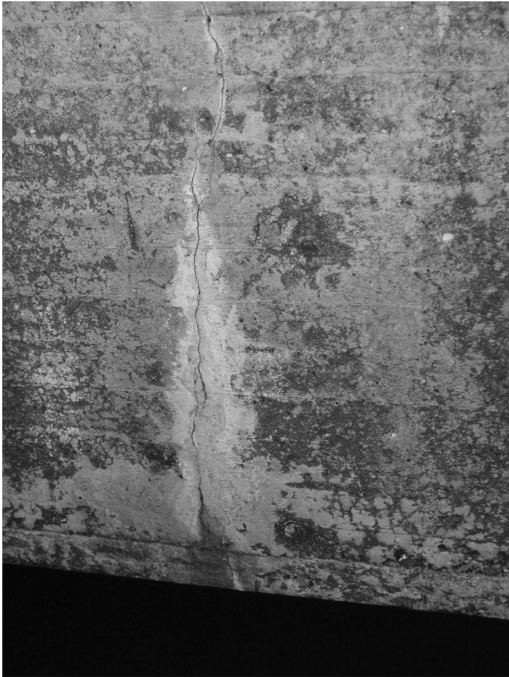
Figure 7. Typical vertical crack with signs of leaching calcium.

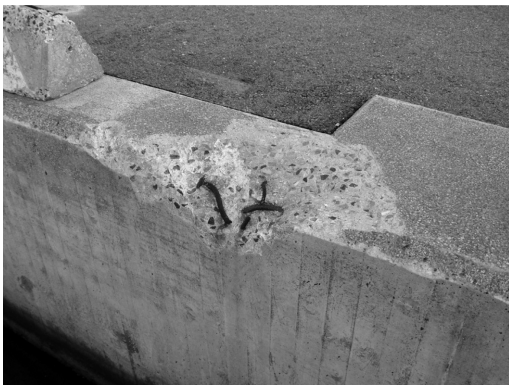
Figure 8. Local damage with corroding reinforcement.

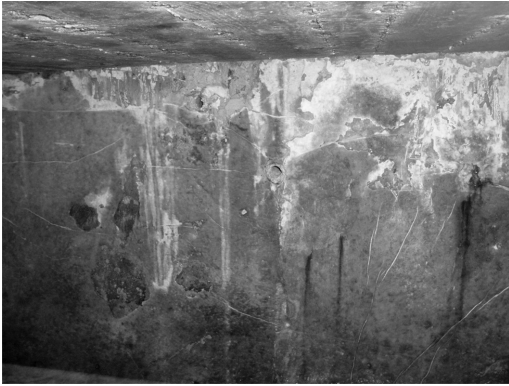
Figure 11. Rust stains and traces of calcium leakage on the side of a prefabricated vertical plate element.

the prefabricated vertical elements had traces of rust stains on the sides and calcium leakage in the connection between the in situ casted quay deck and the prefabricated vertical elements as indicated in figure 11.

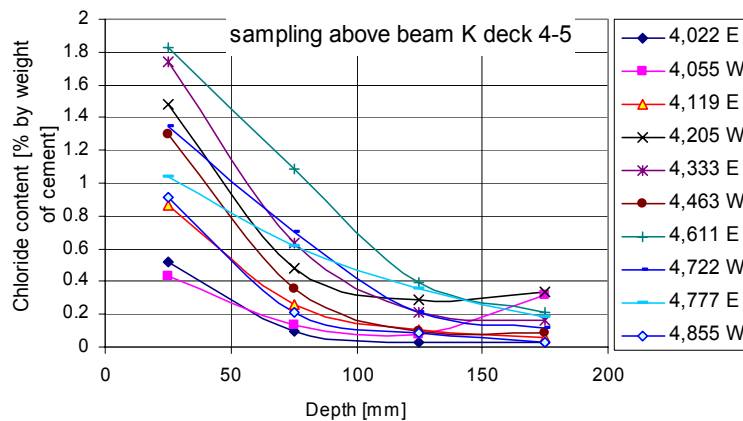
Figure 1: An example of variations of chloride profiles from samples from a small area in homogeneous concrete, after [3]

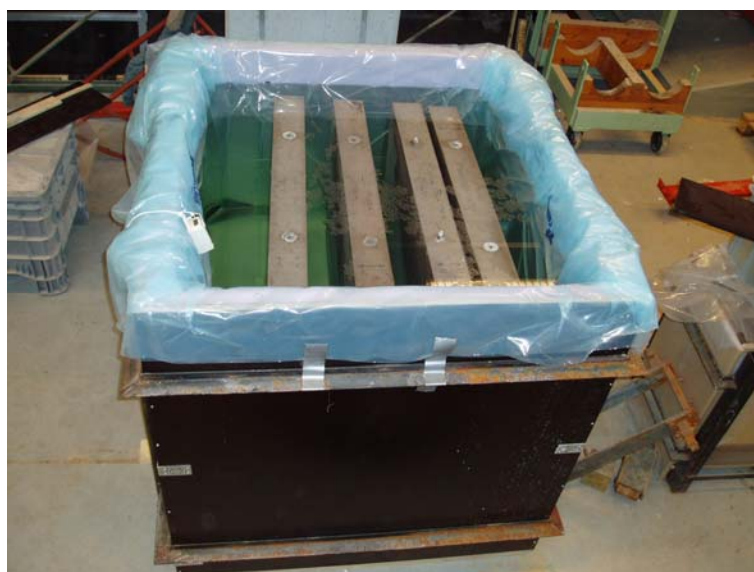
Figure 2: Concrete slabs submerged in saline water in the laboratory

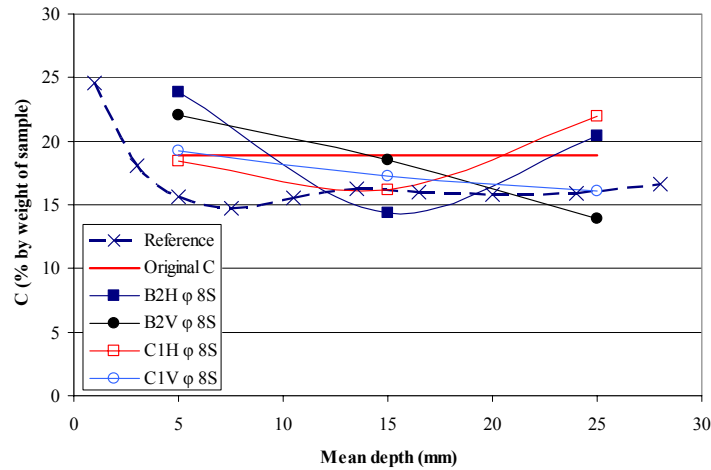
Figure 8: Cement content in % by weight of sample, dry drilling with 8 mm bore. Each point represents two mixed samples

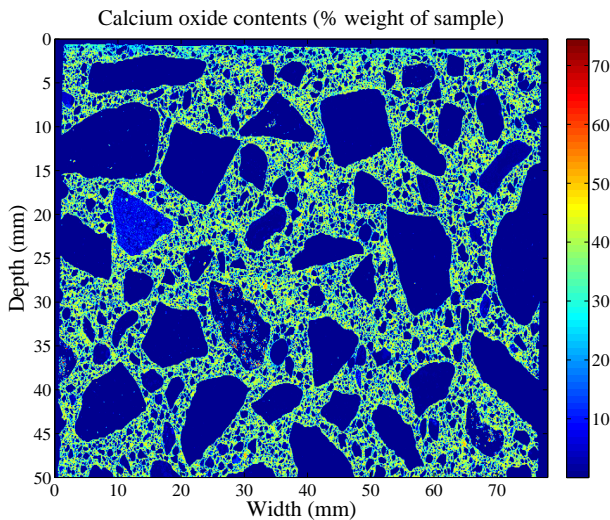
Fig. 1 - Calcium oxide content in the concrete specimen analyzed with the EPMA

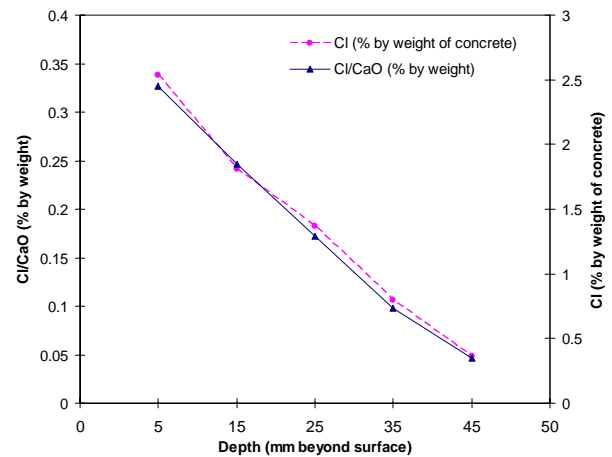
Figure 3: Chloride profile from simulations with a 70 mm strip, expressed in two different ways.

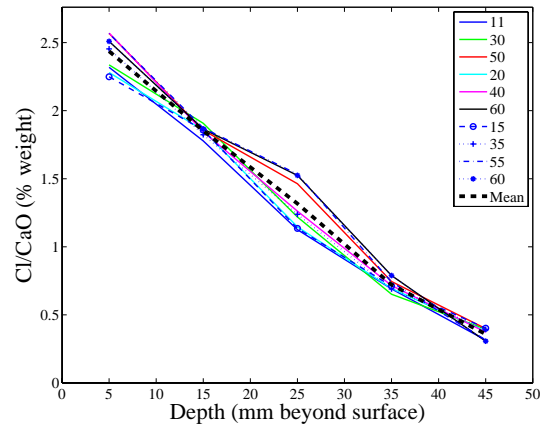
Figure 6b: Chloride profiles from simulations with 20 mm strips, chloride in % by weight of calcium oxide
