Behaviour of Multilayer External Walls with an Exterior Layer of Glazed Ceramic Tiles. Vol. 1

BEHAVIOUR OF MULTILAYER EXTERNAL WALLS WITH AN EXTERIOR LAYER OF GLAZED CERAMIC TILES

Volume 1

DIVISION OF STRUCTURAL MECHANICS AND CONCRETE CONSTRUCTION · BULLETIN 57

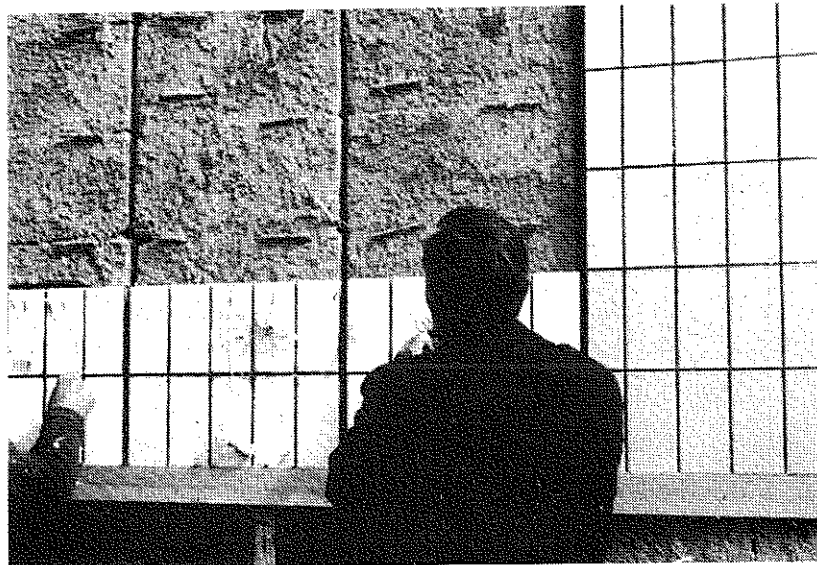
Figure 1.3.2p. House I: openings, two in each wall, left free for moisture observations by use of wedge-shaped test specimens

Figure 1.3.2q. Tile fixing, House I, south wall. Observe the special anchors for the fixing mortar. All wall elements in House I to be observed by strain-gauges etc were provided with these anchors while rest of the wall surfaces were provided with a normal net. The two vertical slots on each wall are holes intended for the moisture observations by use of wedge-shaped test specimens

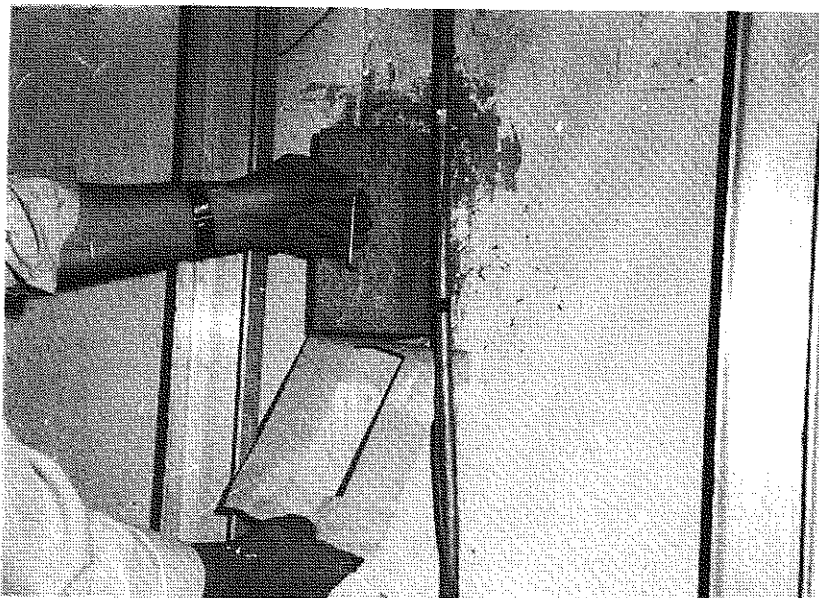
Figure 1.4.4e. The concrete test wedge in wall element no. 25, House I

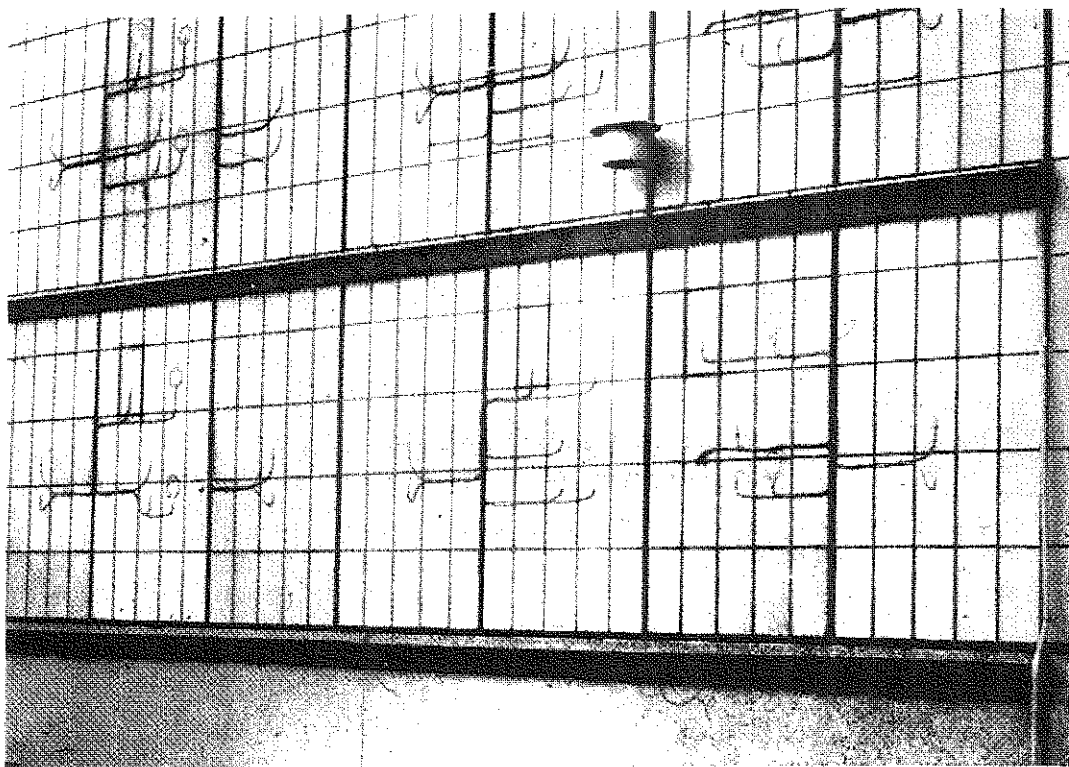
Fig. 40.5. Completed wall with strain-gauged tiles and cables
