# The Emergence of an Aristocratic Environment

## The Danish Archbishops Property at Flyinge

Elias Engdahl  
ARKM22 Master's Degree Project - Historical Archaeology  
Department of Archaeology and Ancient History  
Lund university  
Spring semester 2026  
Supervisor: Martin Hansson

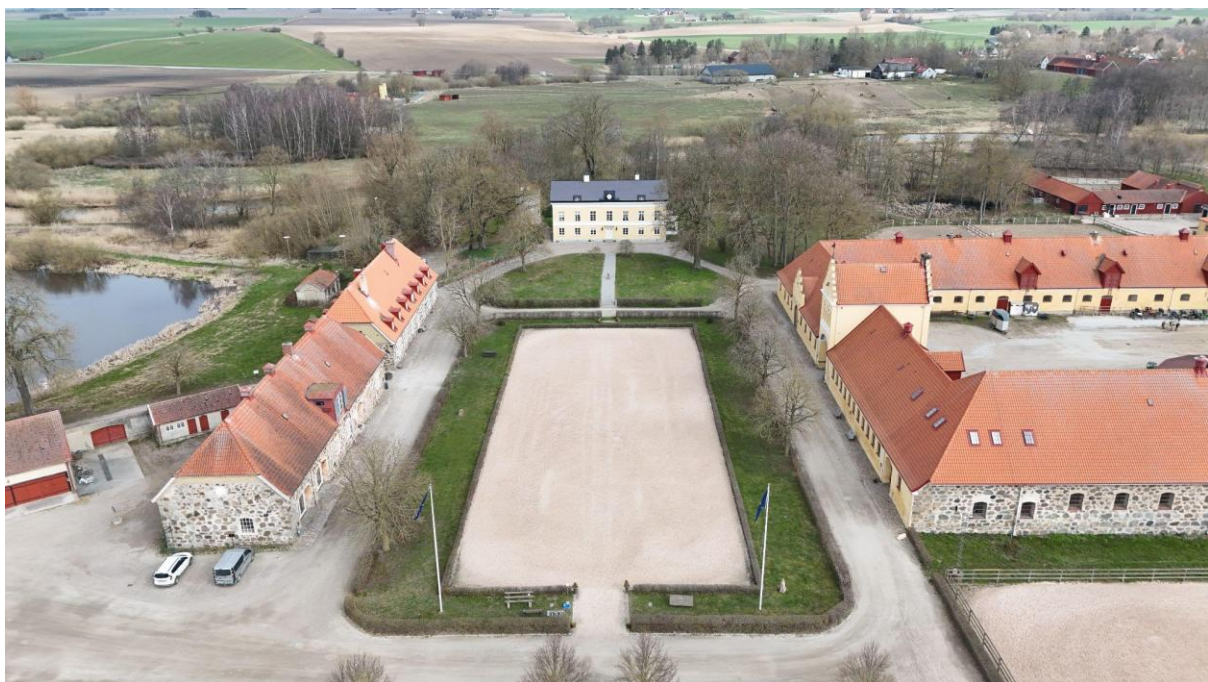
*Fig. 4.* Drone image at Flyinge kungsgård facing north. The yellow building in the centre is the *Chefsbostaden* while the parts of the stable complex is situated to the right. Kävlingeån is seen passing by behind *Chefsbostaden* while the dam is partly visible on the left side. Photo: Author, April 2026.

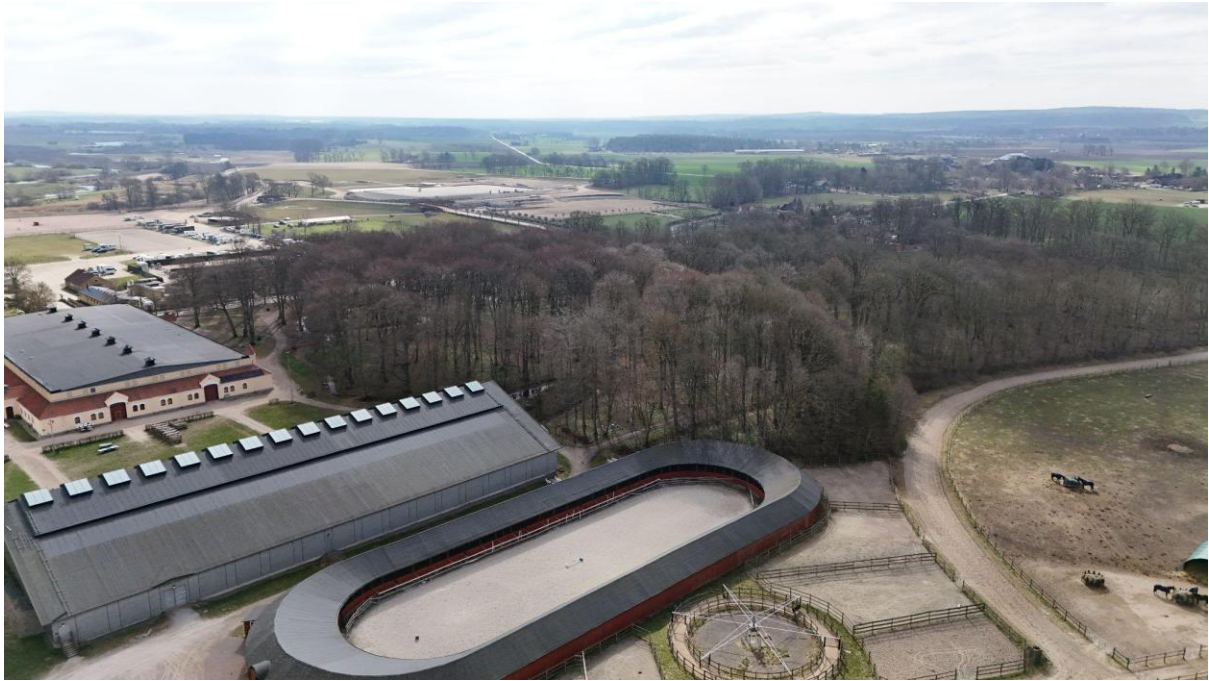
*Fig. 5. Drone image at Flyinge kungsgård facing southeast. The two indoor riding tracks are visible on the left side while the two outdoor riding tracks are visible on the bottom and partly on the bottom right. The park is visible in the middle of the image, going towards the right. Kävlingeån is slightly visible in the top left corner. Photo: Author, April 2026.*

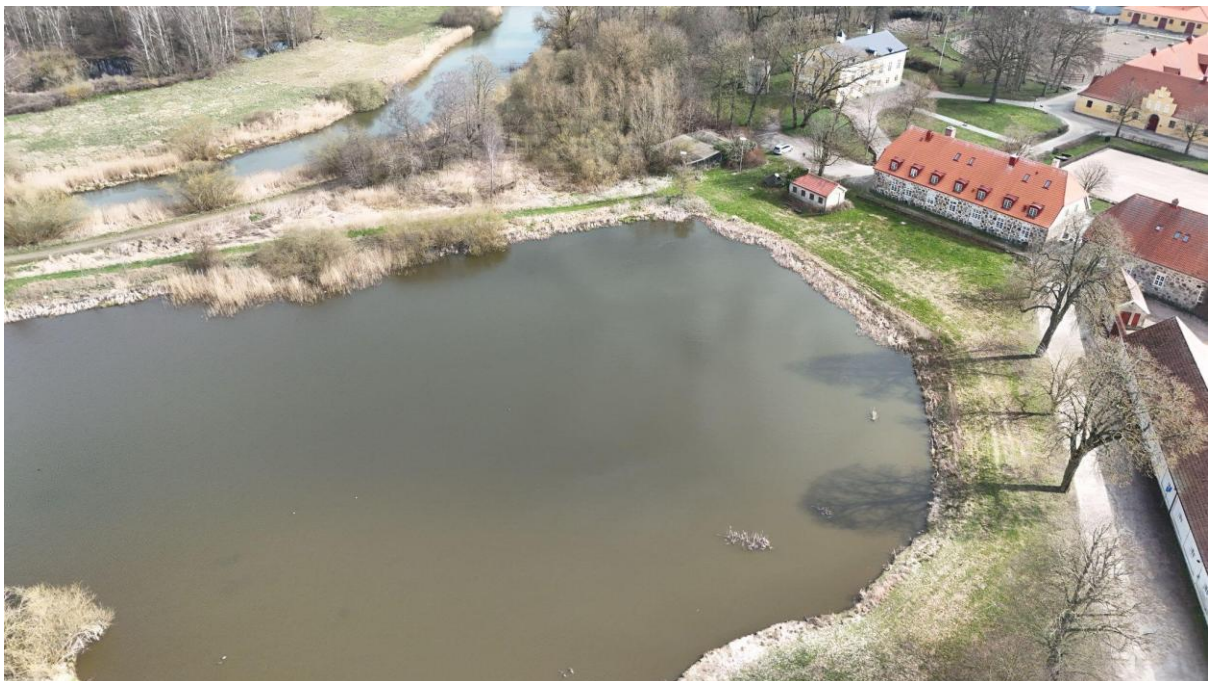
*Fig. 6. Drone image at Flyinge kungsgård facing northeast. This image focuses on the dam and Kävlingeån in the top left. Chefsbostaden and a corner of the stable complex is also visible in the top right corner. Photo: Author, April 2026.*

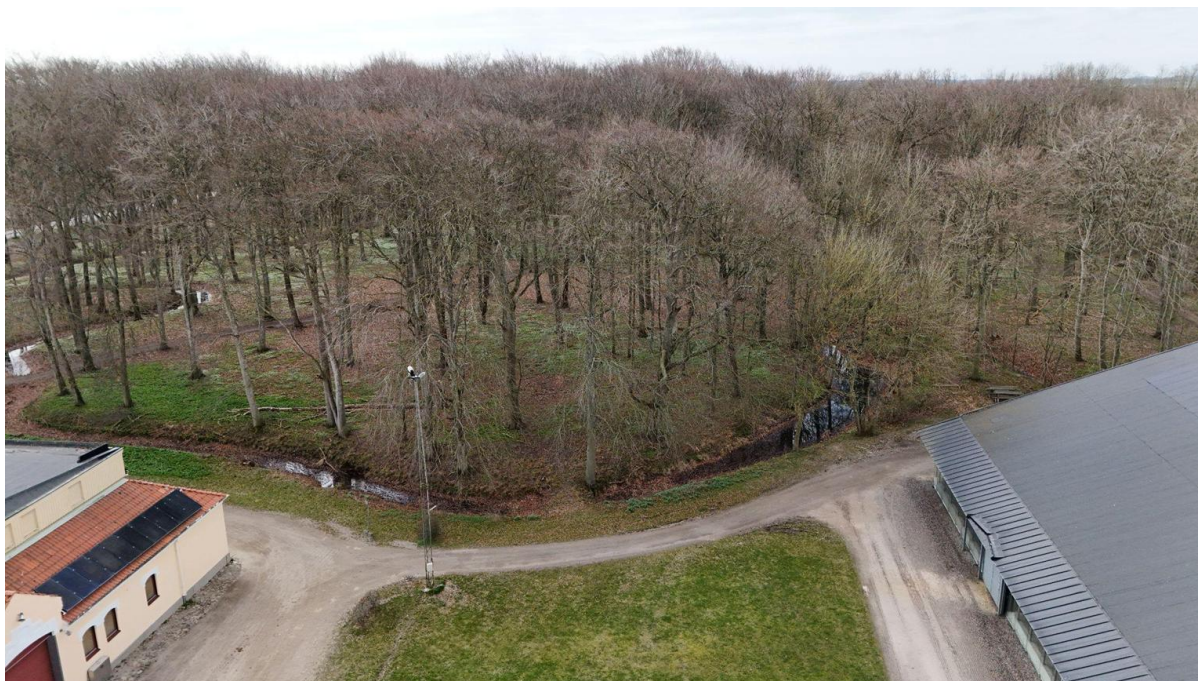
Fig. 8. Drone image at Flyinge kungsgård facing south. The image shows the northern boundary of a park of early modern origin which replaced any remains of medieval gardens. Photo: Author, April 2026.

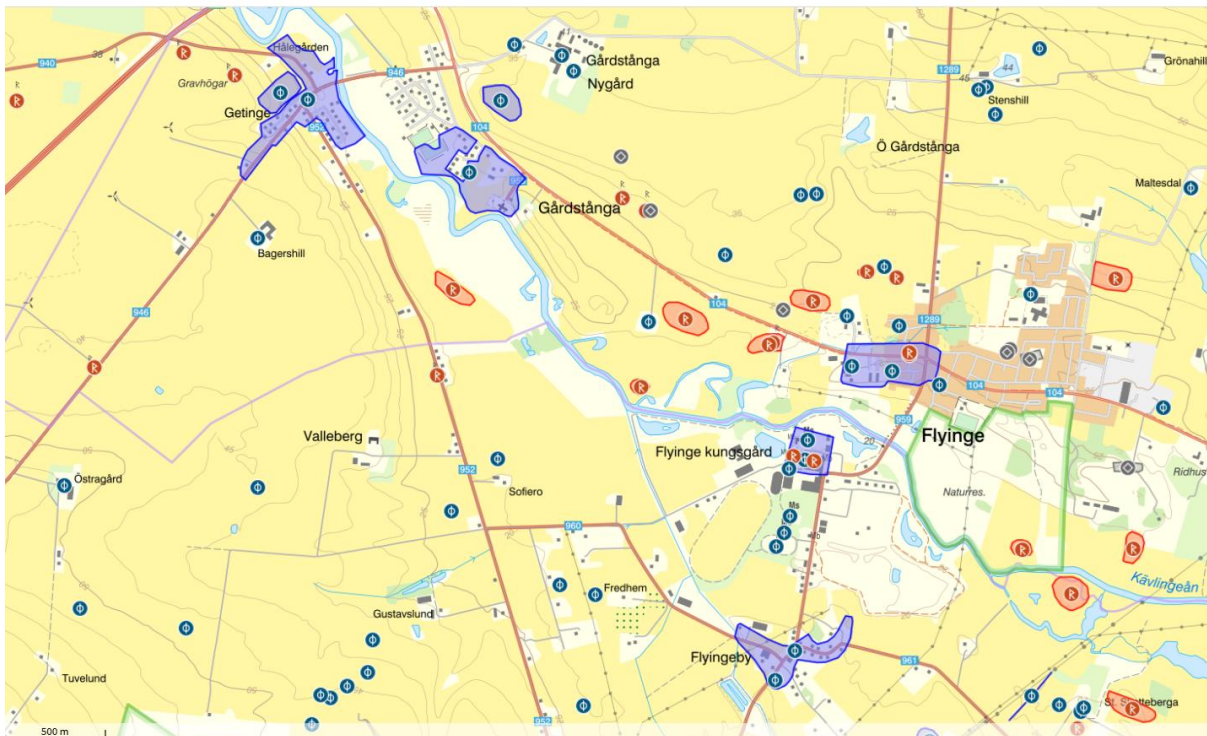
Fig. 9. Part of the Swedish national heritage board's digital database Fornsök, showing Flyinge kungsgård (middle right) and surrounding registered archaeological finds (Fornsök). Accessed 2025-10-28.

Remains of several prehistoric settlements have been discovered close to Kävlingeån and Flyinge kungsgård. Various flint tools have been picked up by farmers tending their properties which show this location has seen lots of activity before the Middle Ages (fig. 9).

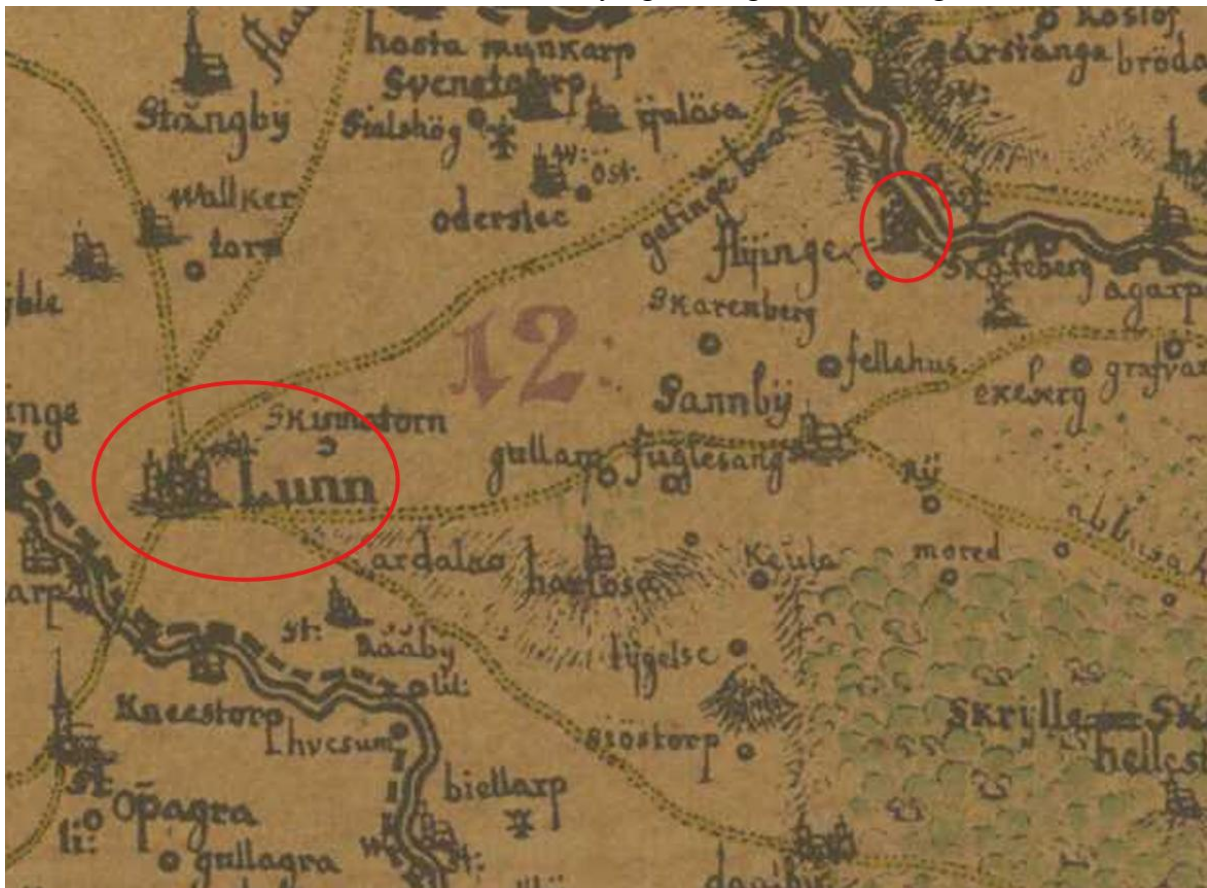
Fig. 12. A cropped image of Buhrman's map from 1684. Lund and Flyinge kungsgård have been circled. Lantmäteriet ©.

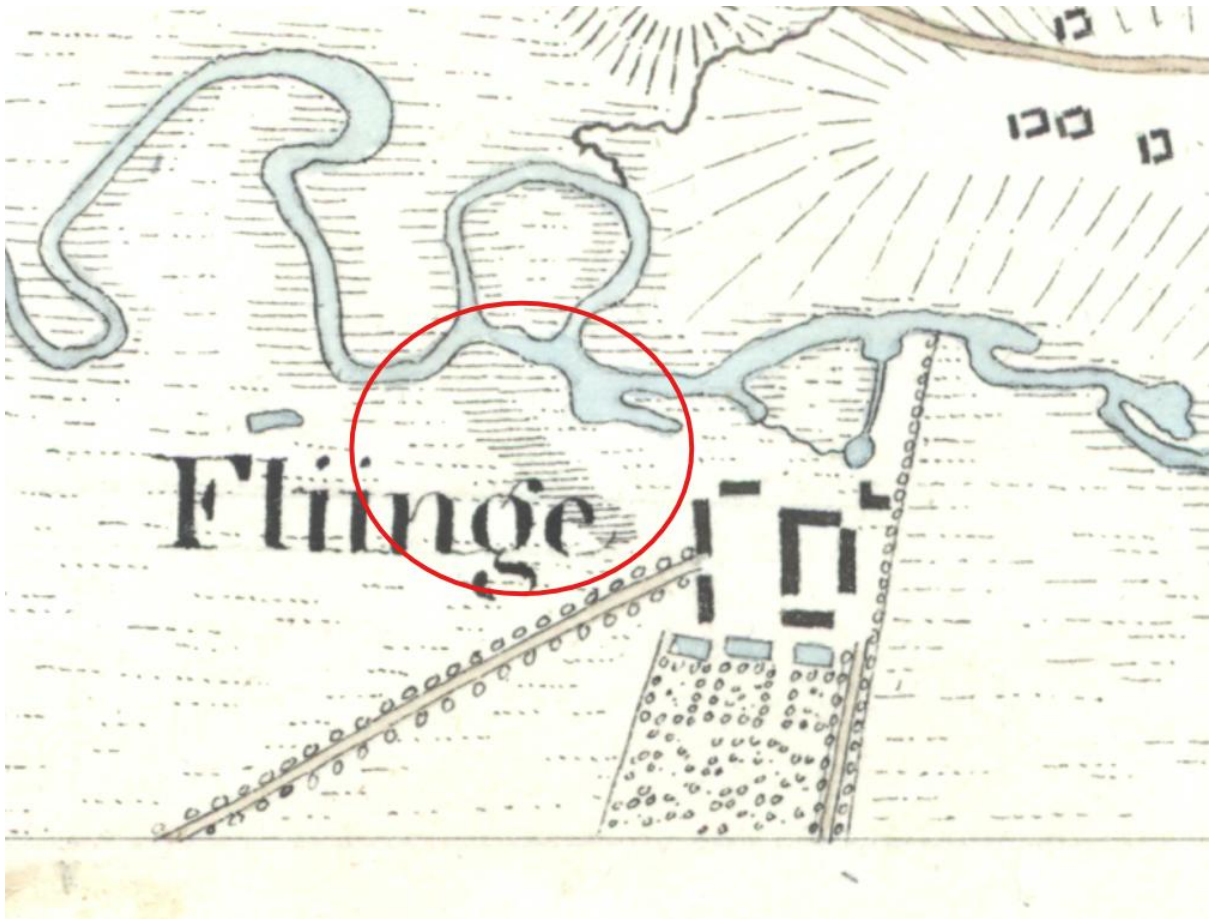
Fig. 25. Cropped image of *skånska rekognosceringskartan* with a focus on Flyinge, made between 1812–1820. The horizontal lines marked with a red circle is an area consisting of wetlands which is the same location as the large dam (Riksarkivet, IIÖ 204).

According to historical maps, the large pond directly west of the buildings appears to have been overgrown during the eighteenth century. Today it is well maintained and many different animals gather and live in and next to the dam. While it is called *damm* (dam) in historical maps, it is not confirmed if it is a man-made dam or not. The space between this dam and Kävlingeån is illustrated as wetlands on the *skånska rekognosceringskartan*, created between 1812–1820 by the Swedish military (compare fig. 25 with fig. 26). Therefore it might be a naturally formed dam originally but that does not mean it was not modified as well. A canal was made leading water from this pond southwards towards the village of Flyinge, past the complex of dams (see red line in fig. 23 & fig. 24). While it is not made clear in the maps, it is possible that this canal also supplied the dams with water to maintain their water levels and thus their function. Dams could be both utilitarian and ornamental at the same time with different functions. *Vivarium* were larger ponds for breeding fish, like the one west of the buildings, and *servatorium* were smaller ponds where small stocks of fish could be before they would be cooked and served at the residence (Creighton 2013: 114–115).

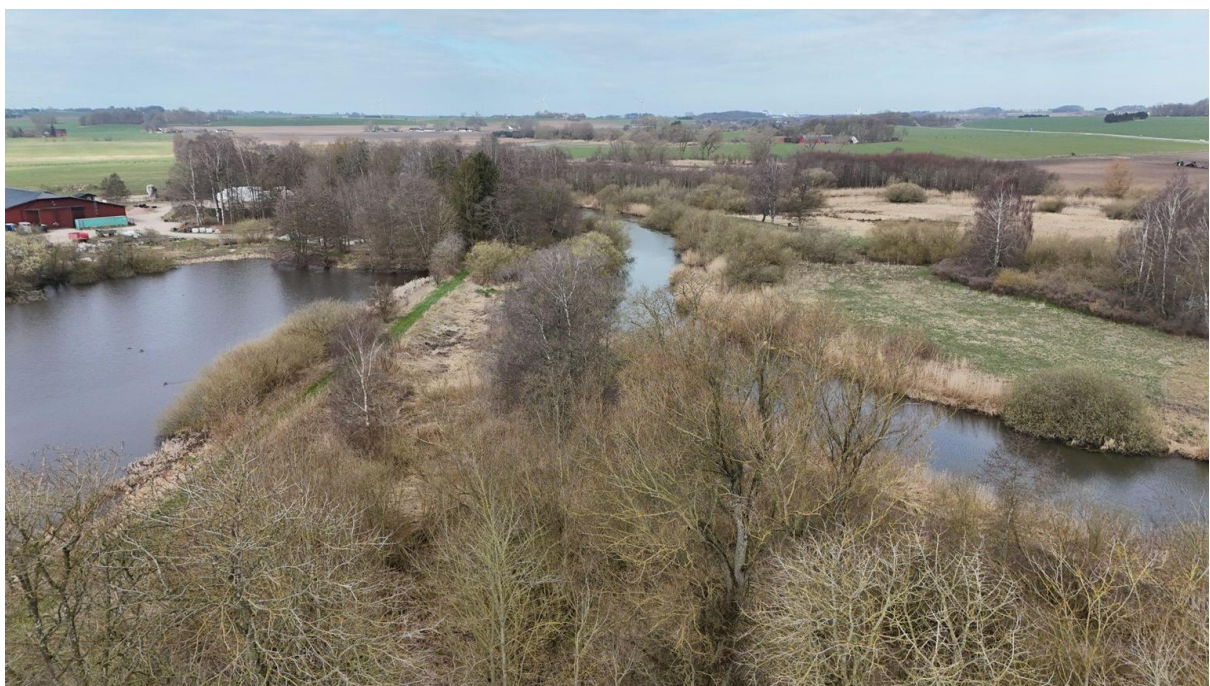
Fig. 26. The large dam to the west in relation to Kävlingeån, photographed with a drone facing west. Photo: Author, April 2026.

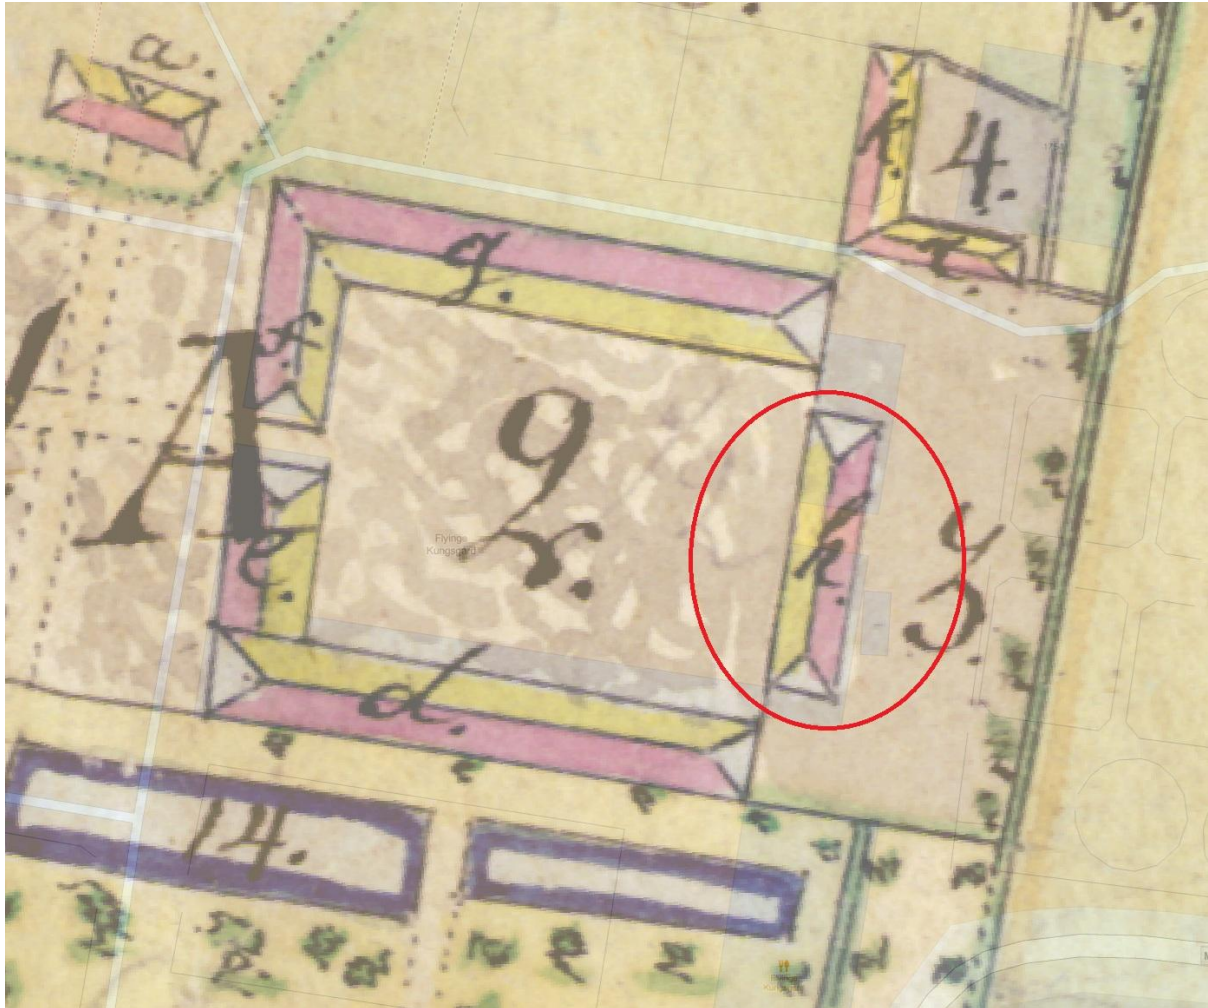
*Fig. 28. Map from 1813 on top of a modern map of Flyinge. The marked building was torn down some years after 1813 and is probably where twelve wheelbarrows of human remains were found. Lantmäteriet ©.*

location next to Chefsbostaden (RAÄ Södra Sandby 80:1). Maps made in 1813 and 1837 show that some buildings were removed in favour of new ones. By comparing these changes, Guldåker suggests that these twelve wheelbarrows of human remains came from the eastern side of the stable courtyard (fig. 28 & Guldåker 2024: 16–17). It is a convincing suggestion for the origins of the remains since further bones and graves have been found close to this area (fig. 37).

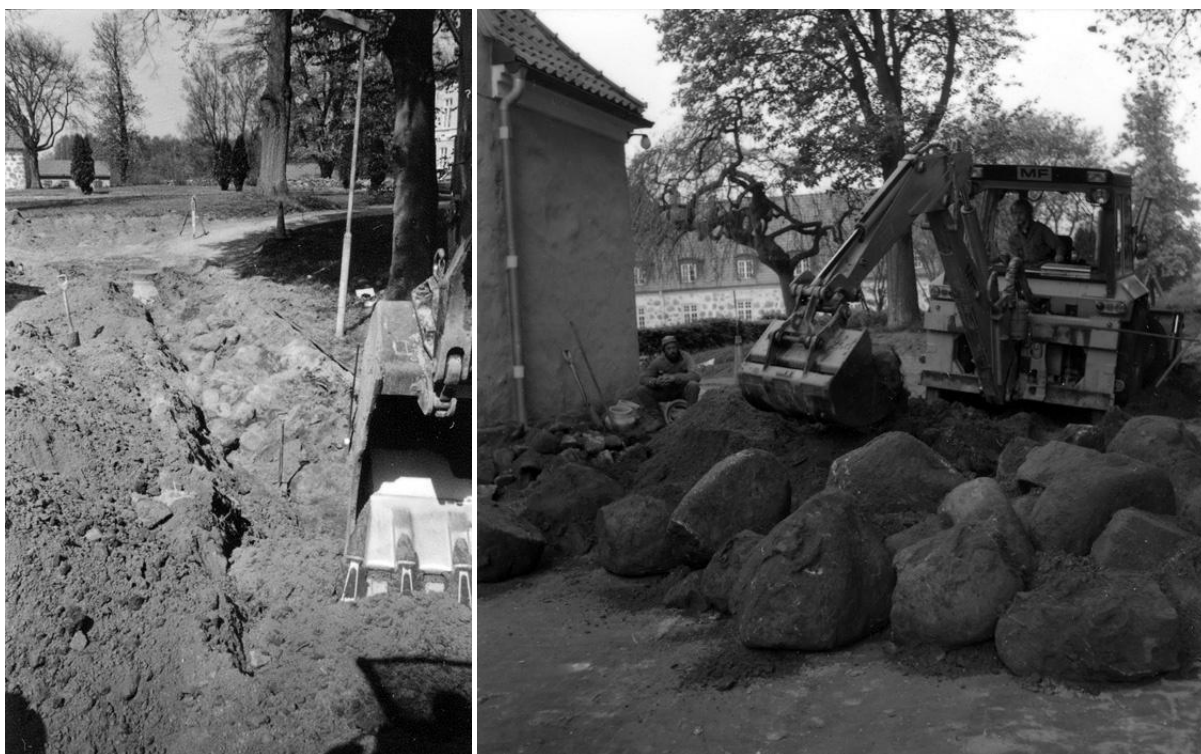
Fig. 30a (left) & fig. 30b (right). Photographs at Flyinge kungsgård taken by Barbro Sundnér in 1982. The left image depicts the top of what was interpreted by Sundnér as a moat filled with stones *in situ*. The right image shows stones excavated from this moat (Regionmuseet Skåne).

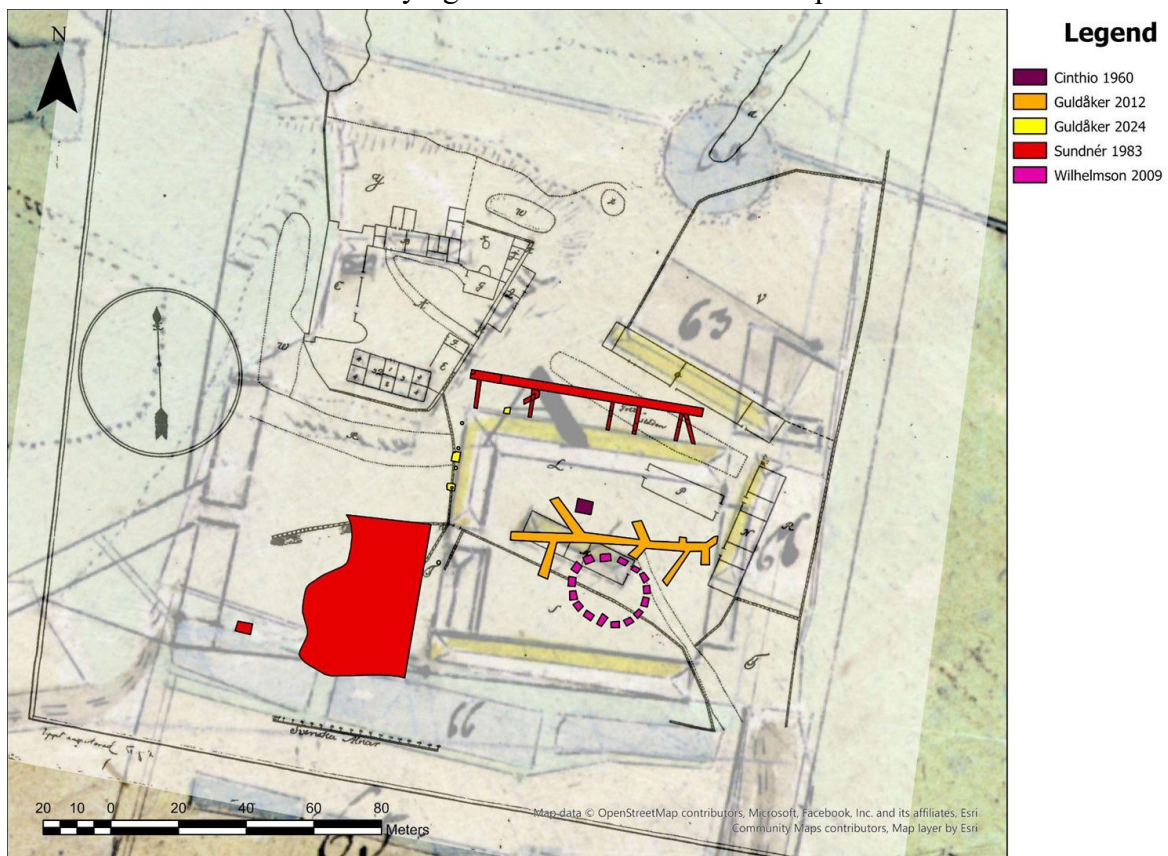
Fig. 40. Georeferenced map from 1748 (Lindblom) over the map from 1783 (Lantmäteriet ©) including archaeological findings. Billström (2020) and Olsson (2004) are left out since they are outside the map from 1748.

In the previous chapter, historical images, written sources and archaeology were analyzed separately from each other to give insight into Flyinge during different points in time. However, to create a new understanding of this site and make it possible to reconstruct the medieval layout, the methodological approach of triangulation needs to be applied. The first step in this approach is to georeference the oldest map of Flyinge, a map from 1783 and all digitized archaeology which has been done at Flyinge onto the same image (fig. 40). These maps were chosen to compare how Flyinge changed in 1783, a layout which is close to how Flyinge kungsgård looks like today. The archaeological findings have been included to show their relation to structures at Flyinge which existed at different periods in time.

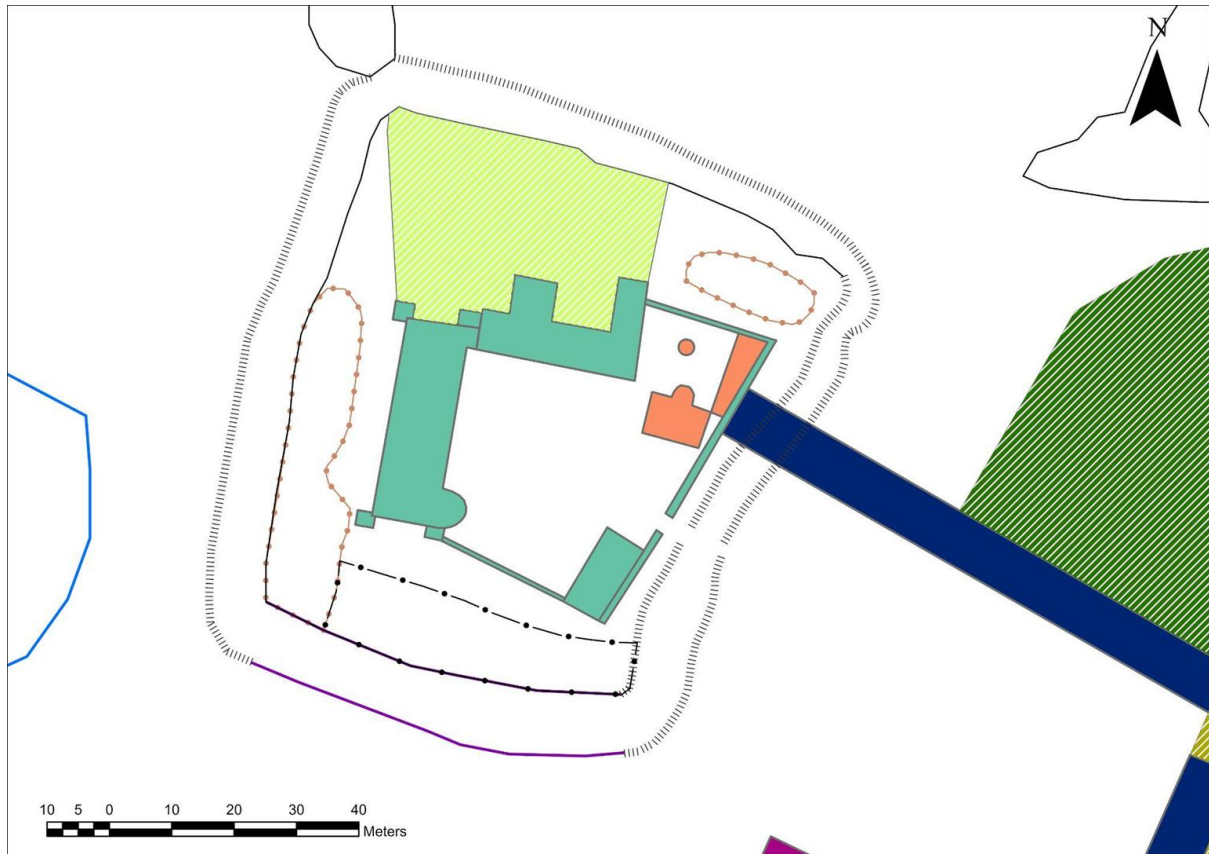
*Fig. 42.* Proposed reconstruction of the moat and ramparts surrounding the inner courtyard at Flyinge. Purple is the moat, visible on the oldest maps of the site, while the connected stretched lines mark the possible continuation of the moat. The brown lines with dots are the ramparts visible on the oldest maps of the site while the connected black lines with dots mark the possible continuation of the ramparts.

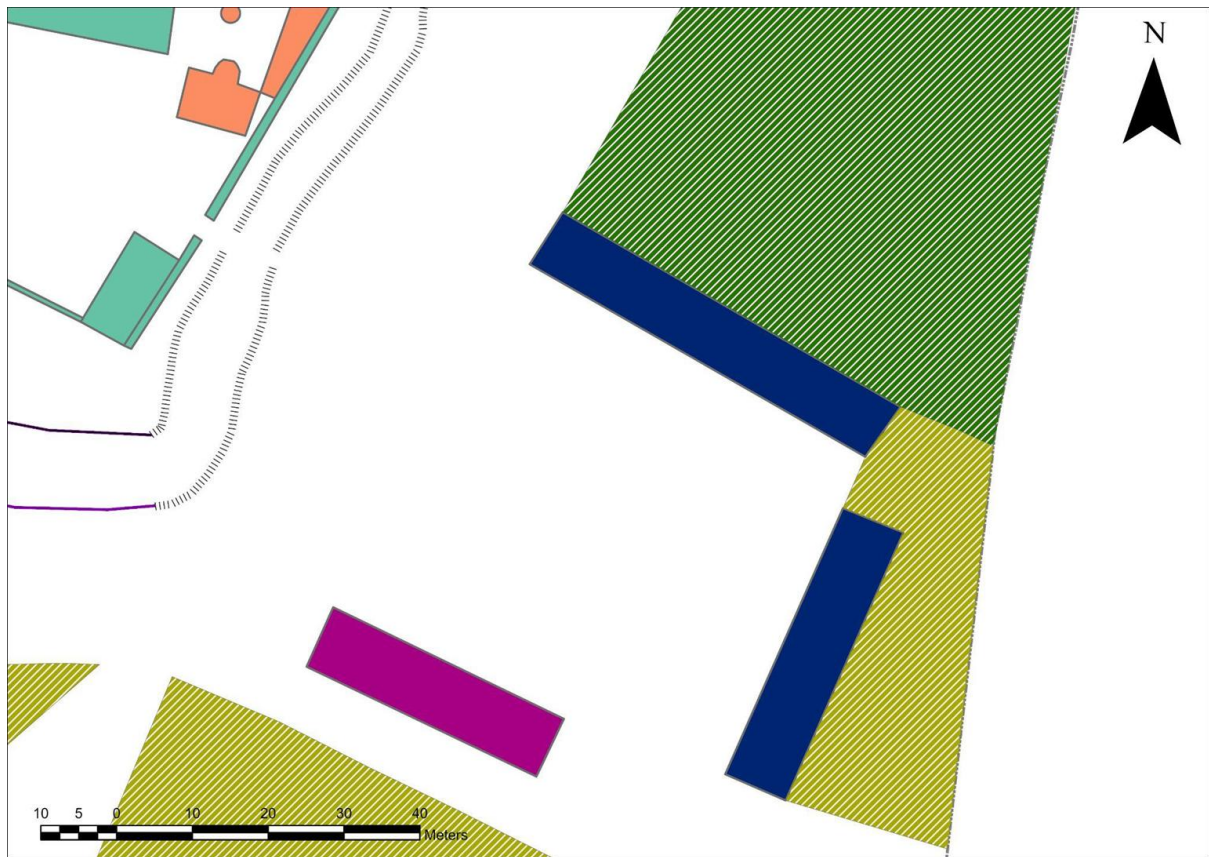
Fig. 43. Proposed reconstruction of Flyinge where the northern stable (dark blue) on the outer courtyard is shorter than what it is on the etching from 1756.

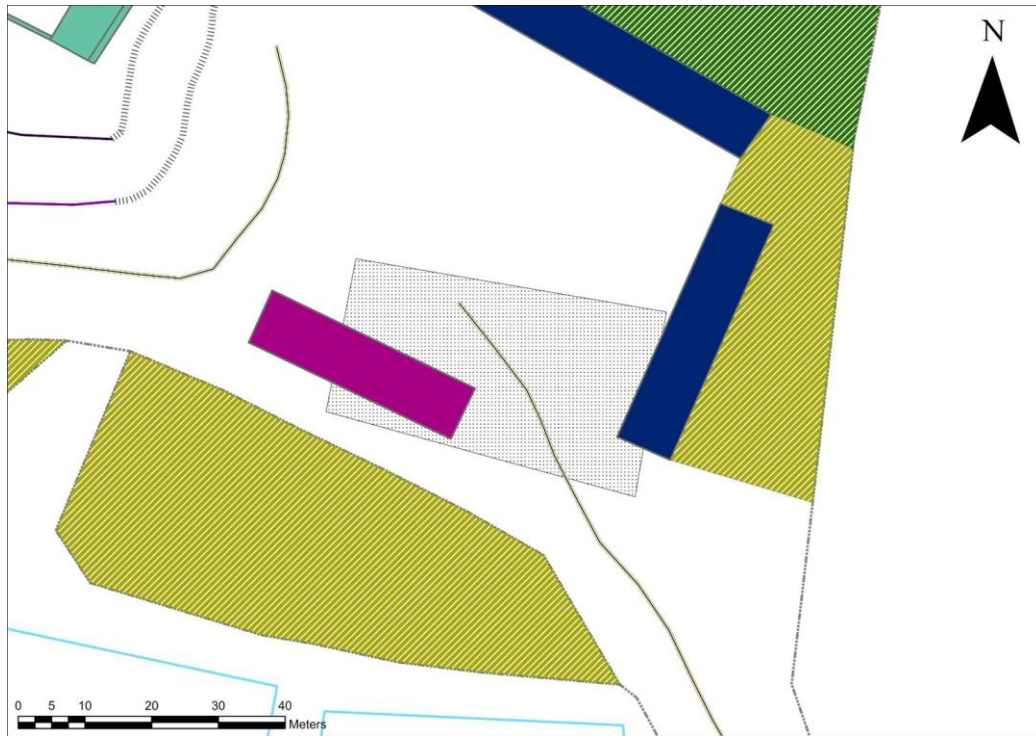
*Fig. 45.* The estimated area of the graveyard, from fig. 33, has been marked with a dotted area and combined with fig. 32.

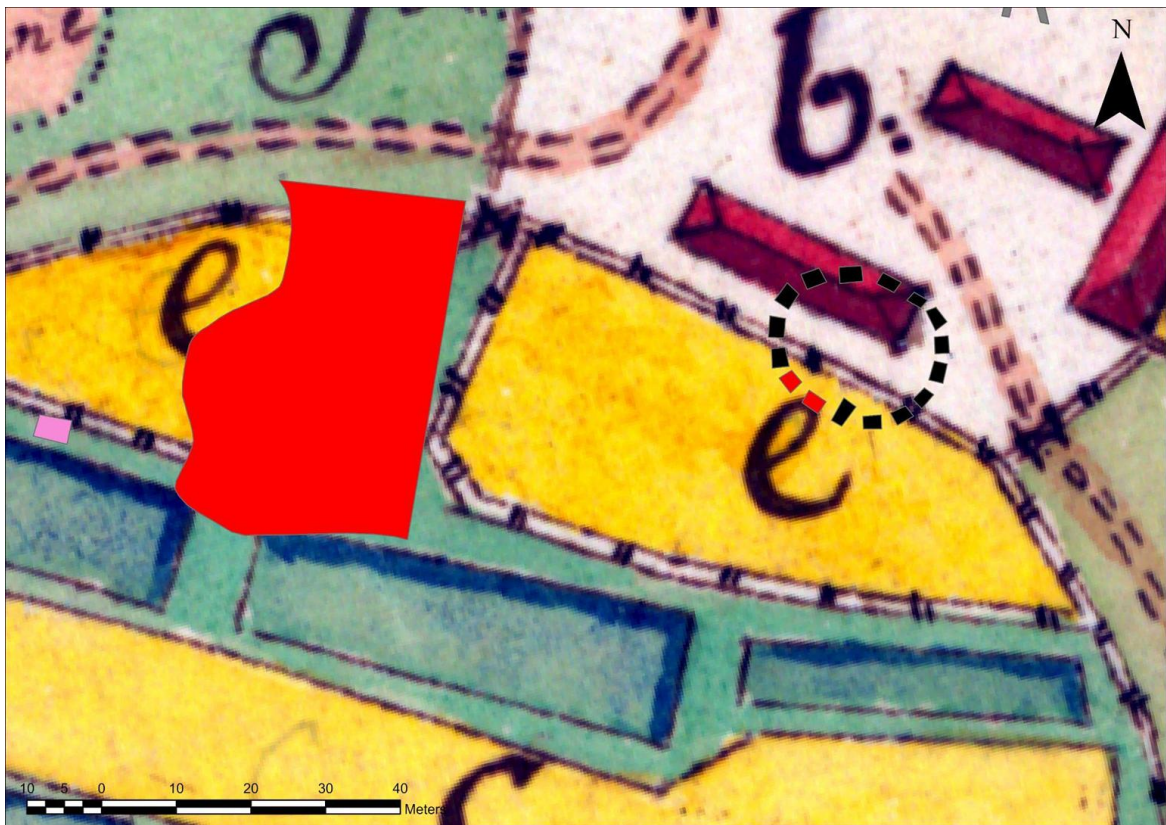
*Fig. 50.* Building remains found by Sundnér (1983) and Wilhelmson (2009) on a map of Flyinge kungsgård from 1750 (Lantmäteriet ©). The two yellow areas marked with *e* are kitchen gardens.

Considering this interpretation, a proposal for a reconstruction can be made (fig. 51). The result of this reconstruction removes the kitchen gardens shown in the previous image and pushes in the boundary of the garden area. The reconstructed area (green rectangle in fig. 51) could have been both one structure or an area for several buildings. It is not possible to know what this area was used for but just to present a few suggestions, the structures in this area could have served as barns or workshops for example.
