Corrosion rate measurements in steel sheet pile walls in a marine environment

Wall, Henrik; Wadsö, Lars

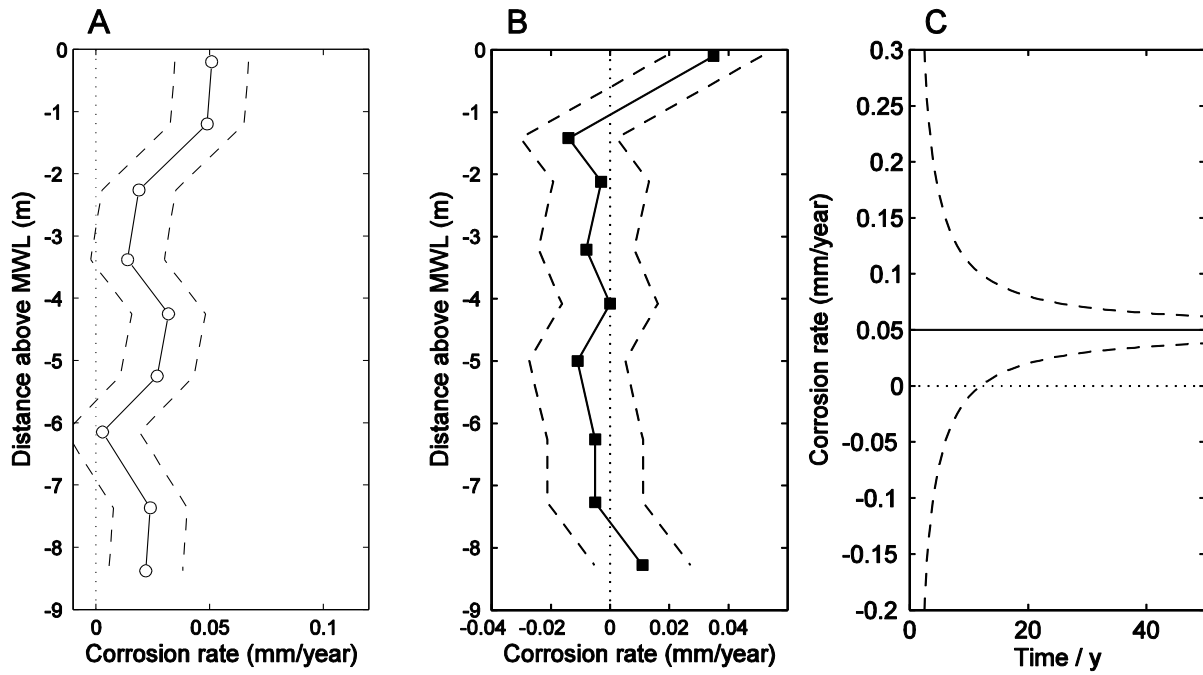
As seen from the graphs, the average corrosion rates for the outer flanges on the sheet pile walls of wharf A peaks about one meter below the mean water surface. Since the effect of tidal water in Sweden is very small (only a few centimeters) it seems that the higher corrosion rate at this level could be water line corrosion as described in [15].

Another interesting observation is that there is also a peak on the average corrosion rate on the outer flanges at the level between -3 and -6 m along the most frequented wharfs, wharf B parts 1 and 3 and wharf C. This level corresponds to the level of the propellers of the ships that frequent the harbor. We hypothesize that the increased corrosion rates at this level are caused by erosion by the water movement from the propellers.

- There is a tendency that the average corrosion rate on the outer flange reaches a peak between 3 and 6 m below the mean water level at the most frequented wharfs. This level correlates with the level of the propellers on the ships berthing the wharfs. Since this is the level where the maximum bending moment occurs, this information is essential for the structural designers.

Fig. 8. Corrosion rates (average values) on sheet pile walls in Halmstad harbor. The measurement points are illustrated in the bottom right figure.
