Design of Safe Timber Structures - How Can we Learn from Structural Failures in Concrete, Steel and Timber?

Frühwald, Eva; Serrano, Erik; Toratti, Tomi; Emilsson, Arne; Thelandersson, Sven

Report TVBK-3053
Lund 2007

**Design of safe timber structures –
How can we learn from structural failures in concrete,
steel and timber?**

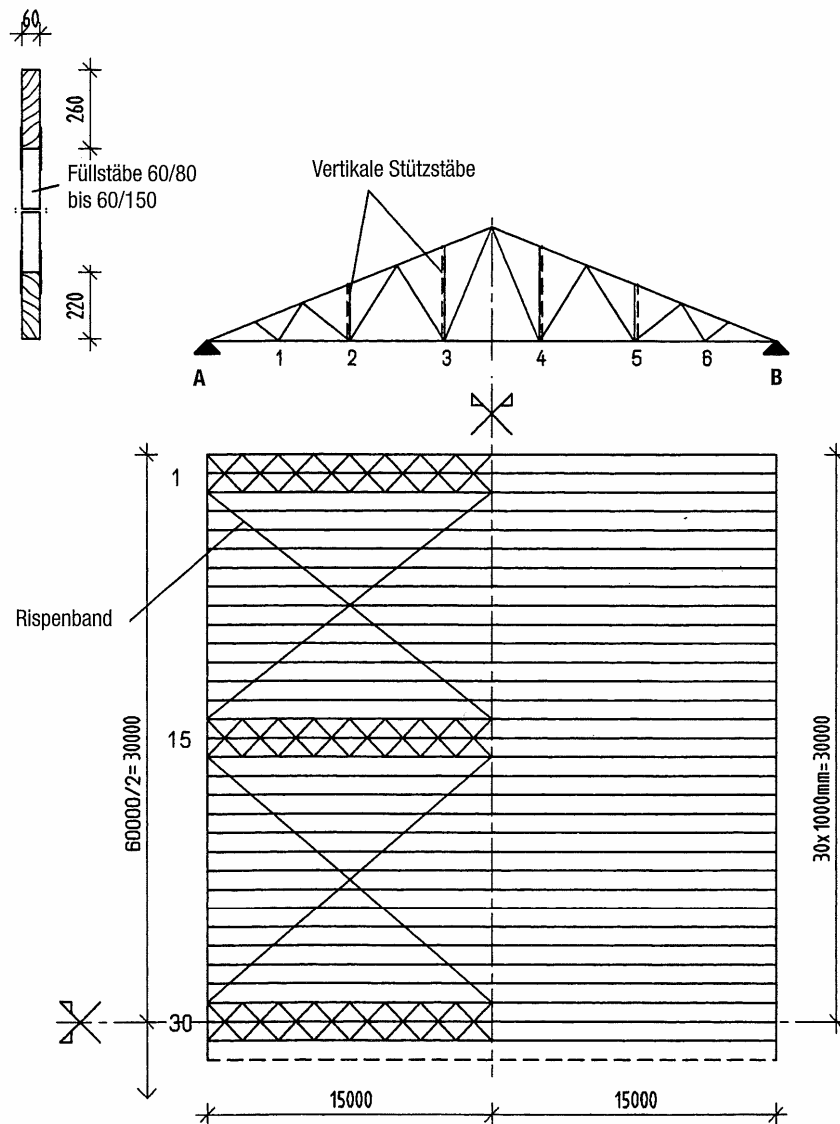
Figure 11-1. Bracing of roof structure. Picture from Dröge G. & Dröge T.: Schäden an Holztragwerken, Schadenfreies Bauen, Band 28, Fraunhofer IRB Verlag, 2003.

According to the structural design, the lateral bracing of the building is provided by lateral trusses at each 15m, diagonal chords between the lateral trusses, purlins with centre distance of 610mm as well as boards in longitudinal direction of the building, connecting the vertical struts in the main trusses (each vertical strut shall be braced by 3 boards). The bracing system is also shown in Figure 11-1. At the time of collapse, only some of the purlins had been installed. Further-more, of the three boards connecting the vertical struts, only one board was present in each half of the truss (instead of 6). Not all the diagonal bracings between the lateral trusses had been built in. Due to the missing purlins, the buckling length of the upper chord was much too long, resulting in failure. There existed no erection instructions.

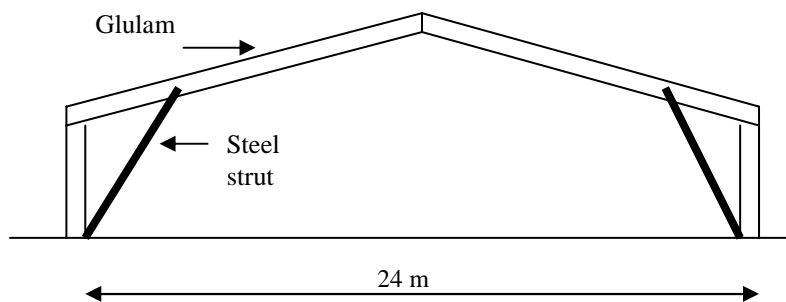
Figure 32-1. Schematic of frame structure

In 1993, a building that originally had served as a temporary exhibition hall in Trondheim since 1984, was erected in Oppdal as a sports hall. The structure consisted of three-hinged frames of glulam, placed at 6 m centres, with a span of 24 m. Inclined steel struts were placed between frame support and frame beam, see figure 32-1.

The building was not designed for snow load in Oppdal, however, extra wind bracing was provided.

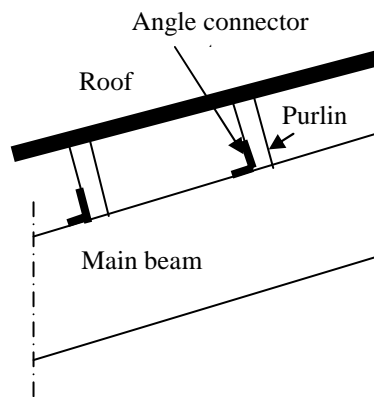
Figure 36-1. Design of purlin-beam connection

The school was built in 1998. The load-bearing structure consisted of glulam beams (140 mm x 800 mm) placed at 3.6 m centres. The building has a roof pitch of 22°. The secondary load-bearing structure consisted of purlins (48 mm x 198 mm) placed at 6 m centres, spanning over two bays (length 7.2 m). The principal bending plane of the purlins (strong direction) is then at an angle of 22° relative the vertical direction. The purlins are connected to the beams with sheet metal angle connectors (70 mm x 80 mm) on the downward side of the slope, see figure 36-1.

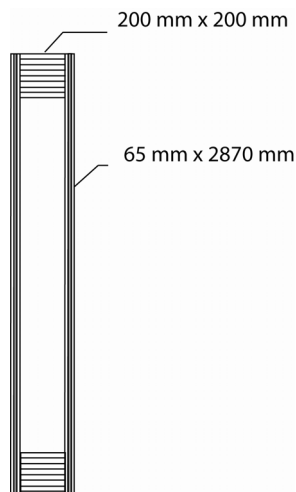
Figure 45-1: Box girders used in roof structure.

A skating hall was built in 1971/72 with a length of 75m and a width of 48m. The roof structure consists of 2.87m high box girders, see figure 45-1. The box girder consists of 200x200mm² glulam in the upper and lower flanges and special webs, consisting of 3 layers of boards, with the boards in the two outer layers oriented parallel with the beams axis and the middle layer being rotated 15° against the beams axis. Both flanges and webs were jointed with finger joints (the flanges consisted of 3 beams with 16 m length each). The structural system is a simply supported beam with 40m span cantilevering 4m beyond both supports. Lateral bracing was provided by purlins (120mm x 460mm) every 3.17m, and trusses for wind bracing in the roof plane.

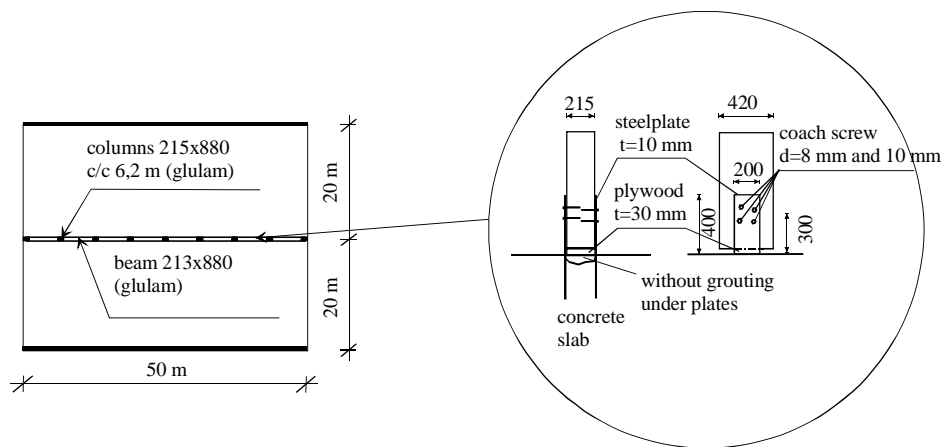
Figure 70-1: Detail of the column connections which provide the only lateral support in the span direction.

Nail plate connected trusses were supported on three vertical support lines with distance of 20.1 m from each other. The external vertical structures were timber walls with studs 42x142x4053 mm c/c 600 mm. Middle supports were glulam columns 210x420x4054 mm (*b*x*h*x*L*) c/c 6.25 m supporting a longitudinal glulam beam 210x810 (*b*x*h*), see figure 70-1.

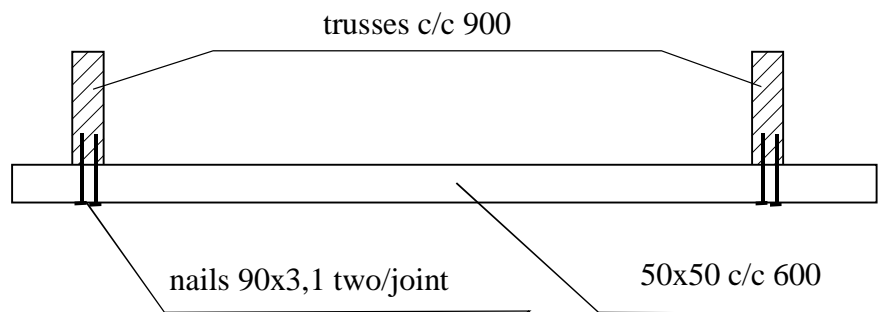
Figure 72-1: Support connection of inner ceiling.

The ceiling strips $50 \times 50 \text{ mm}^2$ are nailed to the roof trusses as a rule by two machine nails 90×3.1 per joint see figure 72-1. The load was axial, withdrawal load for nails, consisting of dead load of ceiling, insulation material, electrical cables and ventilation channels.

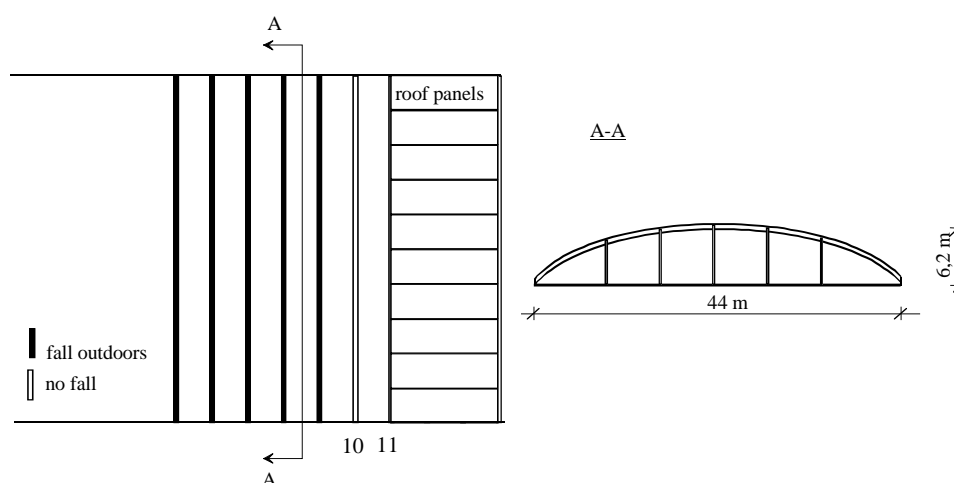
Figure 73-1: Structures installed at the time of failure.

The structure consists of three-hinge-arches supported by columns. Span width is 44 m and the rising height of the arch is 6.2 m. The cross-section of the glulam arch is $b \times h = 190 \times 1260$ mm. Roof panels were planned to be installed on top of the arches. Vertical members were fixed between the arches. Lateral tension loads between arches during installation were carried by temporary rope type binders. In the final structure, lateral tension loads are carried by the roof structure. Figure 73-1 below illustrates the structures installed at the time of collapse.

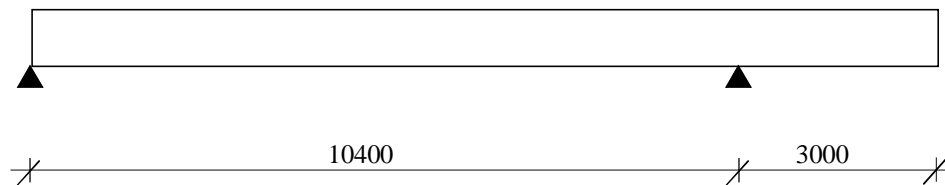
Figure 95-1: Beam in roof structure.

A commercial building, originally 40 to 45 years old, had been enlarged twice. The damaged beam was part of the old building part next to the newer enlargement. The beam was as shown in figure 95-1 below, a single span plus a cantilever. The cross section was $b \times h = 92 \times 845 \text{ mm}^2$ and it was loaded from a 4 m wide tributary area. The other beams were loaded from a 3.8 m wide area. The beams were supported on concrete columns.

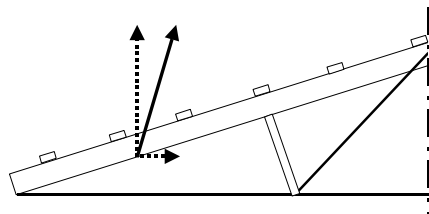
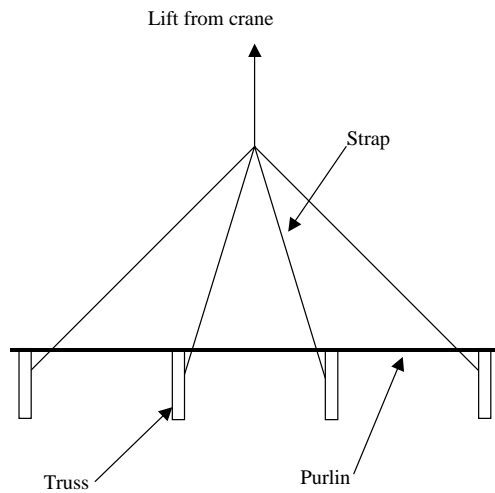
Figure 104-2. Strap placement.

After finalising the roof structure with four trusses and purlins, a crane was used to raise it in place on top of supporting columns. The straps used during rising of the structure were placed according to figure 104-2. The forces in the straps lead to a compressive force in the glulam parts, as indicated below. In addition, the purlins are also subjected to compressive forces, see figure 104-3. Just before putting the roof structure down on its supports, the structure collapsed. According to witnesses, one of the outermost trusses tilted and the structure failed.

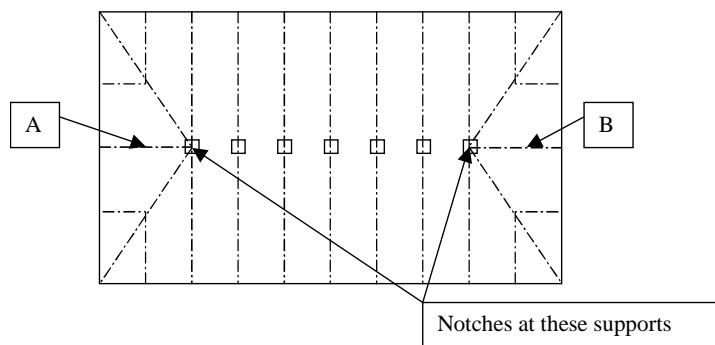
Figure 106-1. Schematic of roof structure

This structure is a glulam roof structure, built in the early or mid 1960s. A schematic of the structure supporting the hipped roof is shown below in figure 107-1. The roof beams had support along the walls and in the middle of the building. At the supports indicated in figure 106-1 the beams had notches. The glulam beams marked A and B had cross-sections of 115 by 697 mm², the remaining beams had cross-sections of about 190 by 700 to 1000 mm².

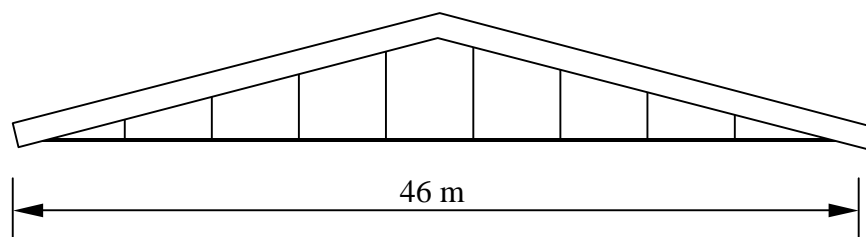
Figure 112-1. Roof structure.

This structure is a roof structure of an ice-hall. The structure is a three-hinged roof truss with a tensile rod as depicted in figure 112-1. A total of 11 roof trusses at a spacing of 6 m make up a total of 60 metres length of the building. The building was erected in 1964.

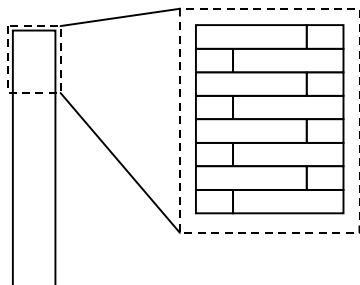
Figure 112-2. Beam cross-section built up from edgewise glued laminations.

Each of the 190 mm wide roof beams was made up from two laminations, edgewise glued to each other. The two laminations had widths of 45 and 145 mm respectively. This is shown in figure 112-2.

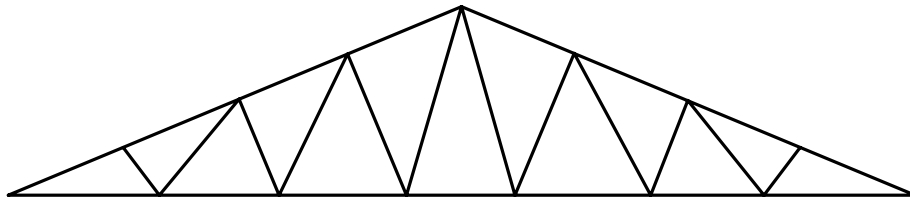
Figure 114-1. Example of roof truss

A large number of similar structures were built in Sweden for a chain of stores. The structure is based on nail-plate connected roof trusses, see figure 114-1. The battens, for support of the roof tiles, are nailed directly to the upper chord of the roof trusses. The roof structure also includes a reinforced plastic sheeting or a hard fibre board, covering the roof trusses, for draining of rain water. At least 26 cases have been documented, where the same principle was used for the load bearing structure. The buildings are relatively large, with free spans of 20-25 m and lengths of up to 65-70 m.

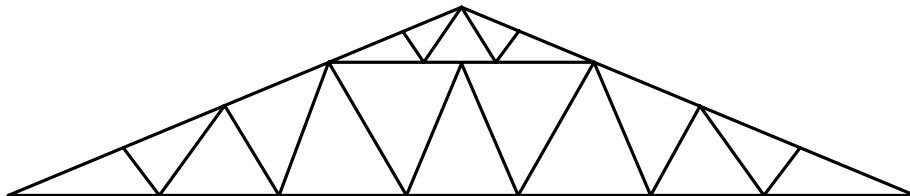
Figure 114-2. Truss divided in two parts for transportability.

Sometimes, the trusses have been manufactured in two parts, for transportability, see figure 114-2.

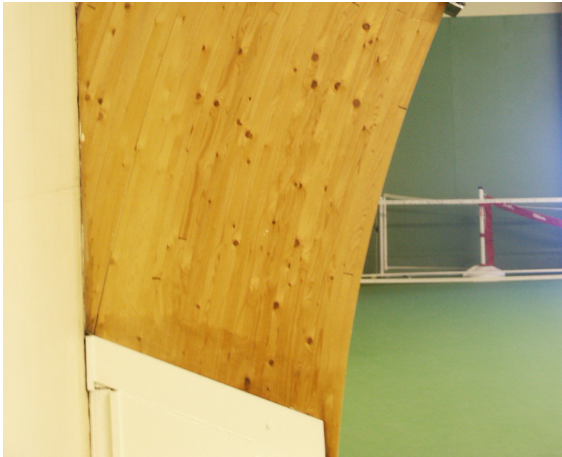
Figure 115-1. Arched column with steel parts (in white).

This structure is a tennis hall built from 3-hinged glulam frames, placed at 9 m distance. The columns are curved, and attached to the ground by steel parts, see figure 115-1.

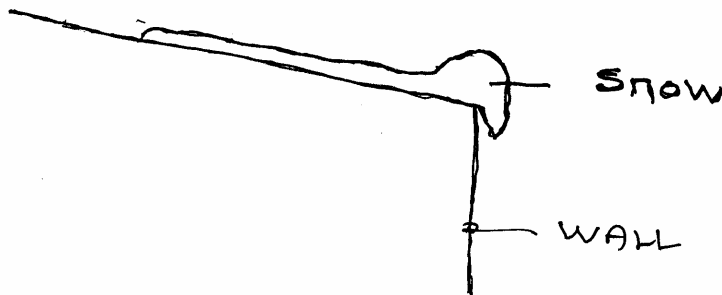
Figure 118-1: Snow load at time of failure.

The investigation showed that the snow load on the roof moved downwards due to the pitch of the roof and melting. Extremely high snow load was present at the eaves, see figure 118-1, which led to overloading of the eaves purlin.

Snow overhanging according to EC1 fig. 6.2 should have been considered.

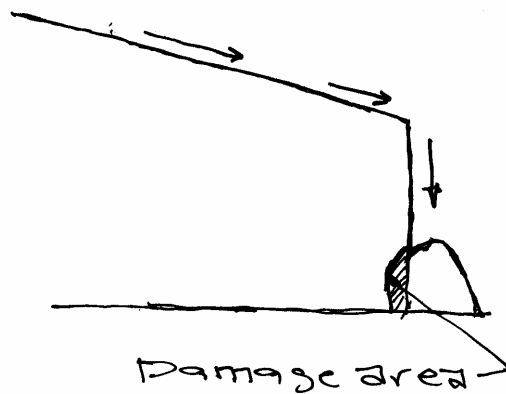
Figure 119-1: Snow load at time of failure.

In winter of 1991, the walls were damaged by snow, as is indicated in figure 119-1.

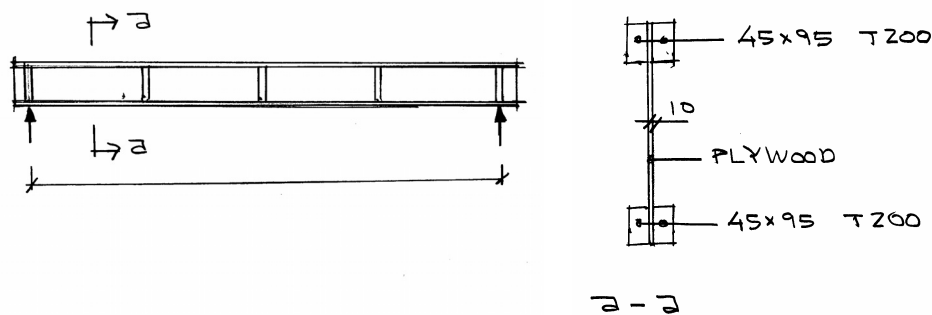
Figure 121-1: Light-weight I-beams.

A farm building (11 m x 24 m) was built in 1973 with light-weight plywood beams and timber columns. The beams had a depth of 630 mm and were placed at 3.5 m centres. The plywood web was butt jointed, see figure 121-1.

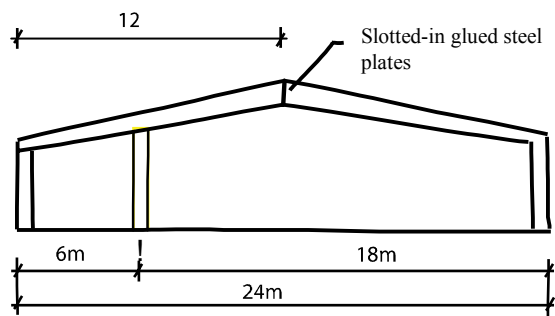
Figure 122-1: Glulam structure.

A school building was built in 1998 with a glulam structure as shown in figure 122-1, using glulam columns and single tapered beams. The spacing between the beams is 6 m. The beams are connected at the ridge by a glued connection with slotted-in steel plates, see figure 122-2.

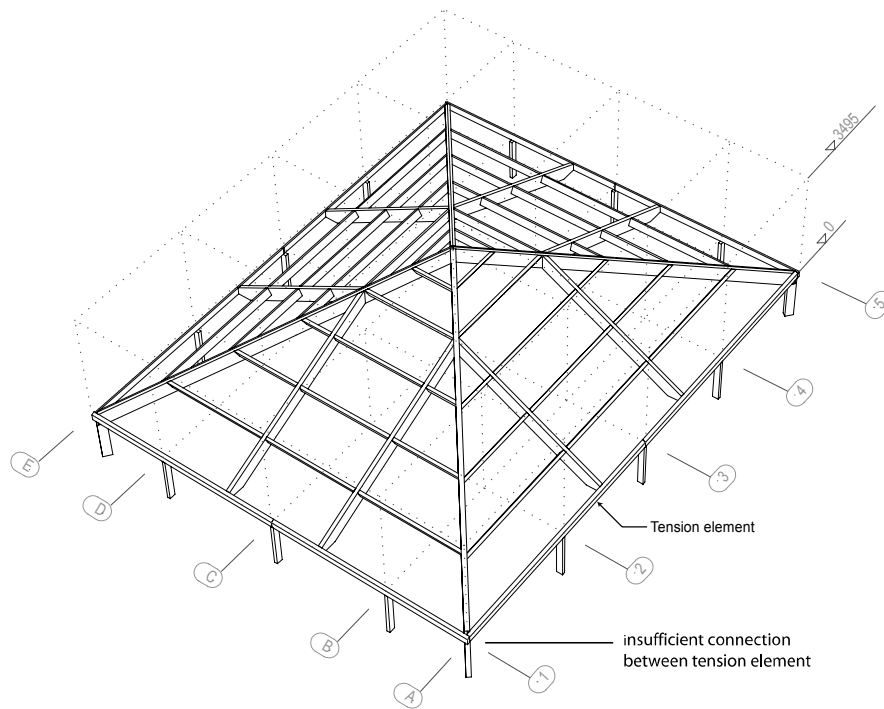
Figure 124-1: Pyramid structure, built with glulam and glass.

In 2005, a glass-glulam pyramid was built according to figure 124-1 below, spanning across 20 m.

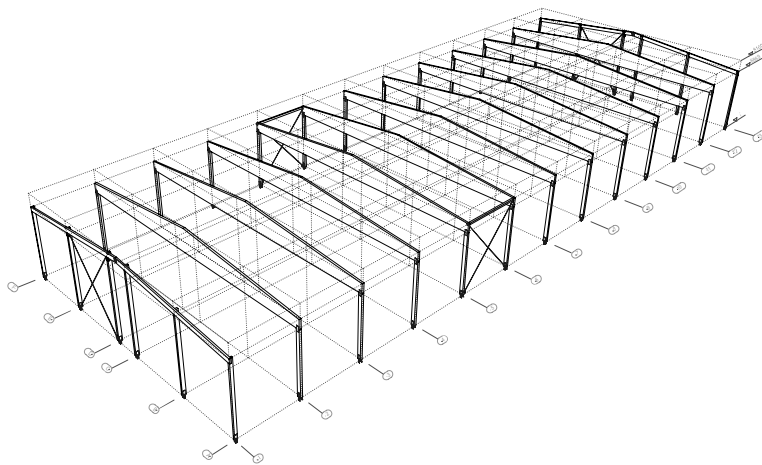
Figure 125-1: Industrial building with glulam beams and columns.

In 2005, an industrial building was built with a span of 26 m and a length of 72 m. The load-bearing structure consists of glulam beams and columns, see figure 125-1.
