HOW A SHIP'S BRIDGE KNOWS ITS POSITION – ECDIS ASSISTED ACCIDENTS FROM A CONTEMPORARY HUMAN FACTORS PERSPECTIVE

Thesis work submitted in partial fulfillment of the
requirements for the MSc in Human Factors and System Safety

Mads Ragnvald Nielsen

LUND UNIVERSITY
SWEDEN

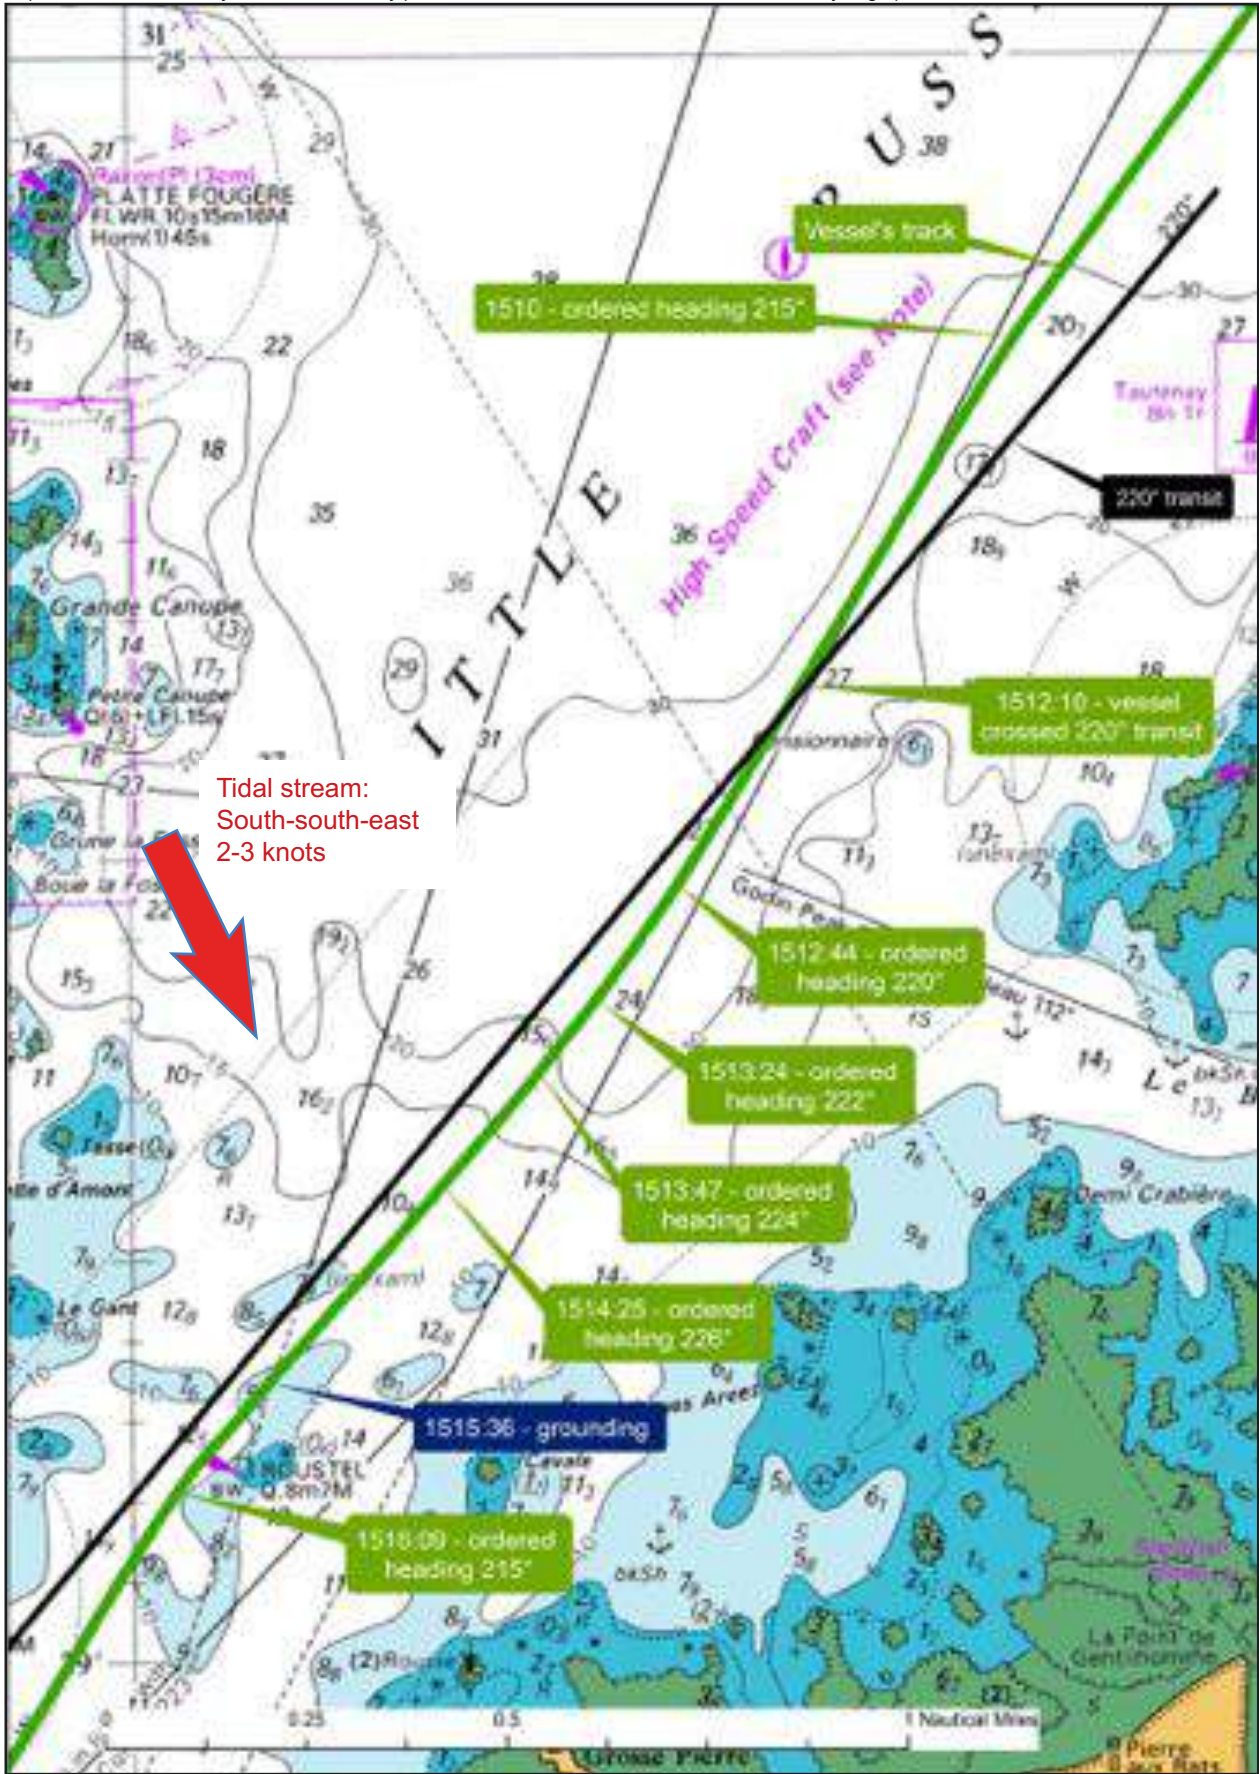
Figure 3: Commodore Clipper's track in the approach to the grounding

been caused by something that the propellers had picked up, such as a string of fishing pots. The master then told the chief engineer to instruct the dive team to inspect the propellers during the planned underwater survey.

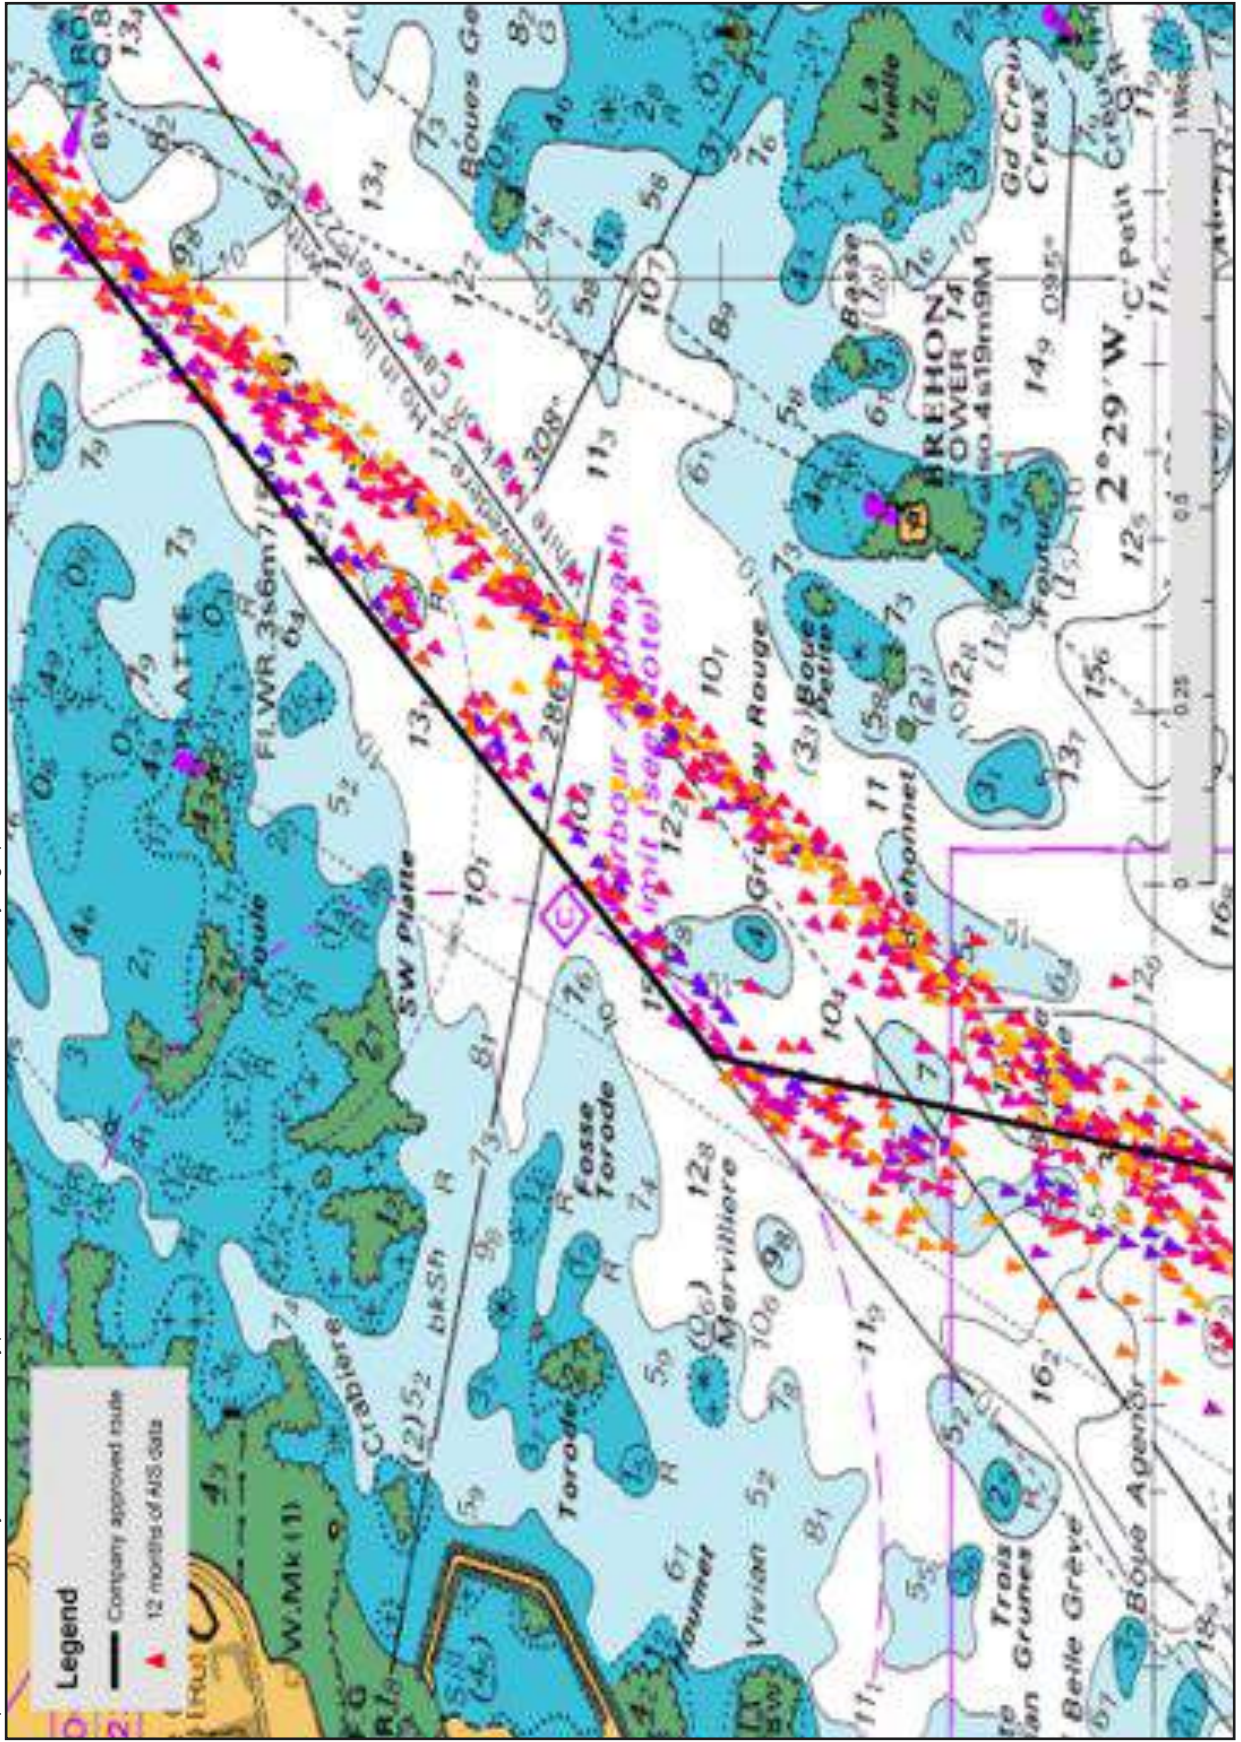
Figure 17: Twelve months AIS history of Commodore Clipper's southbound passages via the Little Russel

In the course of this investigation, the MAIB obtained 12 months of available¹¹ automatic identification system (AIS) data for *Commodore Clipper*'s southbound transits of the Little Russel prior to the grounding. This data (**Figure 17**) showed that the vessel routinely deviated from the company route by passing east of Grune au Rouge.

Teamwork on a bridge is vital, especially in pilotage waters where maintaining continuous, high levels of situational awareness is required and frequent decisions relating to navigational safety are being made. Key to this is a common understanding of the plan. Pre-departure and pre-arrival briefings, both of which were required by the vessel's SMS, provide one method of delivering this. This was particularly important on board *Commodore Clipper* as evidence from its AIS history (**Figure 17**) indicated that its masters routinely deviated from the recommended route.

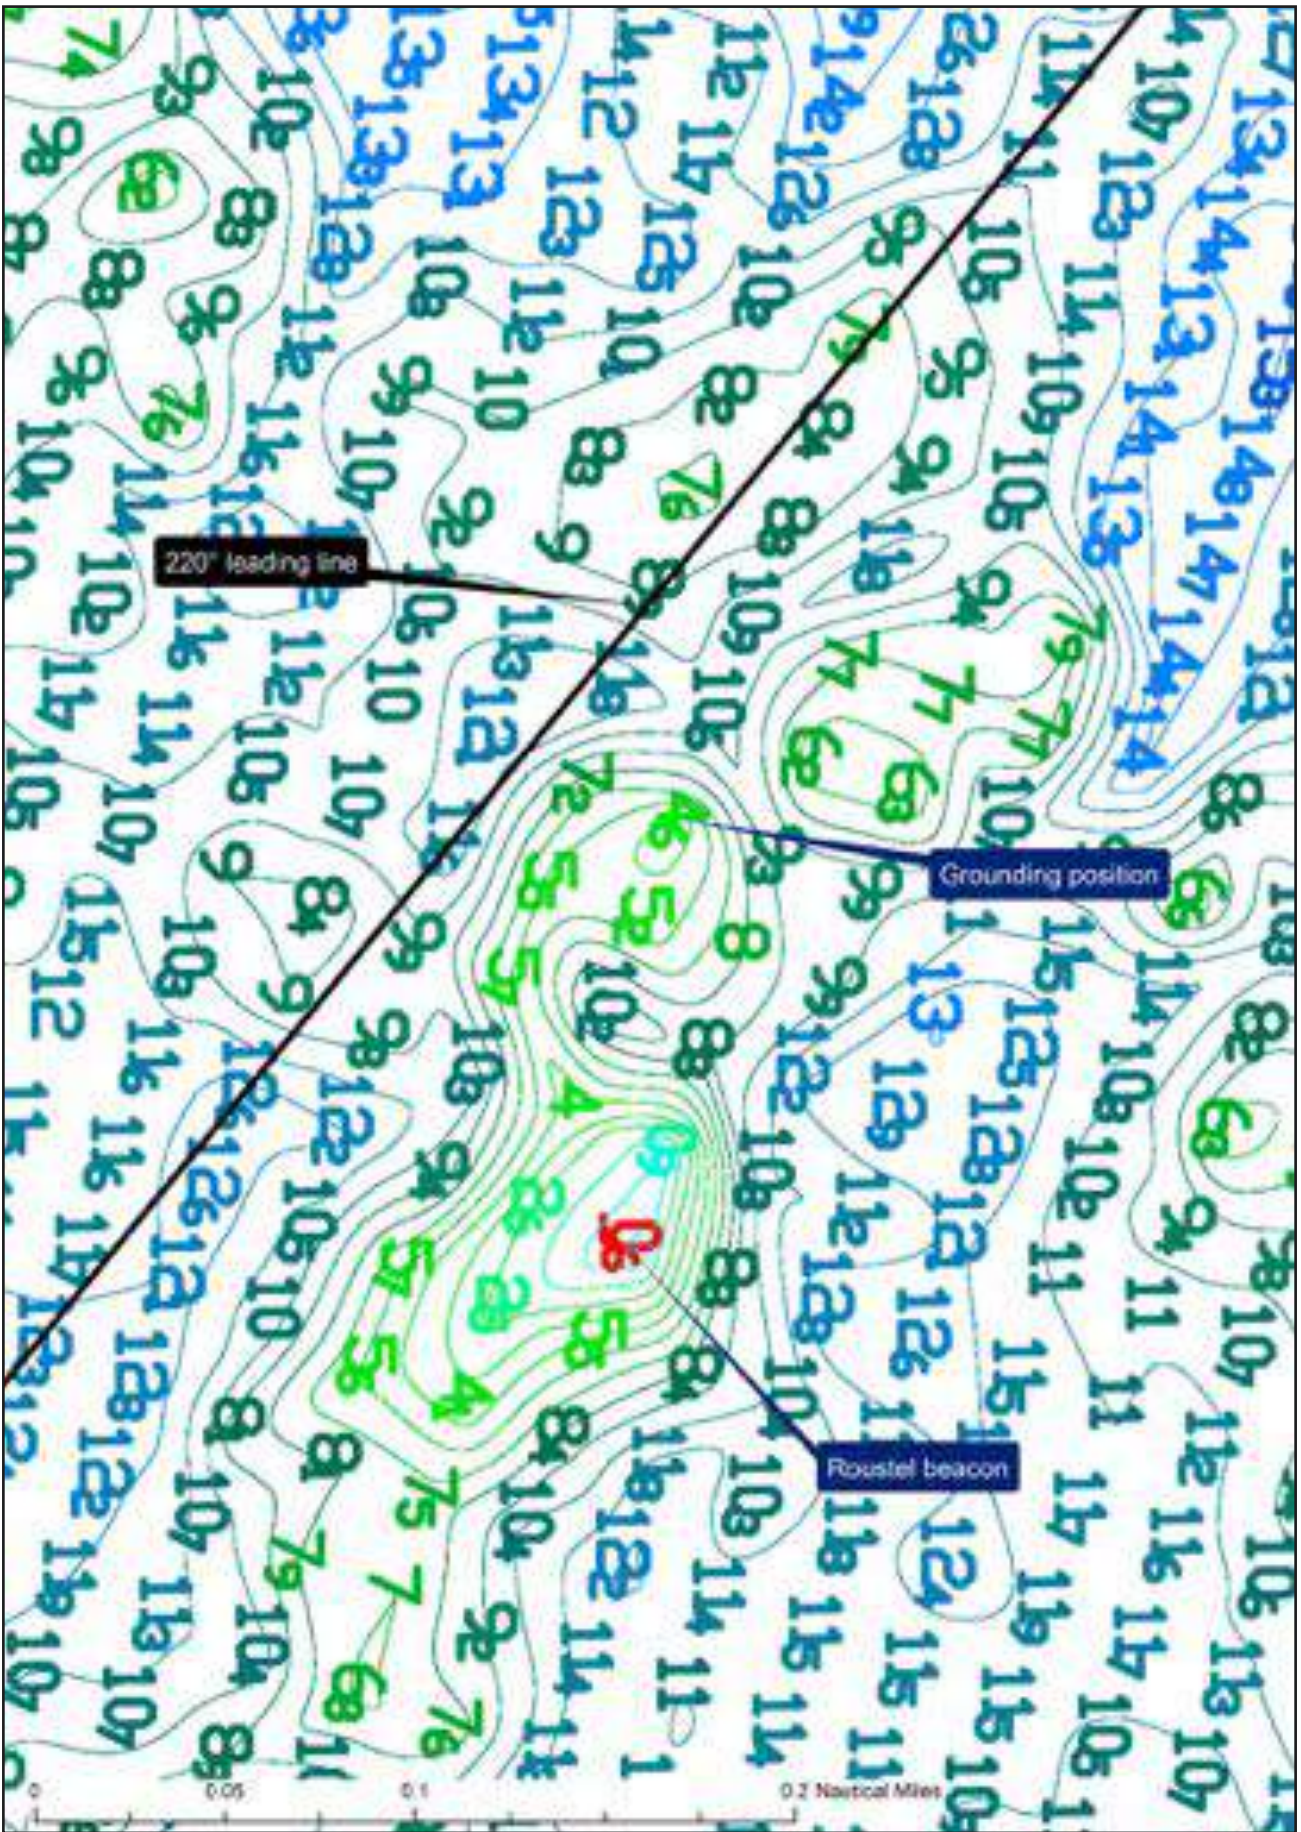
Figure 19: Extract of data from multi-beam survey conducted in March 2014 showing 4.6m sounding in grounding position (orientated north up)

Guernsey Harbours recognised its obligation to maintain accurate hydrographic data in its territorial waters, and in March 2014 it commissioned a commercial multi-beam echo sounder survey of St Peter Port's harbour approaches. The results of this survey were completed and passed to Guernsey Harbours by the survey company at the end of June 2014; the data was then forwarded to the UKHO for analysis. After the accident, scrutiny of this new data showed the rocky shoal in the grounding position had a surveyed depth of 4.6m below chart datum (**Figure 19**).

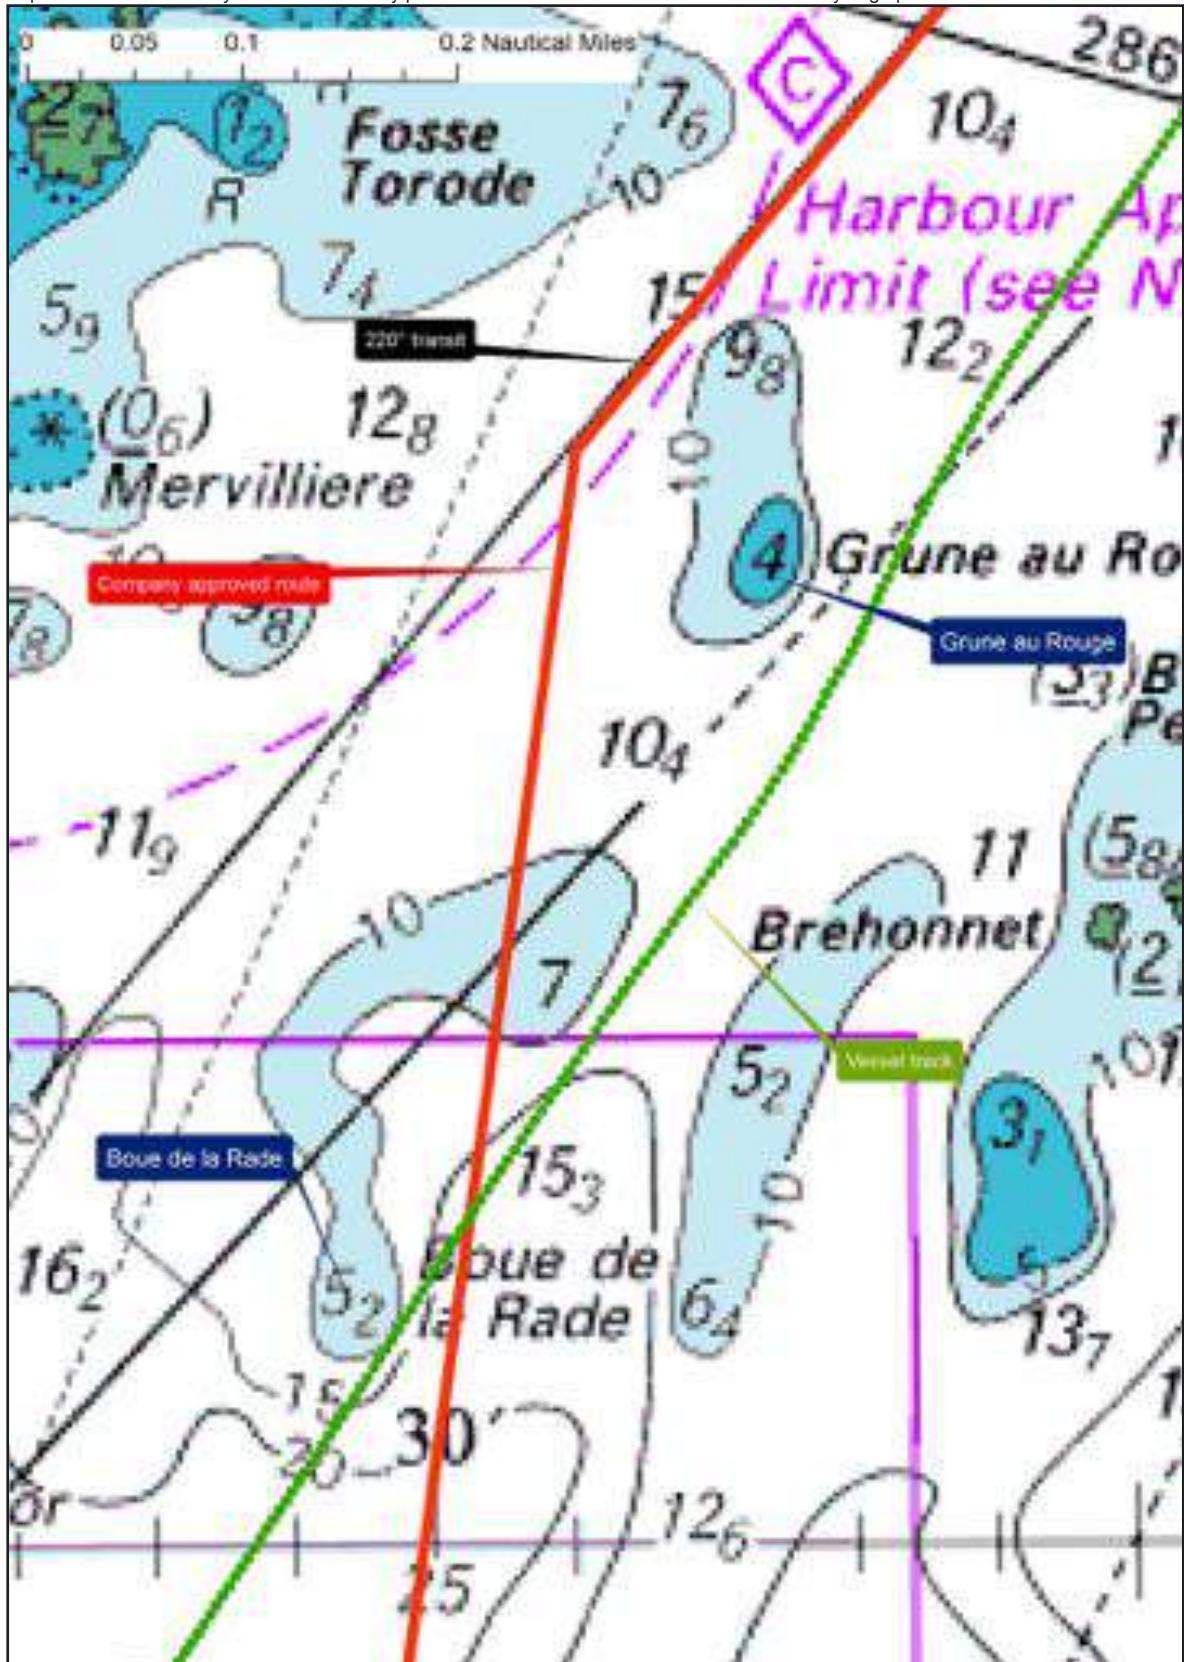
Figure 24: Detail of passage past Grune au Rouge and Boue de la Rade

Figure 23 shows the company approved route and the actual route taken by the vessel. In the approach to the grounding, *Commodore Clipper* was always to the east of the approved track. The vessel then passed under 100 yards to the east of Grune au Rouge (**Figure 24**) and over the eastern side of the Boue de la Rade shoal (**Figure 25**).

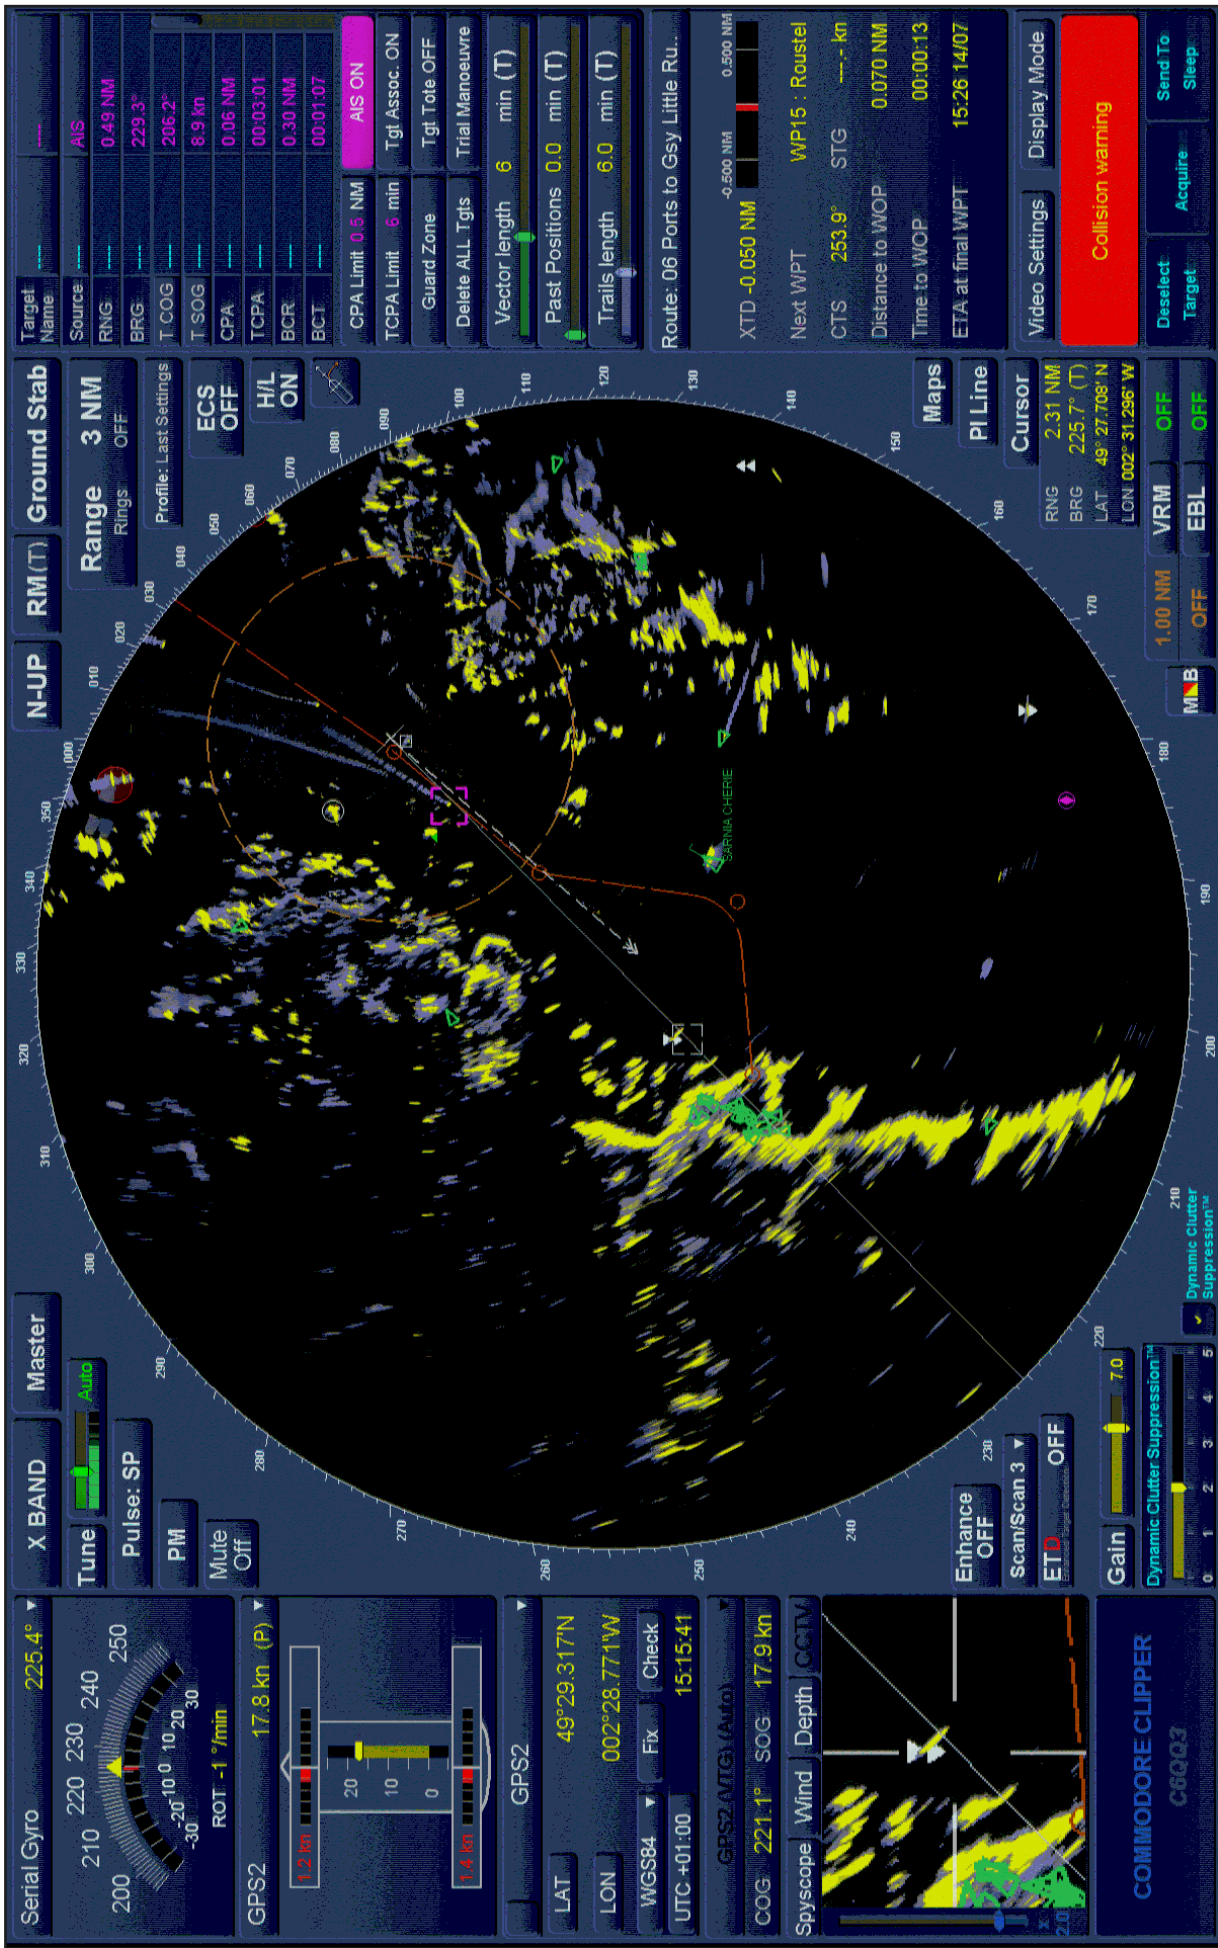
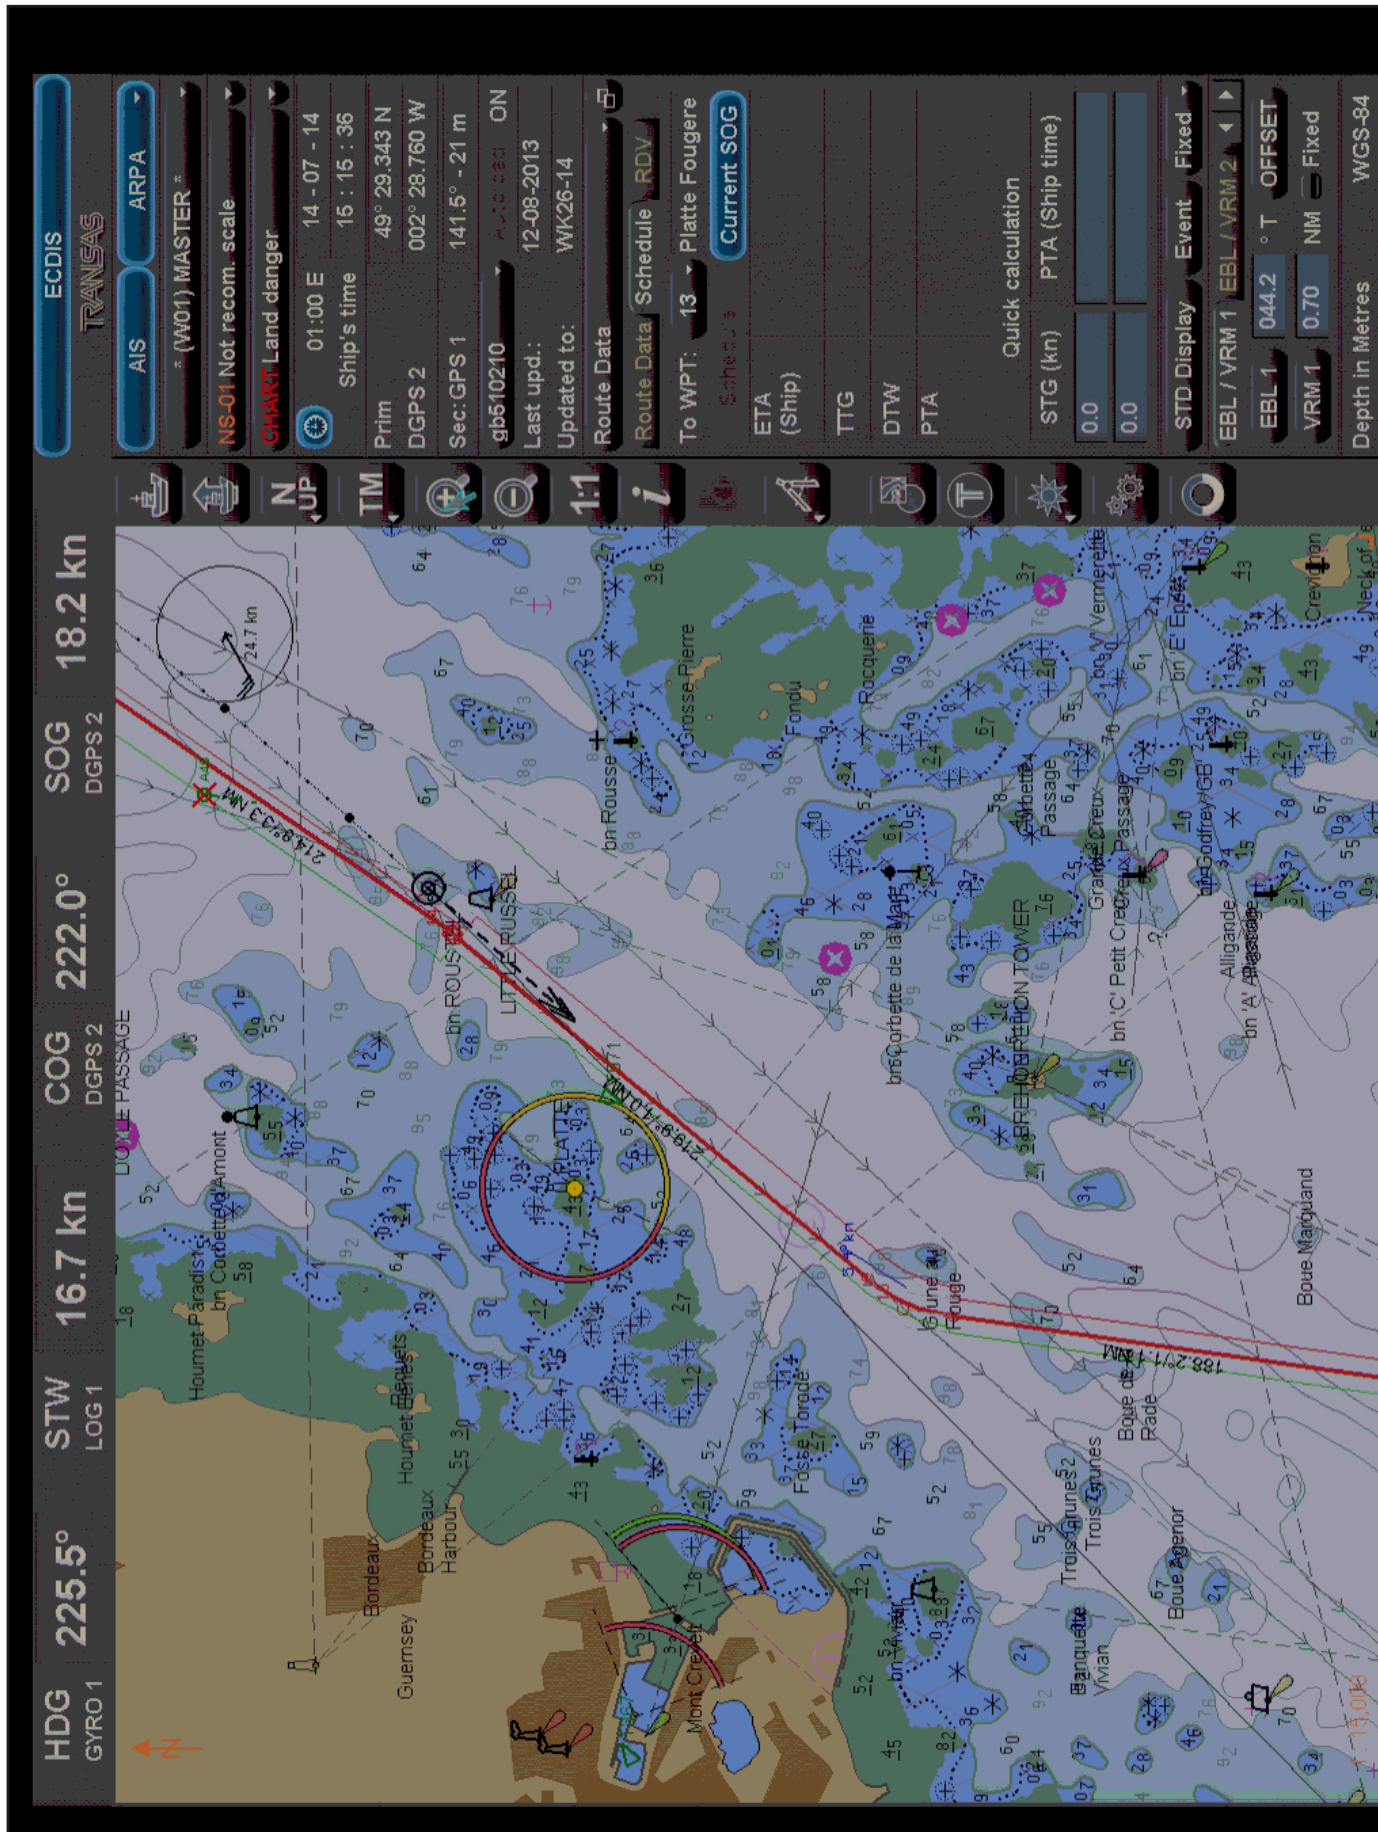
Although the primary means of maintaining track in the Little Russel was visual, electronic navigation aids can provide vital additional data, aiding the bridge team. The master's radar and ECDIS displays at the time of grounding (**Figures 26 and 27**) both showed the company approved route and the vessel's position relative to track. The radar display showed a digital readout of the distance off track of 0.05nm (100 yards). However, given the setting on a 3nm range scale, it would be difficult to use this information for navigational safety. The ECDIS display showed the vessel's course over the ground, which took tidal stream into account and therefore provided an immediate assessment of drift.

Figure 26: Master's radar display when grounding

Figure 27: Master's ECDIS display when grounding

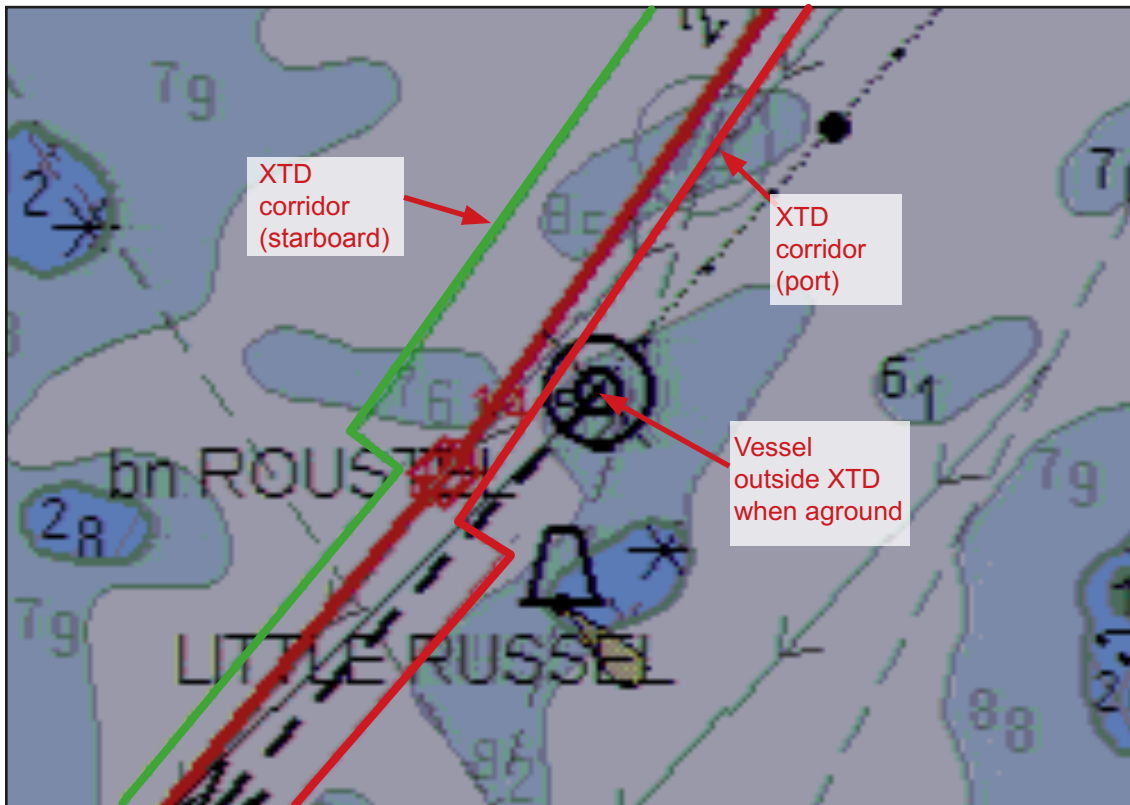
Figure 29: Detail of ECDIS display when grounding showing cross track distances

The ECDIS safety depth setting of 7m was appropriate for the voyage, but the safety contour value of 5m was not. The safety contour could have been set at a minimum value of 6.3m (see Section 2.7) and the ECDIS would have defaulted to the next deeper ENC contour of 10m. However, a 10m safety contour would have given the impression that the Little Russel was impassable. It would have been possible to draw an LDL in ECDIS at 6.3m, which would have given the most accurate electronic picture of the safe water available. An illustration of such a manually constructed ECDIS LDL is at **Figure 28**. Although this facility was available and the crew had been trained in its use, it was not practiced on board. Whilst this method could have provided a more realistic ECDIS picture of the available safe water, it is a method that carries significant risk as the LDL value is unique to a specific height of tide value and would need to be adjusted if the planned time of the passage changed. Nevertheless, on board *Commodore Clipper* the safety depth and safety contour settings were never routinely adjusted for the local conditions.

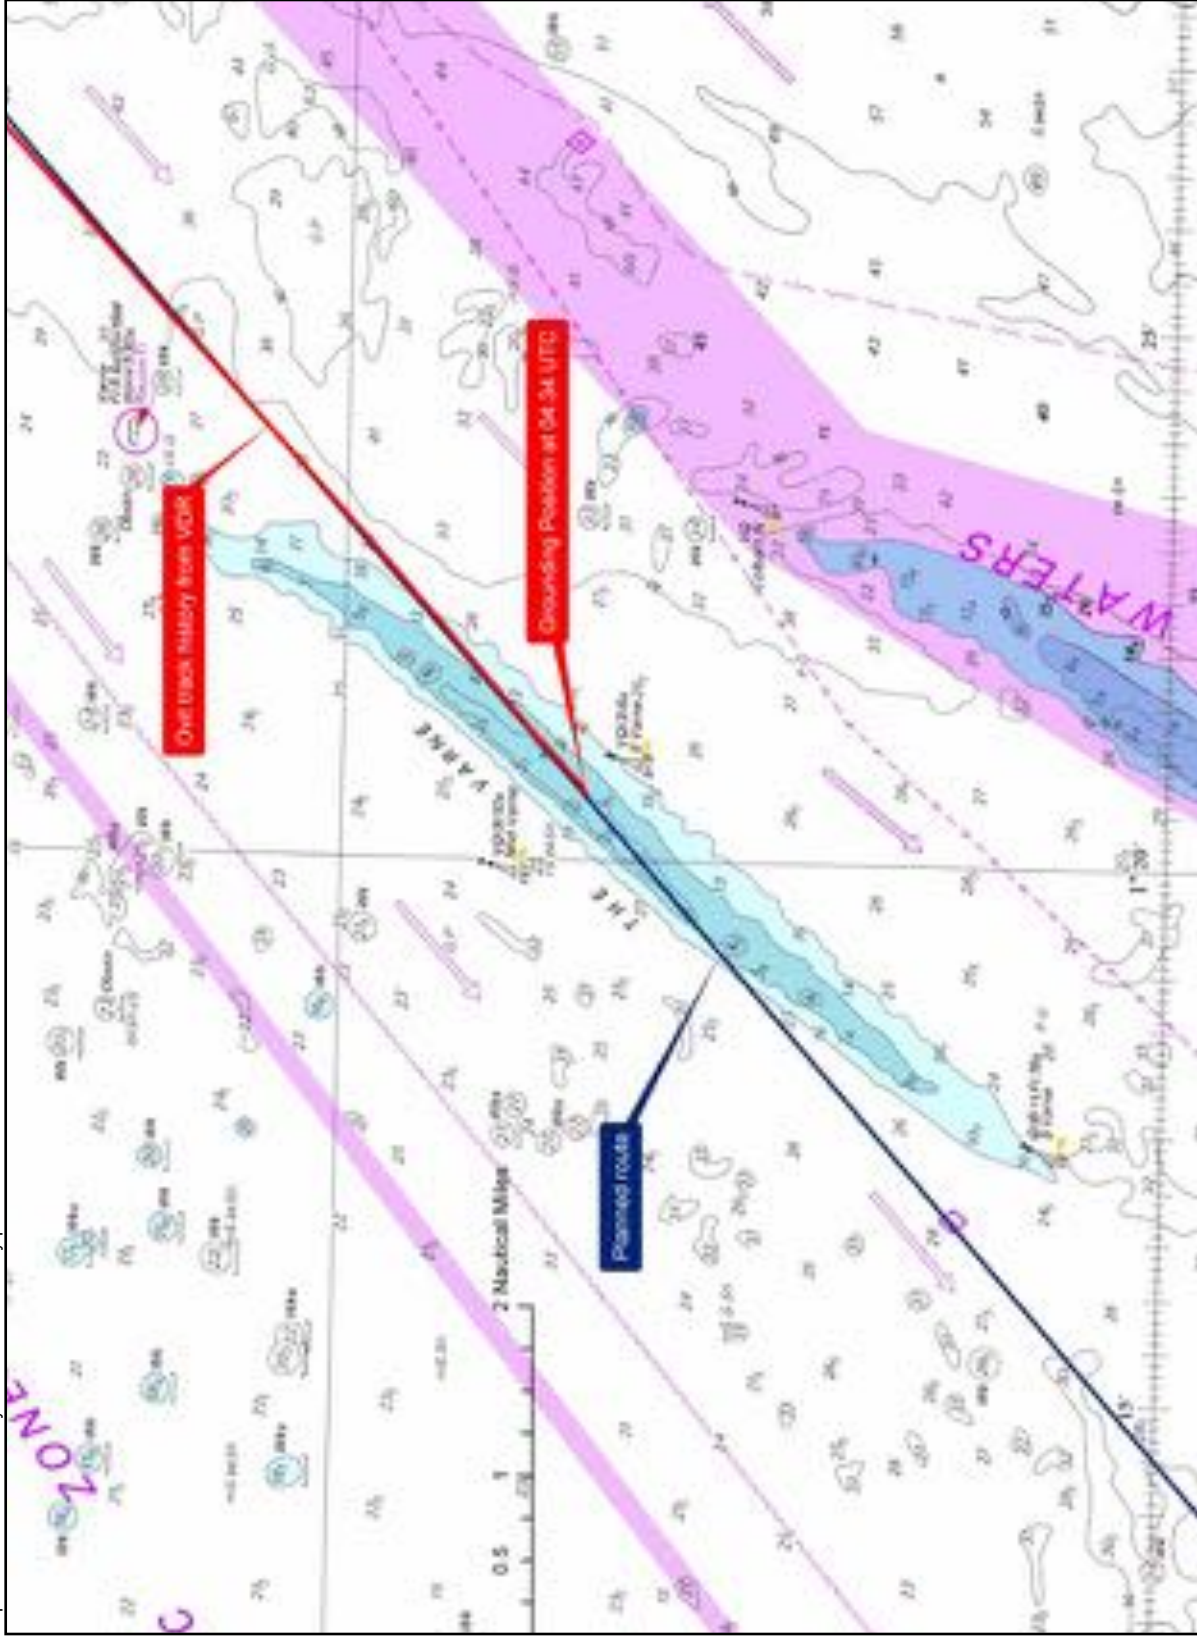
Figure 4: Ovi's grounding position

At approximately 0417, *Ovit* passed close by the Varne Light Float. From 0432 the ship's speed slowly reduced until the vessel stopped when it grounded on the Varne Bank at 0434 (**Figure 4**).

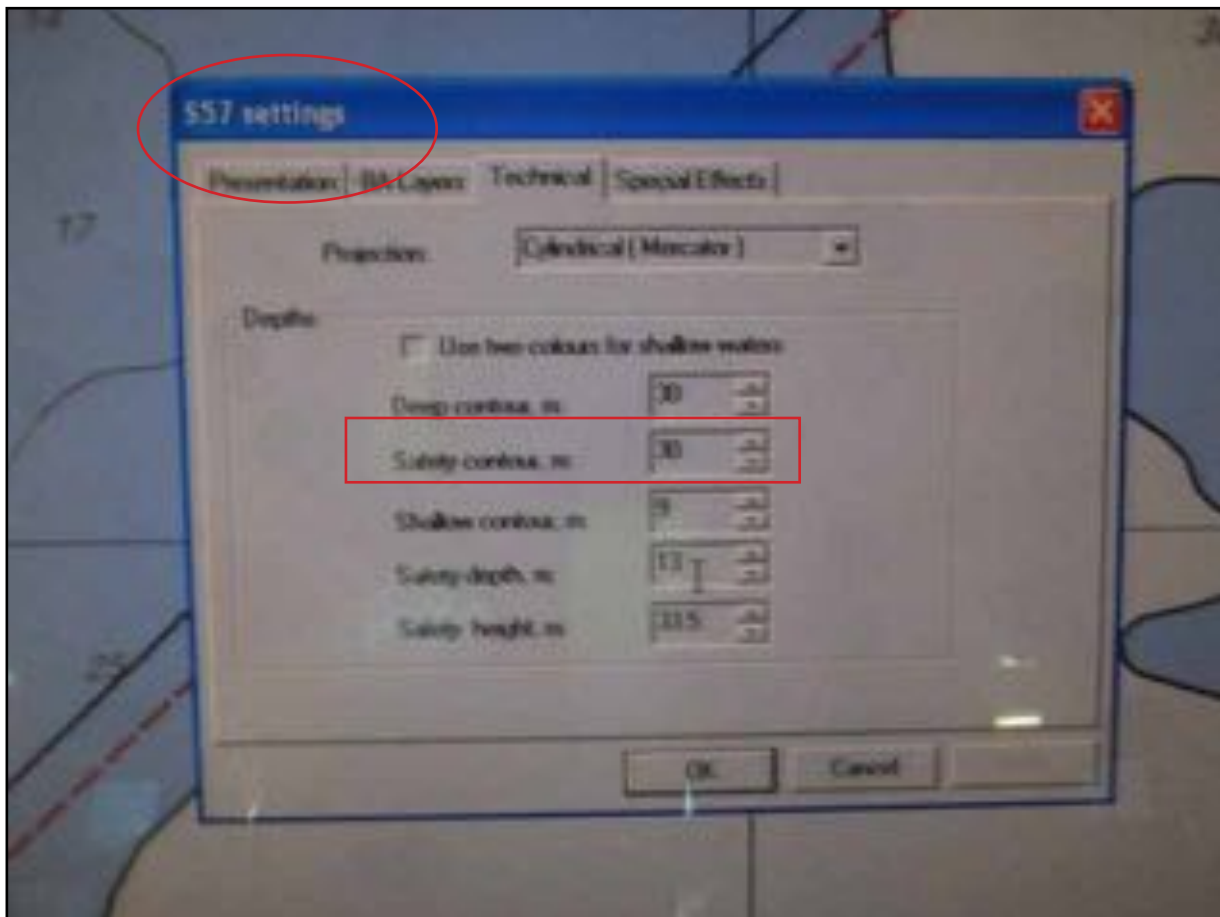
Figure 9: Maris 900 ECDIS 'S57' input page

- The audible alarm was not functioning. The audio output communications port had not been configured⁸. Therefore, when an alarm activated, no signal was sent to the integral speaker in the ECDIS display.
- The route in use was named '*Rotterdam-Vasto*' and had been selected for navigation on 16 September 2013. It had 47 waypoints and totalled 2749.84nm.
- The ENC cell in use was GB202675. ENC cell GB401892 was available. The ENC auto-load feature was switched off.
- The depth settings (**Figure 9**) were:
 - Deep contour: 30m
 - Safety contour: 30m
 - Shallow contour: 9m
 - Safety depth: 13m.

- Despite its critical importance, the safety contour setting is one of several indistinguishable settings on the same page (**Figure 9**). The importance of the safety contour setting is not emphasised to the operator.

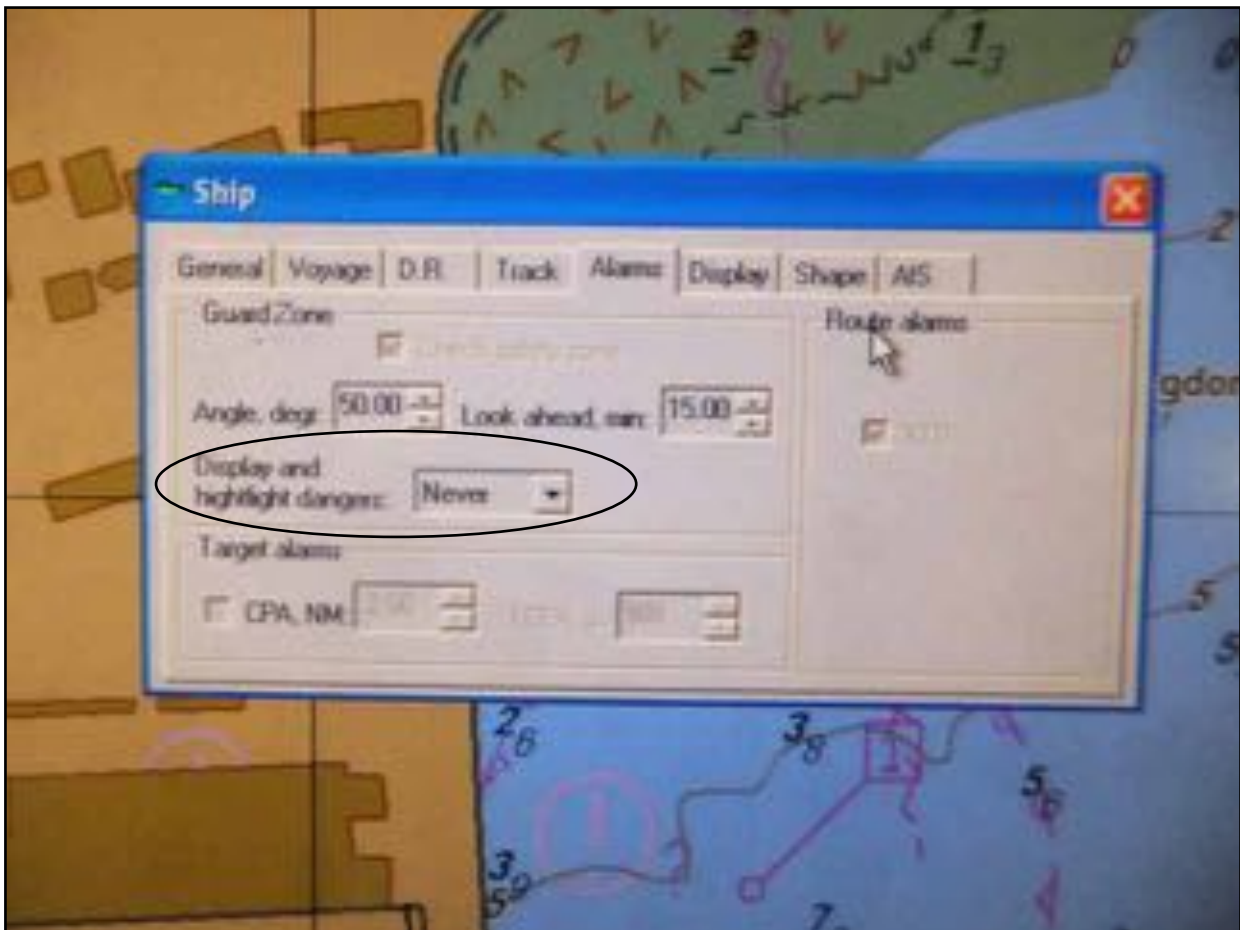
Figure 10: Maris 900 ECDIS guard-zone settings page

- The cross track distance (XTD) was set to 0.00nm. The safety guard zone was set to 50° and 15 minutes. The 'display and highlight dangers' sub menu was selected to 'never' (Figure 10).
- With the *Rotterdam - Vasto* route selected, the 'check-route' page highlighted a significant list of potential hazards including the risk of grounding on the Varne Bank (Figure 11). The page was shown to *Ovit's* deck officers who interpreted the 'no alarms' notation on the lower half of the page to mean that there were no hazards along the route.

- The safety contour alarm should have activated shortly before *Ovit* crossed the 30m contour at 0417. However, the ECDIS display during the grounding (**Figure 6**) shows that only the XTD and grounding alarms were active. As the safety contour alarm is intended to activate when a vessel is about to cross the designated contour, it is almost certain that it did not function because the 'display and highlight dangers' option on the guard zone page was set to 'never' (**Figure 10**). Effectively, this disabled a mandatory alarm.

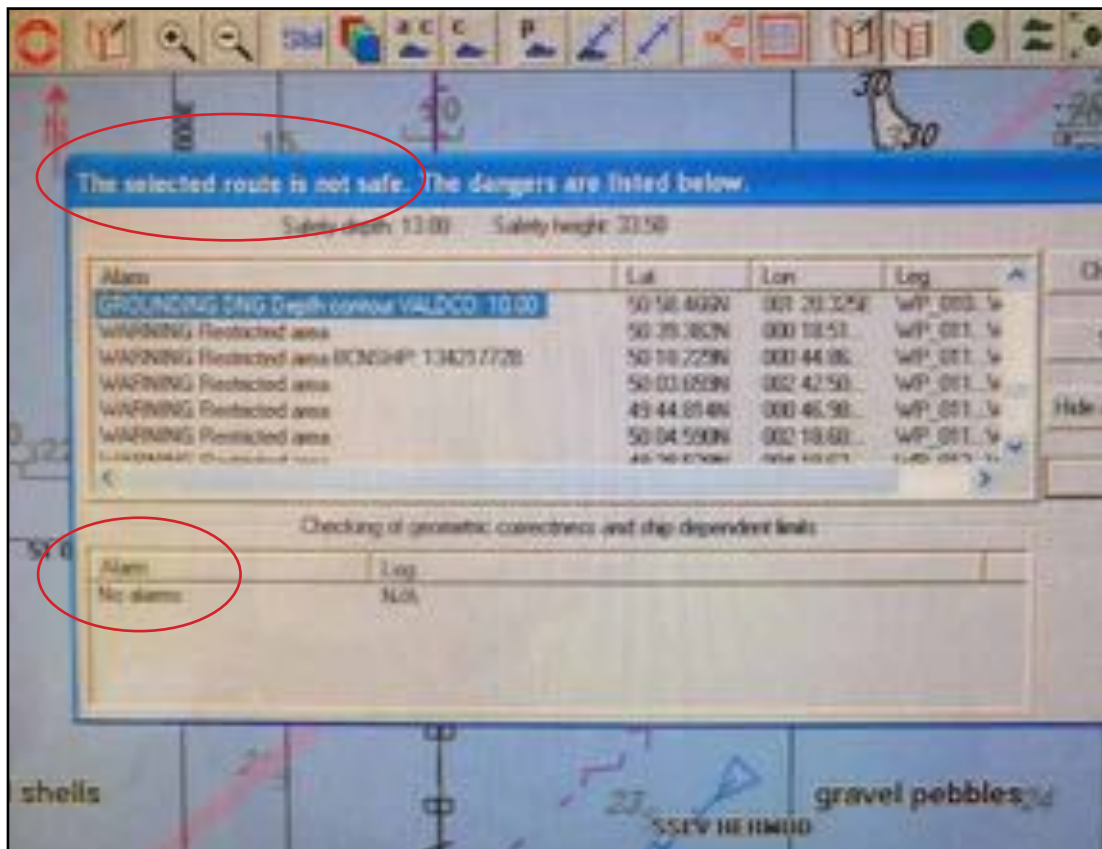
Figure 11: Maris 900 ECDIS check-route page

- At the top of the check-route page, it clearly stated that the selected route was unsafe (**Figure 11**). However, it was unhelpful that the words 'no alarms' could be seen in the bottom left of the same page. The 'no alarms' information refers to system input data but, as shown by *Ovit's* deck officers' understanding of the system, it can be inadvertently linked with the navigational safety data above it.
