HOW A SHIP'S BRIDGE KNOWS ITS POSITION – ECDIS ASSISTED ACCIDENTS FROM A CONTEMPORARY HUMAN FACTORS PERSPECTIVE

Thesis work submitted in partial fulfillment of the
requirements for the MSc in Human Factors and System Safety

Mads Ragnvald Nielsen

LUND UNIVERSITY
SWEDEN

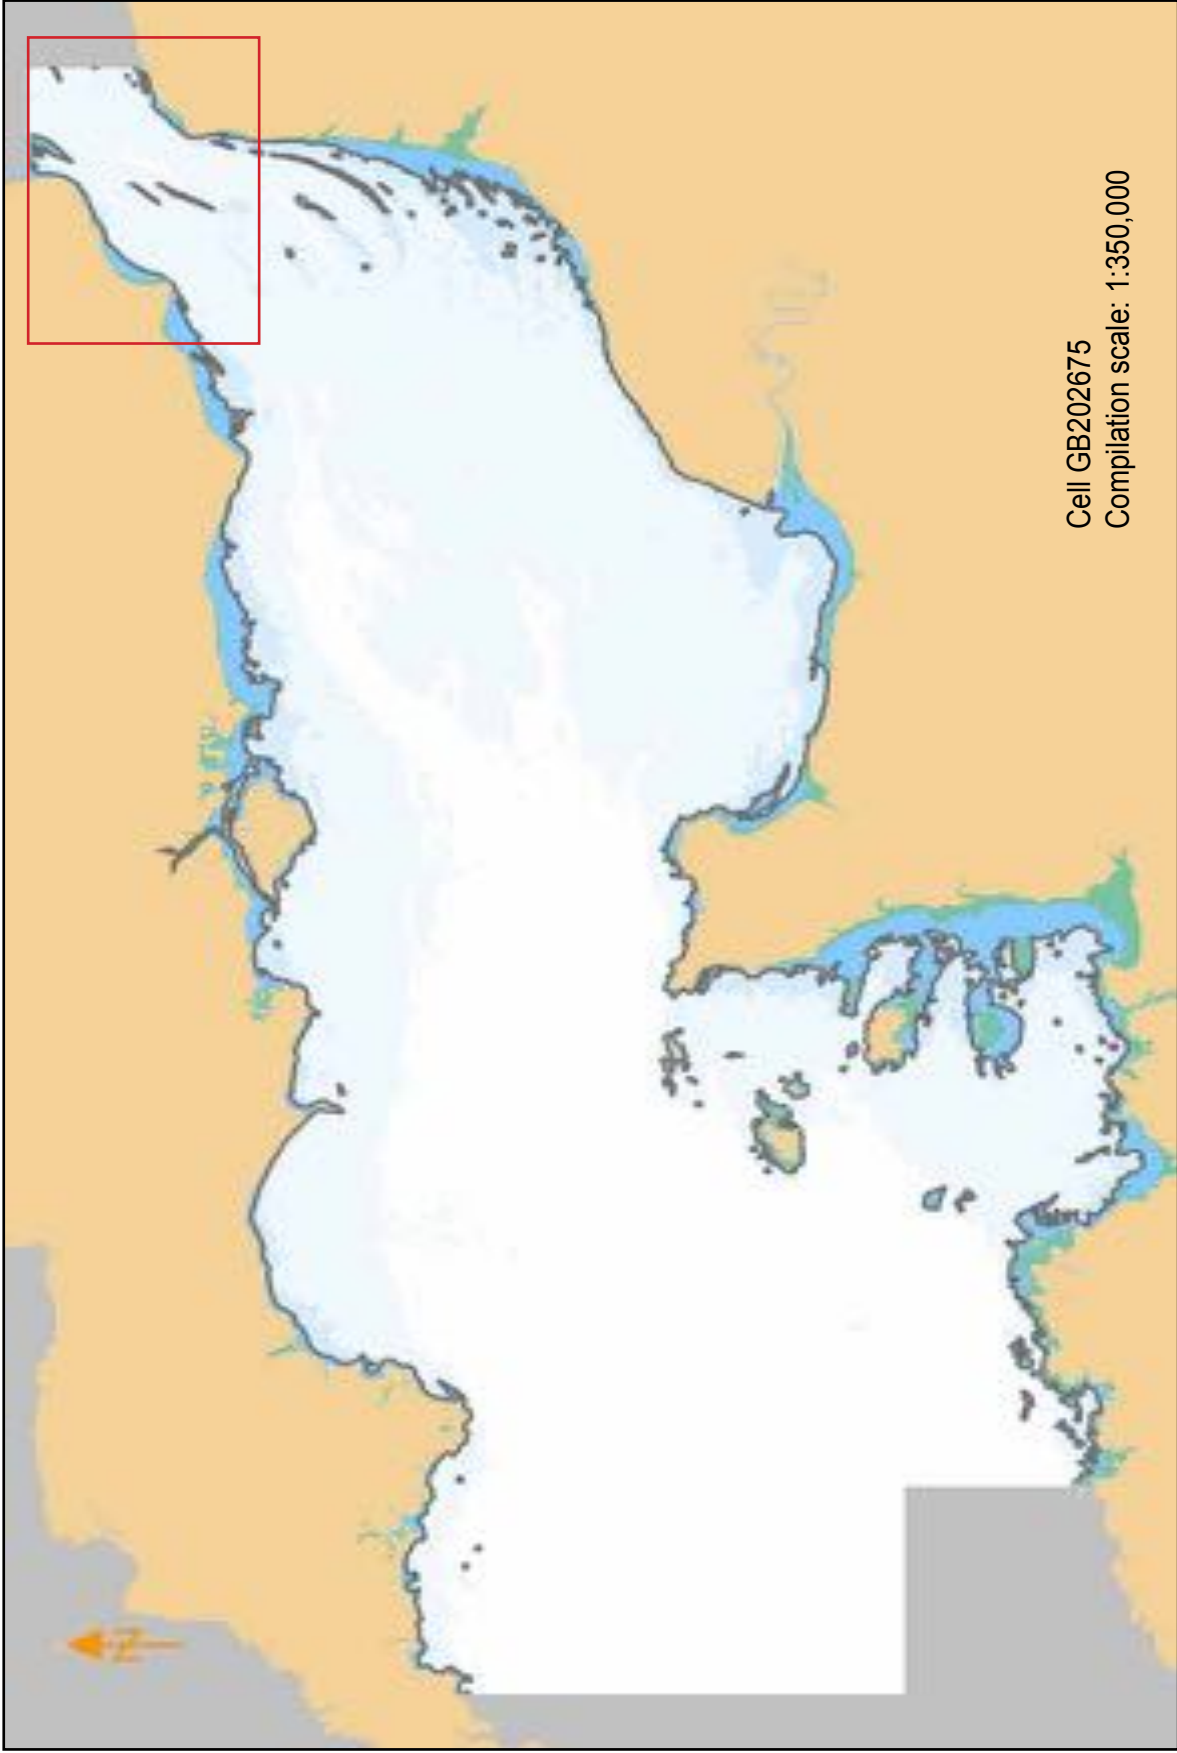
Figure 15: Area coverage of ENC cell 202675

During the Dover Strait passage, the ENC in use was GB202657 which was a 'general' chart on a scale of 1:350,000 (**Figure 15**). In coastal waters, this scale of chart would only be effective for planning purposes. ENC, GB401892 on a scale of 1:45,000 (**Figure 16**), which was suitable for coastal navigation, was available on board but it was not in use. The ECDIS 'auto-load' feature, which would have automatically selected the best scale chart, was switched off.

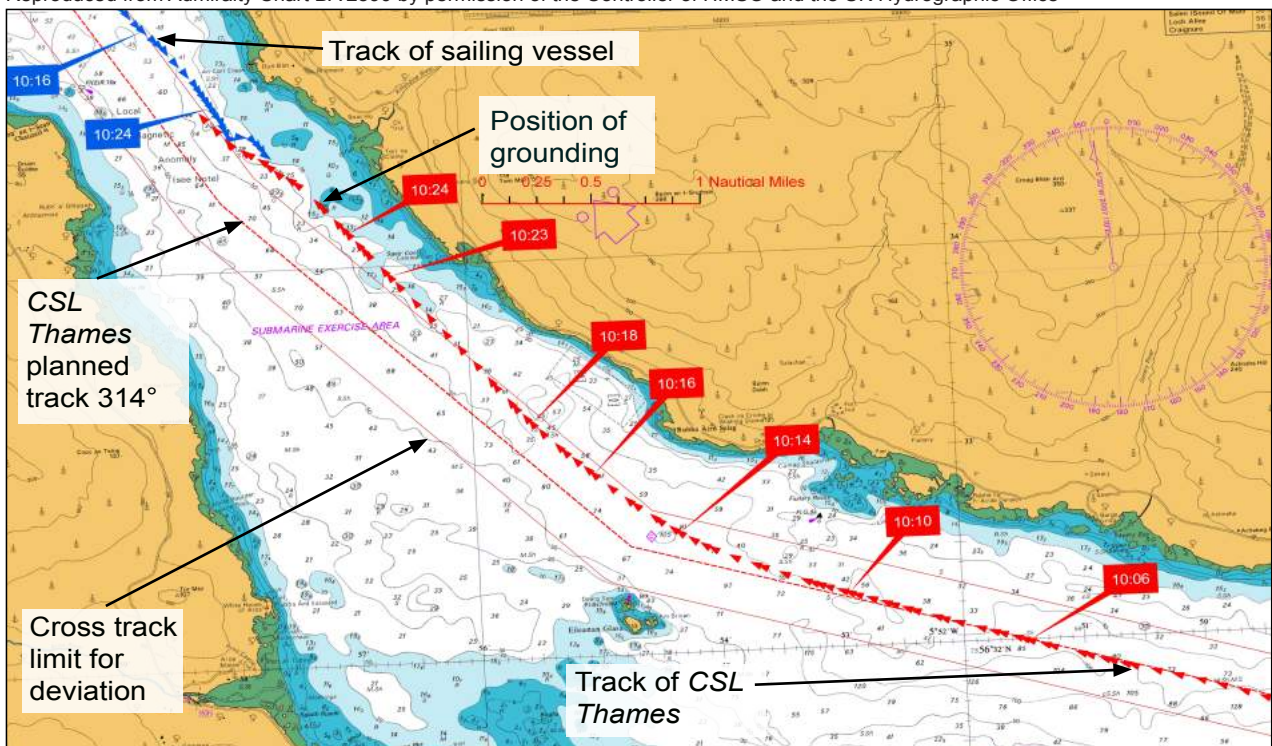
Figure 1: AIS tracks of *CSL Thames* and sailing vessel

At 1006 (**Figure 1**), with *CSL Thames* on a heading of 290°(T) at a speed of 12 knots, the master instructed the helmsman to engage the autopilot and then handed the con to the third officer, who stood facing the starboard radar display, with the

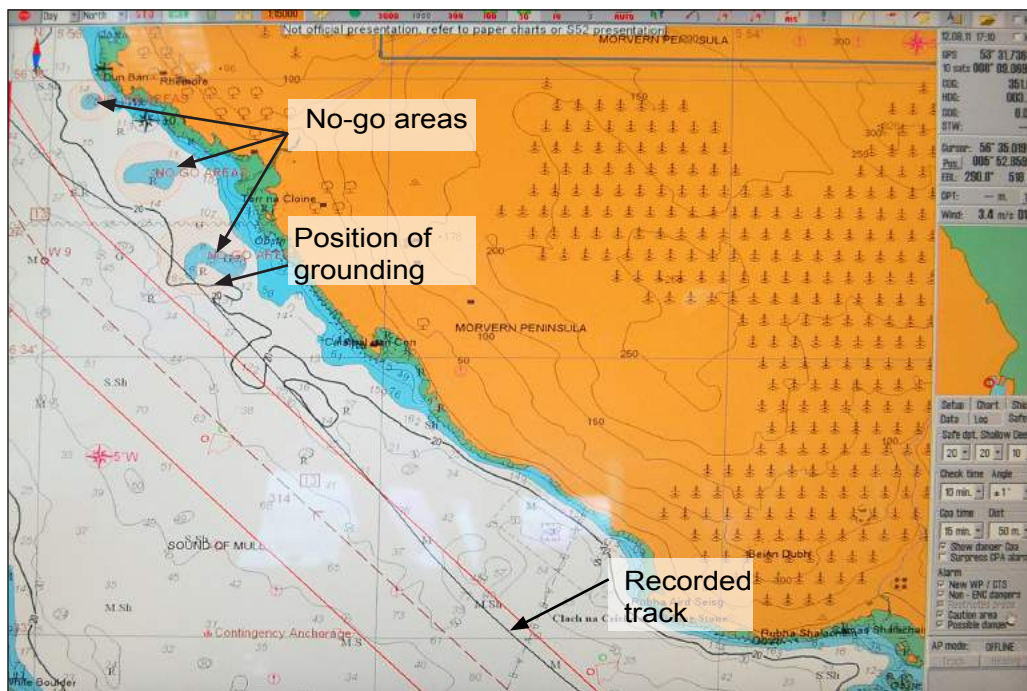
Figure 4: ECDIS display showing recorded track

At 1025, *CSL Thames* grounded in position 56° 34.3'N, 005°57.2'W at a speed of about 12 knots (**Figure 4**). The contact with the seabed lasted 16 seconds and caused the vessel to vibrate loudly. This prompted the master to return to the conning position and to look at the ECDIS display. Recognising that his vessel had run aground, he instructed the helmsman to switch to manual steering and ordered the wheel to hard-a-port. The sailing vessel also altered course to port and both vessels narrowly avoided colliding with each other.
