Characterization of black corrosion in reinforced concrete structures: analyses of field samples from southern Sweden

Dissertations in Geology at Lund University,
Master's thesis, no 554
(45 hp/ECTS credits)

Department of Geology
Lund University
2019

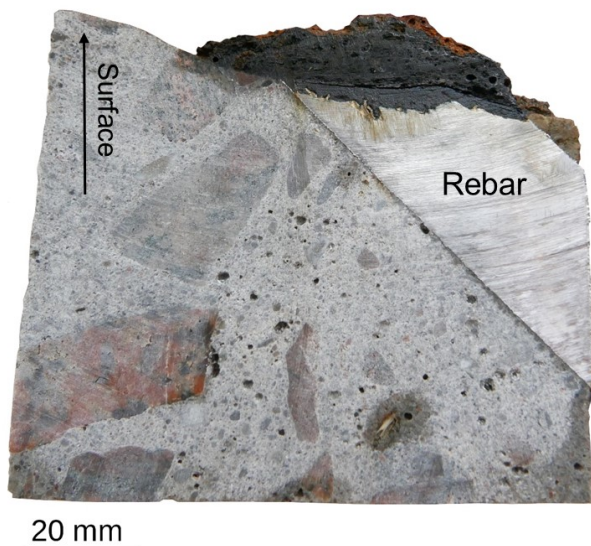
Fig. 6.4. The cross section of the drill core of Sample 1.

General description of hand specimen: The hand specimen of Sample 1 (Fig. 6.4) is a piece of a concrete core, drilled out from a culvert in a seawater chamber connected to The Sound. When looking at the cross section of the core a reinforcement bar is crossing the right corner. On top of the sample, a nodule of black and red corrosion products is covering the reinforcement. In the thin section, small sand particles are visible within the nodule. The upper most part of the reinforcement, up to 5 mm, has been affected by the corrosion process and has left a dark soft muddy substance – black rust.

the rebar (Fig. 6.7) but thins out towards the surface (Fig. 6.8). The nodule covers the surface to a depth of 15 mm in the sample. Pores are evenly distributed in the concrete and are about the same size beneath the reinforcement. Some of the voids seem to be caused

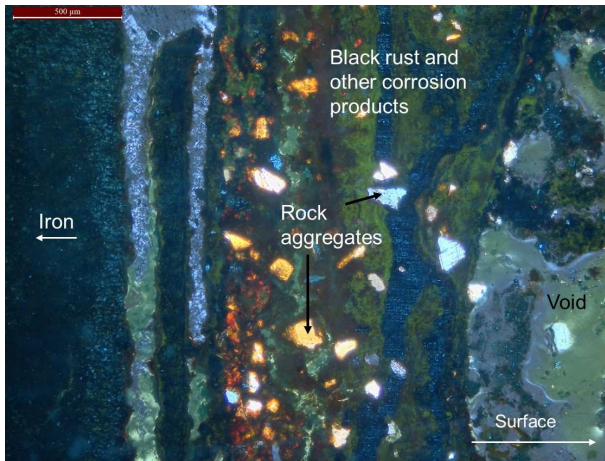
now of a dark soft and porous material with a mud-like texture. Within the nodule, bands of black rust products are observed between the oxidized red rust layers. This is well illustrated by the dark field microphotographs in Figs. 6.7 and 6.8. The black rust is most clearly visible from the darkfield photomicrographs where it is discerned with the black to dark blue color and metallic luster. The red rust is exhibiting a rusty brown to moss-green color with the darkfield method.

Fig. 6.7. This photomicrograph is taken in xpl with the dark-field mode enabled. A part of the corroded reinforcement (iron) is visible on the left side. The surface direction of this photo is to the right edge. Different corrosion products are displayed in the central which is interpreted as the transformed cement paste. *In situ* rock aggregates are the only product left of the concrete material. The scale bar in the upper left corner is 500 µm.

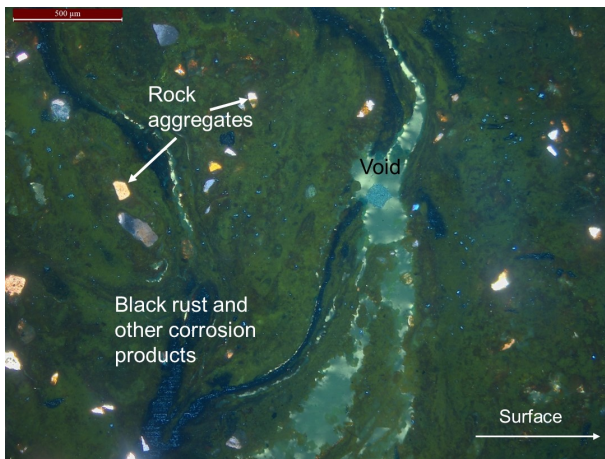
Fig. 6.8. Photomicrograph is taken in xpl with the darkfield mode enabled. This microdomain is situated a few millimeters further towards the surface (arrow pointing the right direction) of this sample, compared to Fig. 6.7. Black rust is seen in thinner bands within another corrosion product. *In situ* rock aggregates are left from the concrete material. The scale bar in the upper left corner is 500 µm.

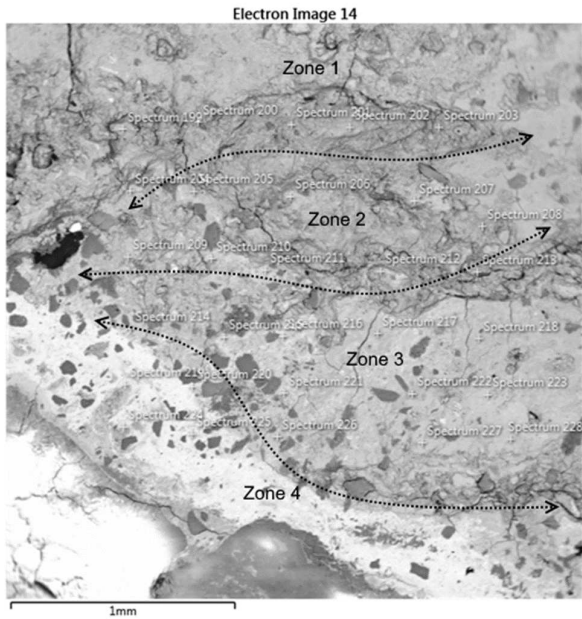
The cement paste at the surface is completely altered by chemistry. Only the concrete texture is still left with ballast particles in the fine-grained mass (Fig. 6.11). The cement paste building elements Ca, Si, Al are leached out, and are close to the detection limit in

Fig. 6.11. BSE image of Slice 1.1 from Sample 1. The dotted lines is illustrating the division between the different zones based on the point analyses. The lighter area (Zone 4) is richer in iron compared to Zones 1, 2, and 3.

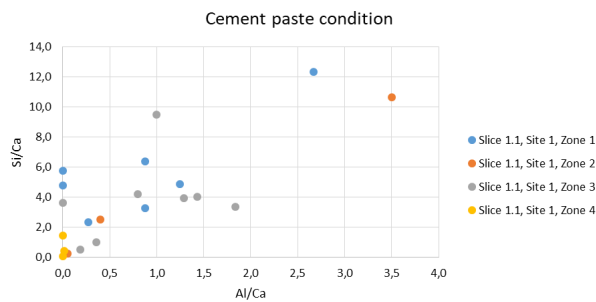
the EDS analysis. Most of the weight percent in the analysis is distributed on Fe, O and S, which speaks for a completely transformed cement paste in that microdomain. It is also clear with the scattered cement paste ratios of Si/Ca and Al/Ca shown in Fig. 6.12. Deeper within the sample the cement paste shows rather normal values, resembling an unaltered cement paste (Figs. 6.13 and 6.14). However the cement paste - rebar boundary is rather sharp and show little signs of alteration in the microdomain of Site 7 (Fig. 6.15).

Fig. 6.12. The cement paste condition is determined by the Si/Ca and Al/Ca ratios in the cement paste. The values in this graph show that Site 1 in Slice 1.1 has an altered cement paste where the cement building elements are reduced. These values are exceeding normal Si/Ca and Al/Ca ratios (0.35 and 0.08 respectively) by several times.

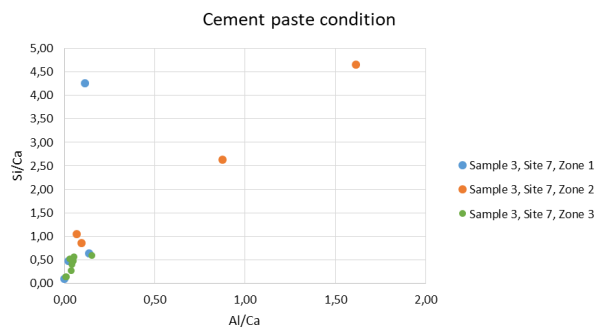
Fig. 6.13. Cement paste that of Site 7 (Zone 3, green dots) show minor alteration even if it is closely situated to the corroding iron.

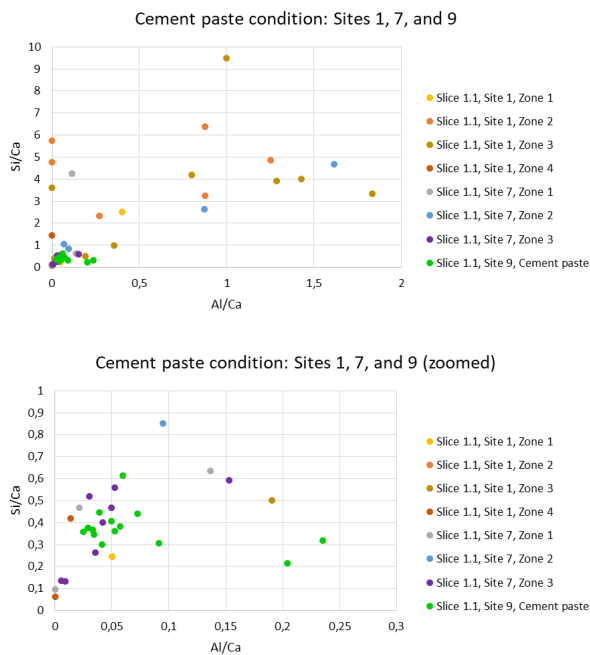
show more deterioration compared to the deeper cement. Fig. 6.17 show that the cement paste ratio distribution is more scattered in the near surface zones (Site 1) compared to the deeper zones, for example Site 7 and the cement paste in Site 9.

Fig. 6.17. Cement paste ratio (Si/Ca vs. Al/Ca) distribution in the near surface zones (Site 1) compared to the deeper zones, for example Site 7 (Zone 3) and the cement paste in Site 9. The scattered ratios in the upper zones indicates a changed chemical composition. Different scales are shown on the axes of the upper and lower graph.

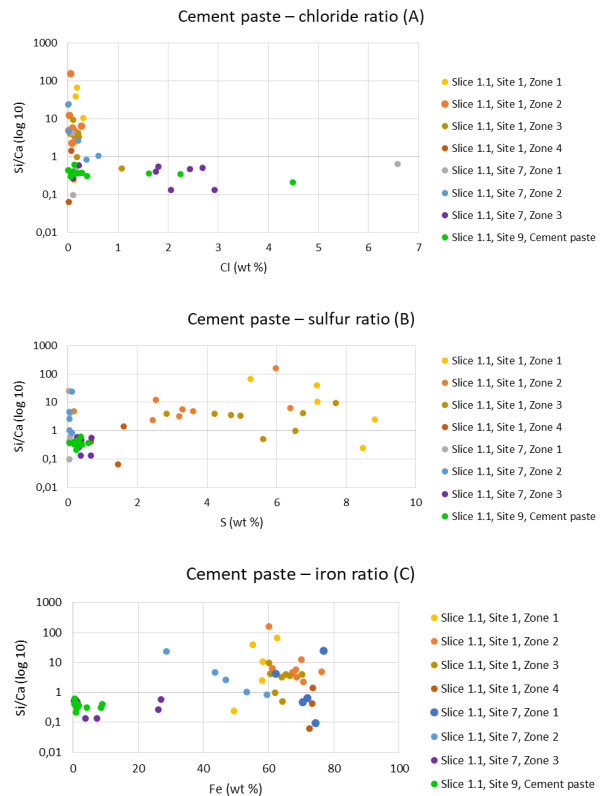
Looking at specific elements compared with the Si/Ca ratio in the cement paste, different sites can reveal trends in the corrosion process and deterioration of the cement paste. Chlorides for example, are more commonly detected deeper within the sample compared to the surface areas (Fig. 6.18A) and the sulfur elements are more represented in the surface cement (Fig. 6.18B). The iron distribution is represented in the near surface cement and at the rebar site showing where the corrosion products are situated (Fig. 6.18C).

Fig. 6.18. Cement paste ratio (Si/Ca) in Slice 1.1 compared to abundant elements (wt. %) from the EDS analysis. **A.** Si/Ca vs. Chloride in shallower (Site 1, Zones 1-4) compared to deeper parts (Site 7, Zones 1-3, and site 9). **B.** Si/Ca vs. Sulfur in shallower (Site 1, Zones 1-4) compared to deeper parts (Site 7, Zones 1-3, and site 9). **C.** Si/Ca vs. Iron in shallower (Site 1, Zones 1-4) compared to deeper parts (Site 7, Zones 1-3, and site 9).

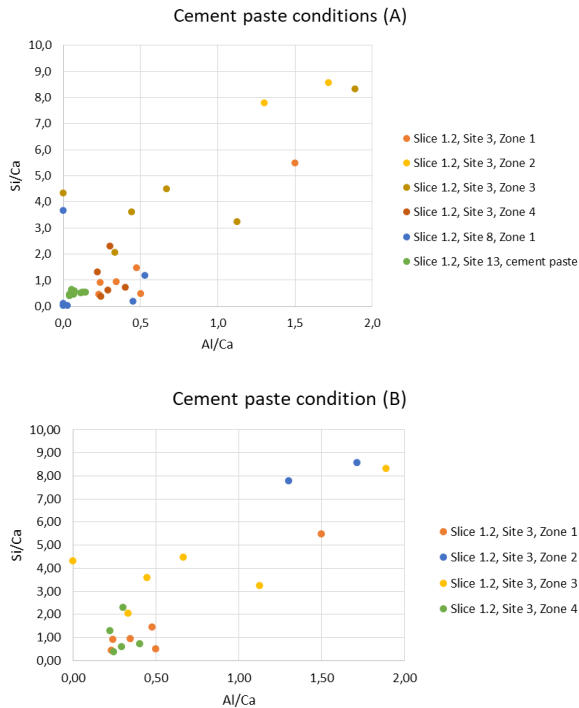
variable depths from the surface concrete show differentiated Si/Ca – Al/Ca ratios. It is visualized in Fig. 6.19A, where the shallower zones of Site 3 show offset ratios compared to the deeper Sites (number 8 and 13) in the unaltered cement paste. Deterioration of the cement minerals are further seen in the misplaced Si/Ca – Al/Ca values of Site 3 (Fig. 6.19B). A very high sulfur content is also registered in the less iron rich parts. This trend is seen especially where the cement paste looks more porous and cracked (e.g. in Site 3, Zone 4; Fig. 6.20A-B and Fig. A15). The iron content is also very high in the altered cement paste material close to the surface. Corrosion products with a high weight percentage of iron and sulfur have replaced the cement elements in the concrete. This is illustrated by the backscatter image of Site 6 (Fig. 6.21A) where ballast particles are left as relict or *in situ* structures in the altered cement paste. The elemental maps of this microdomain (Fig. 6.21B) illustrate the elemental distribution of iron, calcium, magnesium, sulfur, chloride and sodium. Sulfur is enriched in the cracked part, while iron is more prevalent in the center area.

Fig. 6.19. **A.** Cement paste condition of shallower (Site 3) and deeper (Site 8 and 13) sites of slice 1.2 is shown in this graph. **B.** A closer view of the conditions of site 3.

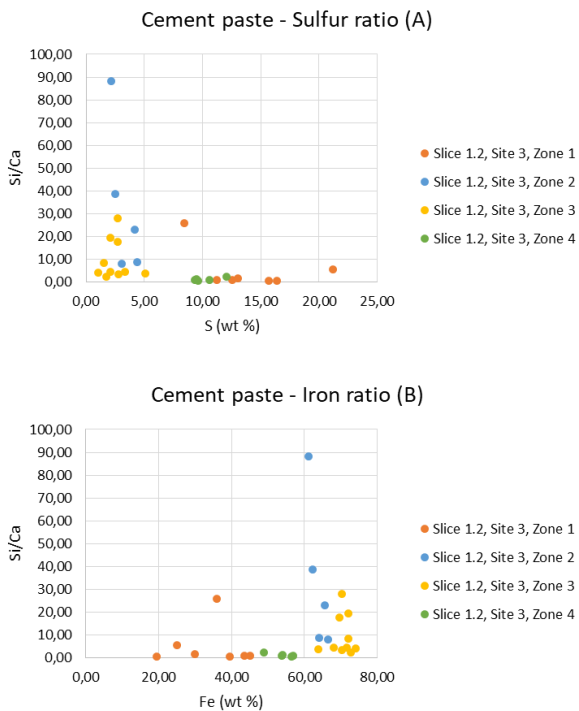
Fig. 6.20. Site 3 in Slice 1.2 is showing elevated amounts of sulfur and iron within the cement paste. **A.** Zones 1 and 4 show higher sulfur content compared to Zones 2 and 3. More cracks and a darker shade of the BSE image is seen in the sulfur rich zones. **B.** Zones 2-3 are richer in iron which express a lighter shade in the BSE image. The BSE image is found in the Appendix (Fig. A15).

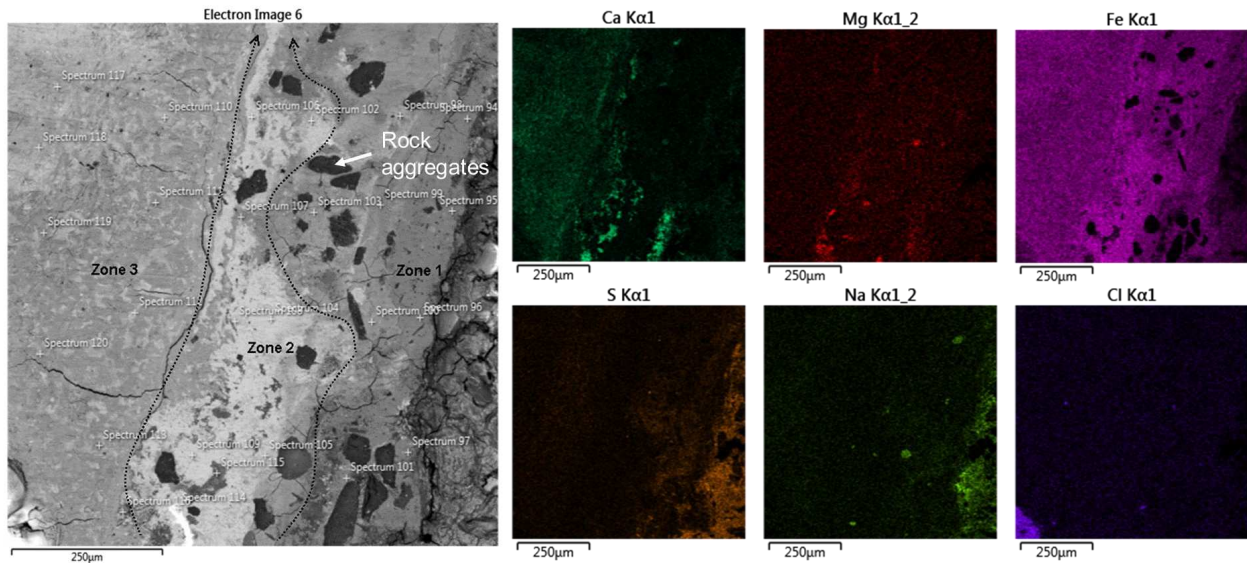
Black rust characteristics: The black rust corrosion products are characterized by high iron content and in some sites by additional chlorides and sulfur content. These compounds are often infiltrated in the altered cement paste and have replaced the ordinary cement paste minerals. Where calcium, silica and aluminum are replaced the cement paste is discolored by the corrosion products which show a brighter shade in the backscatter image. The corrosion products are often banded or layered with altered cement paste in between like seen in Fig. 6.21A.

Fig. 6.21. Site 6 is here displayed in two ways: **A**. BSE image of the microdomain, and **B**. element maps of the most prevalent elements detected. Iron is generally distributed, but seems to be slightly more concentrated in Zone 2. Calcium is mainly occurring in Zone 2-3, and sulfur is more concentrated in Zone 3.

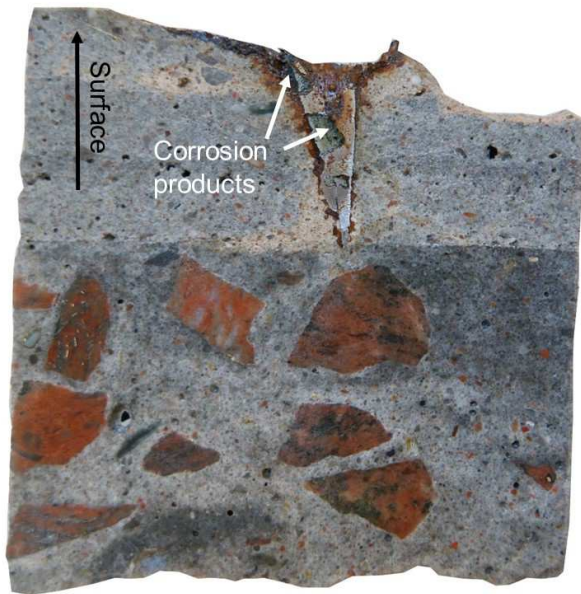
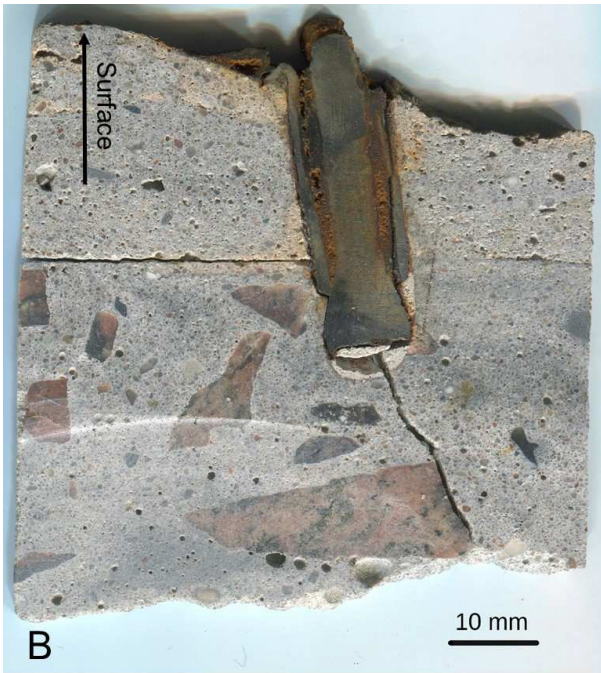
General description hand specimen: This concrete drill core was sampled in the same locality as Sample 1. However the concrete configuration of Sample 2 differs. Sample 2 has a fine grained cement topping with an approximate thickness of about 40 mm. This cement topping forms a distinct border to the original concrete and has a different cement paste color, which is slightly more light grey in comparison. The corroded iron in this core is an expansion bolt. The bolt runs through the cement topping and into the concrete where it is anchored. Inside the bolt black rust with a crust of red rust is visible. Figs. 6.23A, B, are both slices from the center of this core sample. They have been cut to manageable pieces for use in the SEM analysis. A rust nodule was sitting on the surface of this core but were separated to be closer studied in a light microscope. The nodule was initially black but changed to red rather quickly after sampling (Fig. 24).

Fig. 6.23. The central core pieces of Sample 2. These have no reinforcement, but a bolt that has corroded. **A.** The iron bolt has newly formed corrosion products which are red or dark green to black. **B.** The black corrosion products within the bolt have started to transform to red rust.

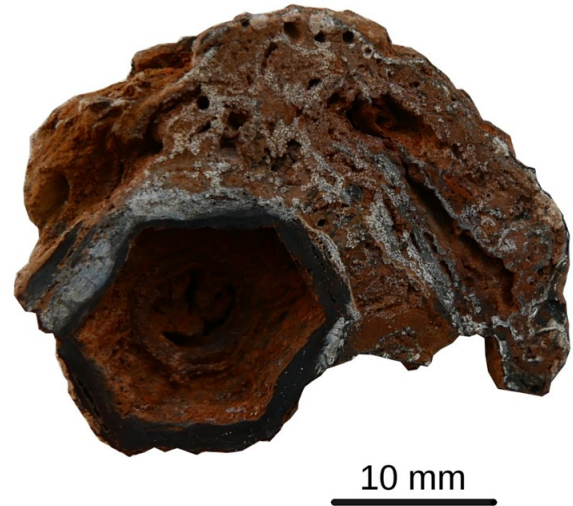
Fig. 6.24. A rust nodule from Sample 2. This one have been sitting on top of the bolt with a screw-nut, from which the hexagonal shape still can be seen. Generally it is a porous part of the corrosion products, however this contain rigid layers of black rust within the red rust matrix.

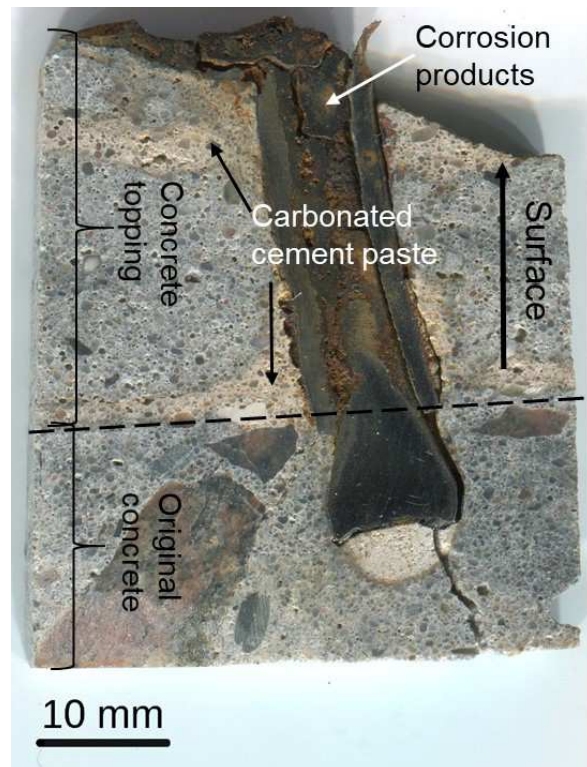
close to the bolt. The visible cracks in Fig. 6.25 are related to the preparation of the sample and its drying process. Characteristic dehydration or expansion cracks were observed in the SEM between sand particles (Fig. 6.26).

Black rust characteristics: The corrosion products have accumulated at the surface, inside and outside of the bolt (Fig. 6.25). In the adhesion zone between the bolt and the cement paste an area of corrosion products has developed (Zone 2; Fig. 6.27). The contact is rather sharp between the cement paste and the corrosion

Fig. 6.25. Corrosion products are visible in the iron bolt. These were initially black, but have by this time started to oxidize to red rust. The cement paste in the concrete topping is carbonated along the surface, bolt and adhesion zone to the original concrete.

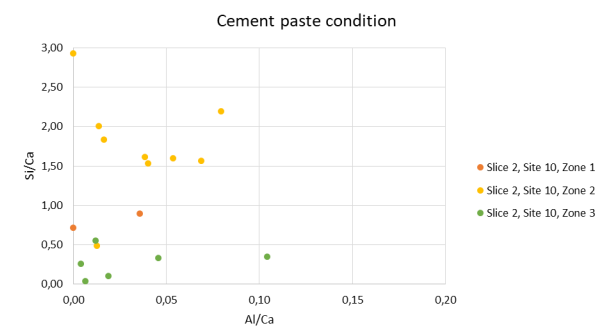
Fig. 6.29. Zone 3 in Site 10, Slice 2.1 show rather normal Si/Ca vs. Al/Ca ratios. Zones 1-2 are other phases (iron and corrosion products respectively) and are thus showing dislocated ratios.

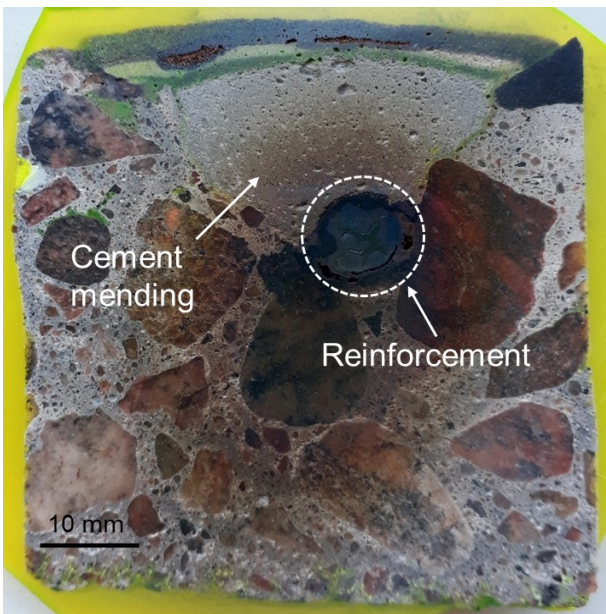
This slice is a part from Sample 3 and is a remainder from the thin section production (Fig. 6.37). The core piece is impregnated with a yellow epoxy resin that has infiltrated the open pore system and is surrounding the core piece. Between the surface and the reinforcement there is a fine grained cement/mortar mending. The mending has a lighter grey shade than the original concrete and is discolored by red corrosion products at the uppermost centimeter. The epoxy resin is sometimes appearing green in contrast to the mortar, as seen close to the surface of the slice. Only remnants of the reinforcement are visible, see Fig. 6.37. The central area, around the reinforcement, has a darker shade due to the carbon coating.

Fig. 6.37. An overview of Slice 3 that was analysed in the scanning electron microscope.

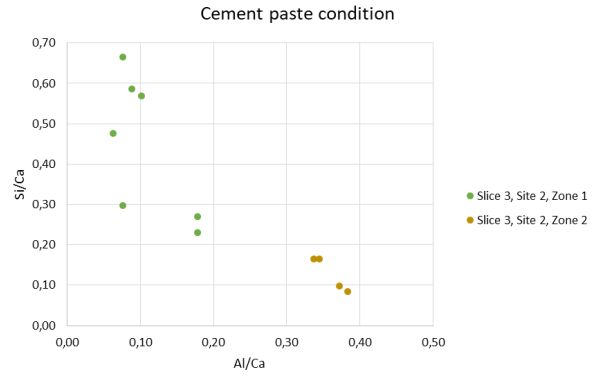
The surface cement paste of Slice 3.1 is not a part of the original concrete but a repair mortar. It has a rather normal chemical composition with respect to the aluminum/calcium and silica/calcium ratios seen in Fig. 6.38. However, the magnesium content is slightly higher than normal. The cement paste in the deeper parts of the sample contain even higher amounts of magnesium, up to almost 20 wt. % in some spots (Table A26). These spots are observed in the cement paste of Site 13. This site has a rather altered composition of cement paste compared to a fresh paste and it shows a network of fine cracks that are smaller than 10 μm (Fig. 6.39).

Fig. 6.38. Cement paste condition of Site 2 in Sample 3. The cement paste in the mending show rather unaltered Si/Ca – Al/Ca ratios.

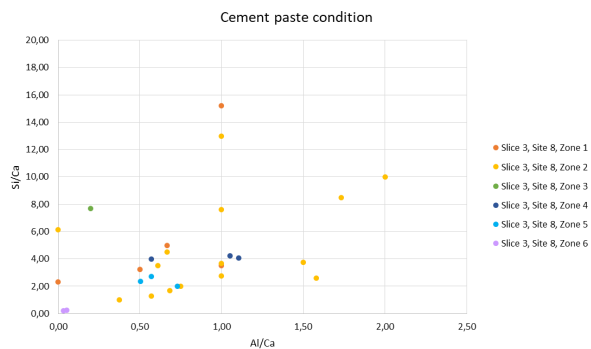
In the areas around the reinforcement the cement paste has an altered chemistry and almost all cement minerals are broken down. Cement building elements (commonly Ca, Al, and Si) are only found in minor proportions in the EDS analysis. Only a small quantity of these compounds is left in the altered cement paste. It is illustrated by the relationship between the silica/calcium ratio and iron in Fig. 6.40. Instead there are mostly iron compounds and chloride rich regions that are replacing the cement building elements. The element maps in Fig. 6.41 are showing the element distribution in Site 8, where corrosion products are infiltrated in the cement paste. The ballast particles are left as relicts in the transformed cement paste, just like in Fig. 21A. The Si/Ca – Al/Ca ratios for this site reveal the degree of alteration in the transformed cement paste (Fig. 6.40).

Fig. 6.40. Most of the Si/Ca vs. Al/Ca ratio values in Site 8 are very high, which indicate that the cement building elements are gone from the structure.

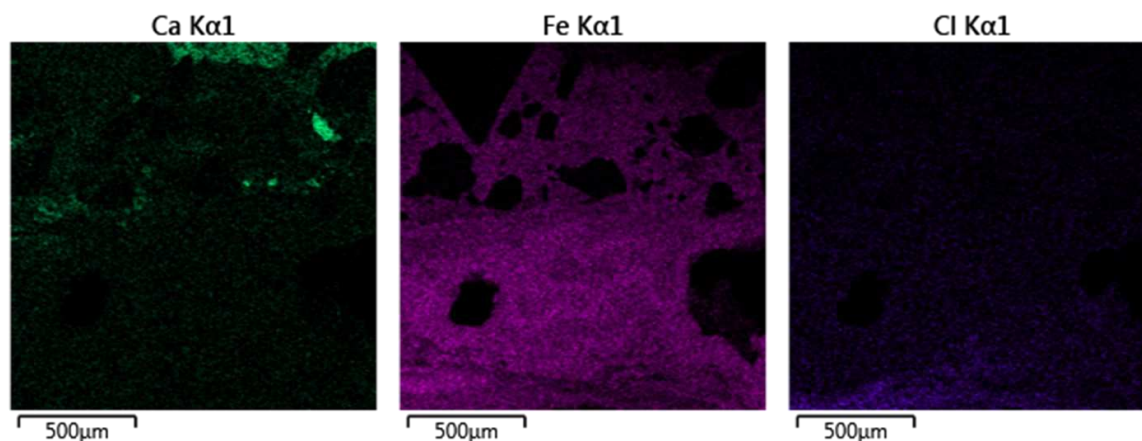
Fig. 6.41. Element maps of Site 8 is showing the lack of calcium and the dominance of iron within this microdomain. Some amounts of chloride is also present in the lower regeon of the microdomain.

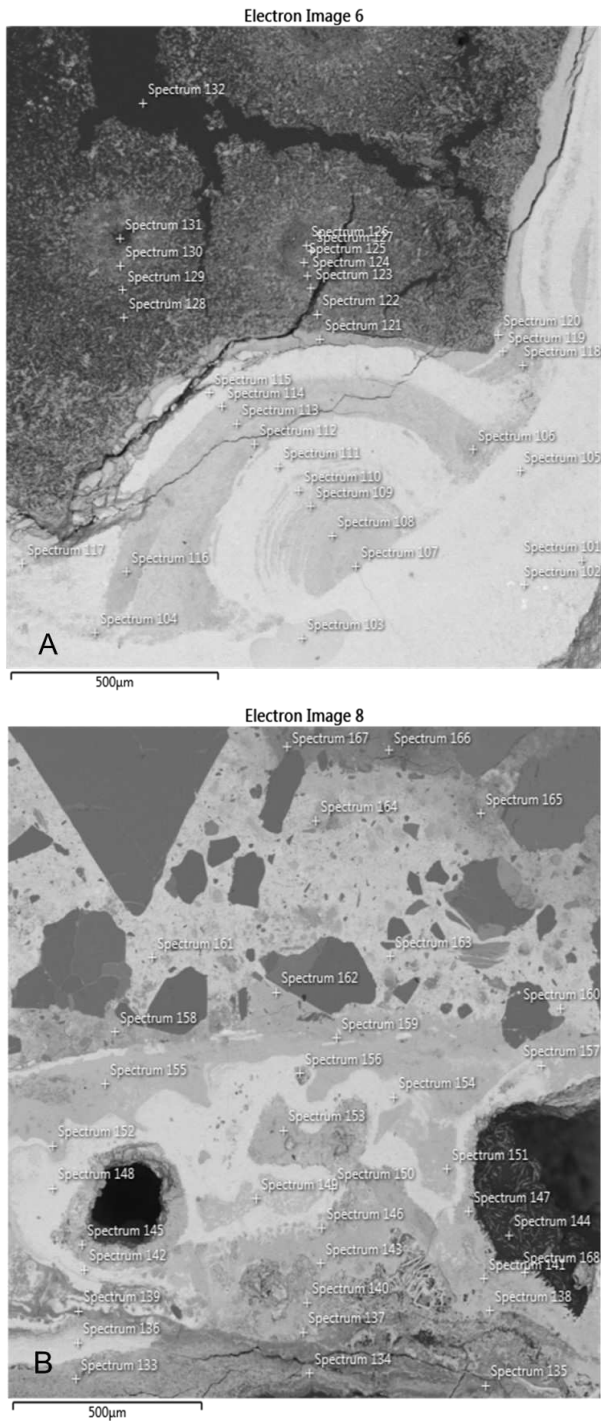
The liesegang-like structures in the iron rich corrosion products are seen in several microdomains. Fig. 6.42A-B are examples of how the iron-rich structures looks like in this sample. Darker and lighter layers are alternating in the backscatter images. A slightly higher iron content is registered in the lighter layers (about 0.5-3 wt. % higher in average).

Fig. 6.42. The BSE images of **A.** Site 6, and **B.** Site 8 are showing iron-rich structures. A slightly higher iron content is registered in the lighter layers.

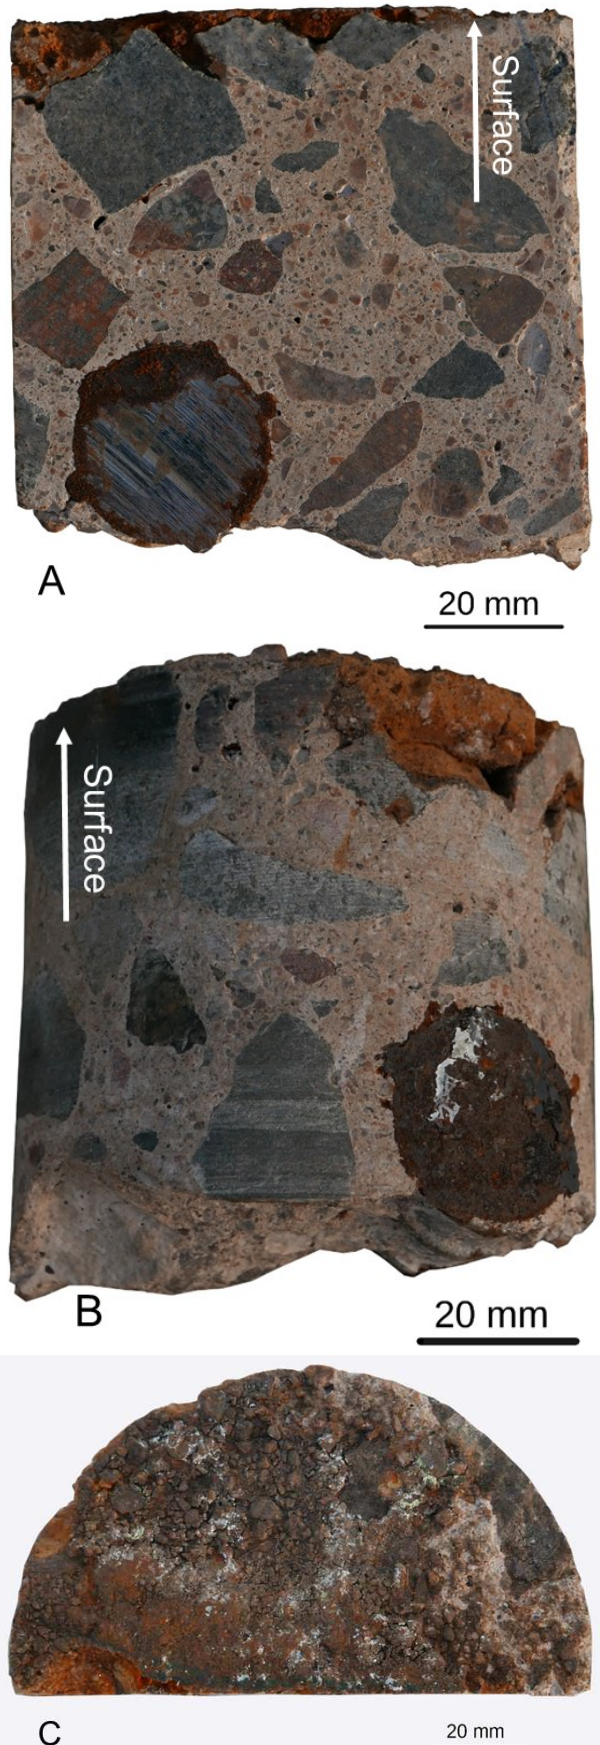
the other cores, which means it is the least processed core. In the cross section (Fig. 6.43A) the first 0 – 10 mm are covered by a discolored rusty layer in the cement paste. On the curved side (Fig. 6.43B), the rust colored cement paste carves deeper into the core than seen on the cross section. The discolored region is surrounding at least one larger cavity in the cement. A view from the top in Fig. 6.43C, show that the surface of the concrete wall is slightly eroded; the cement paste has vanished and only the ballast grains are left in the upper 0-5 mm. The concrete cover above the reinforcement is about 50 mm thick. Both black and red rust products are visible at the reinforcement cross section and the back side.

Fig. 6.43. The hand specimen/drill core of Sample 4 seen from **A.** cross sectional view, **B.** the curved outer side, and **C.** the surface (i.e. outer concrete wall).

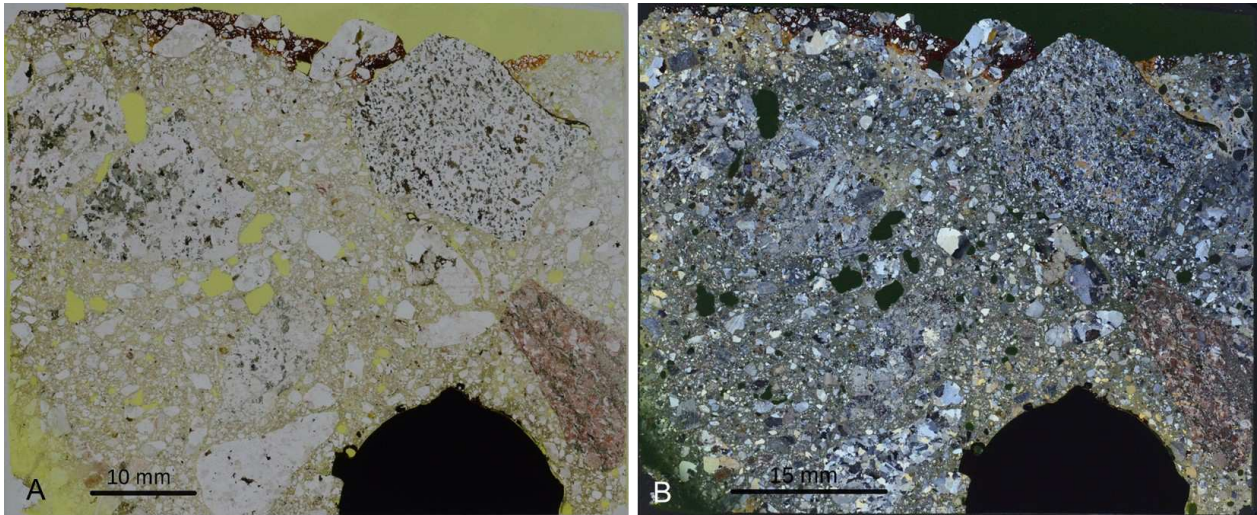
Deterioration of cement paste and reinforcement: The cement paste is highly altered at the surface. Discoloration from the corrosion products is visible within a depth of 0-7 mm from the surface (Fig. 6.44). Signs of carbonation are clearly visible within circa 15 mm from the surface and in patches down to the reinforcement. Around the reinforcement the carbonation appears in a circa 10 mm thick halo (Fig. 6.44B). Carbonated and discolored cement paste are also observed along cracks and air voids that contain corrosion products. Most of these cracks are connected to the concrete surface. Narrow surface cracks that look like

Fig. 6.44. Overview of thin section 4, **A** in normal light, and **B**, in polarized light. The cement paste in the upper centimeter and around the reinforcement looks carbonated.

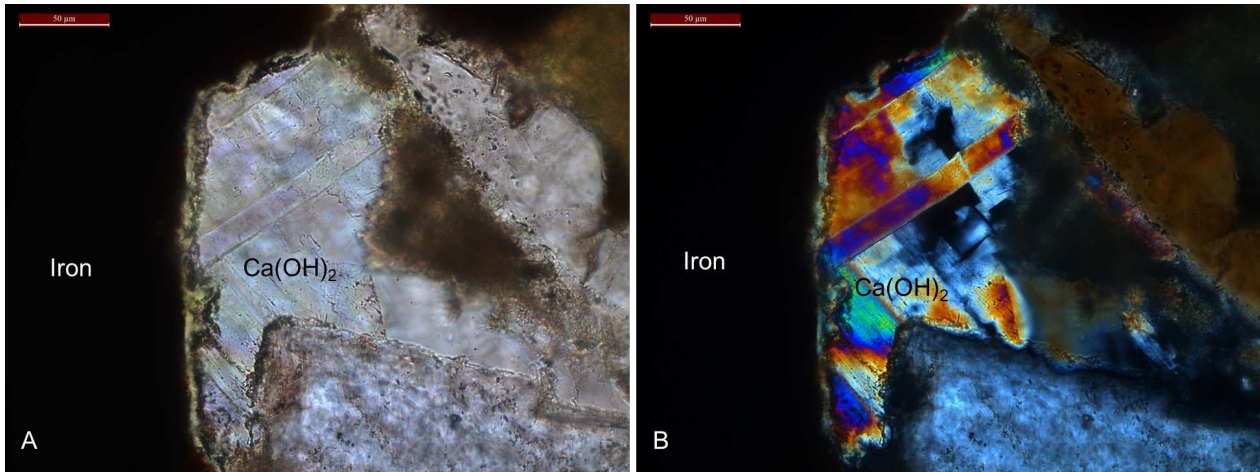
Fig. 6.47. A relatively large crystal of calcium hydroxide ($\text{Ca}(\text{OH})_2$; probably portlandite) observed a crack between the reinforcement and cement paste in Thin section 4, **A**. ppl, and **B**. xpl. Scale 50 μm .

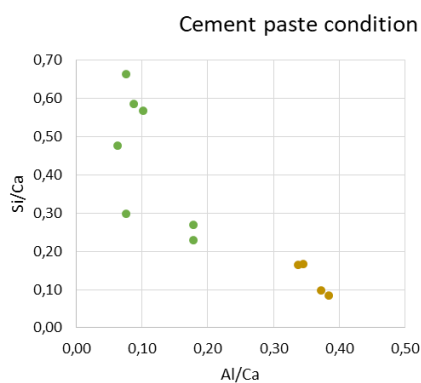
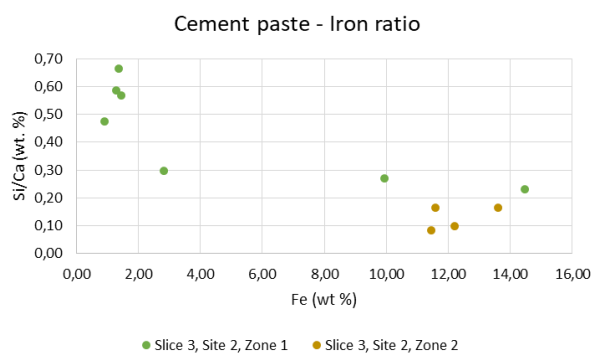
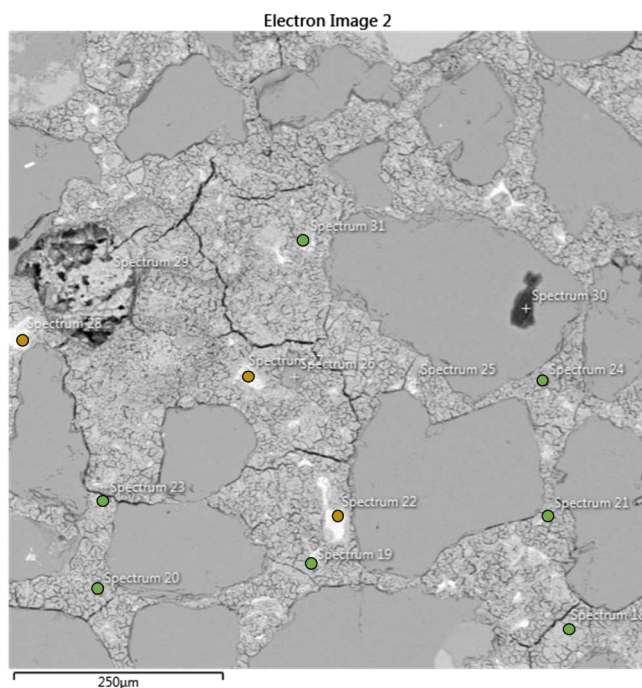
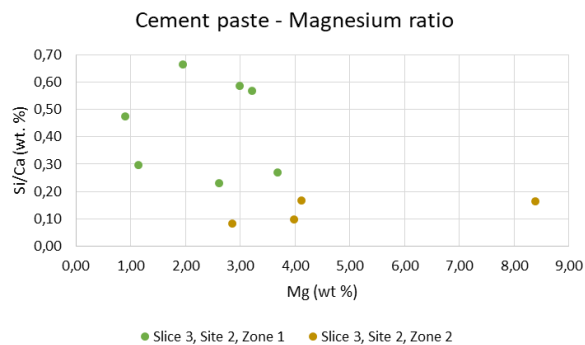
Fig. A27. Graphs and BSE image of Site 2 (the cement paste mending), Slice 3.
