# Performance of joints for glued laminated timber exposed to the ISO fire temperature curve

**Report 5638, Lund 2021**

**Master thesis in fire safety engineering**

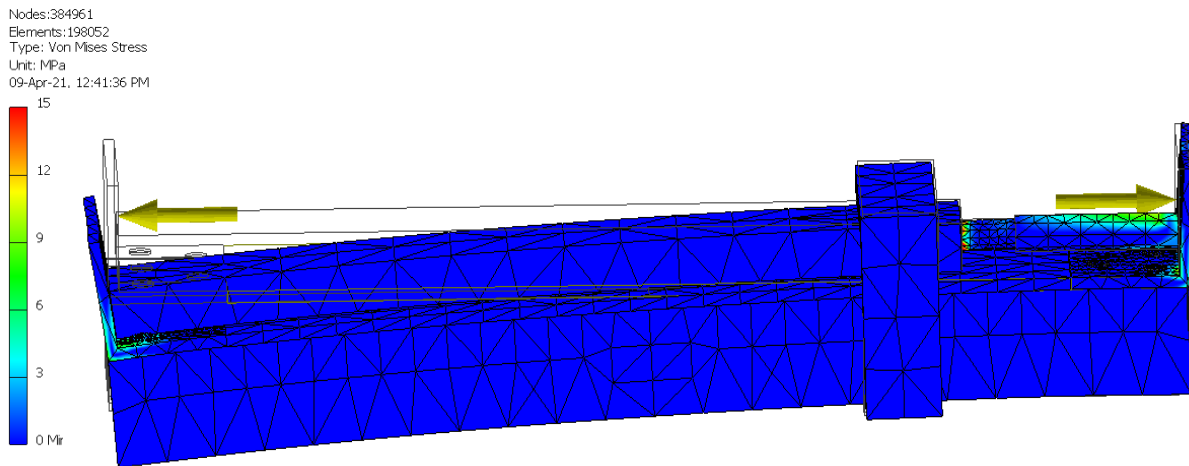
Figure 19. Stress analysis of the samples and their loading system made using Inventor

We can see that the jack in this case due to being off center produces a moment in the overall sample that generates a series of tensile forces on the upper part of the sample and some compressive forces on the bottom, this shows as a small bending angle in the jack, the top timber board used to carry the load, as well as for the exposed glulam .

It was mentioned before that the tensile force applied to the members was of 4.2 KN, the simplification was made that the load were distributed homogenously through the material but as we saw in Figure 19 these produced an overall moment and some bending given by the force and the distance from the jack to the center of the GLT, this moment will be countered by the

Although there were no major deformation samples 1, 2, and 3 showed a slight warping following the contour produced by the bending created by the moments generated by the jack system (see Figure 19). Additionally, these plates were measured after the test to see whether there was any elongation during the application of the forces, and for all samples no increase in the length or width was reported.

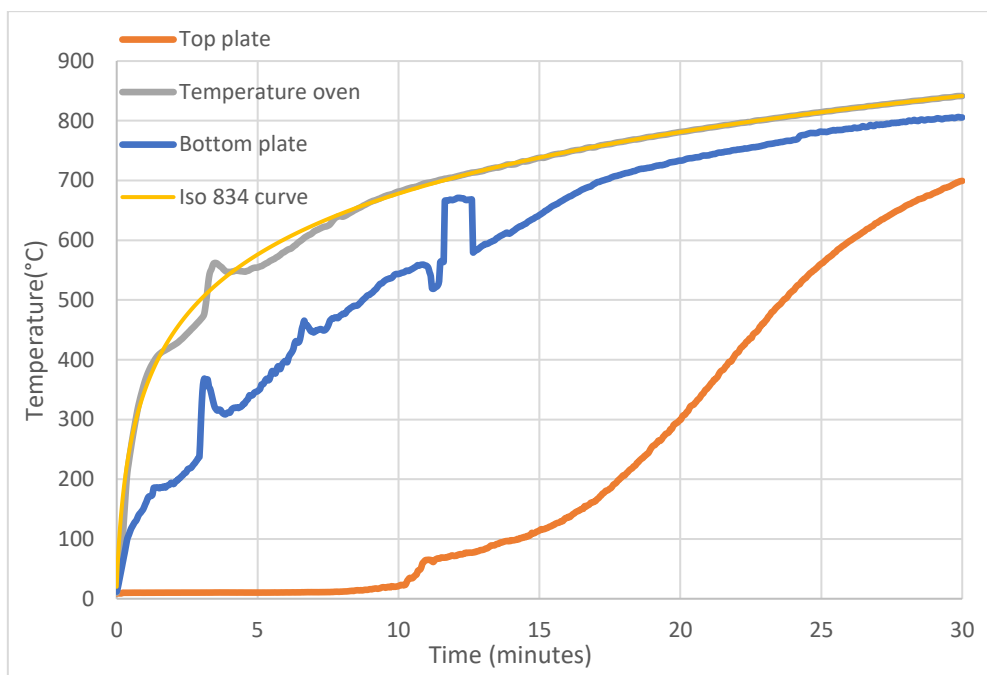
Figure 23. Temperatures recorded during test 1

In Figure 23 we can see that the temperature generated by the mobile furnace adapted quite closely to the one stated in ISO 834, the only mayor difference occurred at around 3 minutes where the temperature in the oven spiked and surpassed the control curve for a matter of seconds, this spike then normalized and continued until the 30 minutes of testing passed.

For the temperature in the top the rate of growth remained small during the first 10 minutes then it saw an increment of about 60 degrees in about a minute, if the bottom plate temperature is compared to the one on the top at this time we can see that the rise of the temperature in the utmost thermocouple happens when the temperature at the bottom decreases, this could signal an intrusion of fresh air into the system through the gap making the temperature briefly decrease and the rate of combustion increase in the oven. This also comes attached with the outflow of hot gases that would in turn heat the upper plate.

By the end of this test the temperature perceived by the top thermocouple only differed by 100 degrees Celsius from the one on the bottom showing a clear intrusion of the hot gases of the oven trough the jointed element.

While in this report the failure time was not studied in detail, by watching the sudden spike in temperature on Figure 23 one can assume that by 12 minutes the exposed section of the structural element went through a significant change that could possibly mark its mechanical failure, as by that time the smoke was running freely through the gap and heating the upper plate. This assumption would match quite well the results provided by Peng.

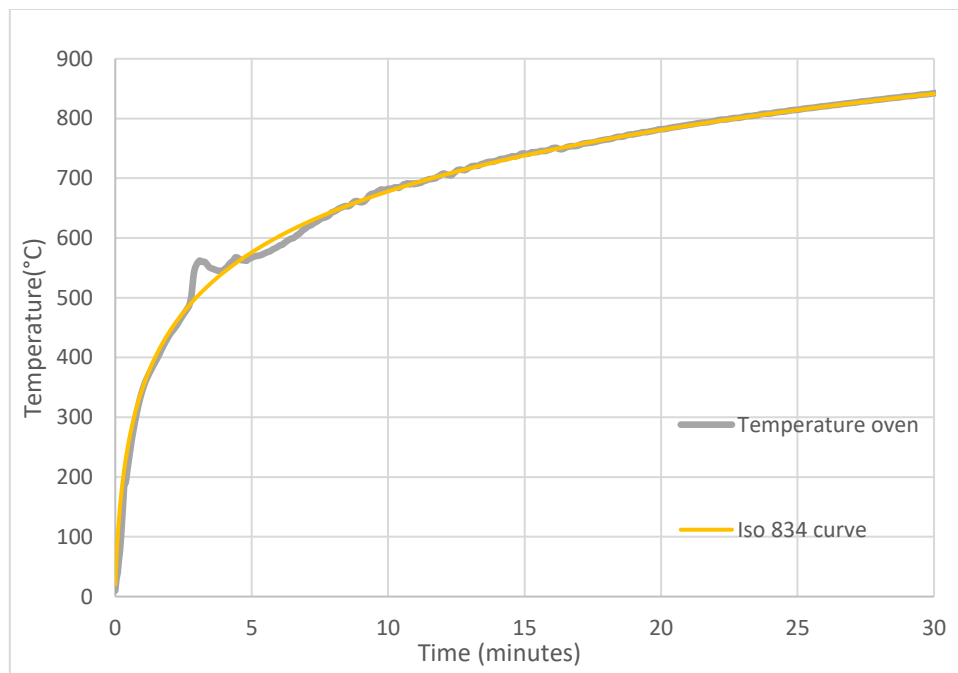
Figure 24. Temperatures recorded during test 2

During the second test the lower thermocouple fell off during the installation of the testing setup onto the oven, this made it impossible to measure the temperature on the bottom joint. However the temperature of the oven was still recorded and it shows a similar pattern as the

one for test 1, with a spike of temperature produced at 3 minutes, that could be caused by the start of the pyrolysis within the sample.

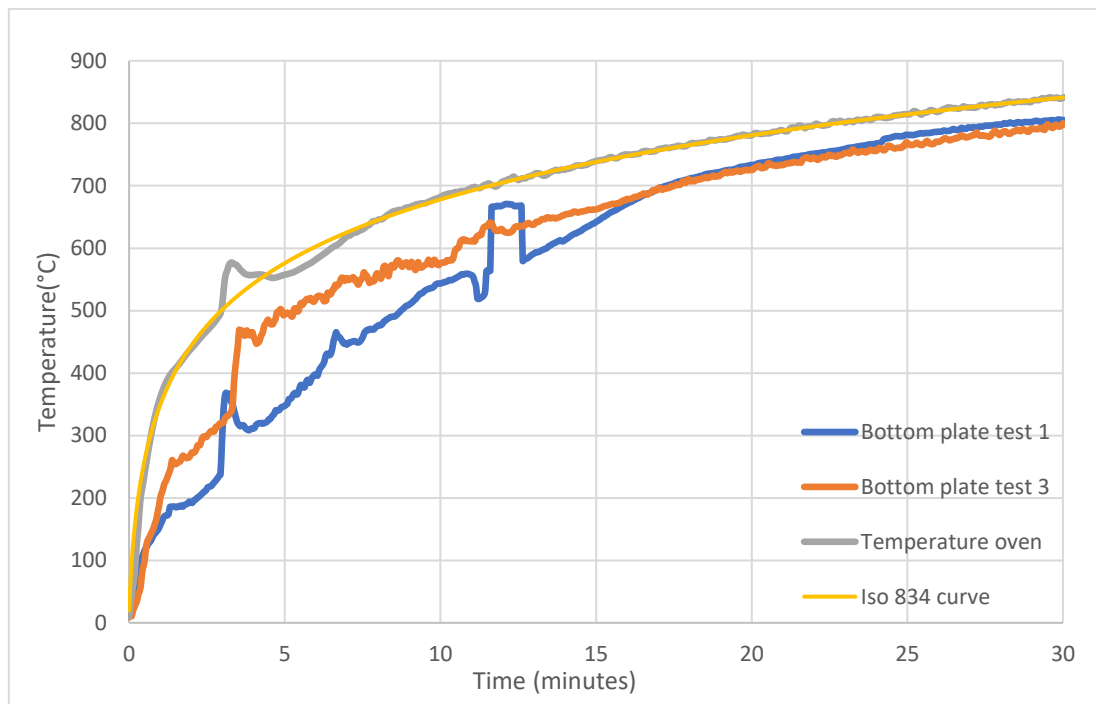
Figure 25. Temperatures recorded during test 3 compared to the bottom temperature of test 1

For the third test we can see again that the temperature in the oven followed quite closely the temperature of the furnace except for the slight increase of temperature at minute 3. To compare the result obtained during the test 1 the results of the bottom joint were also included as to annotate the similarities among the two experiments.

In the 3rd test we see a faster growth in temperature and although the pyrolysis starts at similar times this one leads to overall higher temperatures and unlike for the first test this rise did not disappear after a few seconds but rather increased constantly until the test finished. It is also worth mentioning that for test 1 and 3 the temperature curves met after 16 minutes and shared a similar behavior during the rest of the test.

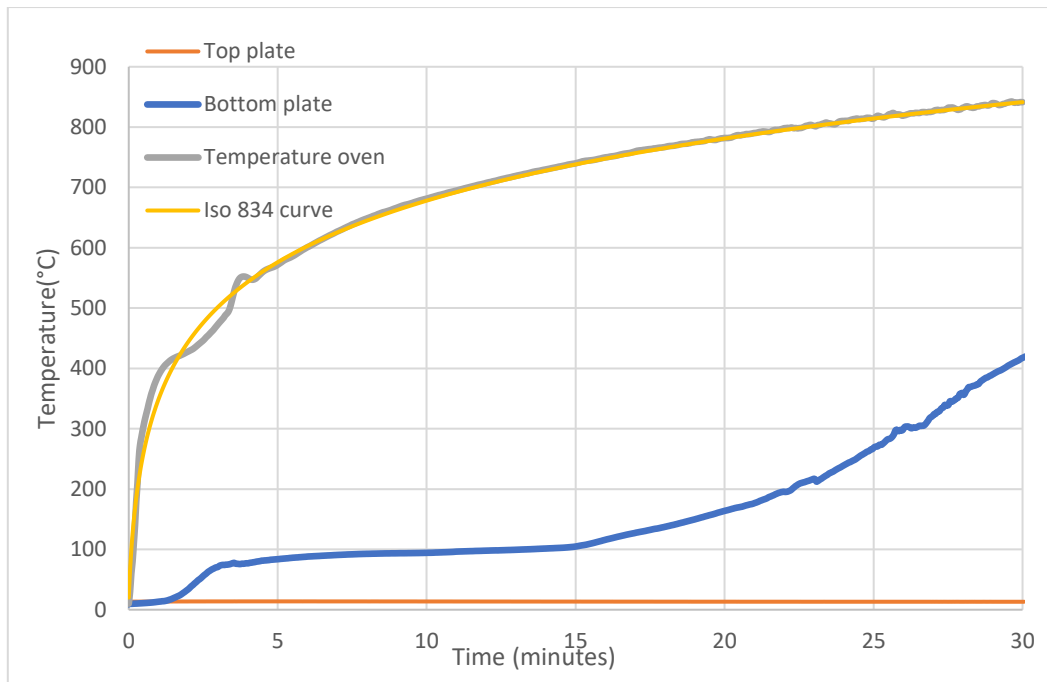
Figure 26. Temperatures recorded during test 4

The results in the protected member seen in Figure 26 had a different behavior than the one observed for the past tests, at 3 minutes we start seeing the effect of the pyrolysis on the oven temperature but this time is smaller since most of the timber used during the test was covered by gypsum.

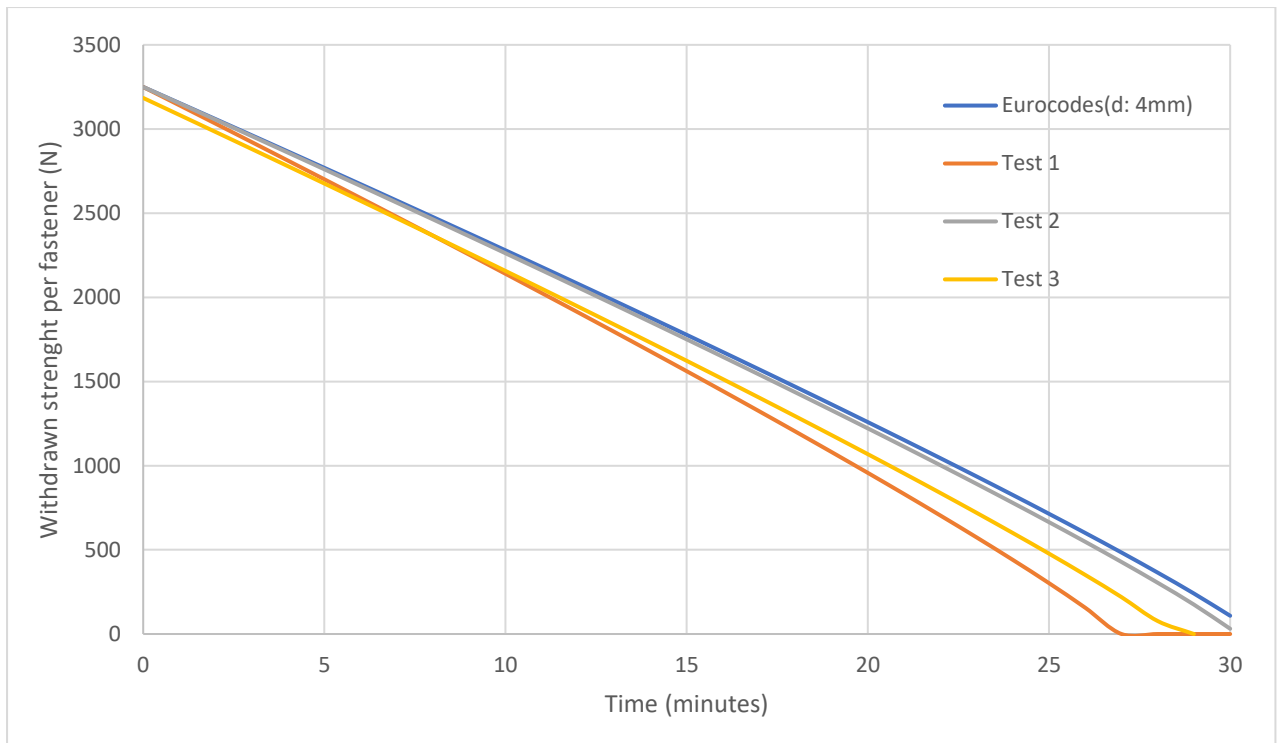
Figure 32. Withdrawn strength of the fasteners according to their effective depth and time

In Figure 32 we can see the withdraw strength needed to pull out the fasteners for test 1, 2 and 3 as well as what is recommended by the Eurocodes, a clear result is that the force needed to pull the fasteners embedded in the jointed area was smaller than the one calculated using the Eurocodes; this difference between the results became more severe as the time of the testing passed, for example by 15 minutes the test 1 had 92.6% of the strength predicted by the Eurocodes and 45% by minute 25.

As for the bigger plates the result conformed better to those provided by the Eurocodes as seen in Figure 32, and since for test 1 and 3 the delimiting factor for failure was the yielding strength on the plates it seem to be best practice to increase the area of the plates used, not only to delay the charring on the jointed area but also to increase the yielding force needed for failure.

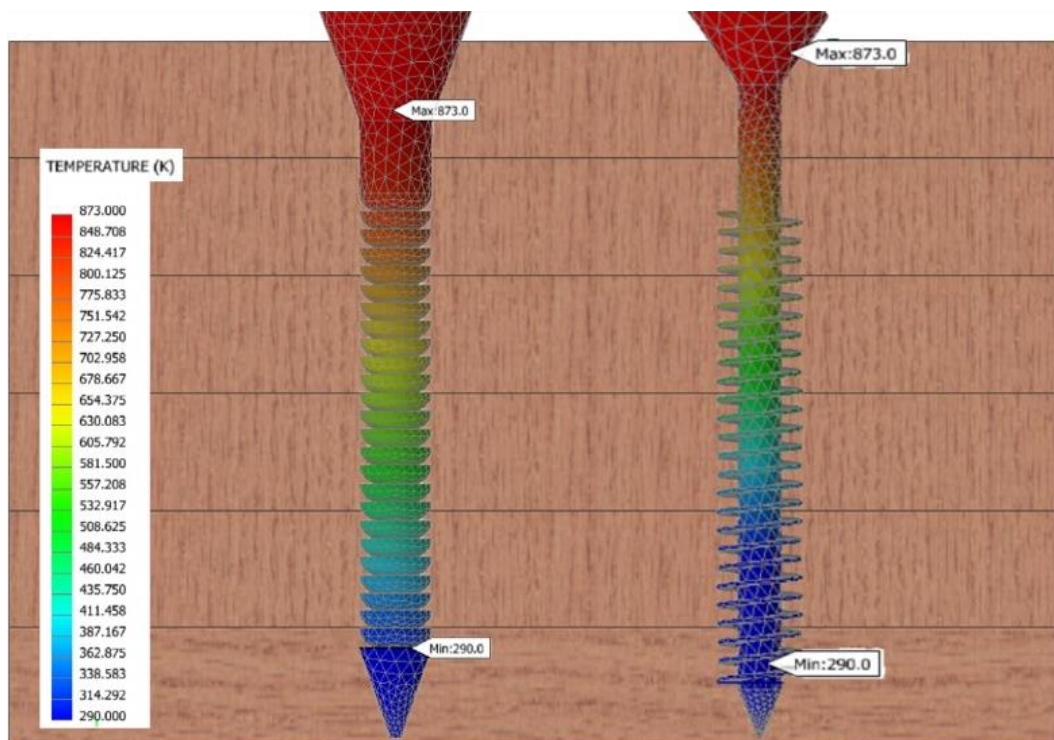
Figure 36. Linear steady state heat transfer of the two fasteners on a highly convective environment showing the temperature gradient (°Kelvin)

As the previous figure shows the temperature on the more massive nail was more constant across the nail, carrying more energy to the bottom, on the other side we see a faster “drop” on the energy for the narrower nail on the account of a bigger area of exposure to the colder environment and the smaller amount of material to retain the heat.

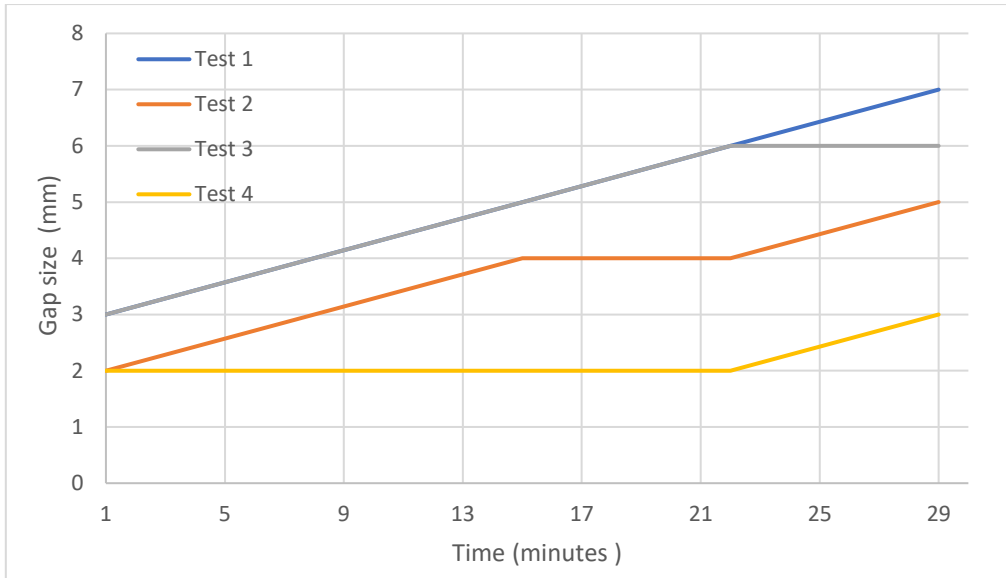
Figure 38. Top gap size measurement during the fire exposure

It is possible to see in the previous figure that there was an increment of the gap size for all samples, the biggest increment of length in the gap was for sample 1, which had an increase of 4 mm during the testing, this increase was followed by the samples 2 and 3 which showed an increase of 3 mm each, finally the protected sample had an increase of only 1 mm by the end of the test.

During the testing all the samples showed gaps sizes below 3 mm in the beginning but in the case of the unprotected joints these sizes increased by 4 mm for the first test and by 3 mm for the second and third test. The size of the gap was an apparent driver of heat through the sample as the bigger size on the gap led to more charring in the interface as seen in Figure 29. The charring in the gap is not the only problem as we can see after minute 15 in Figure 23 the temperatures rise above what is accepted for EI, making the joint fail in this aspect before the end of the test.

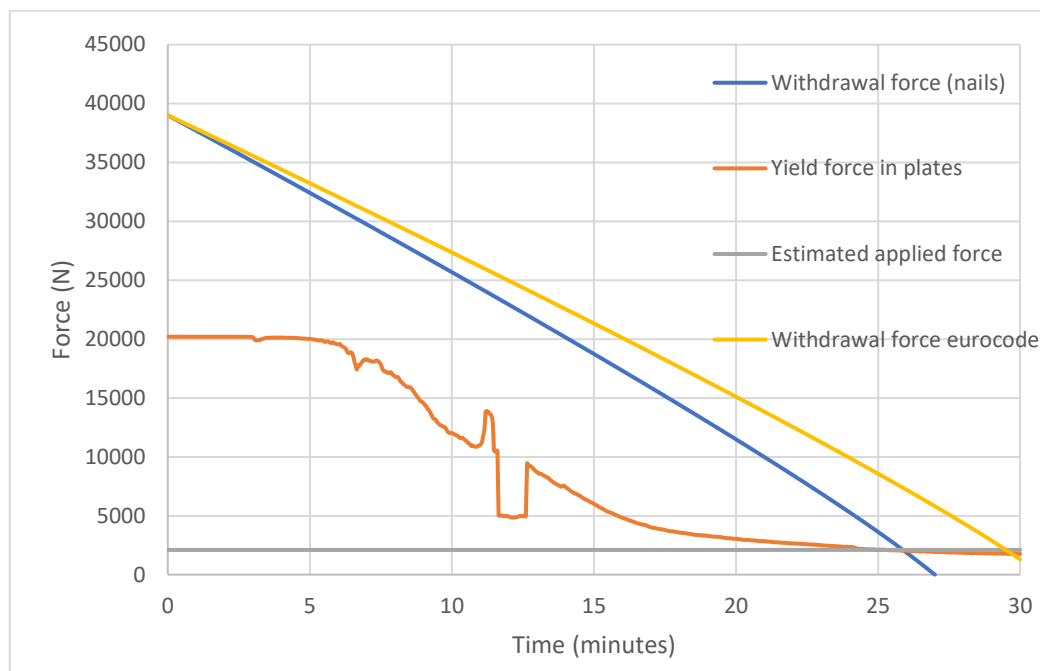
Figure 39. Yielding, withdrawal, and applied forces during the ISO 834 for test 1

In Figure 39 we can see the forces necessary for what would be considered failure in a mechanical assembly, either the release of the mechanical fasteners or the yielding of the exposed plates. Just like it was seen in Figure 32 we can see the pullout force reduction due to the losses in the effective depth of the nails, in this case however it is also possible to see and compare how the yielding force is also diminished during the testing.

The loss in the yielding strength reaches the applied force at around 24.8 minutes and close to a minute before the withdrawal total loss of strength, meaning that by this time the joint was being held down mostly by the upper plate.

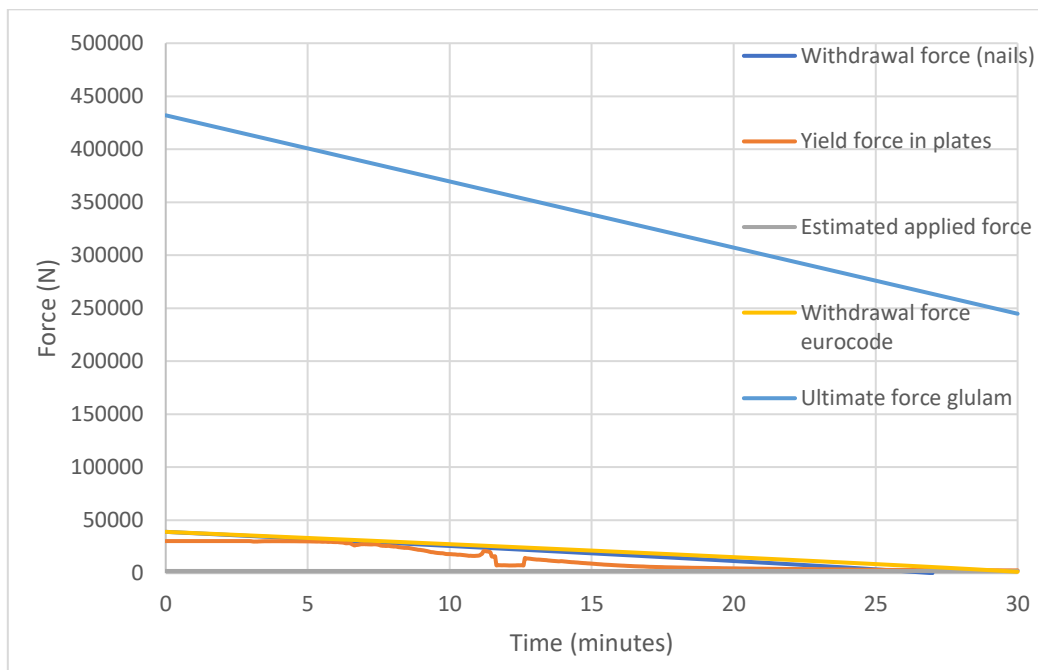
Figure 40. Yielding, withdrawal, glulam tensile failure, and applied forces during the ISO 834 for test 1

When compared to the loss of strength of the samples due to the reduction of the timber area it is possible to observe that the reduction of it is linear and at lower pace that for the plates and the mechanical fasteners, for example by minute 15 glulam remains at 79.5 % of its strength while at the same time the total withdraw force was at 49.5 % of his maximum and at 28.59 % for the plates. This signals that in this setup the point of failure would be the joints not only due to the smaller overall resistance but also the speedier loss of their mechanical attributes during heating.

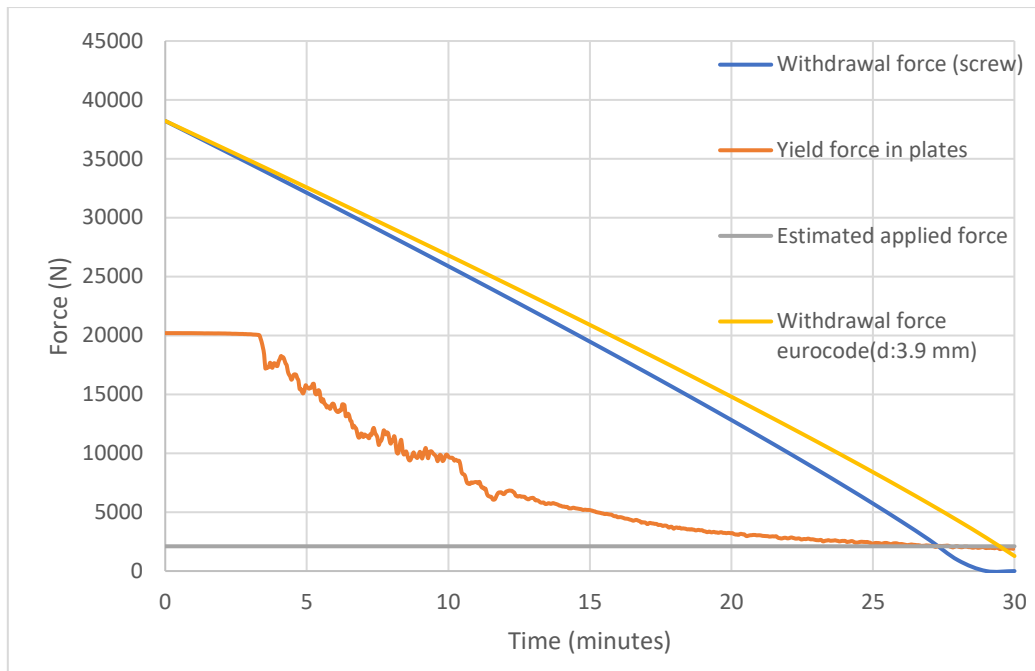
Figure 41. Yielding, withdrawal, and applied forces during the ISO 834 for test 3

As for the third test the yielding strength much like for the first test remained almost constant during the first minutes of the curve, then it also saw a most of its lost on the strength of the plates before half of the test had passed keeping 25.44% of its strength at 15 minutes.

Although the lost in strength during the beginning of the test was more severe for the 3<sup>rd</sup> test it took longer for the plate to reach the idealized applied force, 26.5 minutes instead of the 24.8 minutes in the first sample.

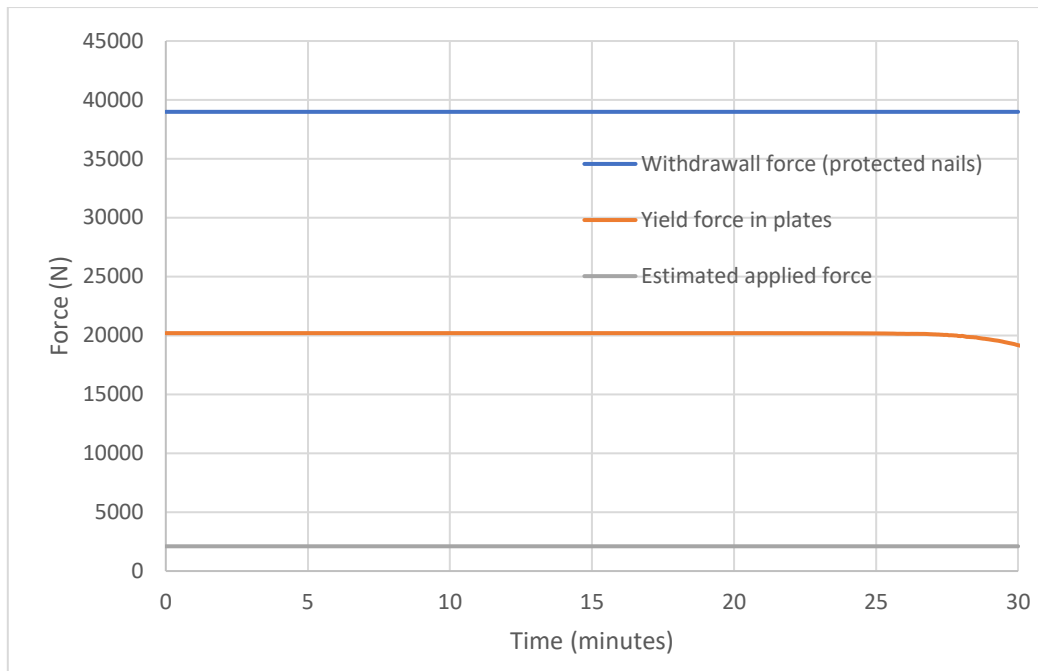
Figure 42. Yielding, withdrawal, and applied forces during the ISO 834 for test 4

For the protected samples the force of withdrawal was kept constant during the 30 minutes that the test lasted, as there was not visible charring under the fasteners, none the less the discoloration present in some of the area around where the fastener was present could signal some loss of the embedment strength, for the purpose of this test however these losses were not considered.
