Design of Safe Timber Structures - How Can we Learn from Structural Failures in Concrete, Steel and Timber?

Frühwald, Eva; Serrano, Erik; Toratti, Tomi; Emilsson, Arne; Thelandersson, Sven

Report TVBK-3053
Lund 2007

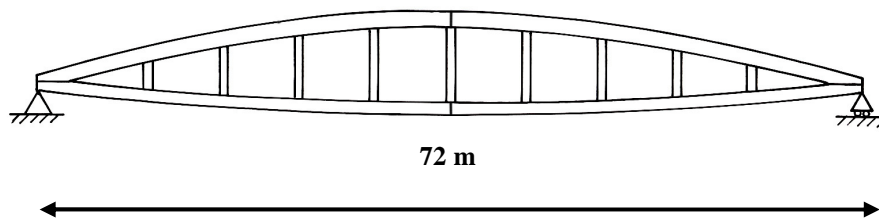
Figure 41-1. Design of glulam truss.

The roof structure of the cycle velodrome is a fish-shaped truss with double upper and lower rafters and single verticals (placed at 6.4 m centres), but no diagonals, built in 2001, see figure 41-1. The trusses span 72 m and are supported by concrete columns. One of the supports allows horizontal movements in the trusses direction. The verticals are connected to the rafters with two bolts including bulldog. The upper rafter has dimensions 2 times 160 mm x 900 mm (with 160 mm gap), the lower rafter has dimensions 2 times 160 mm x 533 mm (with 160 mm gap), and verticals are 160 mm x 160 mm (in between the rafters). The upper rafter is braced by purlins (220 mm x 440 mm) placed at 6.4 m centres (as the verticals). Diagonal bracing is also provided in the roof plane. The lower rafter is braced by boards (160 mm x 200 mm), placed at 12.8 m centres.

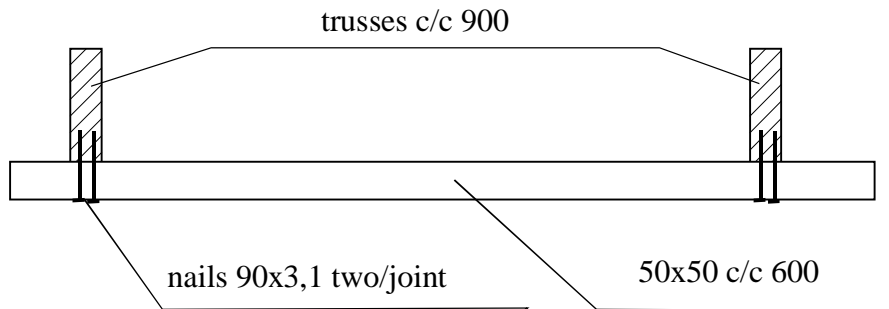
Figure 72-1: Support connection of inner ceiling.

The ceiling strips $50 \times 50 \text{ mm}^2$ are nailed to the roof trusses as a rule by two machine nails 90×3.1 per joint see figure 72-1. The load was axial, withdrawal load for nails, consisting of dead load of ceiling, insulation material, electrical cables and ventilation channels.

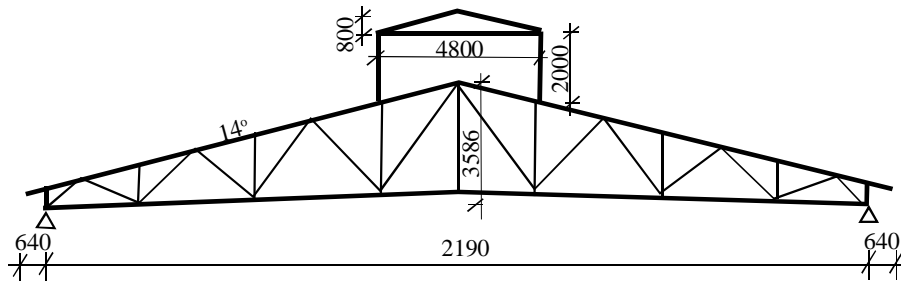
Figure 75-1: Roof structure with elevated part.

Nail plated connected trusses were used as roof structure of a manege. The timber frame building was not heat insulated. Span of trusses was 22 m, height 3.6 m, slope of roof 14°. Roof boards 35x72 mm² were placed with c/c 600 mm. Length of the building was 45 m and it had an elevated part in the middle for roof windows, see figure 75-1. The size of this elevated part was 4.8 m in direction of the truss span, 20 m in length direction of the building and it had a height of 2 m. This elevated structure had its own roof trusses with a span of 4.8 m. These trusses were supported on top of the long trusses by 1.6 m long studs corresponding to the height of the window.

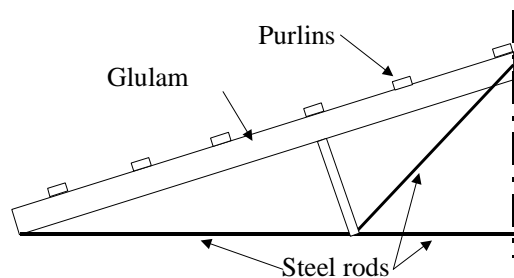
Figure 104-1. Combined glulam-tension rod truss (not to scale).

The roof structure of a complete building was assembled on the ground. The structure consisted of four trusses according to figure 104-1. The trusses were joined by purlins. No additional lateral bracing was present. The total span of the trusses was approximately 42 m and the spacing between the trusses was approximately 7.2 m.

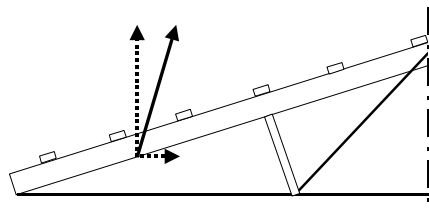
Figure 104-2. Strap placement.

After finalising the roof structure with four trusses and purlins, a crane was used to raise it in place on top of supporting columns. The straps used during rising of the structure were placed according to figure 104-2. The forces in the straps lead to a compressive force in the glulam parts, as indicated below. In addition, the purlins are also subjected to compressive forces, see figure 104-3. Just before putting the roof structure down on its supports, the structure collapsed. According to witnesses, one of the outermost trusses tilted and the structure failed.

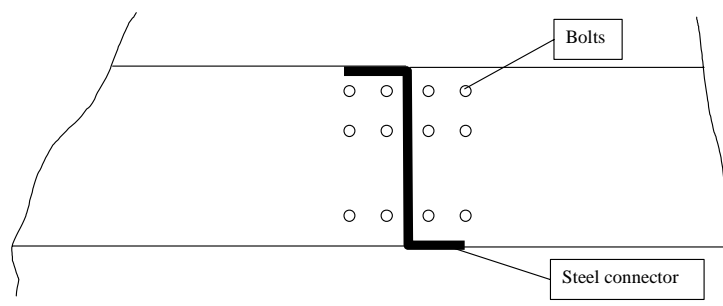
Figure 109-1. Schematic of beam connection.

The roof structure of this library and lecture hall consists of primary load bearing glulam beams of depth between 855 and 1350 mm. The beam width is 215 mm. The beams are connected at supports with a steel connector, schematically shown in figure 109-1. The structure was erected during March – April.

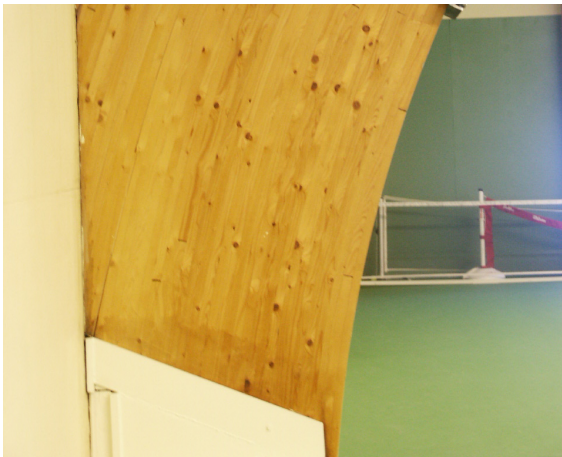
Figure 115-1. Arched column with steel parts (in white).

This structure is a tennis hall built from 3-hinged glulam frames, placed at 9 m distance. The columns are curved, and attached to the ground by steel parts, see figure 115-1.

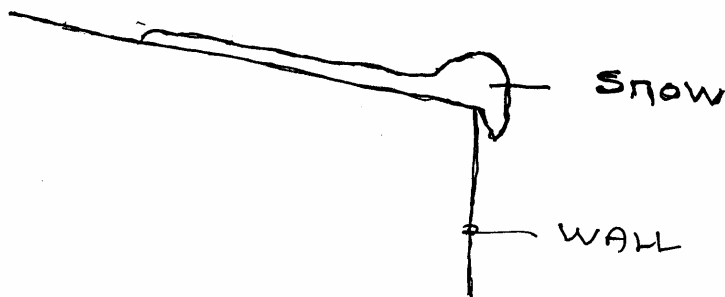
Figure 118-1: Snow load at time of failure.

The investigation showed that the snow load on the roof moved downwards due to the pitch of the roof and melting. Extremely high snow load was present at the eaves, see figure 118-1, which led to overloading of the eaves purlin.

Snow overhanging according to EC1 fig. 6.2 should have been considered.
