Delamination of Cross-laminated timber and its impact on fire development

Focusing on different types of adhesives

**Report 5562, Lund 2018
Examensarbete på Civilingenjörsprogrammet i Riskhantering**

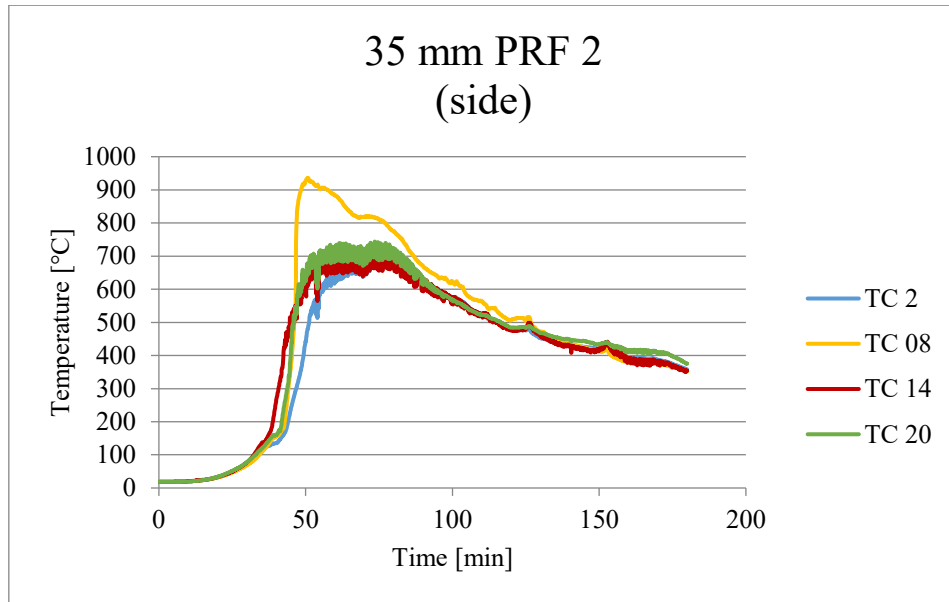
fig. 6-12. All thermocouple temperatures at the depth 35 mm (bondline), for the PRF 2 specimen.

As the temperature measurement of 35 mm for PRF-2 clearly deviated from the rest in fig. 6-9 the individual temperature profiles for all thermocouples at 35 mm and 50 mm for PRF-2 are presented below, see fig 6-12 and 6-13.

The chosen measurement data for PRF-2 at the depth 35 mm (TC8) was indeed the highest registered temperature measurement for that depth series, see fig 6-12. Following TC 8 at the depth 50 mm was TC 9, which peaked at approximately 500°C, see fig 6-13.

One can also observe that the PRF-2 specimen in set 2 also registered a high peak temperature, which sets it apart from the rest since it didn't show any sign of delamination during testing. However, we believe this to be a local irregularity caused by defects in the specimen at that particular measurement point, possibly a crack or cavity. This wouldn't be surprising as the overall quality of the specimens was quite poor, see Appendix G for images. To somewhat verify that this deviation wasn't caused by local delamination, the individual temperature profiles for the PRF-2 specimen for the 35 and 50 mm depths were included in the result, which includes all thermocouple series of that specimen (see fig 6-12 and 6-13). When studying fig. 6-12 one can confirm that the thermocouple that was chosen (TC8), indeed deviates from the rest. The following thermocouple in that series is TC 9 and as shown in fig. 6-13 it registered a higher peak temperature than most thermocouples at 50 mm. Still, when compared to the peak temperatures of the delaminating specimen PUR-A1 and -A2 at the 50 mm depth (see fig. 6-10 and 6-11), this temperature is more than 300°C lower, suggesting that it's a question of a local deviation rather than delamination.

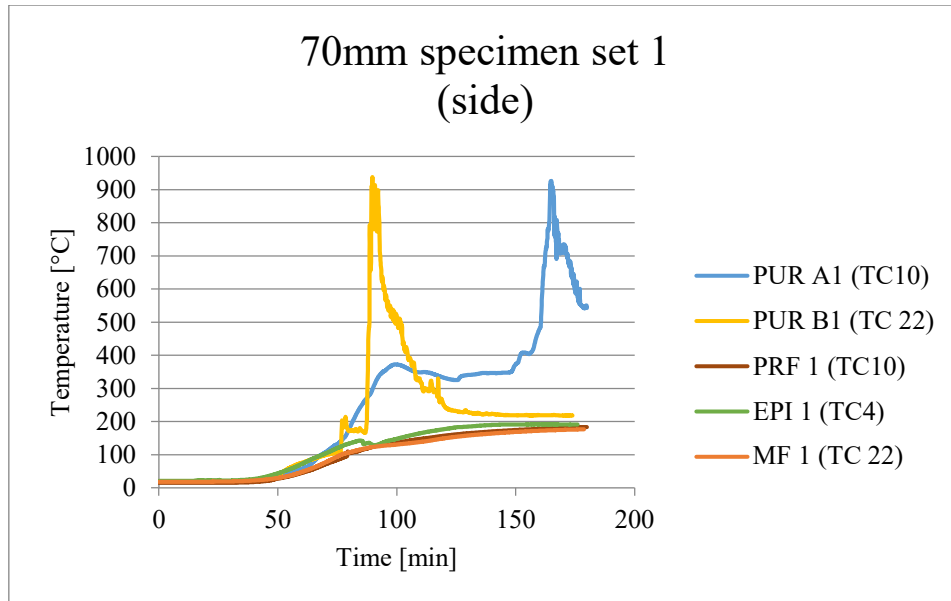
fig. 6-14. Top registered temperatures of specimens set 1 from the side series, at the depth 70 mm (2nd bondline).

For most specimens, the temperature development at 70 mm started slowly and levelled out at approximately 200°C. However, this was not the case for the PUR-A specimens and the PUR-B1 specimen. The PUR-A specimens increased to around 400°C, and towards the end rapidly increased to 600 or 900°C, depending on set. The top registered temperature for the PUR-B1 specimen on the other hand, was reached after just 80 minutes, peaking at 900 °C.

The second delamination of PUR-A1 was visually observed at around 163 minutes into the test (see section 6.5), which is in good agreement with the heat peak at approximately 165 minutes for the 70 mm bondline-depth, see fig. 6-14. For the PUR-A2 specimen complete delamination of the second lamella was not observed during the full duration of the test (see section 6.5). Still, when studying the bondline temperature of PUR-A2 (see fig.6-15) it seems that the temperature increase towards the end of the test could indicate delamination, although delayed.

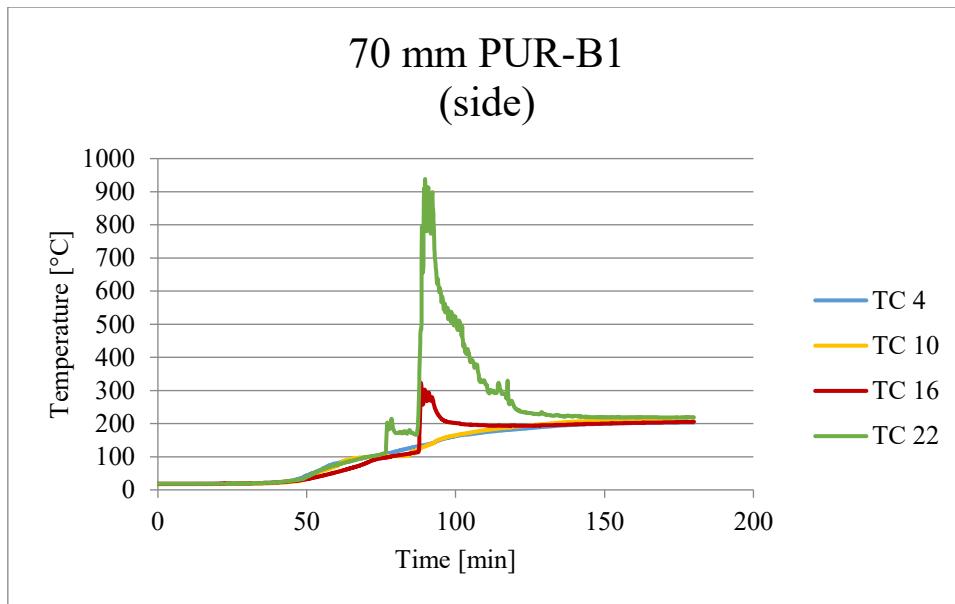
fig. 6-16. All thermocouple temperatures at the depth 70 mm, for the PUR-B1 specimen.

As this result was somewhat deviating, the individual temperature profile for the PUR-B1 specimen at the 70 mm depth, with all the thermocouple readings, was included in the result, se fig. 6-16.

The temperature for the PUR-B1 specimen also differed noticeably, as thermocouple 22 registered an extremely rapid temperature increase at approximately 80 minutes, peaking at 900 °C, see fig. 6-14. It's our theory that this was not the result of localized delamination, but rather a faulty thermocouple reading, as no significant activity was observed around this time mark, see appendix G. This theory is enforced when comparing thermocouple 22 to the rest of the thermocouples at the 70 mm depth for PUR-B1, as it's clearly deviating, see fig. 6-16. Additionally, if delamination or any other mechanism had exposed the thermocouple to the hot gases of the furnace, the temperature would have stayed high and not decreased back down to the same level as the rest of the thermocouples.

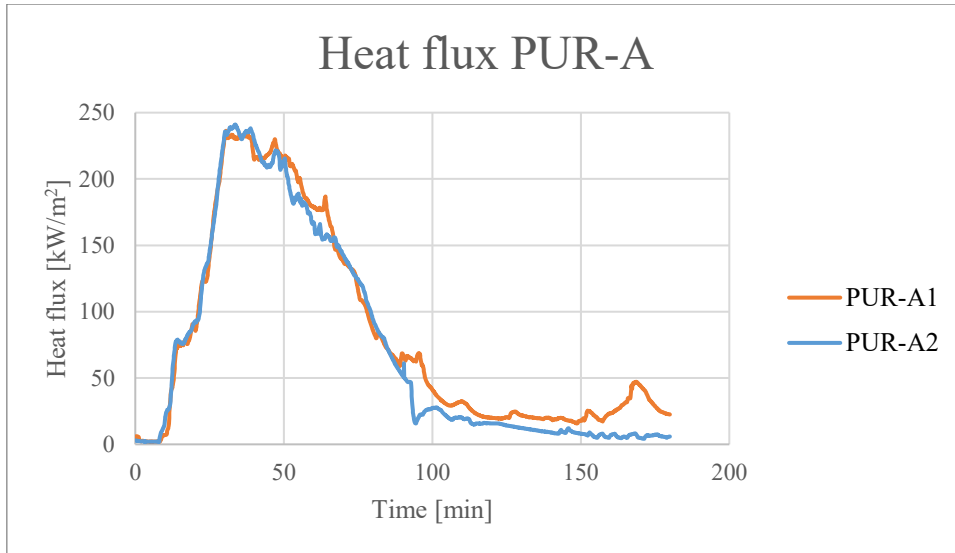
fig. 6-24. Comparison of heat flux between PUR-A1 and PUR-A2.

The PUR-A1 as well as the PUR-A2 presented a minor increase and fluctuations at around 48 minutes just before the start of the decay phase, see fig. 6-24. After approximately 92 minutes PUR-A2 exhibited a major drop in heat flux. However, PUR-A1 rose slightly at the same time. The end phase also differs somewhat for the two tests, the PUR-A1 exhibits an increase up to just below 50 kW/m², while the PUR-A2 continues to decay.

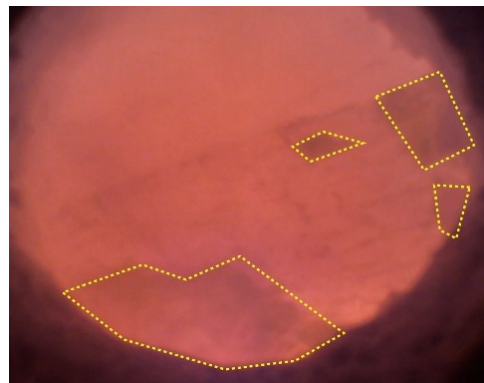
First delamination

The test with PUR-A1 started to show signs of delamination when a smaller part delaminated after approximately 51 minutes and within a minute later a major part of the first lamella delaminated.

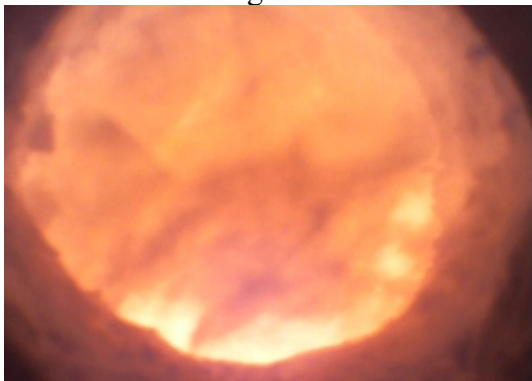
Reignition

Shortly after the first delamination the intensity of smoke and flames increases inside the furnace and reignition of the wood was shown.

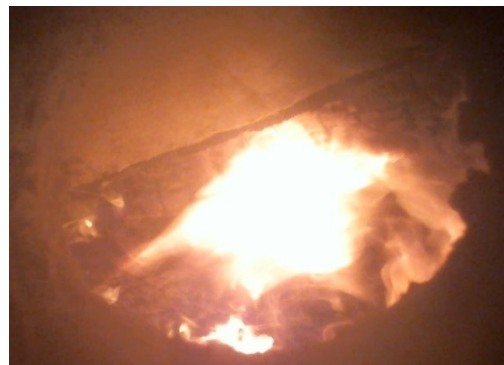
Second delamination

After approximately 2 hours and 43 minutes a second layer of the specimens are delaminating from the element.

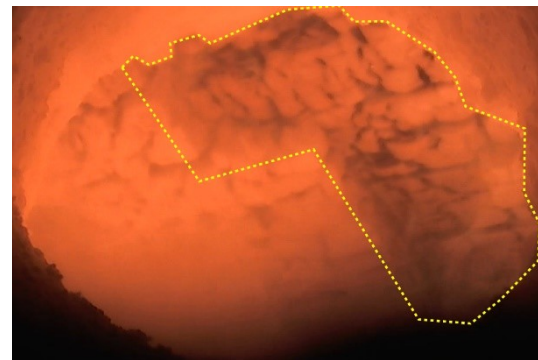
First delamination

After approximately 42 minutes smaller parts of lamellas are falling off, and 2 minutes later a larger part of the first lamella falls off as well. After this an increase in flames occurred as well as turbulence of gases.

After 48 minutes further delamination of the first lamella occurred. Shortly after this an increased intensity of smoke and flames occurred and more parts of the first lamella were gone.

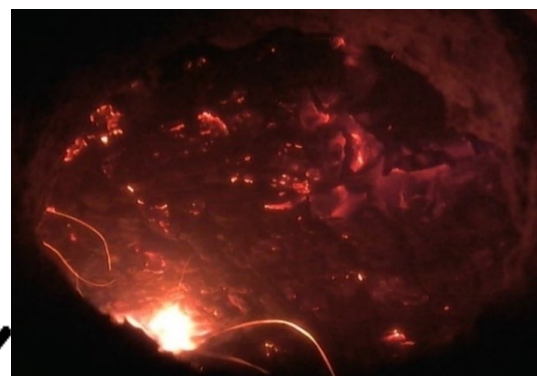
Second delamination

After a while of low activity on the screen, small parts of the second lamella fell off at around 2 hours and 48 minutes. The newly exposed wood in the furnace began to burn, causing flames and increased glowing of the wood.

After 2 hours and 58 minutes a highly increased intensity of light, glowing parts as well as flames occurred after a period of darkness. On the specimen way up from the furnace observations showed that a larger part delaminated in the down left corner of the picture.

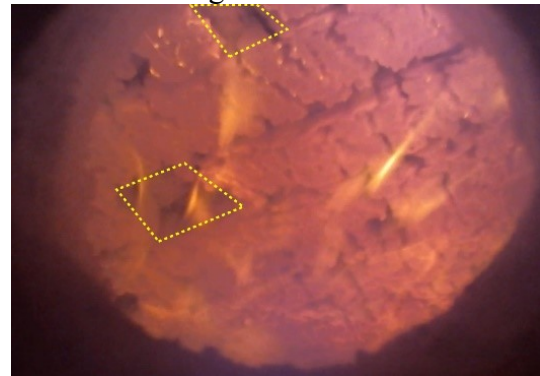
First stage of delamination

Small and local parts of the first lamellas started to fall off around 1 hour and 16 minutes.

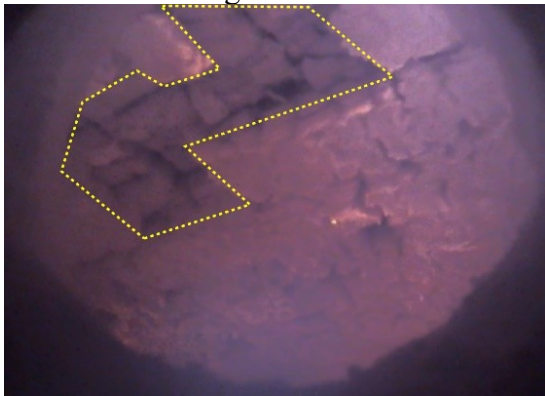
Second stage of delamination

Approximately 1 hour and 30 min into the test a larger part delaminated in the first lamella. This was the last visible stage caught on camera before it became too dark in the furnace.

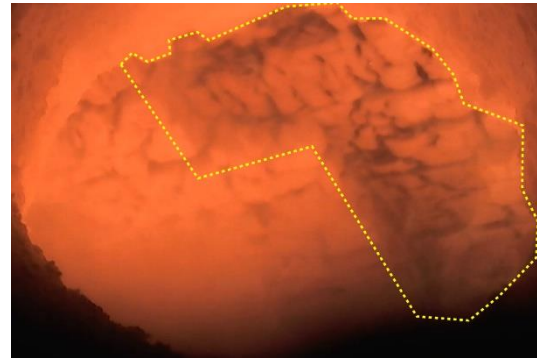
First delamination

After 48 minutes further delamination of the first lamella occurred. Shortly after this an increased intensity of smoke and flames occurred and more parts of the first lamella were gone.

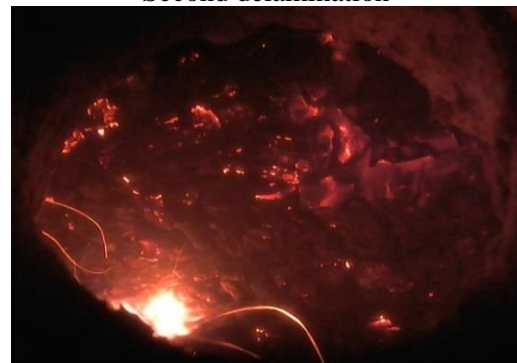
Second delamination

After 2 hours and 58 minutes a highly increased intensity of light, glowing parts as well as flames occurred after a period of darkness. On the specimen way up from the furnace observations showed that a larger part delaminated in the down left corner of the picture.

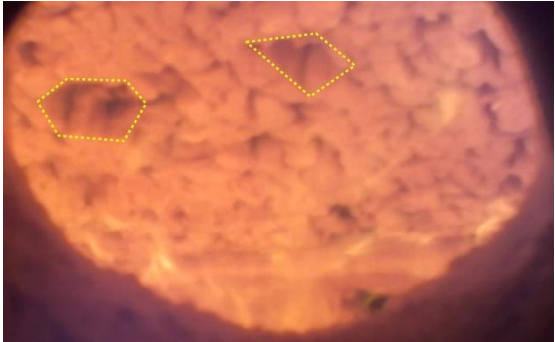
After 41 minutes, a smaller local part of the lamella has fallen off, see mark ups on picture. No major signs of change of the fire development were observed.

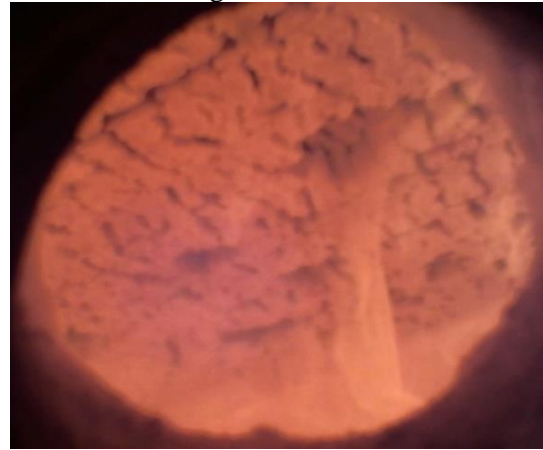
Small signs of delamination was appearing on the specimen when a small piece of the lamella fell off after approximately 40 minutes of time.

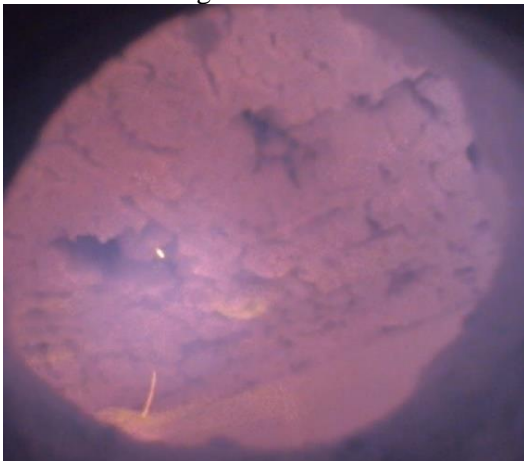
Small signs of delamination

After 1 hour and 27 minutes another small piece fell off, in that time period the video material no longer showed visible flames on the screen and the brightness in the furnace were slowly turning to black.

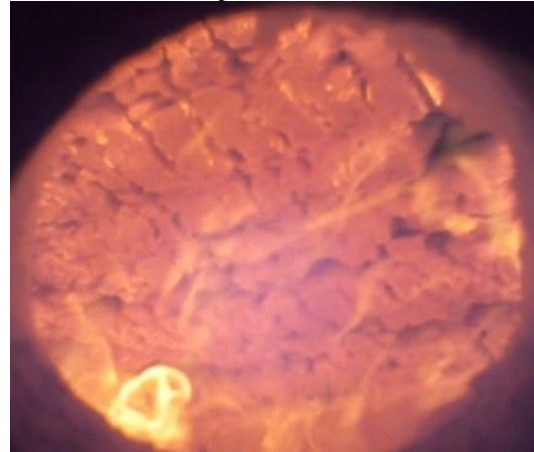
Small local parts of delamination

Partly and local signs of delamination of first lamella were shown after 1 hour and 15 minutes. Smaller pieces of charcoal have fallen off.

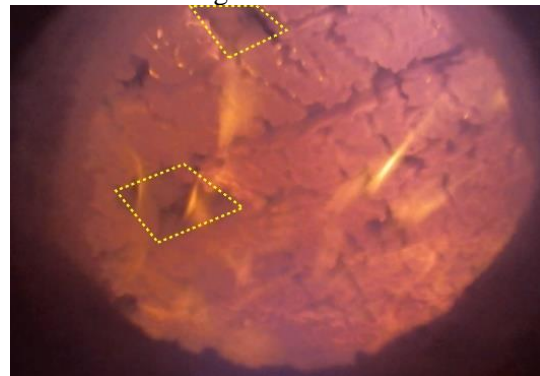
First stage of delamination

Small and local parts of the first lamellas started to fall off around 1 hour and 16 minutes.

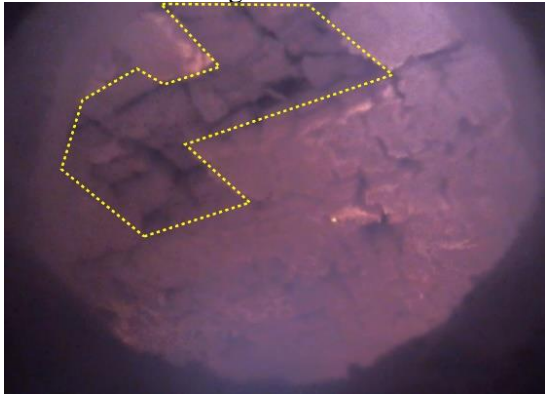
Second stage of delamination

Approximately 1 hour and 30 min into the test a larger part delaminated in the first lamella. This was the last visible stage caught on camera before it became too dark in the furnace.

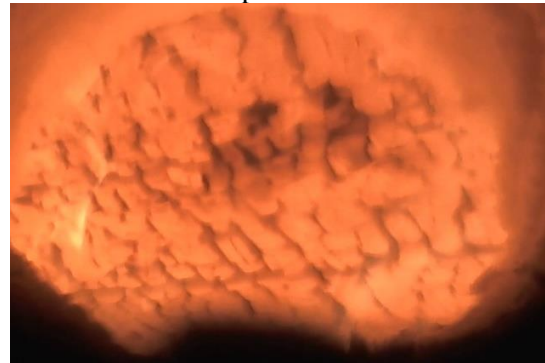
Smaller pieces falls off

Approximately after 40 minutes a smaller piece delaminated from the lamella. No noticeable change on the fire development were observed.

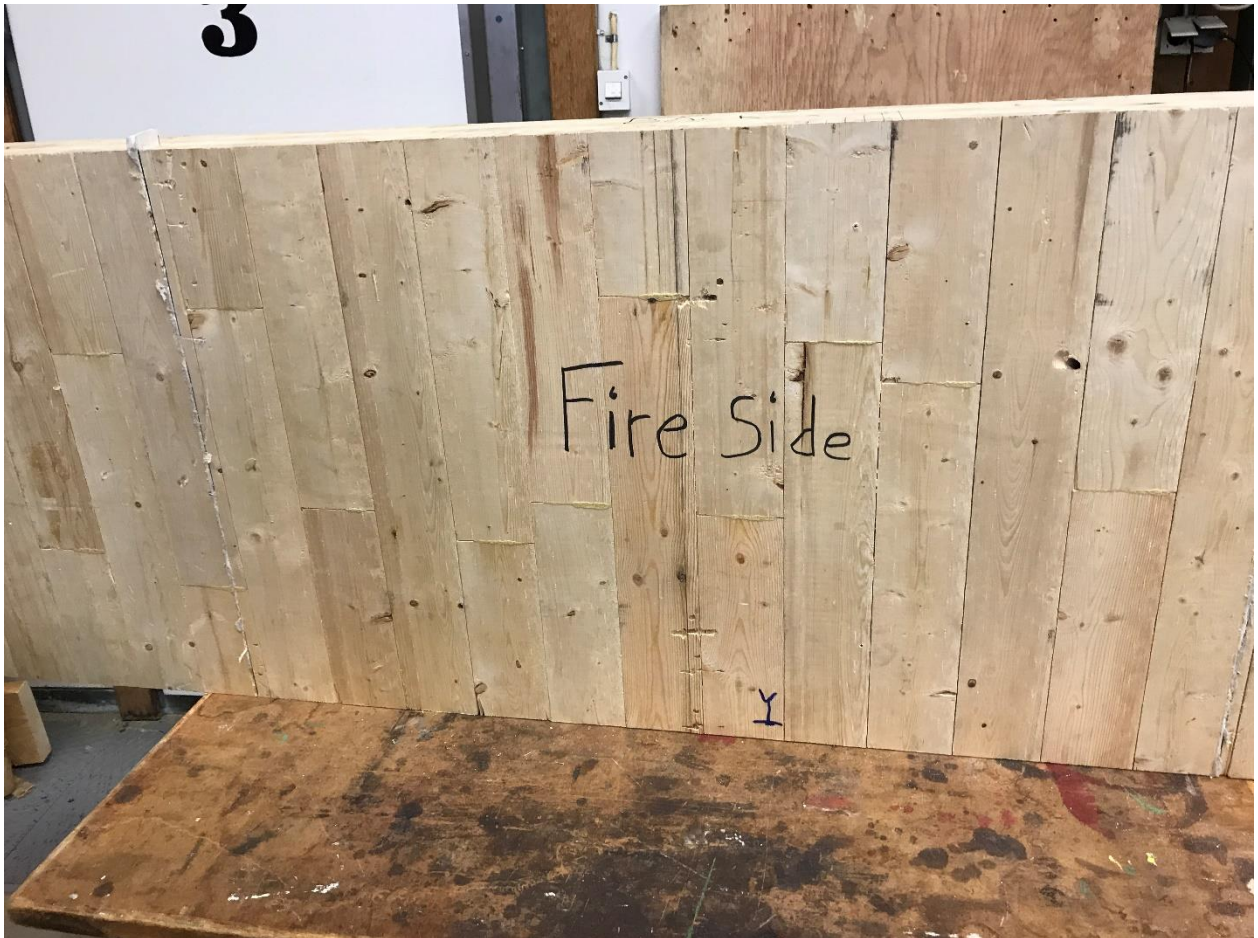
fig. G-1. The fire exposed side of specimen PUR-A1. As these specimen were cut from larger original element from the previous full-scale test, the boards of each lamella were not evenly distributed.
