Water Supply Study at Manama, Southern Zimbabwe

Patrich Holmström
Per Möller
Mats Svensson

LUND 1991

This paper describes a groundwater prospecting project, including two parts, in the rural area in southern Zimbabwe. The first part deals with a geological survey and locating of waterbearing fracture zones with the electromagnetic methods Slingram and VLF, and a resistivity instrument.

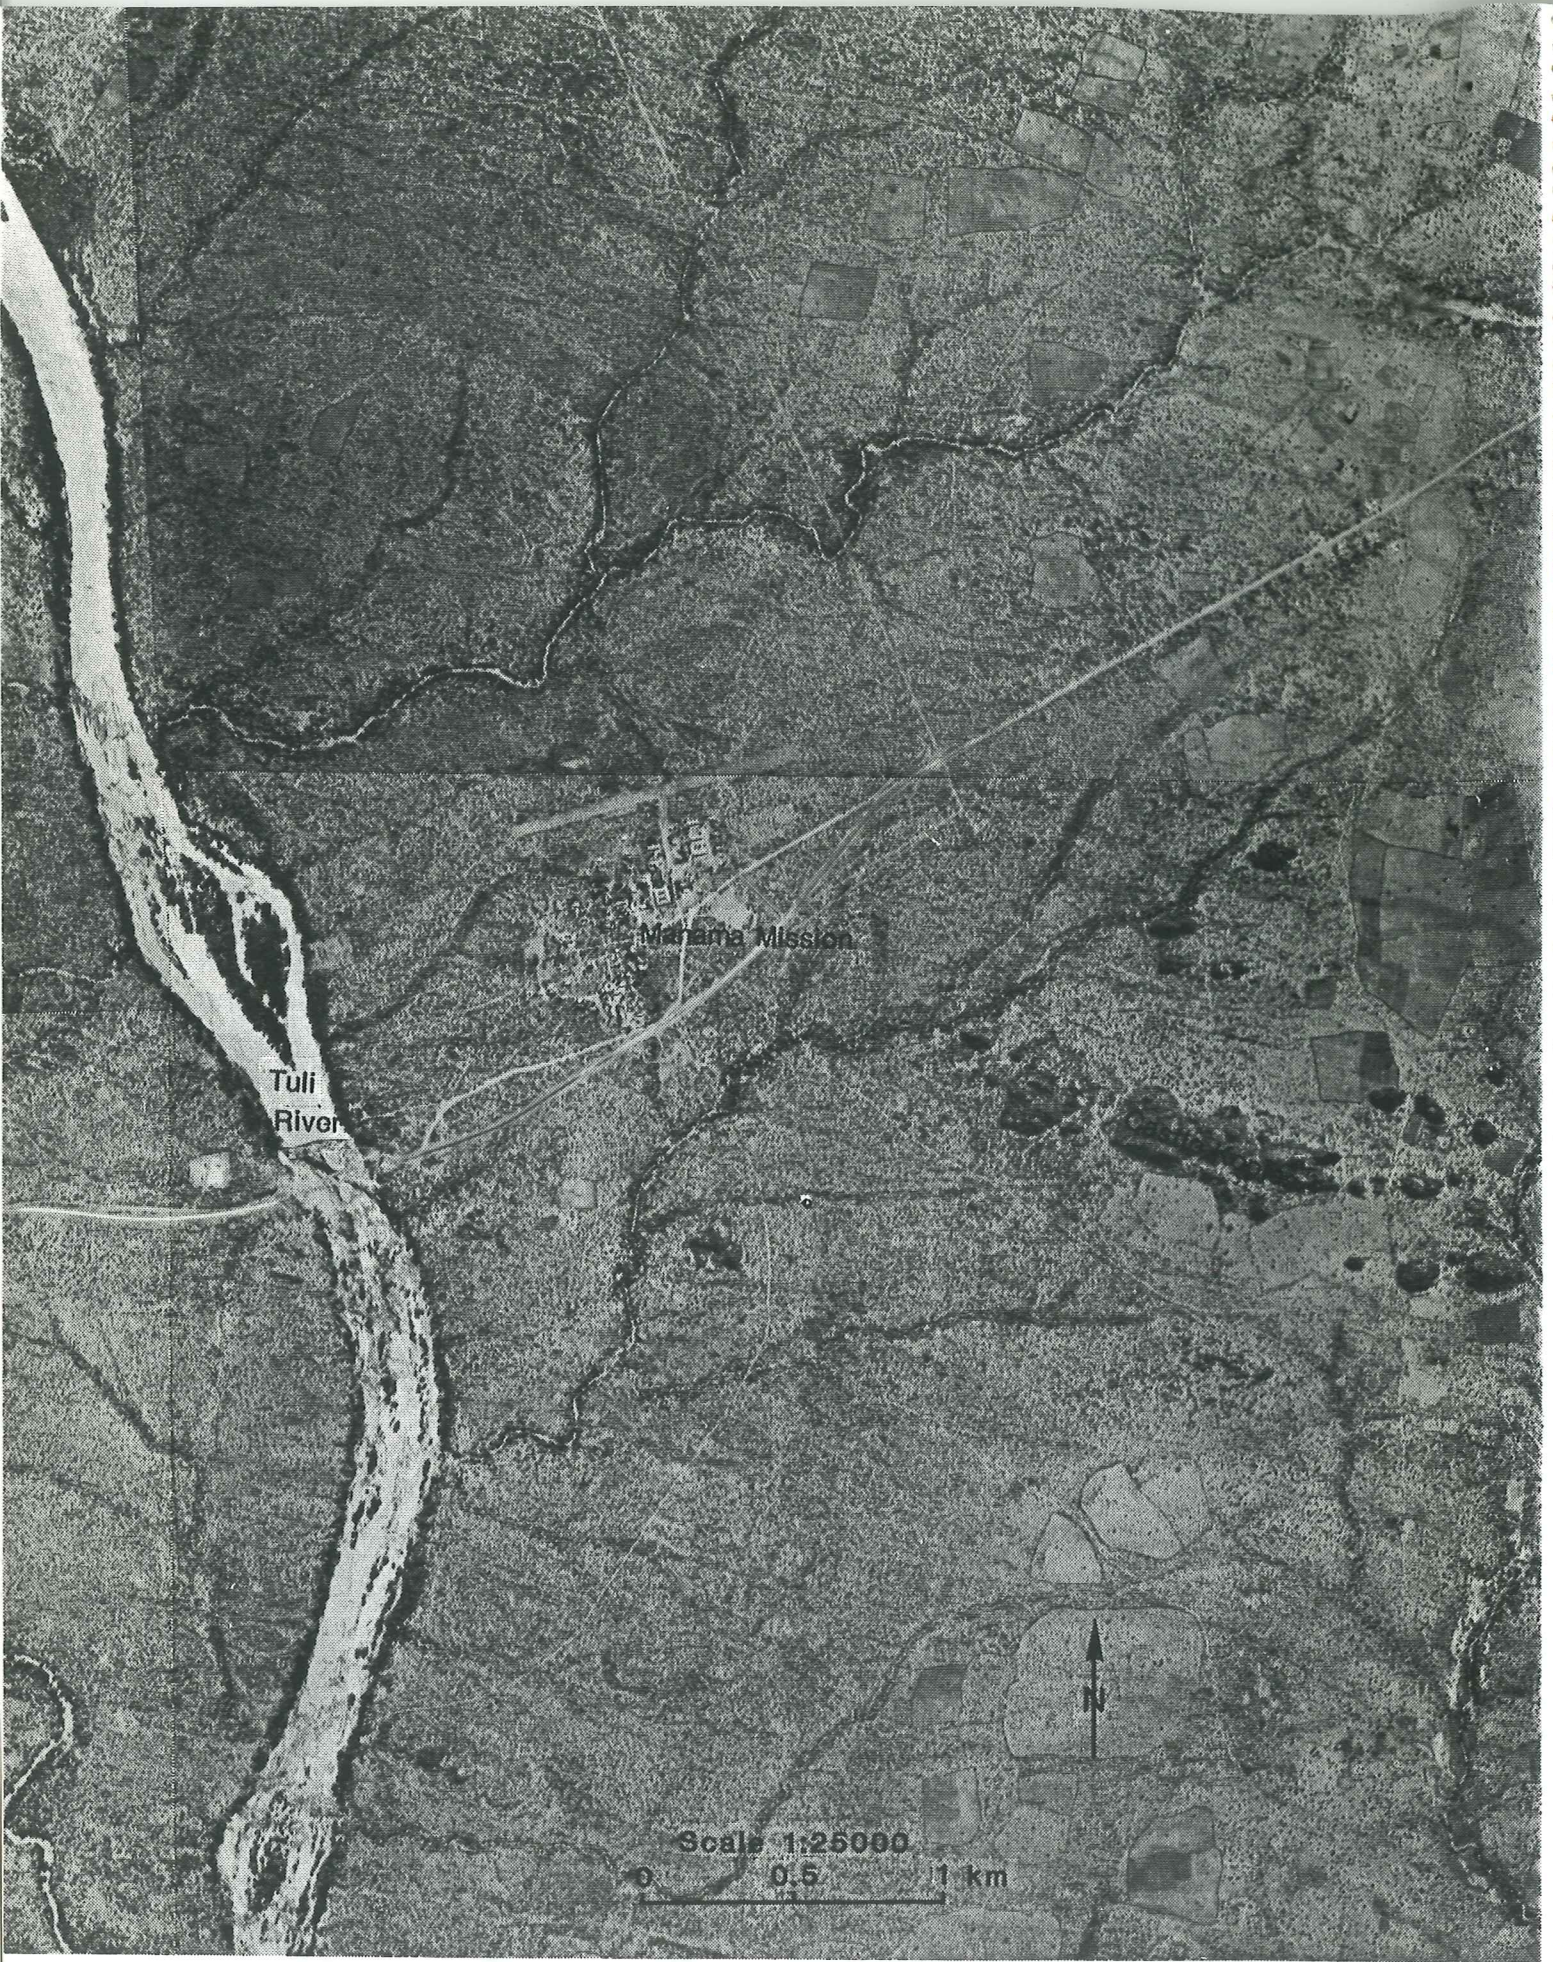
Fig 2.4.3 Aerial photo of the Manama area. Scale 1:25000.

Many small rivers join the Tuli river in the area, and cut themselves some metres down in the flat basement (see fig 2.4.3). Like the Tuli, these rivers are dry for most of the year.

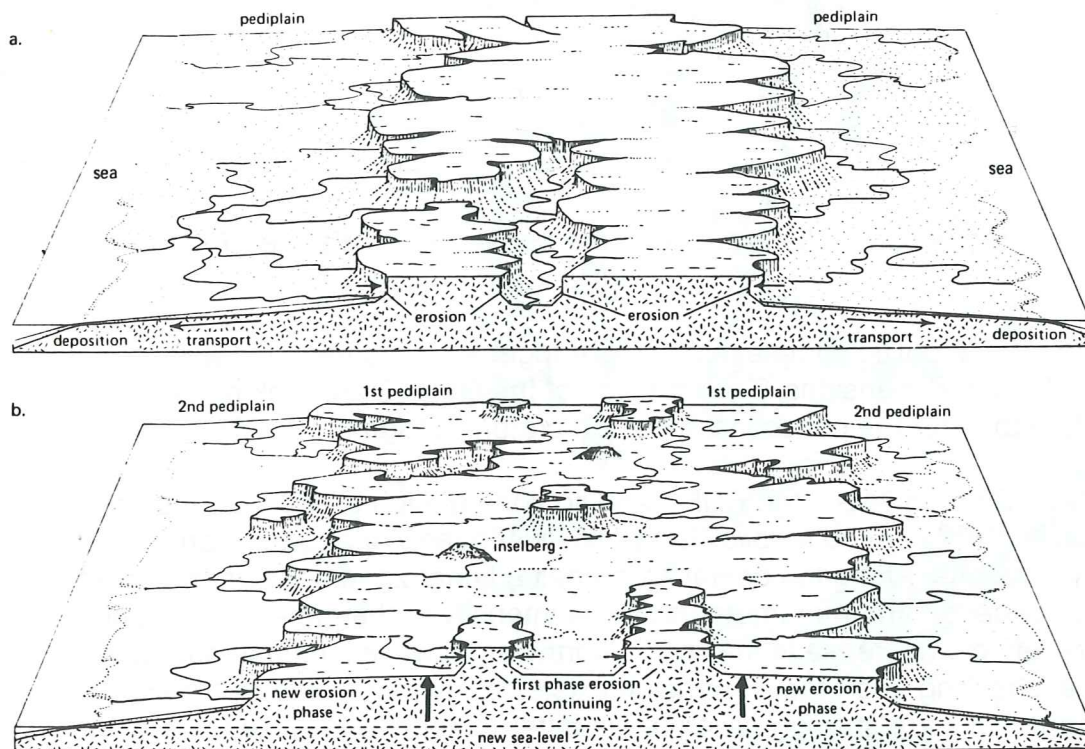
Fig 3.2.1.1 Principles of pediplanation: a) First face of erosion: sharp retreat and waste material to continental shelf. b) Isostatic uplift and second erosion face extend pediplanes at a new lower level. (Pritchard, 1979)

As the rest of Africa, Zimbabwe has over millions of years gone through cycles of *erosion* during *isostatic uplift*. Deep vertical weathering and erosion through scarp retreat have formed flat *pediplanes*. Different generations of pediplanes form a so called *polycyclic landscape*, with each generation at different elevation, the highest surface being the oldest (see fig 3.2.1.1).

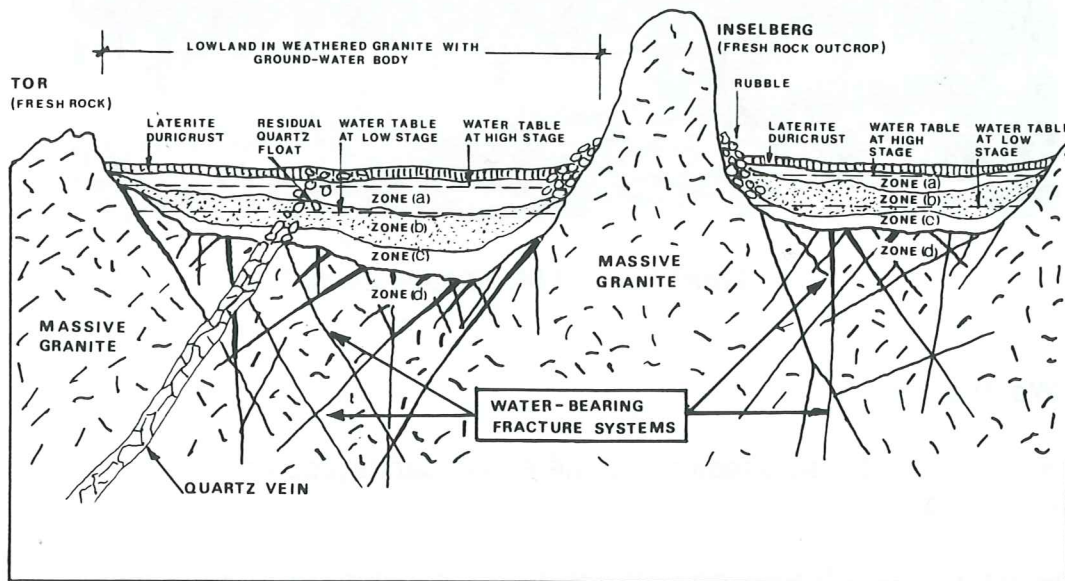
Fig 3.2.2.1 Lowlands of weathered granite separated by inselbergs. Weathered zone: a) clayey sand, b) clay, c) rock progressively altered upward to gravel and sand material, d) fresh fractured rock with waterbearing fractures. (UNESCO, 1984)

In arid and semi-arid climates deep weathering is often restricted to zones of fractured rock, where deep percolation is possible (Clark, 1985). This weathering increases the storage capacity of the fractures. When enough groundwater is circulating in the fractures, a saprolite weathering profile can be formed (see fig 3.2.2.1). Its upper clayey part has a high porosity and a low permeability, which slow down percolation into the fractures. At the base, where more coarse grained weathering material intersect with the fresh fractured rock, a higher permeability enables the best groundwater outtake.

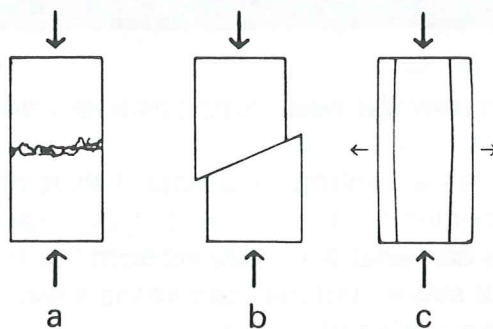
Fig 3.3.1 Behaviour of rocks under compression: a) compressive failure, b) shear failure, c) tensional failure (Ollier, 1984).

The fracture pattern of the cratons originate mostly from the stresses of large scale orogenic movements. These stresses have a similar influence on all hard rocks. If they are too big rupture of the rock develops a fracture pattern. *Shear fractures*, which are a result of movement along a plane, develops at an angle of around 45° with the main compressional stress direction. Often two intersecting shear planes develop under the same stress conditions (see fig 3.3.1).

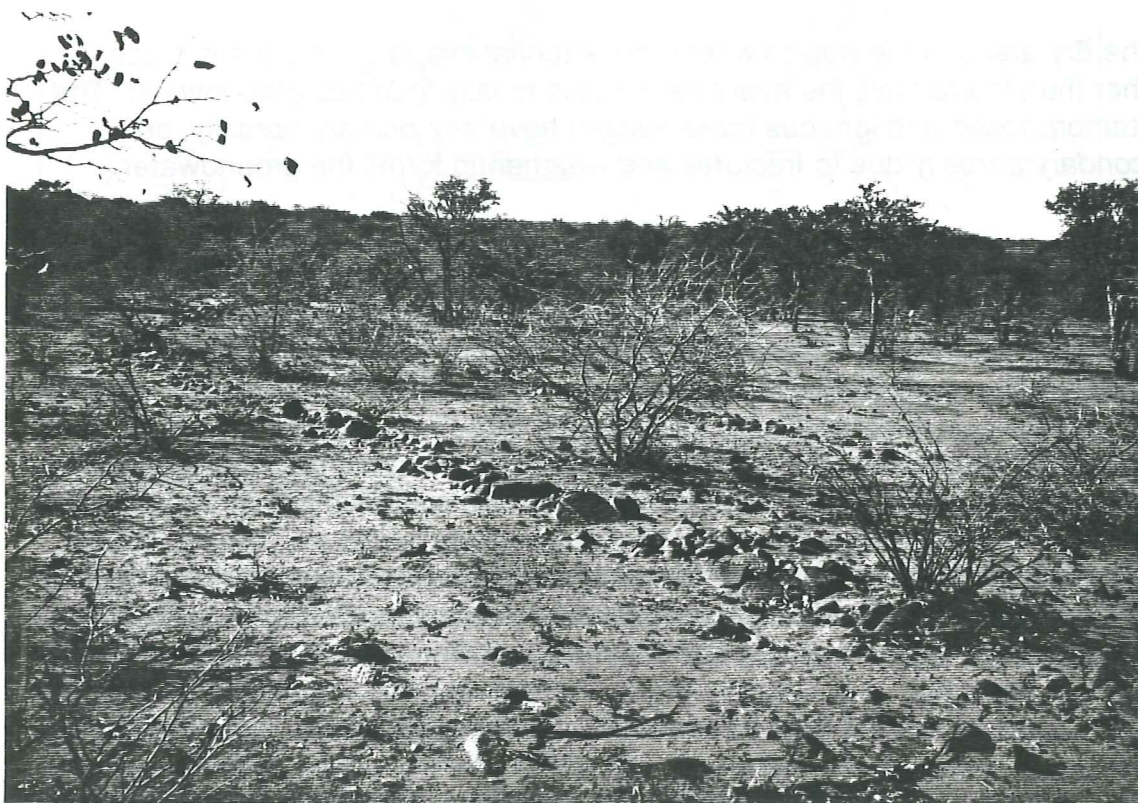
Fig 3.3.2 Dolerite dykes rising over the weathered basement near Manama.

Along the compressional stress direction *tensional fractures* develop due to parting and dilation perpendicular to the compressional stress direction. These tensional fractures are mostly the open and potentially waterbearing ones. However, dykes often fill up these tensional fracture (UNESCO, 1984). Dykes are important indicators of fracture directions (see fig 3.3.2).

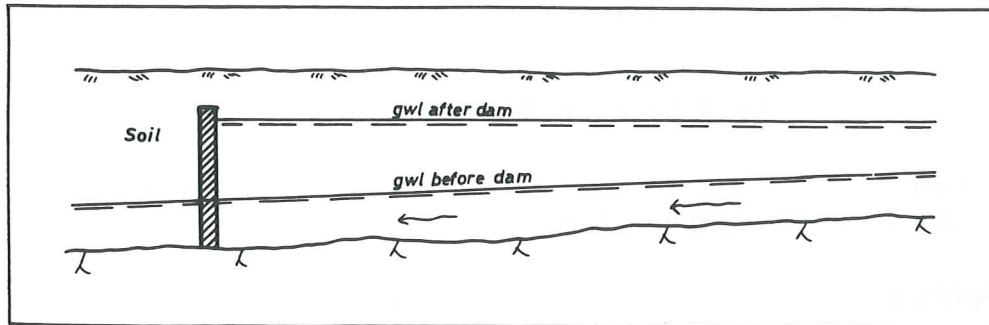
Fig 4.1.1 *Subsurface dam* (Modified from Destouni and Johansson, 1989)

The *Subsurface dam* is built as a barrier in the river alluvium below the surface in order to stop the natural groundwater flow.

- *Subsurface dam* and (fig 4.1.1)
- *Sand dam* (fig 4.1.2)

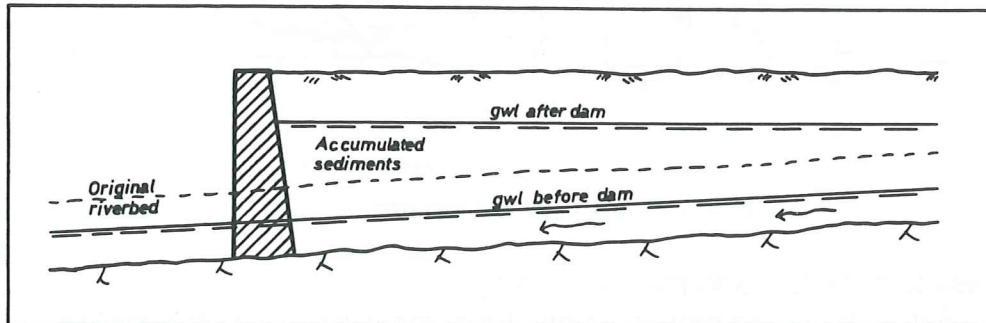
Fig 4.1.2 *Sand dam* (Modified from Destouni and Johansson, 1989)

The *Sand dam*, which is the only type considered in this project, is built as a weir in a stream or in a river preferably on top of bedrock in order to create a new reservoir. The construction is carried out in the dry season. The water speed will be reduced by the weir during flood and this will cause coarse material transported by the water to settle upstream the weir. Every year some decimeters of material is accumulated and eventually there is a new manmade aquifer built up, which will store the water for use in the dry season.

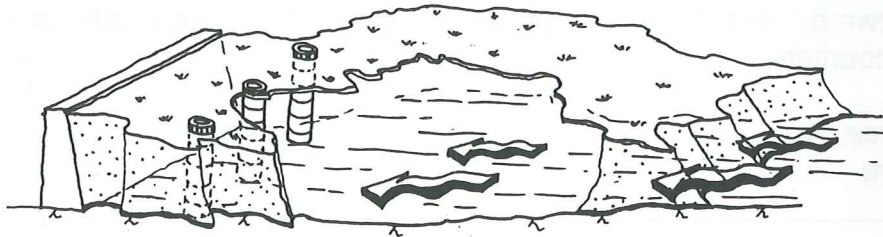
Fig 4.1.3 Hand dug wells.

Advantages: Cheap.

Disadvantages: Will be destroyed during flood.

1 Hand dug wells with perforated concrete rings or stone rings

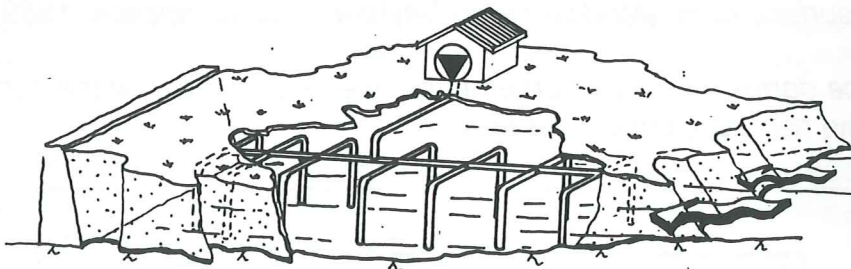
Fig 4.1.4 Vertical wellpoints.

Advantages: Easy to construct and maintain the system.

Disadvantages: Before the sand dam is empty the pump will take in air because of too low groundwater table, and that will damage the pump.

2 Vertical wellpoints

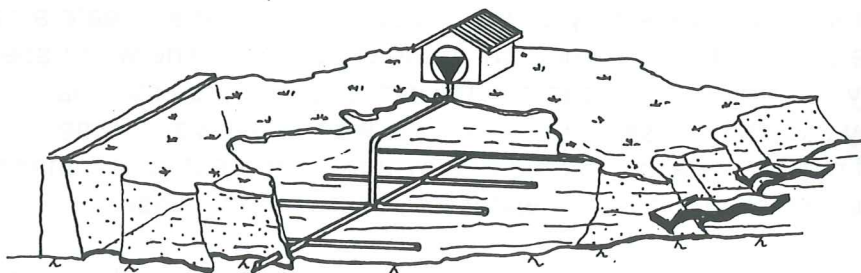
Fig 4.1.5 Horizontal pipes.

Advantages: It's possible to get as much water out of the sand dam as possible because of the location of the pipes at the bottom of the aquifer.

3 Horizontal pipes

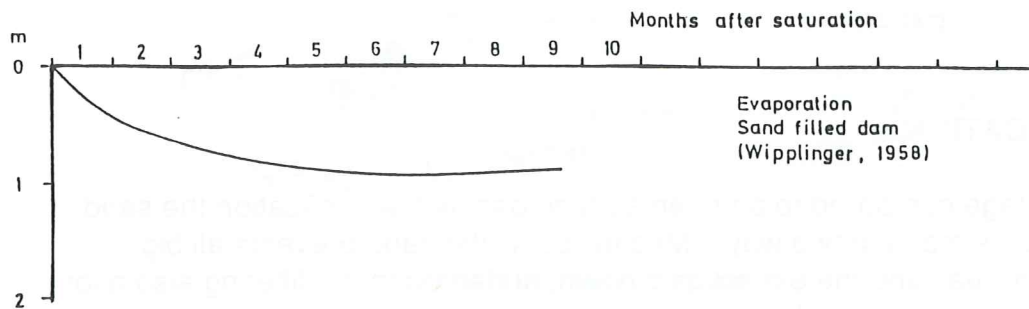
Fig 4.3.1 Evaporation, sand filled dam. (Wipplinger, 1958)

Evaporation losses from a sand river bed occur at high rates immediately following saturation, with the rate decreasing as the groundwater table drops. Results based on experiments carried out by Wipplinger (1958) show that when the depletion of the the groundwater table is about 1 m the evaporation stops (fig 4.3.1). (Wipplinger, 1958).

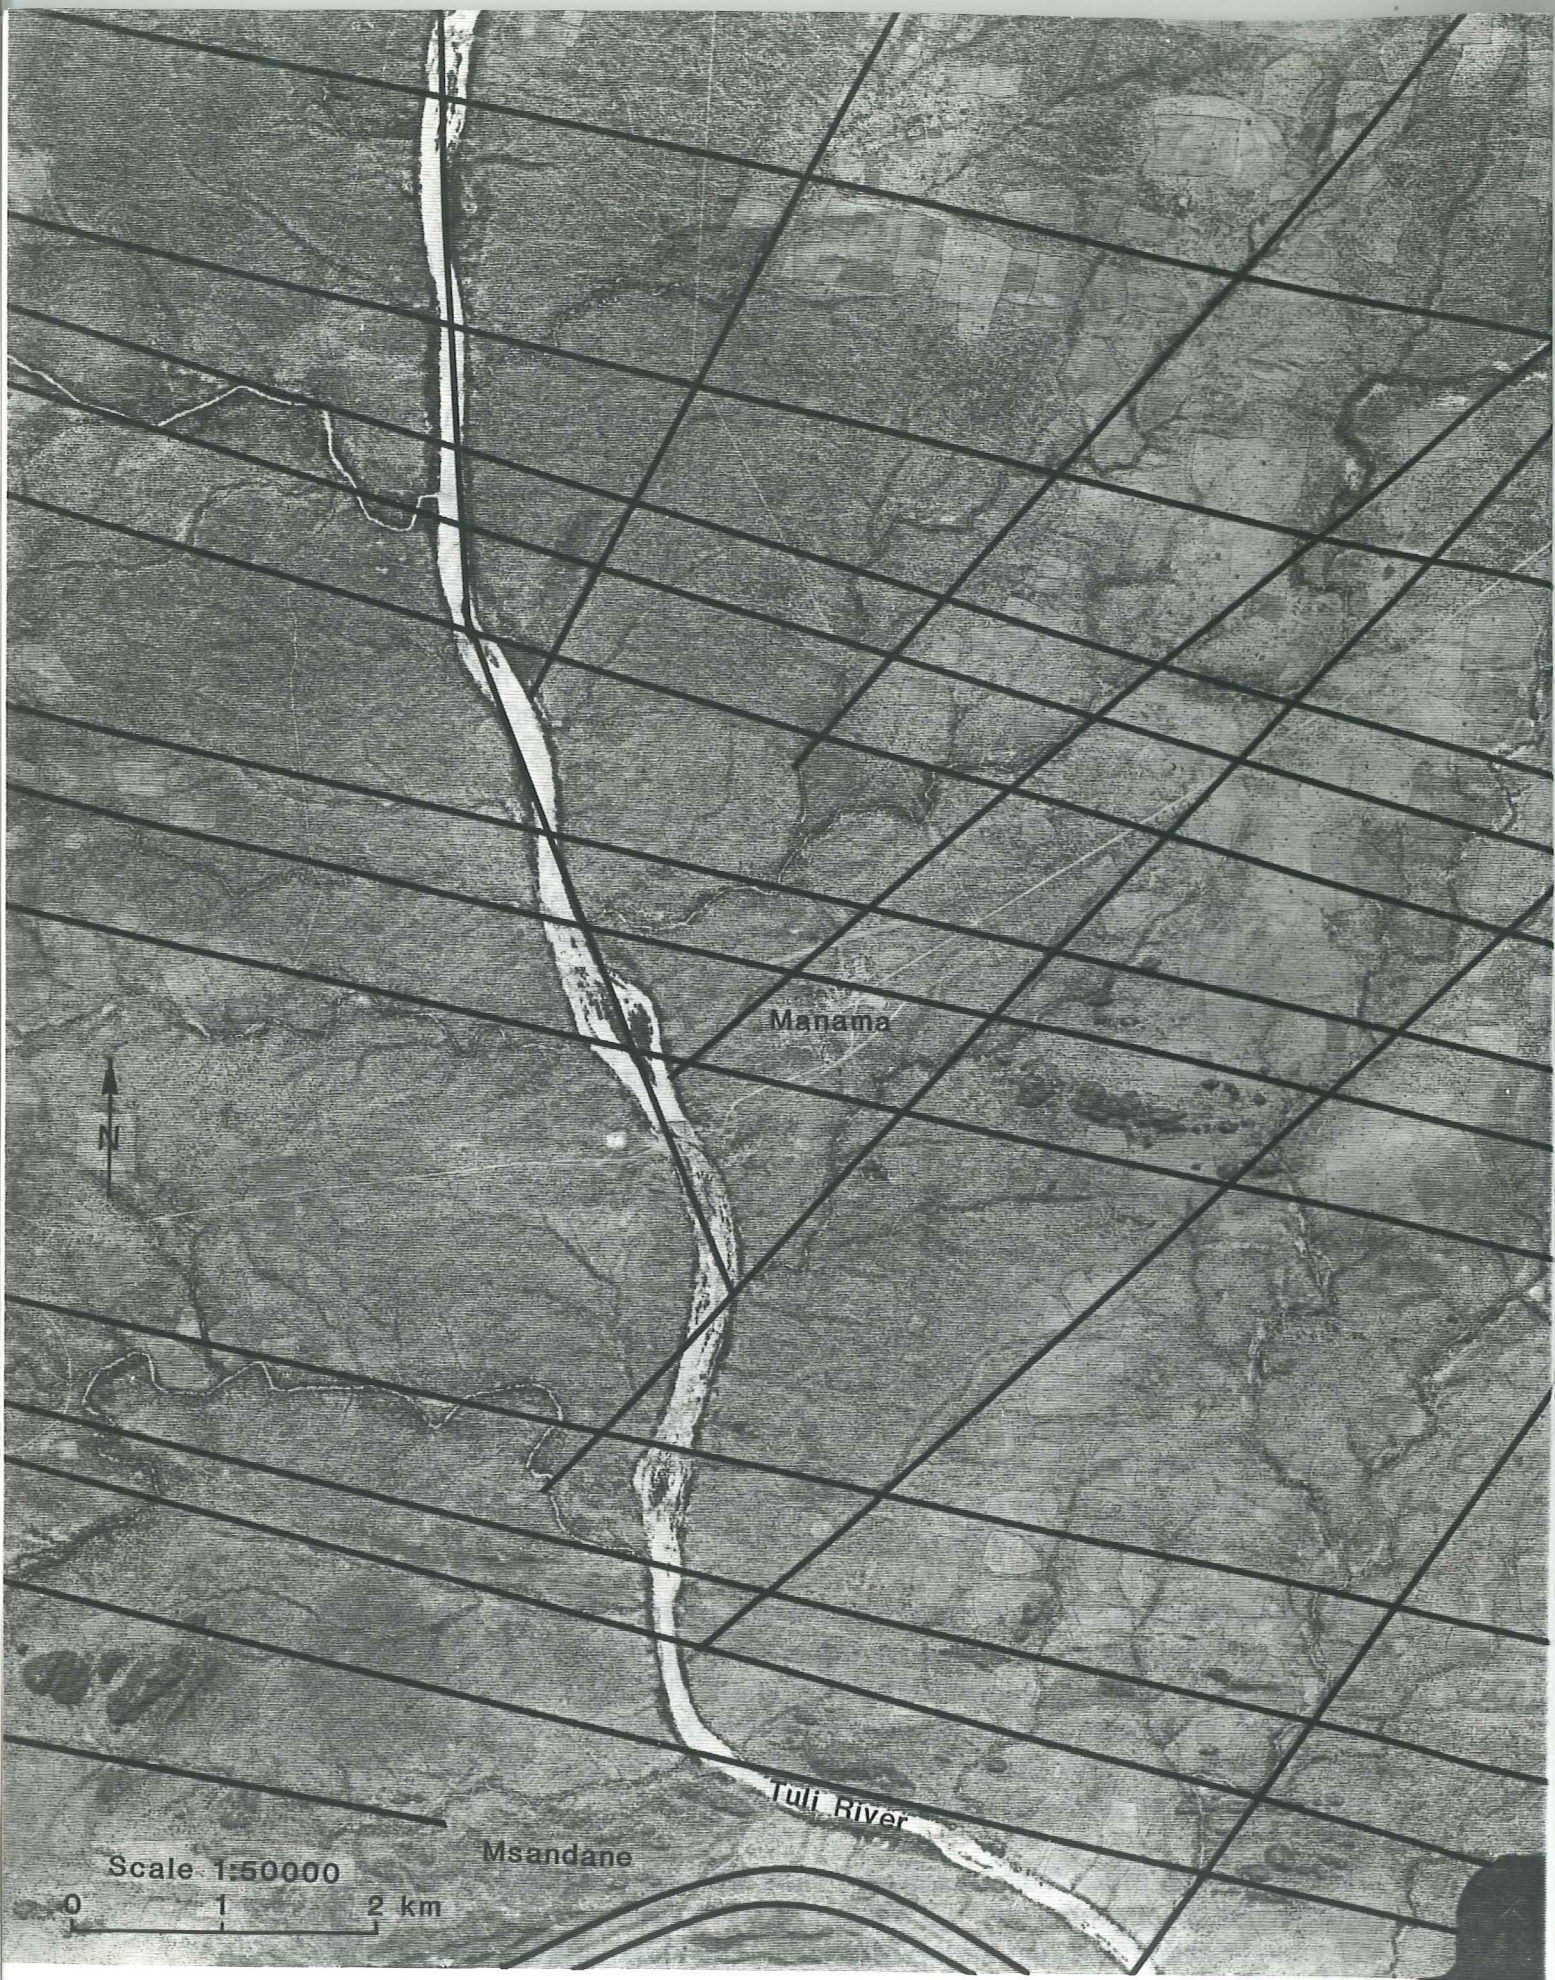
Fig 5.1.1 Major lineaments for the area around Manama.

On the larger scale of aerial photos these lineament directions are still valid (see fig 5.1.1). They are mostly traced in the drainage pattern of small rivers, whose flowpaths are probably controlled by fault lines. The WNW trending lineaments are clearly dominating the area, controlling the drainage direction of rivers west of the Tuli river and controlling the bends of the rivers east of the Tuli. The small inselbergs SE of Manama extend in this direction.

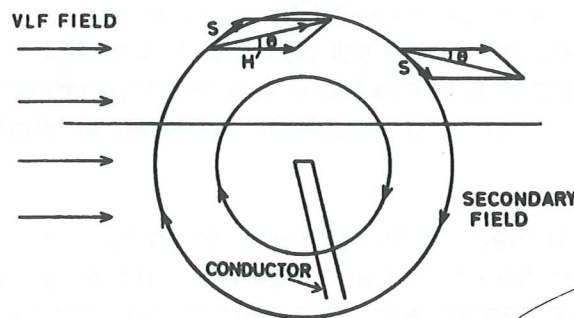
If an in time varying electromagnetic field is produced on the surface of the ground, currents will flow in sub surface ground conductors in accordance to the laws of electromagnetic induction. These currents give rise to secondary electromagnetic fields which distort the resultant field observed at any point on the surface. In general the resultant field, which may be picked up by suitable search coil, will differ from the primary field in intensity, direction and phase (see fig 6.2.1) and reveal the presence of a conductor. (Parasnis,1979)

Fig 6.2.1. At the presence of a conductor the primary field (VLF-field) will give rise to a secondary field (see fig 6.2.2). (Parasnis,1979.)

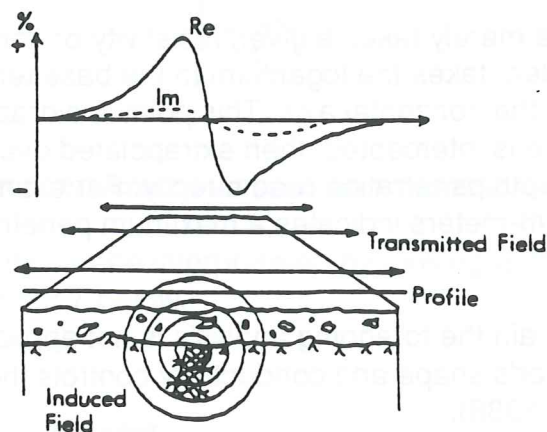
During ideal conditions (good receiving conditions and a very long uniformed conductor) a VLF-anomaly from a sheet conductor, for example a water bearing fracture zone, could look like shown below.

Fig 6.2.4. An ideal VLF-anomaly over sheet conductor. (Follin, date unknown.)

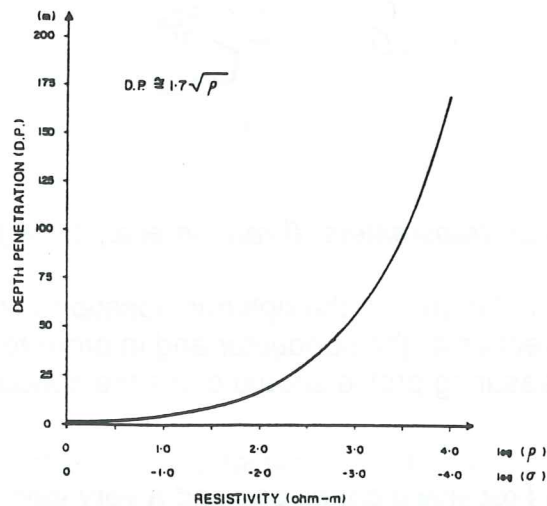
Fig 6.2.5. Depth penetration diagram for VLF. (Wright, 1988.)

To use the chart, one merely takes a given resistivity or conductivity for the host rock and/or overburden, takes the logarithm to the base ten (log) of it and locates this value on the horizontal axis. This point is extrapolated directly upward until the curve is intercepted, then extrapolated over to the vertical axis, and the maximum depth penetration read directly. For example, a host resistivity of 1000 ohm-meters indicates a maximum penetration of 55 meters (Wright, 1988).

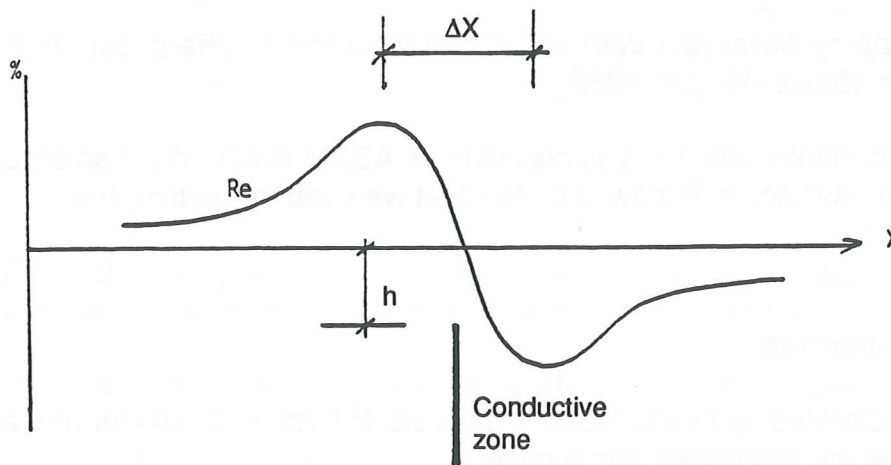
Depth to the top of a sheet conductor can be approximated to $h = \Delta X / 2$ according to the fig 6.2.6 below. However, if strike length or depth extent is limited, this can change to become equal to the full distance between peaks . (Wright, 1988.)

Fig 6.2.6. Depth to sheet conductor. (Hansson and Jeppsson, 1982.)

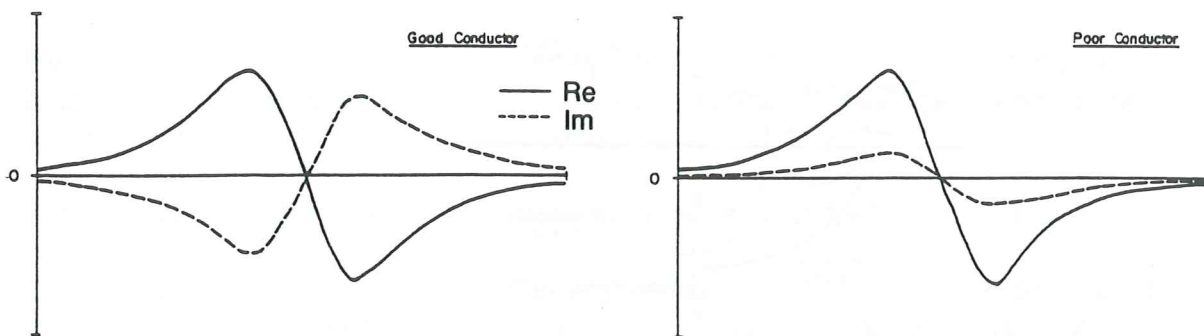
The degree of conductivity can be interpreted by looking at the Im-phase in an anomaly shown in figure 6.2.7 below.

Fig 6.2.7. Good conductor contra poor conductor. The shape of the left anomaly can also be caused by a conductive overburden - for example clay with water content. (Wright, 1988.)

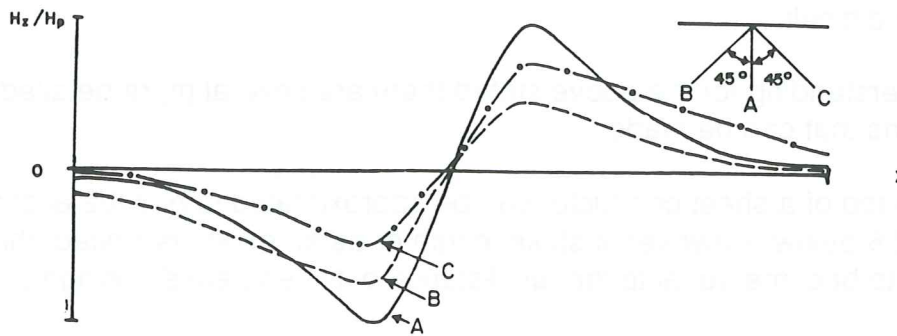
If the sheet conductor has a dip, this can be interpreted sometimes (see fig 6.2.8).

Fig 6.2.8. A dipping sheet conductor will distort the anomaly (Re-phase) in the manner shown above. (Wright, 1988.)

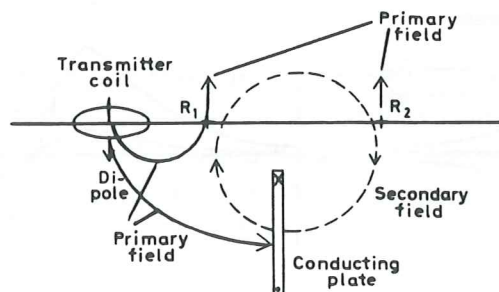
An EM-field (primary) is produced through the transmitter coil, when profiling is done over a conductor the primary field will cause the conductor to produce a secondary field (see fig 6.2.9). The receiver registers how the total field varies from the primary field.

Fig 6.2.9. When profiling over a sheet conductor with a Slingram the transmitted primary field will give rise to a secondary field. (Parasnis, 1979.)

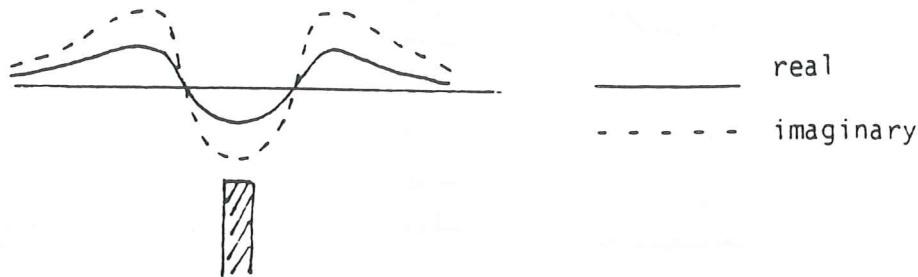
During ideal conditions a slingram-anomaly from a sheet conductor (for example a water bearing fracture zone) could look like shown below.

Fig 6.2.10. Ideal Slingram-anomaly over a vertical sheet conductor, for example a water bearing fracture zone. (Jämtlid, date unknown)

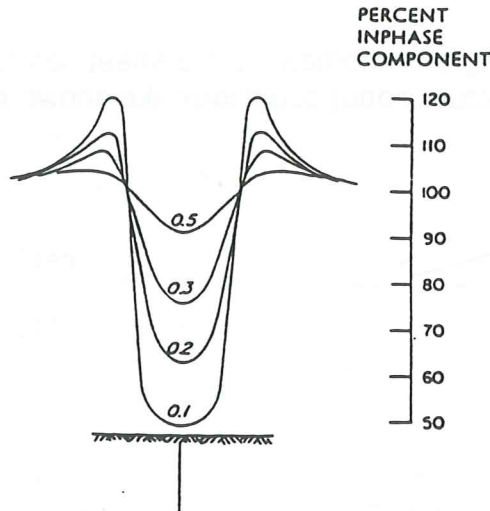
Depth to conductor can be sometimes be interpreted by looking at the shape of the anomaly. As showed in the figure below, a shallow buried conductor will cause an anomaly with larger amplitude than a deeply buried conductor.

Fig 6.2.11. Slingram anomlies observed over vertical sheet conductor for various d/r . d is depth of cover, r is the receiver-tranmitter distance. (Keller, date unknown.)

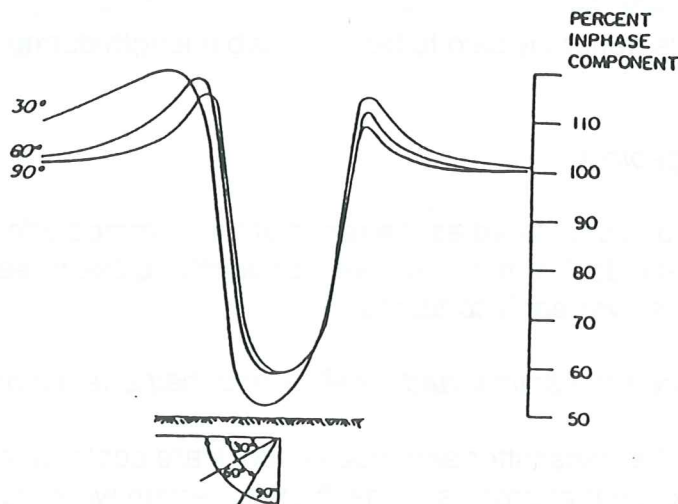
The dip can also sometimes be interpreted if very clear and significant anomalies has been obtained (see fig 6.2.12).

Fig 6.2.12. Slingram anomalies observed over a dipping sheet conductor. (Keller, date unknown.)

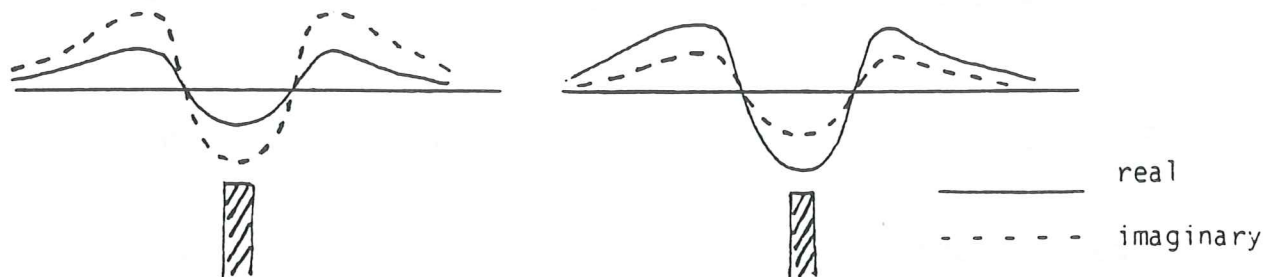
To interpretate if it is a good conductor (for example an ore body) or a poor conductor (a water bearing fracture zone) one can compare the Re-phase with the Im-phase in the anomaly. As showed in figure 6.2.13 a poor conductor will have a larger amplitude in the Im-phase compared to the Re-phase.

Fig 6.2.13. A poor conductor (left) compared with a good conductor (right). (Jämtlid, date unknown)

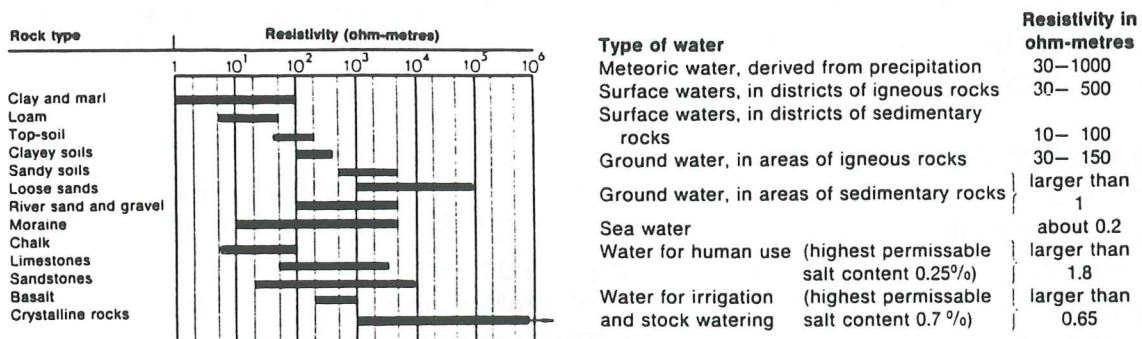
Resistivity is a material constant depending on the capability of electric conductivity in the material. This capability will vary for different kinds of soils and rocks and with the water content of these materials (see fig 6.2.14). The resistivity increases with decreasing conductivity. Water bearing fracture zones and soils below the ground water table will have low resistivity compared to the surrounding ground.

Fig 6.2.14. Resistivity of soils and rock (left) and natural water (right). (Kollert, 1969.)

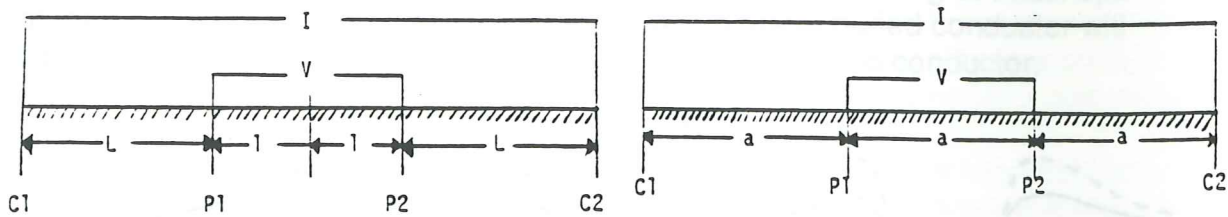
Fig 6.2.15. Schlumberger (left) and Wenner configurations. (Olsson and Jönsson, 1982)

In both configurations four electrodes are used. By applying current through the ground between the two outer electrodes and measuring the potential between the inner electrodes, resistivity can be calculated.

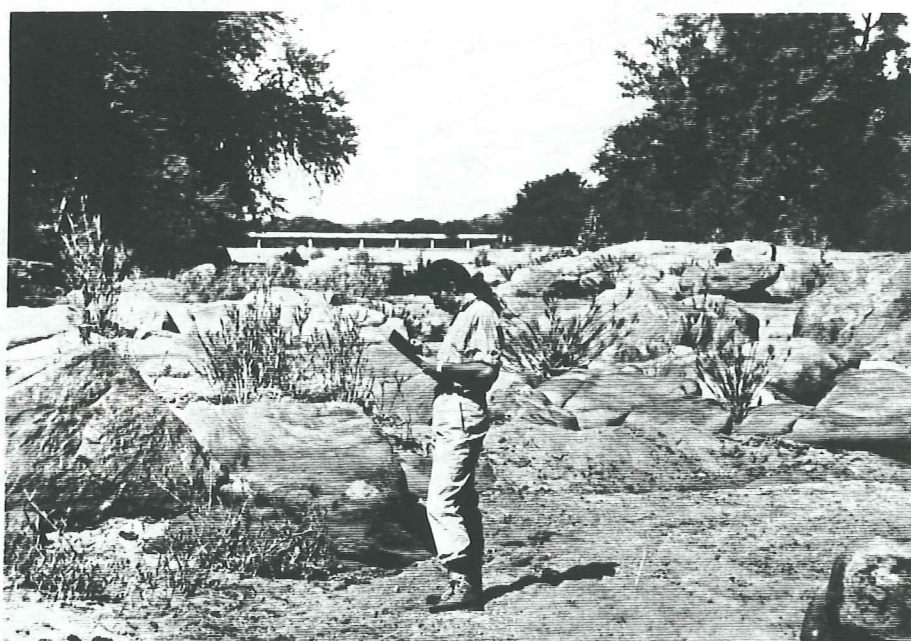
In this area, from the northern part of the islands in the Tuli River up to the first two connecting rivers, there are frequent outcrops projecting through the sand like big boulders (see fig. 6.3.1.1). Only the larger slabs of rock were big enough for fracture mapping. All the mapped fractures were as minimum some metres long and irregular, curvilinear fractures were ignored.

Fig 6.3.1.1 Fracture and geological mapping by Mats in Area 1. In the background the boulder-like bedrock outcrops and the Tuli bridge.

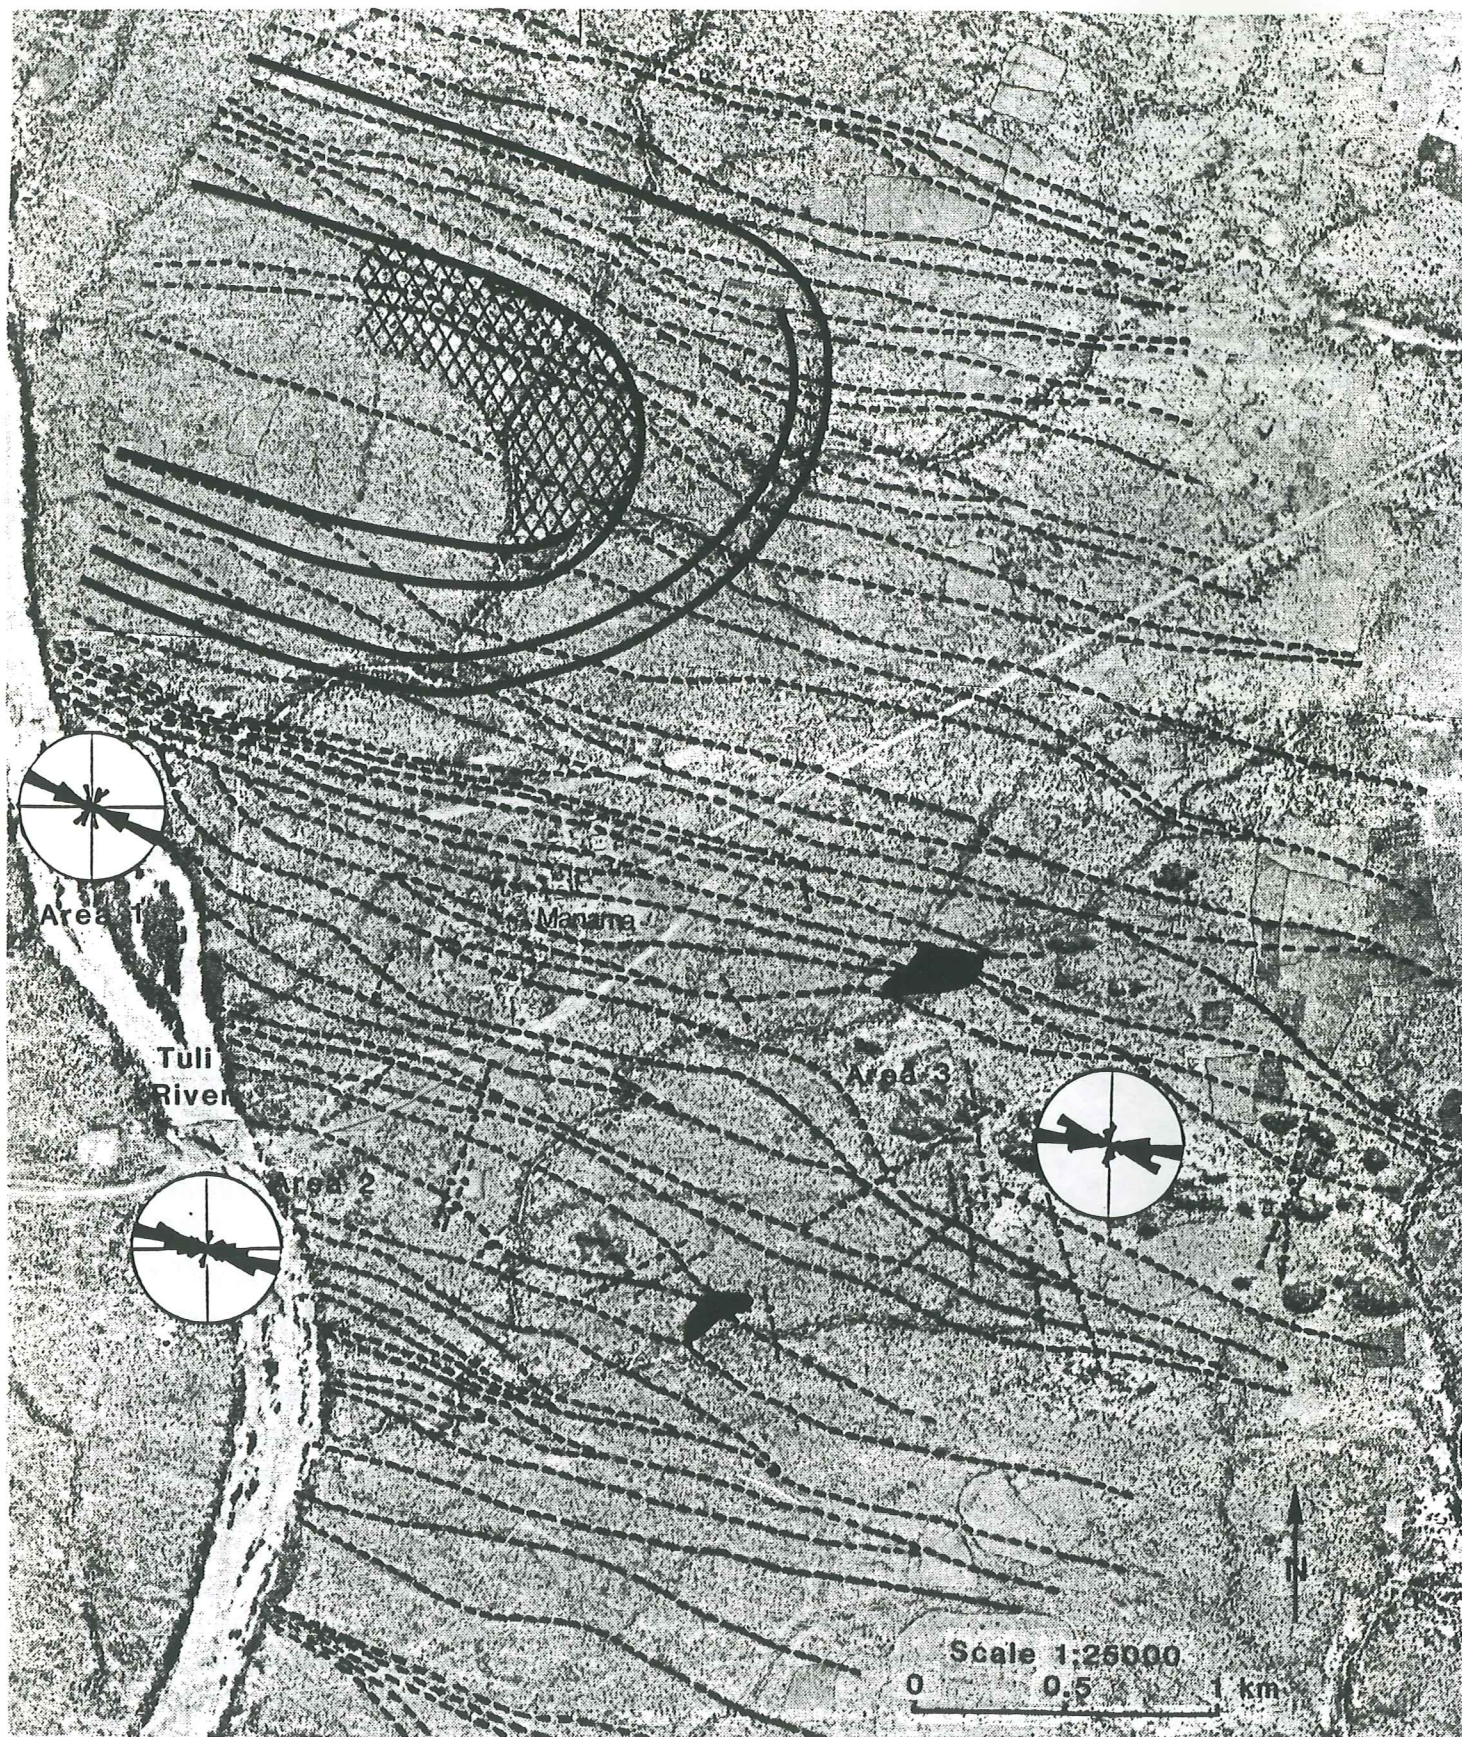
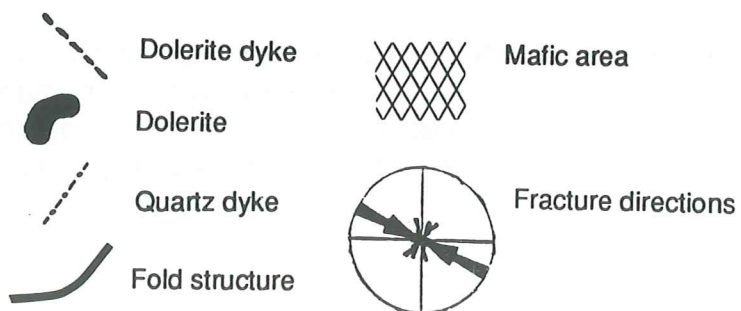
Fig 6.3.1.2 Geological map of the Manama area.

In search for bedrock outcrops, a reconnaissance in an area of about 3 km in radius around Manama was carried out. Three areas, suitable for fracture measurement, were found (see fig 6.3.1.2).

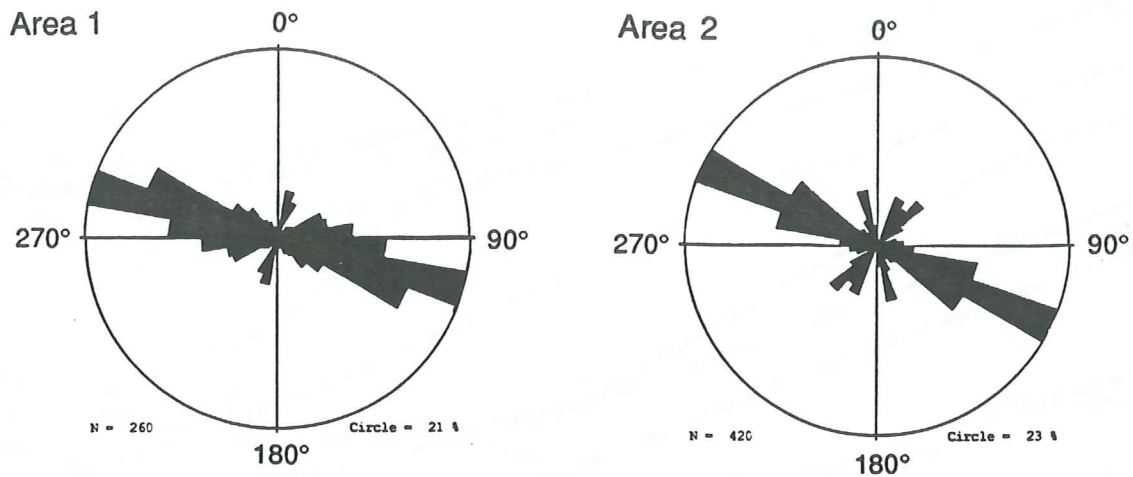
The strike of 260 fractures was measured. The main fracture direction is between 260° and 300° , with a peak at 280° - 290° (see fig 6.3.1.3 and fig 6.3.1.4). A majority of the fractures are almost vertical (80° - 90°). A set of closely parallel fractures, which sometimes is weathered below the level of the adjacent bedrock, is here called a fracture zone. Eight of nine observed fracture zones in the area have a direction of 280° - 290° . A few major dolerite dykes were found in this area. All of them strike in the main fracture direction.

Fig 6.3.1.3 Fracture directions of Area 1 and 2.

area is in the range of 280° - 310° , with a pronounced peak at 290° - 300° (see fig. 6.3.1.3). The strike of 420 fractures was measured. The dip was measured for 155 of those fractures, and the majority was about vertical. South of the weir we also found 33 fracture zones, of which a majority coincided with the main fracture direction of area 2.

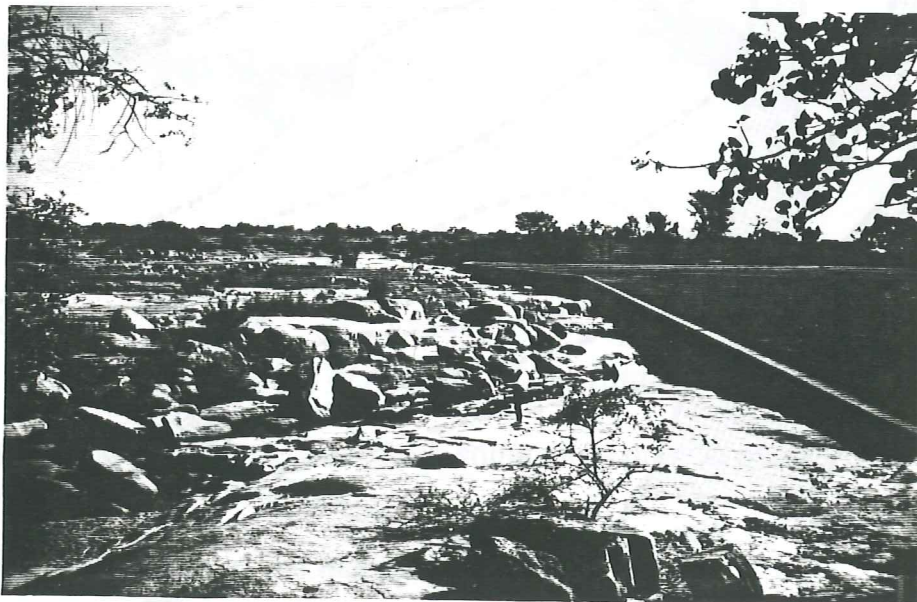
This area is located immediately south of the Tuli weir (see fig 6.3.1.5), but it also includes bedrock outcrops around the small river south of Manama. South of the weir the riverbed is almost free from alluvium. Some bedrock outcrops are boulder-like, but most are flat bedrock outcrops with long persistent fractures. A through, about 300 m long and filled with water, is crossing in a direction of around 300°. This structure might be a result of a linear zone of weakness in the rock, that has been weathered and eroded.

Fig 6.3.1.5 The Tuli weir and bedrock outcrops of Area 2.

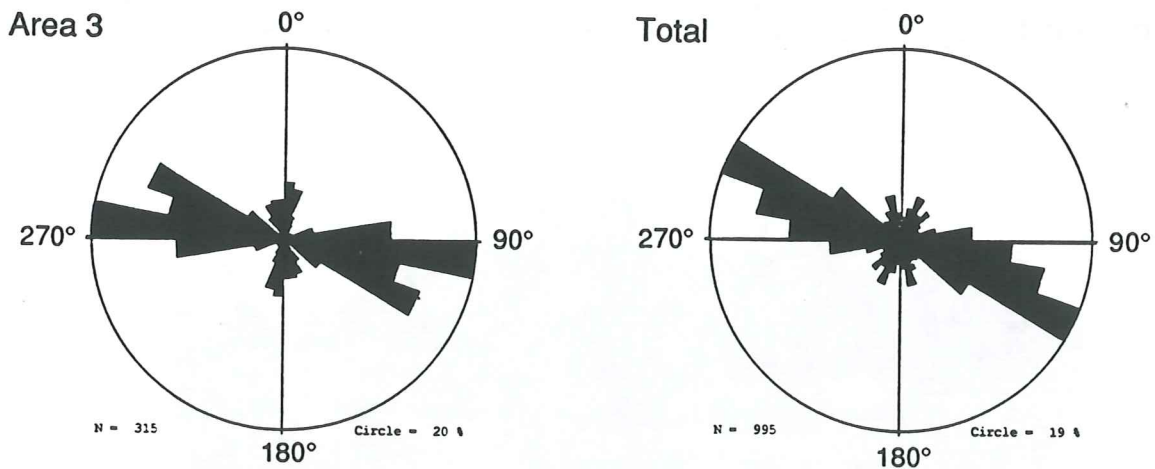
The last area for fracture mapping is situated around the castle kopjes SE of Manama. Its flat bedrock outcrops rise insignificantly above the adjacent weathered ground. The rock is gneiss and granitic gneiss, grey coloured and medium to coarse grained. The 315 measured fractures are mainly directed between 260° and 300° . However, the peak in the fracture pattern is lying more easterly than before, in the direction of 270° - 280° . A second peak trends 290° - 300° (see fig 6.3.1.6).

Fig 6.3.1.6 Fracture directions of Area 3 and the Total area (areas 1,2 and 3).

The 995 measured fractures for the whole area (areas 1,2 and 3) shows only one major fracture direction. It's broad and strike between 260° and 310° , with a peak at 290° - 300° (see fig. 6.3.1.6). This main WNW direction coincides with the more regional lineament direction seen on the aerial photos.
