Water Supply Study at Manama, Southern Zimbabwe

Patrich Holmström
Per Möller
Mats Svensson

LUND 1991

This paper describes a groundwater prospecting project, including two parts, in the rural area in southern Zimbabwe. The first part deals with a geological survey and locating of waterbearing fracture zones with the electromagnetic methods Slingram and VLF, and a resistivity instrument.

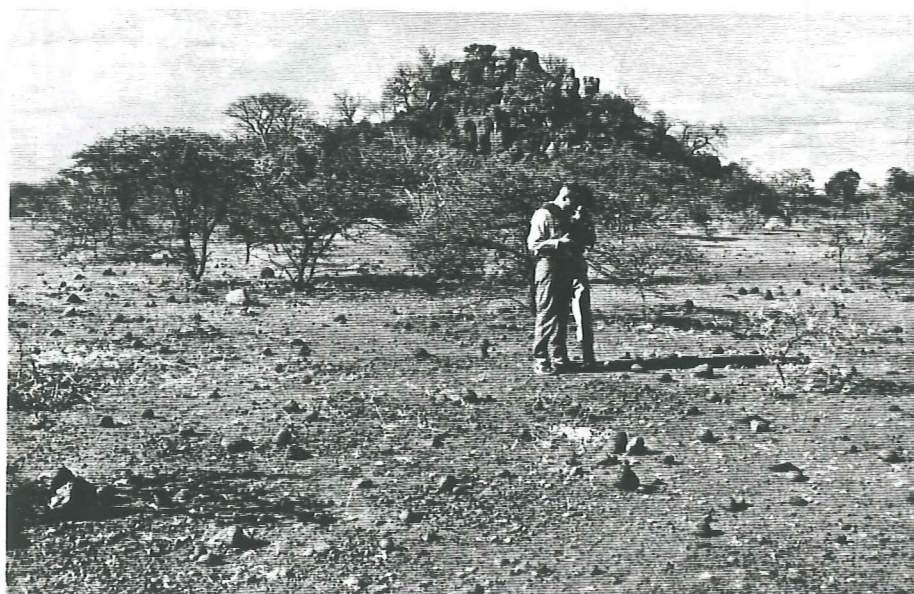
Fig 6.3.1.7 Geological mapping of a dolerite dyke with its spherical weathered stones. In the background a castle kopje.

On the weathered ground, the dolerite dykes can be distinguished due to the occurrence of brown spherical weathered stones and tiny outcrops of very fractured dolerite dyke (see fig 6.3.1.7). Where the bedrock is better exposed,

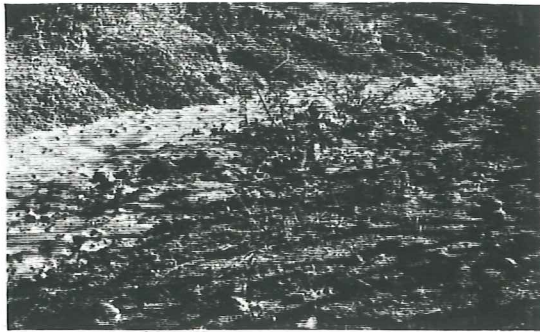
as in the small rivers and streams, more fresh and unweathered dolerite dykes can be seen (see fig 6.3.1.8). These dykes often show a gradation of mineral and/or rocktype across their width. The outer parts consist of the regular, fine grained dolerite, where contraction-fracturing has resulted in centimeter thick lenses in a direction almost perpendicular to the dyke (see fig 6.3.1.9). Towards the center of the dykes, the composition changes to a olivine-bearing type, which is more coarse grained and due to weathering, yellow to rust-coloured. In some very wide dykes, parts (often meters wide) are built up of epidote, sometimes with small quartz veins within them.

Fig 6.3.1.8 (left) Alluvium from a small stream running in a dolerite dyke. The stream has eroded its path in the olivine-bearing part of the dyke.

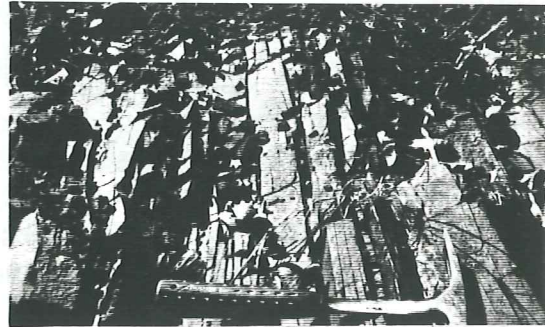
Fig 6.3.1.9 (right) Typical contraction fractured dolerite.

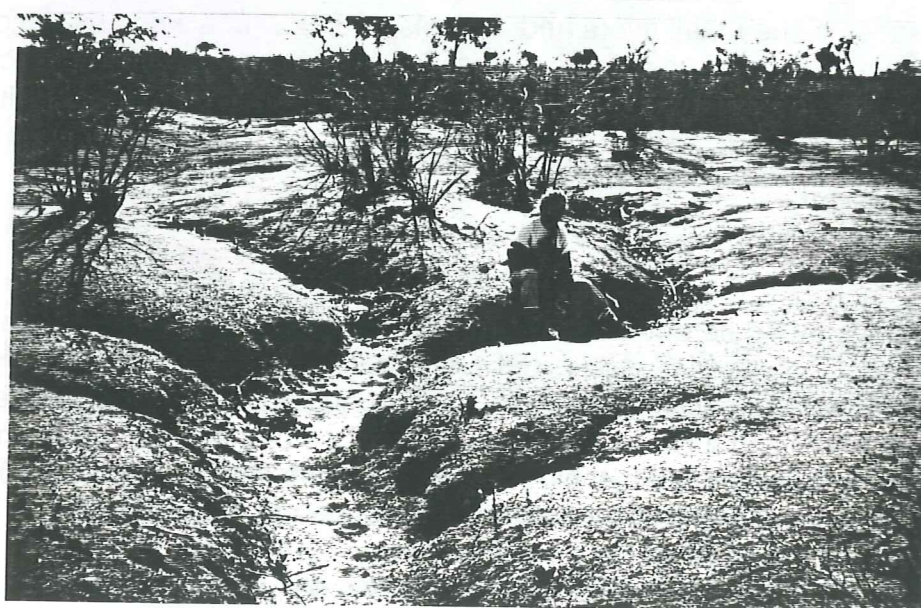
The soils in the area are immature pale-coloured and sandy, without any organic top-soil material. The combination of intense growing, heavy seasonal rains, drought and clearing of vegetation by man seems to cause heavy soil erosion. Everywhere signs of intense run-off can be seen, in form of gullying and small rills. They are however not eroded deep down, since the bedrock is close to the ground surface (see fig 6.3.1.10). In some slopes close to small rivers, sharp gullies have been eroded to the depth of about one meter. They show a coarse grained weathering profile, not easily eroded, and often bedrock at their base.

Fig 6.3.1.10 Gully formed by intense run-off.

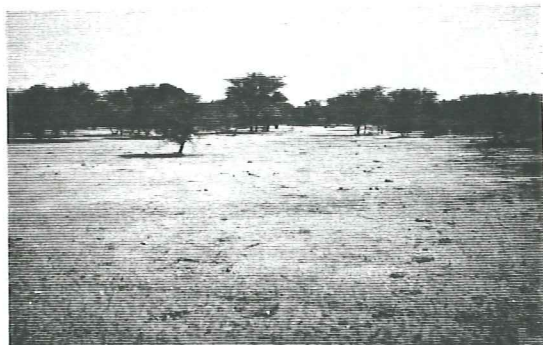
All over the area small bedrock outcrops show that the weathering isn't deep, though a few places indicate a deeper weathering. For instance, one km NW of Manama on the north side of the small river, a white spot can be seen on the aerial photos. In the field it turns up as a flat, vegetation-free and outcrop-free area with an almost white sandy soil, indicating that downward percolating water has leached the soil (see fig 6.3.1.11).

Fig 6.3.1.11 (left) Area with white sandy soil, probably due to leaching by downward percolating water, indicating deep weathering.

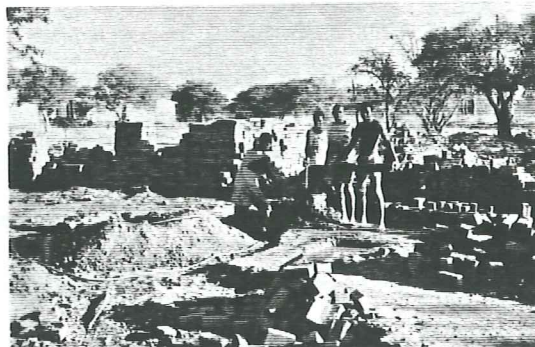
Fig 6.3.1.12 (right) Brickmaking at Manama mission.

Inside Manama village more than one meter deep pits are dug into a clayey soil, which is used for brickmaking. This soil also indicates deep weathering (see fig 6.3.1.12) and is probably a remanent from a period of a more humid climate.

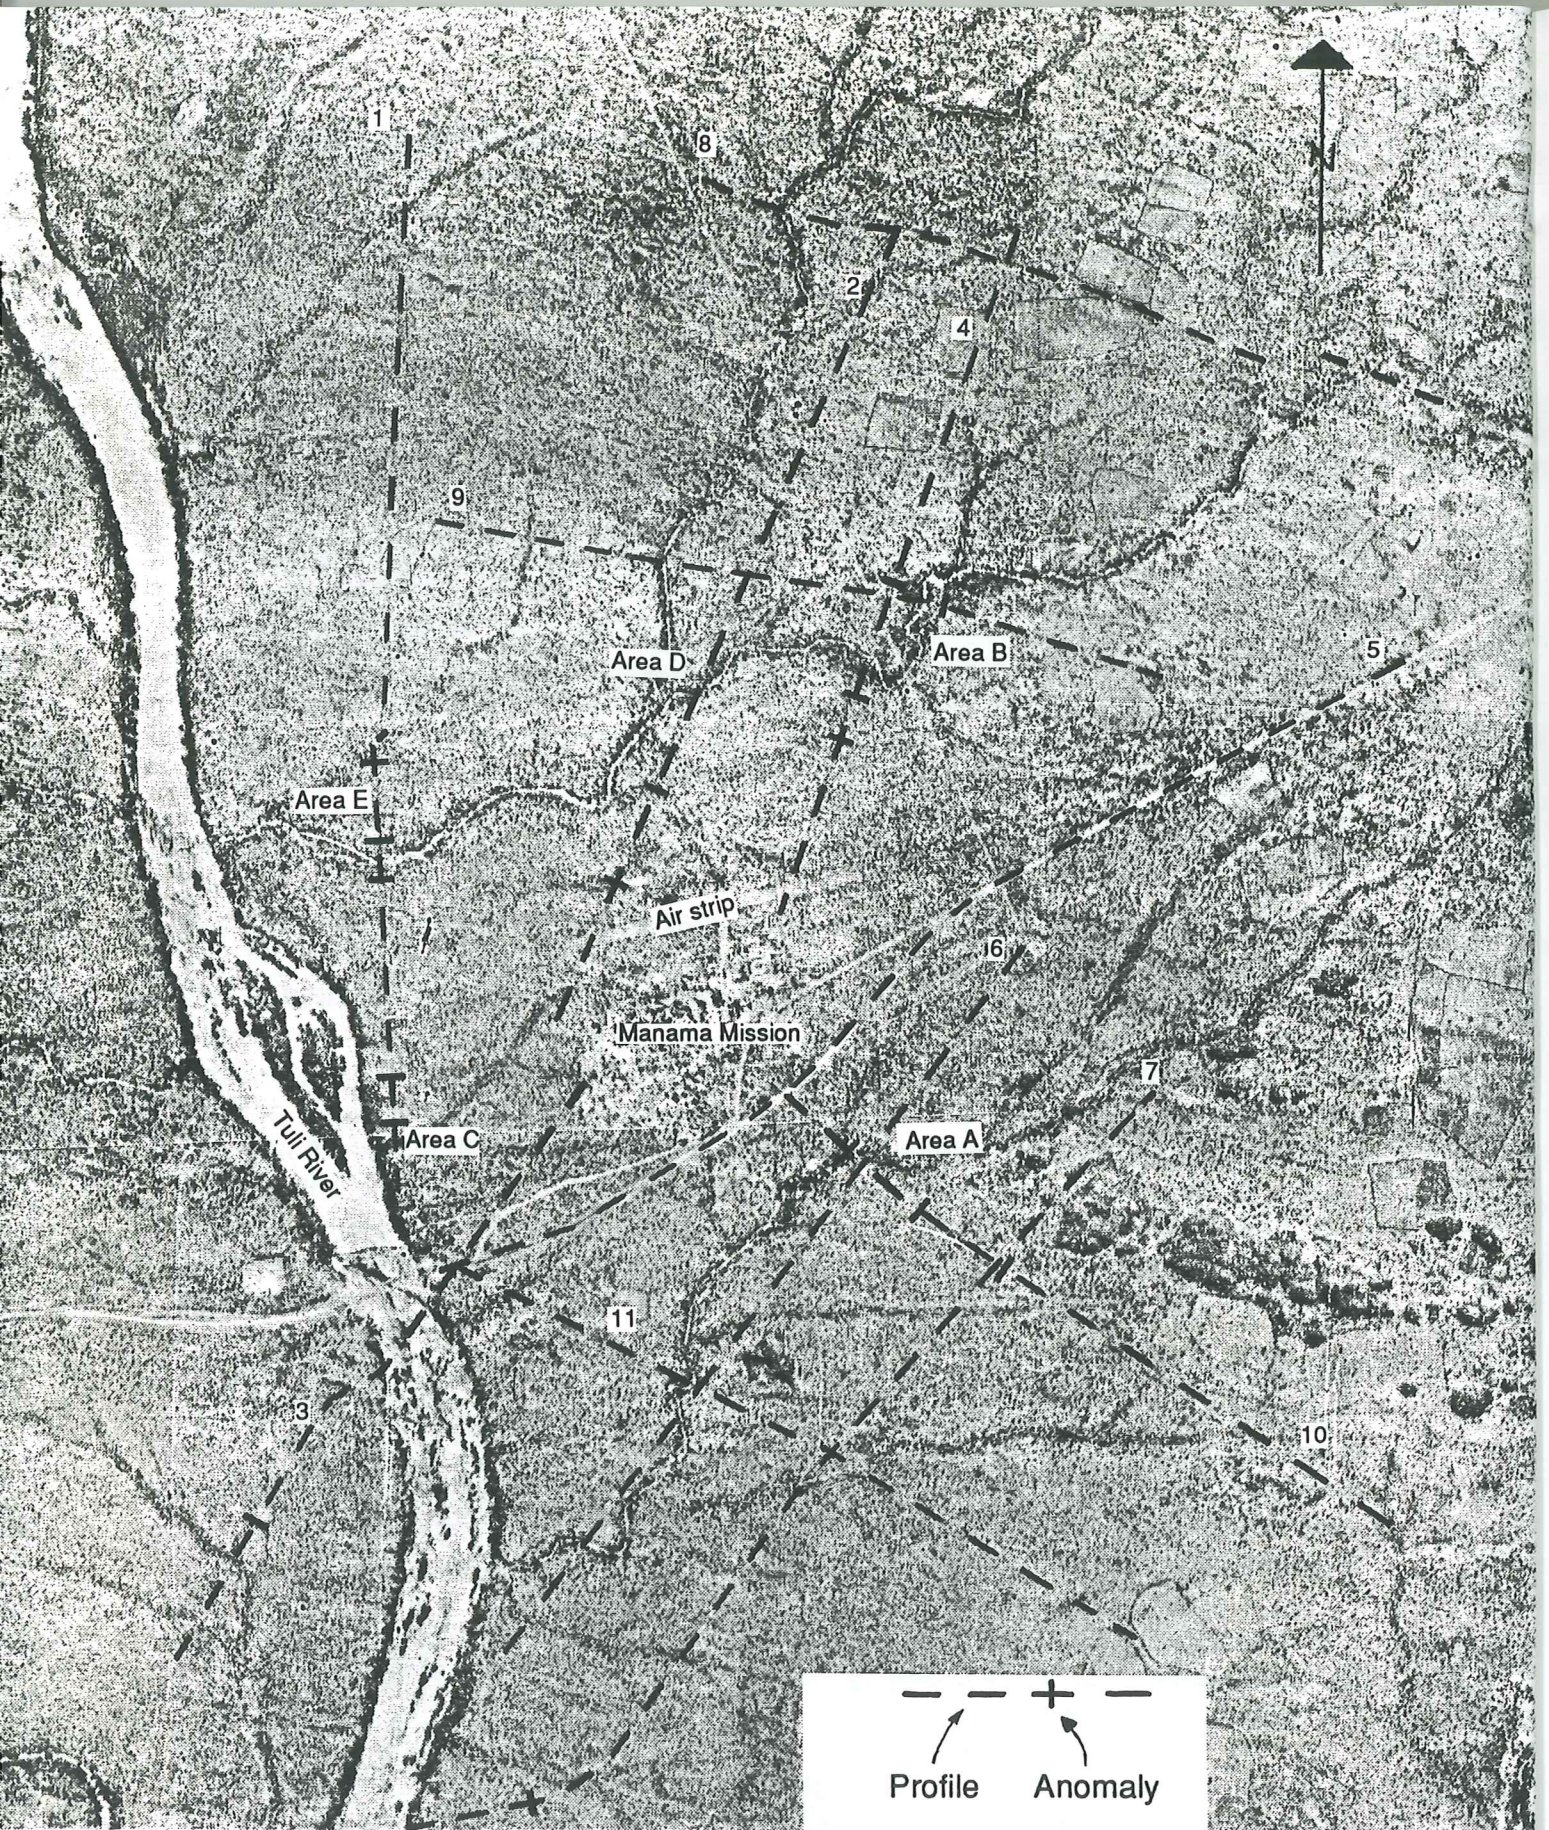
In order to get a clear view of the results from the long profiles, the profiles with marked anomalies are presented in an areal photo (see fig 6.3.2.1). On the basis of the results from the long profiles, we selected five areas for more detailed investigations. The location of these areas are also shown in figure 6.3.2.1. Each plotted profile graph can be found along with comments and interpretations in appendix A.

Figure 6.3.2.1. Aerial photo presenting the long profiles, anomalies and the areas that were chosen for detailed investigations. Scale 1: 20 000.

Few anomalies were found after several long VLF and Slingram profiles crossing the main fracture direction and the dolerite dykes (see fig 6.3.2.1). At the dolerite dykes just a few small anomalies occurred, which might seem strange. However, instead of what is often the case, that the contact between the dolerite dyke and the adjacent bedrock is fractured because of thermal contraction, we have seen that the huge dolerite dykes around Manama have transformed the contact-zones. Contact metamorphism has obviously "welded" the dykes together with the adjacent bedrock and prevented fractures to form between them.

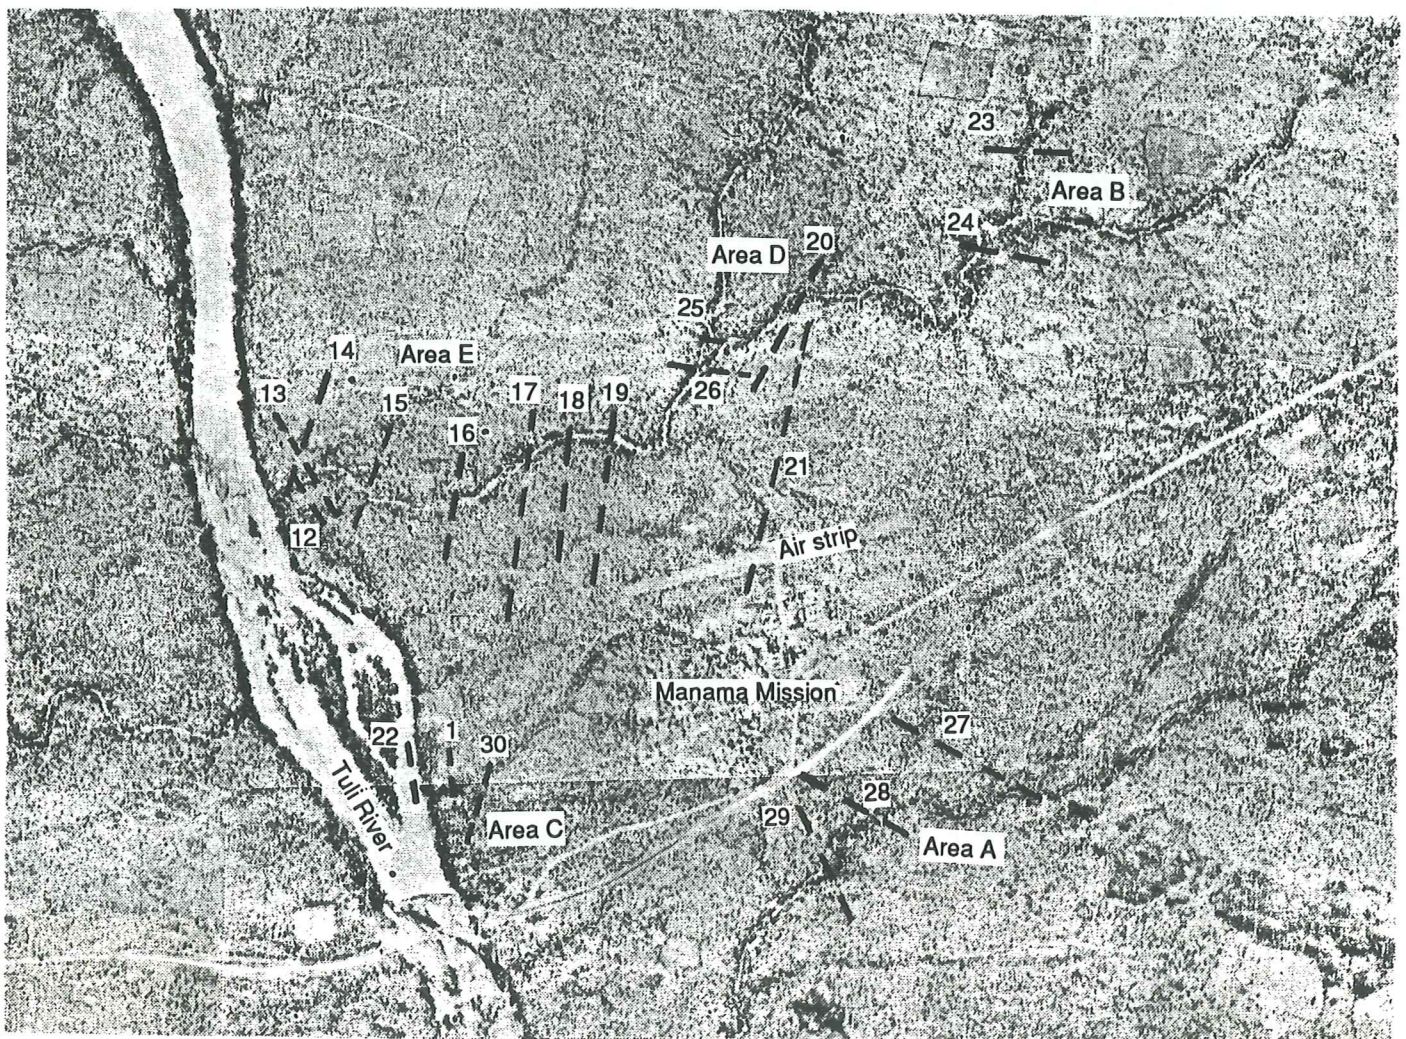
In two of these areas, C and E, we also used resistivity mapping as a supplementary investigation method. The profiles that were carried out in each detail area are shown in the areal photo below (fig 6.3.2.2). The plotted graphs for each profile are shown together with comments and interpretations in appendix A.

Figure 6.3.2.2. The profiles performed in the selected areas. Scale 1: 20 000.

In area B, the field observations indicated that the location of the anomaly on profile No 9 is deep weathered (can also be seen as a white spot on the aerial photo - see fig 6.3.2.2). The anomaly together with observations from aerial photos indicates a direction of a probable fracture zone towards NNE. This direction coincides with the foliation observed in the riverbed just south of where the electrical cable crosses the river. Earlier this direction has been stated as a secondary fracture direction.

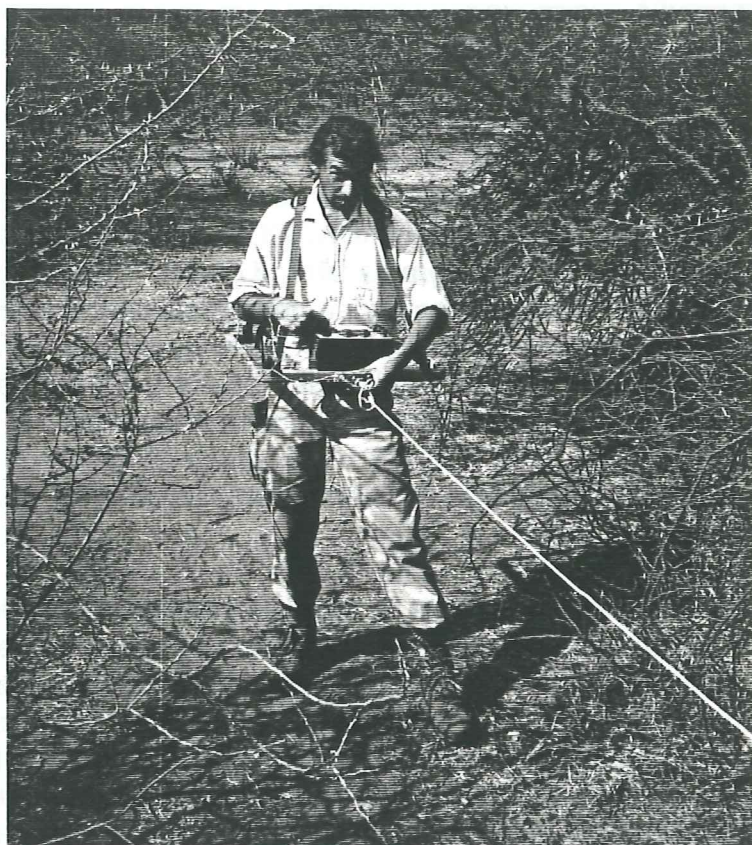
Fig 6.3.3.1 Mats handling the receiver unit of the Slingram in the sometimes scrubby terrain around Manama Mission.

Figure 6.3.3.1 shows Mats taking a reading with the Slingram.

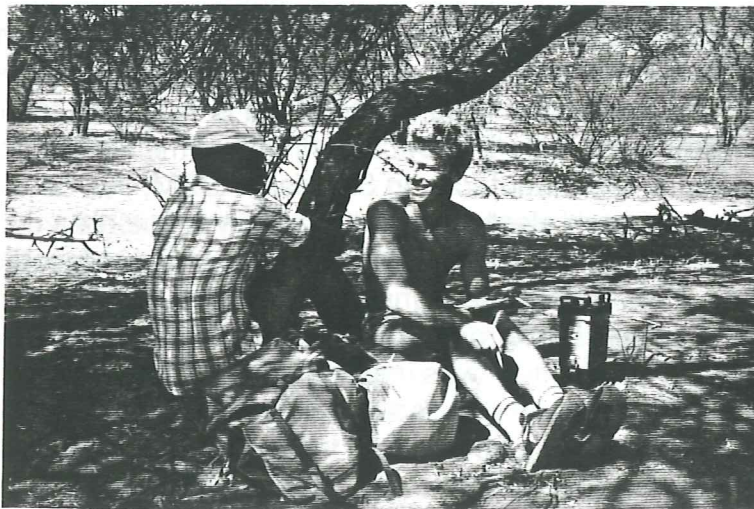
Figure 6.3.3.2. Abraham, our assistant and Per during evaluation of performed resistivity measurements. The Terrameter can be seen to the right.

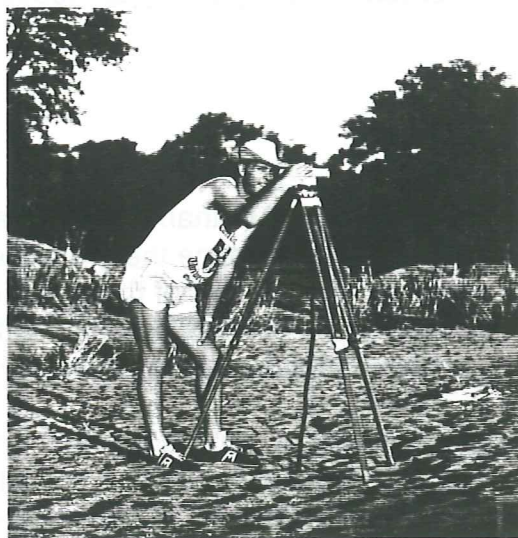
Fig 6.4.1.1 Leveling of the sand dam by Patrich.

The leveling of the surface of the dam was made with a WILD leveling instrument rigged on a wooden tripod. Since we weren't interested in the absolute altitude but relative levels between the dam and its surroundings, we didn't need to connect our level system to a real one. As a reference point we used a steel nail in concrete on the solid rock, which they probably used for the same purpose when they built the bridge in 1982. We gave it a relative height of 10 m.

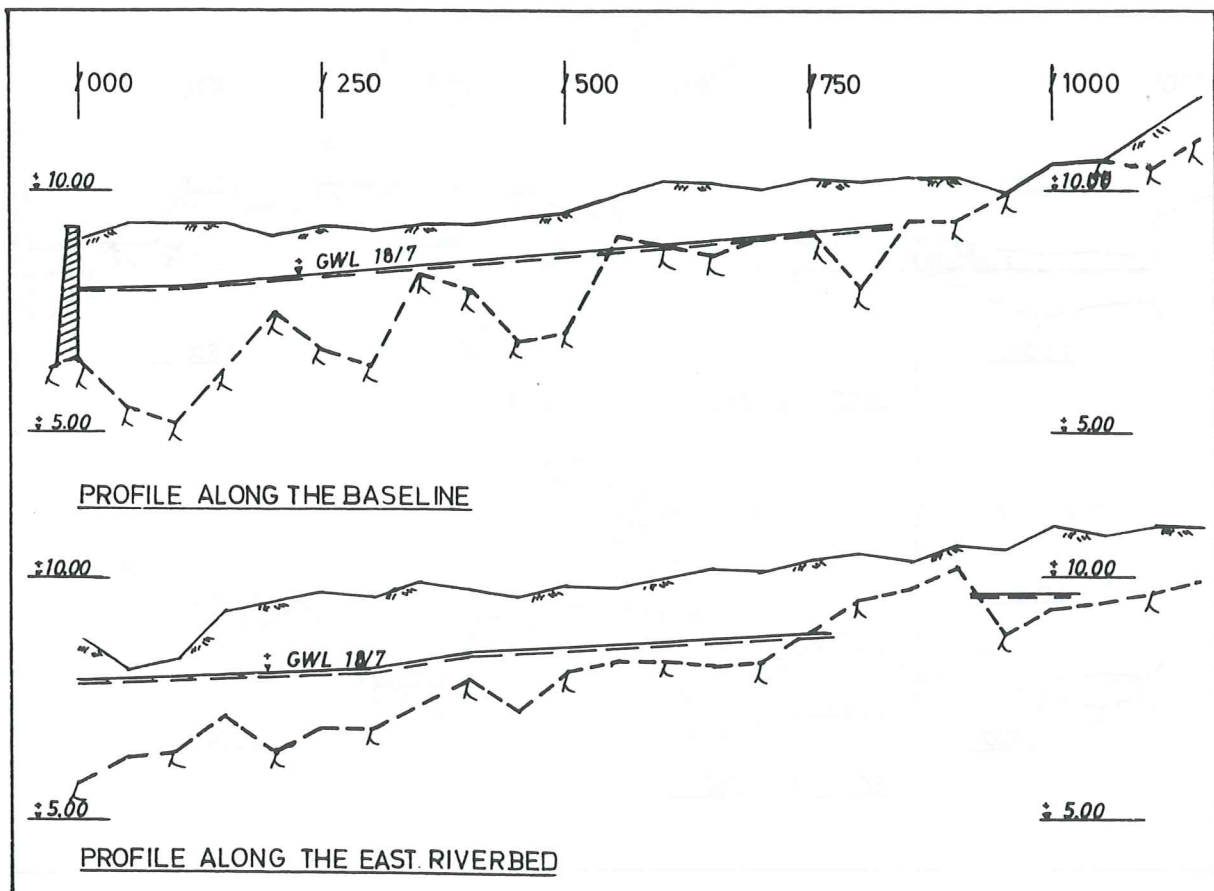
The largest depth between the surface and the bedrock was about four meters and appeared in the southern part of the dam. The altitude of the surface of the bedrock seems to vary quite a lot, especially on the west side of the islands, but without doubt, the more north the sections goes the more shallow the bedrock comes. On the west side of the islands the bedrock goes very shallow in section /950 and on the east side in section /900.

Fig 6.5.2.1-6.5.2.2 Profiles of Manama sand dam, Tuli river.

All of the soundings are presented as cross sections in the scale H 1:100 and L 1:1000 in Appendix B. Below we present a few typical sections and also two profiles from the south to the north, fig 6.5.2.1-6.

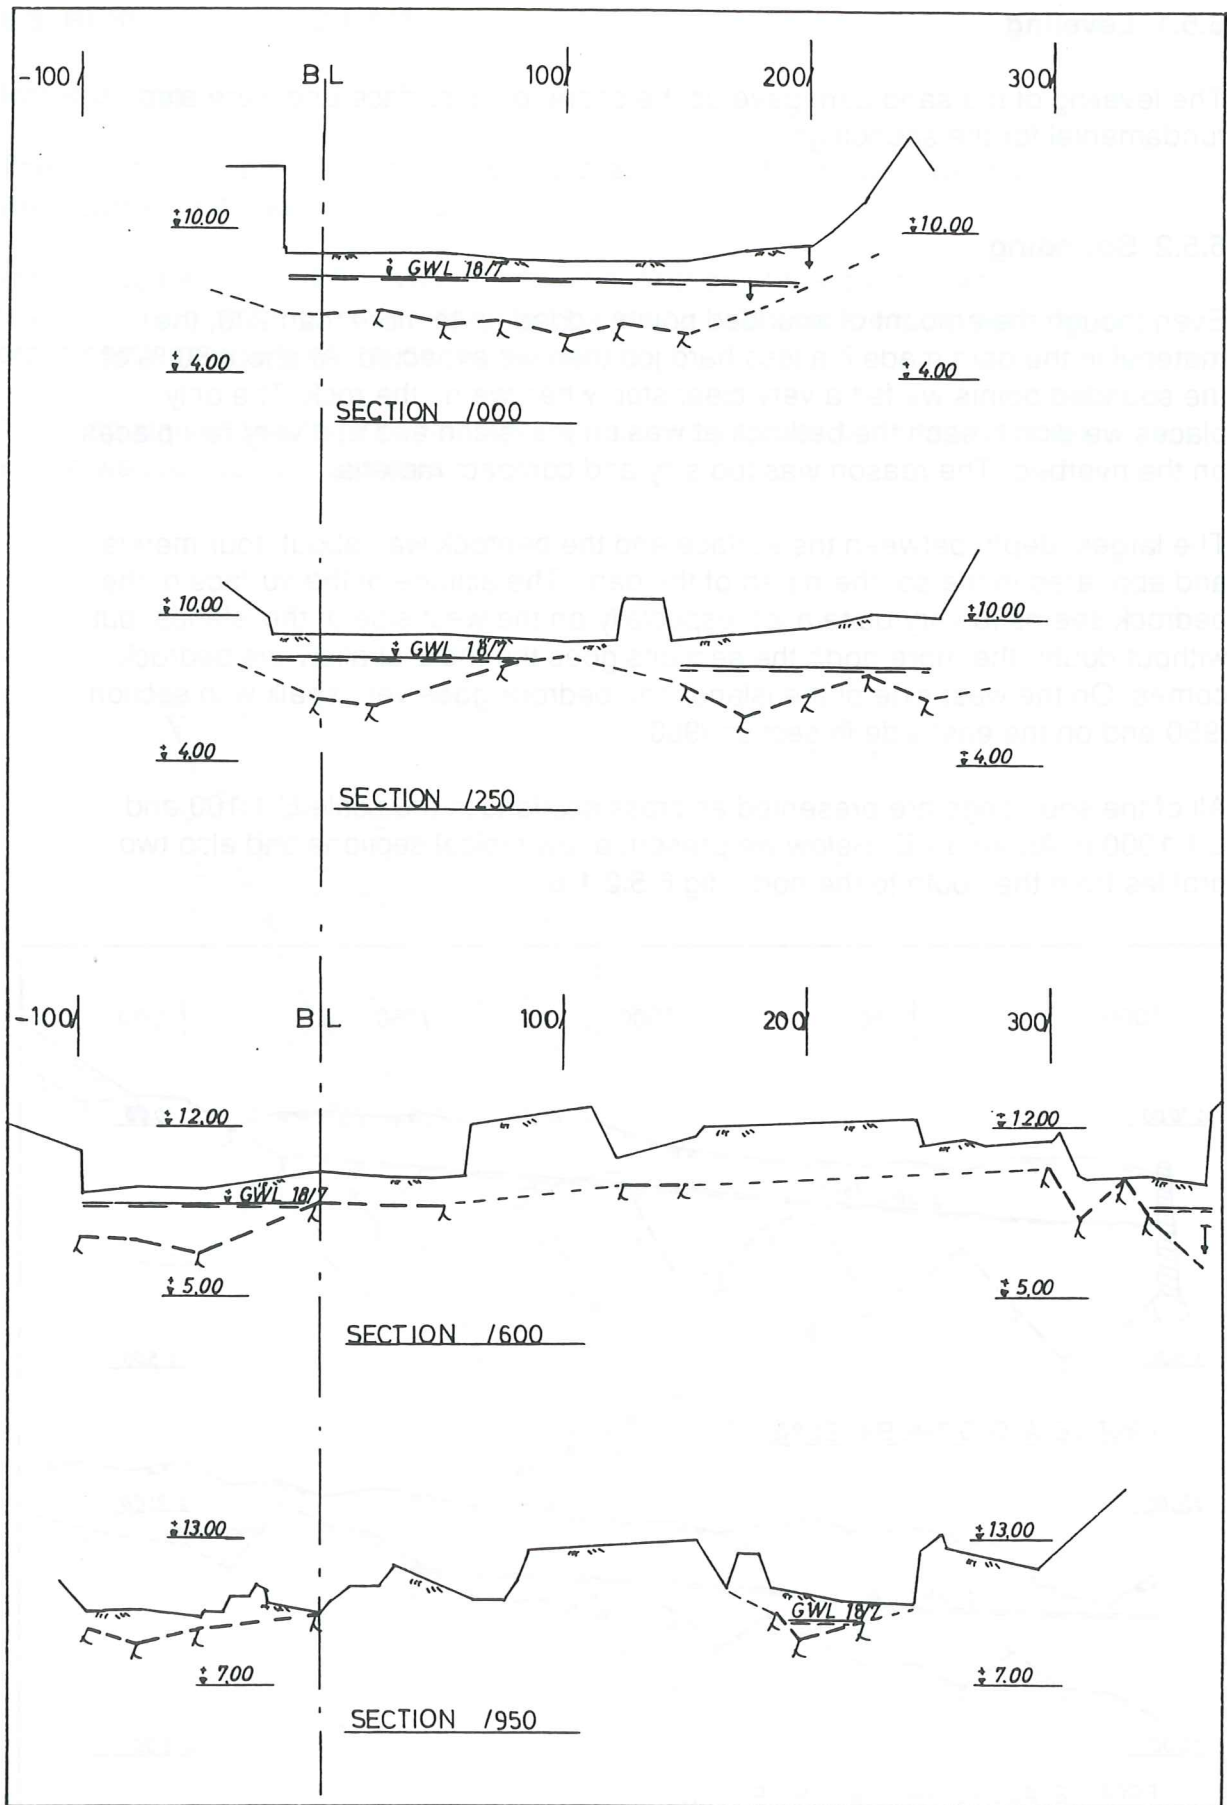
Fig 6.5.2.3-6.5.2.6 Cross-sections Manama sand dam, Tuli river.

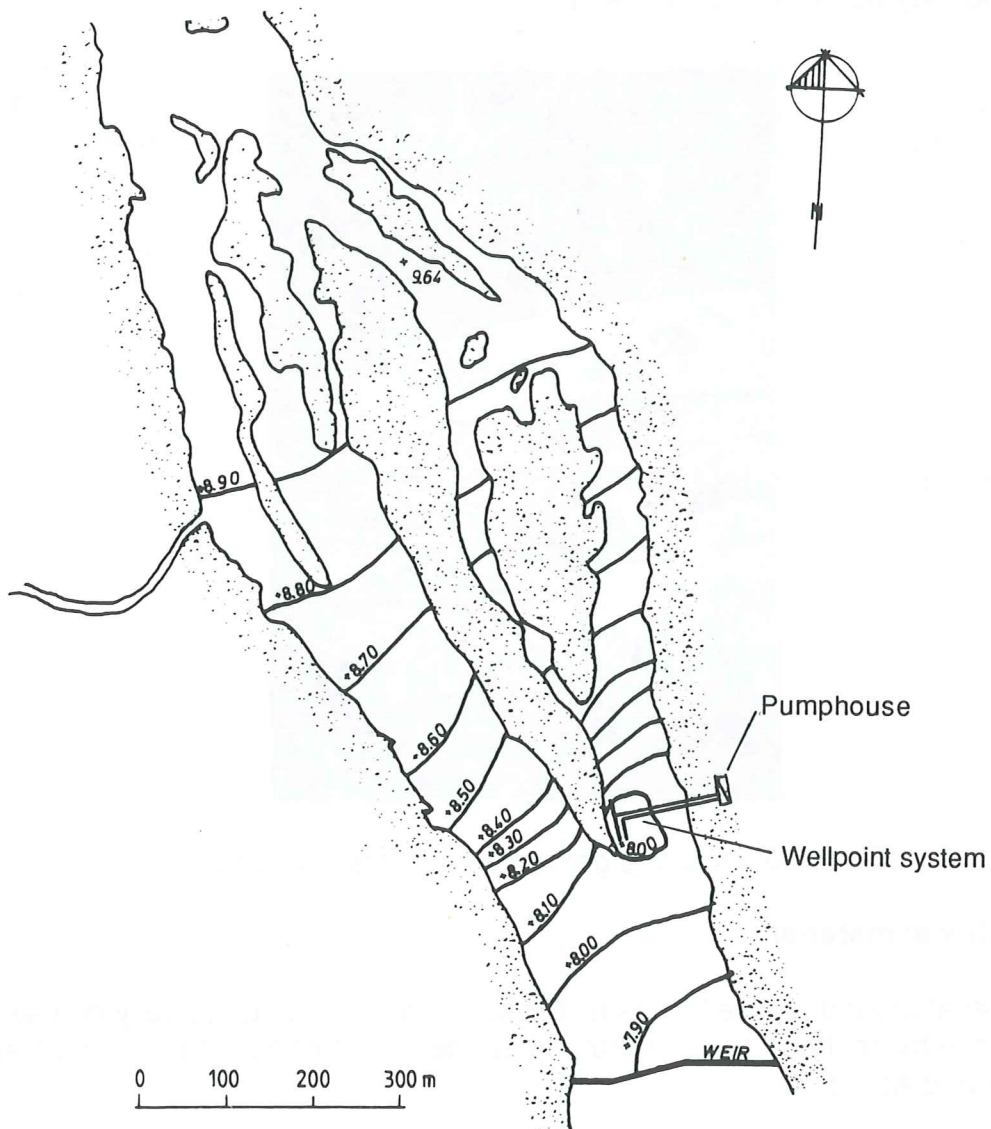
Fig 6.5.3.1 Groundwater altitude 180790.

Altogether we put down 27 groundwater pipes. The location of these are found in fig 6.5.1. No 1 - 27 are pipes and No A - F are open groundwater surfaces. In Appendix D the readings are presented and they are also converted to a groundwater altitude map shown in fig 6.5.3.1. The depletion of the groundwater table between the two last readings is continuously calculated and also shown in Appendix D. The observations were made between 120790 and 070890, totally 26 days.

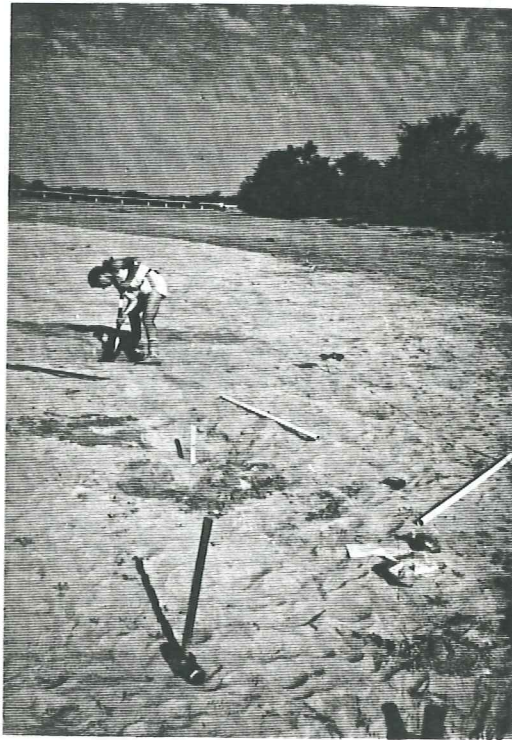
Fig 6.5.3.2 Putting groundwater pipes in position.

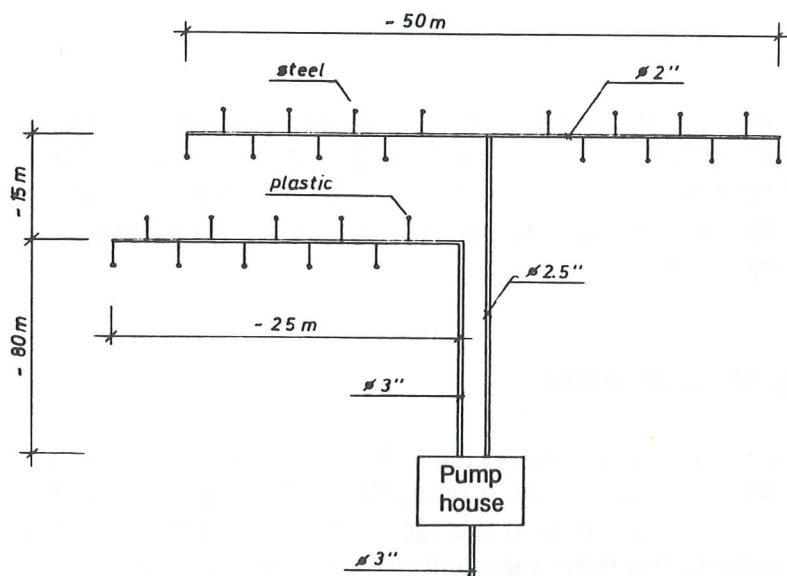
There are two rows with 10 respectively 16 wellpoints. Each of these rows are connected to pipes (2.5 respectively 3.0 inch diameter) that leads to the pump house on the east side of the river bank (see fig 6.5.5.1).

Fig 6.5.5.1 Wellpoint system, plan view.

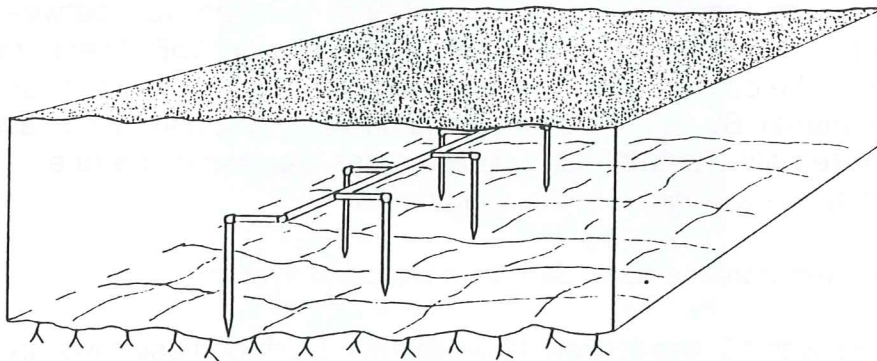
There are two different types of wellpoints in Manama; factory made in iron and self made in PVC. They are put down vertically in the sand by digging and hammering until they reach the rock, see fig 6.5.5.2. The iron ones let the water in through holes and the PVC ones in slits.

Fig 6.5.5.2 The wellpoint system shown in a three dimensional sketch diagram.

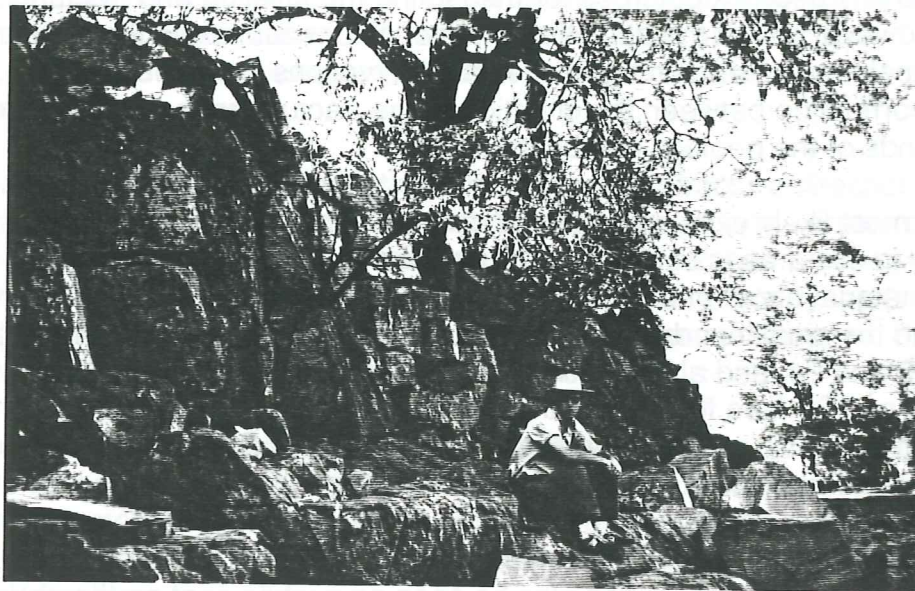
Fig 7.1.2 A rock wall cracked up into angular blocks.

Hopefully an hydraulic continuity exists between different parallel fractures in this area, since indications of two major fault lines in the secondary north-eastern direction have been found. The first was seen near the river mouth as a sharp wall, cracked up into many angular blocks and the wall stroke in a direction that could be followed in a small stream towards NE (see fig 7.1.2). A similar wall was found on the western side of the river, close to the anomaly on profile No 17.

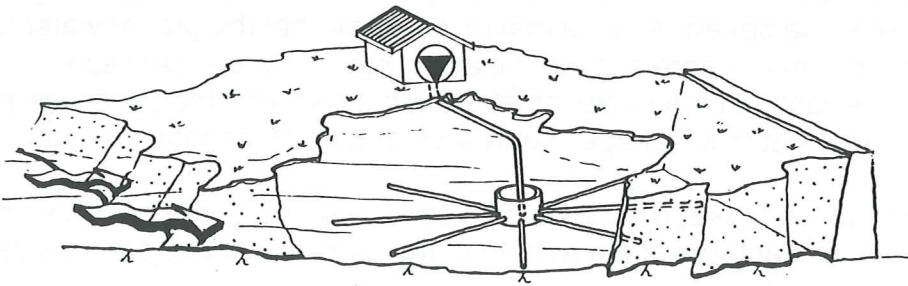
The estimation that every 10 mm:s lowering of the intake level gives the Mission one more day of available water, makes an extraction system consisting of horizontal pipes at the very bottom of the dam an attractive solution. Such pipes can be arranged in many different ways. They can be arranged as galleries, (see fig 7.2.3.1) in a radial formation connected to a central well or in a more right-angled formation (see fig 7.2.3.2) also connected to a central well or directly to a main pipe to the pump.

Fig 7.2.3.1 Galleries, radial formation.

If drilling of the proposed boreholes will be impossible or unsuccessful, improvements of the sand dam can be carried out, thus making it possible to extract more water from it. The best solution is to make a new extraction system. A choice from one of the types shown in fig 7.2.3.1 - 7.2.3.3, will give the lowest intake-level.

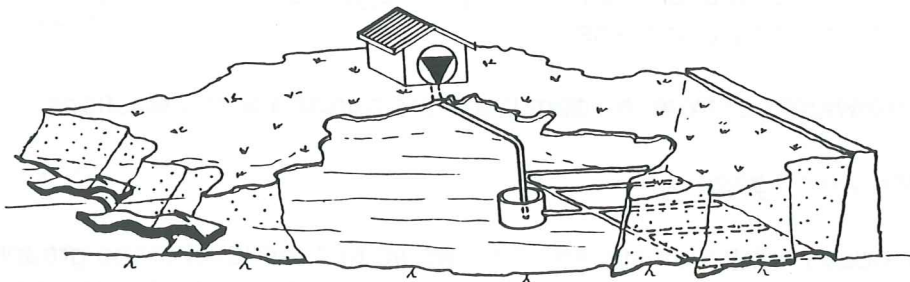
Fig 7.2.3.2 Galleries, right-angled formation.

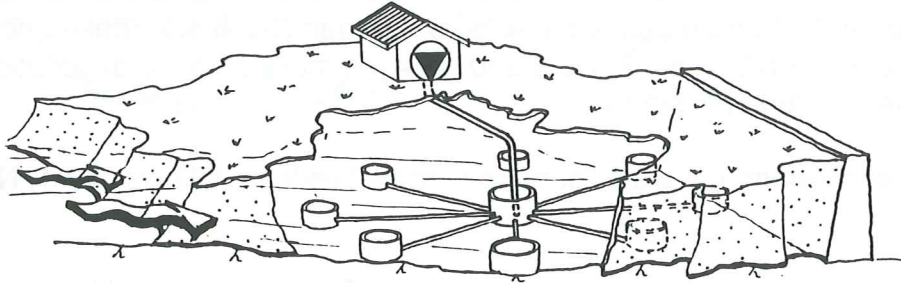
Another way of lowering the intake level, although not as efficient as above, is to use concrete rings with an artificial filter at the bottom end, see fig 7.2.3.3. (DHV, 1979). It will be needed a couple of these to compensate the present system, but

Fig 7.2.3.3 Wells with artificial filter.

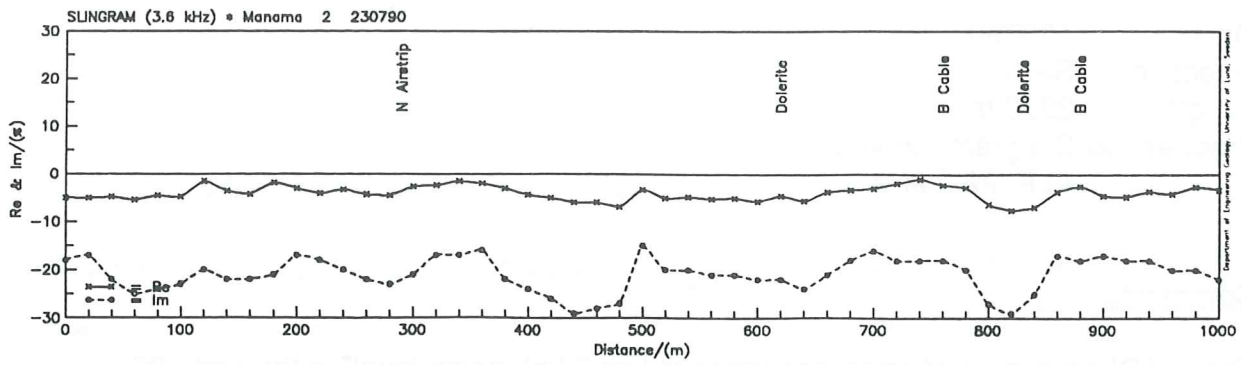
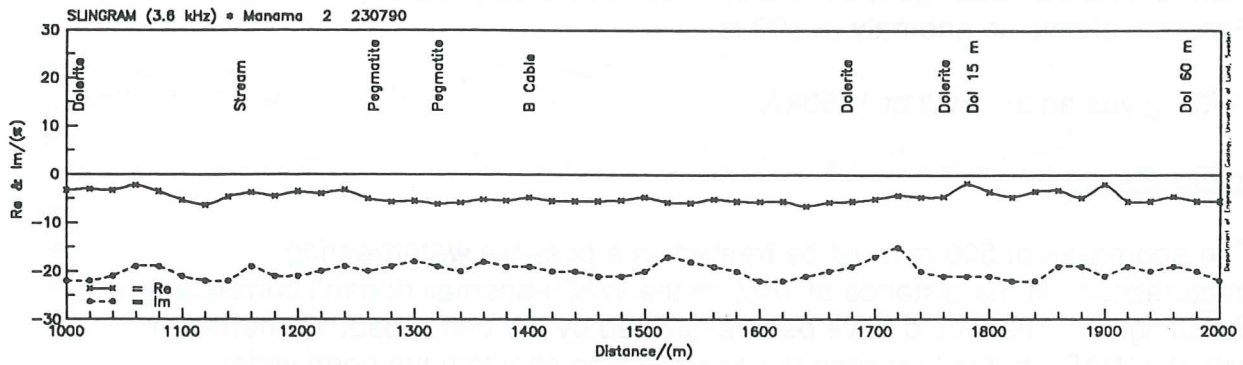
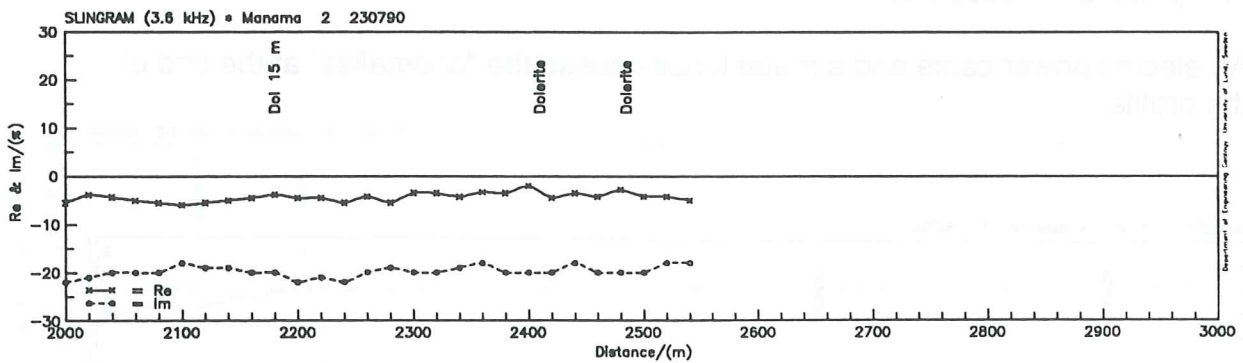
PROFILE NO 2

Date: 230790
Direction S - N
Length: 2540 m
Frequencies: Slingram 3.6 kHz

Possible waterbearing fracture zone, perhaps at the contact between the dolerite and the basement rock.

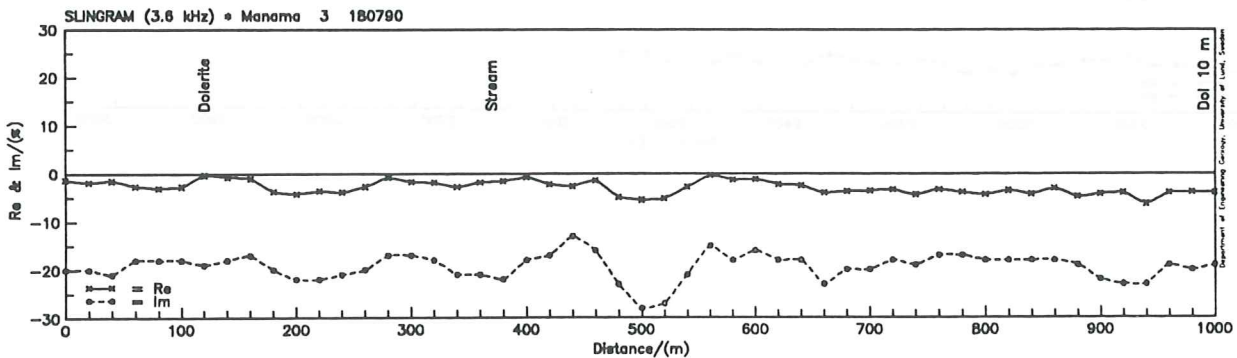
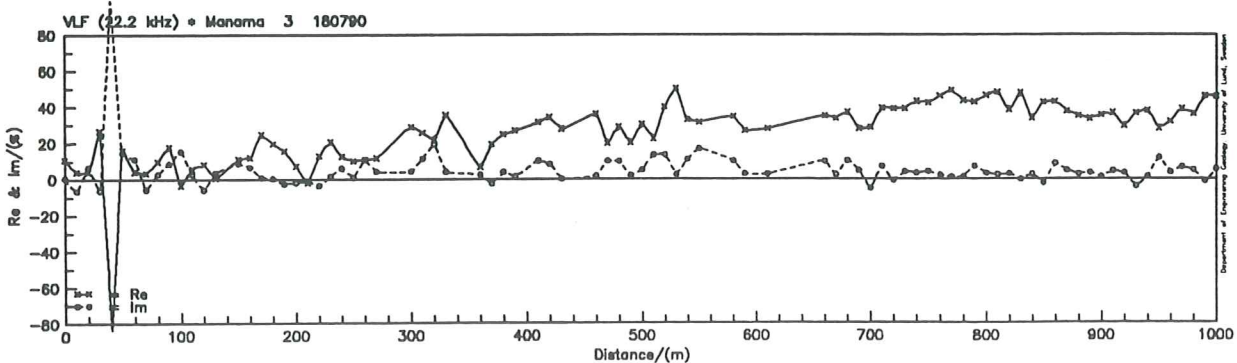
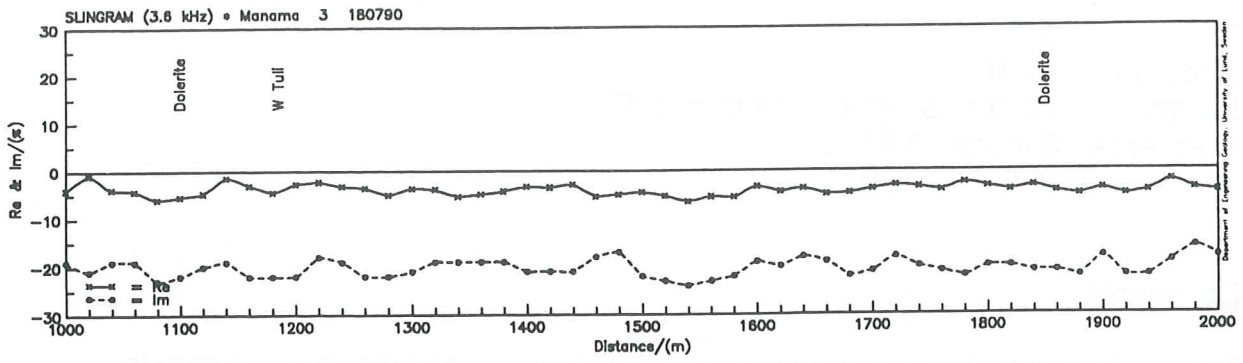
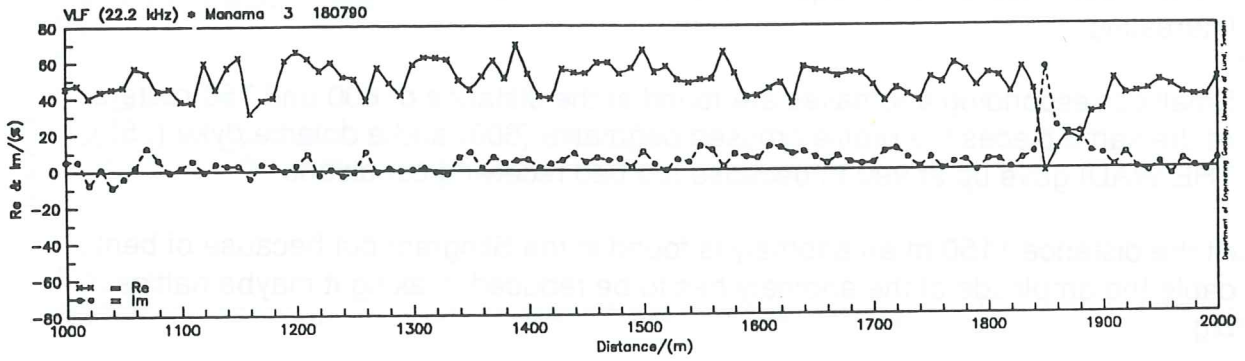
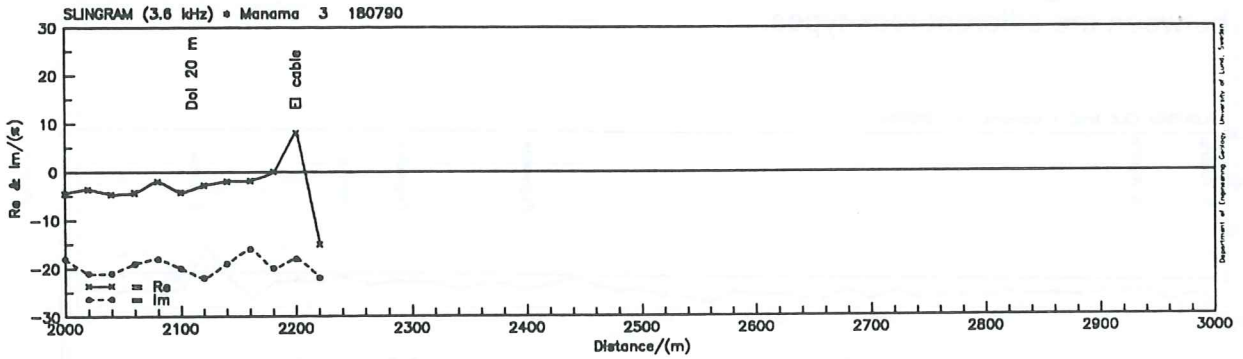
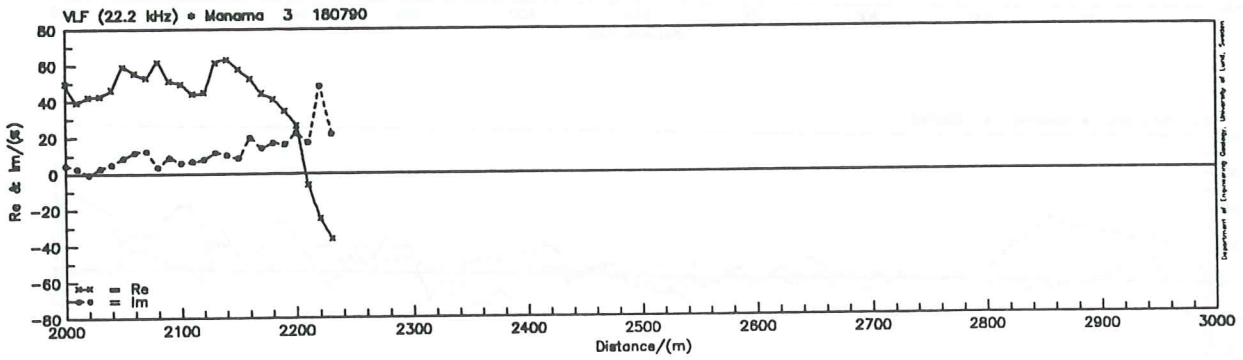
PROFILE NO 3

Date: 180790
Direction: S - N
Length: 2220 m
Frequencies: Slingram 3.6 kHz
VLF 22.2 kHz

The anomalies at 500 m must be treated as a possible waterbearing fracturezone. At the distance of 1850 m the WADI-anomaly doesn't correlate with the Slingram. That could have been explained by the better depth penetration with the WADI, but in that case the anomaly also should have been wider. Interpretation impossible.

An electric power cable and a metal fence caused the "anomalies" at the end of the profile.
