Water Supply Study at Manama, Southern Zimbabwe

Patrich Holmström
Per Möller
Mats Svensson

LUND 1991

This paper describes a groundwater prospecting project, including two parts, in the rural area in southern Zimbabwe. The first part deals with a geological survey and locating of waterbearing fracture zones with the electromagnetic methods Slingram and VLF, and a resistivity instrument.

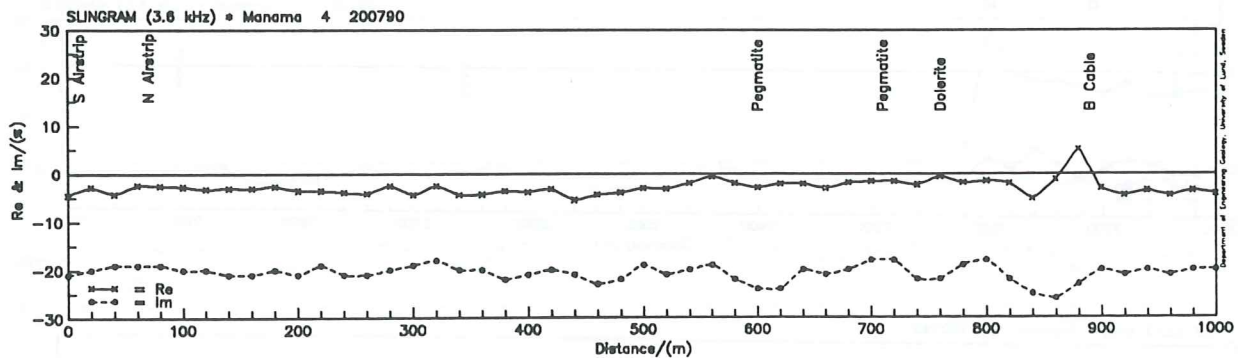
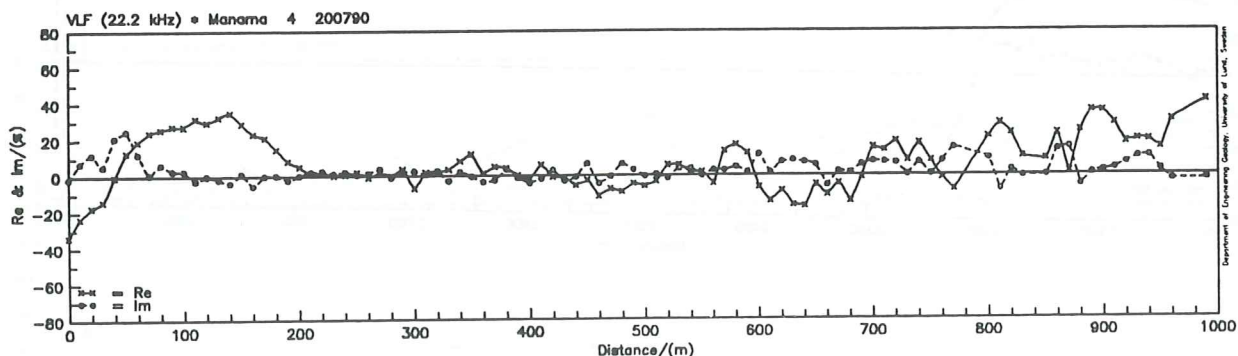
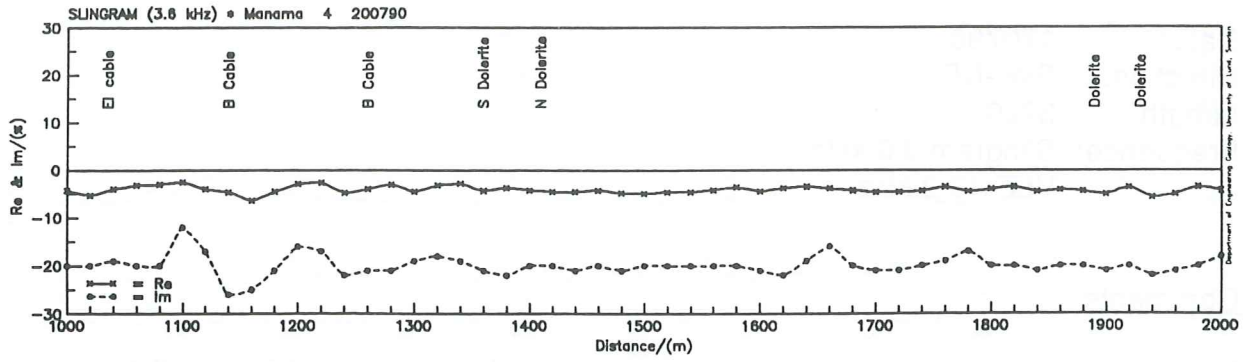
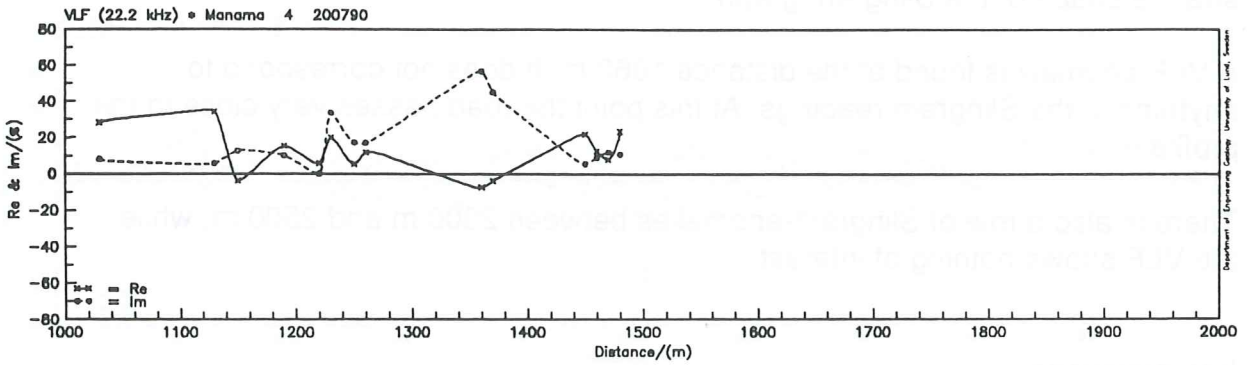
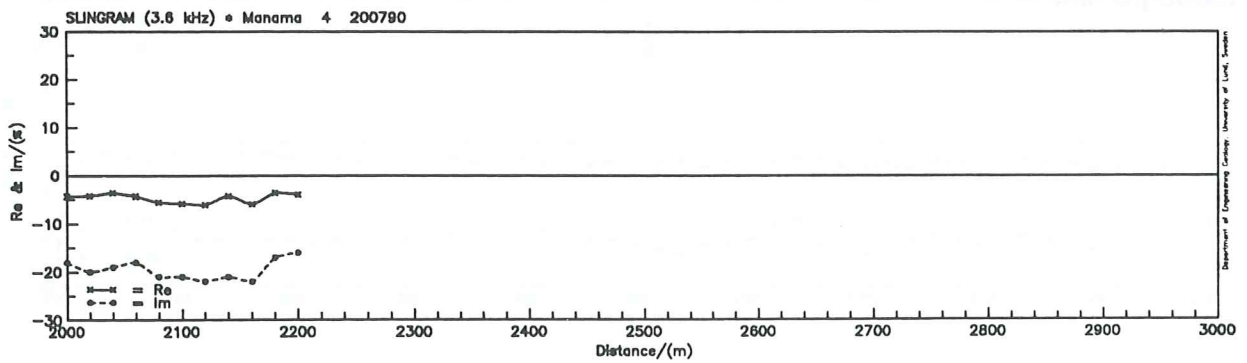
PROFILE NO 4

Date: 200790
Direction: S - N
Length: 2200 m Slingram, 1480 m VLF
Frequency: Slingram 3.6 kHz
VLF 22.2 kHz

The relatively small anomalies could be caused by not very deep and small waterbearing fracture zones. In the two first cases it could be in the contact between the different rock-types.

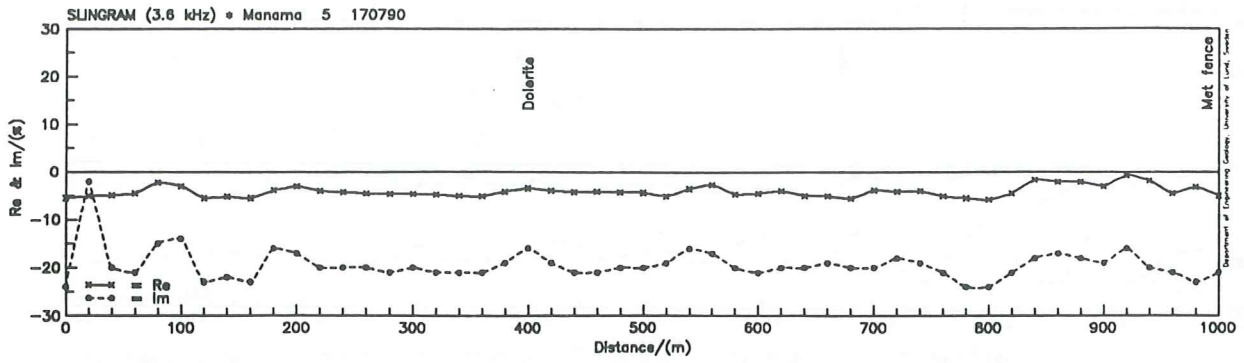
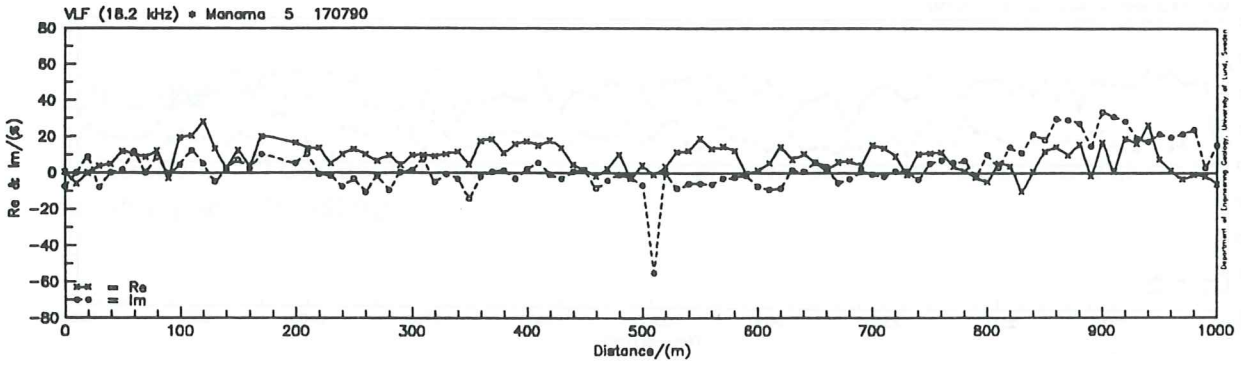
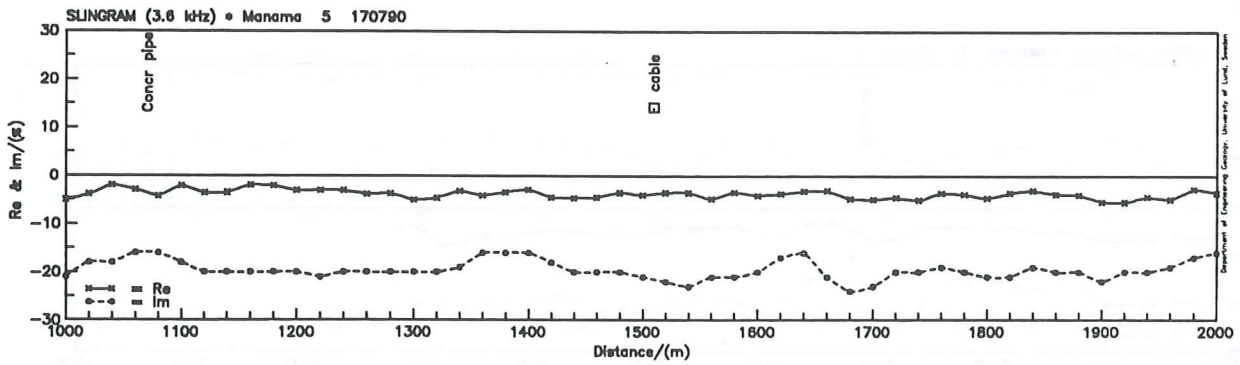
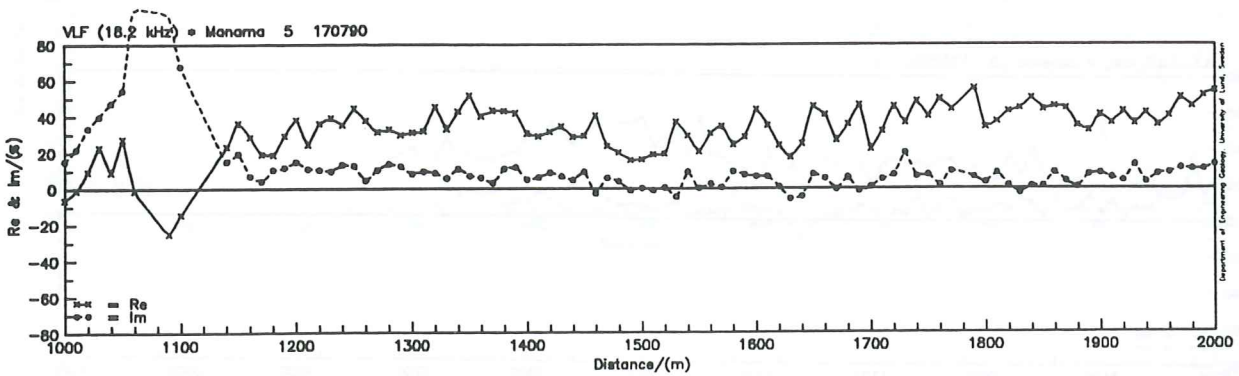
PROFILE NO 5

Date: 170790
Direction: SW -NE
Length: 3720 m
Frequency: Slingram 3.6 kHz
VLF 18.2 kHz

All the anomalies found in this profile are probably due to manmade conductors like electric power cables, metal fences etc. which were present at, or close to, these points.

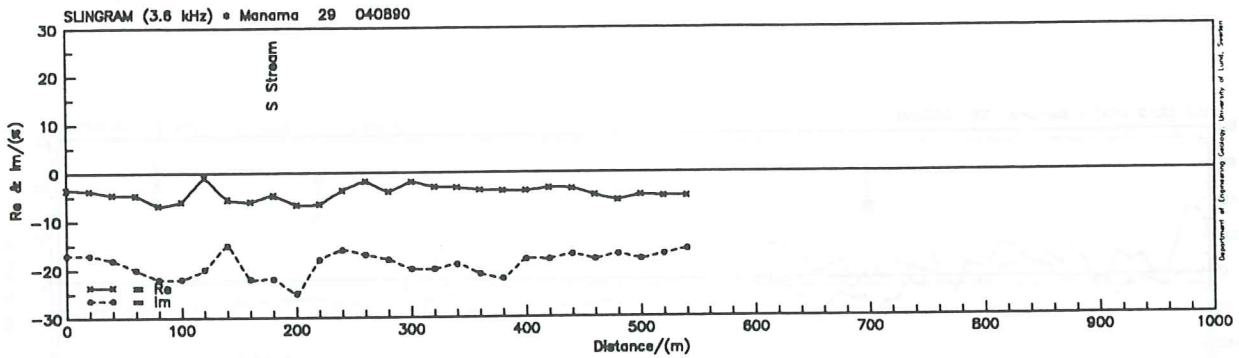
Comments

The profile doesn't show any big anomalies at all.

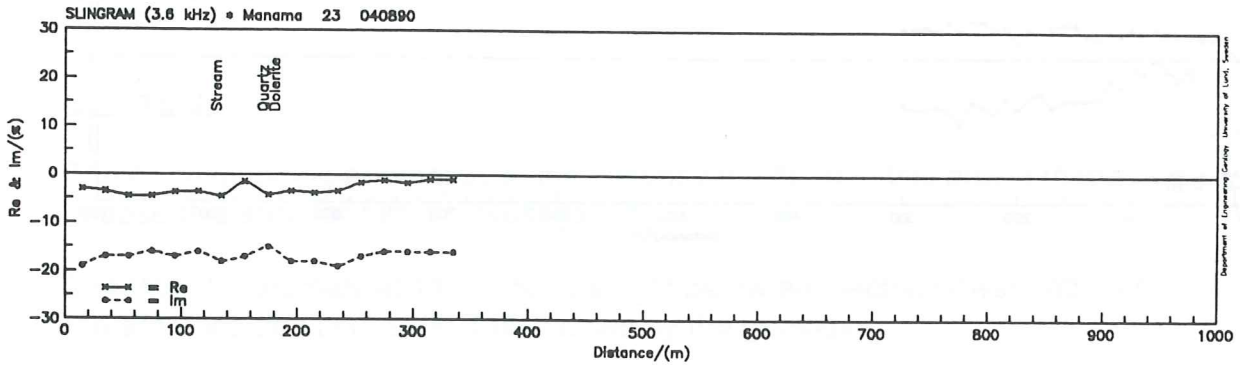
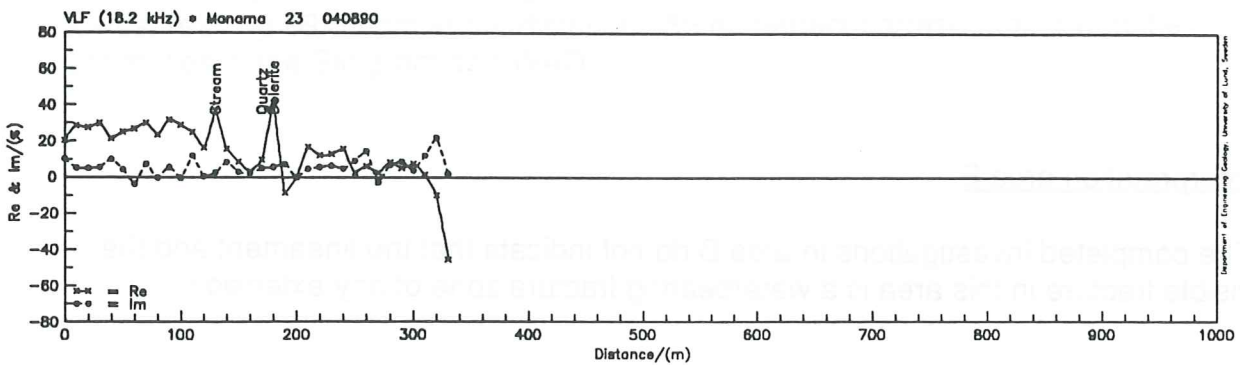
Comments

The profiles do not show any interesting anomalies at all.

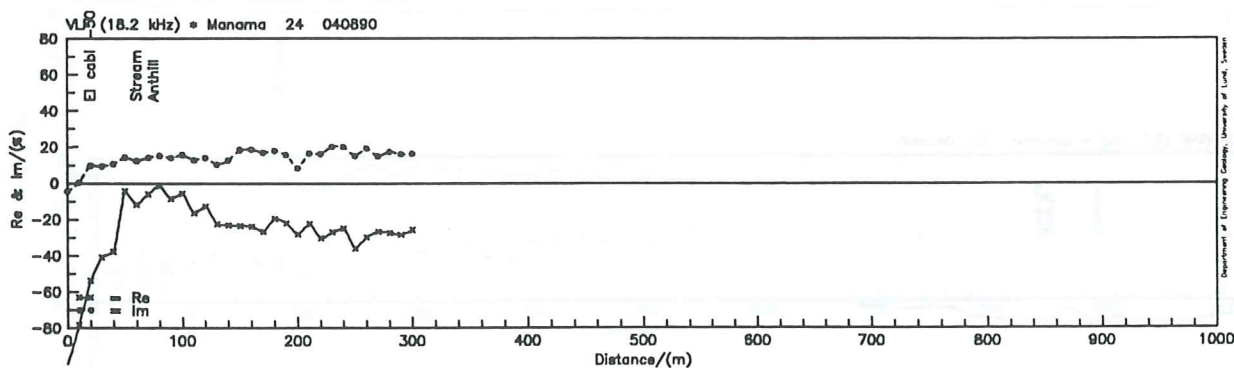
PROFILE NO 24

Date: 040890
Direction: W - E
Length: 300 m
Frequency: VLF 18.2 kHz

Comments

The low readings in the beginning of the profile are caused by an electric power cable. Otherwise nothing of interest.

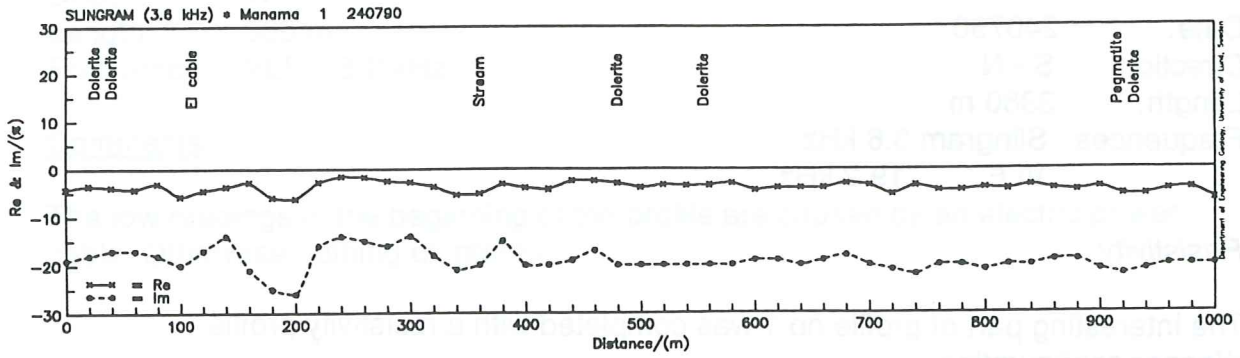
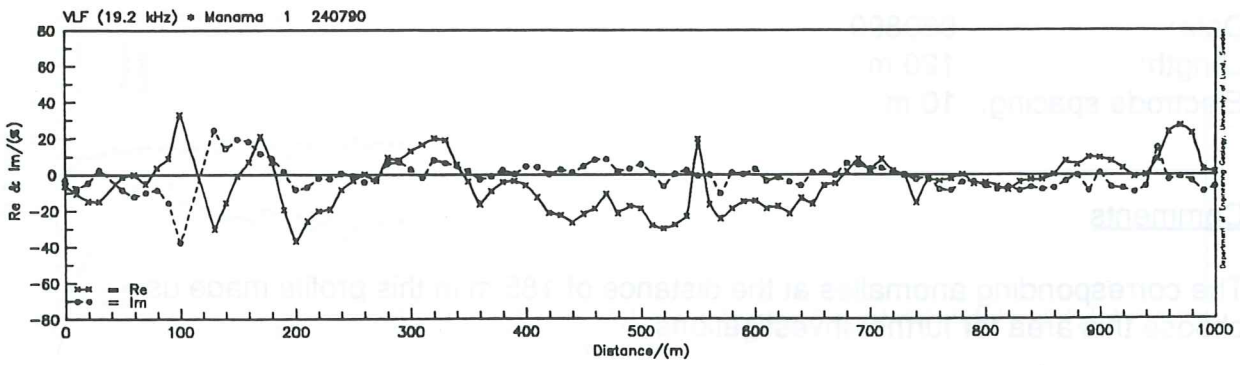
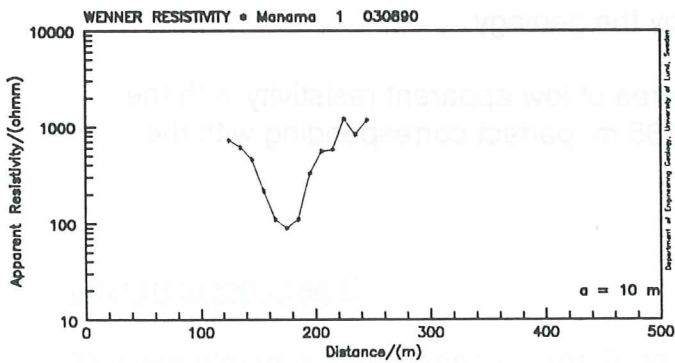
The WADI - anomaly at 110 m occurs right below an electric power cable and therefore we don't consider it as caused by the geology.

The resistivity profile shows a significant area of low apparent resistivity with the lowest reading 89 ohmm at the distance 185 m, perfect corresponding with the anomalies in the Slingram and WADI.

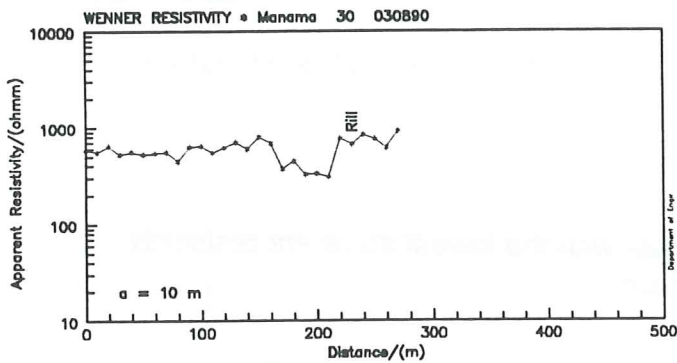
PROFILE NO 30

In this profile only the resistivity instrument was used because of the location close to the electric power cable. The purpose was to find an anomaly corresponding with the ones in profile no1, in our expected fracture direction, 290 °.

Comments

A significant area of low apparent resistivity is found at the distance of 190 m, and the lowest reading 305 ohmm is found at 210 m.

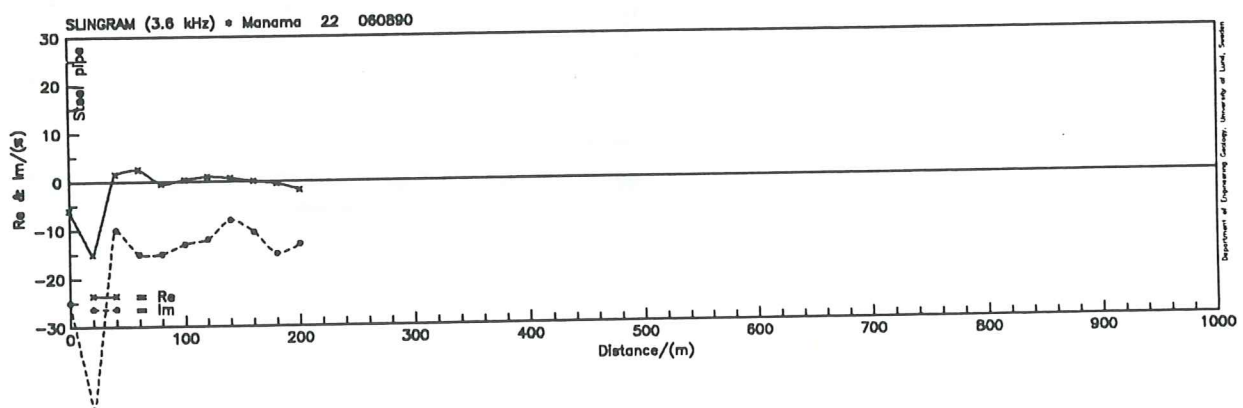
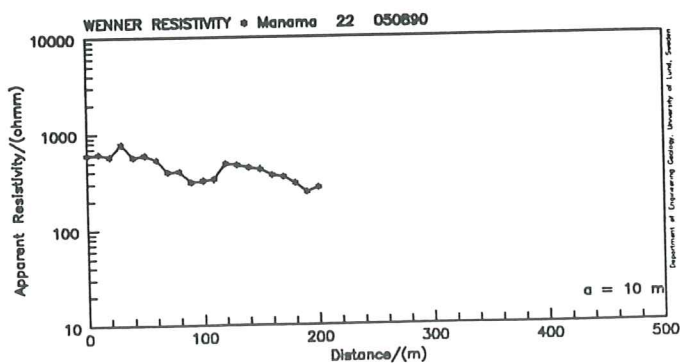
PROFILE NO 22

The purpose of this profile was to find an anomaly corresponding to the ones found in profile no 1, in our expected fracture direction, 290 °.

Comments

At the distance of 100 m there is an anomaly with the lowest apparent resistivity 298 ohmm. However, it's not very significant.

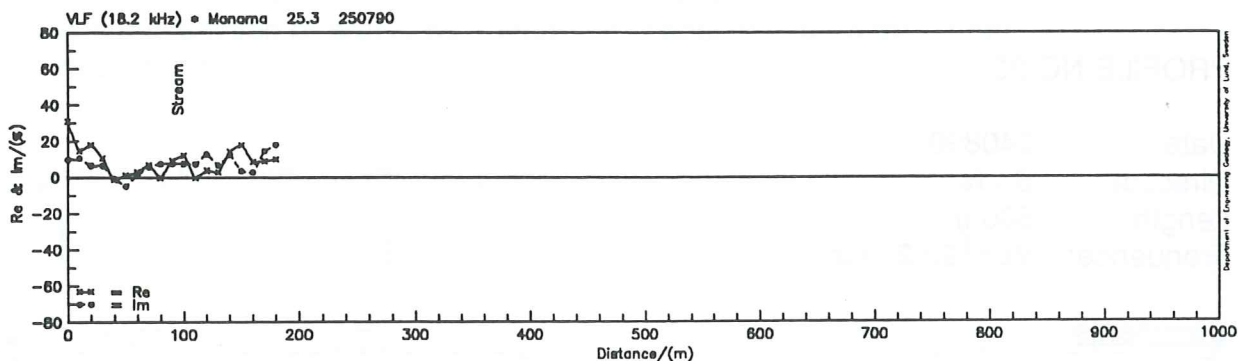
Comments

No interesting anomalies are found.

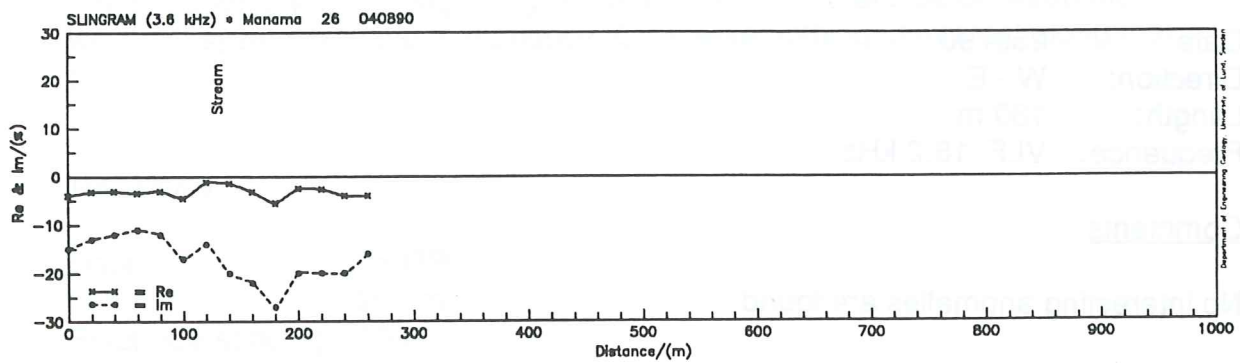
PROFILE NO 26

Date: 040890
Direction: W - E
Length: 280 m
Frequency: Slingram 3.6 kHz

Comments

Small anomaly shown at the distance of 180 m.

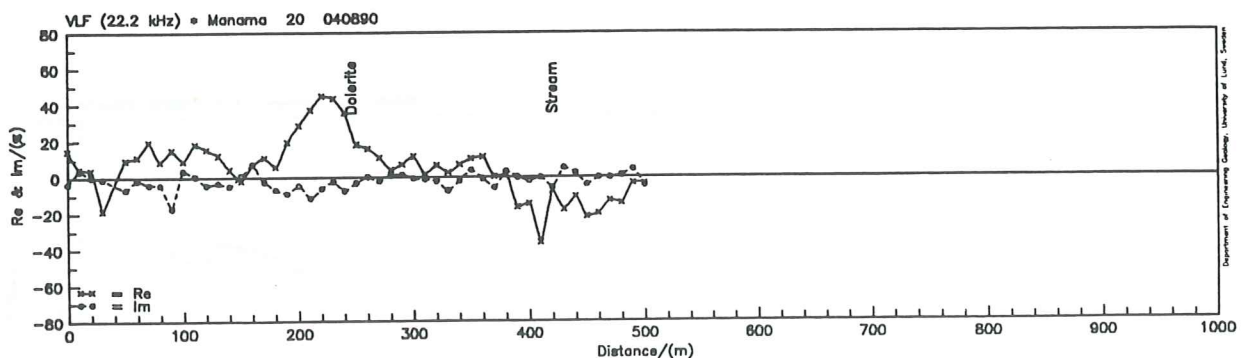
PROFILE NO 20

Date: 040890
Direction: S - N
Length: 500 m
Frequency: VLF 22.2 kHz

Comments

Anomalies are shown at the distance of 260 m and 390 m. However, these do not occur when entering the mafic area, or correspond with anomalies found in other profiles in the area.

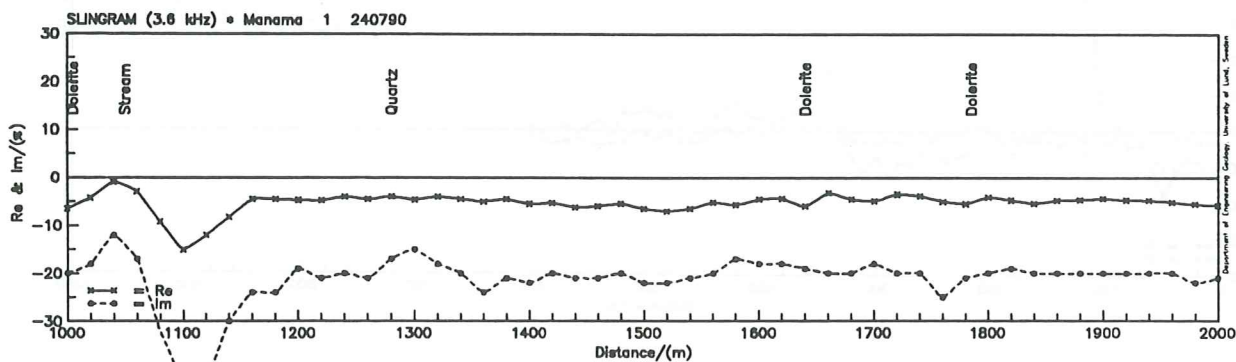
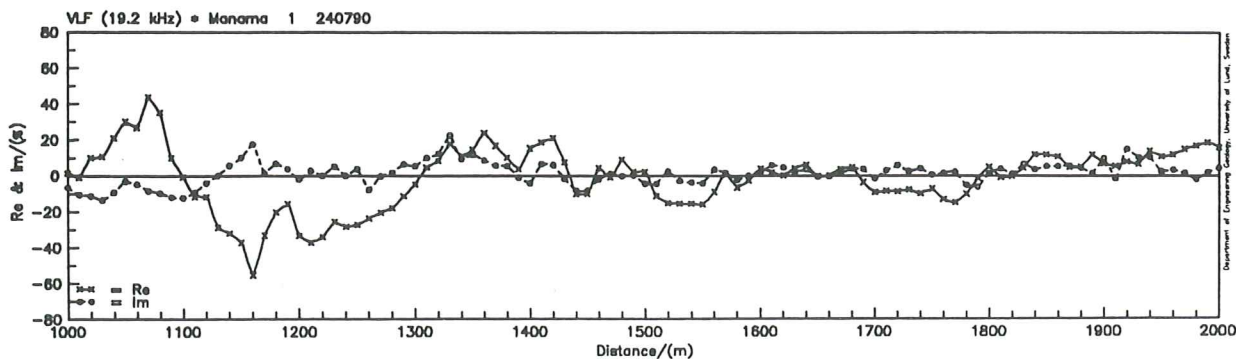
Comments

The very significant, large and corresponding anomalies at the distance of 1100 m in this section of profile no 1 made us choose this area for further investigation.

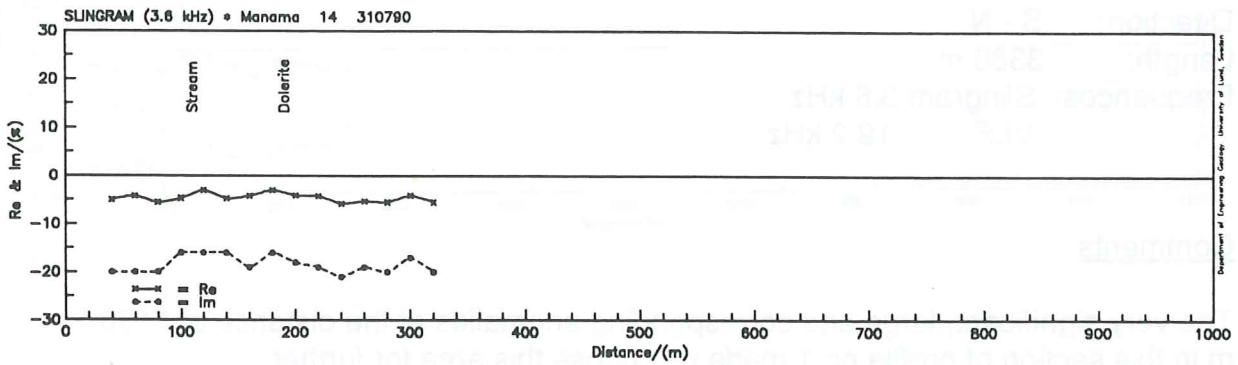
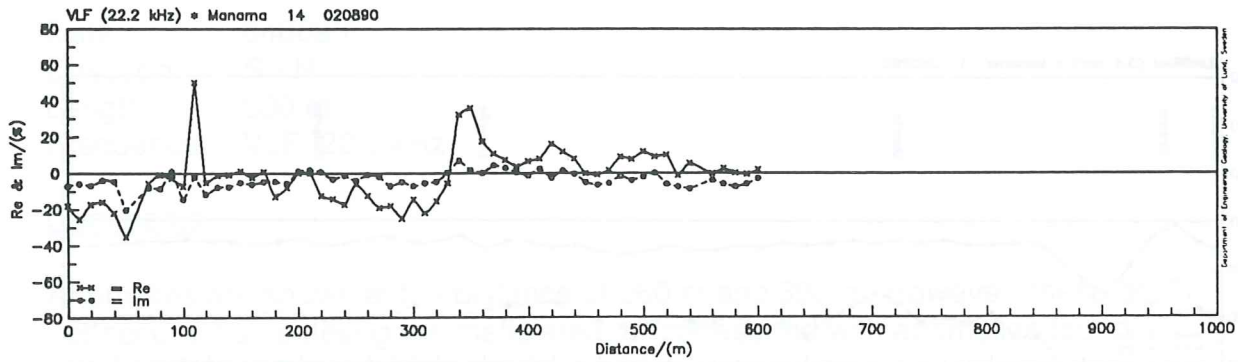
PROFILE NO 14

Date: 020890
Direction: S - N
Length: 280 m Slingram, 600 m VLF
Frequencies: Slingram 3.6 kHz
VLF 22.2 kHz

Comments

The Slingram-graph shows no anomalies. Something looking like an anomaly occurs at the distance of 360 m. The distorted shape could be explained by assuming a second anomaly at 430 m.

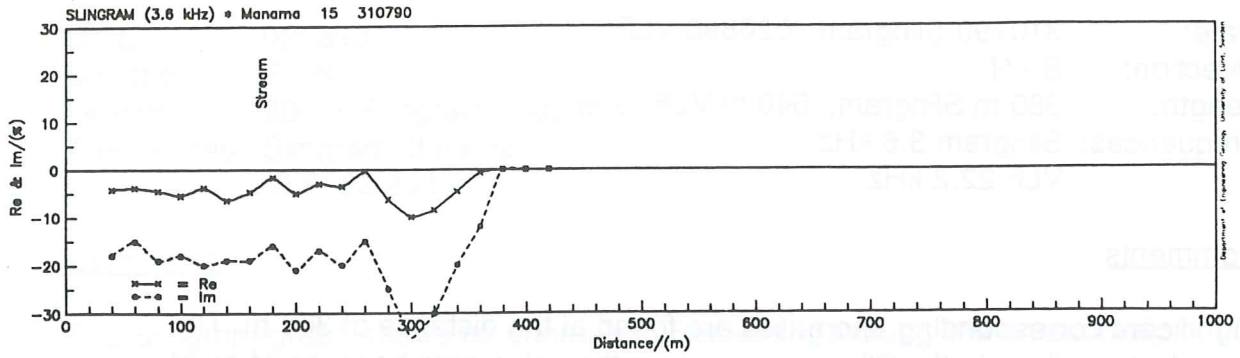
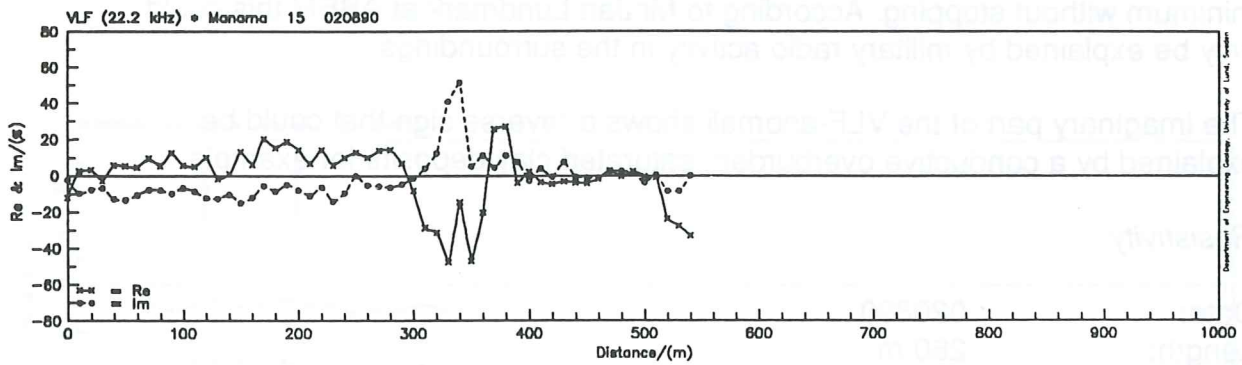
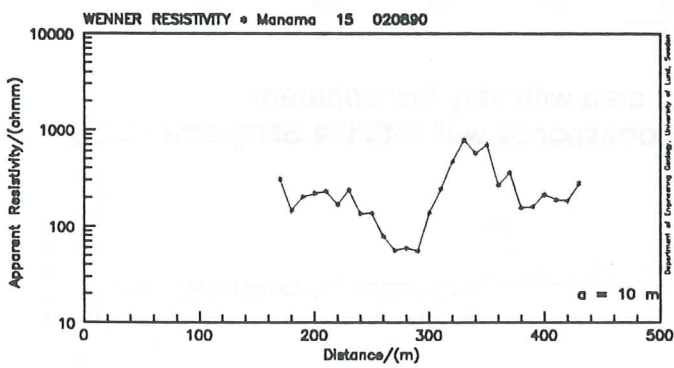
PROFILE NO 15

Date: 310790 Slingram, 020890 VLF
Direction: S - N
Length: 380 m Slingram, 540 m VLF
Frequencies: Slingram 3.6 kHz
VLF 22.2 kHz

Significant corresponding anomalies are found at the distance of 300 m. The three last readings in the Slingram are given the value zero because of great disturbances. The readings at this points oscillated between maximum and minimum without stopping. According to Mr Jan Lundmark at ABEM this could only be explained by military radio activity in the surroundings.

Comments

At a distance of 110 m the profile shows an area with very low apparent resistivity, the lowest resding 55 ohmm. It corresponds well with the Slingram- and the VLF-anomalies.

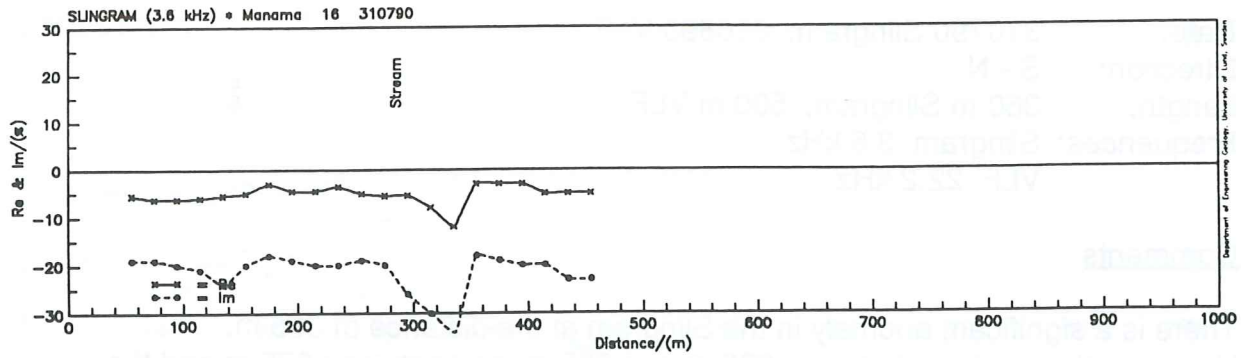
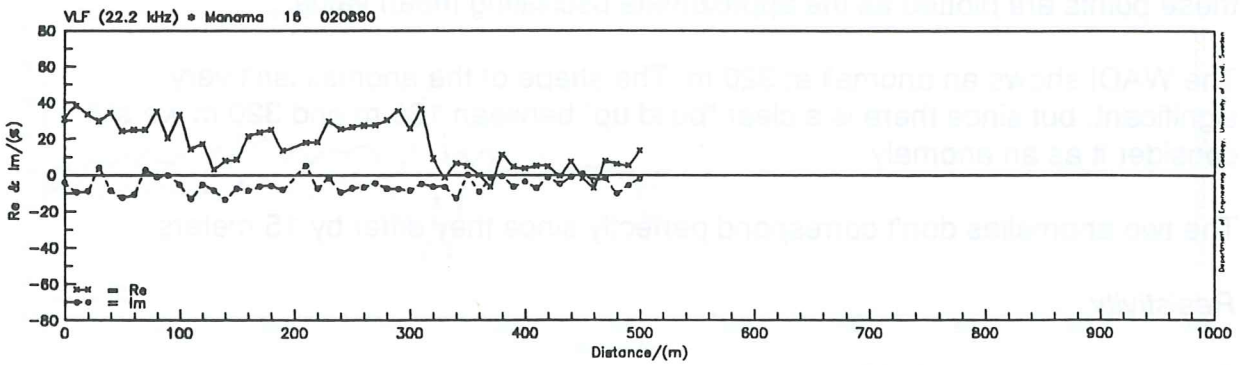
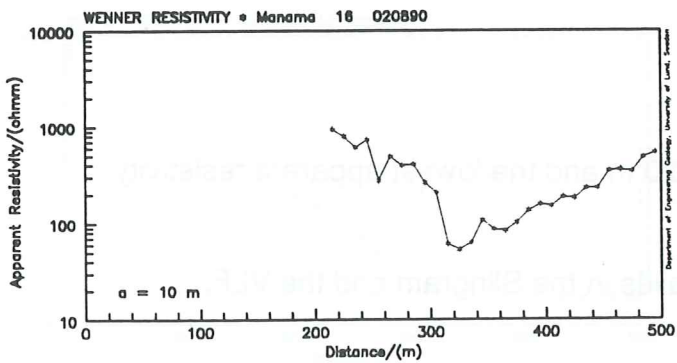
PROFILE NO 16

Date: 310790 Slingram, 020890 VLF
Direction: S - N
Length: 360 m Slingram, 500 m VLF
Frequencies: Slingram 3.6 kHz
VLF 22.2 kHz

An anomaly is shown at the distance of 320 m and the lowest apparent resistivity reading is 53 ohmm.

This anomaly occurs between the anomalies in the Slingram and the VLF.

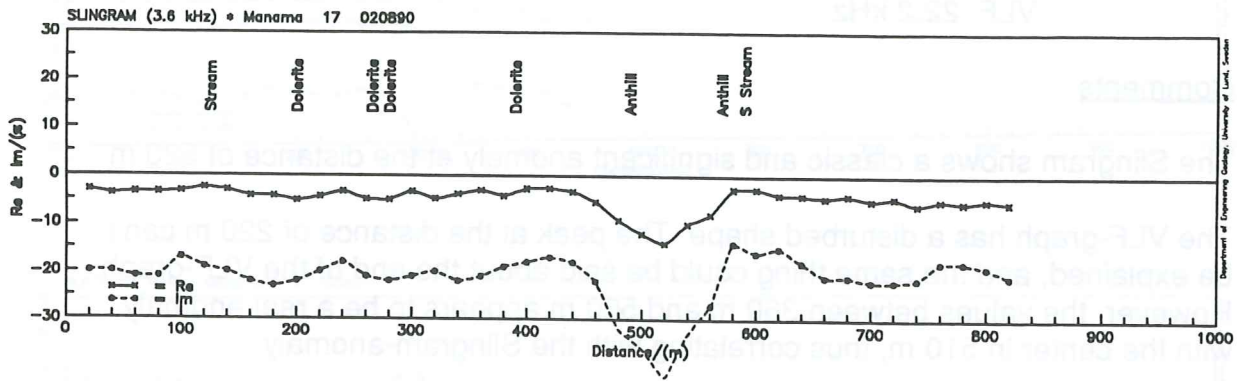
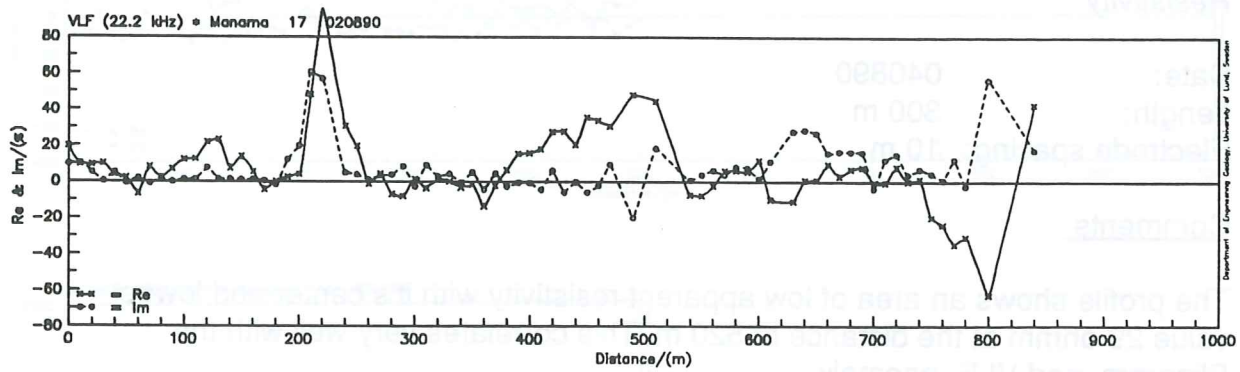
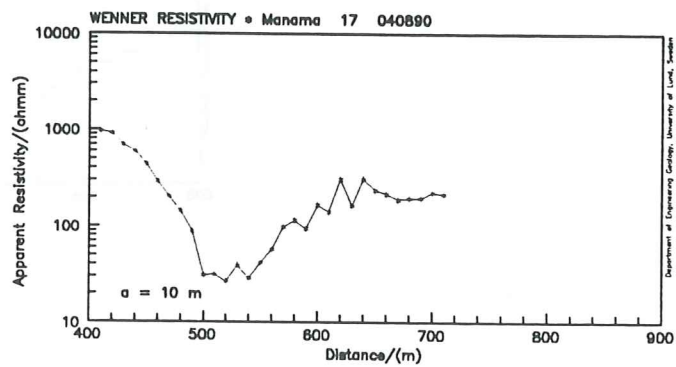
PROFILE NO 17

Date: 020890
Direction: S - N
Length: 800 m Slingram, 840 m VLF
Frequencies: Slingram 3.6 kHz
VLF 22.2 kHz

Comments

The profile shows an area of low apparent resistivity with it's center and lowest value 29 ohmm at the distance of 520 m. This correlates very well with the Slingram- and VLF -anomaly.

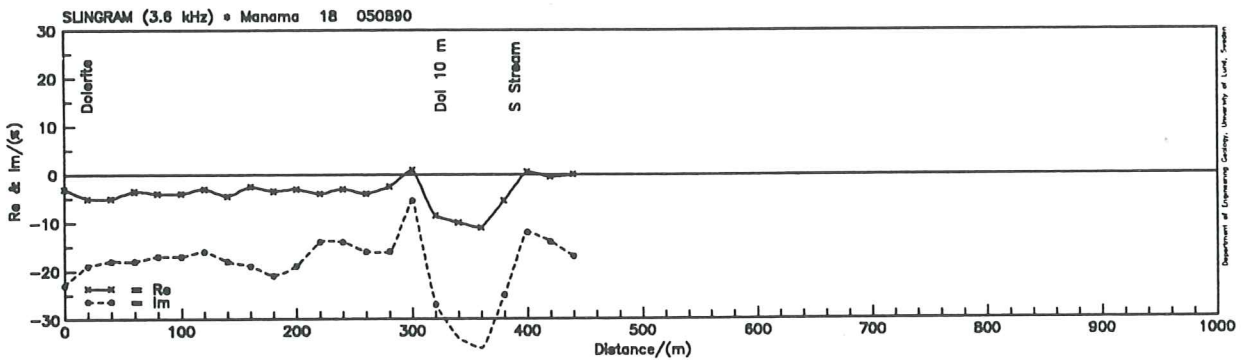
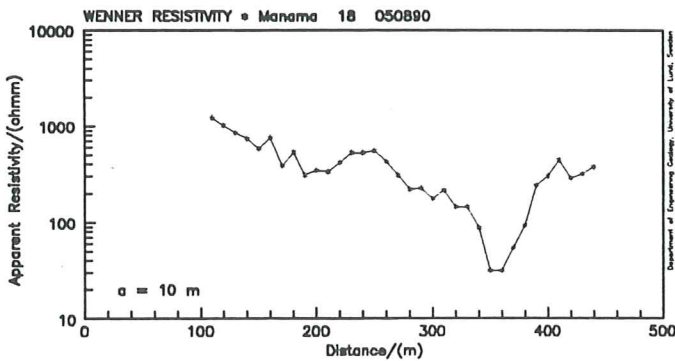
PROFILE NO 18

Date: 050890
Direction: S - N
Length: 440 m
Frequency: Slingram 3.6 kHz

Comments

An area of low apparent resistivity with a lowest value of 32 ohmm is shown at the distance of 350 m, which corresponds very well with the Slingram-anomaly.

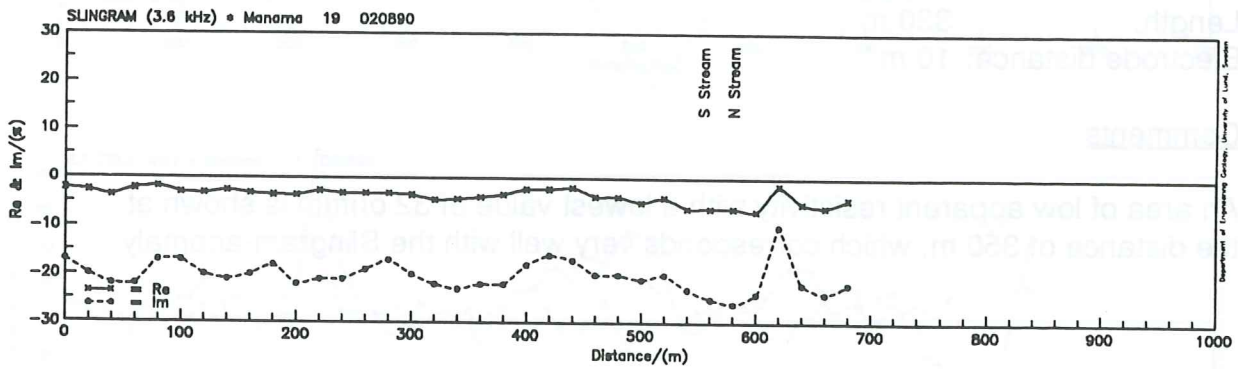
PROFILE NO 19

Date: 020890
Direction: S - N
Length: 680 m
Frequency: Slingram 3.6 kHz

Comments

There is something that could be taken for an anomaly at the distance of 590 m, but it's mostly caused by a single reading at 620 m and therefore a bit unsure.

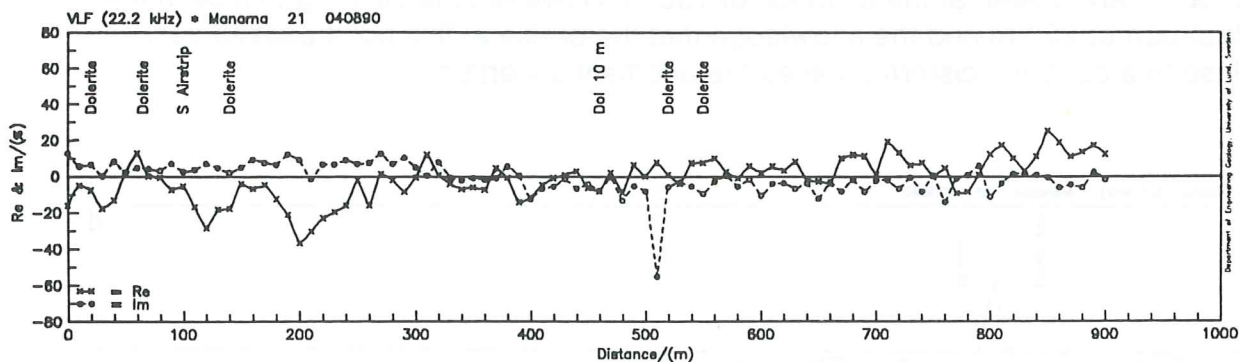
PROFILE NO 21

Date: 040890
Direction: S - N
Length: 900 m
Frequency: VLF 22.2 kHz

Comments

Small anomalies are seen at the distances of 90 and 190 m.

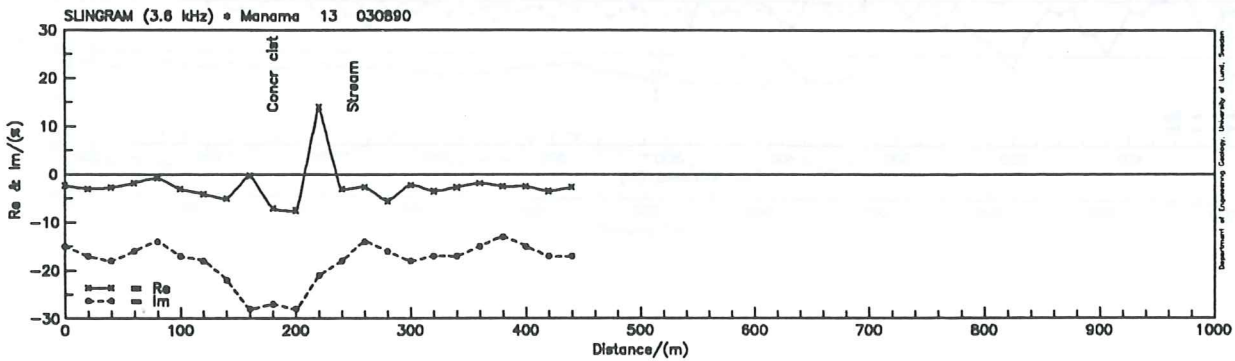
PROFILE NO 13

Profiles no 12 and 13 were carried out with the purpose to investigate a possible fracture zone in a SW - NE direction.

Comments

An anomaly is seen at the distance of 180 m. However, the very high value in the Real-part at 220 m and the knowledge that the profile at this point passed very close to a concrete cistern, makes the anomaly uncertain.

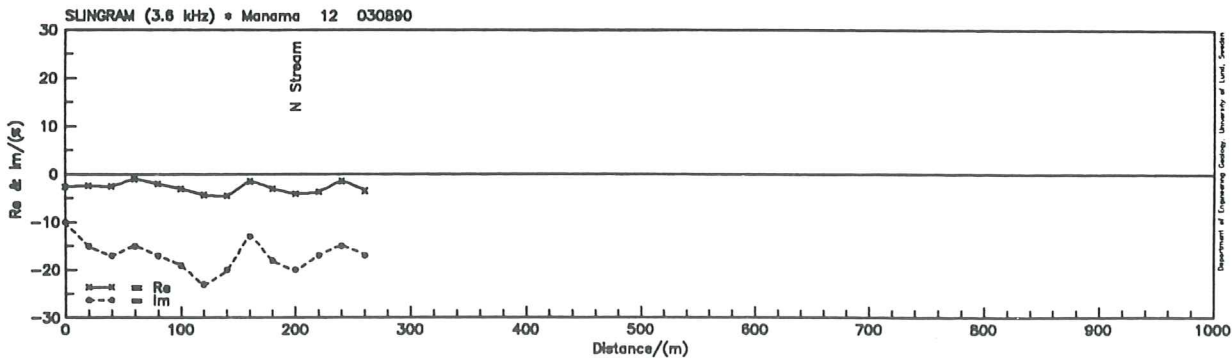
PROFILE NO 12

Date: 030890
Direction: SE - NW
Length: 260 m
Frequency: Slingram 3.6 kHz

Comments

This profile was made to check the reliability of the anomaly in profile no 13. Nothing of interest appeared.

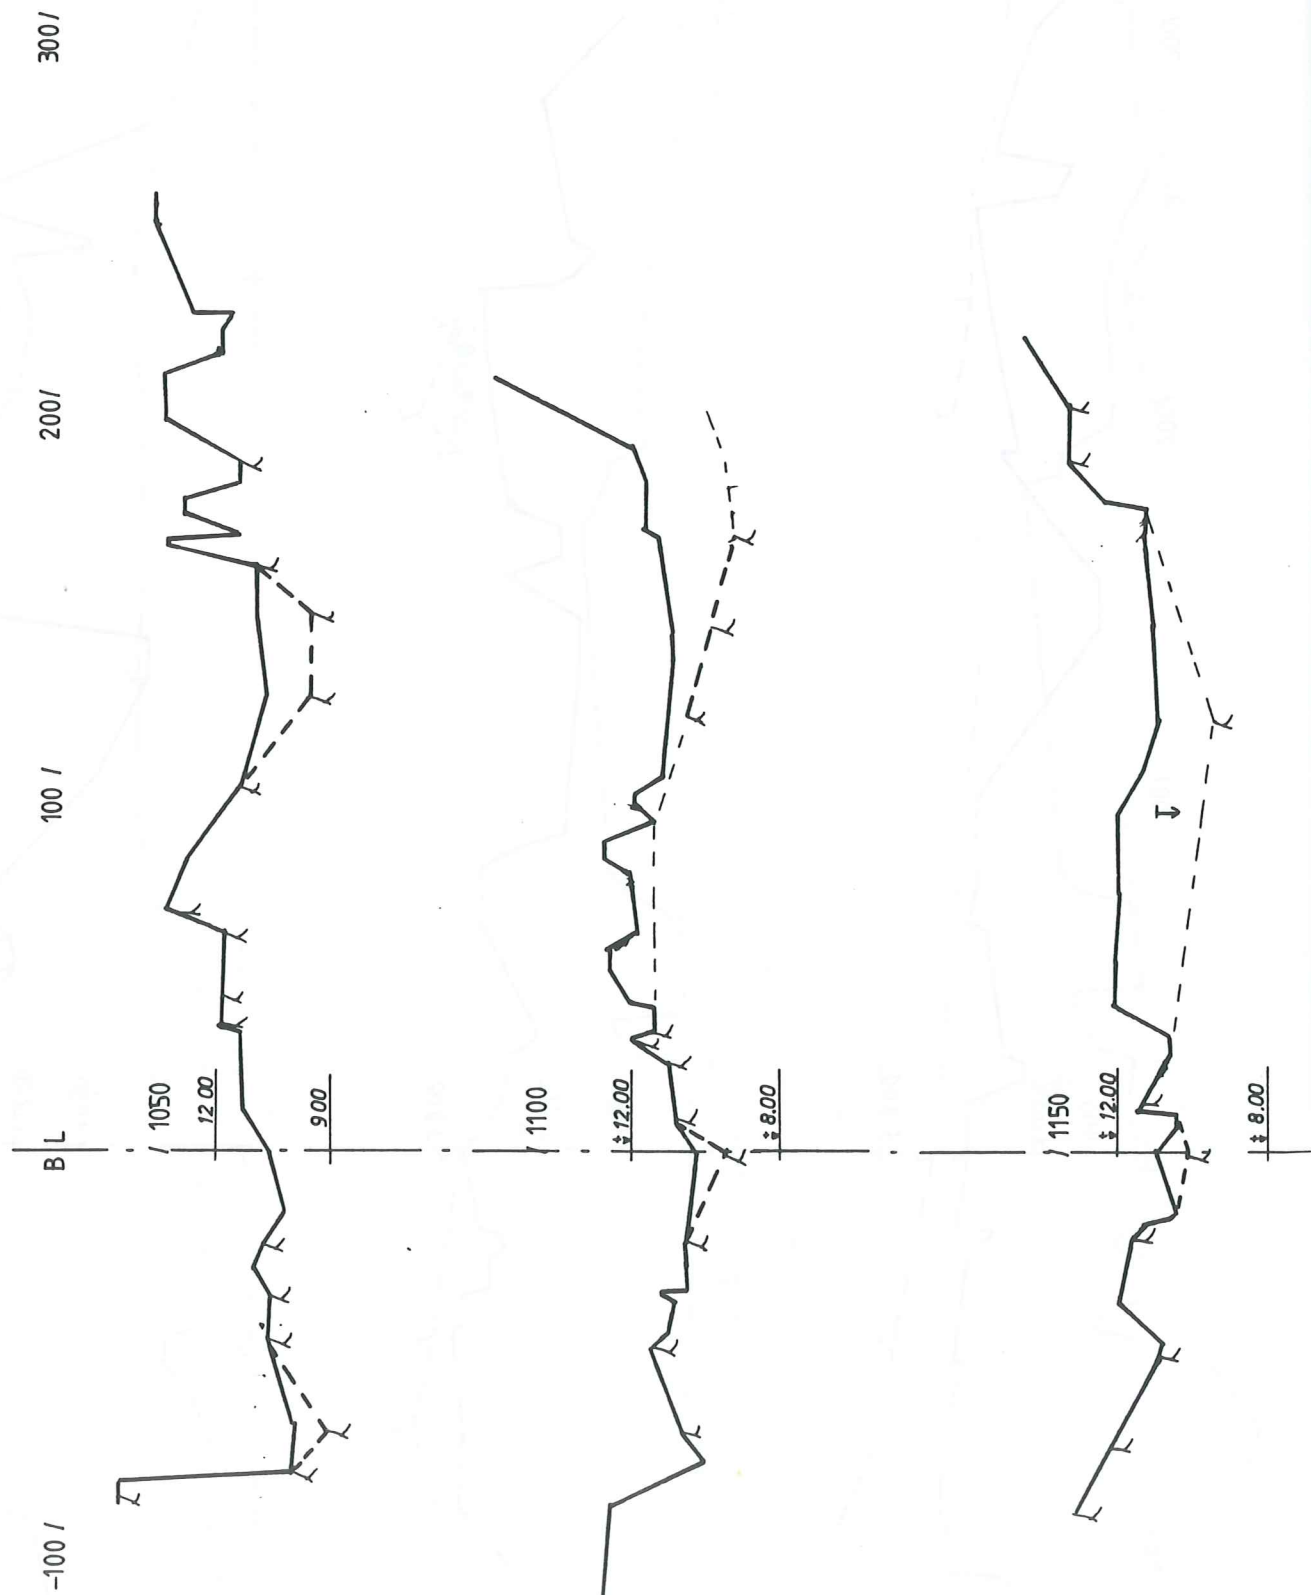
B 8

RESULT - ALLUVIAL MATERIAL - Soil classification
