# **Firefighting in large FRP composite cruise ships**

***Fredrik Falkman***

**Report 5396, Lund 2012**

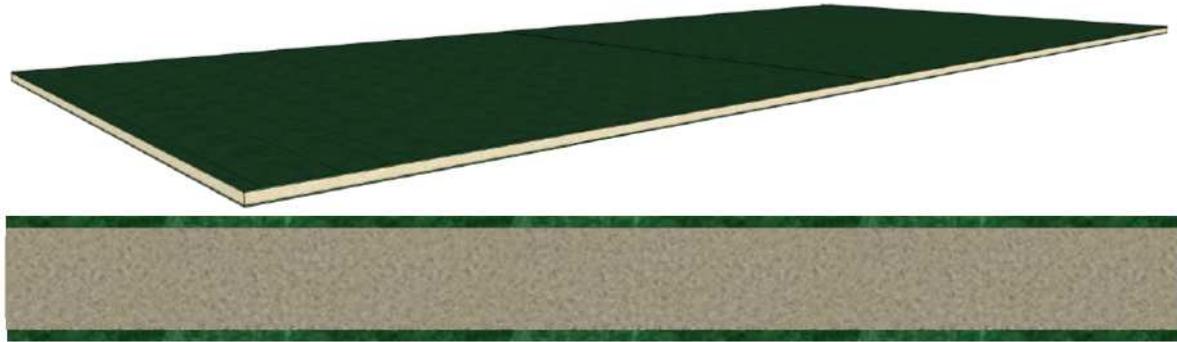
Figure 1. Illustration of an FRP Composite with its laminates on each side of a lightweight core (Evegren, 2010).

In order to achieve light weight, Fibre Reinforced Polymer (FRP) composite has been used since the 1970s on Navy crafts. An FRP composite is a sandwich type construction generally consisting of two laminates on each side of a light core, creating one stiff panel. Typically, the laminates are made of glass or carbon fibre bonded together by a resin, while the core is a PVC polymer or a lightweight wood such as balsa, as seen in Figure 1. The FRP composite panels are often suitably stiffened with T-joint stiffeners to increase its load-bearing capacity. This type of construction enables the panels to bear loads not only perpendicularly but also laterally, making them practical for constructing both decks and bulkheads (Evegren, 2010).

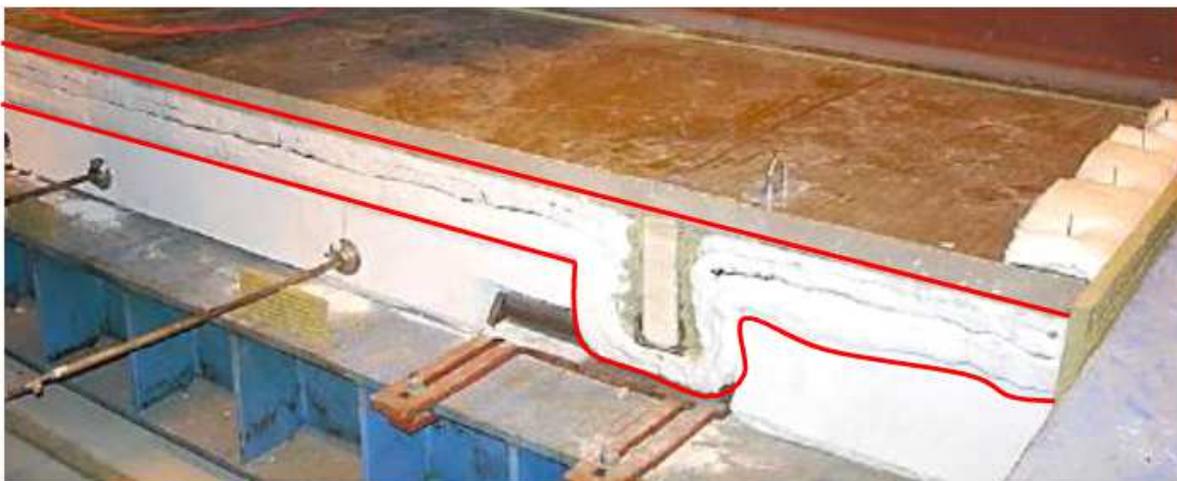
Figure 2. Insulation fitted to an FRP composite construction marked in red (Evegren, 2010).

However, These FRP panels introduce new complications with regards to fire safety on board since they are combustible. Tests have shown that when exposed to a fire and the laminate on the exposed side reaches a critical temperature, the FRP composite will delaminate and start to lose its load-bearing capabilities. The temperature at which this happens depends on what type of resin is used. Polyester or a phenolic polymer mix are commonly used resins and they will have lost their bonding capabilities at around 130°C and 200°C respectively (Hertzberg, 2009). As the construction gets heated further, more load-bearing capacity is lost and eventually the structure will collapse after 60 – 140 minutes of sustained fully developed fire (More detailed information on this time-span can be found in chapter 6.3.2). In order to provide sufficient protection from fire, all interior FRP composite surfaces will be insulated. SOLAS Regulation II-2/11-2 states that load-bearing structures shall be built in *Steel or other equivalent material* (IMO, 2009). With additional safety measures, such as the added insulation, a ship with FRP composite structures can be designed with equivalent fire safety (Evegren, 2010). Figure 2 shows an FRP composite with a T-joint and insulation.

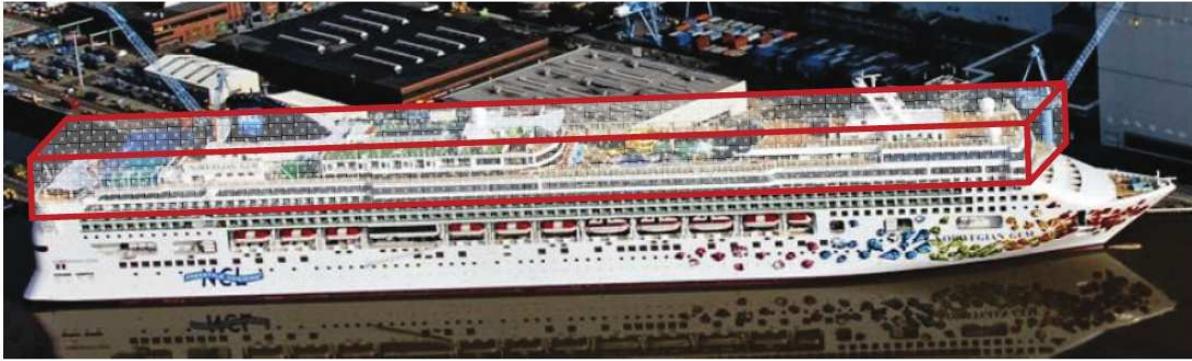
Figure 4. Norwegian Gem, with the five uppermost redesigned decks marked in red (Evegren, 2010).

The Norwegian Gem is a 295m long cruise ship built in 2007 by Meyer Werft in Germany. It is capable of accommodating around 2400 passengers and 1150 crew members. Onboard the Gem, the five uppermost decks constructed in steel and aluminum were replaced in the virtual design by a superstructure built in FRP composite, highlighted in Figure 4. The redesign resulted in 1200 tons of weight savings. However, since the FRP superstructure does not contribute to global hull strength, the resulted loss of strength required engineers to reinforce the remaining steel hull with around 400 tons of steel, thus making the final weight savings 800 tons. This in turn meant that the engineers could add approximately one third of a deck, consisting of 100 extra cabins plus some recreational areas and crew space. The novel design of the ship resulted in an added capability of around 200 passengers while hull strength, fuel consumption, displacement and stability all remained the same (Evegren, Hertzberg, & Rahm, 2011).

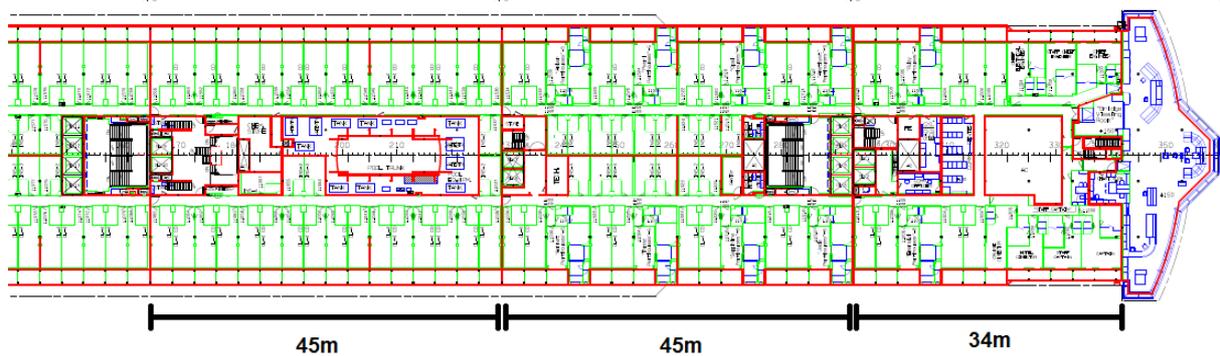
Figure 5. Top-down perspective of a deck with cabins on board the Norwegian Gem. Red lines indicate load-bearing parts of the structure (Evegren, 2010).

In this novel virtual design, all load-bearing bulkheads and decks were replaced with FRP composite in the five uppermost decks. But what does this mean? Figure 5 shows a schematic top-down overview of a deck with cabin compartments on board the Norwegian Gem. The red lines in the figure make out the load-bearing structures and thus what is redesigned in FRP composite. As seen in the figure, not all parts of the ship's interior are load-bearing. At an interval of 34-45 meters apart, main vertical zones can be seen. These are large load-bearing bulkheads that also make out fire zones (main vertical zones). All other red lines are also load-bearing, such as the hull and several other parts.

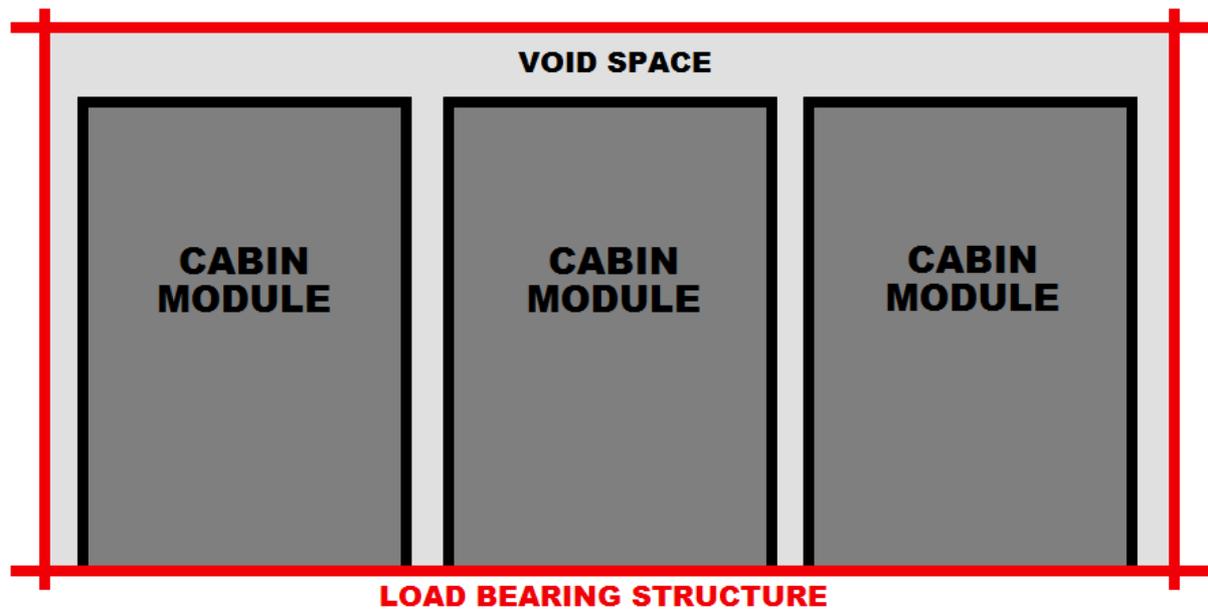
Figure 6. Schematic view of cabin modules in an FRP composite design.

To picture how a cabin area on board this type of ship is constructed, many similarities can be drawn to a typical office space. One can imagine a larger area on a deck where the boundaries are two bulkheads and both sides of the hull in the horizontal plane. In the vertical axis the boundaries are determined by the deck and the bottom side of the above deck. Into this volume several cabin modules are inserted. Above the cabin modules is a void space between the ceiling of the modules and the bottom of the deck above. There is also to some extent a void space between the cabins, as well as between the cabins and the bulkheads. The following figure 6, illustrates the construction schematically.

Much like in an office building this void space is used for wiring, ventilation, plumbing et cetera. As of now the novel design does not change these interior modules, it affects only the load-bearing structure such as described above. However, in the future there shall hopefully also be more lightweight cabin modules available on the market.

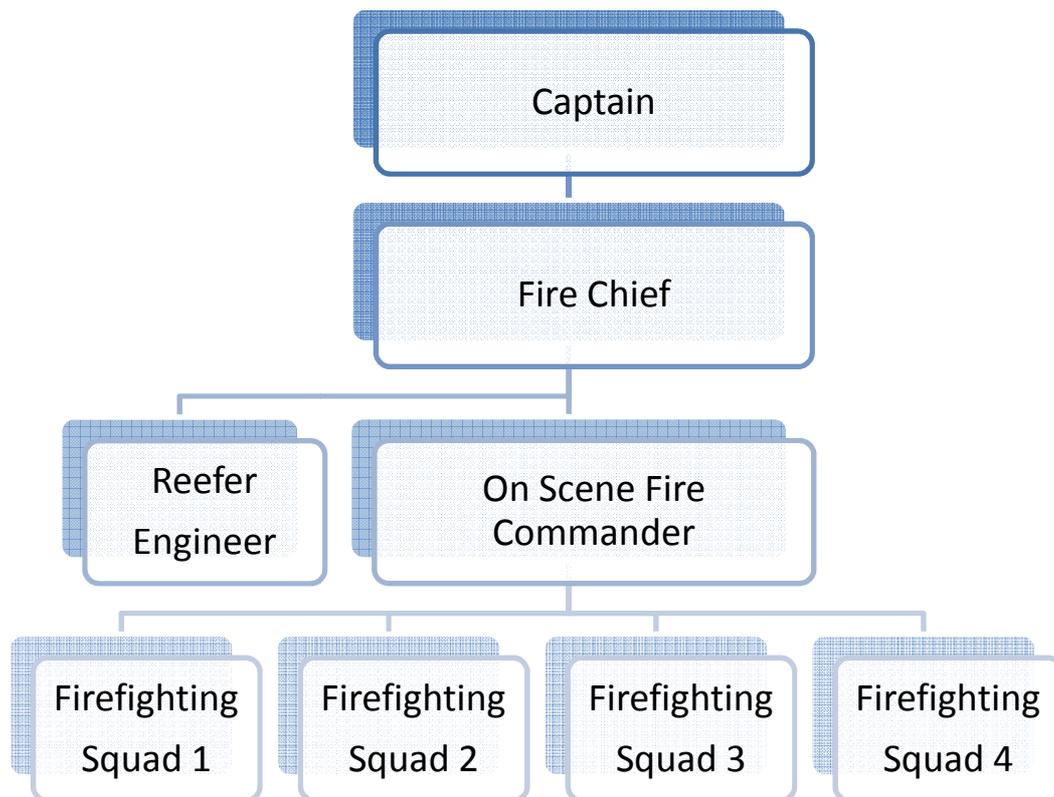
Figure 7. Schematic overview of onboard firefighting organization

It was found that regulations governing how the firefighting organization is to be managed are performance based. Further information can be found in Appendix B.2. This means that organizations may differ between shipping companies and ships et cetera. Figure 7 displays an overview of how a firefighting organization generally is set up on board large cruise ships. It was compiled with the assistance of Håkan Warnemyr (Warnemyr, 2012) at MSB Revinge College and Gabor Szemler at the maritime fire safety department of the Swedish Transport Agency (Swedish Flag).

The captain on board is always the commanding officer and ultimately in charge of all onboard operations. The Fire Chief is in charge of firefighting operations and is a position normally appointed to the Chief Engineer. The Reefer Engineer is in charge of managing ventilation systems on board and the On Scene Fire Commander has operative command at the site of fire. Additional crew is also available to assist the Captain, Fire Chief, Reefer Engineer and On Scene Fire Commander. The number of Firefighting Squads, and also the amount in men in each squad, may vary on different ships but generally a squad consists of around ten to twentyfive men, of which four or six are designated BA-team members. In addition to this “core” firefighting organization, all crew members have a designated task to perform in case of a fire on board such as ensuring compartments are closed, assisting passengers, et cetera.

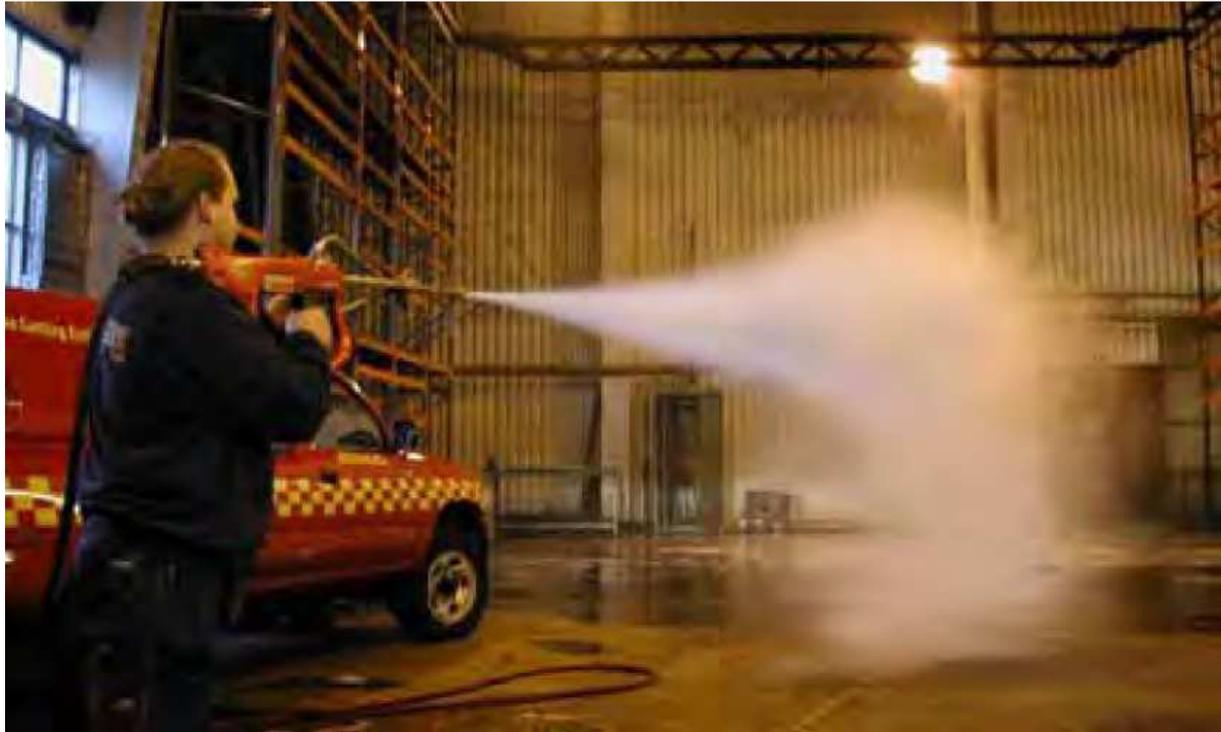
Figure 9. A Cutting Extinguisher's spray pattern (Skärsläckarkonceptets operativa användande, 2010)

The CE (Figure 9) is a tool that shoots out water with an added granulated abrasive under very high pressure (200 - 300+ bar), enabling it to cut through all materials used in constructions today. The abrasive is added to the water stream by the command from a radio transmitter and is used when cutting. When a hole has been established no abrasive is needed. To use the CE the operator simply puts the nozzle against the wall/ceiling/floor, applies pressure and pulls the trigger. The water spray will cut through the wall in a matter of seconds, forming a hole through which water is allowed to flow and cool the adjacent space. In the targeted compartment, the powerful water spray will have fully broken up into a mist after 5-7 meters. The water flow velocity through the hose is around 4,8m/s, indicating that there is an approximate 22s delay in a 100m hose, after abrasive is added to the water (at the pump). Furthermore,

The study by Carlsén & Winkler also shows that the CE is fully capable of penetrating an FRP composite construction. However, it is at this point unclear whether the CE has the power to penetrate both the FRP composite construction, insulation and also the inner ceilings/walls of the cabins/compartments. This is something that needs to be tested.

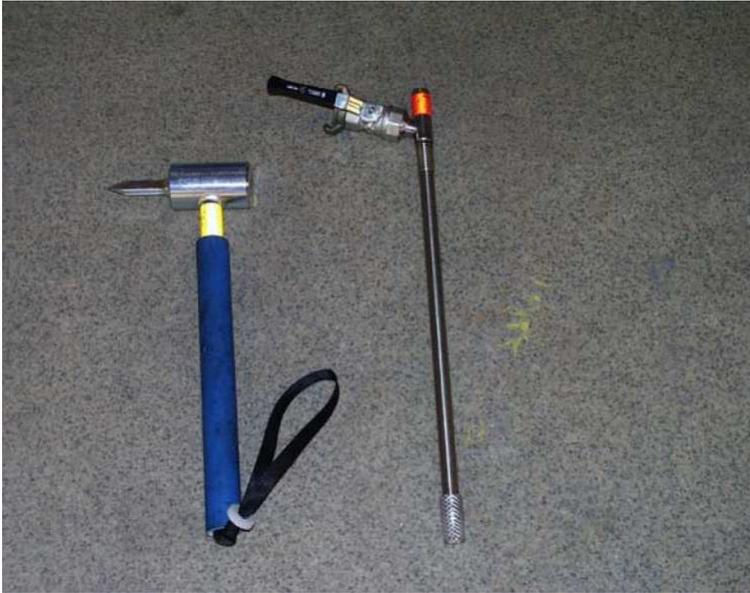
Figure 10. Fog Nail and hammer (Andersson & Krasniqi, 2001)

The FN (Figure 10) is basically a steel pipe that connects to a fire hose at one end and has a nozzle at the other to disperse the water flow into a mist. The FN comes in different lengths to accommodate for different geometries. It is adapted to operating at the lower pressure of onboard fire pumps and does not need to be powered by a high pressure pump. The FN is either hammered through a wall/ceiling/floor or inserted through a hole predrilled with a battery-powered power-tool, depending on the toughness of the construction. Tests have shown that it is difficult or impossible to hammer a FN through an FRP composite; a drill is thus required for aiding placement (Andersson & Krasniqi, 2001), if adequate holes are not already installed during construction of the ship. Furthermore, a FN is not capable of penetrating a steel construction.

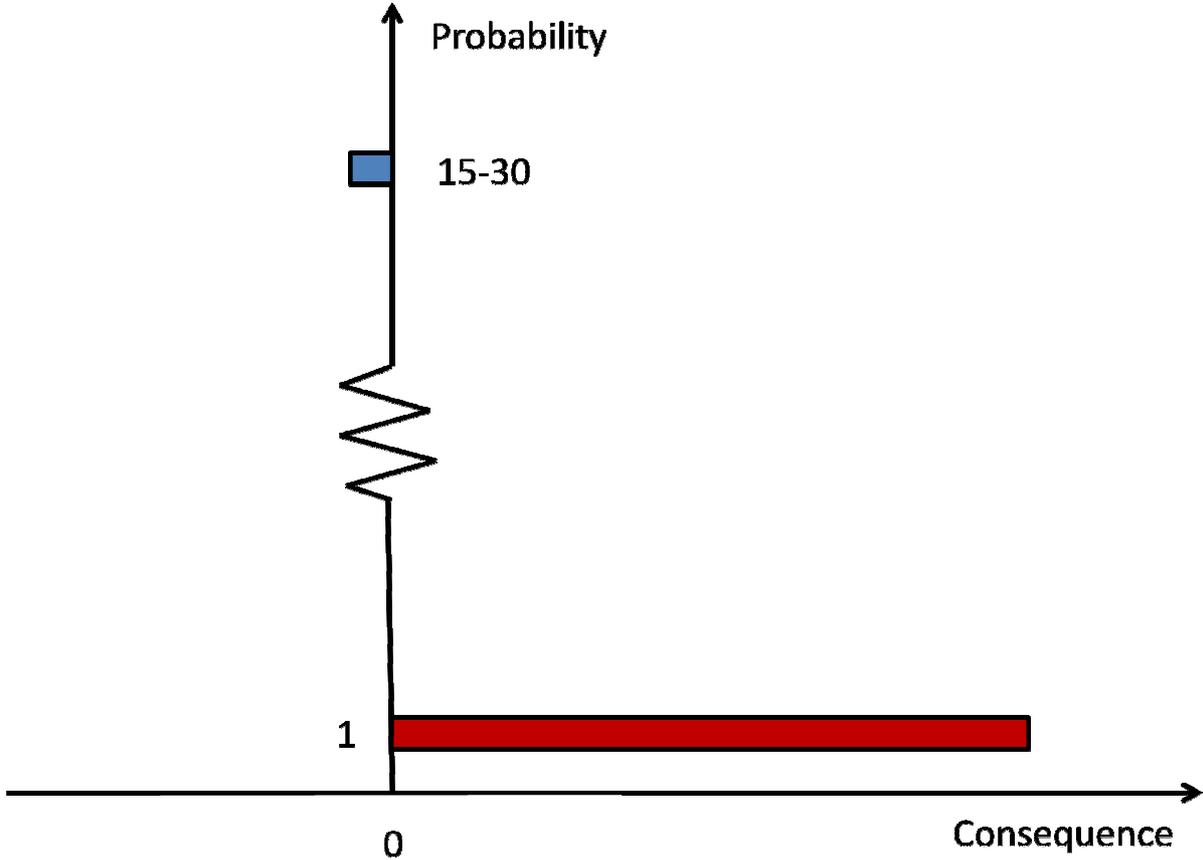
Figure 12. Illustration of how different scenarios may affect RR. If the beneficial scenarios each reduce firefighters' absolute personal risk by an amount that corresponds to at least 1/30<sup>th</sup> - 1/15<sup>th</sup> of the personal risk increase caused by one detrimental scenario, the consequence is zero or negative. This would indicate that RR is at the most 1.

The different scenarios' consequences for the RR comparison are again illustrated in figure 12 below. The figure illustrates how a number of beneficial scenarios with a modest decrease in consequence (thus lowering firefighters' personal risk), may balance the increase caused by a detrimental catastrophic scenario. If it is so, that the beneficial scenarios balances or outweighs the detrimental one, the summarized consequence to firefighters' personal risk remains at, or below zero. This indicates that in a comparison of relative risk prior to, and after the introduction of the novel design, the RR is at the most 1.

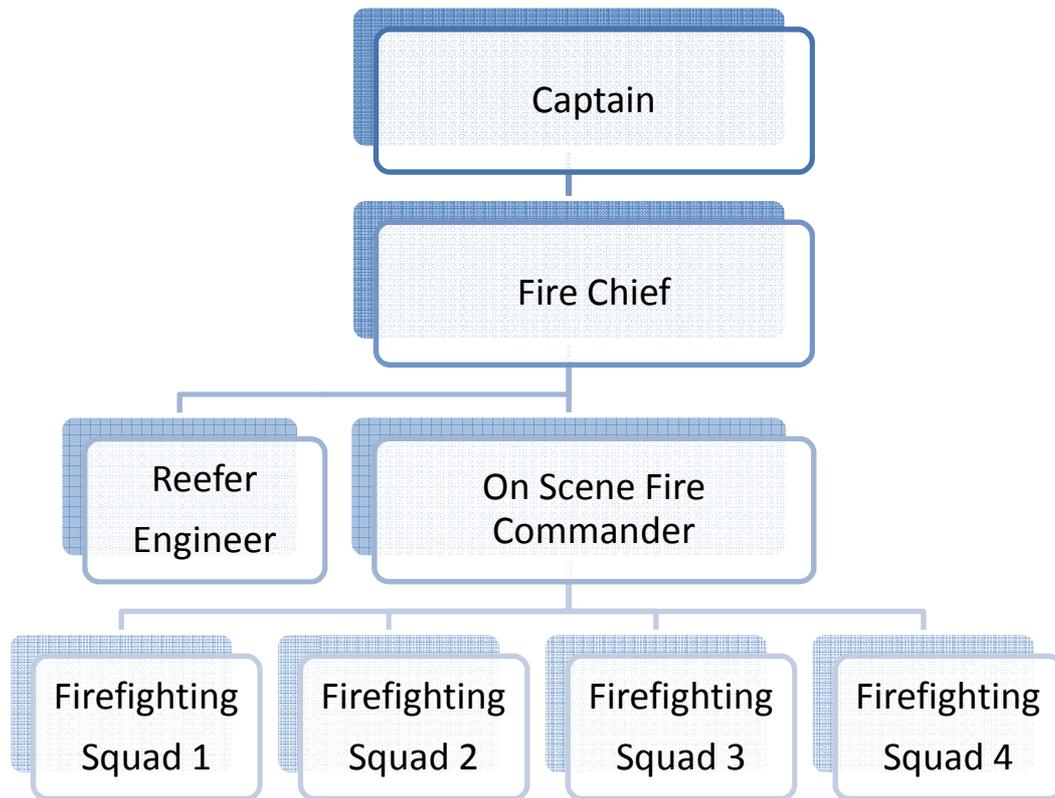
Figure 13. Schematic overview of an onboard firefighting organization

An example of a firefighting organization on a large scale cruise ship is presented in general terms in the figure 12. It was compiled with assistance from Håkan Warnemyr (Warnemyr, 2012) and Gabor Szemler at the fire safety department of Transportstyrelsen.

The captain on board is always the commanding officer and ultimately in charge of all onboard operations. The Fire Chief is in charge of firefighting operations and is a position normally appointed to the Chief Engineer. The Reefer Engineer is in charge of managing ventilation systems on board and the On Scene Fire Commander has operative command at the site of fire. Additional crew is also available to assist the Captain, Fire Chief, Reefer Engineer and On Scene Fire Commander. The number of Firefighting Squads, and also the amount in men in each squad, may vary on different ships but generally a squad consists of around ten to 25 men, of which four or six usually are assigned to BA-teams.

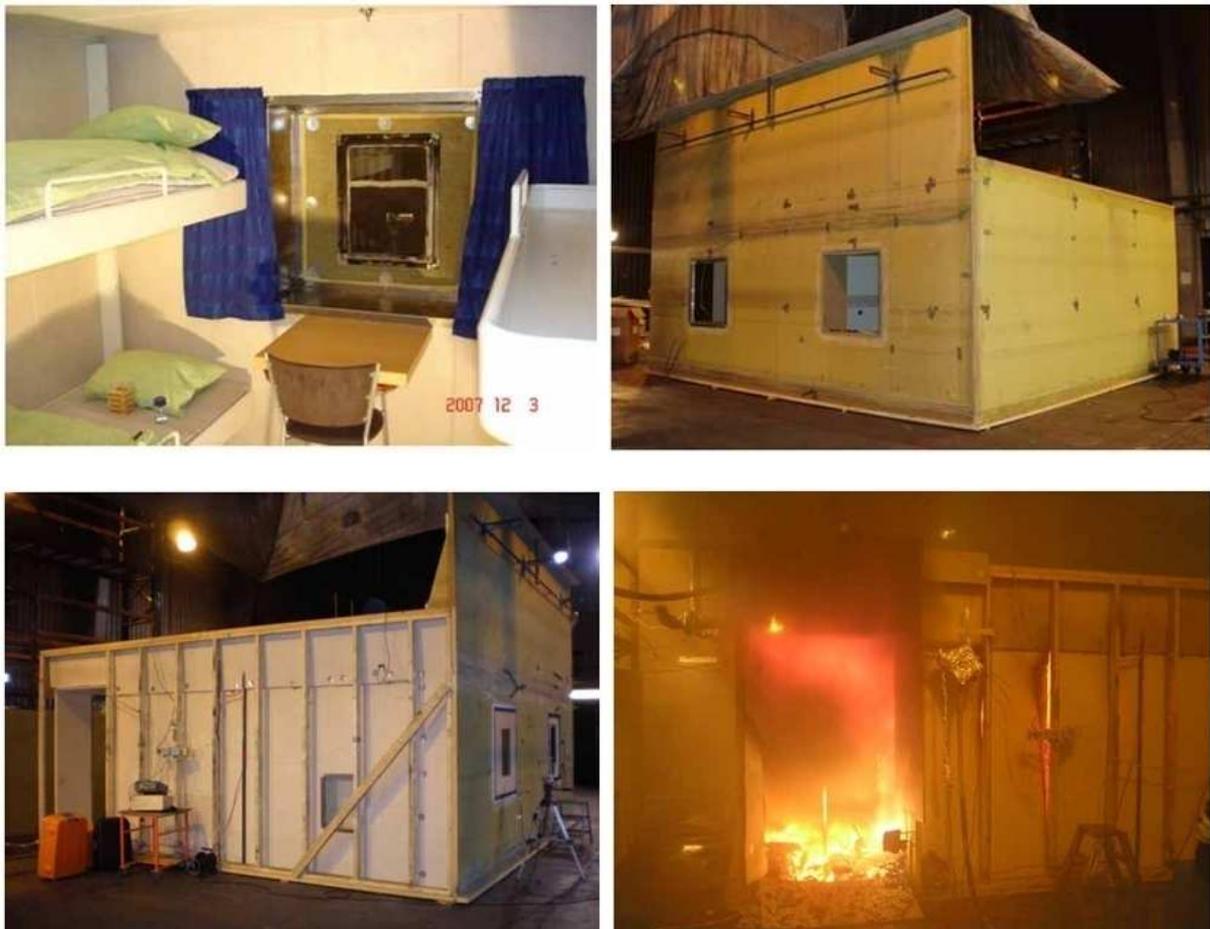
Figure 14. Interior and exterior of the large scale cabin test, before testing commenced. The bottom right image was taken after flashover had occurred in the cabin. Not shown in the interior picture are the luggage and clothes (Hertzberg, Axelsson, & Arvidson, 2008).

A series of tests were performed at SP (Hertzberg, Axelsson, & Arvidson, 2008), with different setups of fire safety systems failing in the case of a cabin fire. It was concluded that for the fire to be able to become severe it was necessary that both sprinklers and door closers failed. One of the test setups was meant to represent a plausible worst case scenario with a fully developed fire in the furnished cabin with 54 additional kilos of luggage. Total fire load in the cabin was 3,1 GJ at 12,9m<sup>2</sup>. The door to the cabin was left open and fire was allowed to burn unhindered, reaching a fully developed stage in less than 9 minutes. Most of the fuel had been consumed in the cabin after 45-60 minutes and the test was terminated after 156 minutes.

The composite superstructure was constructed from sandwich panels made of glass fibre reinforced plastic on a core of 50mm thick PVC Divinycell. The panels had stiffeners and were produced at Kockums using infusion technology. The resin used was polyester.

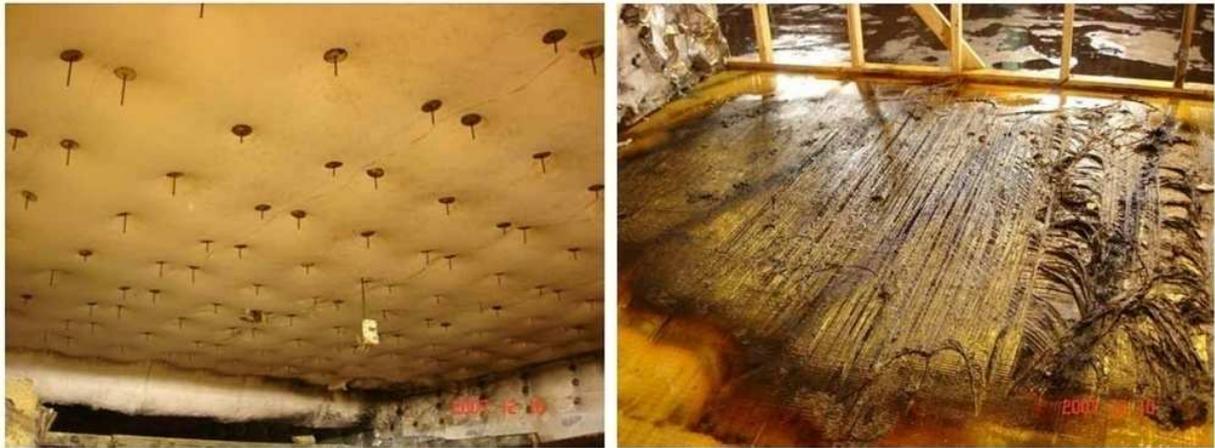
Figure 15. Overhead deck's bottom side and cabin floor, after completed test (Hertzberg, Axelsson, & Arvidson, 2008).

It was concluded that the FRP bulkheads and overhead deck in this setup were able to withstand the fire without critical damage. Furthermore, it was observed that the heat exposure the construction received was localized to right above the cabin that was burnt, since the FRP composite combined with the insulation is a poor conductor of heat. However, it was discovered that the bottom deck of the cabin sustained higher temperatures and more heat radiation that expected, resulting in quite a bit of damage to the floor and an estimated 10% mass loss. The floor was not weight loaded and was supported from underneath by a concrete slab and it is thus unclear how much load-bearing capacity was lost. The test concluded that the 20mm insulation that was tested for the floor was not sufficient for the floor construction while bulkheads and top deck passed the test. This amount of floor insulation was subsequently recommended to be increased to 30mm in another project as a result of this test.

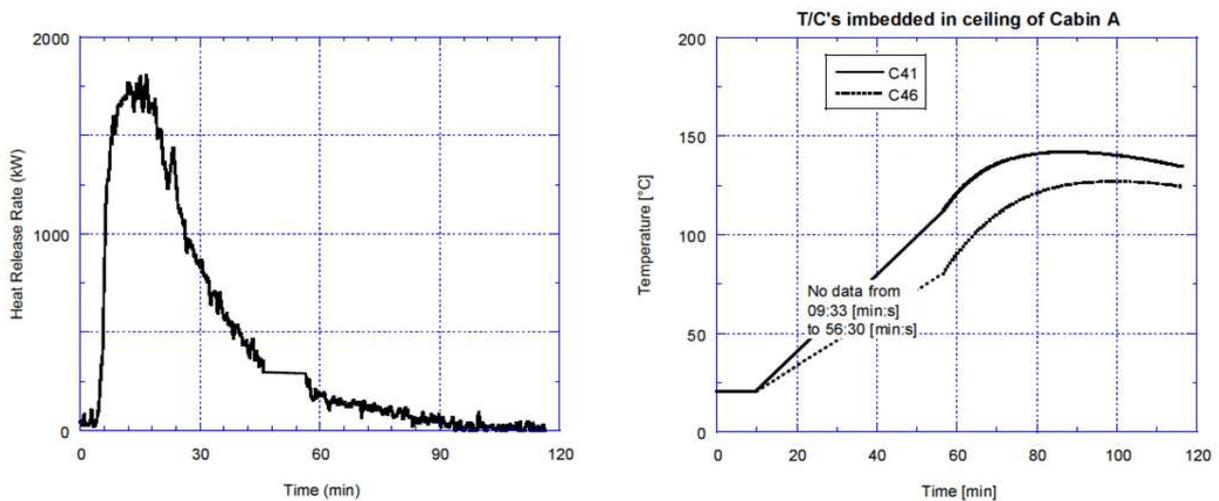
Figure 16. HRR and temperature in the FRP ceiling construction (Hertzberg, Axelsson, & Arvidson, 2008).

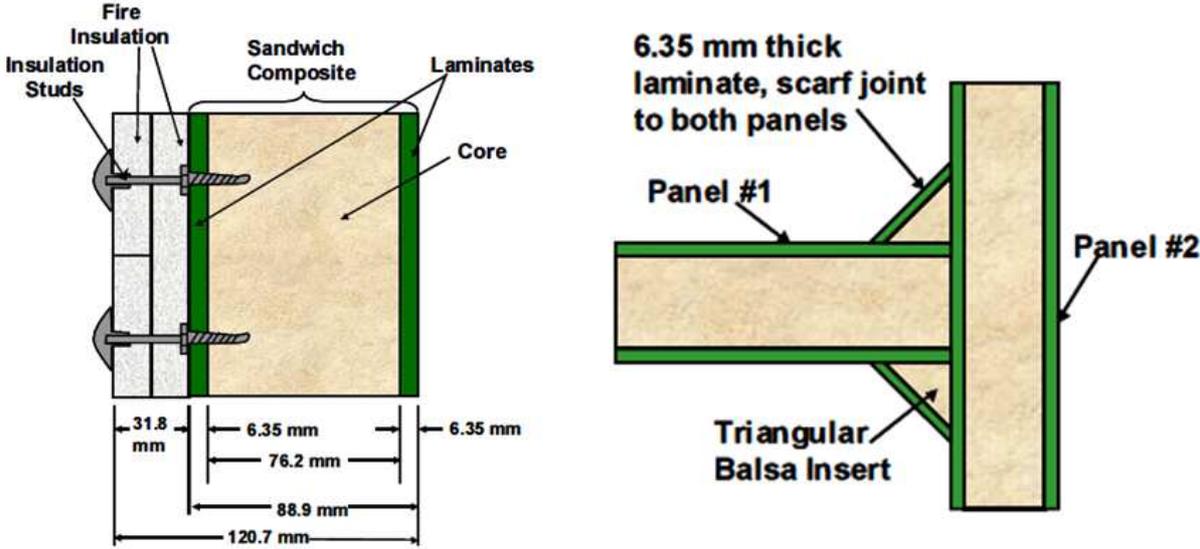
Figure 17. The tested FRP composite's construction, with insulation fastening and a T-joint (Lattimer, Oulette, & Sorathia, 2004).

This test report (Lattimer, Oulette, & Sorathia, 2004) tells of a series of six loaded tests; four bulkheads and two overhead decks both with and without insulation. The FRP panels were quite sturdy with a total thickness of 88,9mm. Its laminates were both 6,35mm thick with 10 layers of fibre glass on each side of a balsa wood core of 76,2mm thickness. Insulation was in applicable cases 31,8mm thick. Samples were subjected to a temperature of about 1100 °C. Load applied to bulkheads were 87,5kN/m. Deck loads applied to the uninsulated and insulated subjects were 14,4kN/m<sup>2</sup> and 8,6kN/m<sup>2</sup> respectively. All bulkheads and the insulated deck had some form of stiffening on one side of the panel while the uninsulated overhead deck did not have any stiffeners.

The following figures illustrates in order of appearance the FRP composite panel with insulation, T-joint detail, T-joint stiffened bulkhead test setup, T-joint installed un-stiffened overhead deck test setup, bulkhead stiffened with carbon stiffener test setup, T-joint stiffened overhead deck test setup and finally a carbon stiffener detail.

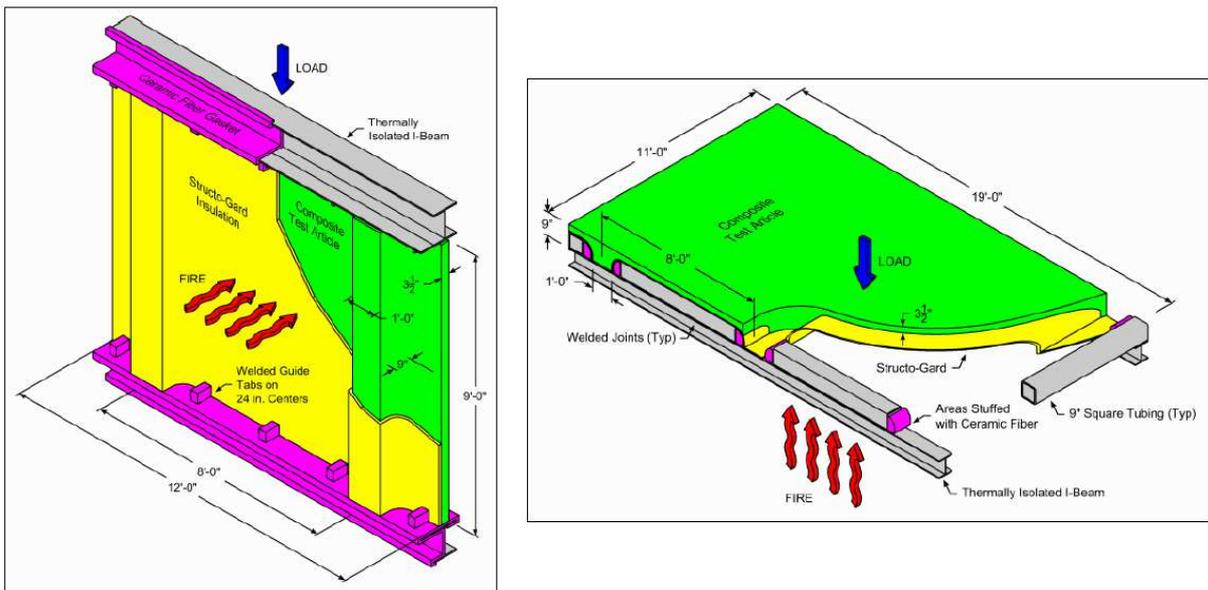
Figure 18. T-joint stiffened bulkhead and un-stiffened deck (Lattimer, Oulette, & Sorathia, 2004).

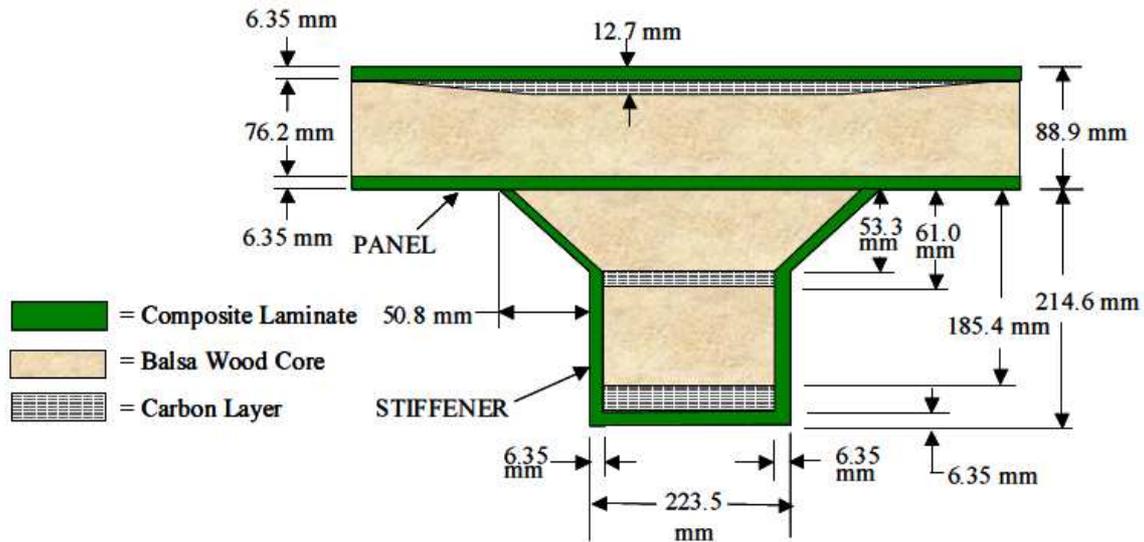
Figure 19. Bulkhead with carbon stiffeners and deck with T-joint stiffeners (Lattimer, Oulette, & Sorathia, 2004).

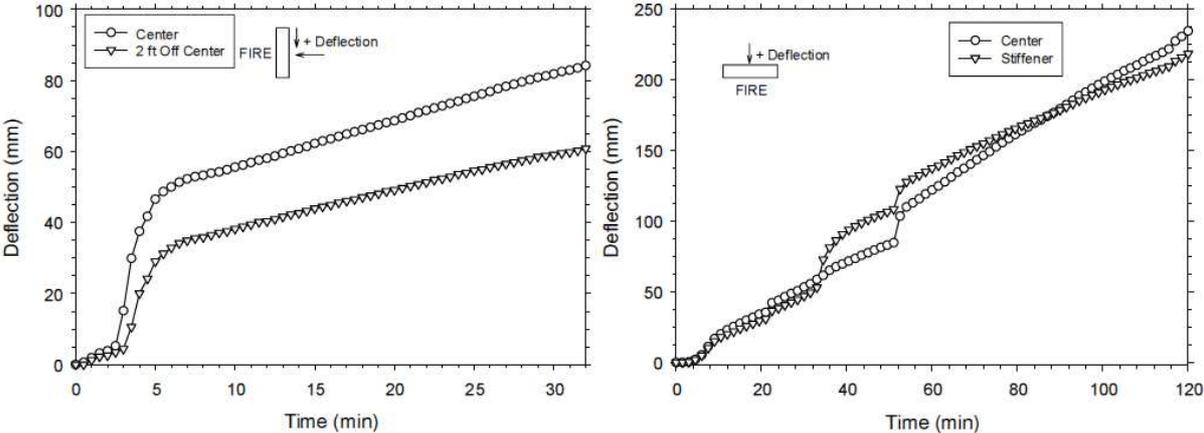
Figure 21. Graphs picturing transversal deflection in centre of tested FRP panels. Left hand graph is from test #2, Right hand graph is from test #6 (Lattimer, Oulette, & Sorathia, 2004).

Examining the graphs one can clearly see the initial deformation spike from delamination and the subsequent linear behaviour in the un-insulated case (left graph). In the insulated case this process is more gradual, because of the fact that there is insulation and a stiffener. The volatility in the region  $35 < t < 55$  is caused by the supporting steel structure deflecting due to high temperatures.

The report concludes some interesting results since all tested panels were measured for deflection which is something that occurred in all incidences, whether insulated or not since insulation was rather thin. The conclusion of the report was that neither bulkheads nor decks would collapse suddenly and without warning. The panels general behavior when subjected to the fire was such that as the laminate on the exposed side reached its critical temperature for loss of bonding, the panel would start to bulge or sag. This initial deflection caused by the first delamination would occur over a rather short period of time. The deflection would then continue to increase in a linear fashion as the fire proceeds to weaken the core.

about these two subjects that they remained intact on the unexposed for the duration of the test with no flame or smoke spread. Both subjects experienced quite a bit of sag: 85mm and 240mm respectively after 30 and 120 minutes, but no collapses. Do note that the difference in size of the panels, different loads and the addition of stiffeners to the insulated panel means that no real correlation can be made between the two in regards to amount of deflection as a function of time. Figure 20 pictures the two overhead deck panels deformation as a function of time.

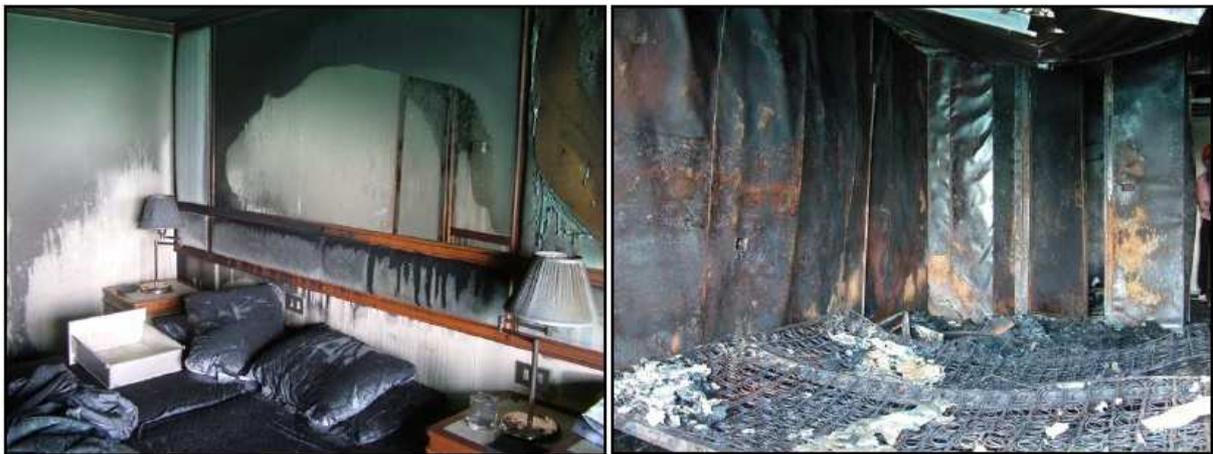
Figure 22. Damage done to a cabin with a functioning hi-fog system (left), and damage to the cabin with a malfunctioning hi-fog system (right) (MAIB, 2006).

This is an interesting case, as it is a recent major fire on board a large cruise ship that involved both outboard and interior spaces. In conclusion several important lessons can be taught from this accident. First of all, the crew made a commendable effort in combating the rapidly spreading large fire. They responded quickly and efficiently, proving that a well functioning firefighting organization can perform admirably. Second, the hi-fog system installed in all interior spaces was a huge factor in tipping the scale in favor of firefighters. In the cabins where the system was fully or partially functional, the fire was unable to take root. However, in a few cabins the system malfunctioned, probably due to broken sprinkler bulbs. One cabin got almost completely burnt out, resulting in a badly buckled and nearly breached inner ceiling and alleyway door. The following figure shows the cabins in which the hi-fog system was functional, respective non-functional.

Some further details on this incident are hereby summarized: In March 2006, a fire broke out on a balcony on the port side of cruise ship Star Princess. At the time 2690 passengers and 1123 crew were on board. The fire started on deck 10 and after an estimated 20 minutes of smoldering phase, it quickly spread once established. Within six minutes after fire establishment, deck 11 and 12 and two main vertical fire zones were involved. After 24 more minutes it had spread further, involving a third main vertical fire zone. The fire spread to the cabins after the glass doors separating them from the balconies shattered from the heat. Here, the fire was contained by the cabins' Marioff Hi-Fog fire-smothering system and was hindered from spreading further inboard. Temperatures on the balconies were high, in excess of the 550°C that is required to melt the aluminum structure. A total of 79 cabins were condemned by the fire, and another 218 were damaged by fire, smoke or water. During the fire a total of 168 water mist heads were activated. 8 failed to operate, 7 of which due to glass bulbs being empty. The cabins in which the water mist heads failed to operate were much more severely damaged, compared to the other cabins. They were

all but burnt out and their interior walls, ceilings and alleyway doors were buckled and almost breached, as opposed to the relatively slim damage in the other cabins where the Hi-Fog system functioned.
