THE DECISION TO EVACUATE A PASSENGER SHIP – AN ASSESSMENT OF THE NORMATIVE VIEW OF THE SHIPMASTER

Thesis/Project work submitted in partial fulfillment of the
requirements for the MSc in Human Factors and System Safety

LUND UNIVERSITY
SWEDEN

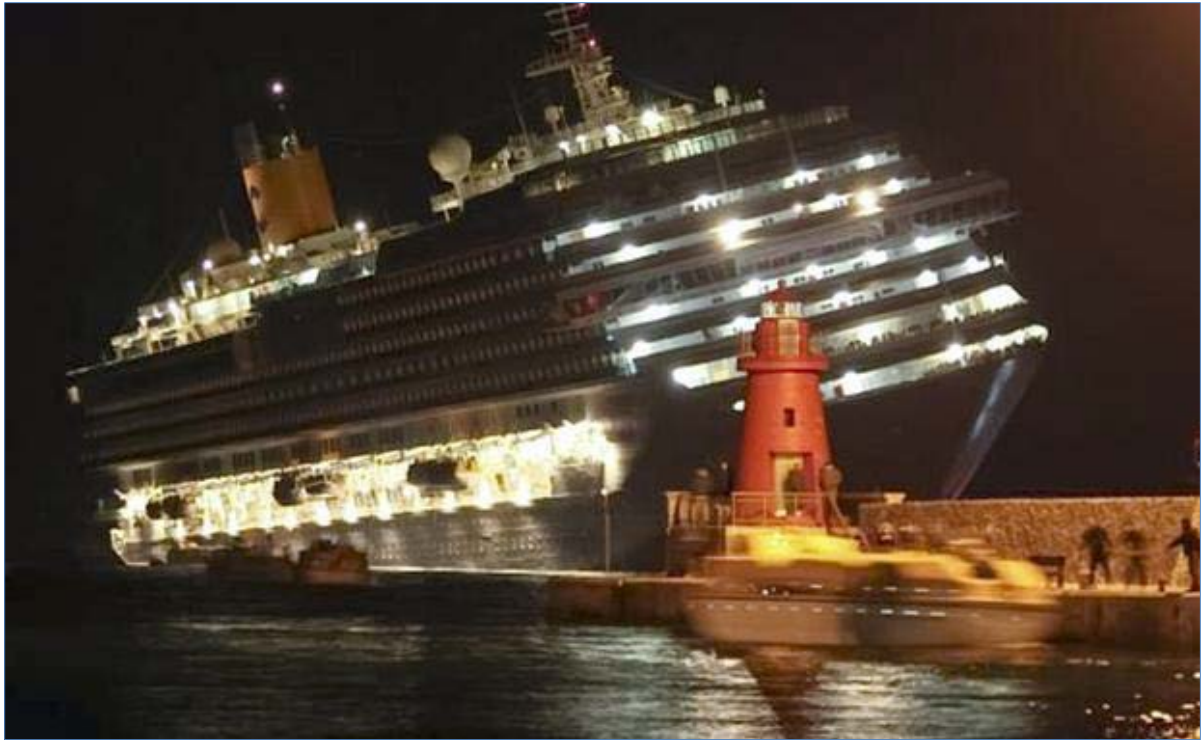
Figure 4: Costa Concordia shortly after the grounding at 2240
Source: MIT (2013)

At 2245 hours, the personnel at the MRSC⁹ Livorno contacts the shipmaster, who informs them that the ship is still floating and they will try to manoeuvre the ship closer to shore and attempt to anchor (MIT, 2013, p. 17), in fact the anchors had already been lowered at 2149 (MIT, 2013, p. 92) with the purpose of being ready to anchor when the ship reached shallow water. Below is a picture that illustrates the ships distance to shore shortly after the final grounding.

Figure 4: Picture of Costa Concordia shortly after the final grounding.

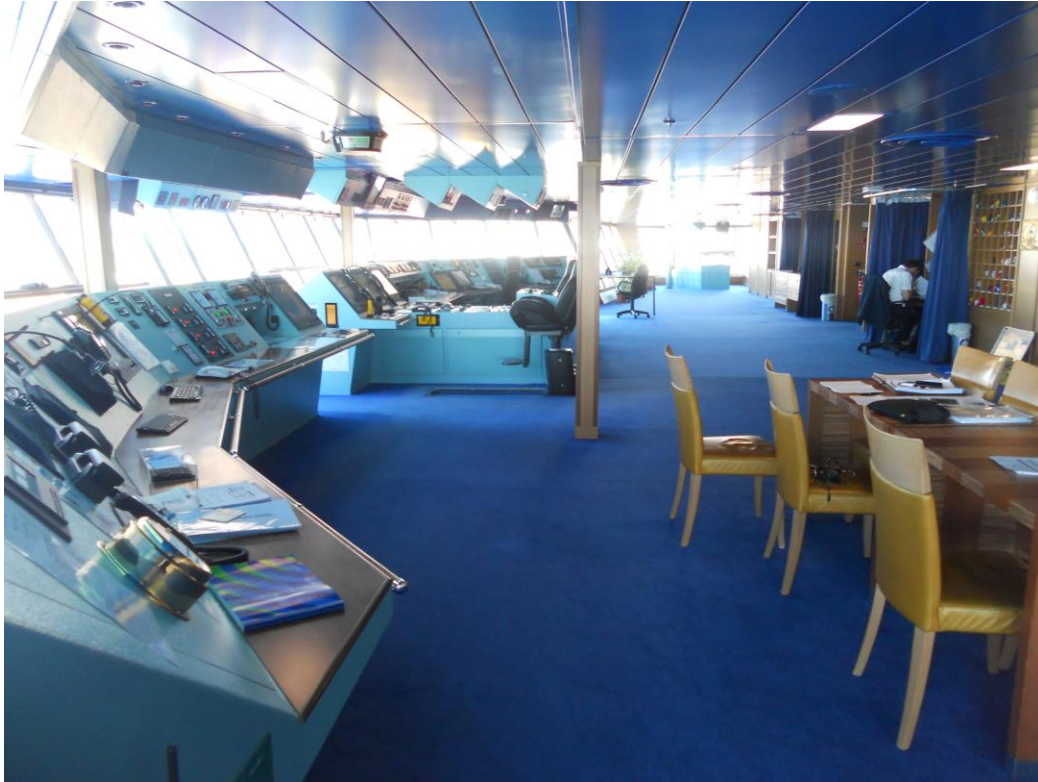
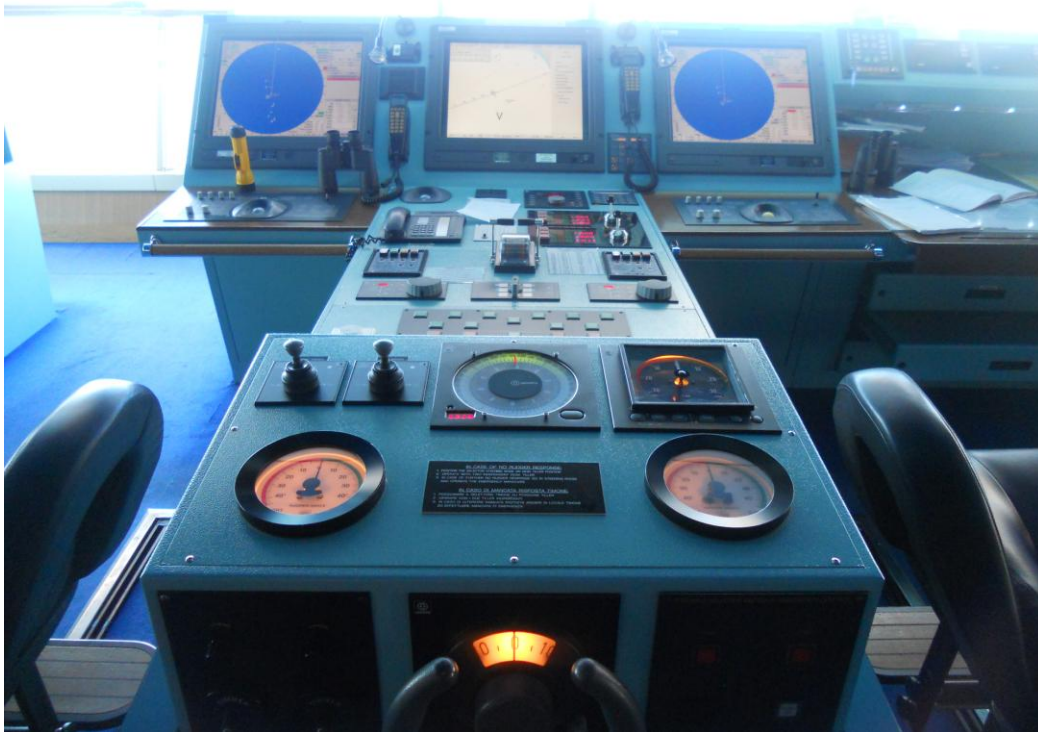
Following pictures taken from sister-ship Costa Serena:

At 21:34 The Master arrived at 21:39 on the bridge and took the guard. In the moments immediately prior to the accident the structure of the bridge, as described by the 1st Deck Officer (Appendix 3 - Excerpt from the testimony of the 1st Deck Officer) is as follows:

The Master moved between the position indicated by 1st Deck Officer and the windows of the bridge in the central area.

Figure 3: Picture from the bridge on the sister ship of Costa Concordia.

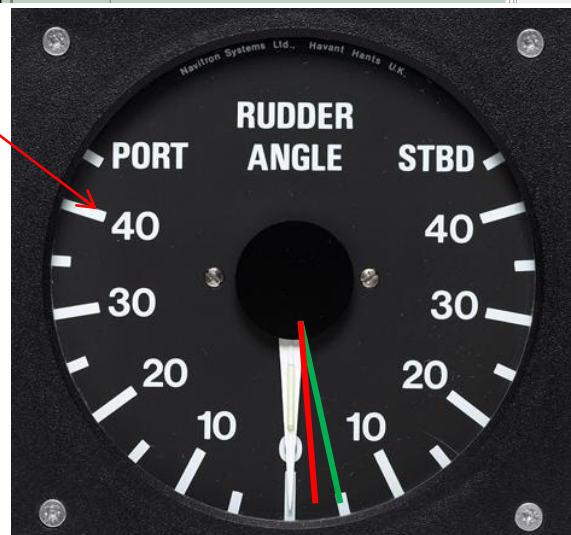
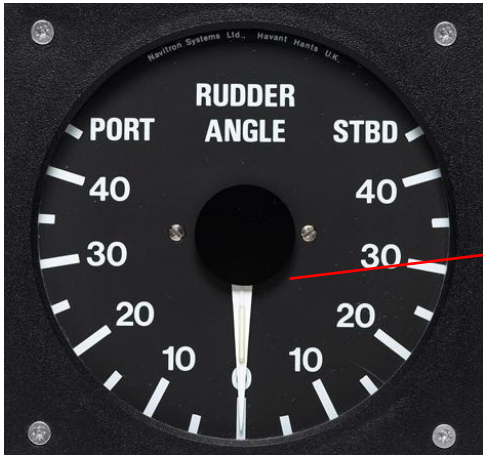
At 21:44:43 the Master ordered the helmsman "Port ten" (ten degrees to the left)

The helmsman, comes a little more than 5 on the left and the rudders move to the left to reach 2 degrees → to starboard effective - to the left - and 3.9 degrees to starboard effective - to starboard.

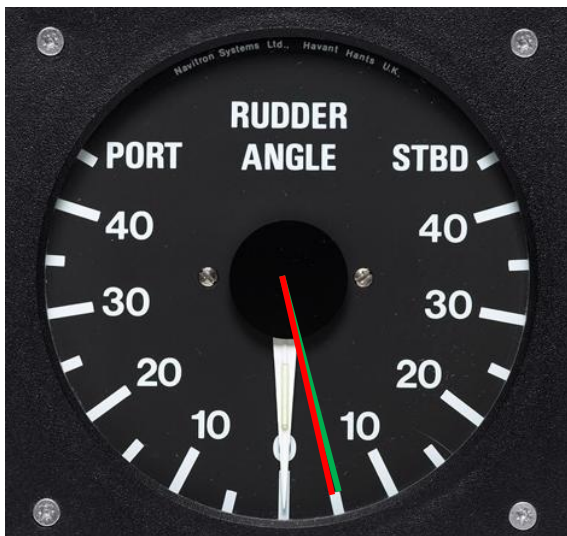
The helmsman realizes the error and corrects it by bringing the left rudder (spend about 8 seconds from the moment when the helmsman maneuver from 20 degrees to starboard at 20 degrees to the left) but the effect on the rudder given by the previous maneuvers carried determines a further shift to the left toward the starboard side and a slight movement to the left of the starboard. In fact, the rudder left up to 5.4 degrees to starboard actual (before 4.5 degrees to starboard) and 5.5 degrees to starboard to starboard (before 5.7 degrees to starboard).

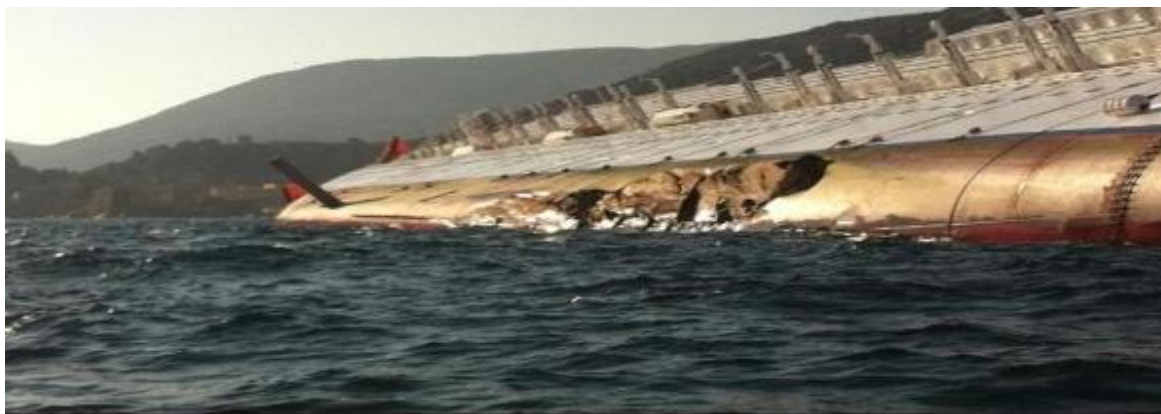
The hole on the left side upon impact, it is continuous for about 60 meters (about frames 52 to 124) located too far above the deck of the Double Bottom (so well over two meters from keel line). This was crucial in terms of severity of the accident, because rather than be hit the bottom of the ship, if the more defence due to the double hull, was vice versa affected area clear that, over the plate rail, relies directly its operating compartments (the heart). In particular, the testimonies of the 3rd Engineer Officer and 2nd Engineer Officer, as well as the 2nd Chief Engineer) - combined with audio recordings of communications between the VDR machine and Bridge - have established that in a few minutes (about 3 mins for the EMP and 7 for Diesel Generators Room. aft) the ship has lost Watertight Compartments (WC) nr. 5 and 6 (PEM and then Local DD.GG. aft), while the adjacent WC nr. 4 and 7 (respectively Compressors Galley Room and DG Room), were initially partially flooded, becoming initially dangerous free liquid water surfaces, and then completely filled after about 40 minutes from the contact.

The water appears to have also affected the adjacent WC nr. 3 and 8 (respectively Local Stores and Local Evaporators), which consists of more than free liquid surfaces, hazardous for the purposes of further reduction of the dynamic stability.

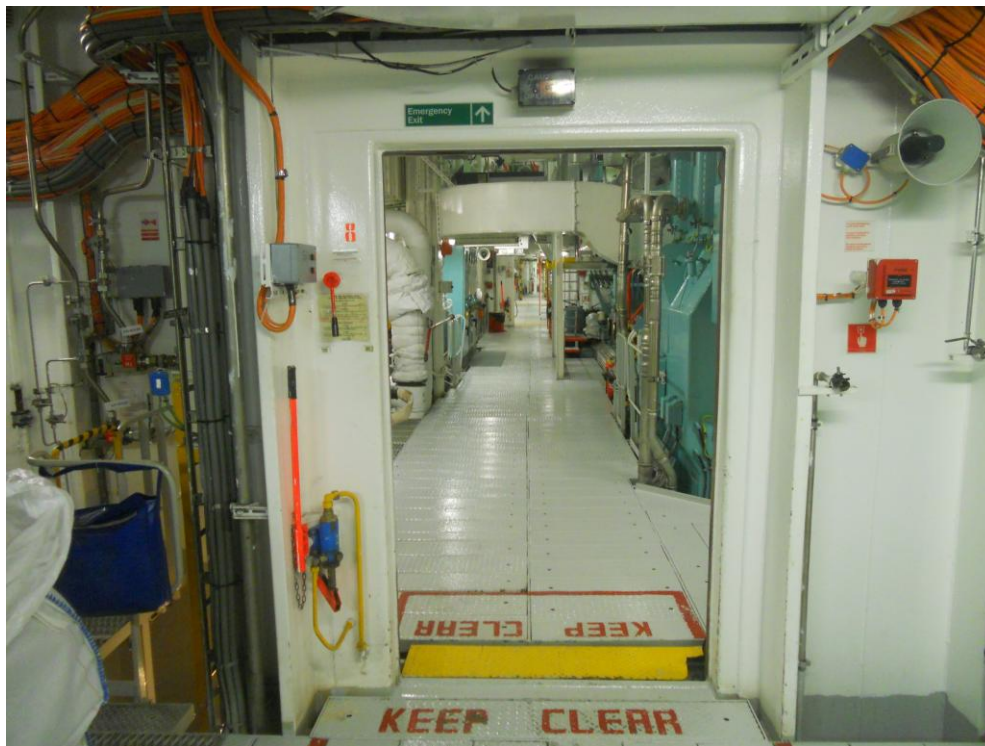
WTCs nr. 6 and 7 (depth view) sight from 5th

Following pictures taken from sister-ship C/s Costa Serena:

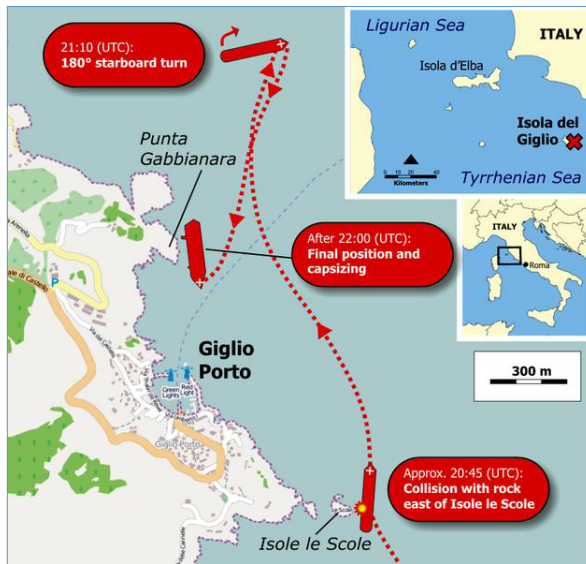
Figure 2: Main events before the foundering
Source: MIT (2013)

Figure 2: Overview of events during the emergency on Costa Concordia.

The main events are illustrated on figure 2 below. A picture of the bridge where the shipmaster was located is seen on figure 3.
