Sediment Transport in the Piura River. Piura, Peru.

An application with the HEC-RAS model

Master Thesis

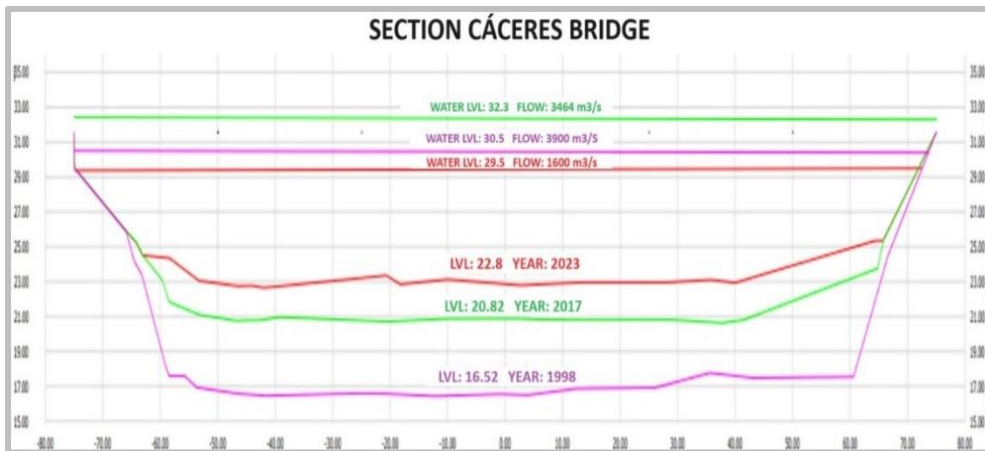
Figure 3- Section Cáceres Bridge showing bottom level development. (adapted from Reyes Salazar, 2024b)

The semi-arid climate in the lower basin changes during El Niño episodes, during which there is frequent and heavy rainfall for a period of 4-5 months (UDEP & UNP, 2001e). Flood events in Piura are generally linked to the increased precipitation experienced during El Niño. The current river system is incapable of controlling the large quantities of water that develop during this event (UDEP & UNP, 2001e). In the past, flooding occurred due to a lack of urban drainage together with erosion of the riverbed which resulted in the collapse of river infrastructure (Reyes Salazar, 2024b). However, the most recent flood event of 2016-2017 revealed an ongoing process of aggradation which is reducing the capacity of the river (Reyes Salazar, 2024a). Figure 3 shows data collected by the University of Piura for the bottom level and water level for three different years at three different flows. The bottom level in the urban reach has increased 6m since 1998. Consequently, the capacity of the river has decreased.

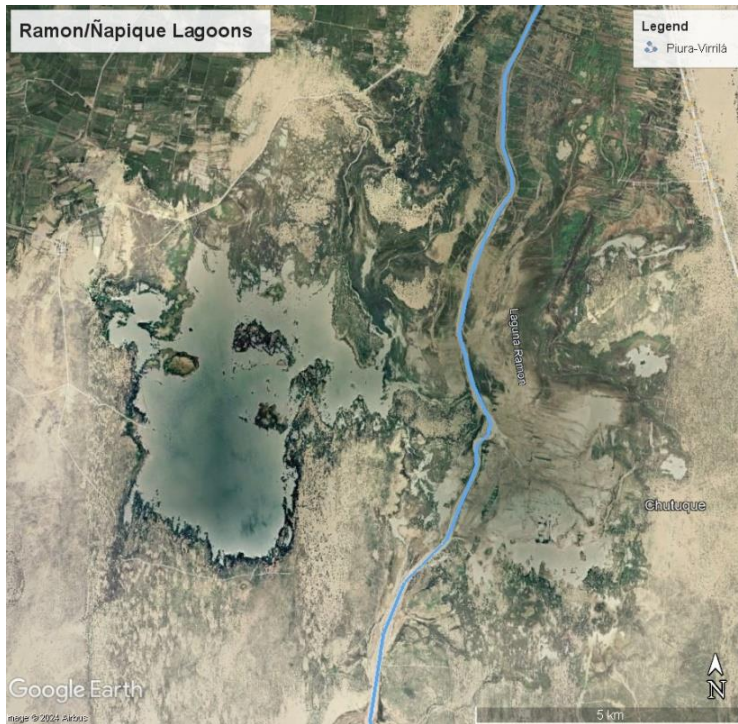
Figure 4- Sedimentation of the Ramón Lagoon (Google Earth, 2024)

before exiting into the ocean. For that reason, it should be noted that the Ramón Lagoon has been steadily filling up with sediments. An estimated 30% of the original capacity remains (Reyes Salazar, 2024b), the sedimentation can be observed as shown in Figure 4.

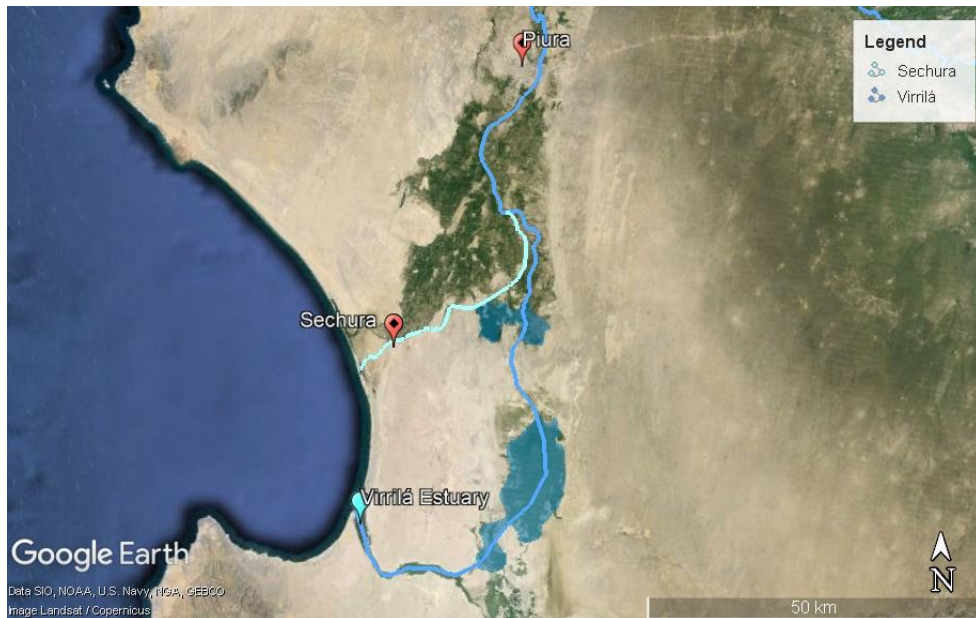
Figure 5- Piura River routes through Virrilá and Sechura (Google Earth, 2024).

The aim of this thesis is to compare sediment transport in the Piura River for two different river courses. The routes are shown in Figure 5, these are the existing course through the Virrilá Estuary, and a proposed course through Sechura. The software HEC-RAS is used to create a river model for the two routes. Velocity and depth output is used to compare transport capacity.

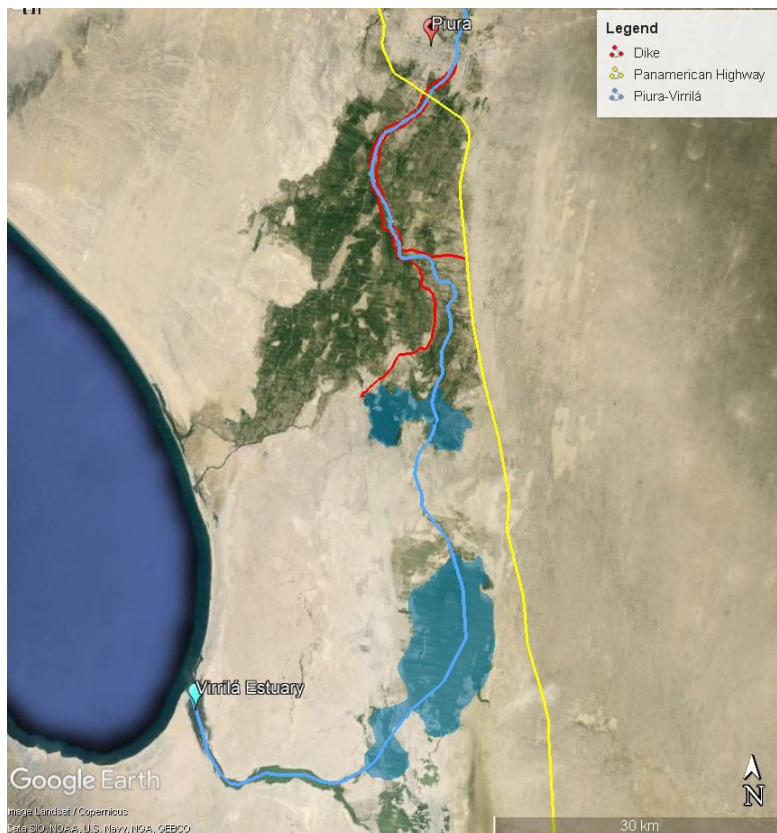
Figure 9- Dikes in lower basin (Google Earth, 2024)

Agriculture plays an important role in the Piura region; it is considered the main reason for regional employment (MGI, n.d.) and makes up 5.7% of the national GVA (CIIFEN, 2020). Consequently, the river has been subject to land use changes due to agricultural activity and human settlements. (Alvarado Ancieta, 2023). At the beginning of the 20th century, the rapid growth of the cotton industry led to the construction of dikes to protect crops in the floodplain during increased flow (Zegarra Dávila, 2023). This was the beginning of a gradual redirection of the river towards the lagoon system in the south through the construction of dikes. Large flows would regularly breach the dikes, consequently these were reinforced in the 1970's and became permanent structures (Azurin Gonzáles, 2010). The location of the dikes is shown in Figure 9.

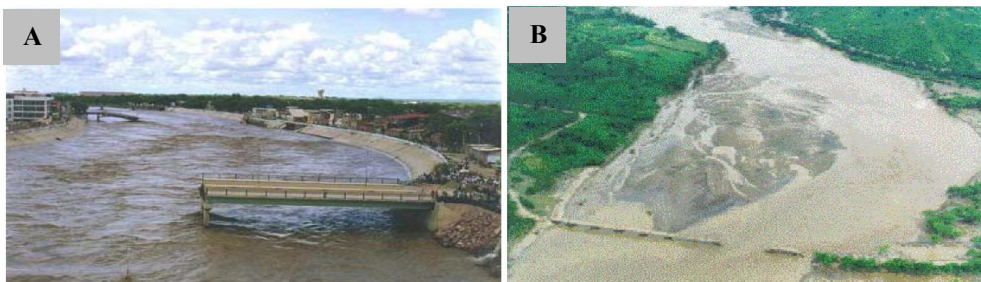
Figure 10a- collapsed San Miguel and Bolognesi Bridges 1998. 10b- collapsed Independencia bridge 1998. (Alvarado Ancieta & Ettmer, 2007)

In 1998 the flow in the river reached a peak at $3,900\text{m}^3/\text{s}$ (Fariás Zegada, 2008). The event had similar impacts as that of 1983 with losses of approximately S/13,100 million, or 6.2% of the GDP (SENAMHI, 2014). During this event, the increased transport of sediments resulted in erosion at the foot of the dikes and breached the left dike, further the bridges San Miguel, Bolognesi, and Independencia collapsed as shown in Figure 10 (Alvarado Ancieta & Ettmer, 2007). The San Miguel and Bolognesi are a part of the urban reach while the Independencia bridge is further downstream of the city Piura as shown in Figure 11.

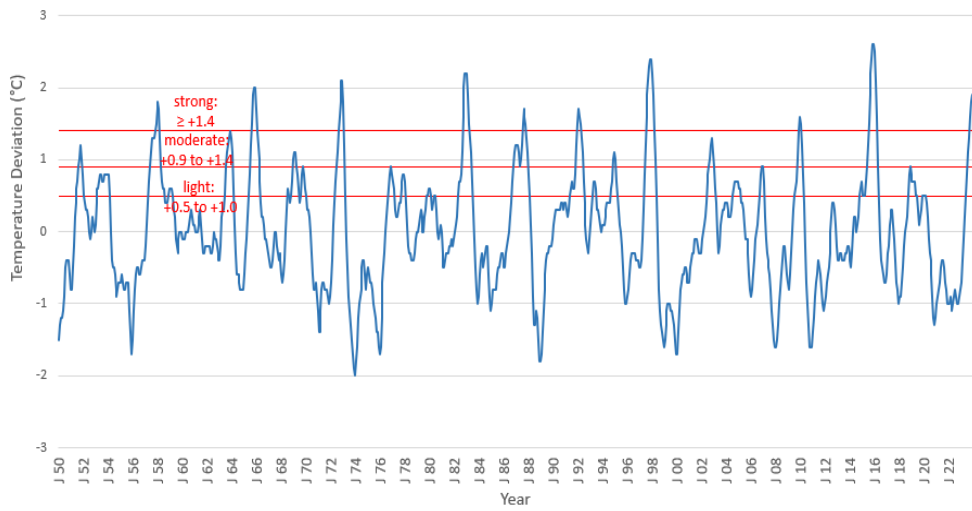
Figure 13- ONI values for Niño Zone 3.4 for 1950-2023. Temperature deviation for averages of 3 consecutive months. Thresholds at neutral -0.5 to +0.5, light +0.5 to +1.0, moderate +0.9 to +1.4, and strong > +1.4 (SENAMHI, 2014). (NOAA, 2023a)

Zone Niño 3.4 is used to monitor the Oceanic Niño Index (ONI). This index is measured as an average of temperature anomalies during three consecutive months in the region Niño 3.4. Cold and warm episodes are indicated when a threshold of $\pm 0.5^{\circ}\text{C}$ is exceeded (NOAA, 2023b). When the threshold is exceeded for a minimum of five consecutive months, an El Niño (warm) or La Niña (cold) episode is defined (NOAA, 2023b). Further, the National Study of El Niño (ENFEN), a multisectoral committee in charge of studying El Niño in Peru, has developed an index to describe the variation in temperature in Niño region 1+2 called ICEN (SENAMHI, 2014). The index is calculated in the same way as the ONI and indicates the occurrence of an El Niño event on the coast of Peru, known as El Niño Costero. The ONI index is shown for 1950-2023 in Figure 13 together with threshold values for El Niño classification. Figure 14 shows the El Niño Costero (ICEN) occurrence since 1950.

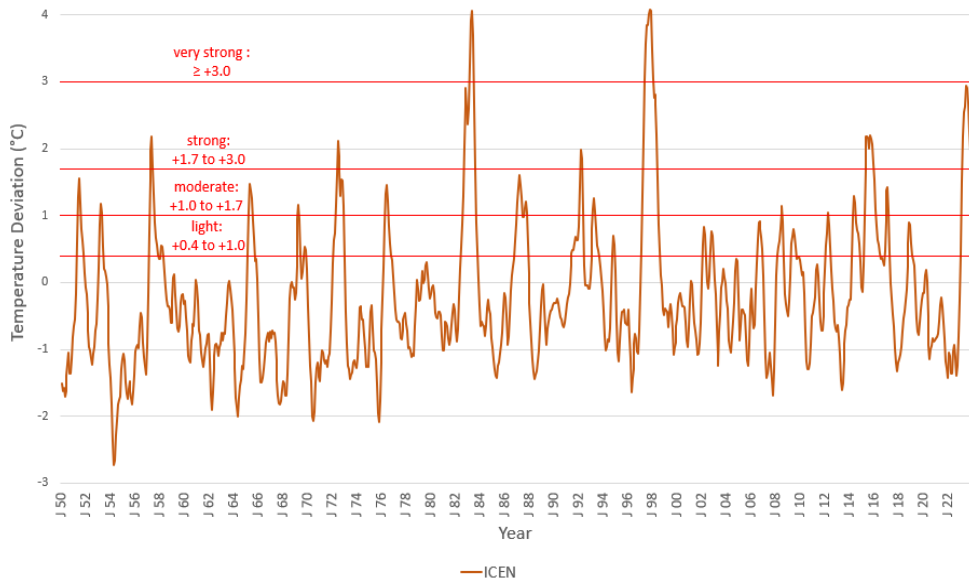
Figure 14- ICEN values for Niño Zone 1+2 for 1950-2023. Temperature deviation for averages of 3 consecutive months. Thresholds at neutral -1.0 to +0.4, light +0.4 to + 1.0, moderate +1.0 to 1.7, strong +1.7 to +3.0, and very strong > +3.0. (Instituto Geofísico del Perú, 2023)

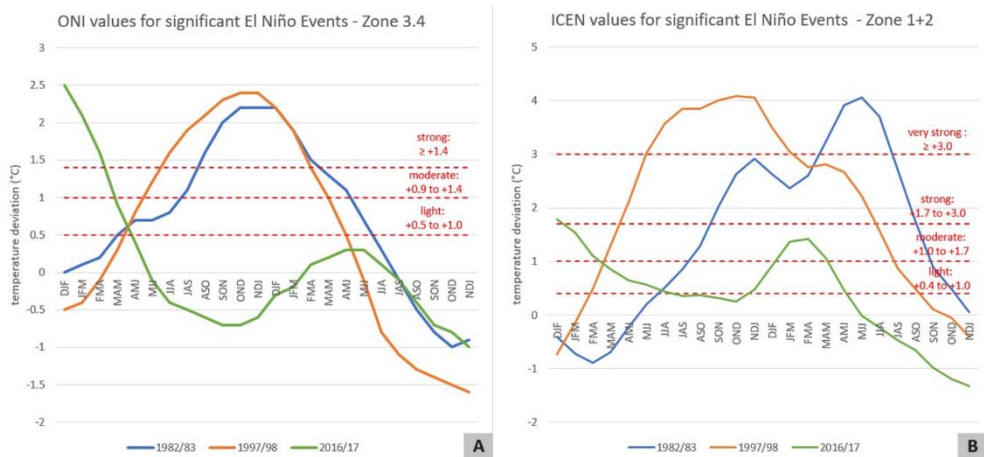
Figure 15a- ONI values for El Niño Events 1982/83, 1997/98, and 2016/17. Temperature deviation for averages of 3 consecutive months (NOAA, 2023a). 15b- ICEN values for El Niño Events 1982/83, 1997/98, and 2016/17. Temperature deviation for averages of 3 consecutive months (Instituto Geofísico del Perú, 2023).

Figure 15 shows that the events of 1983 and 1998 were characterized as ‘strong’ El Niño events on the ONI scale, the 2017 event was below the El Niño thresholds. However, the ICEN value indicating temperature anomalies in El Niño zone 1+2 coast show that there was a temperature increase locally along the coast, which created the conditions for the increased precipitation and flow experienced in 2017 although Zone 3.4 was in La Niña (cold) conditions.

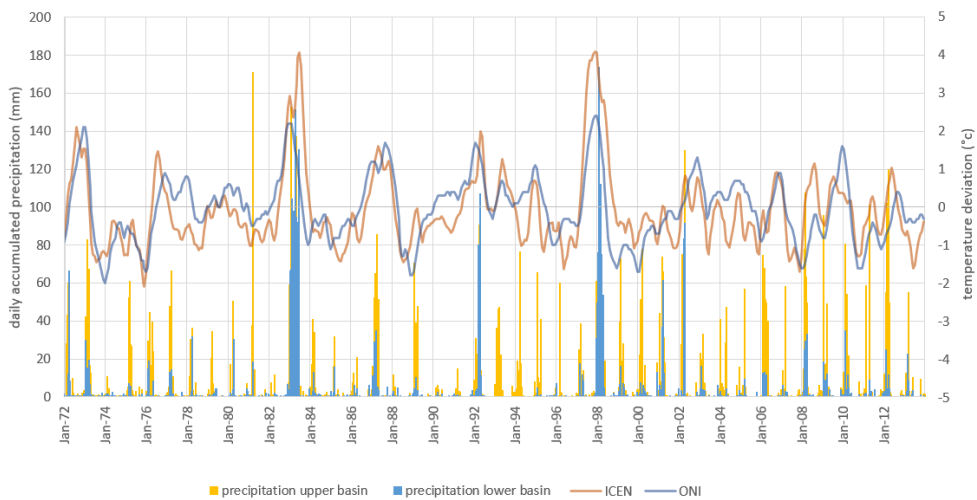
Figure 16- ICEN and ONI values with daily accumulated precipitation values for the upper and lower basin from 1972-2013

precipitation of around 3,000mm (Azurin Gonzáles, 2010), this is an increase in yearly precipitation by a factor of 30-60. The relationship between precipitation and ONI/ICEN is shown in Figure 16 for stations in the upper and lower Piura River basin for the years 1972-2013. The data ranges to 2013 as this is what was available on the website of the National Meteorological and Hydrological Service (SENAMHI) for chosen stations.

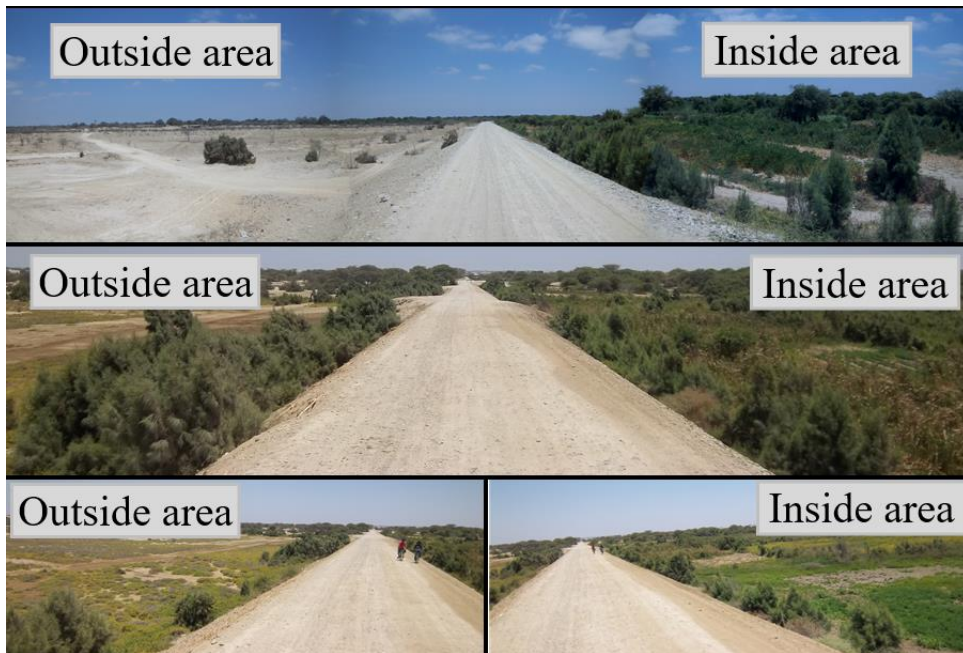
Figure 17- Vegetation difference inside and outside the dikes (Guererro et al., 2015)

formation of an alluvial fan. Research by the University of Piura indicates that flooding of the river used to bring nutrient rich sediment to the floodplains which allowed for vegetative growth (Guererro et al., 2015). However, now the floodplains are restricted to the area within the dikes, this has been made evident by the difference in vegetative coverage inside and outside the dike area as shown in Figure 17.

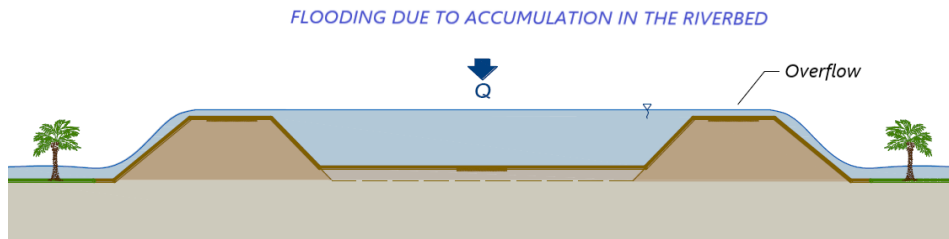
Figure 18- Accumulation of sediments inside the floodplain restricted by dikes (adapted from Castillo Zavaleta, et al., 2019)

As concluded by the Class-Salzgitter study in 2001, this vegetative growth creates resistance to flow, thereby causing an increase in the level within the enclosed zone (Class-Salzgitter, 2001 cited in Córdova Elera, 2020). In combination with the restriction of the flood plain created by the protective dikes, there is a more concentrated accumulation of sediments which creates overflow as shown in Figure 18 (Castillo Zavaleta, et al., 2019).

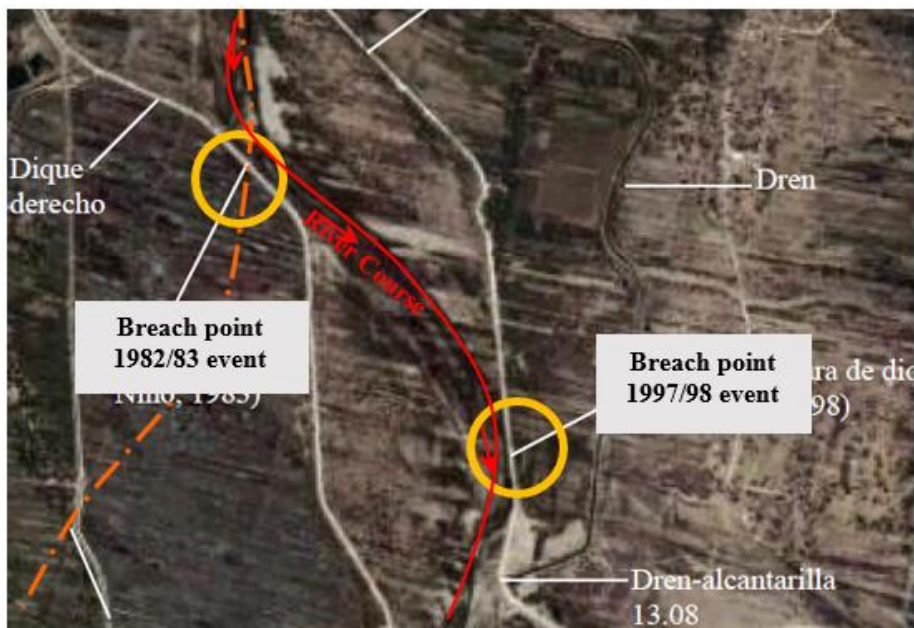
Figure 19- Dike breach points in 1982 and 1997 (adapted from Alvarado Ancieta & Ettmer, 2007)

According to Alvarado and Ettmer (2007), the sinuosity of the river should be greater than what it currently is considering the slope and the annual average flow, they conclude that the ability of the river to meander is constricted by the dikes (Alvarado Ancieta & Ettmer, 2007) as can also be seen from satellite images where the river frequently meets the dikes as shown in Figure 19. In the years 1982 and 1997, the dikes were breached at these points (Alvarado Ancieta & Ettmer, 2007).

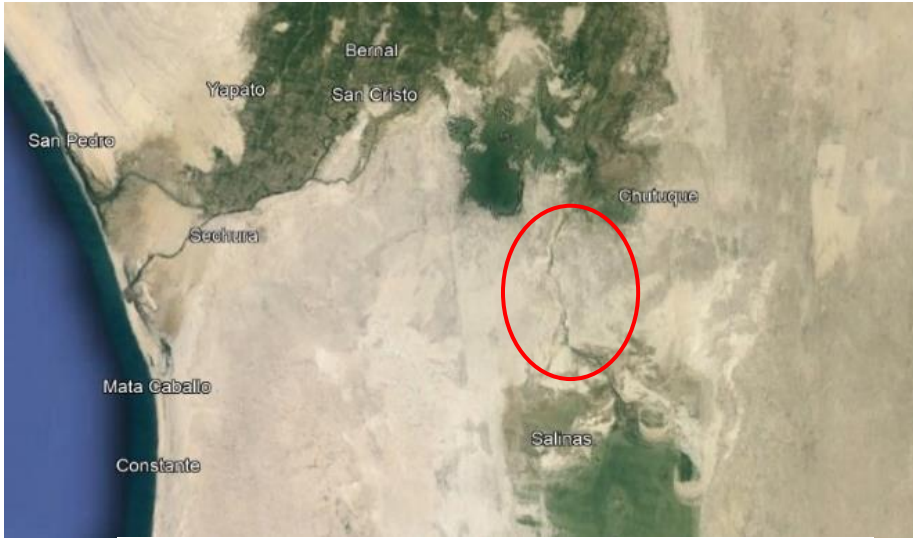
Further works are being undertaken to redirect the river towards the south to exit through Reventazón. This is a part of the ARCC's "Integrated Master Plan for Flood Control and Sediment Transport Management in the Piura River Basin", where a relief channel will be built between Chutuque and Pampa Las Salinas as shown in Figure 20 to improve flow conditions in the lower basin (ARCC, 2022).

Figure 20- Location of Chutuque channel (Google Earth, 2024)

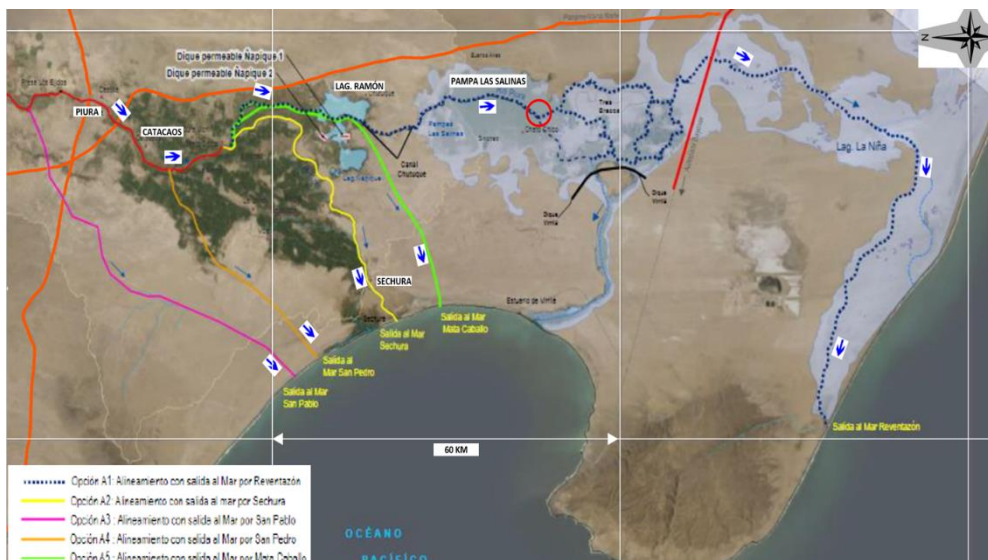
Further, Zegarra presented various potential routes during the Conference for Hydraulic Structures during Flood Events organized by the Colegio de Ingenieros del Peru (Chapter of Civil Engineering of Peru) in 2023. The routes are shown in Figure 22. For Option A2 (yellow) through Sechura, a pilot channel has already been designed to compare to the planned route through Reventazón. Zegarra estimates that the costs for the exit through Sechura are approximately 60% of the investment needed for the exit through Reventazón (Zegarra Dávila, 2023).

Figure 22- Potential routes for Piura River discharge (Zegarra Dávila, 2023)

In this thesis, option A2 (yellow) through Sechura is compared to the current exit through Virrilá. This proposed route was chosen after a virtual meeting with Zegarra during the time in Piura. This proposal already has design parameters since the aforementioned pilot channel was used for cost estimation. As such, a comparison of this route to the existing route using river modelling is a further step to determine the effectiveness of the proposal. The upcoming Chapter 4 describes a field visit following the proposed river course through Sechura.

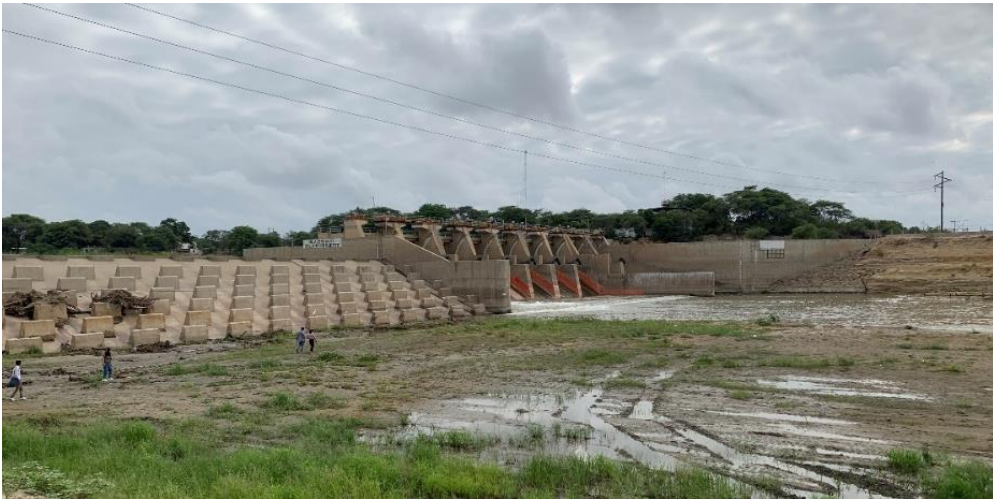
The excursion began at Los Ejidos Dam located approximately 3km upstream of the city center. The dam is shown in Figure 24 where a weir structure on the left and the gated spillway on the right are visible. The flow through the river on this day was low and consisted primarily of water supplied by the Chira River to the north.

Figure 24- Los Ejidos dam spillway

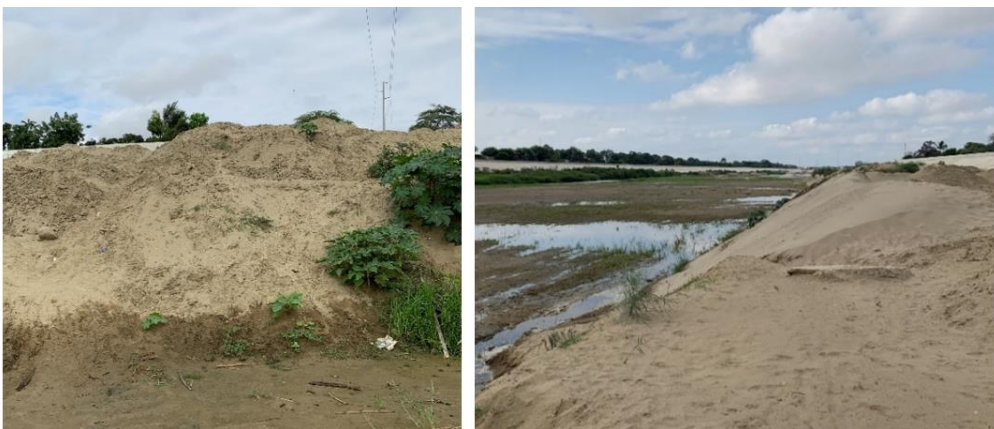
Sediment in this area was found to be mostly sand with clayey-sand deposits closer to the riverbank. At the dam works have been conducted to remove approximately 3m of accumulated sediment as shown in Figure 25.

Figure 25- Sediments at Los Ejidos dam. 25a- View from bottom. 25b- View from top

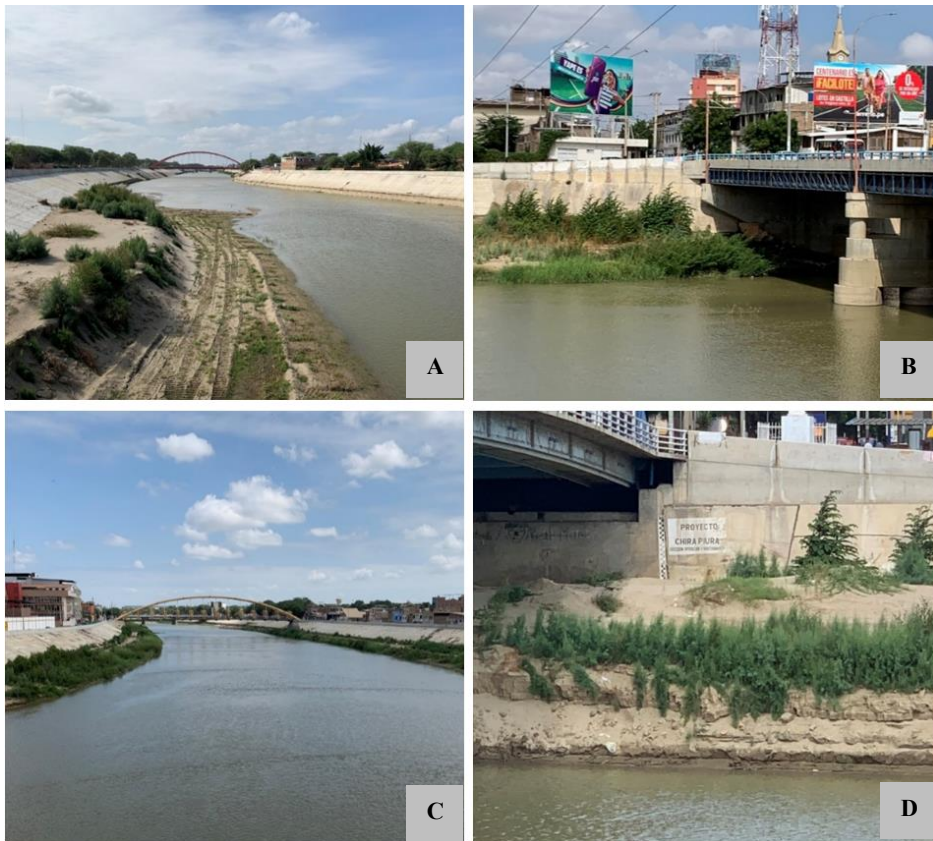
The excursion continued through the city where stops were made at different bridges. As mentioned, the river is channeled in the city and the riverbanks are made of concrete. Aggradation is visible along the riverbanks as shown in Figure 26. Further, the areas where sediment has been deposited promote vegetative growth.

Figure 26- Vegetative growth at riverbanks. 26a- View downstream of Cáceres. 26b- Below Cáceres Bridge. 26c- View upstream of Bolognesi. 26d- Below Bolognesi Bridge

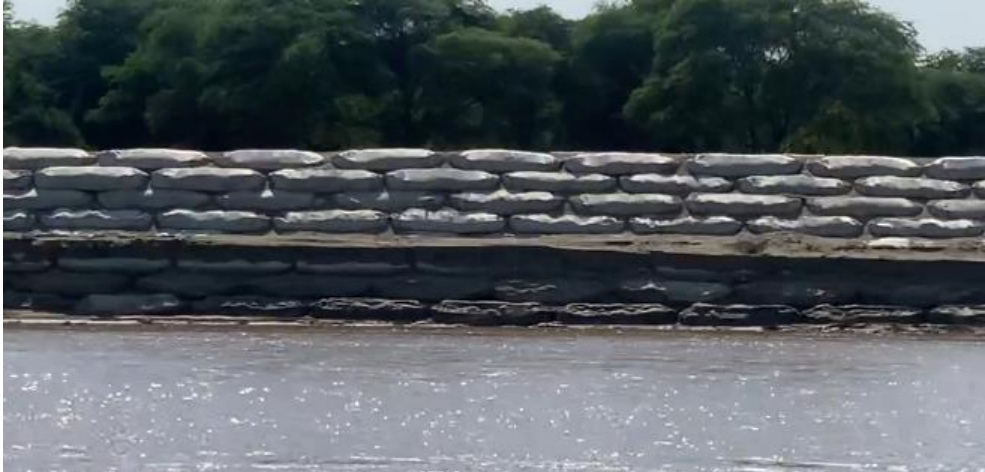
General aggradation is visible since the level of the floodplain was often observed to be above the level outside of the dikes. However, in some spans erosion is visible. This can be seen in Figure 29, taken close to Drain 13.08

Figure 29- Erosion close to Drain 13.08

The drain crosses the Piura River in a pipeline. The location of the pipeline is visible across the Piura River. This may be due to erosion in this section of the river. As shown in Figure 34 many rows of the river defense have been revealed due to transport of sediment. This may put the pipeline in risk of failure.

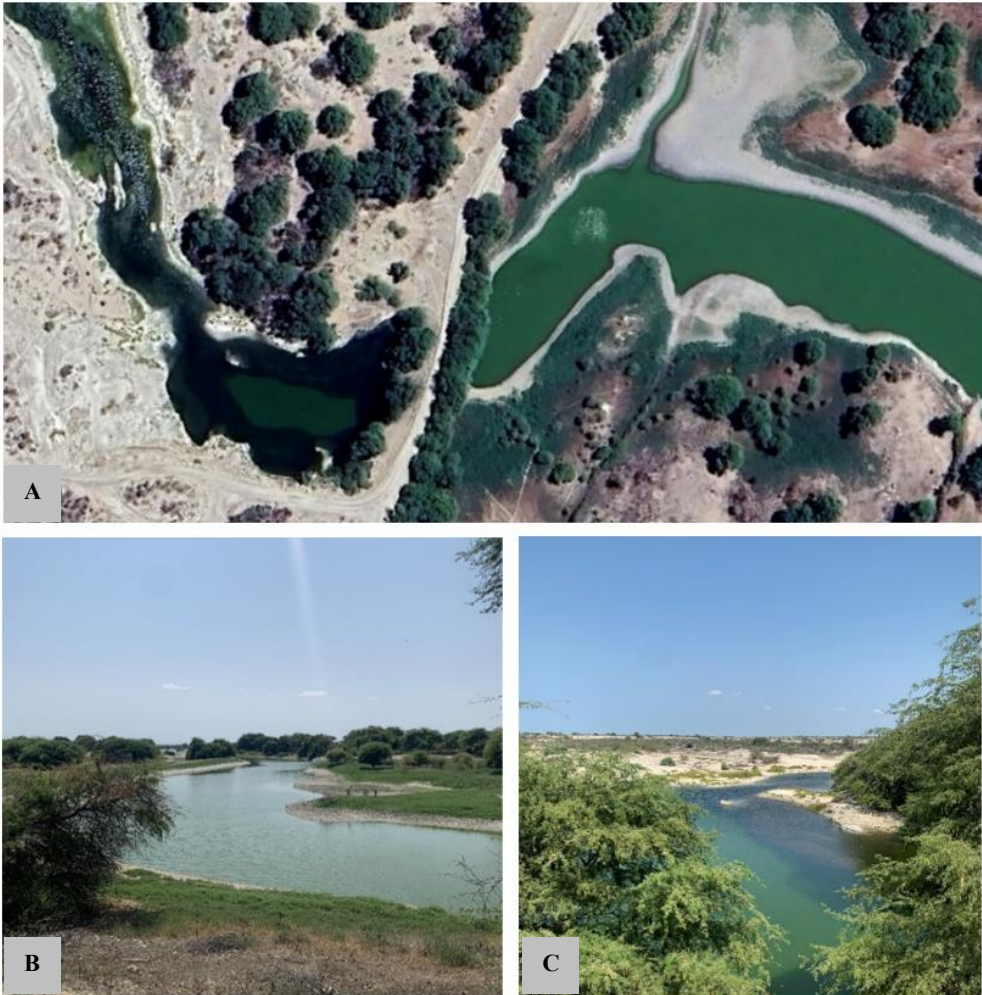
Following the dike on the right side of the river, The Ramón/Ñapique Lagoon is bordered by the dikes as shown in Figure 31. The vegetation differs upstream and downstream of the dike, where the surroundings upstream have more greenery than downstream.

*Figure 31a- Ñapique Lagoon dike (Google Earth, 2024). 31b- Upstream of dike.
31c- Downstream of dike*

The location where the river used to pass towards Sechura is shown in Figures 40 and 41 where Figure 40 is inside of the dike and Figure 41 is outside towards Sechura. The two sides are separated by the dike structure shown in Figure 42 and could be easily reconnected.

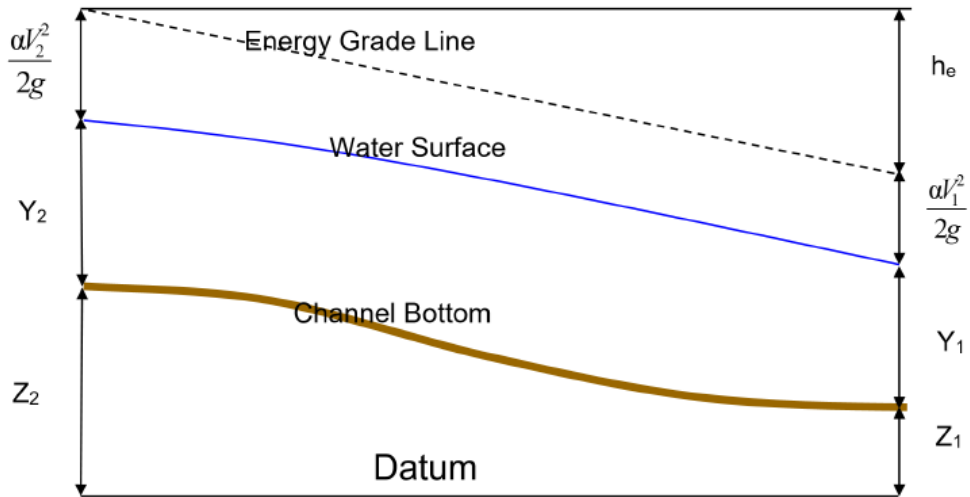
water surface profiles from cross section to cross section as shown in Figure 34 (HEC, 2024a).

$$(5) \quad Z_2 + Y_2 + \frac{\alpha_2 V_2^2}{2g} = Z_1 + Y_1 + \frac{\alpha_1 V_1^2}{2g} + h_e$$

Figure 34- Water surface profile calculation in HEC-RAS (HEC, 2024a)

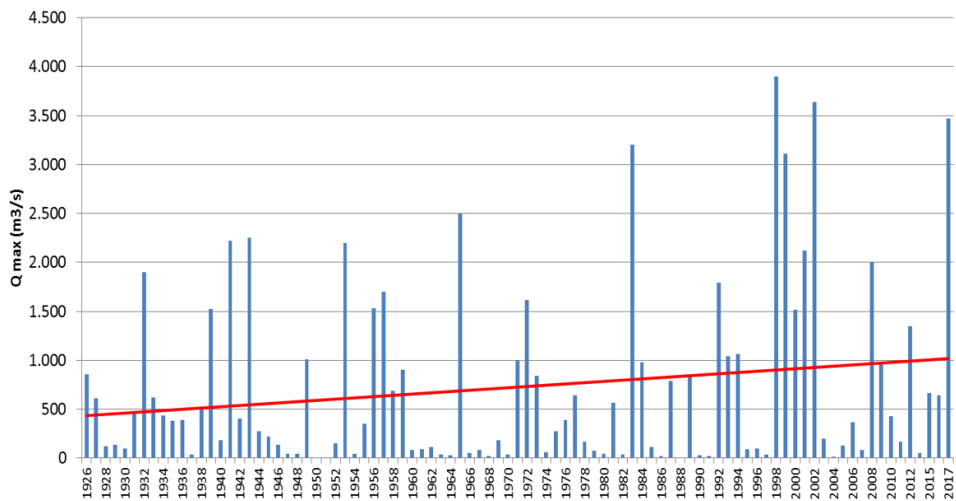
As mentioned, the Piura River is non-perennial. The flow through the lower basin is heavily influenced by the presence of El Niño due to the increased precipitation during this weather event. Data for maximum flow through the river has been available since 1926 and is shown in Figure 35. The trendline indicates that the flow through the river is increasing over time.

Figure 35- Maximum flows through the Piura River from 1926-2017 (Fariás Zegada, 2008)

Data shows that following 1983, maximum flows were larger and more frequent. Statistical analysis of the flows has been conducted in previous studies using different models such as Gamma, Exponential, Person III,

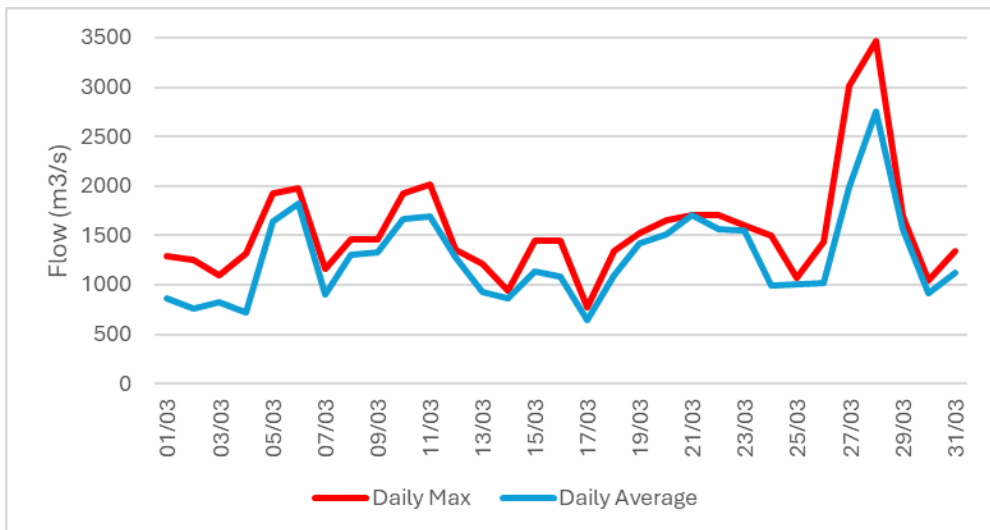
Further, the Piura-Chira Project provides daily flow data since 2015 for five stations along the Piura River (PECHP, 2017). The stations provide flow data for daily average, maximum flow, and precipitation. Of these, the station at the Sánchez Cerro bridge provides flow information for the lower basin. The flood event in March 2017 is shown in Figure 36. The hydrograph shows a peak flow of 3,468 m³/s on March 28th.

Figure 36- Flow measurements at Sánchez Cerro Bridge for March 2017

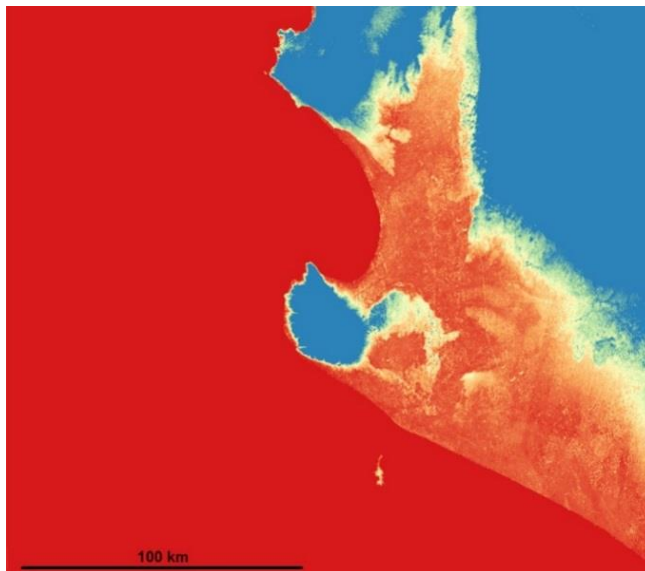
The study area, however, is larger than what is provided in the LIDAR scan. As such, digital elevation model (DEM) data was obtained through GEO GPS Peru (n.d.), where it was available in GeoTiff format with a resolution of 30m taken in 2008. The file is shown in Figure 40.

Figure 40- ASTER GDEM Piura region

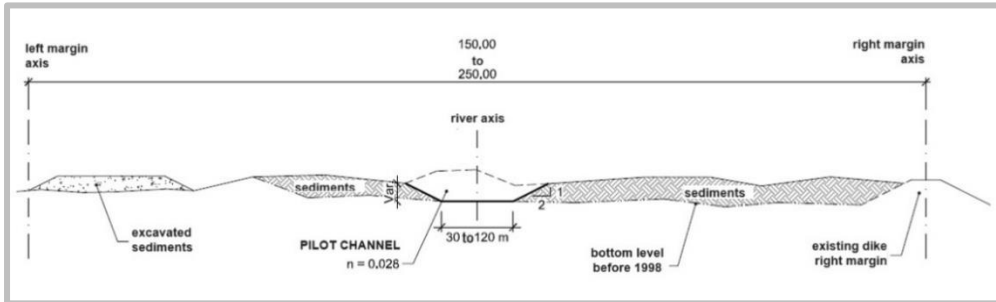
For the redirection towards Sechura, a pilot channel is to be constructed with a depth of approximately 4m and capacity for $375\text{m}^3/\text{s}$ (Zegarra Dávila, 2023). The pilot channel is proposed for the reach from the split point up to the connection to Río Loco. Río Loco is estimated to have a flow capacity of $3,200\text{m}^3/\text{s}$ considering that this was the flow of the flood in 1983, and the river contained this flow following the breach of the dikes (Zegarra Dávila, 2023). The small flow capacity is attributed to the idea that this course will have sufficient transport capacity to flush out sediment and thereby begin to widen

overtime without further construction (Zegarra Dávila, 2023). The general section of the proposed pilot channel is shown in Figure 42.

Figure 42- General cross section of the pilot channel through Sechura (Zegarra Dávila, 2023)

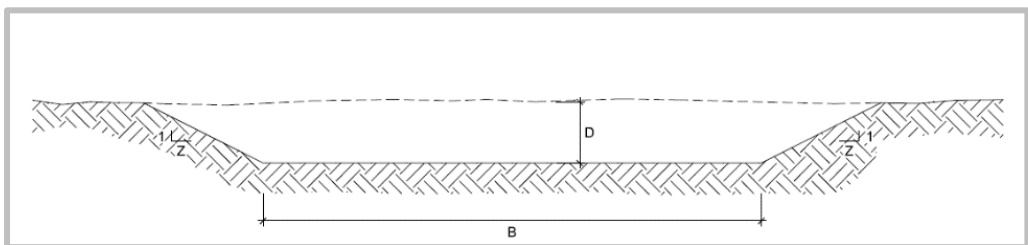
Table 3 shows a more detailed description of the pilot channel based on the typical section shown in Figure 43. Station 0+000 is the split point and 24+000 is the connection to Río Loco. In this, the slope of the pilot channel varies depending on the existing terrain.

Figure 43- Parameters for the pilot channel (Zegarra Dávila, 2023)

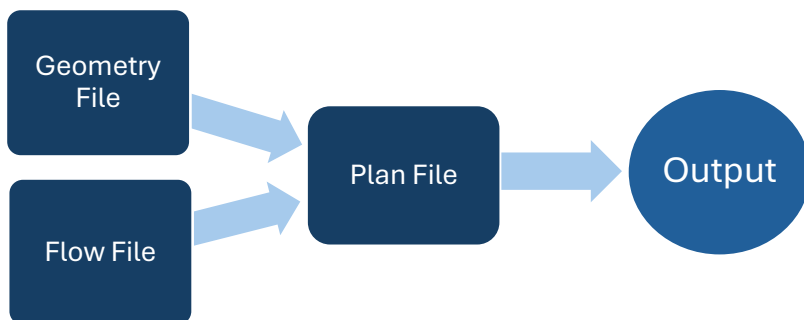
In order to run a flow model in HEC-RAS two files are needed; these are a geometry file and a flow file which are combined in a plan file for computation as shown in the scheme in Figure 45.

Figure 45- HEC-RAS file setup

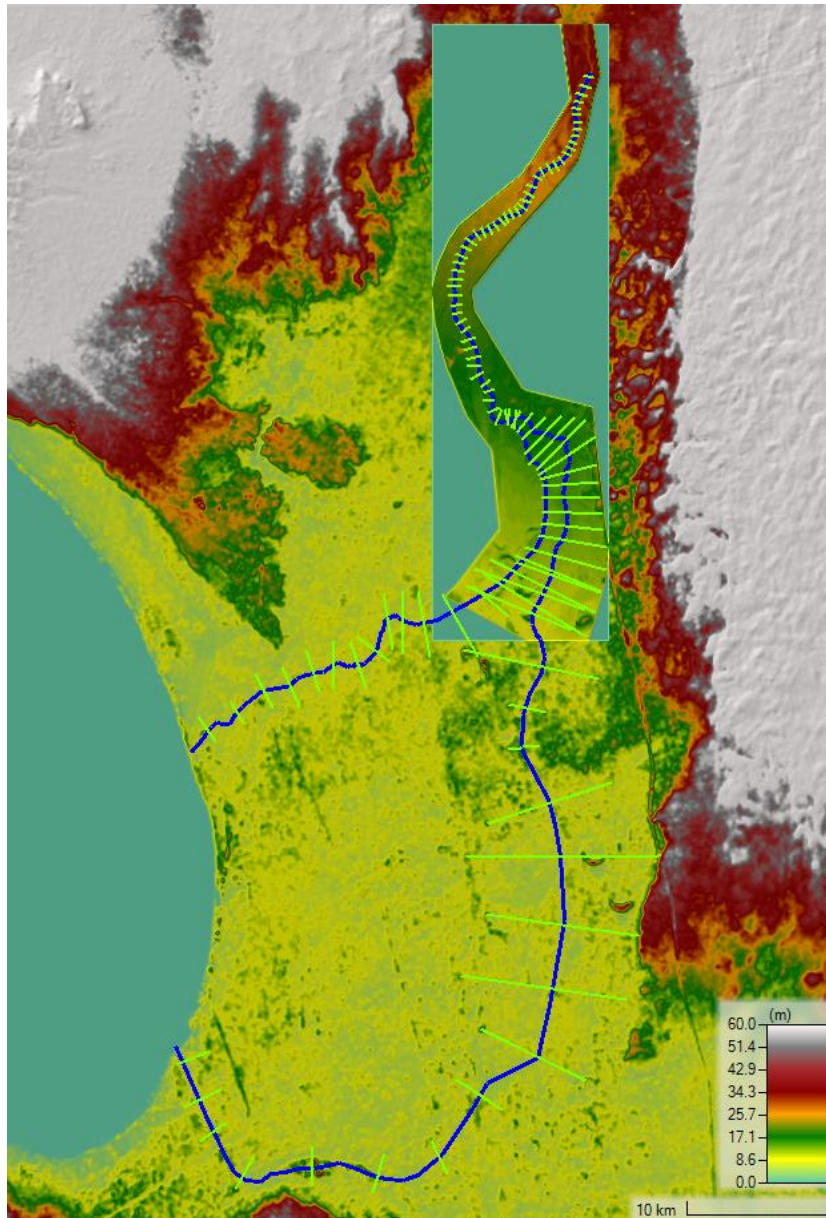
The river centerline has the same shape for both courses up to just downstream of Drain 13.08, after this the geometry differs for both courses. Cross sections are spaced at approximately 500m up to Drain 13.08, then spacing increases

to approximately 1,000m up to the end of the LIDAR topography file. Finally, spacing of cross sections created using the ASTER file are spaced at varying distances. Figure 46 shows the geometry file created using RAS-MAPPER. Detailed spacing and cross section data is provided in Appendix B.

Figure 46- LIDAR topography and ASTER Topography opened in RAS-Mapper

HEC-RAS generates river stationing based on the distance from the most downstream point of the river centerline. As such, the stationing for the courses differs. While Virrilá reaches from station 1+568 downstream to 117+307 upstream, the geometry for the river through Sechura has a downstream river station of 1+870 and upstream station of 71+617.

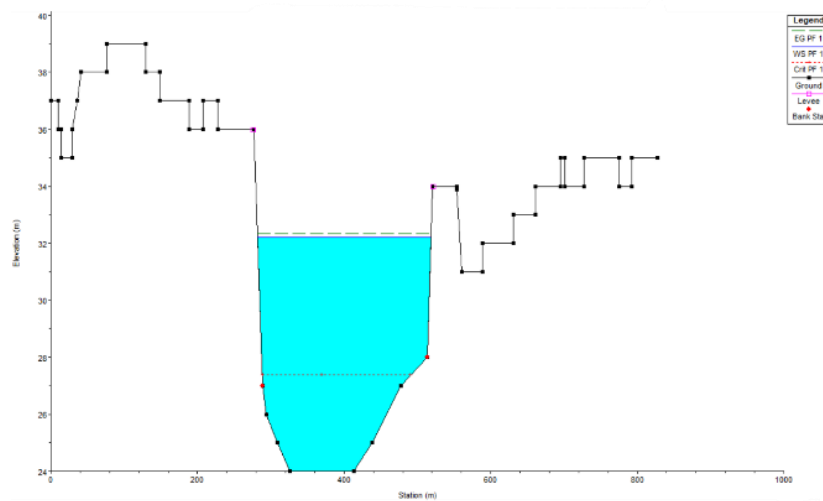
Figure 47- Reach Virrilá: cross section 117+307

This section of the geometry spanning from Los Ejidos to Drain 13.08 is the same for both river courses. The section spans from 117+307 to 87+776 and from 71+617 to 42+086 for Virrilá and Sechura respectively. Cross sections comprise of bank stations, levees and ineffective areas. The riverbanks are approximately placed following the main riverbed. Levee structures are used along the top of the channel in the urban zone as shown in Figure 47 and on top of the dikes in the rural areas as shown in Figure 48.

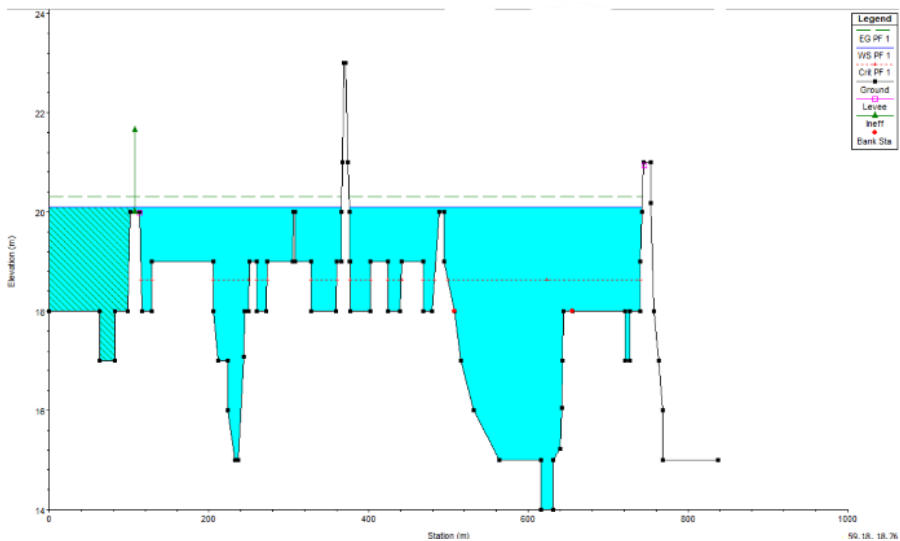
Figure 49- Reach Virrilá: cross section 88+621

In sections where water is likely to overflow the levees or where flooding is expected to happen, ineffective areas were used outside of the dikes as shown in Figure 49. This ensures that water outside of the floodplain is not contributing to results.

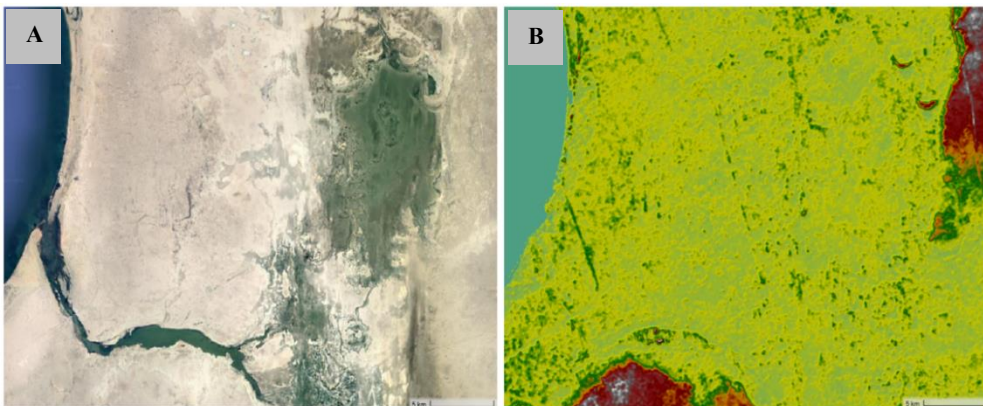
The existing reach to Virrilá follows the same set up as previously described reaching up to the Ñapique/Ramón Lagoon. Levees are used to mark high ground or existing dikes and riverbanks are defined following the main river course. After this the ASTER topography is used and cross sections are drawn to span the width of the riverbed or lagoon. As shown in Figure 50, some features such as high ground, dunes, and the Panamerican highway are visible in the ASTER data. However, the riverbed and estuary are not clear.

Figure 50a- Virrilá Estuary satellite imagery (Google Earth, 2024). 50b- area of Virrilá Estuary in ASTER data.

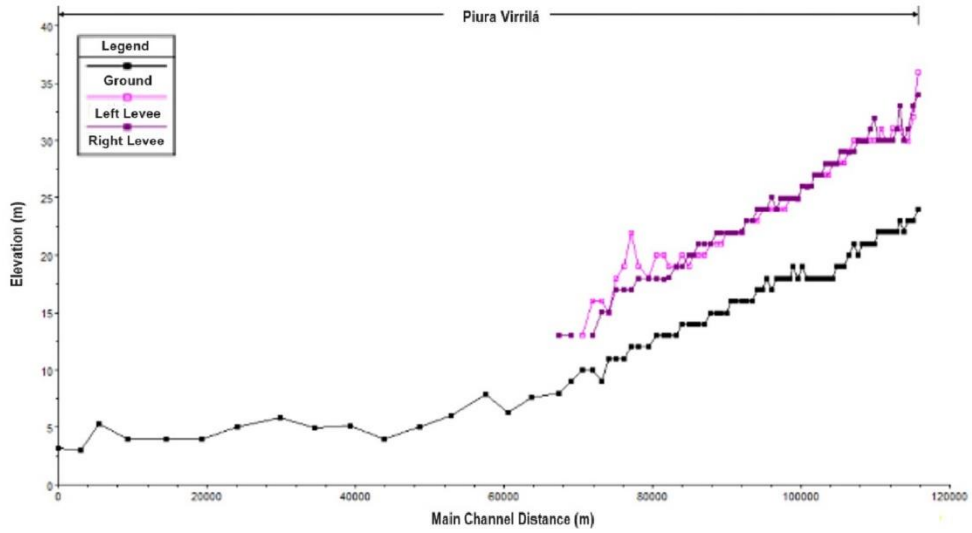
Figure 51- Reach Virrilá: Profile before adjustment

The Virrilá estuary is influenced by tidal activity up to approximately 20km upstream and is estimated to have an average depth of 2m (Céspedes, 2005). Since detailed bathymetric data was not available for the estuary, the bottom level in the last cross section 1+568 was calculated to be at -1m based on an assumed slope of 0.2‰ along the estuary. The topography of cross sections along the estuary was modified using this slope of 0.2‰. Similarly, due to the uncertainty in accuracy of the topography in the lagoon area, elevations were adjusted between riverbanks to create a gradual slope towards the estuary as shown in Figure 51 and Figure 52 for a schematic model.

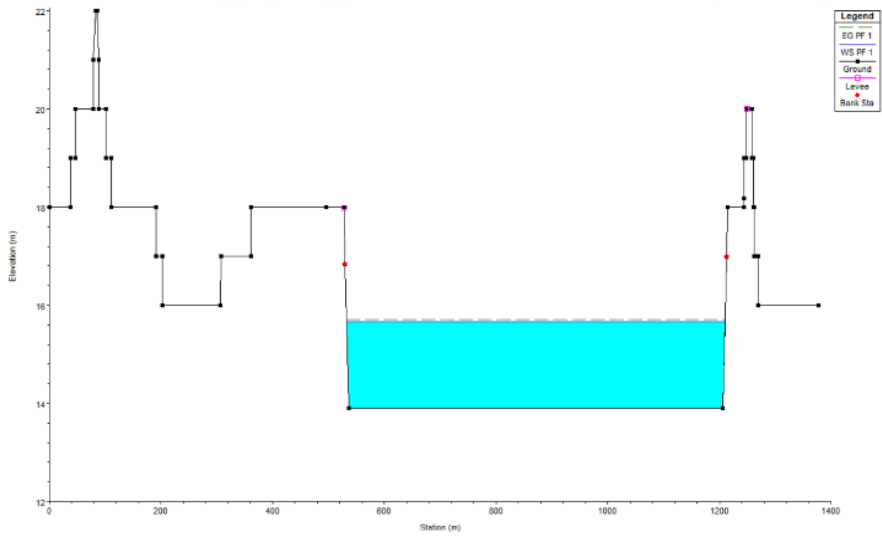
Figure 53- Reach Sechura: cross Section 40+847

Figure 53 shows a sample section of the channel along the right dike for topography data from the LIDAR scan. The depth of the channel has been assumed to be 4m and the riverbanks have a slope of approximately 1:2. Similar sections are placed on the ASTER topography as shown in Figure 54.

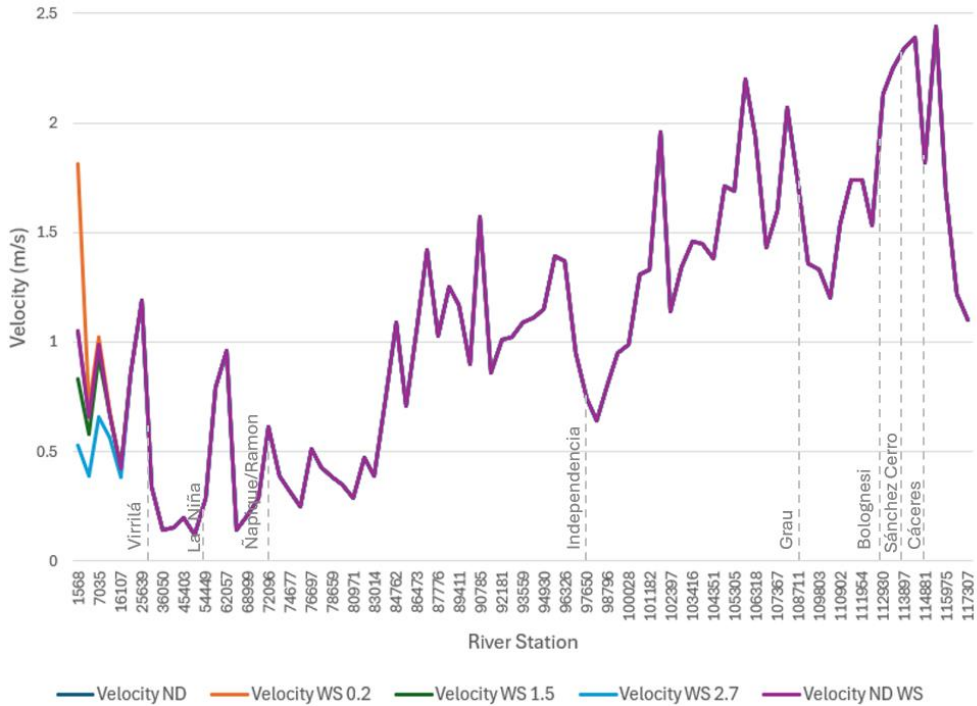
As shown in Figure 56, it was found that the boundary condition does not have an impact on upstream stations. The effect of the boundary condition is noted up to approximately 15km from the end of the reach. As such, the known water surface of +1.5m is chosen for simulations as this is the average sea level in the region.

Figure 56- Reach Virrilá: Sensitivity analysis for boundary conditions at $Q=1,000\text{m}^3/\text{s}$
