Sediment Transport in the Piura River. Piura, Peru.

An application with the HEC-RAS model

Master Thesis

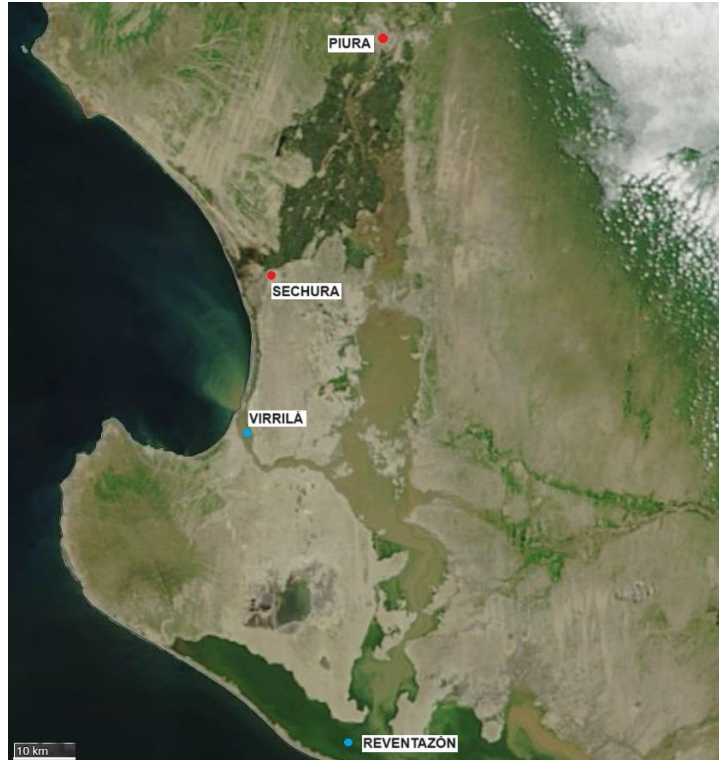
However, additional information is needed to describe the flow regimen further downstream. Since exact water surface elevations are not known, satellite imagery was used to assess the extent of flooding. NASA's EODIS Worldview provides historic satellite images as shown in Figure 57 for the 5th of April 2017. Although the peak flow occurred on March 28th, previous dates showed significant cloud coverage and could not be used for assessment. The resolution of the image is not high; however, the size of the lagoons can be estimated, and the image gives insight into whether flooding occurred in certain regions.

Figure 57- Extent of flooding in 2017. Satellite imagery from April 5th, 2017 (adapted from Nasa Worldview, 2017)

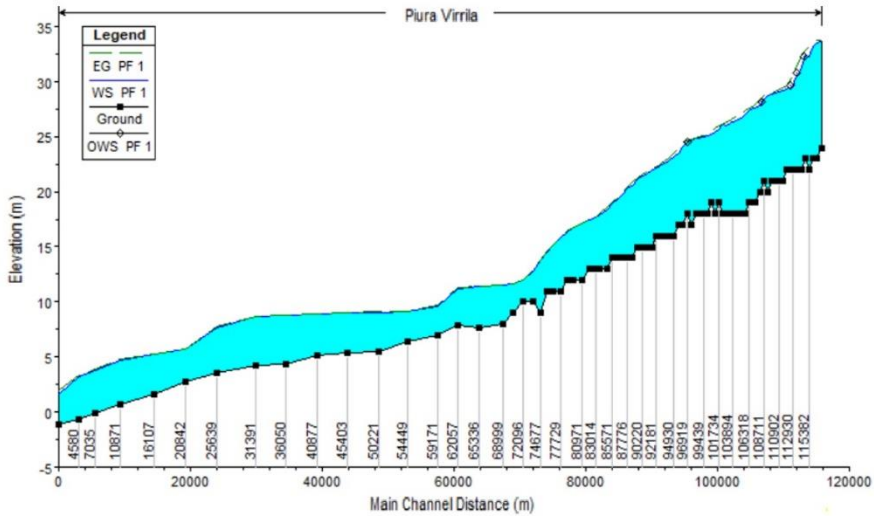
As mentioned, no precise measurements were available further downstream. However, satellite imagery showing the extent of flooding in 2017 was used for approximation. Namely, the Mannings numbers were adjusted in some areas to allow flooding to occur, or to keep the water level below the levee structures modelled in HEC-RAS. The calibrated model is shown in Figure 58, where the points on the upstream portion indicate the observed water surfaces listed above.

Figure 58- Reach Virrilá: water surface profile for calibration $Q=3468\text{m}^3/\text{s}$

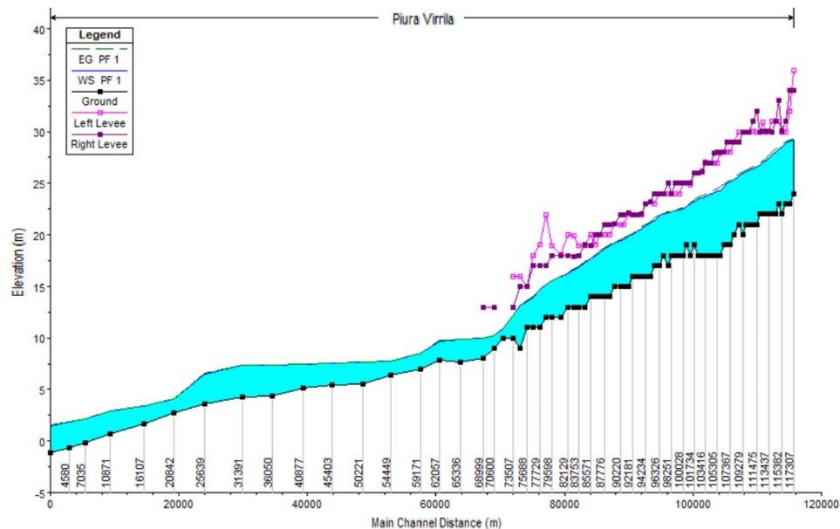
Figure 59 shows some increases in depth as between station 25+639 to 31+691 and stations 62+057 to 65+336, which is expected as these are the areas between the lagoons where the river is narrower than the lagoon.

Figure 59- Reach Virrilá: water surface profile for $Q=1,000\text{m}^3/\text{s}$

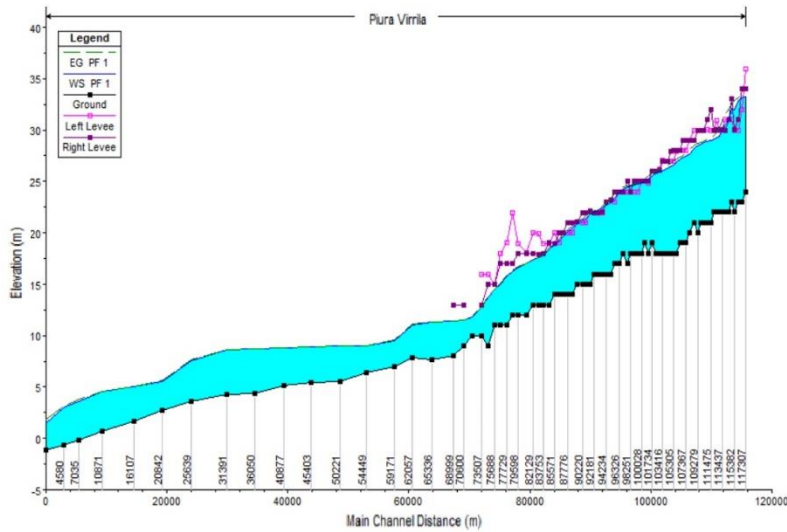
Figure 60 shows the increase in water depth during the larger flow event. Flooding can be seen along some stretches of the river.

Figure 60- Reach Virrilá: water surface profile $Q=3,200\text{m}^3/\text{s}$

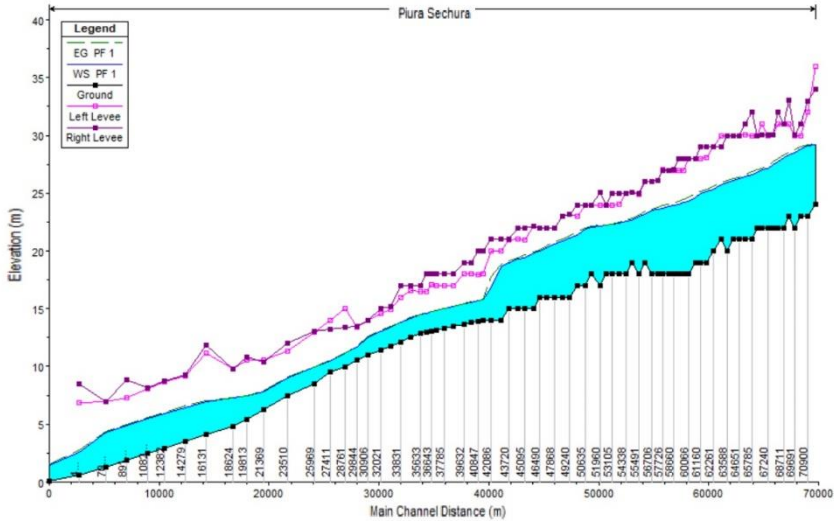
The profile in Figure 61 shows the flow through the course towards Sechura. The levees indicated in the lower reach here are not dike structures but are used for modelling purposes. The flow shows a step drop at around station 40+847, this may be due to the transition from the original river course to the new channel towards Sechura.

Figure 61- Reach Sechura: water surface profile for $Q=1,000\text{m}^3/\text{s}$

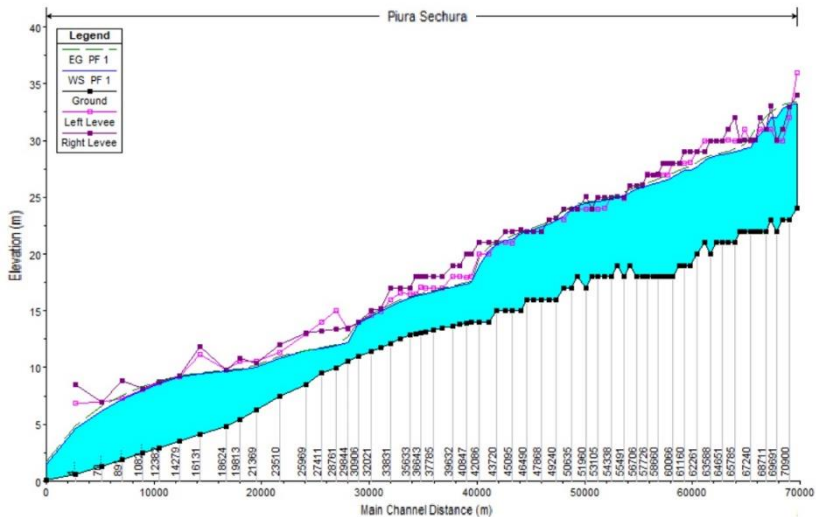
Figure 62 shows the surface profile for a flow of $3,200\text{ m}^3/\text{s}$. An increase in depth is seen at station 21+369 as this is the exit of the Ñapique/Ramón Lagoon, since the river is narrower than the lagoon, there is an increase in depth.

Figure 62- Reach Sechura: water surface profile for $Q=3,200\text{m}^3/\text{s}$

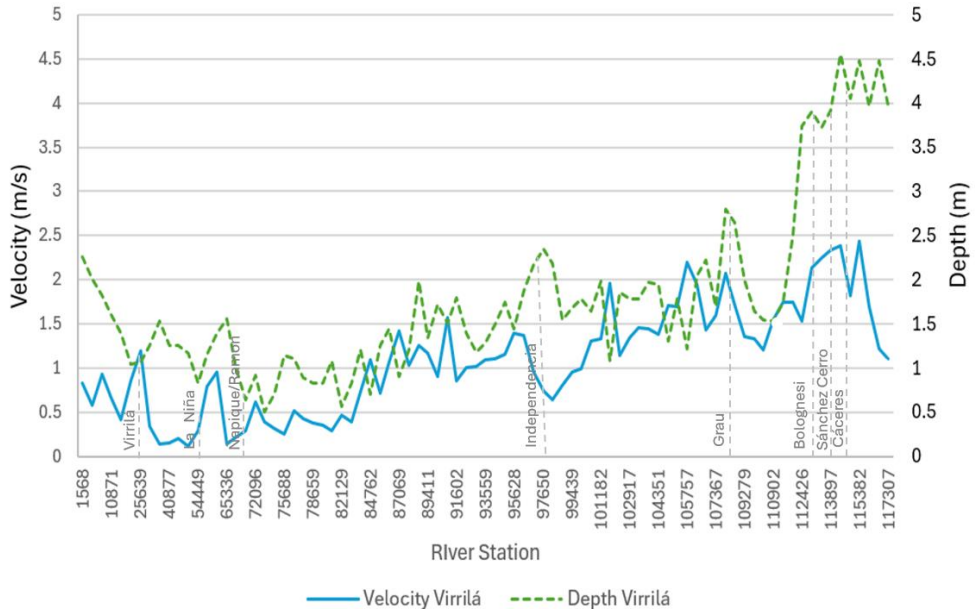
Figure 63 and 64 show the velocity and depth variation for $Q=1,000 \text{ m}^3/\text{s}$ and $Q=3,200 \text{ m}^3/\text{s}$ respectively for the course along Virrilá. Velocity and hydraulic depth are average values across each cross section.

Figure 63- Reach Virrilá: velocity and depth output for $Q=1,000 \text{ m}^3/\text{s}$

The course through Virrilá shows velocities reaching from 0.12-2.44 m/s for a flow of $1,000 \text{ m}^3/\text{s}$. Hydraulic depth and velocity is higher upstream due to the channeling of the river and both decrease towards the lagoons, which is expected due to the expansion of the flood plain.

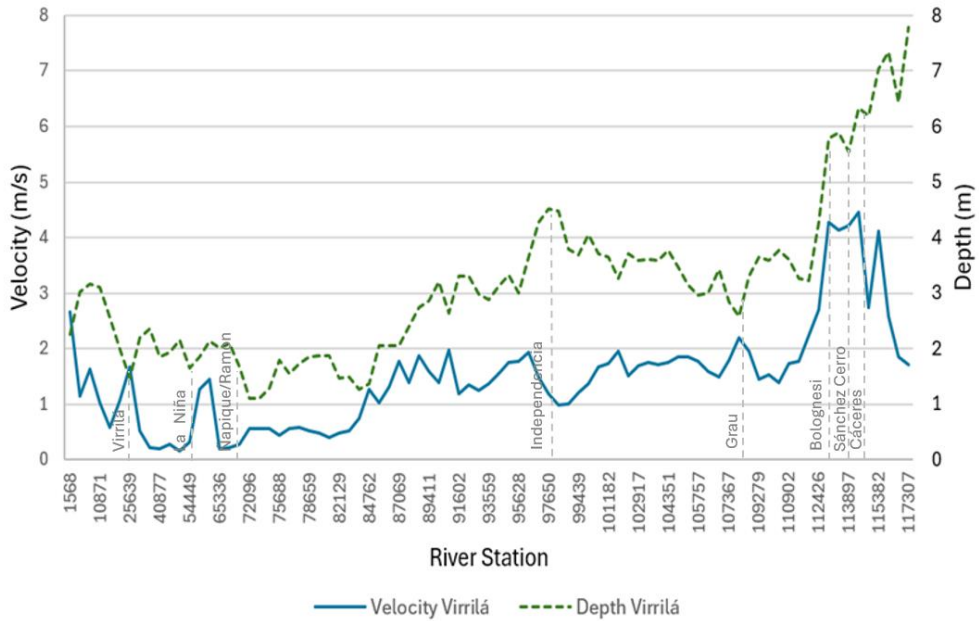
Figure 64- Reach Virrilá: velocity and depth output for $Q=3,200\text{m}^3/\text{s}$

For a flow of $3,200\text{ m}^3/\text{s}$, a range of 0.16-4.46 m/s develops through the river. The same general trend exists where there are larger velocities in the upstream region and very low velocities in the lagoons. However, for this flow, the velocity is approximately twice as large in the peaks. The hydraulic depth relates to the velocity in that when velocity increases, depth decreases and vice versa. This is particularly relevant for narrower reaches such as the urban reach from 117+307-111+954 but is less notable in the lagoons where larger floodplains exist.

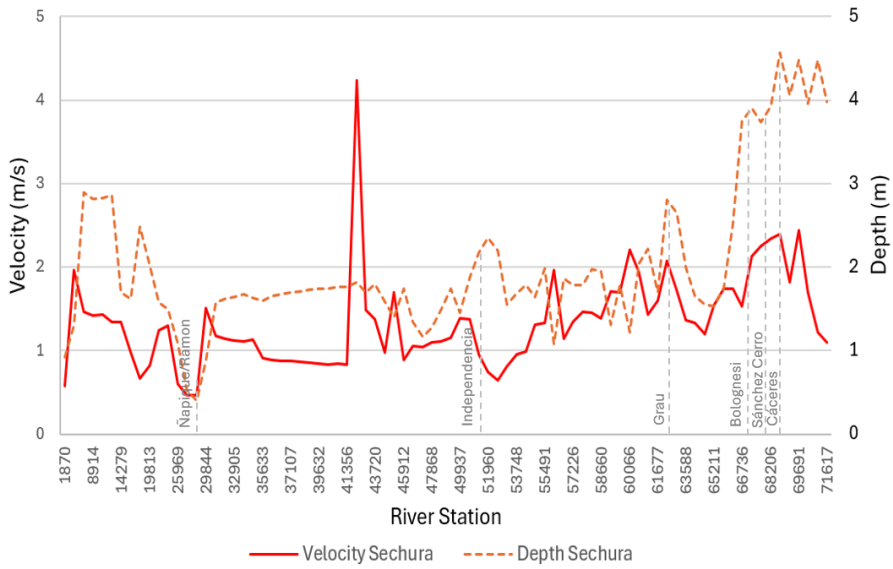
Figure 65 and Figure 66 show the velocity and depth variation for $Q=1,000\text{m}^3/\text{s}$ and $Q=3,200\text{m}^3/\text{s}$ respectively for the course along Virrilá. Velocity and hydraulic depth are average values across each cross section.

Figure 65- Reach Sechura: velocity and depth for $Q=1,000\text{m}^3/\text{s}$

The course through Sechura shows velocities reaching from 0.46-4.23 m/s for a flow of 1,000 m³/s and a range of 0.38-4.46 m/s for a flow of 3,200 m³/s. Velocity shows a spike in Figure 65, this is due a transition between cross sections where in one cross section the floodplain is flooded and in the next it is contained by the riverbed. This peak is larger for Q=1,000 m³/s than that of Q=3,200 m³/s because the larger flow causes the floodplain to be flooded in both cross sections. However, disregarding the peak, the velocity range for Q=1,000 m³/s would be 0.46-2.44 m/s. This is a similar max velocity to that which develops in the reach through Virrilá, however, the minimum velocity is slightly higher.

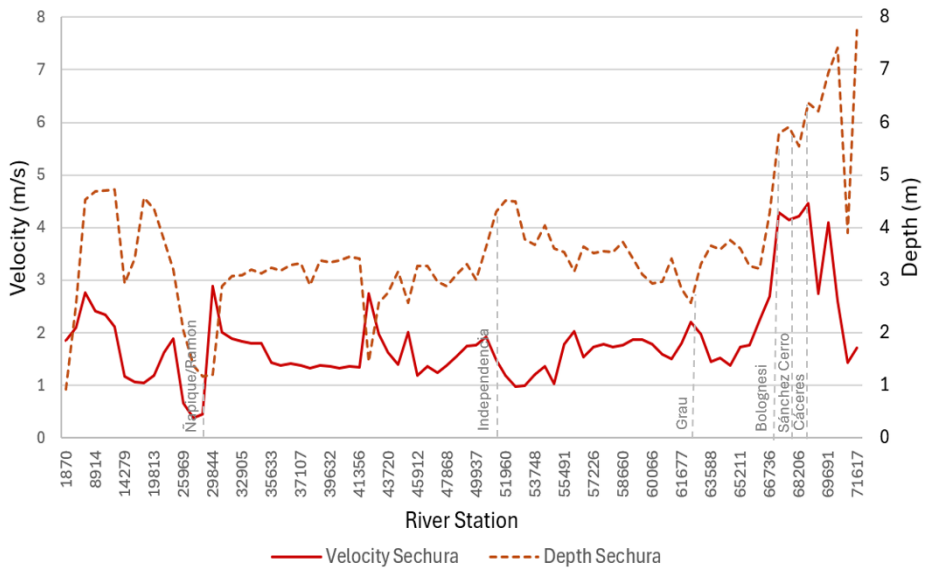
Figure 66- Reach Sechura: velocity and depth for $Q=3,200\text{m}^3/\text{s}$

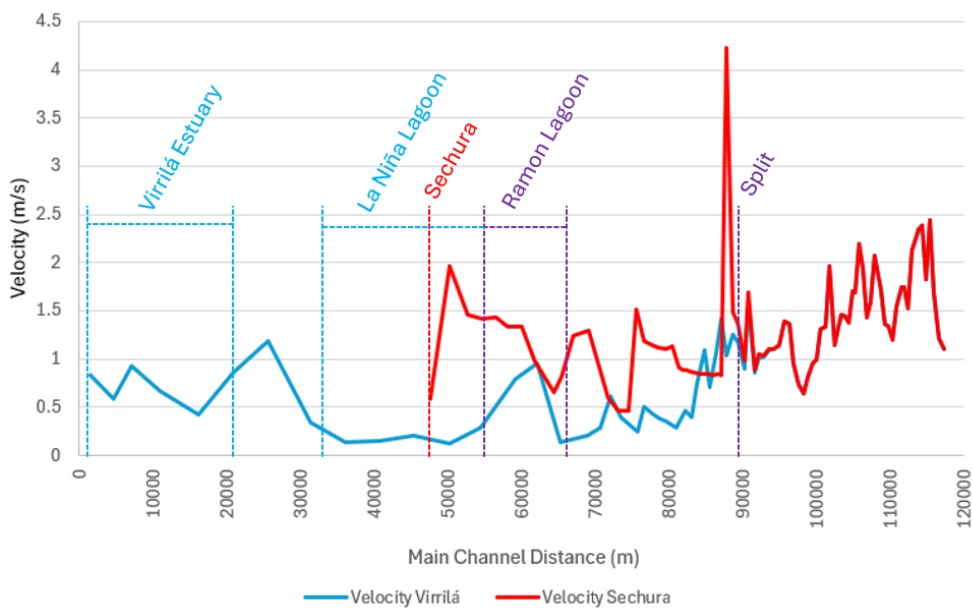
The upstream velocity is similar in both courses for both flows. Further downstream the course towards Sechura develops higher velocities than the course through Virrilá as shown in Figure 67 and Figure 68 for comparison of the velocity development.

Figure 67- Velocity through Virrilá and Sechura at Q=1,00m³/s

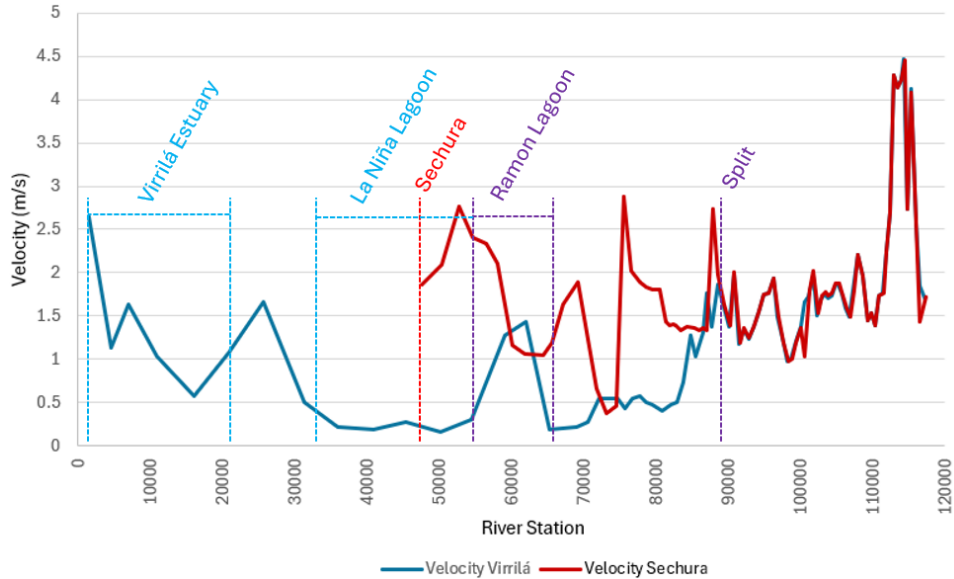
Figure 68- Velocity through Virrilá and Sechura at $Q=3,200\text{m}^3/\text{s}$

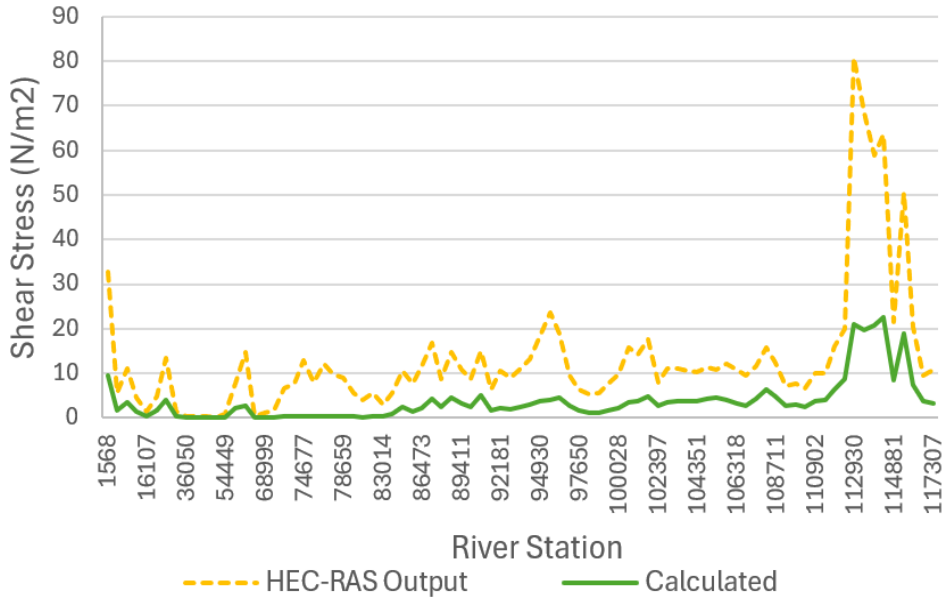
HEC-RAS provides a shear stress value for each cross section based on the hydraulic radius and slope of the cross section. Figure 69 and Figure 70 compare the shear force calculated by the program and shear force calculated using the drag law for a flow of $Q=3,200 \text{ m}^3/\text{s}$ for both river courses.

Figure 69- Shear output comparison for Virrilá $Q=3,200 \text{ m}^3/\text{s}$

The shear stress computed in HEC-RAS is significantly higher than that calculated using the drag law. Figure 71 and Figure 72 show shear stress results for Virrilá and Sechura for calculations based on the drag law and for HEC-RAS output shear stress in relation to the critical shear stress. Values of $\tau_b < \tau_{cr}$ indicate that the section is stable. For clear visualization of results, the y-axis range is reduced from 0-5 considering that the critical shear stress is a small number, it should be noted that exact shear stress values are listed in Appendix C.

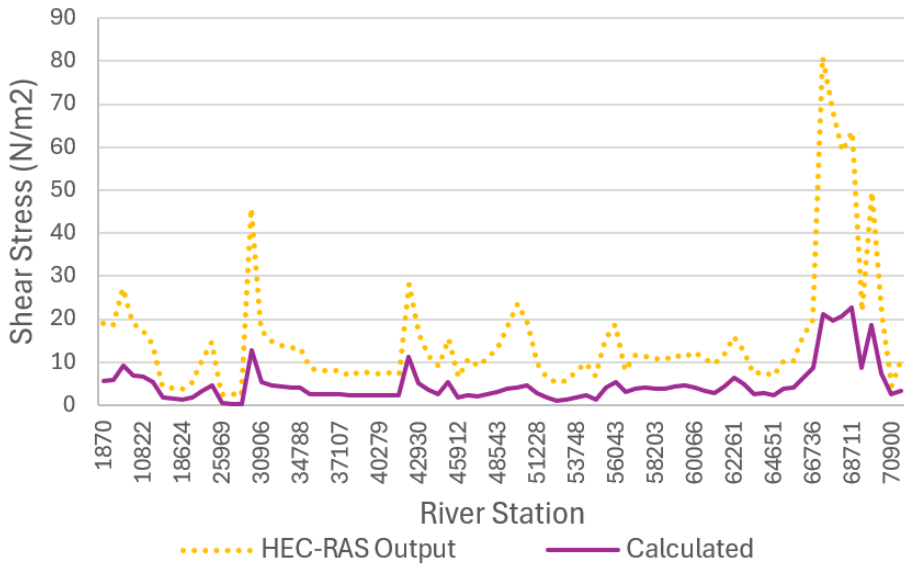
Figure 70- Shear output comparison for Sechura $Q=3,200 \text{ m}^3/\text{s}$

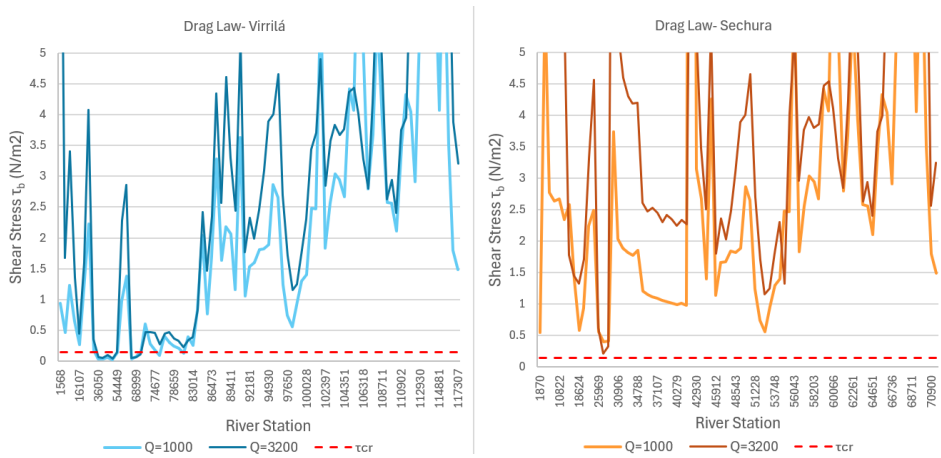
Figure 71- Drag law shear stress and threshold of motion for $Q=1,000\text{m}^3/\text{s}$ and $Q=3,200\text{m}^3/\text{s}$ for Virrilá and Sechura

The route through Virrilá indicates sections where the calculated shear stress along the bed τ_b is less than τ_{cr} . This implies that the threshold for sediment motion is not exceeded and therefore sediment transport is not expected. The course through Sechura indicates some drops in shear stress but remains above the critical shear stress, therefore indicating that the riverbed is not in a stable state and likely to be eroding. HEC-RAS output does not indicate any sections in stability. The HEC-RAS output is generally larger than that of the drag law calculated shear stress. This is due to the difference in the formulas used for computation where HEC-RAS output is calculated using slope and hydraulic radius (HEC, 2024a) while the drag law is based on bed roughness.

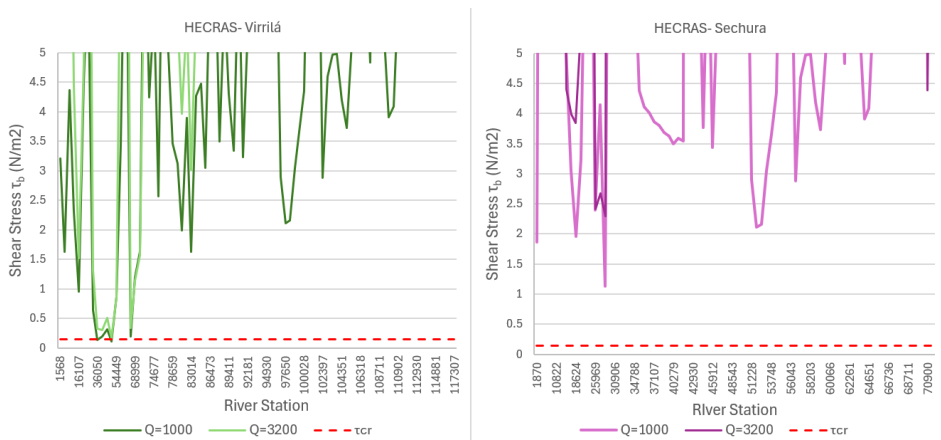
Figure 72- HEC-RAS shear stress output and threshold of motion for $Q=1,000\text{m}^3/\text{s}$ and $Q=3,200\text{m}^3/\text{s}$ for Virrilá and Sechura

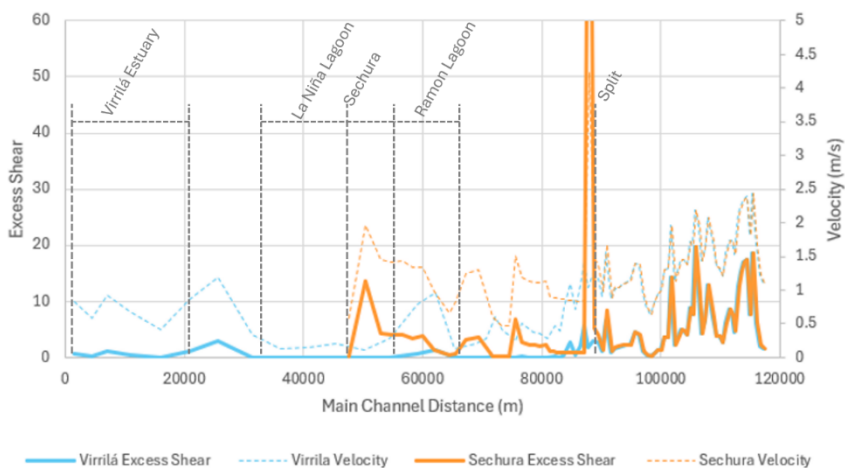
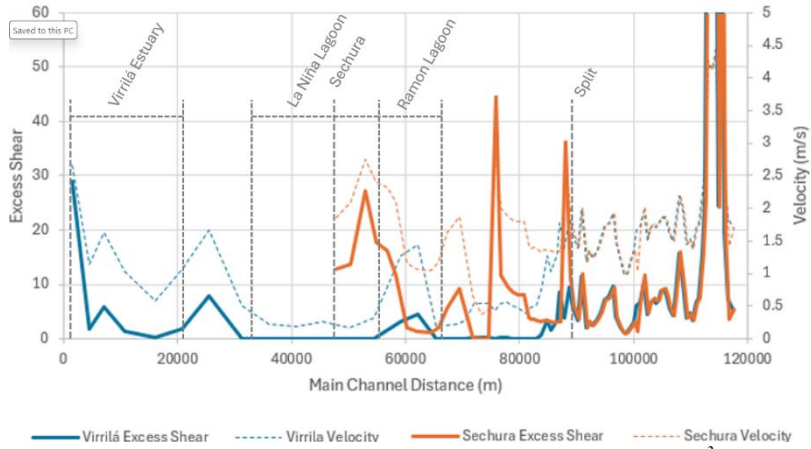
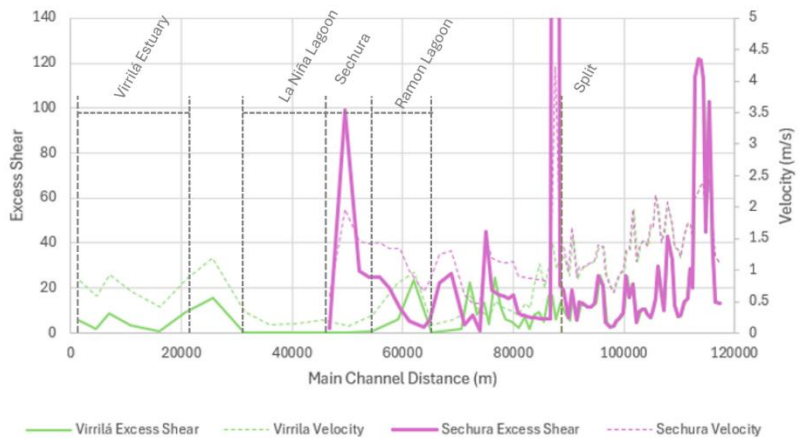
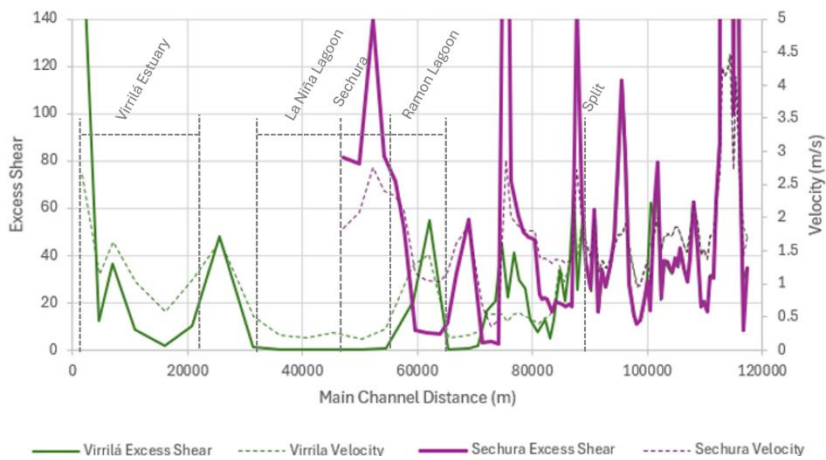
Although the shear stress and critical shear stress comparison gives insight into the sediment transport conditions, the excess shear stress is assumed to be proportional to transport. As such, it can be used to approximate in which sections of the river erosion or deposition is likely to occur. As shown in Figures 73-76, the excess shear is larger along most sections of the river towards Sechura as toward Virrilá. For visual purposes, the y-axis is set from 0-60 for the drag law computations and from 0-140 for the HEC-RAS output results, full results are listed in Appendix C.

Figure 73- Excess shear based on drag law for $Q=1,000m^3/s$

Figure 74- Excess shear based on drag law for $Q=3,200\text{m}^3/\text{s}$

Figure 75- Excess shear based on HEC-RAS output for $Q=1,000\text{m}^3/\text{s}$

Figure 76- Excess shear based on HEC-RAS output for $Q=3,200\text{m}^3/\text{s}$

Although the shear stress along the course towards Sechura did not go below the critical shear stress, the gradient of excess shear is indicative of erosion or deposition. Erosion occurs when excess shear increases while deposition occurs when it decreases. The figures above show various peaks which are likely due to the computation process in HEC-RAS. For analysis of erosion or deposition, trendlines are used to simplify the peaks as shown in Figure 77 for Virrilá and Sechura at a flow of $Q=3,200 \text{ m}^3/\text{s}$ for the drag law computation and HEC-RAS shear output. The trendlines are approximations purely created for visualization and are not based on numerical values.

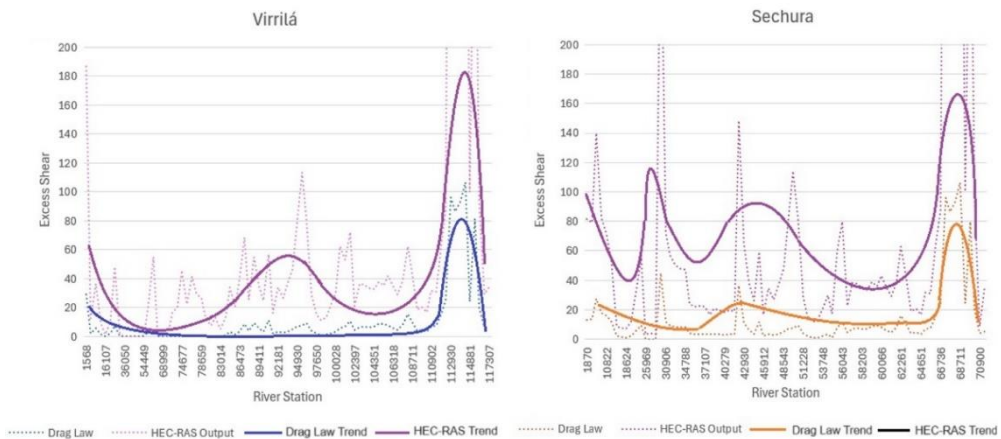
Figure 77- Trend for excess shear along Virrilá and Sechura

Erosion likely occurs immediately downstream of Los Ejidos Dam, then the excess shear drops for both scenarios indicating likely deposition of sediments. Following this, the route towards Virrilá shows some smaller peaks but has a decreasing trend due to the decreased transport capacity in the lower reach. The route towards Sechura shows more defined peaks in the lower reach and a general increasing trend in excess shear. There is however a drop in excess shear in the lower reach which is a result of the assumption that the Ramón Ñapique Lagoon still fills with water. This implies an increased width and a drop in velocity, therefore the excess shear also drops. Comparing both

the HEC-RAS output and the calculated shear stress, the general trend for Virrilá is a decrease in excess shear towards the lower reach while increased larger shear is seen in the course towards Sechura.

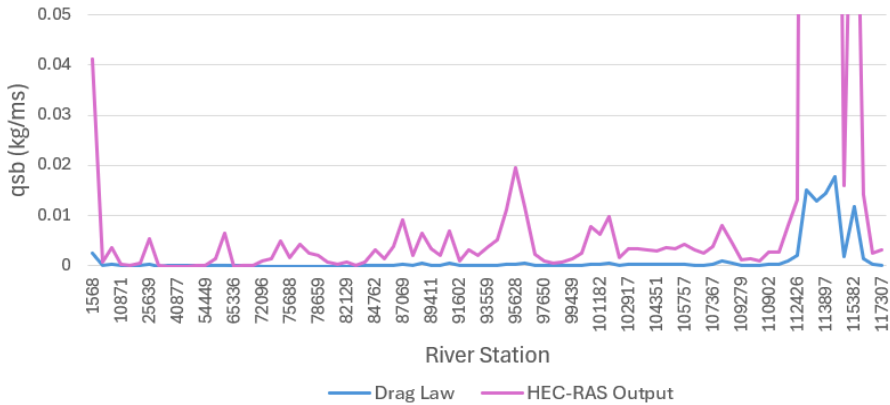
Figure 78- Bed load transport for Virrilá at $Q=3,200\text{m}^3/\text{s}$

As mentioned in Chapter 5, excess shear is related to the Meyer-Peter and Müller bed load transport formula. Bed load transport is calculated for both the shear stress based on the drag law and for the HEC-RAS output shear for a flow of $Q=3,200\text{m}^3/\text{s}$. As shown in Figures 78 and 79, bed load in load per unit width shows small peaks for the transport through Sechura while it stays quite insignificant for transport through Virrilá. The y-axis was adjusted to 0-0.05 for visualization purposes, full data is provided in Appendix C.

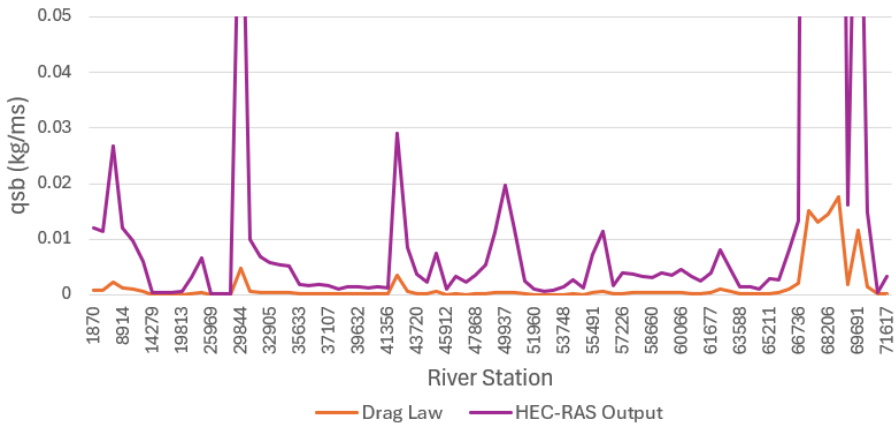
Figure 79- Bed load transport for Sechura at $Q=3,200\text{m}^3/\text{s}$

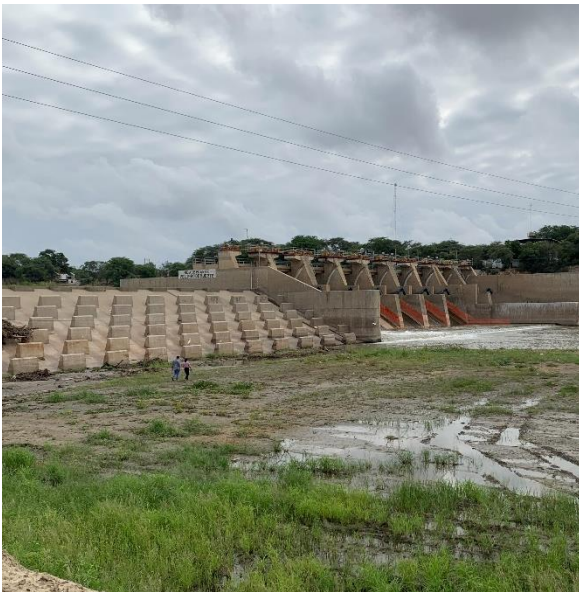
The visit began at Los Ejidos Dam. Figure 3 shows the gated spillway on the right and the weir structure (which collapsed in the 80s) on the left. The Los Ejidos Dam is situated approximately 3km from Piura city center.

Figure 3- Los Ejidos Dam

The floodplain just downstream of the dam shows some of the riverbed clearance works which have been conducted. Sediment accumulated at approximately 3m in height as shown in Figures 3 and 4. It has been/is in the process of being removed.

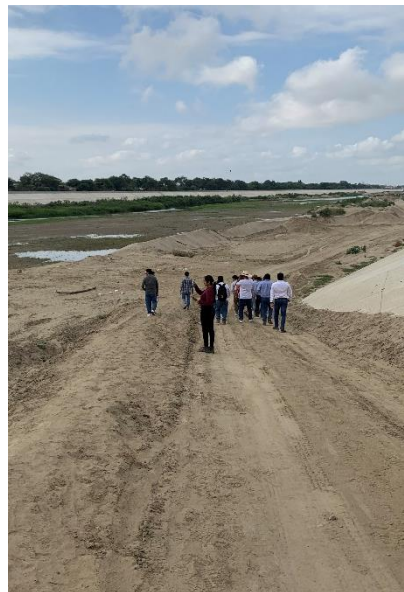
Figure 4- Ramp into the floodplain at Los Ejidos

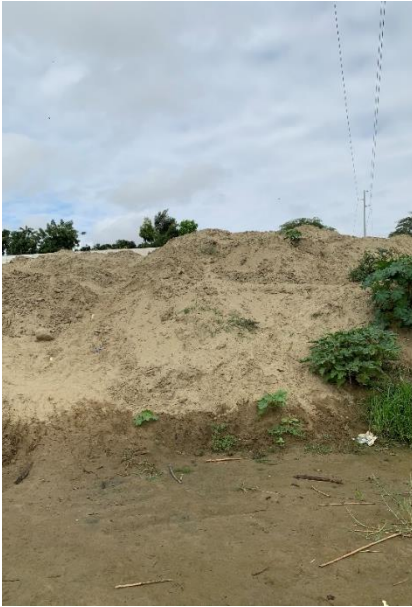
Figure 5- Sediment build up at Los Ejidos view from bottom

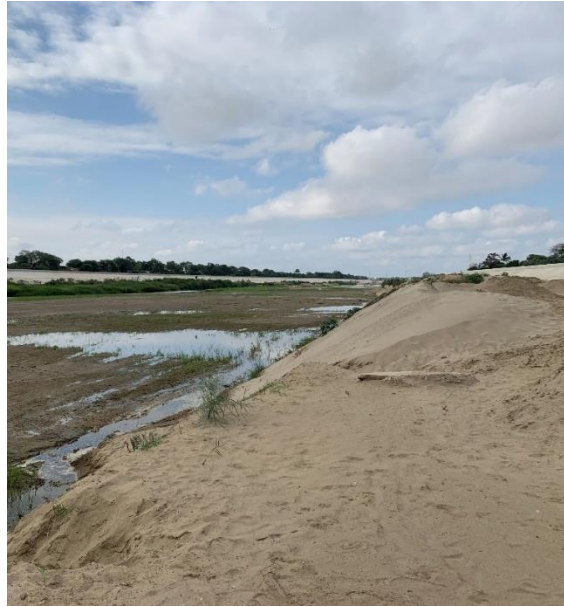
Figure 6- Sediment build up at Los Ejidos view from top

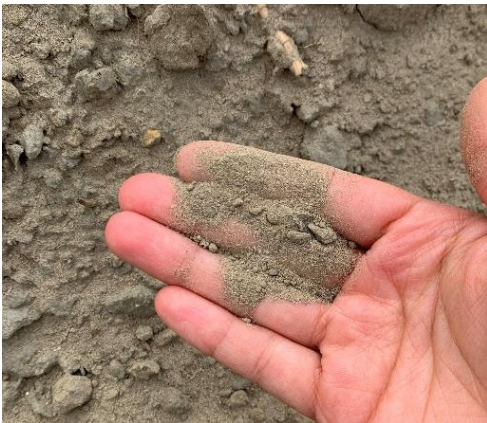
Figure 7- Sandy sediment at Los Ejidos

Sediment in the floodplain in this area was found to be mostly sandy, and also clayey/silty-sand closer to the riverbed as shown in the figures below.

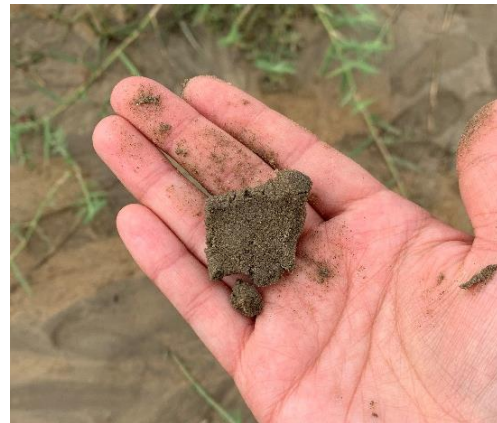
Figure 8- Clayey sediment at Los Ejidos

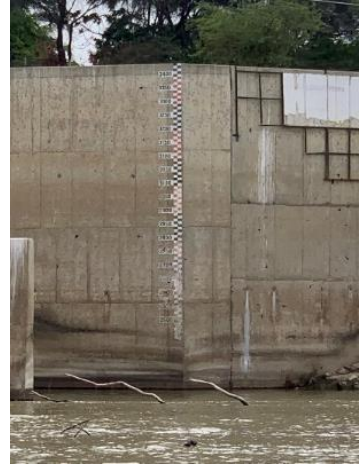
The dam is fed by a channel from the Chira River which provides a steady flow of 60m³/s. On the day of the excursion, a low flow was observed, which may have been exclusively from the Chira River. The gauge at Los Ejidos indicating potential water levels which can be reached is shown in Figure 9.

Figure 9- Gauge at Los Ejidos

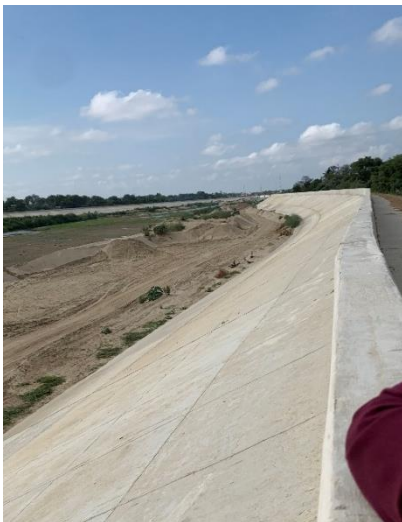
Starting at Los Ejidos, the river through the urban area is channeled by concrete banks as shown in Figure 10. The dry side of the bank is constructed of compacted sediment. However, local erosion can be seen which exists in different scales and often causes holes large enough to cause instability of the banks, as shown in Figure 11.

Figure 10- Concrete riverbank

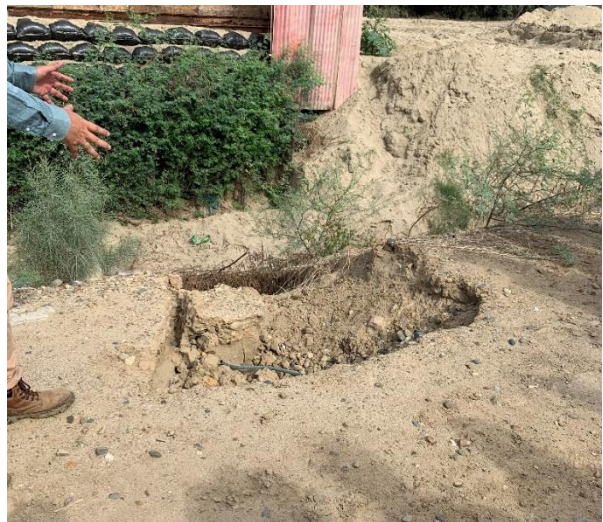
Figure 11- Hole on 'dry side' of riverbank

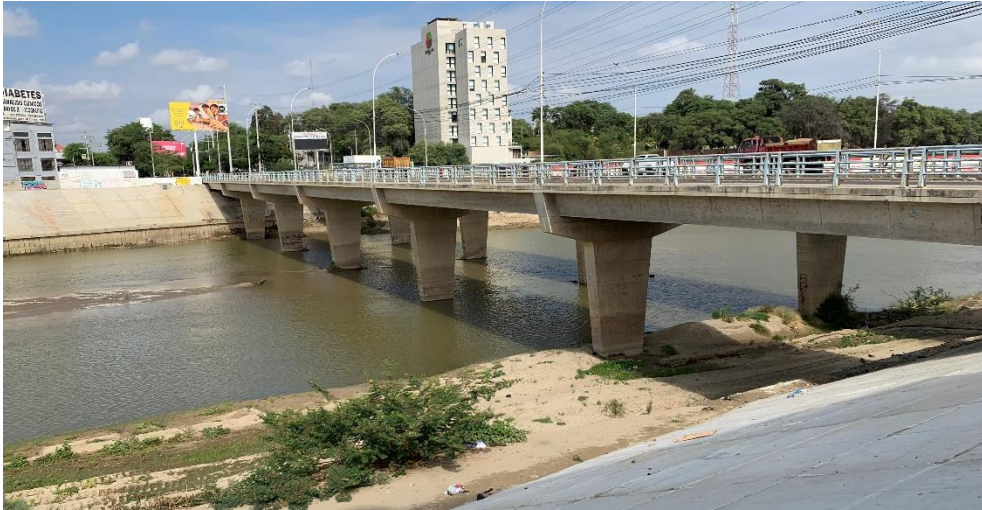
The channel section at the Cáceres bridge is approximately 140m.

Figure 12- Cáceres Bridge

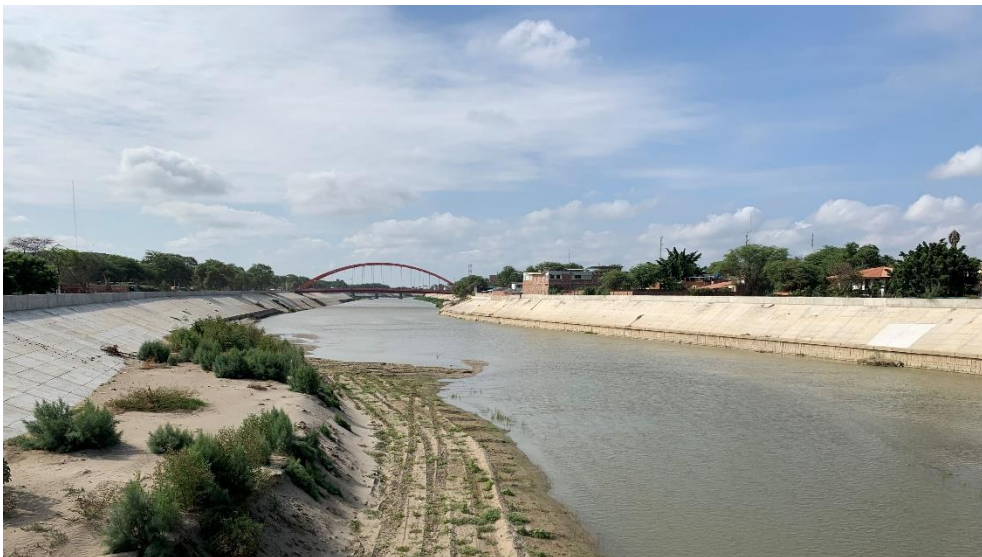
Some sedimentation and vegetative growth is visible at the left bank of the Cáceres bridge as shown below in the view downstream of the bridge in Figure 13.

Figure 13- View downstream of Cáceres Bridge

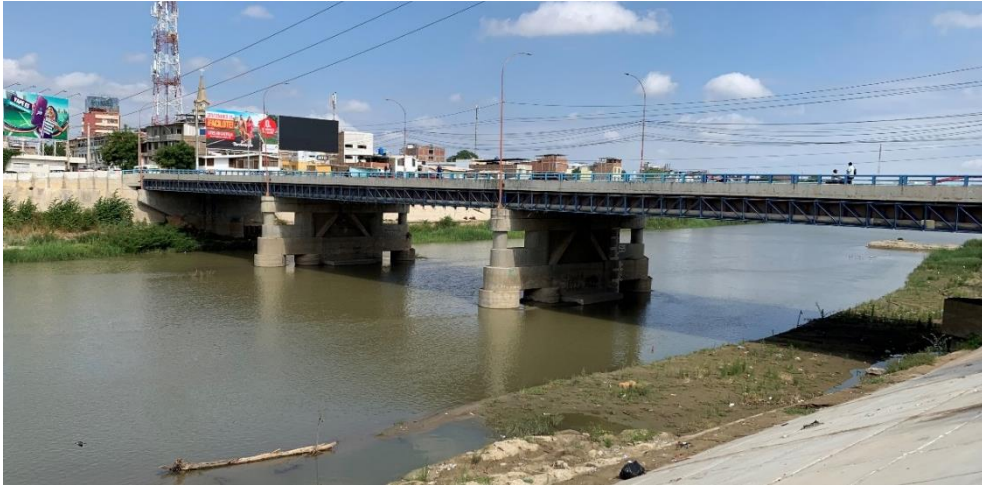
The channel section at the Sánchez Cerro Bridge is approximately 130m.

Figure 14- Sánchez Cerro Bridge

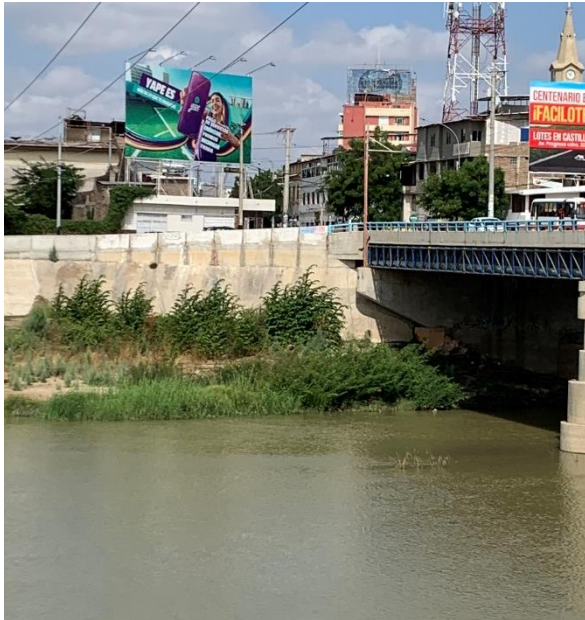
As was seen at the Cáceres Bridge, there is significant vegetative growth along the right bank as shown in Figure 15. A gauge was also found at this point of the river.

Figure 15- Below Sánchez Cerro Bridge

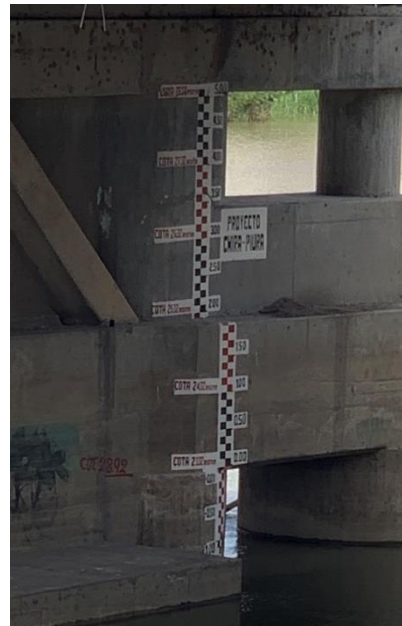
Figure 16- Gauge at Sánchez Cerro

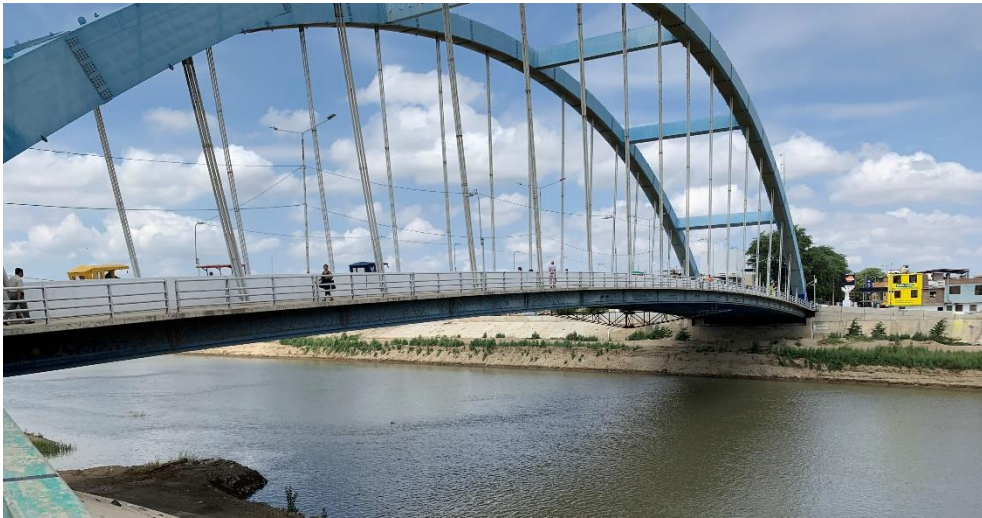
The channel section at the Bolognesi Bridge is approximately 150m.

Figure 17- Bolognesi Bridge

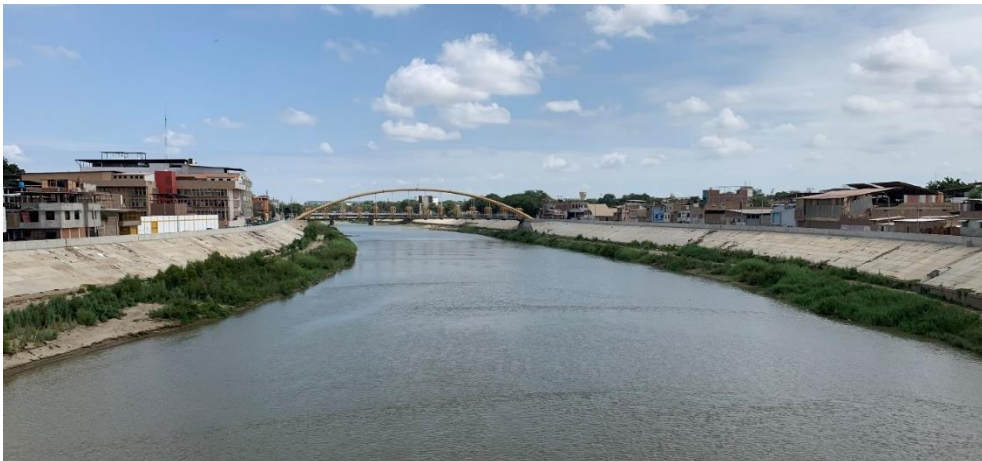
The Bolognesi Bridge marks the end of the Urban zone of the river. Similar to the other bridges, there is aggradation occurring close to the concrete banks with some vegetative growth as shown below in the upstream view of the bridge in Figure 18.

Figure 18- View upstream of Bolognesi Bridge

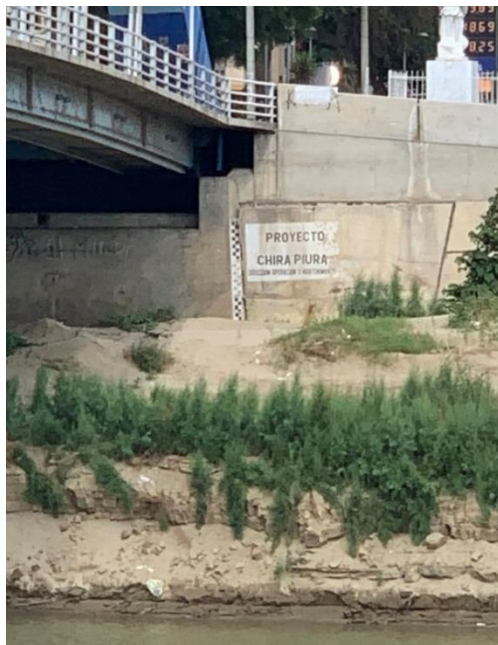
The gauge on the right bank is partially covered by sediments as shown in Figure 19.

Figure 19- Gauge at Bolognesi Bridge

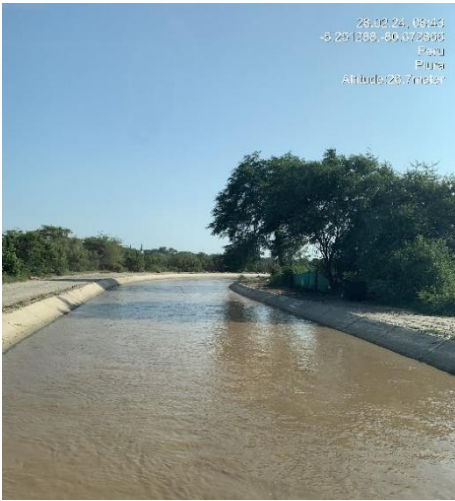
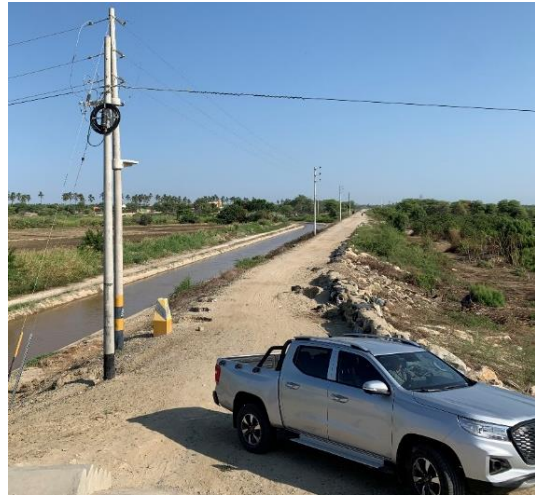
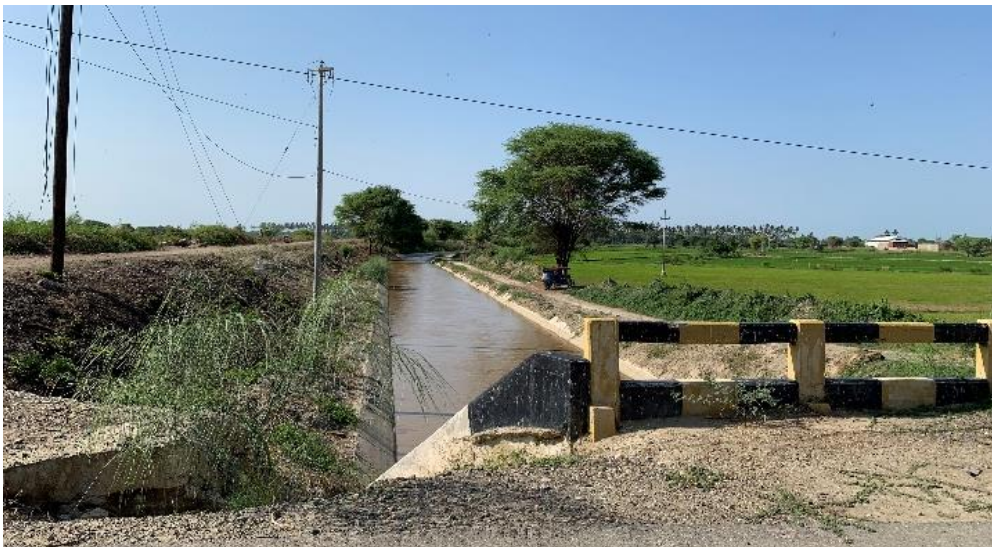
The Biaggio Arbulú channel flows along the right side of the river in the rural area, it provides a steady supply of water for irrigation in the lower basin.

Figure 21- Biaggio Arbulú Channel

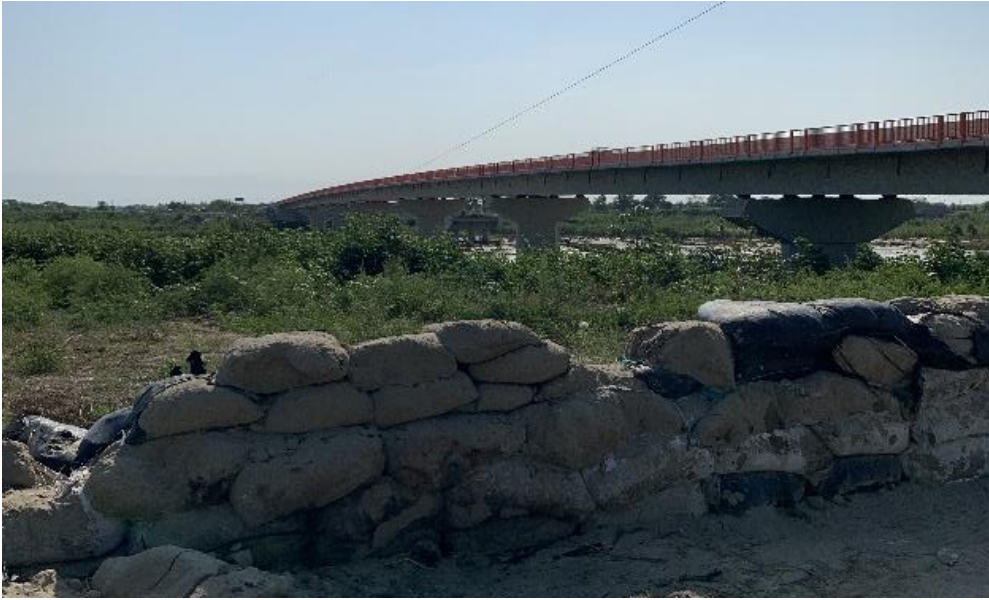
The Indpendencia bridge has a width of approximately 360m.

Figure 24- Independencia Bridge

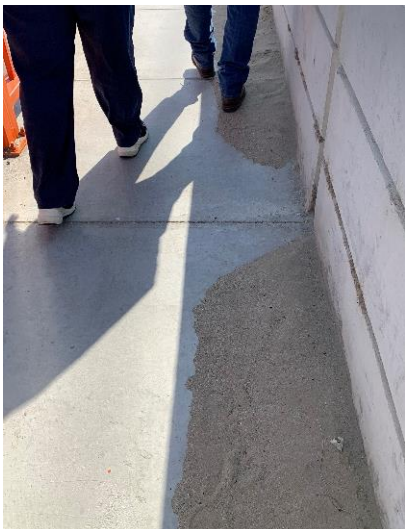
On the bridge, there is a lot of sandy sediment which has been deposited by the wind. Following the riverbanks comes there is vegetation as shown in Figure 25.

Figure 25- Eolian Sediment on Bridge

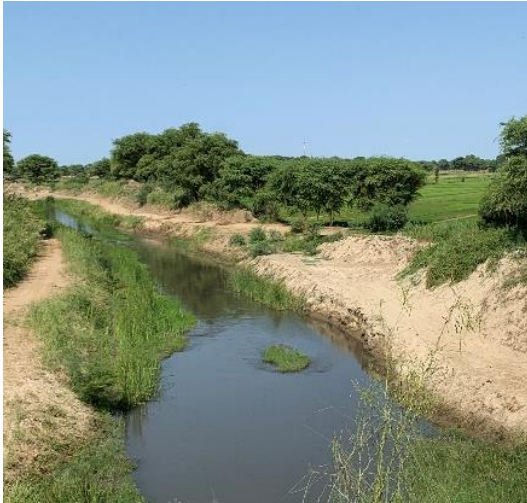
The drain 13.08 drains water from Castilla. The sediment around the river in this section is very clayey as shown in Figure 32.

Figure 31- Drain 13.08 on right side of river

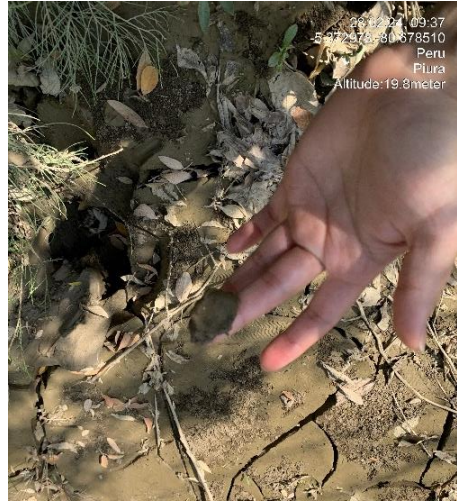
Figure 32- Clayey sediment at Drain 13.08
