Sediment Transport in the Piura River. Piura, Peru.

An application with the HEC-RAS model

Master Thesis

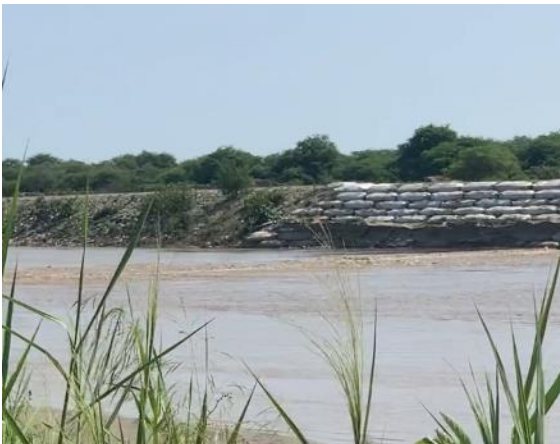
The drain crosses the Piura River in a pipeline. The location of the pipeline is visible across the Piura River. This may be due to erosion in this section of the river. As shown in Figure 34 many rows of the river defense have been revealed due to transport of sediment. This may put the pipeline in risk of failure.

Figure 33- Drain 13.08 crossing through Piura River

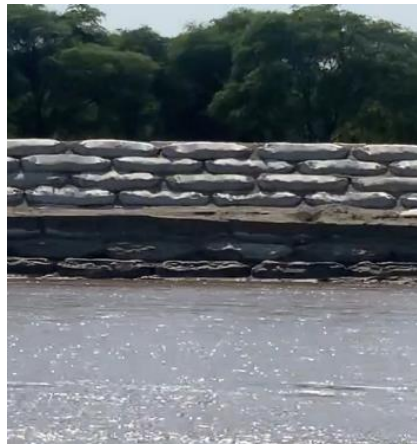
Figure 34- Erosion close to Drain 13.08

General aggradation is visible since the level of the floodplain was often observed to be above the level outside of the dikes. However, in some spans erosion is visible. This can be seen in Figure 29, taken close to Drain 13.08

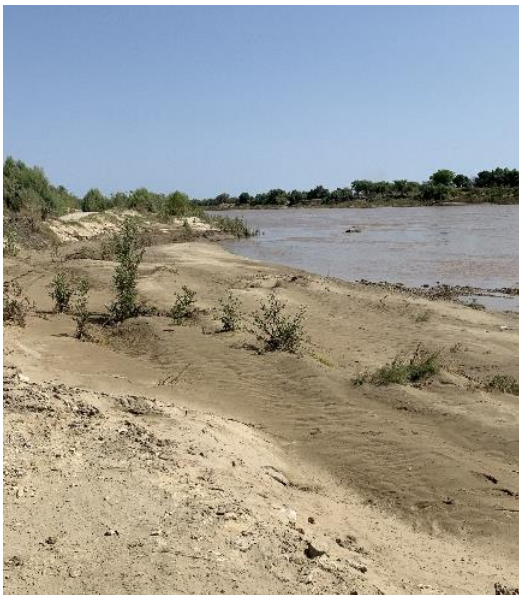
The banks are very sandy. Some clayey sediments are also present again. The deposition in this area is evident as seen by this dried sediment with a thickness of approximately 15cm as shown in Figure 37.

Figure 36- Sandy riverbank

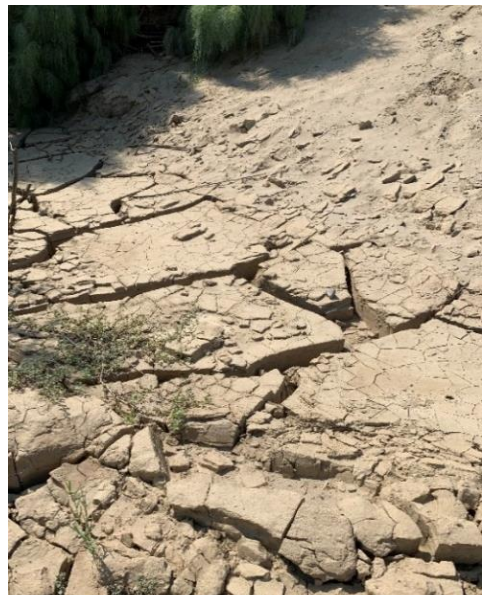
Figure 37- Clayey sediment deposit

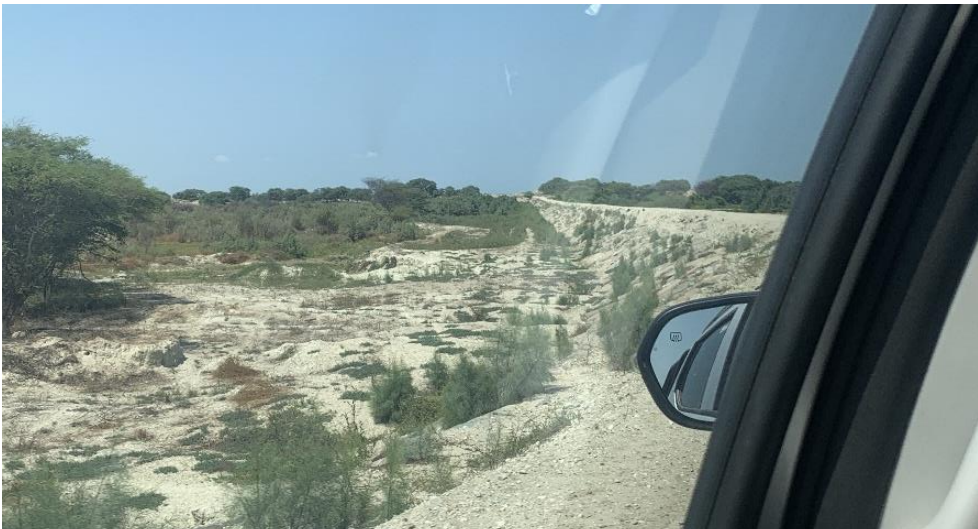
The lagoon system is protected by dikes. These feature a very steep slope of 1:1 and are made of large stones. However, this may be deemed unnecessary for the current system since the flow in this section is less aggressive.

Figure 39- Old dikes along Lagoon

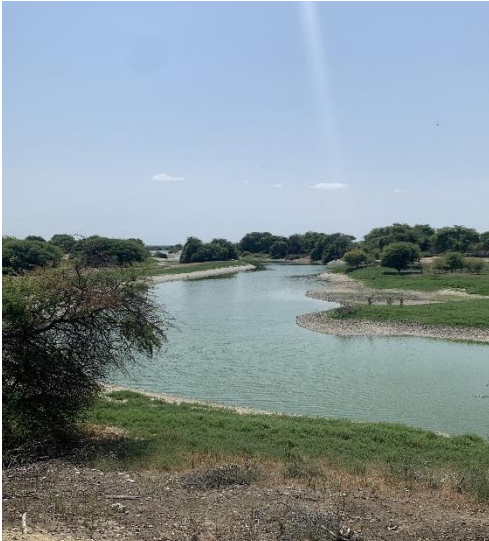
Figure 40- Upstream of dike, in Lagoon

The location where the river used to pass towards Sechura is shown in Figures 40 and 41 where Figure 40 is inside of the dike and Figure 41 is outside towards Sechura. The two sides are separated by the dike structure shown in Figure 42 and could be easily reconnected.

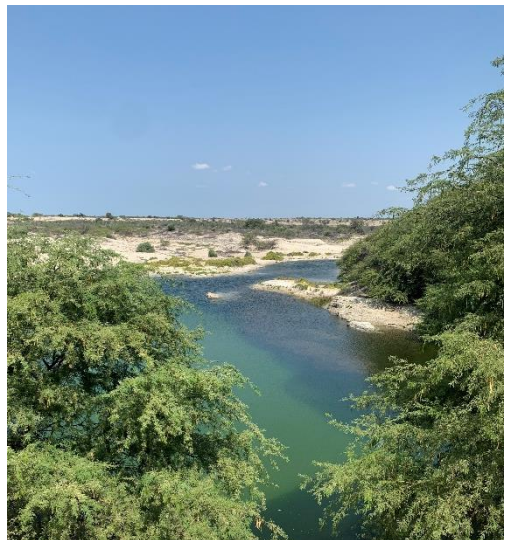
Figure 41- Downstream of dike, outside of the Lagoon

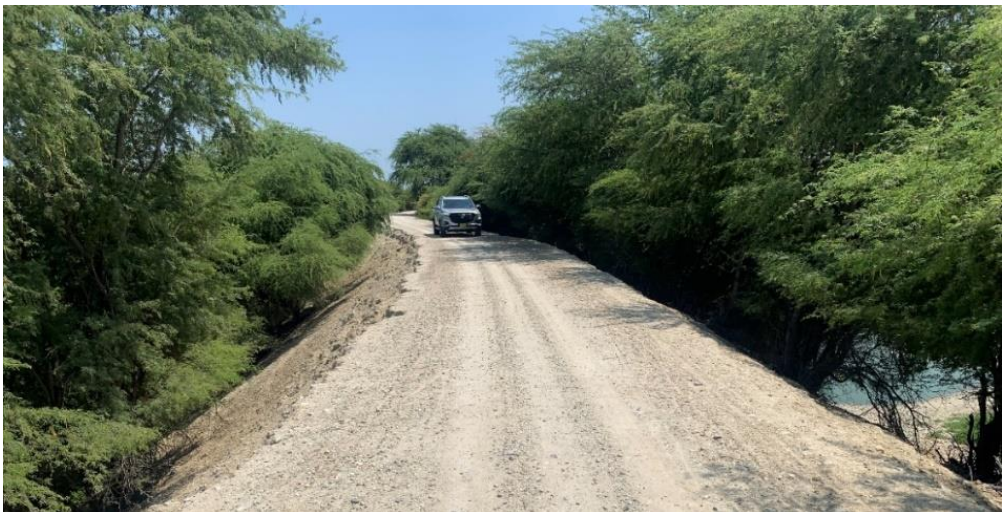
Figure 42- Dike bordering Lagoon

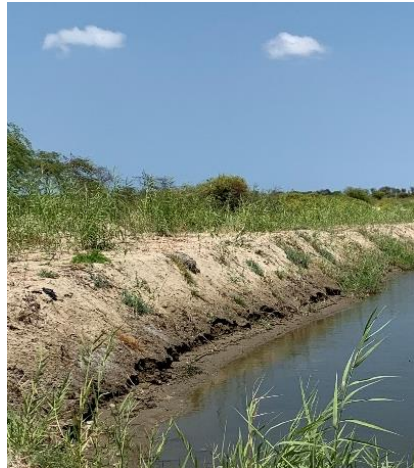
The old river course is called Río Loco and is currently fed by agricultural discharge and by Drain 13.08. This section of the river is influenced by tidal activity as visible in Figure 47 where around 20cm of sediment is moist.

Figure 47- Tidal influence at Río Loco

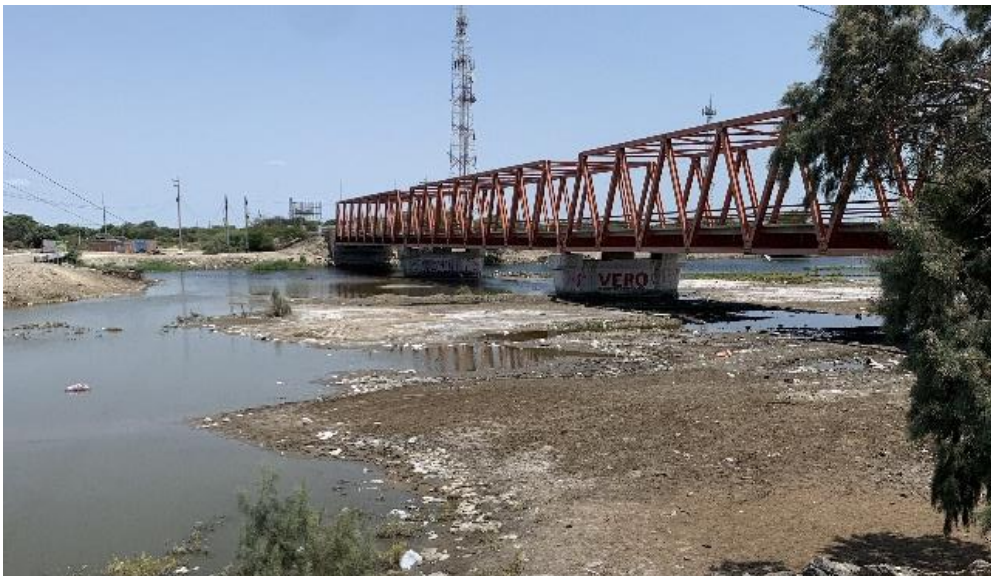
Río Loco passes through Sechura. The Sechura bridge is shown in Figure 48.

Figure 48- Sechura Bridge

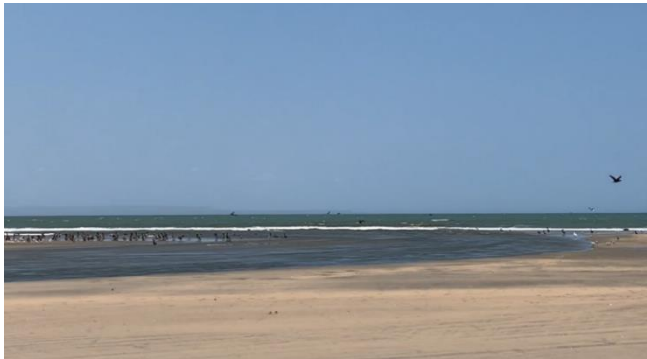
Río Loco currently discharges into the Pacific Ocean through three branches. The pilot channel is designed to exit through Chulliyache.

Figure 51- River exit at Chulliyache

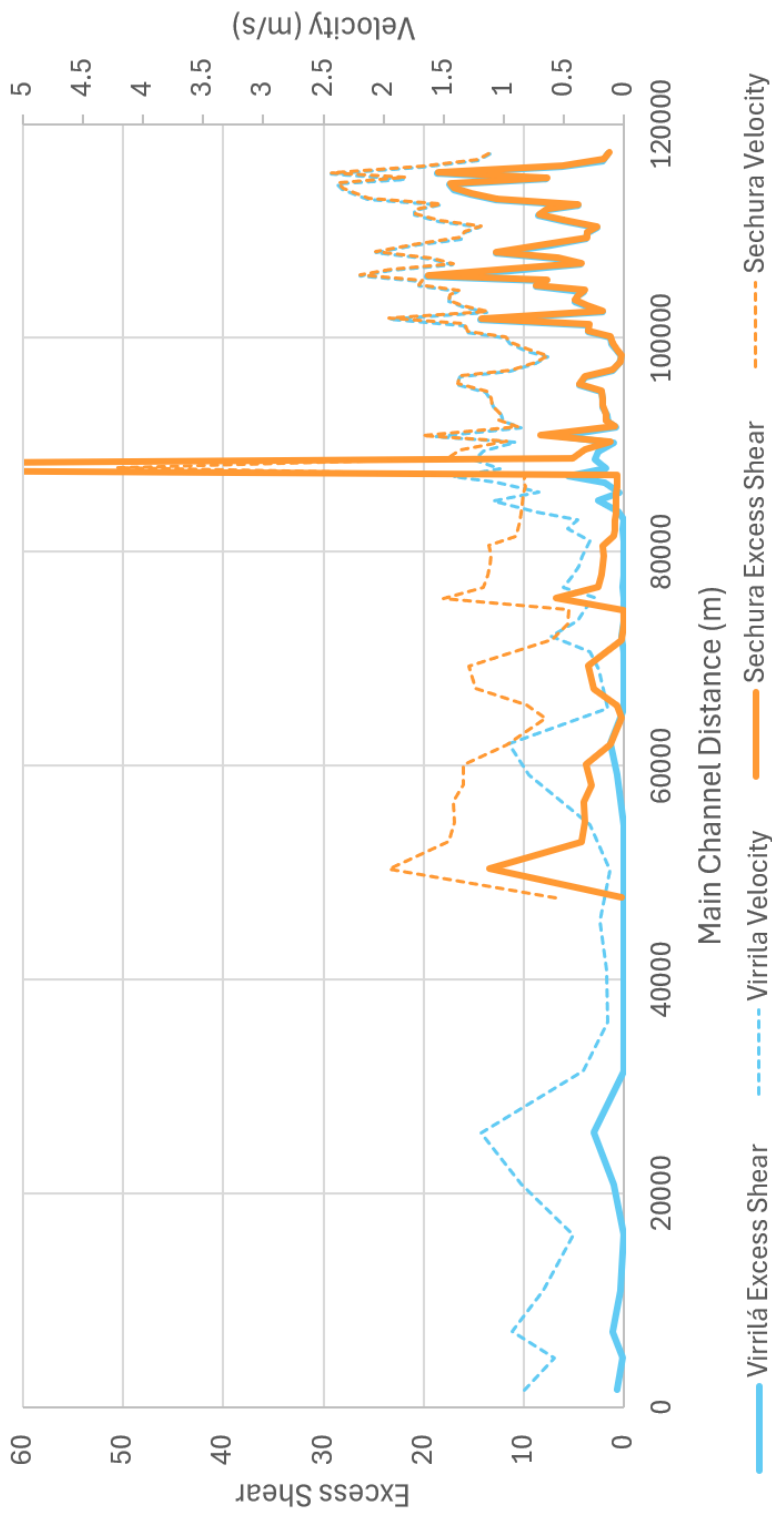
Figure 1- Excess shear based on drag law for $Q=1,000m^3/s$

Critical shear stress is found to be $\tau_{cr}=0.144 \text{ N/m}^2$

Shear stress is calculated using Equations 4-7 assuming a rough bed condition.

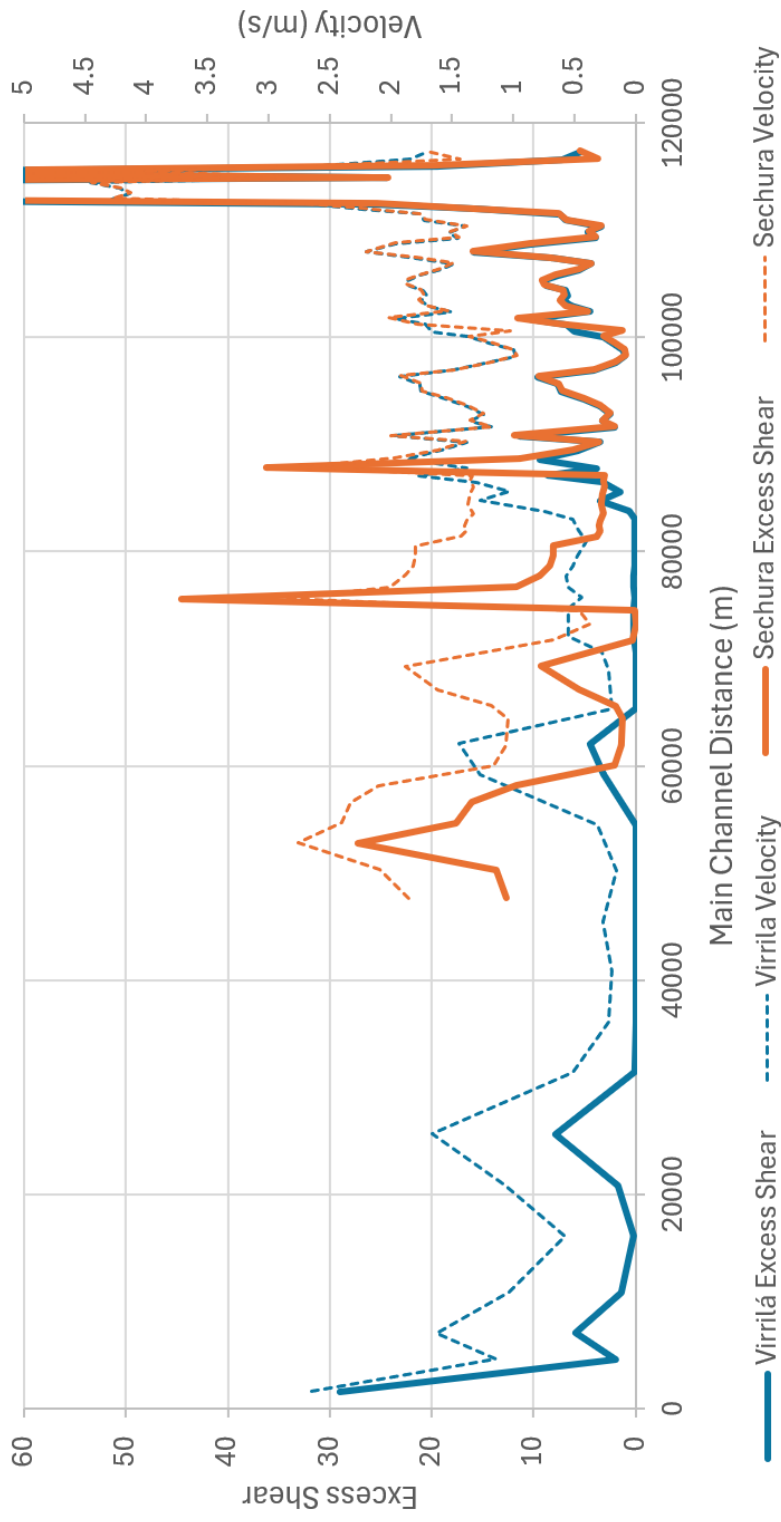
Figure 2- Excess shear based on drag law for $Q=3,200m^3/s$

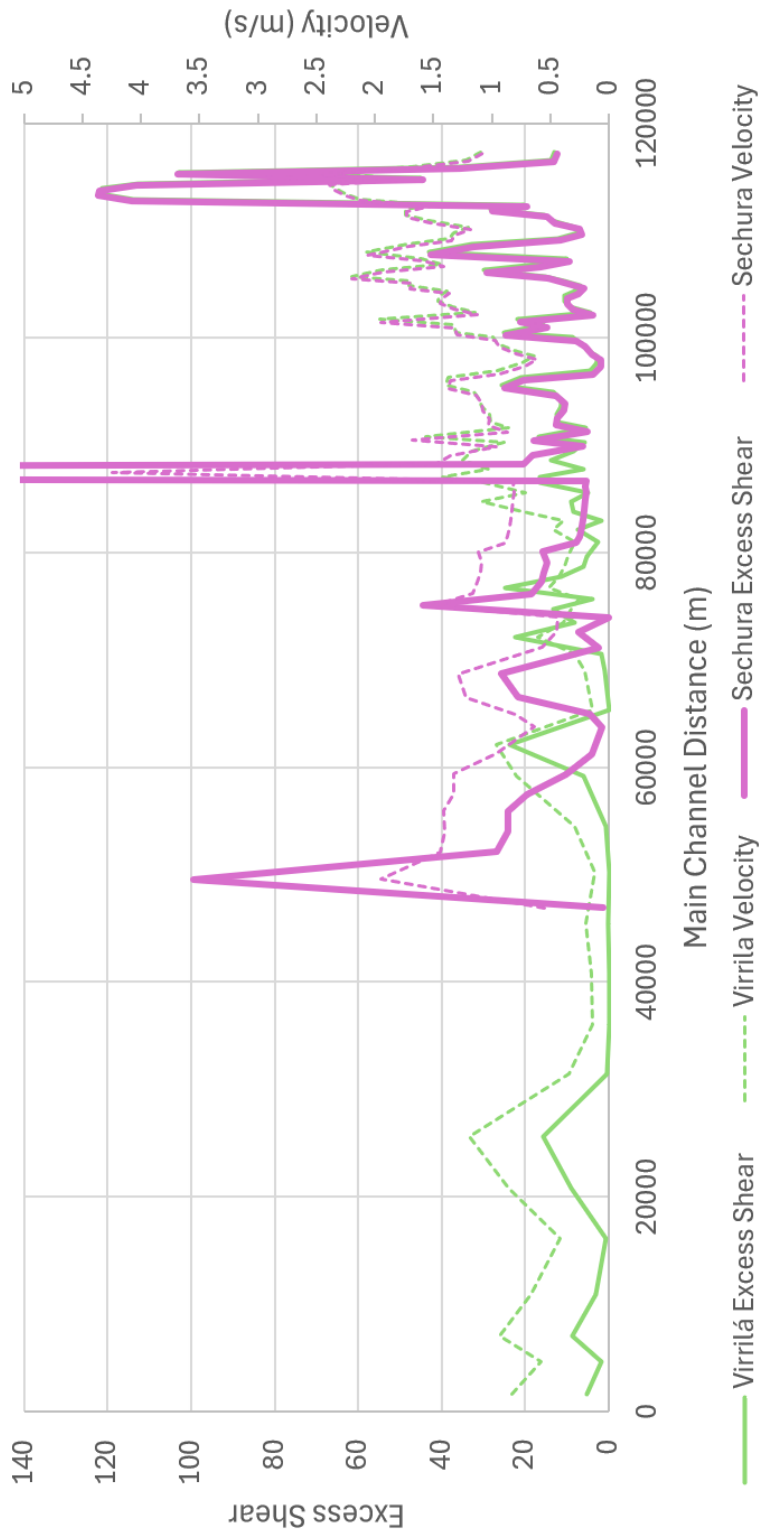
Figure 3- Excess shear based on HEC-RAS output for $Q=1,000m^3/s$

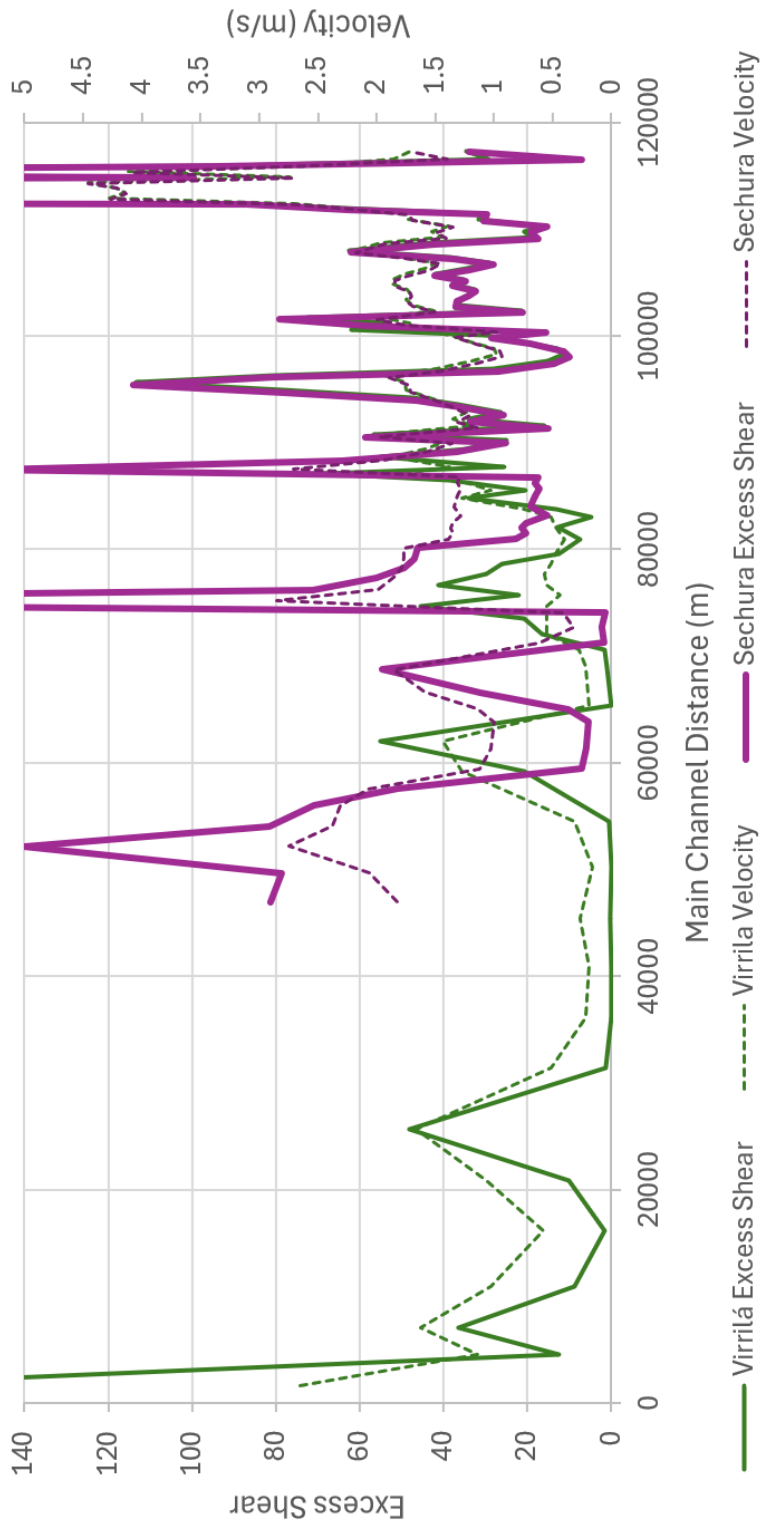
Figure 4- Excess shear based on HEC-RAS output for $Q=3,200m^3/s$
