Tests of Full Size Rubber Foil Adhesive Joints

2007

TESTS OF FULL SIZE RUBBER FOIL ADHESIVE JOINTS

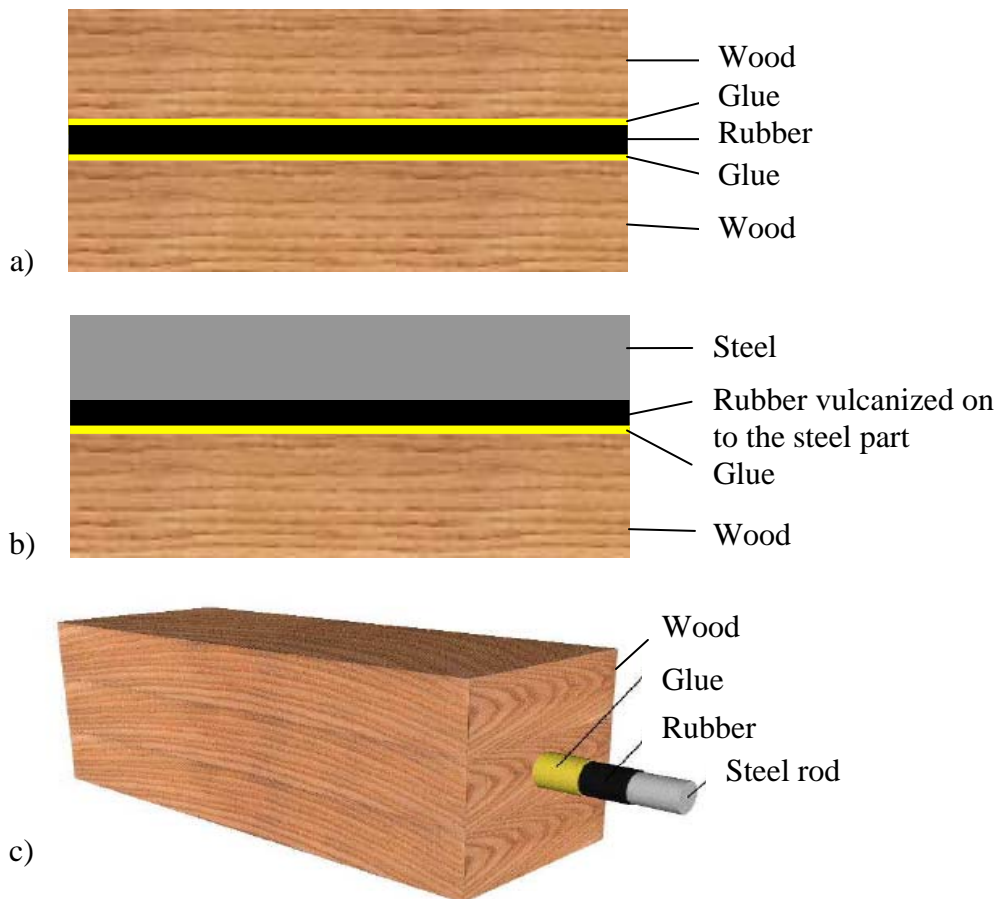
The configuration of rubber foil adhesive joints is illustrated in the below figure. The purpose of the rubber foil is to increase the load bearing capacity and enable elastic joint behavior. Increase in load bearing capacity is because the flexibility of the rubber layer enables distribution of the load, thus reducing stress concentrations and making the entire bond area active in carrying the load. Also other advantages with the elastic bond performance are probable, e.g. very good impact strength, less cracking and moisture variation induced stresses in the wood and good interaction with nails due to the possibility to choose bond stiffness.

Build up of rubber foil adhesive joints:

- a) Wood-to-wood joint.
- b) Steel-to-wood joint.
- c) Glued-in steel rod.

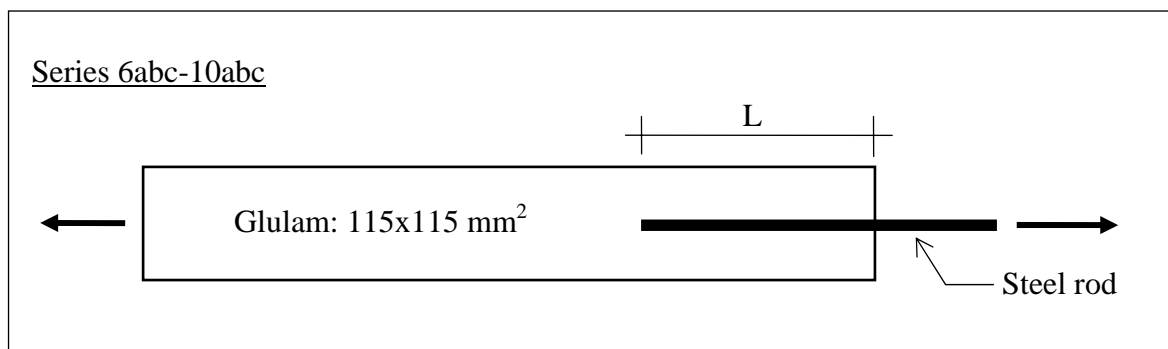
2.3 Steel rods glued into glulam

The pull-out strength of glued-in steel rods were tested in 12 ramp loading test series and in 9 time-to-failure at constant load test series. The 9 duration of load (DOL) test series were made at three different load levels. 8 of the series related to steel rods vulcanized with a rubber coating while the other series served as reference tests series. The glued-in rod tests are presented in Chapter 6.

Series	N.o.s.	Rod surface	Rod diameter	L, mm	Loading
6a	4	Smooth	18.3 mm	160	Ramp
6b	4	Vulcanized	18.3 mm	160	Ramp
6c	4	Threaded	M20	160	Ramp
7a	4	Smooth	18.3 mm	320	Ramp
7b	4	Vulcanized	18.3 mm	320	Ramp
8a	4	Smooth	18.3 mm	480	Ramp
8b	4	Vulcanized	18.3 mm	480	Ramp
9a	4	Smooth	18.3 mm	640	Ramp
9b	4	Vulcanized	18.3 mm	640	Ramp
10aR	2	Smooth	14.6 mm	160	Ramp
10bR	3	Vulcanized	14.6 mm	160	Ramp
10cR	3	Threaded	M16	160	Ramp
10aD1	3	Smooth	14.6 mm	160	DOL-1
10bD1	3	Vulcanized	14.6 mm	160	DOL-1
10cD1	3	Threaded	M16	160	DOL-1
10aD2	3	Smooth	14.6 mm	160	DOL-2
10bD2	3	Vulcanized	14.6 mm	160	DOL-2
10cD2	3	Threaded	M16	160	DOL-2
10aD3	3	Smooth	14.6 mm	160	DOL-3
10bD3	3	Vulcanized	14.6 mm	160	DOL-3
10cD3	3	Threaded	M16	160	DOL-3

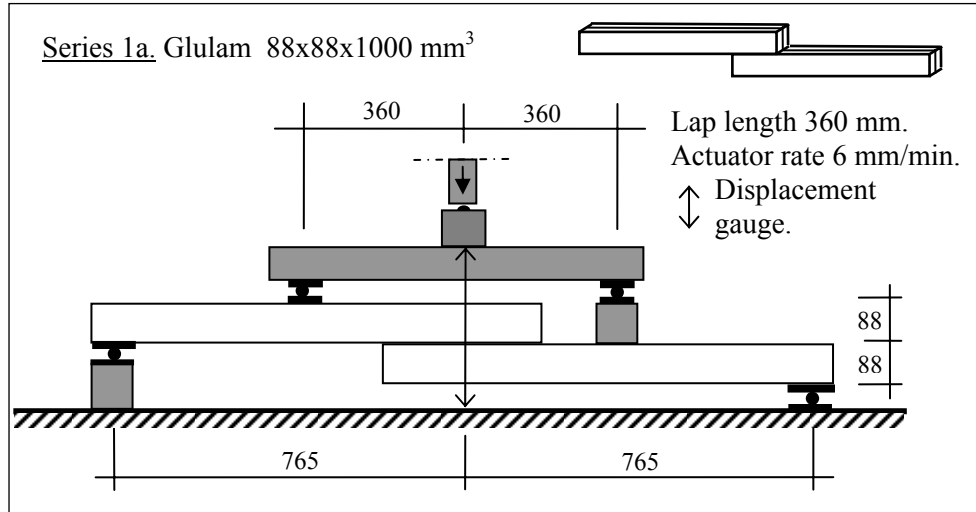
4.1 Test series 1a, single lap joint in flatwise bending

3 nominally equal specimens were tested. Specimen geometry, lamellae orientation, test setup and the speed of the loading actuator are indicated in the above figure. Load and displacement were recorded.

The flatwise bending test is hard, exposing the rubber foil to high tensile normal stress and cleavage perpendicular to the bond area and not allowing the beneficial shear flexibility of the rubber layer to be activated.

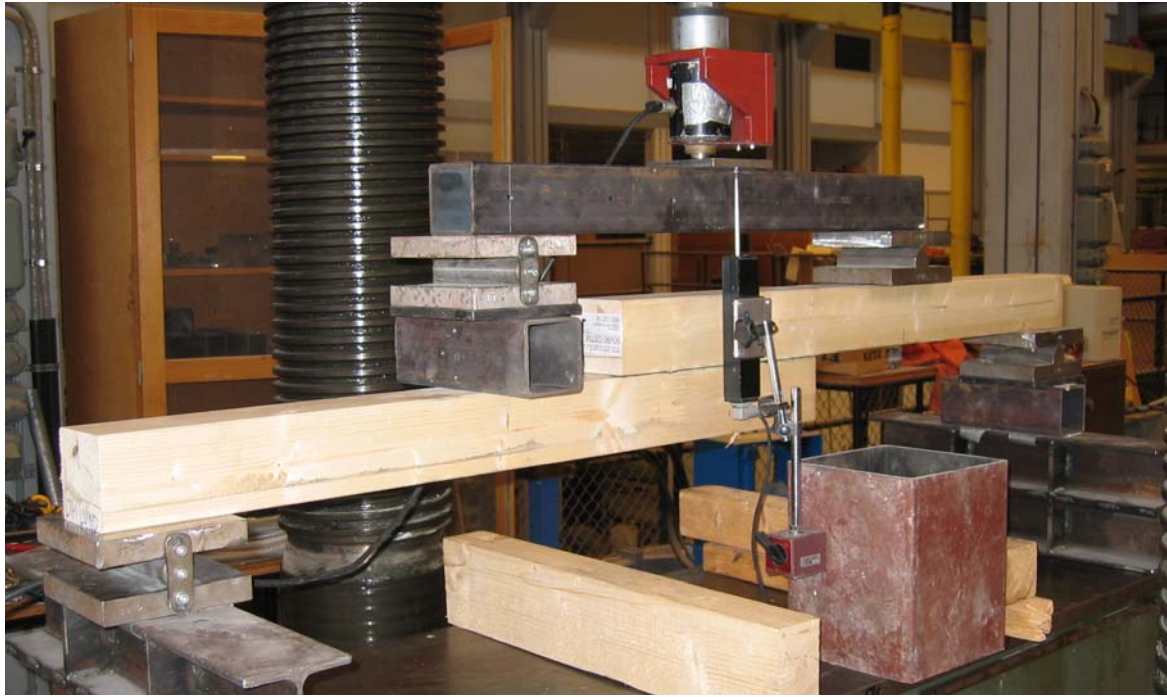
The test results are presented in the below table, pictures and diagram. The tests results seem good. Bond area fracture was obtained only at high load. In two of the three tests was failure initiated by fracture in the wood, not within and neither in the close vicinity, of bond surface. The bending stress at failure indicated in the table is calculated as $\sigma_f = M_f / (bd^2/6)$, where M_f is the bending moment at failure and $b=d=88$ mm. The value of σ_f for a solid wood or glulam beam sawn to the same geometry as the tested beams can by use of equations and material parameter values given in (Gustafsson and Enquist, 1988) be estimated to be the order of 15-20 MPa.

Test no.	P_f kN	δ_f mm	σ_f MPa	Cause of failure
I	22.7	15.4	40.4	Fracture in the rubber foil surface, at the rubber-glu interface
II	12.7	9.9	22.7	Perp. to grain tensile fracture in the wood, ~1-2 cm from the bond surface
III	18.9	12.9	33.6	Perp. to grain tensile fracture in the wood, ~1-2 cm from the bond surface

Series 1a, single lap joint in flatwise bending

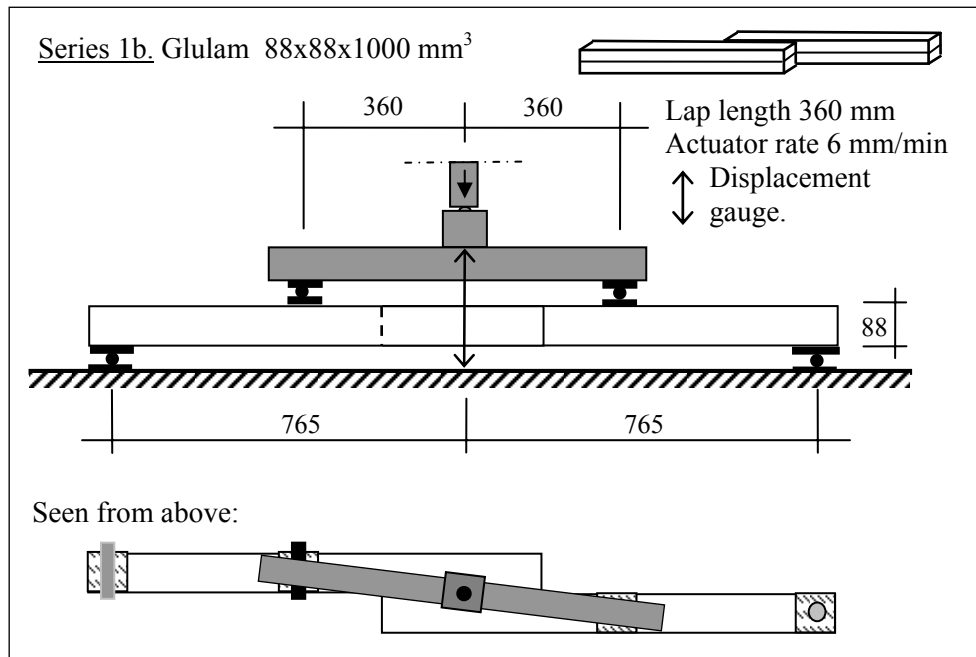
4.2 Test series 1b, single lap joint in edgewise bending

The single overlap edgewise bending test could also be named a single bond area torsion test. Failure developed in all three tests in the wood in the overlap region. These wood failures seemed to be caused by rolling shear, longitudinal shear and perpendicular to grain tensile stress in the wood. No fracture was observed in the bond area. Small rolling shear cracks in the wood close to the corners of the bond area were observed well before maximum load. The course of failure had a somewhat more ductile character than the flatwise bending test failures and some crackling could be heard before the final failure. In the below table is σ_f the magnitude of the bending stress at failure, i.e. $M_{failure}/(bh^2/6)$, where M is the cross section bending moment and $b=h=88$ mm.

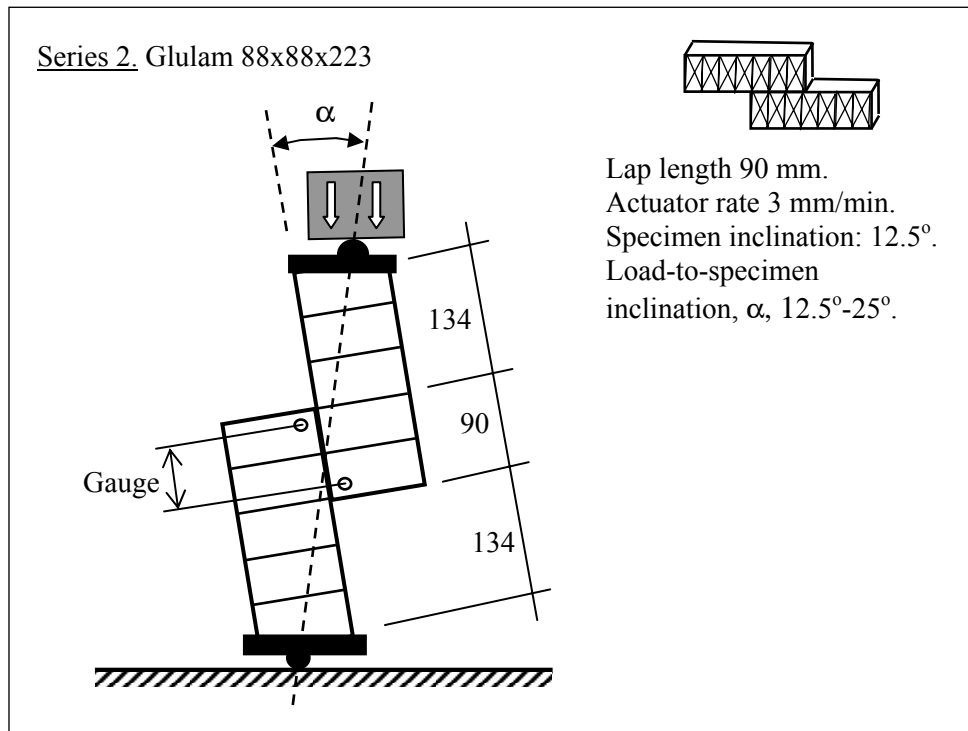
4.3 Test series 2, single lap joint in rolling shear

Rolling shear failure was not obtained due to poor loading setup design. Instead failure developed as a perpendicular to grain tension bending failure. Although the load-to-specimen angle was increased in tests II and III, the same kind failure occurred in all three tests. The recorded load indicated in the below table and diagram is the vertical component of the total load. The numbers indicated in the τ_f -column show the bond area mean shear stress at failure, i.e. the tangential force at failure divided by the bond area. σ_f is the tensile bending stress at failure as calculated by the conventional Navier's bending stress equation.

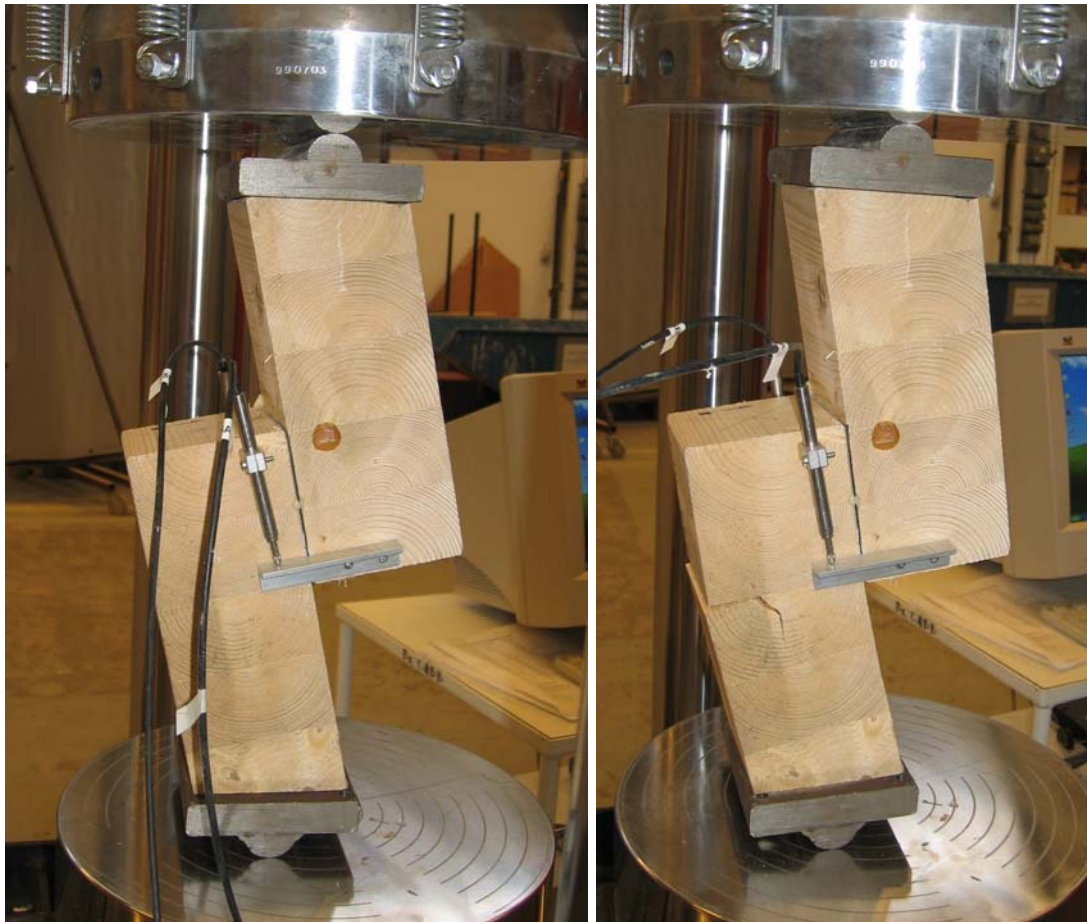
Test no.	P_f kN	δ_f mm	α	τ_f MPa	σ_f MPa
I	12.9	0.91	12.5°	>1.6	2.1
II	15.2	1.35	~20°	>1.8	2.5
III	16.7	1.61	~25°	>2.1	2.6

Series 2, rolling shear

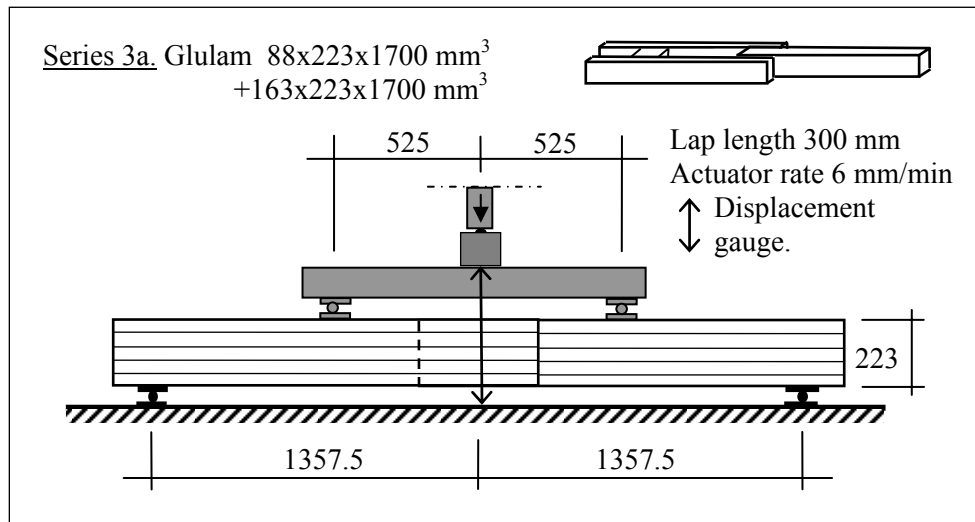
4.4 Test series 3a, 300 mm double lap joint in bending

Fracture in the wood started well before ultimate load was reached, starting with development of 45° inclined rolling shear stress cracks in the wood at the corners of the bond area. The development of these first cracks had no or insignificant influence on the recorded load versus displacement performance. Significant crackling and development of a number of fairly small cracks in the wood was observed before final failure. The final failure seemed to include the development of large longitudinal shear, rolling shear and perpendicular to grain tensile cracks in the bulk part of the wood members and also rolling shear cracks in the wood in the vicinity of the bond area. After failure was moreover shear fracture in the rubber-to-wood interface observed at some locations. In the below table is σ_f the nominal bending stress in the middle wooden member at failure.

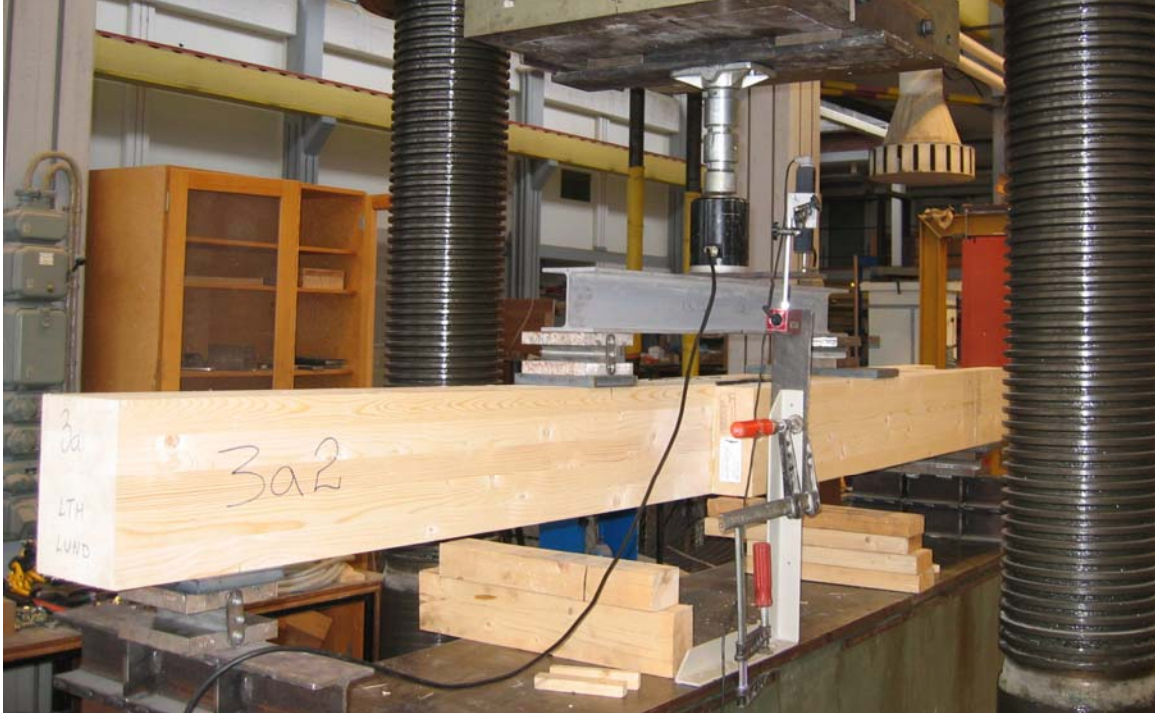
Test no.	P_f kN	δ_f mm	σ_f MPa	Estimated predominant cause of failure
I	63.6	27.3	19.6	Combined rolling shear, longitudinal shear and perp. to grain tension in the wood.
II	68.4	26.0	21.1	Combined rolling shear, longitudinal shear and perp. to grain tension in the wood.
III	70.9	29.3	21.8	Combined rolling shear, longitudinal shear and perp. to grain tension in the wood.

III at ~80% of failure load

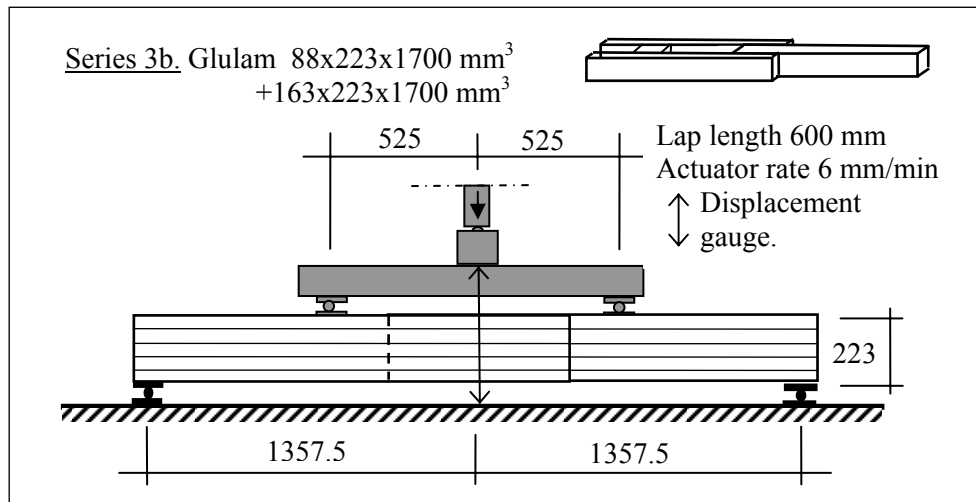
4.5 Test series 3b, 600 mm double lap joint in bending

The 600 mm double overlap bending specimens showed, - just as the corresponding 300 mm specimens - , development of 45° inclined rolling shear stress cracks in the wood at the corners of the bond area well before peak load. The development of these first cracks had no or insignificant influence on the recorded load versus displacement performance. The course of final failure was more abrupt than for the 300 mm specimens. Also the failure loads and the beam stiffness were significantly higher. In the below table is σ_f the nominal bending stress in the middle wooden member at failure.

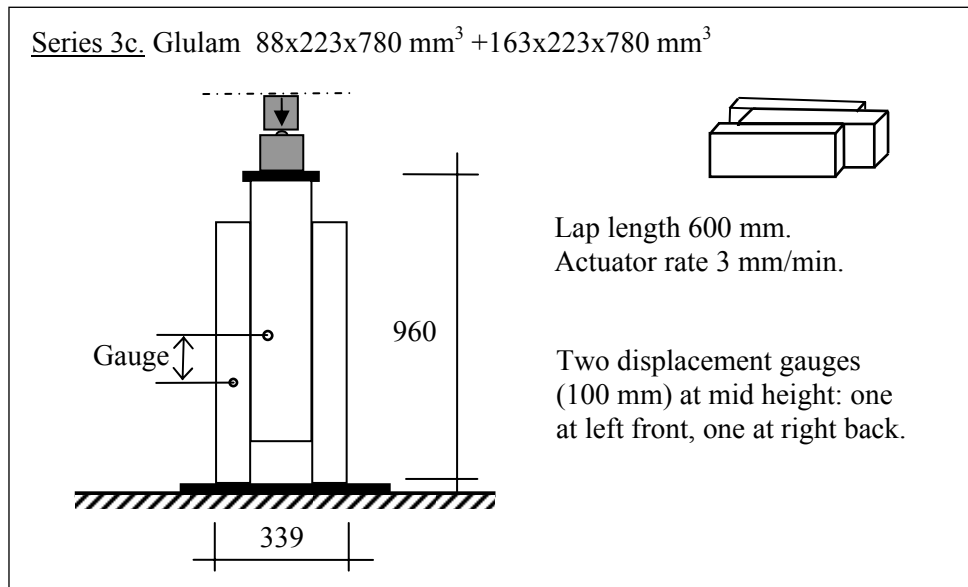
4.6 Test series 3c, 600 mm double lap joint in shear

The shear test specimen joints had the same geometry as the 600 mm double lap bending test specimens. Development of a small perpendicular to grain tensile crack in the middle of the lower end of the mid wooden element started at about 50% of the ultimate load. This happened for all three specimens, but it didn't seem to influence the performance of the joint. The final failures were sudden and involved a loud bang due to the high loads at failure. In the below table is τ_f the average bond area shear stress at failure, i.e. $\tau_f = P_f / (2ba)$, where $b = 223 \text{ mm}$ and $a = 600 \text{ mm}$ and σ_f is the compressive parallel to fiber normal stress at failure, i.e. $\sigma_f = P_f / (bh)$, where $h = 163 \text{ mm}$.

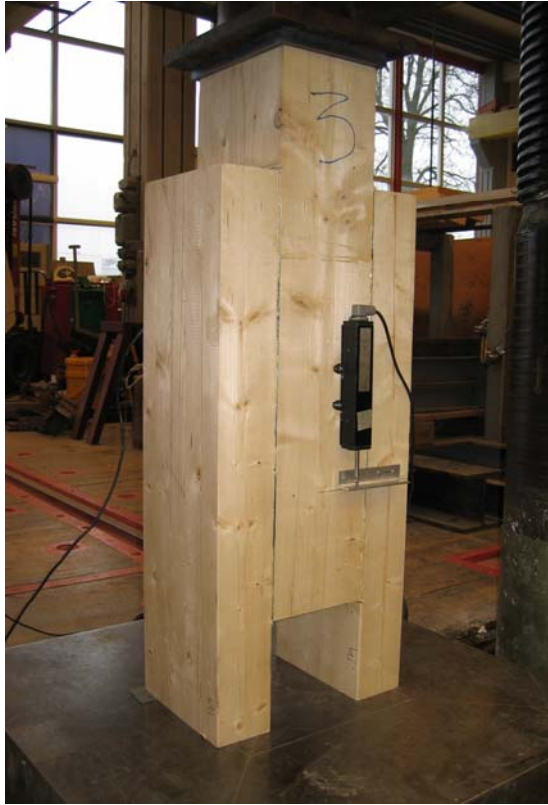
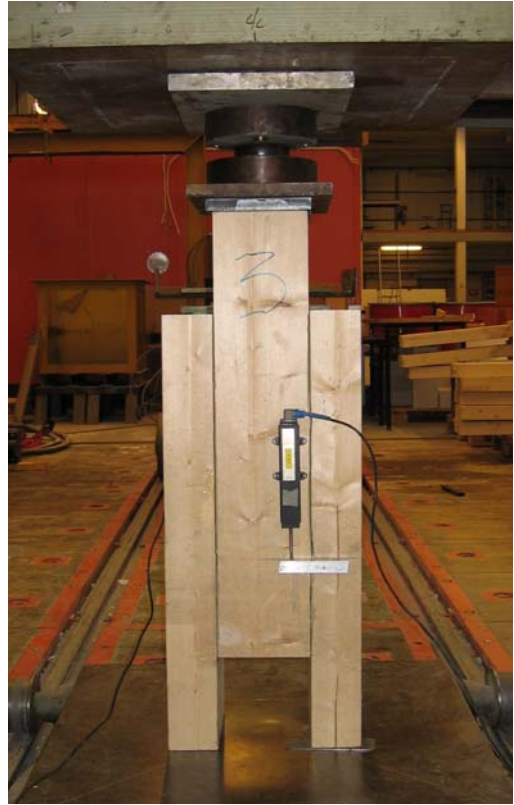
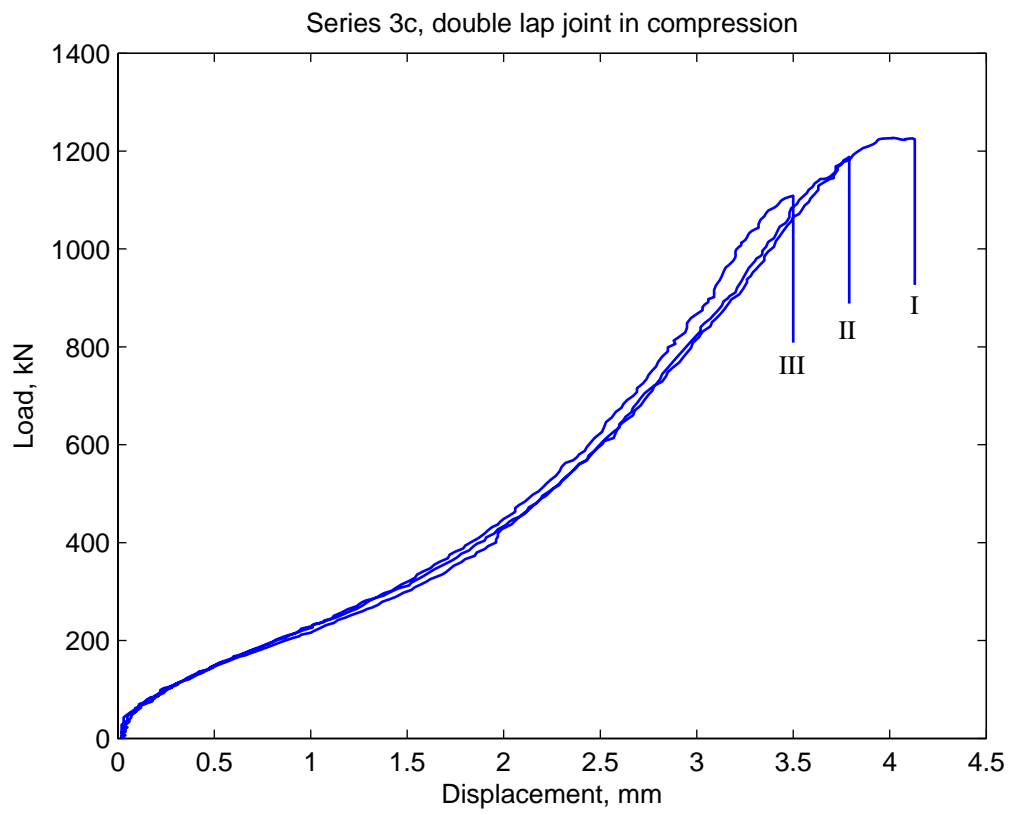
Test no.	P_f kN	δ_f mm	τ_f MPa	σ_f MPa	Cause of failure
I	1227	4.11	4.58	33.8	Shear failure in the wood along the bond area.
II	1188	3.77	4.44	32.7	Compressive bending failure of the wood.
III	1109	2.48	4.14	30.5	Shear failure in the wood perpendicular to and along part of the bond area, possibly due to non-uniform contact between the specimen and the supporting steel plate.

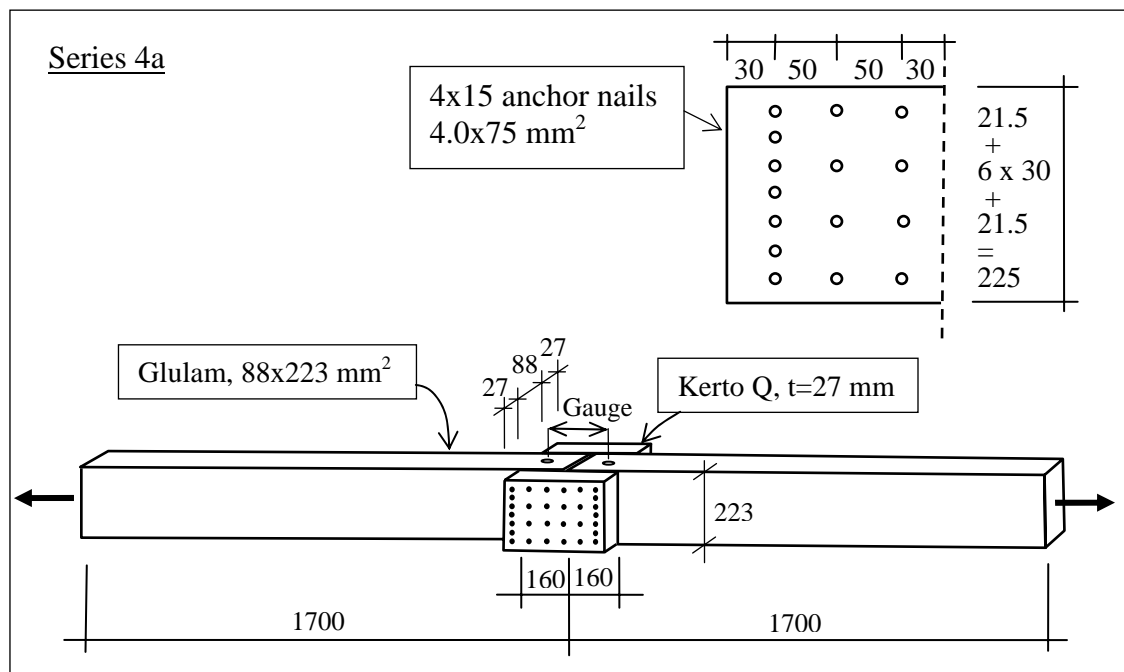
5.1 Test series 4a, 160 mm lap joints in shear by tensile loading

The test results are indicated in the below table, diagram and pictures. The notations used for type of failure is defined in the below figure. σ_f indicates the mean tensile stress in the LVL at failure.

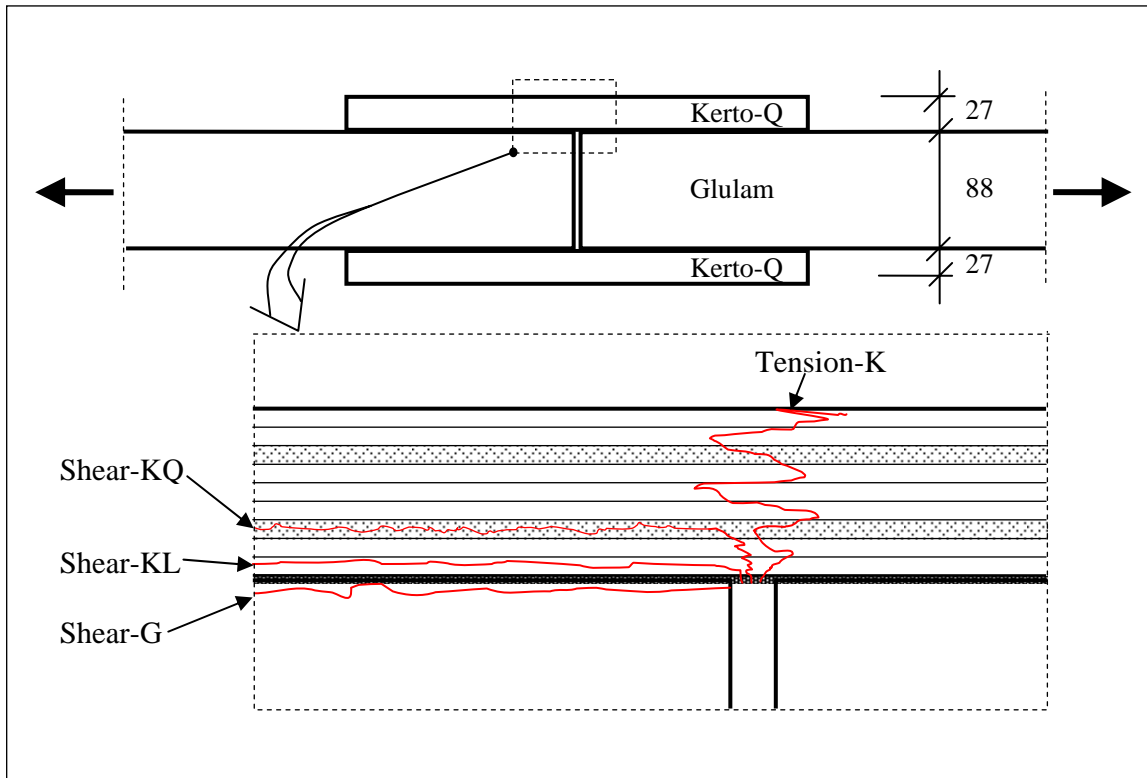
Various conceivable failure locations are illustrated in the above figure. "Tension-K" is tensile rupture of the LVL (the Kerto), "Shear-KQ" is rolling shear fracture in the inner-most veneer layer with fiber orientation in the cross-direction, "Shear-KL" is shear fracture in the inner-most veneer layers with fiber orientation along in the direction of the global load, and "Shear-G" is shear fracture in the glulam. Failure of the rubber layer or the in the adhesive interfaces was not observed to be dominating for any of the specimens tested in Series 4a. Adhesive interface fracture was observed locally when "Shear-KQ" or "Shear-G" was predominant.

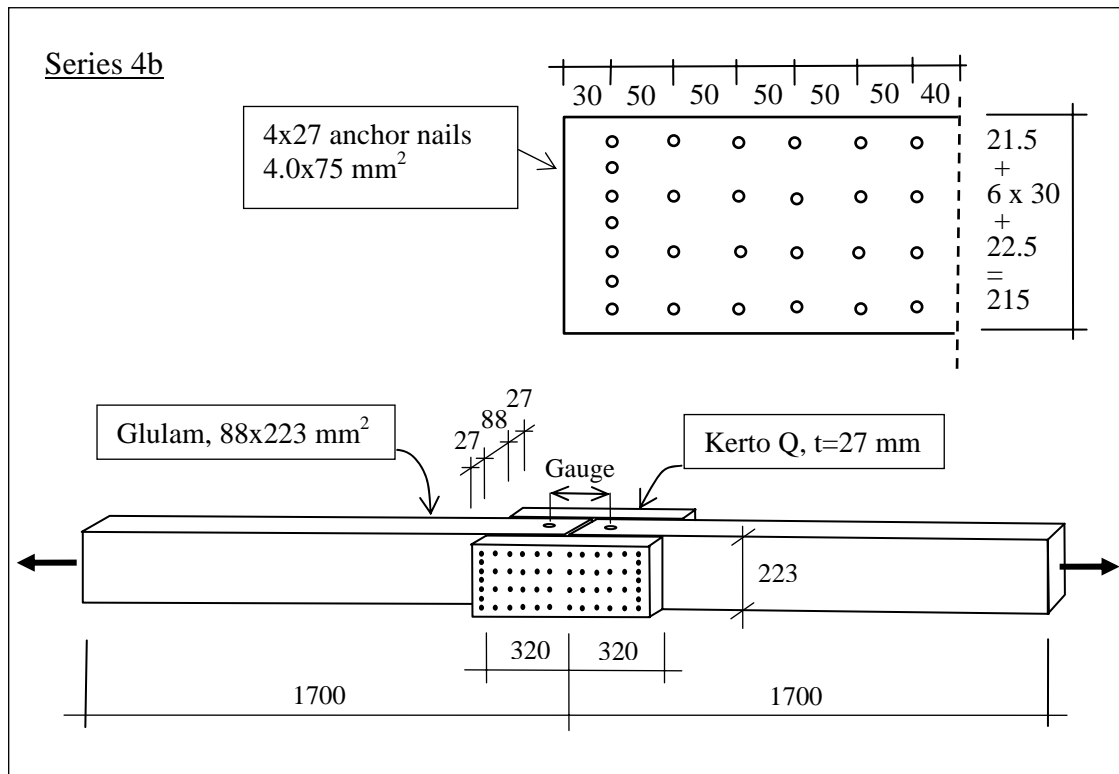
5.2 Test series 4b, 320 mm lap joints in shear by tensile loading

The test results are indicated in the below table, diagram and pictures. The failure mode notation given in the below table are defined in section 5.1. σ_f indicates the mean tensile stress in the LVL at failure.

In addition to the three specimens with a glued rubber foil and nails was one specimen without the rubber foil manufactured and tested. This additional specimen was nailed and glued in the same way as the other specimens, but without the rubber foil.

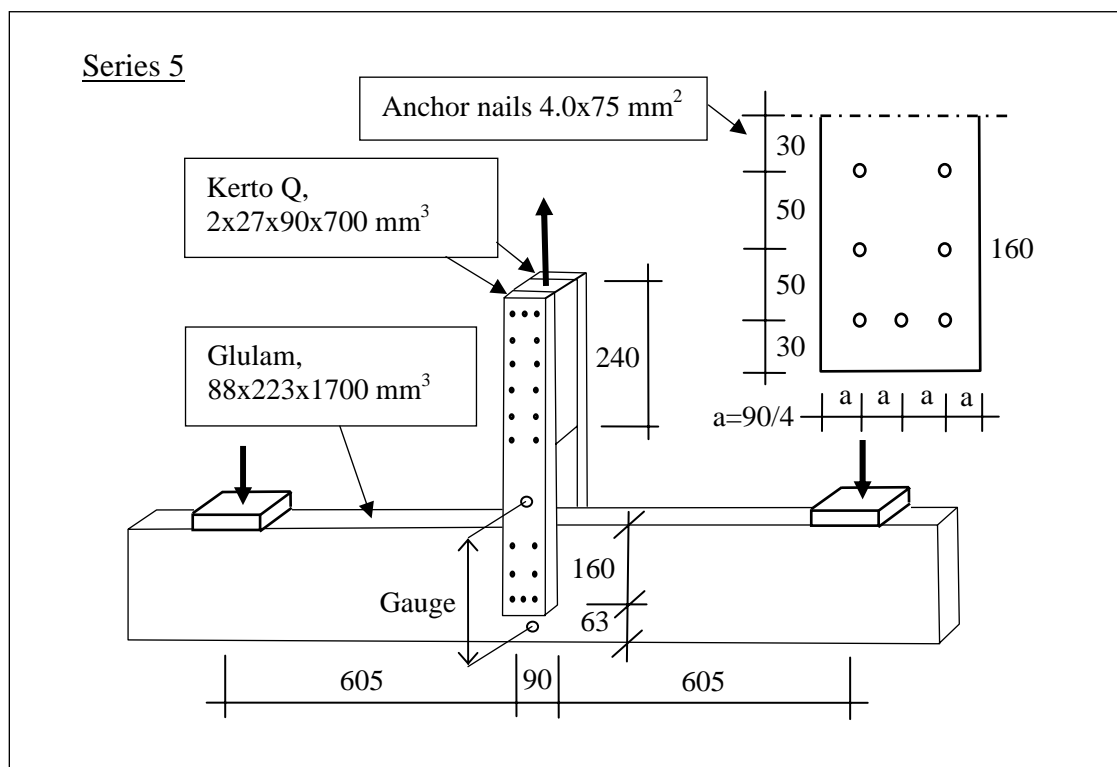
5.3 Test series 5, 160 mm lap joint in perpendicular tension

The test results are indicated in the below table, diagram and pictures. The shear stress is the mean shear stress across the bond areas at failure, i.e. $P/(2xLxb)$, where $L=160$ mm and $b=90$ mm.

During test number II it was found that glue was missing in one of the rubber-LVL interfaces. The results obtained by specimen II are thus not valid for a symmetric specimen, having both LVL-parts glued to the rubber.

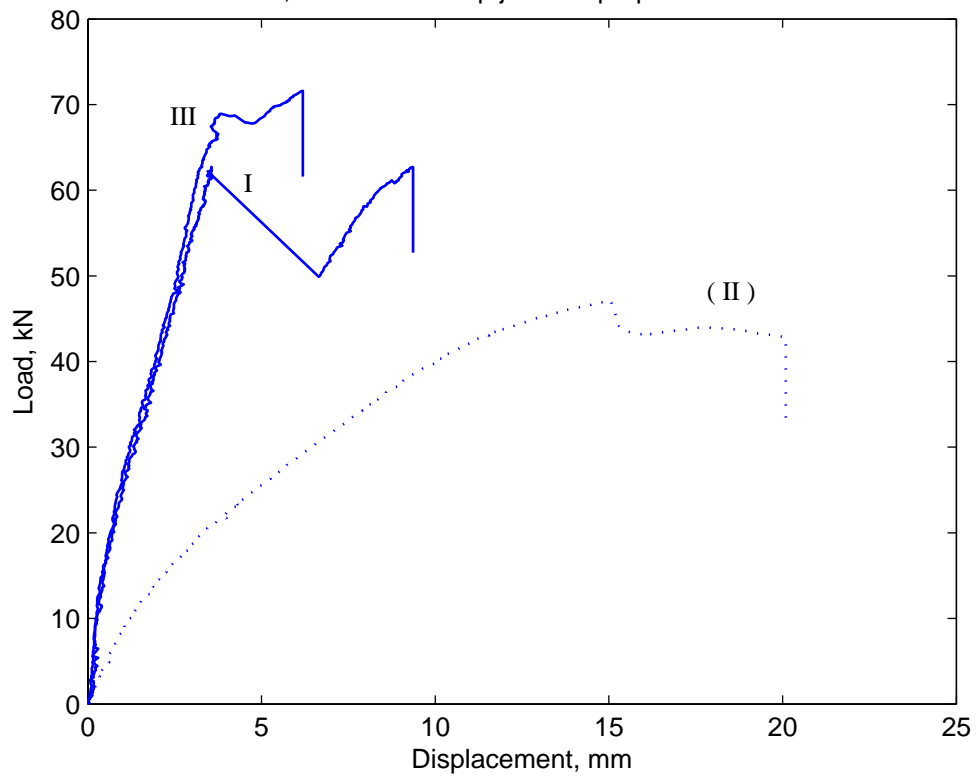
Series 5, 160 mm LVL lap joints in perpendicular tension

Test no.	P_f kN	δ_f mm	τ_f MPa	Failure, failure area 1	Failure, failure area 2
I	62.7	3.6	2.18	Longitudinal shear in LVL + rolling shear in glulam (+ Perp. to grain failure in beam.).	No failure. (Minor perp. to grain tensile failure at upper edge of beam.)
(II)	(47.2)	(15.1)	(1.64)	Glue missing.	Shear and tension-bending failure in LVL.
III	71.6	6.2	2.49	Longitudinal shear in LVL + perp. to grain failure in beam.	Longitudinal shear in LVL + perp. to grain failure in beam.

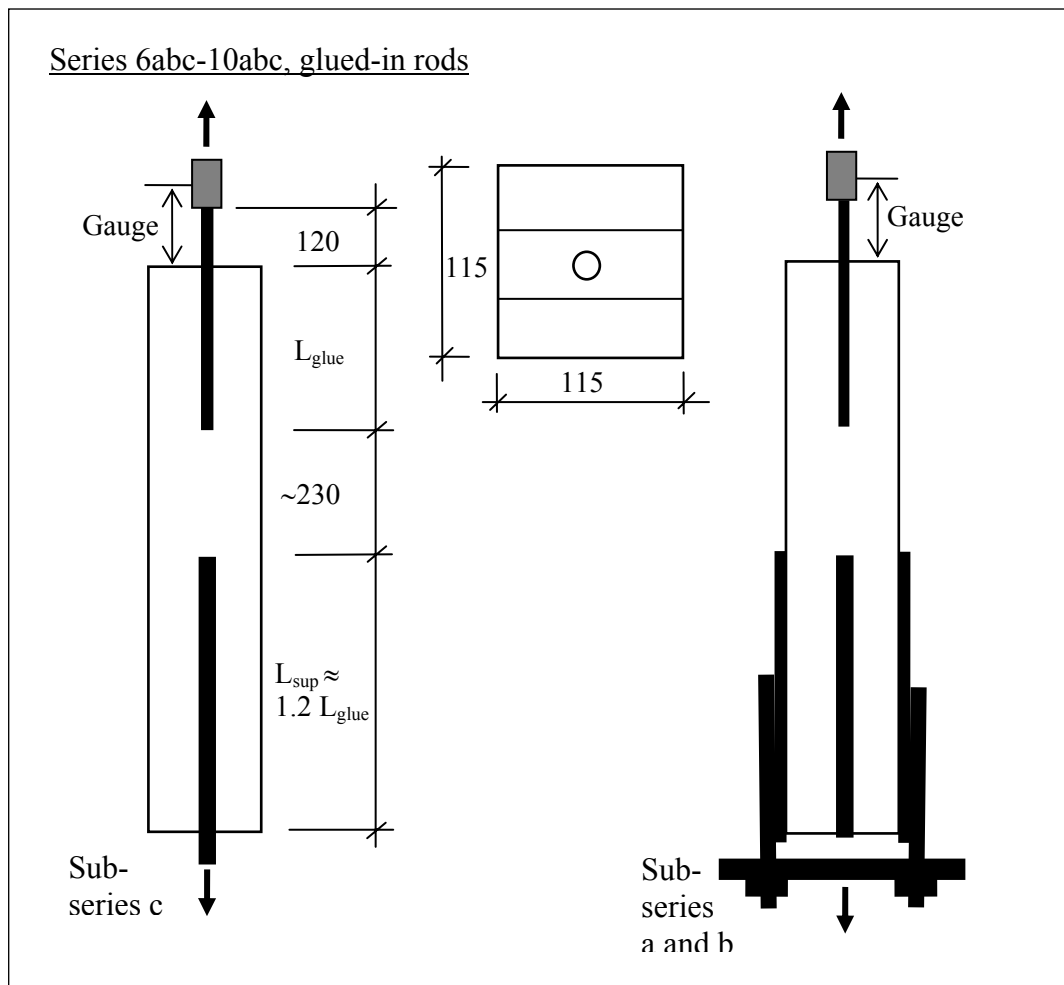
The geometry of the glued-in steel rod specimens is shown below. The tested rod is the upper rod. In initial tests it was found that the lower support rod in some cases was poorly glued. Therefore the support end of the specimens in series denoted a and b were completed with nailing plates as shown in the right hand side of the figure.

The rod diameters for b) indicated in the table show that the thickness of the rubber was about 1.1 mm.

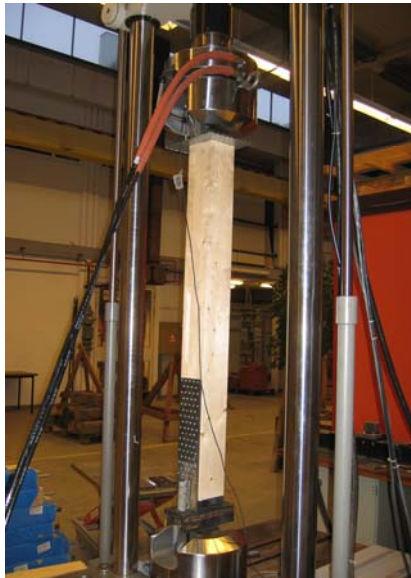
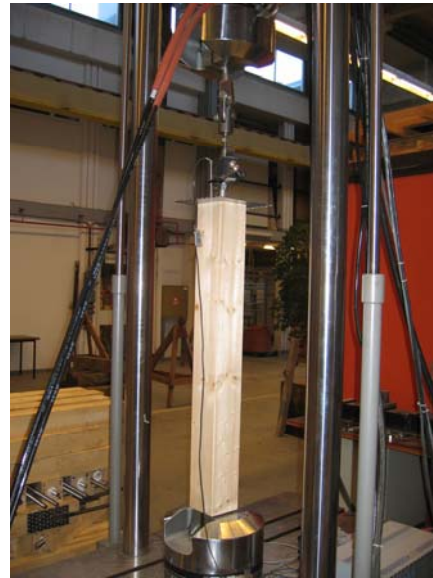
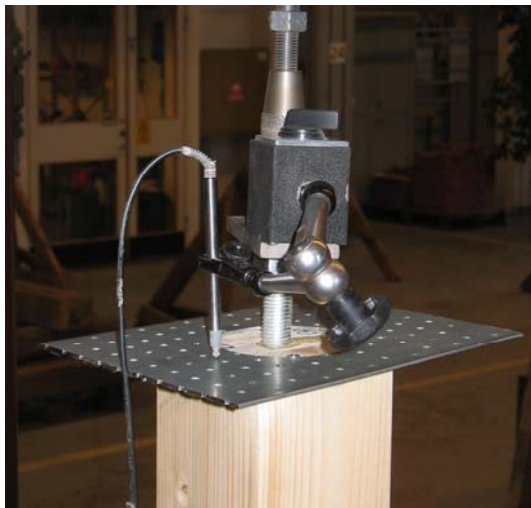
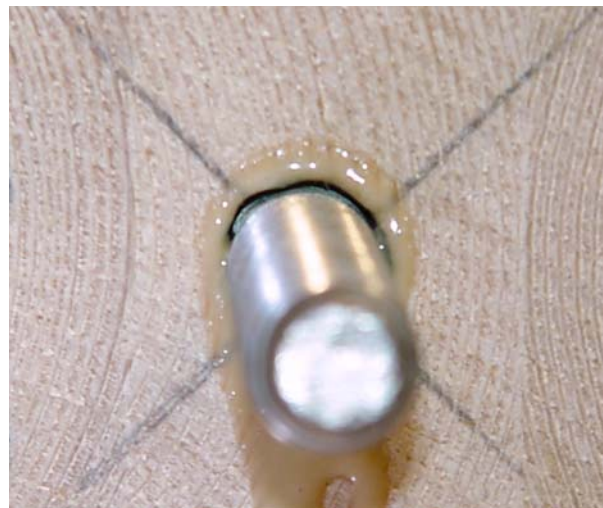
The scatter in recorded displacement might partly be explained by the fact that the displacement was recorded only at one side of the rod, see above picture. For series 6c (glued threaded rod), it was apparent that many of the specimens were somewhat poorly glued. Glue had flown out from the hole when specimens were placed on the side before the glue was hard, leaving a non-glued area of a few cm^2 in size, see above picture. The ramp loading test results for series 10 are presented in section 6.3 together with the long duration of load test results. The rust seen on naked parts of the rods of the b I-IV specimens, i.e. parts not covered with rubber, may be related to the acid rinsing, see section 3.1.

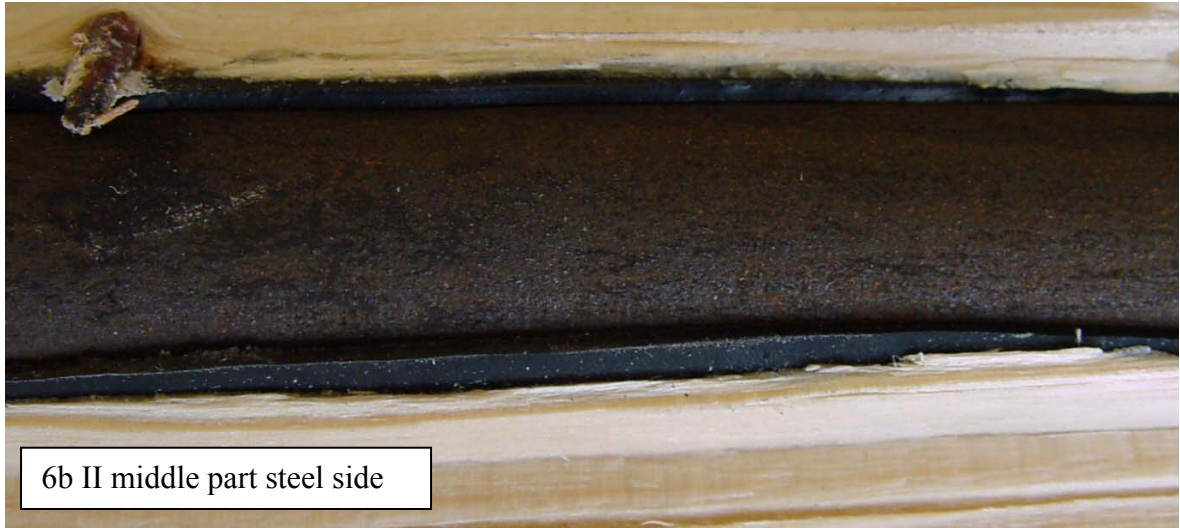
6b II middle part steel side

Fracture surface pictures are shown for specimens 6b I and 6 b II in the below. These specimens were opened by saw cuts and a by use of a wedge after the testing. The actuator

RS = Rubber-to-steel interface shear fracture. During fracture a sound like tearing was heard. The course of fracture was not visible from the outside of the specimen. Pull-out of an entire rod showed on part of the area thin remains of fractured rubber on the rod. The appearance of the rubber-to-steel interface with spots of some brown/red coloring and remains (see pictures of specimens that were cut open after testing) suggests some corrosion of the steel surface.

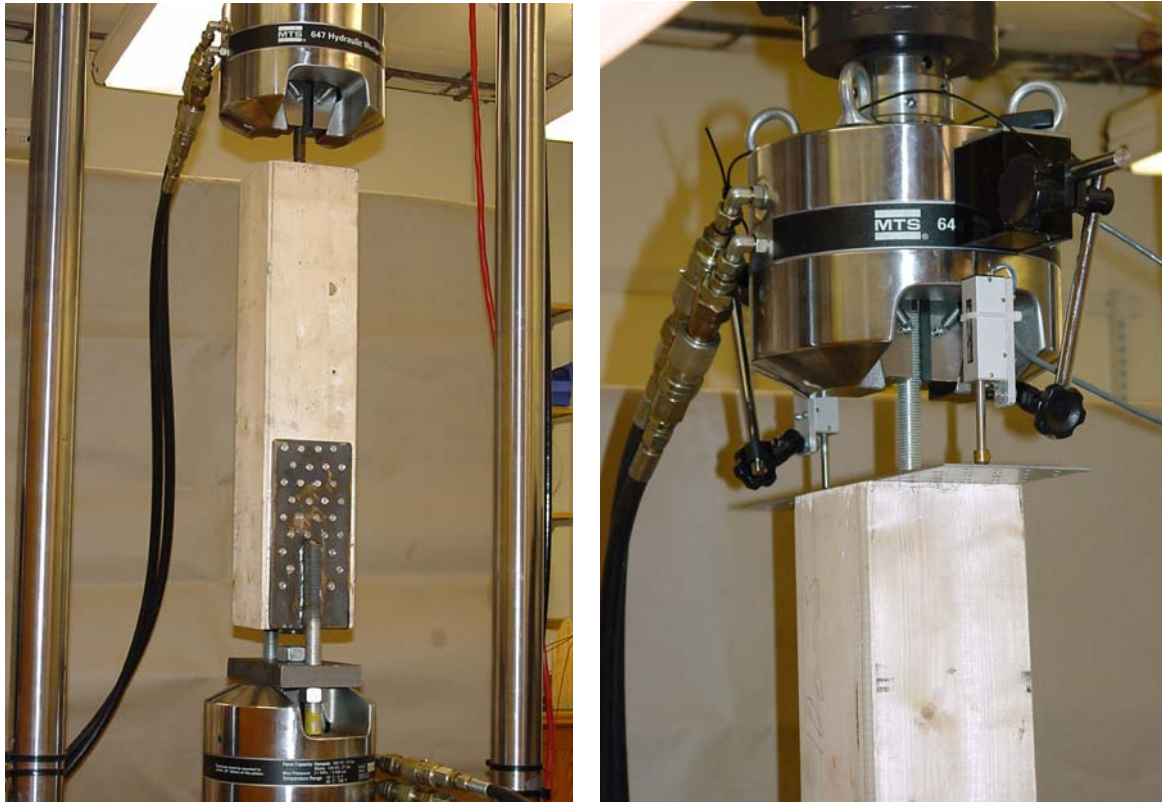
Above are photos showing the ramp load reference test before the constant load DOL tests. The actuator speed was constant during each ramp loading test, but different for the different tests, giving times to failure about in the order of 5-10 minutes. The following results were obtained:

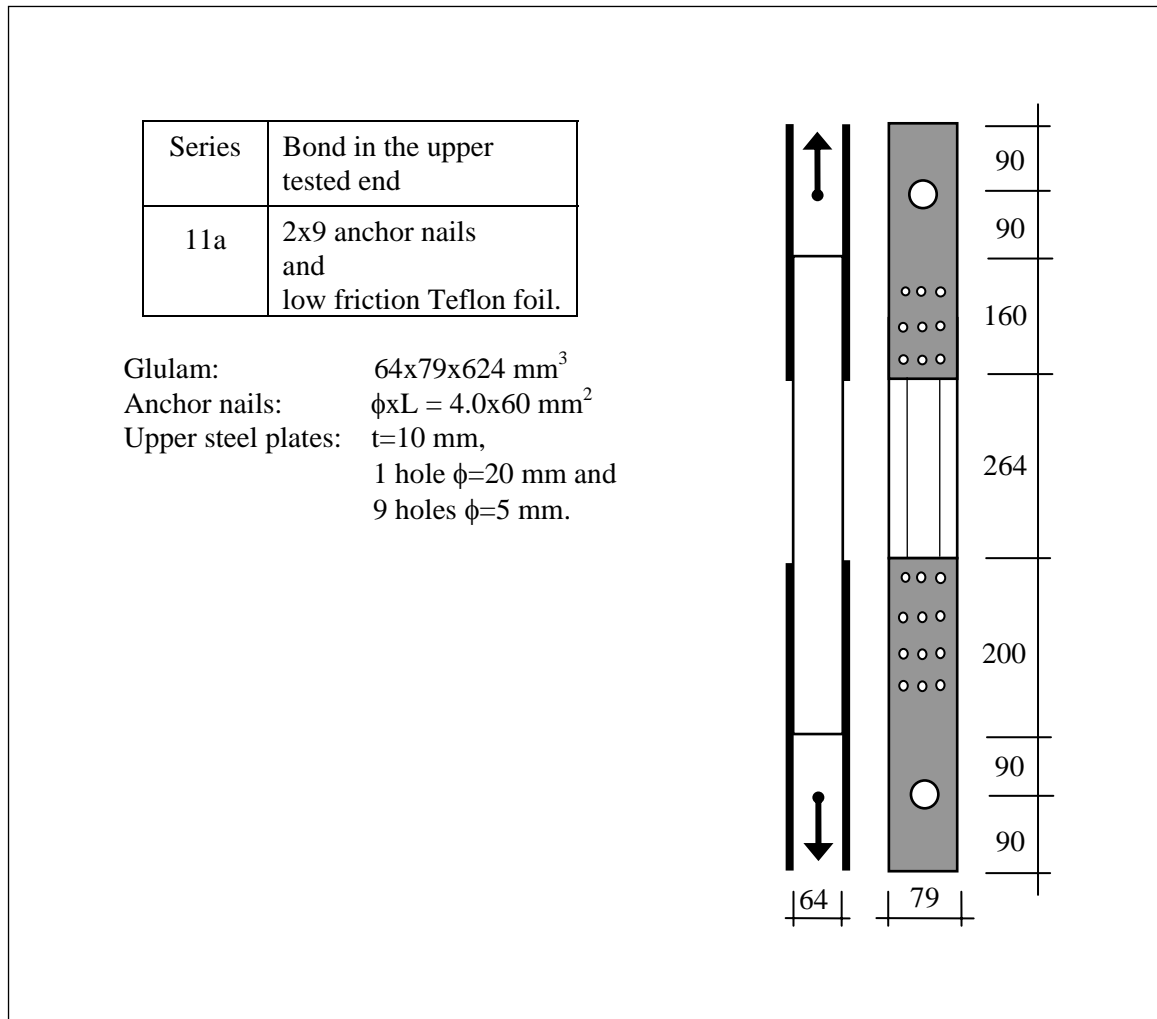
7.1 Test series 11a, nailed 160 mm outer double lap joint

The shaping of the specimens is given in the below figure. Three nominally equal specimens were tested. The actuator speed was 3 mm/min. The displacement recorded was the movement of the actuator.

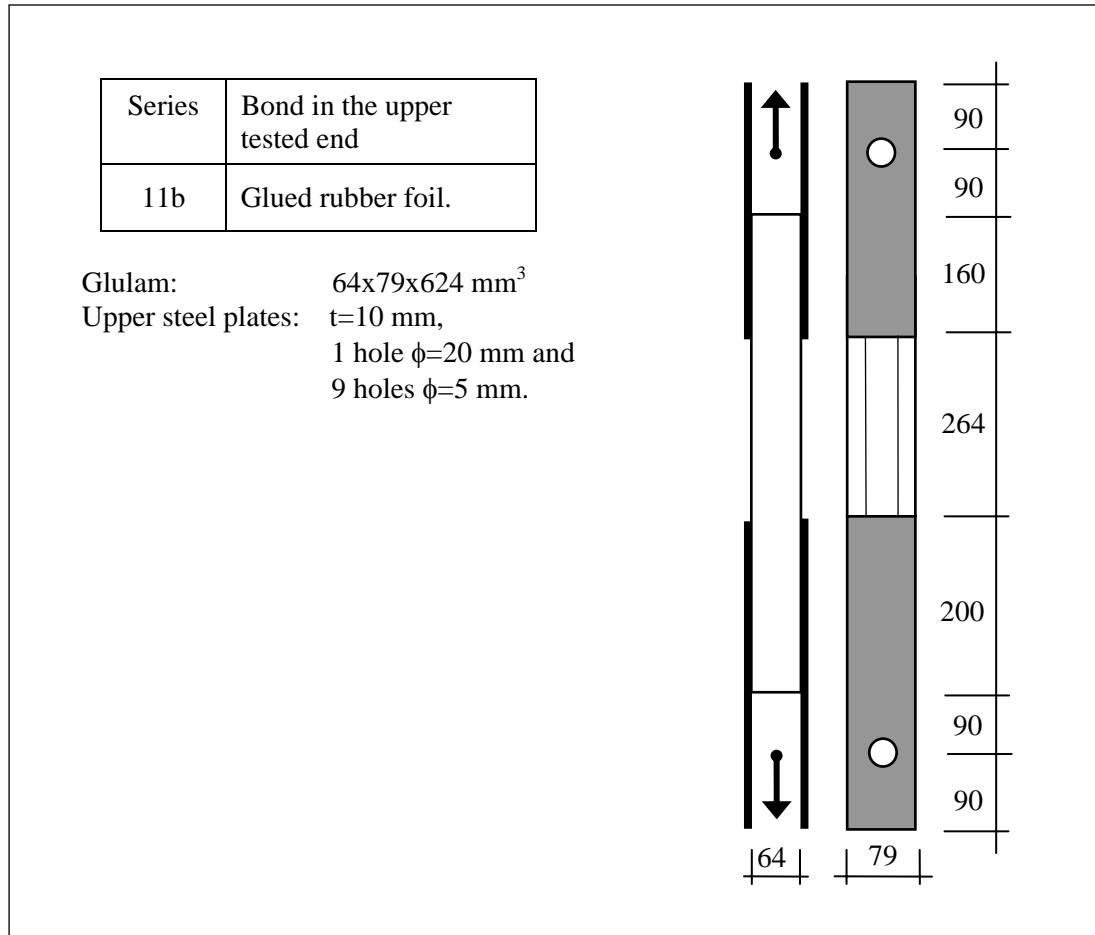
7.2 Test series 11b, glued 160 mm outer double lap joint

The shaping of the specimens is given in the below figure. Only two nominally equal specimens were tested. The actuator speed was 3 mm/min. The displacement recorded was the movement of the actuator.
