Tests of Full Size Rubber Foil Adhesive Joints

2007

TESTS OF FULL SIZE RUBBER FOIL ADHESIVE JOINTS

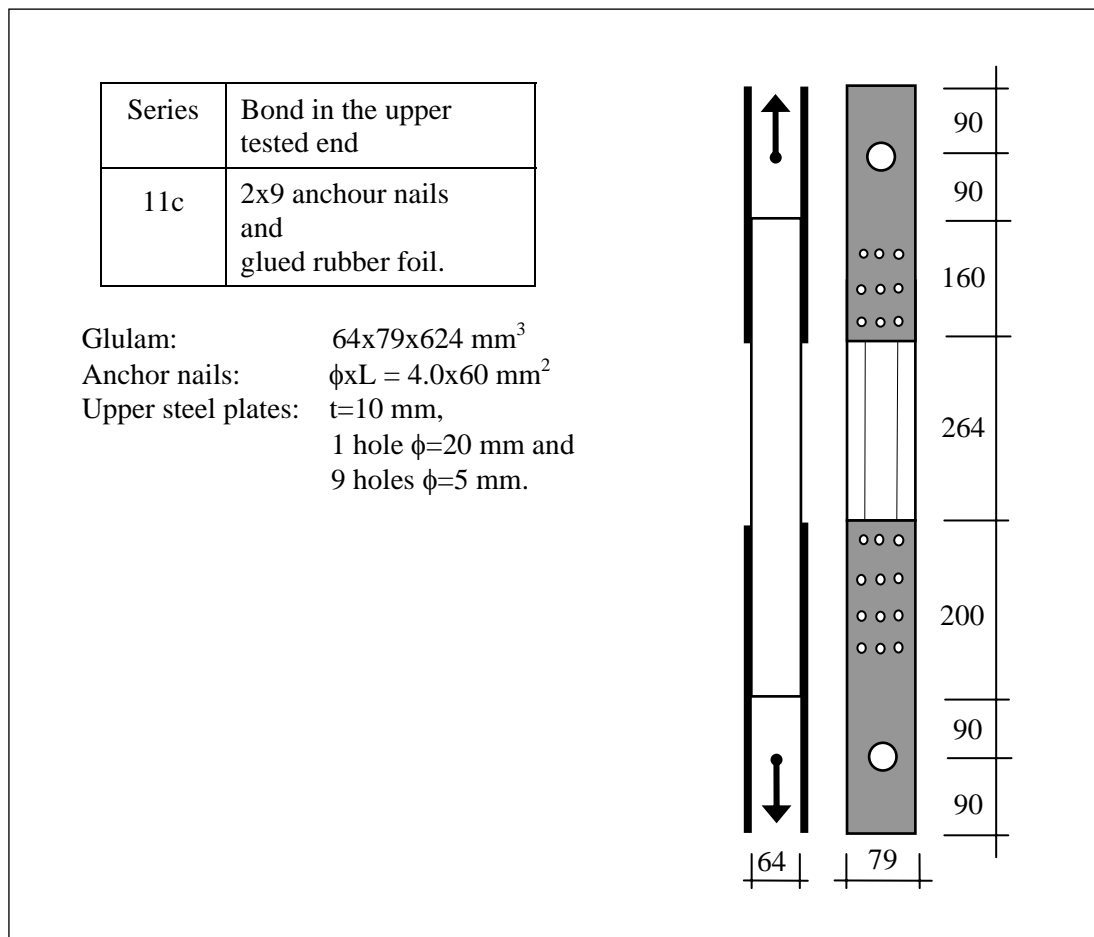
7.3 Test series 11c, nailed and glued 160 mm outer double lap joint

The shaping of the specimens is given in the below figure. Three nominally equal specimens were tested. The actuator speed was 3 mm/min. The displacement recorded was the movement of the actuator.

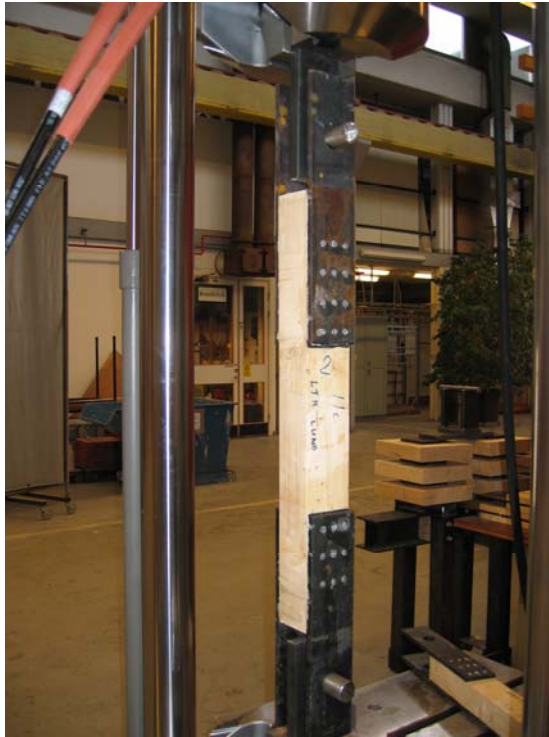
In the below are two diagrams shown, one giving a comparison between the results of series 11c with the results of 11a.

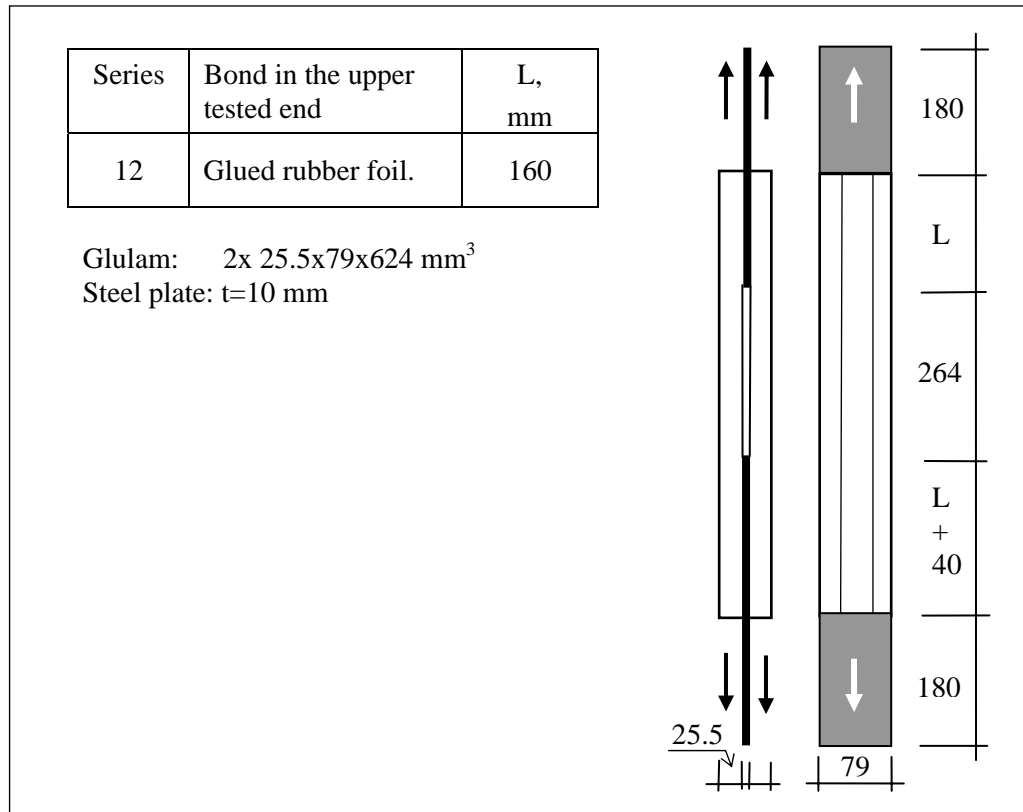
7.4 Test series 12, glued 160 mm inner double lap joint

The shaping of the specimens is given in the below figure. Three nominally equal specimens were tested. The actuator speed was 3 mm/min. The displacement recorded was the movement of the actuator. The test results are indicated by the below table, diagram and pictures.

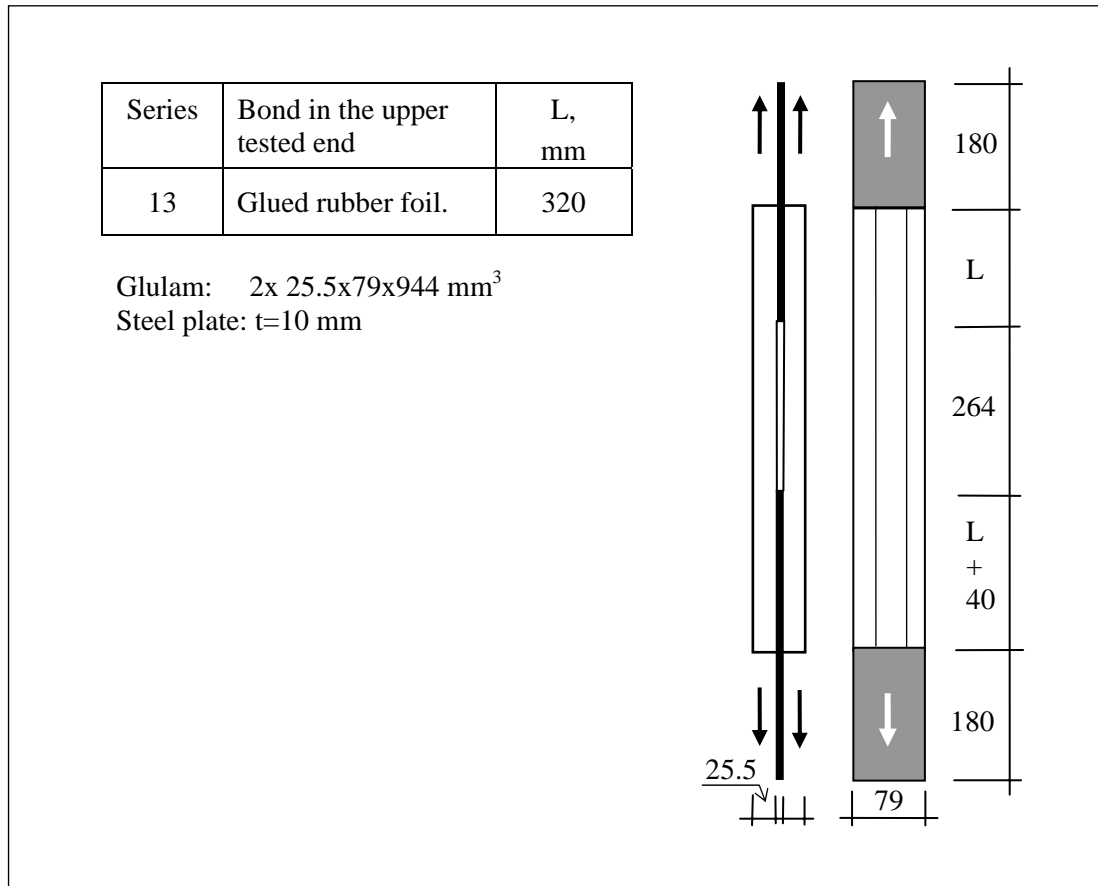
7.5 Test series 13, glued 320 mm inner double lap joint

The shaping of the specimens is given in the below figure. Three nominally equal specimens were tested. The actuator speed was 3 mm/min. The displacement recorded was the movement of the actuator. The test results are indicated by the below table, diagrams and pictures. One diagram shows a comparison with test series 12.

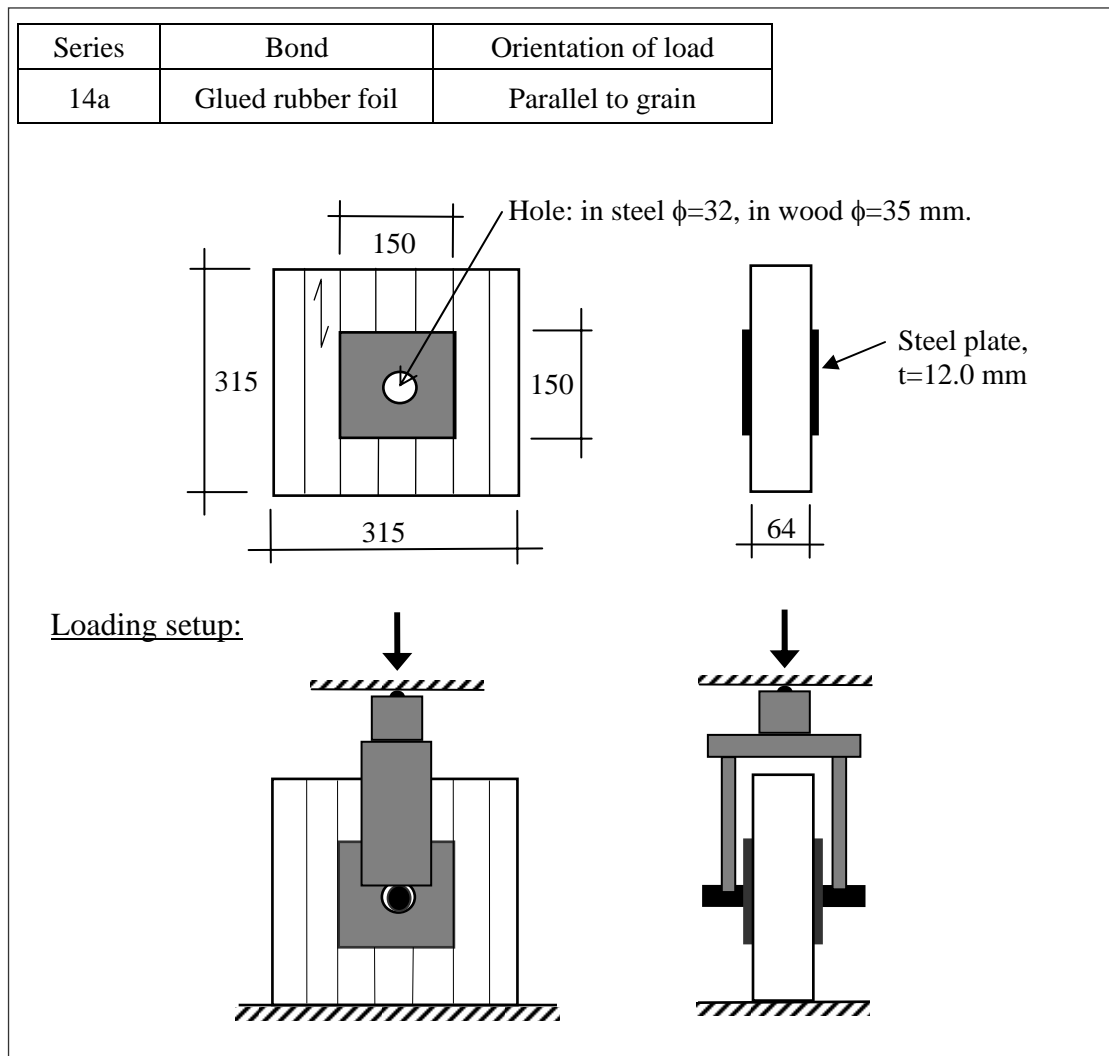
The shaping of the specimens is given in the below figure. Three nominally equal specimens were tested. The actuator speed was 3 mm/min. The displacement recorded was the movement of the actuator. The test results are indicated by the below table, diagrams and pictures. δ is the piston movement, τ is the mean shear stress acting across the bond areas and σ is the mean normal stress in the wooden member, i.e. the load divided by the total cross section area $64 \times 315 \text{ mm}^2$.

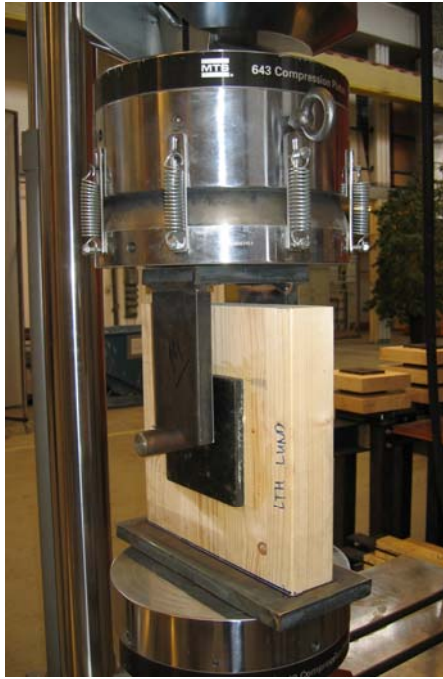
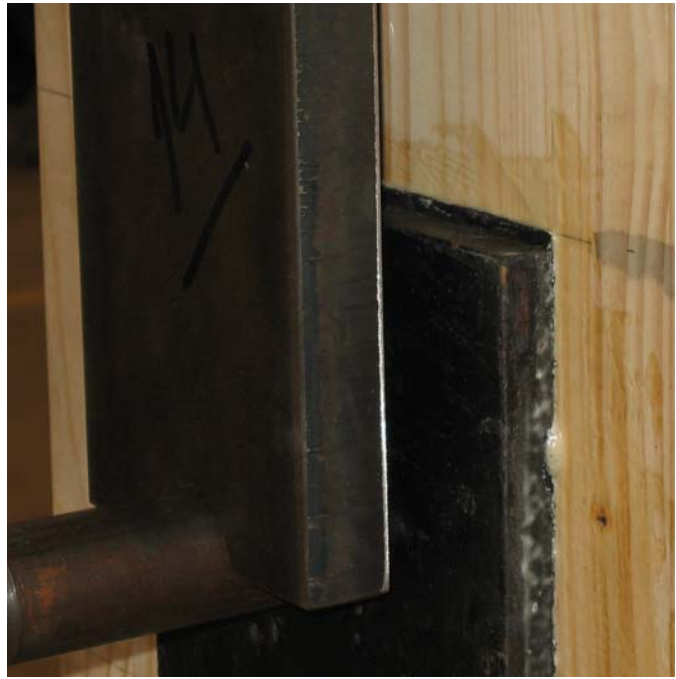
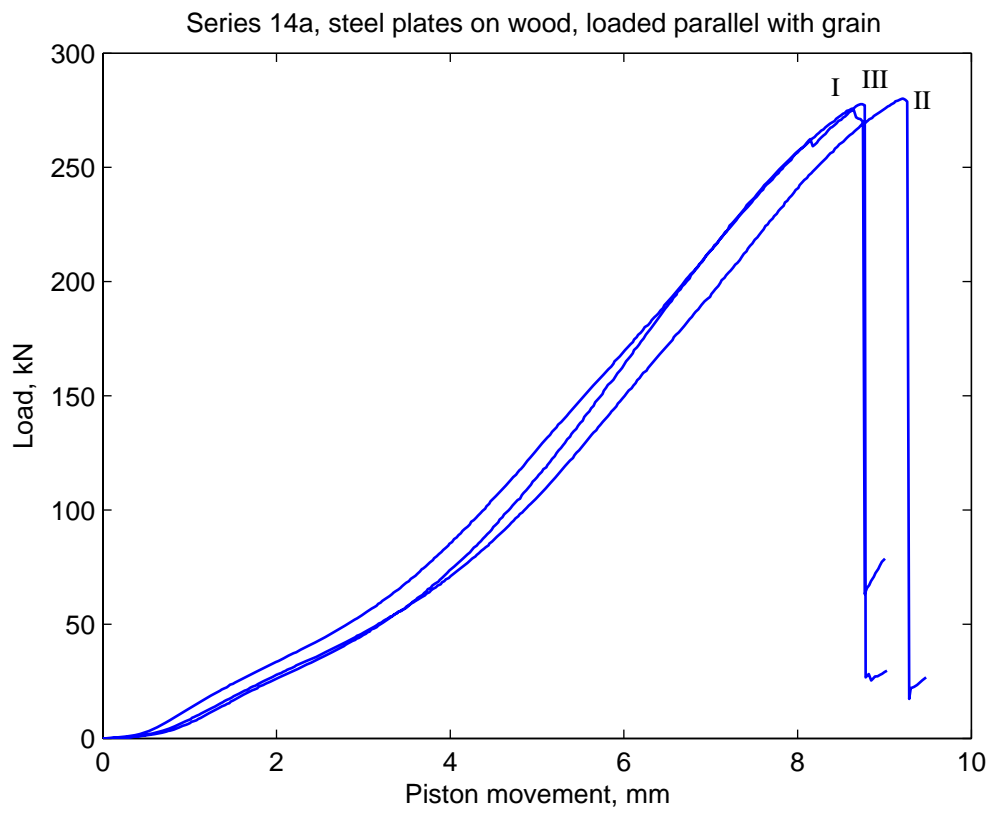
Test no.	P_f kN	δ_f mm	τ_f MPa	σ_f MPa	Cause of failure,
I	275.0	8.6	6.38	13.6	~100% shear fracture in wood
II	280.1	9.2	6.50	13.9	~ 70% shear fracture in wood ~ 20% fracture in rubber surface at wood side ~ 10% fracture in rubber layer
III	277.7	8.7	6.45	13.8	~ 70% shear fracture in wood ~ 30% fracture in rubber surface at wood side

Since no well defined bond fracture was observed, it is difficult to estimate strength parameters valid for bond fracture. The results of testing series 14a suggests that shear stress giving bond fracture may be about 6.0 MPa or possibly somewhat higher for the qualities of glue and rubber used in the present tests. In evaluation of test series 14a, note that some small fraction of the load could have been carried by direct contact bolt-to-wood in spite of different size of the hole in the wood and in the steel.

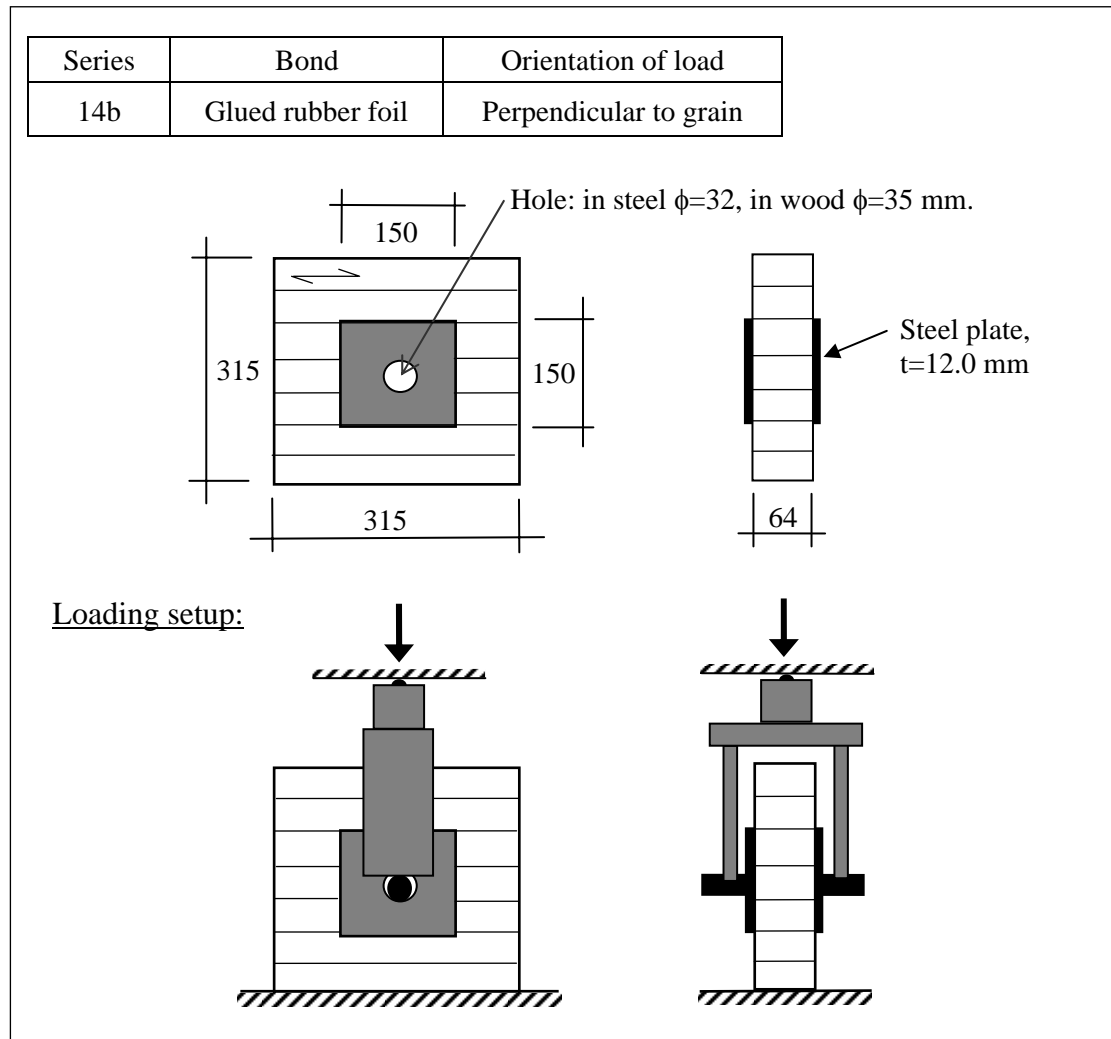
The shaping of the specimens is given in the below figure. Three nominally equal specimens were tested. The actuator speed was 3 mm/min. The displacement recorded was the movement of the actuator. The test results are indicated by the below table, diagrams and pictures. δ is the piston movement, τ is the mean shear stress acting across the bond areas and σ is the mean normal stress in the wooden member, i.e. the load divided by the total cross section area $64 \times 315 \text{ mm}^2$. One diagram shows a comparison with test series 14a.

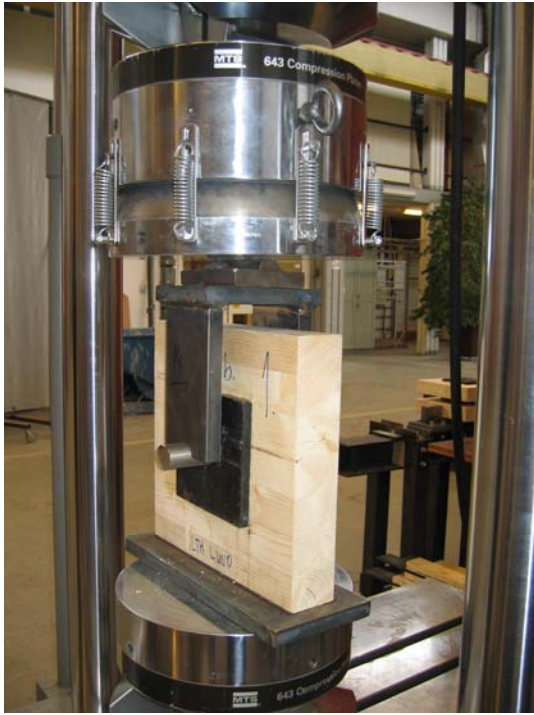
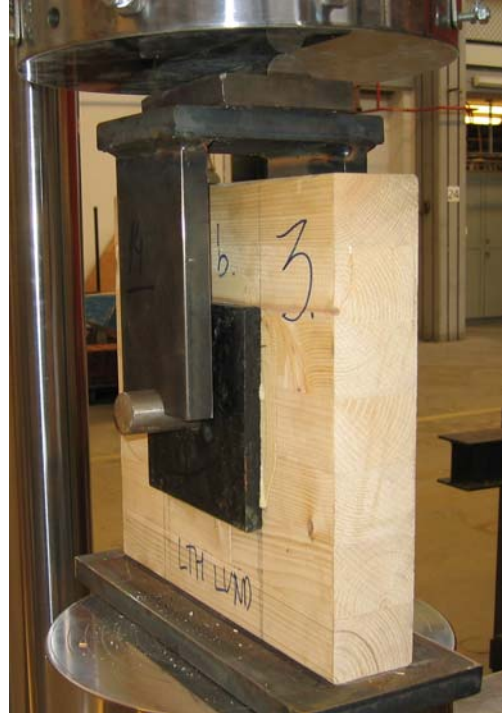
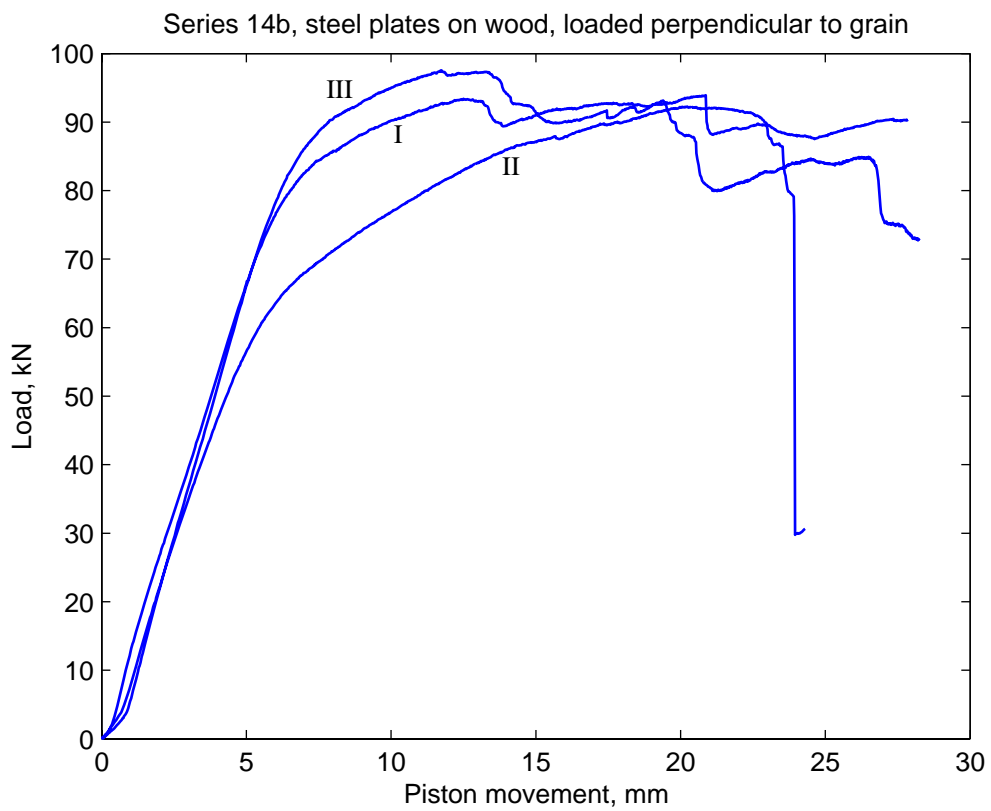
Test no.	P_f kN	δ_f mm	τ_f MPa	σ_f MPa	Cause of failure,
I	93.4	12.5	>2.17	4.6	Perp. to grain compressive failure of wood.
II	92.3	20.2	>2.14	4.6	Perp. to grain compressive failure of wood.
III	97.5	11.7	>2.26	4.8	Perp. to grain compressive failure of wood.

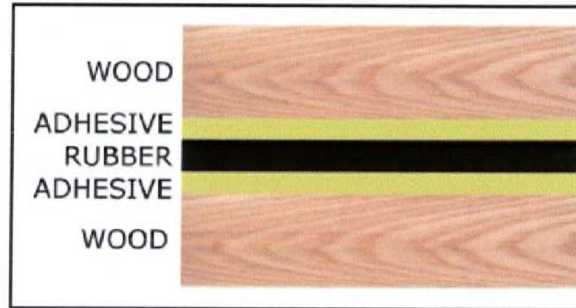
Figure 1. Structure of the rubber joint.

The layer of rubber makes the joint somewhat flexible and makes the stresses acting across the bond layer uniform. This means that the entire bond area is made active in carrying the load, which in turn means that the load carrying capacity of the joint can be made very high. Also in the case of impact loading, the capacity of a joint can be made very high by means of the thin rubber layer.

As a part of the project “Innovative design, a new strength paradigm for joints, QA and reliability for long span constructions” a study has been carried out on adhesive joints of rubber sheets glued between layers of wood or steel substrates, see *figure 1*¹. The substrates were glulam-glulam, glulam-LVL (Kerto-Q), glulam-steel plates or glulam-steel rods. The adhesives were two-component polyurethanes and the rubber was a SBR-type (styrene-butadiene-rubber).

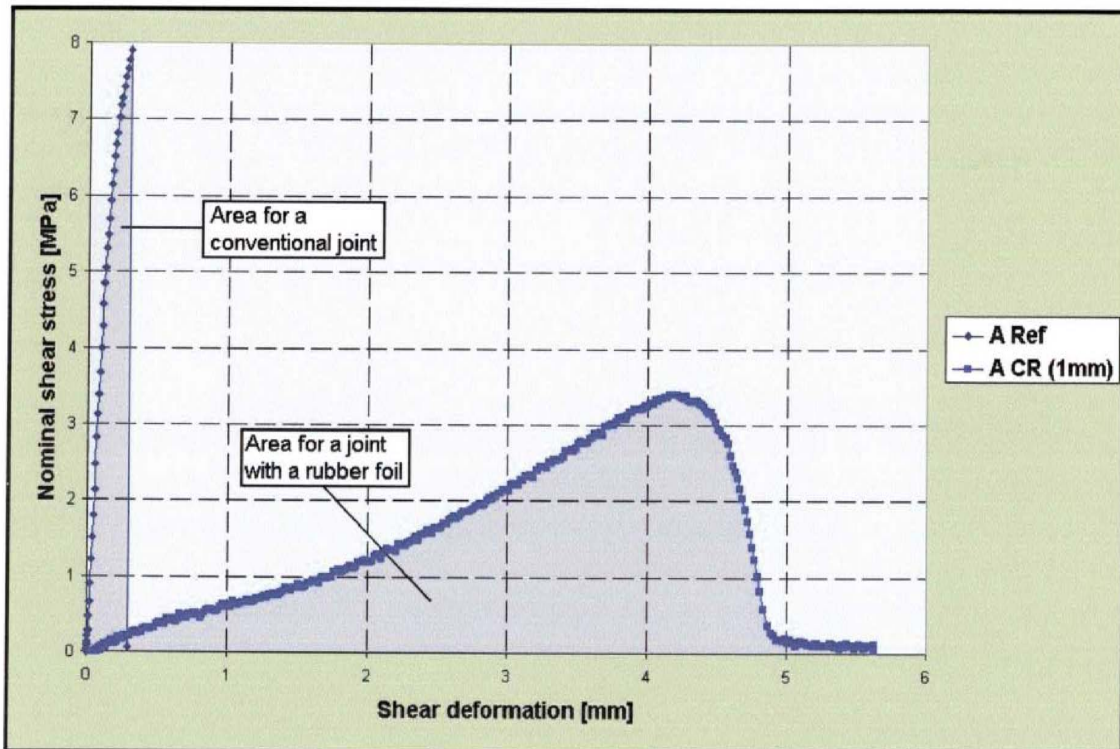
Figure 2. Comparison between a conventional joint (A Ref) and a joint with a rubber foil (A CR 1mm).

High load capacity in static loading and impact loading can be achieved even if the local shear strength of the bond layer may be lower than of a conventional bond layer made up of a stiff glue. *Figure 2²* shows local shear stress versus shear deformation of a conventional bond layer and of a rubber type glued bond layer. The area under a curve represents the fracture energy of the bond (energy/area).

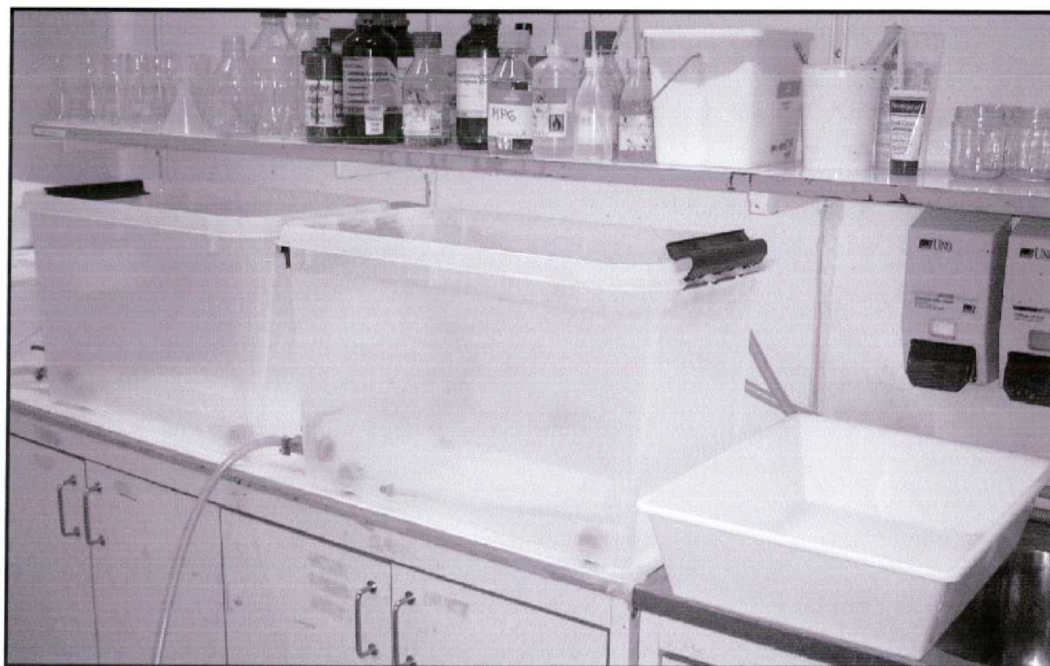
För att möjliggöra syrabehandling av gummi krävdes att en sköljningsanordning av tillräckligt stora dimensioner kunde användas. Två stora syrabeständiga plastbehållare, tillverkade av polypropen, införskaffades på Clas Ohlsson och förseddes med krananordning och slanganslutningar, se *figur 3*. Till dessa anslöts kommunalt vatten via en vanlig vattenkran som möjliggjorde fortgående utbyte av vatten i behållarna.

Figur 3. Vattenbad (till vänster och i mitten) och syrabad (till höger).

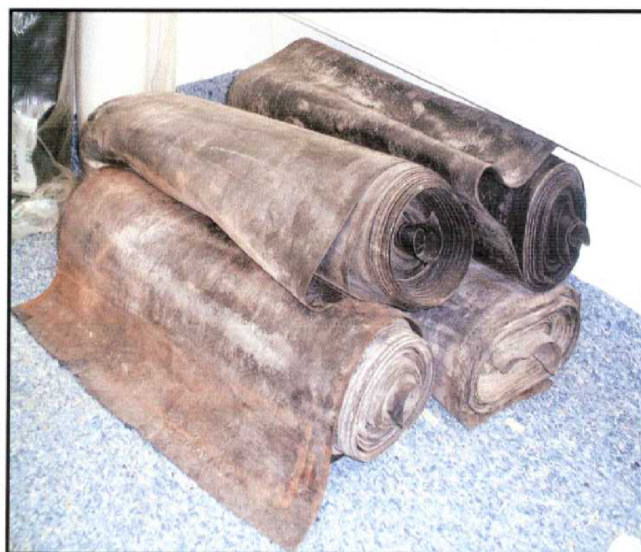
1. Gummidukarna, se *figur 4*, klipptes i samma dimensioner som de föreslagna provkropparna plus ett par extra centimeter för eventuella variationer i virkesstorlek.
2. Gummimaterialen borstades under rinnande vatten för att ta bort en del restprodukter från framställningen.
3. Ruggades med cirkelgående slipmaskin utrustad med NAXO 100 sandpapper,
4. Tvättades med etanol.
5. Betades i konc. svavelsyra (96%, 22°C) under 30 sekunder.
6. Sköljdes i vattenbad 15-30 min.
7. Lades på pappersbädd för att torka.

Figur 4. Gummidukar, obehandlade.

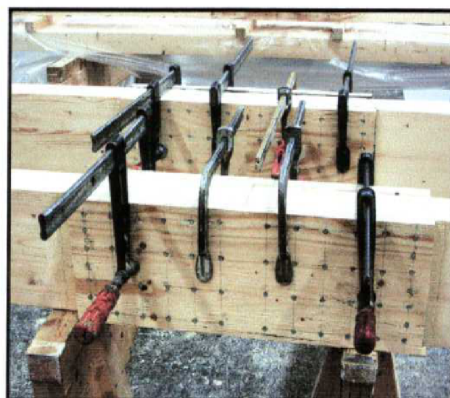
- Fogarna utsattes för presstryck m.h.a. tvingar eller limknektar som skruvades/spändes för hand, se *figur 5*. För provserie 1 pressades 3-4 prover samtidigt med samma limknektar, medan för provserie 2-5 pressades varje fog individuellt. För provserie 4-5 limmades fogarna och fixerades med tvingar innan spikning skedde. Spikningen utfördes med spikpistol. Därefter flyttades tvingarna och resten av spikarna sattes fast.

Figur 5. Presstryck m.h.a. tvingar.

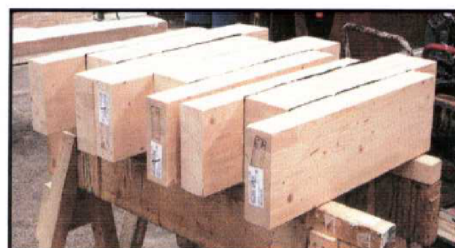
Figur 6. Förvaring av färdiga provkroppar (3c) på pallbockar.

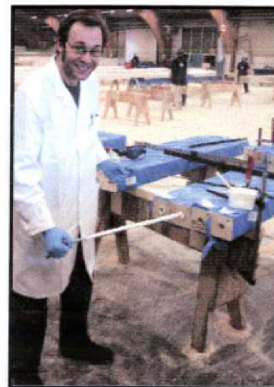
Figur 7. Applicering av lim, inlimmade stänger.

- Nedre hål: För att få in limmet i borrhålen användes en ca 1m lång järnstång som doppats i lim, se *figur 7*. Lim applicerades även direkt på stängerna för bättre spridning. De gängade stängerna applicerades med en maskin som skruvar in stängerna i provkroppen, se *figur 8*.

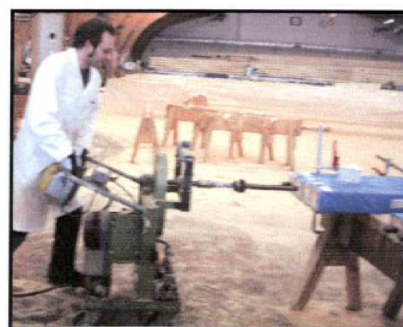
Figur 8. Applicering av gängade stänger.

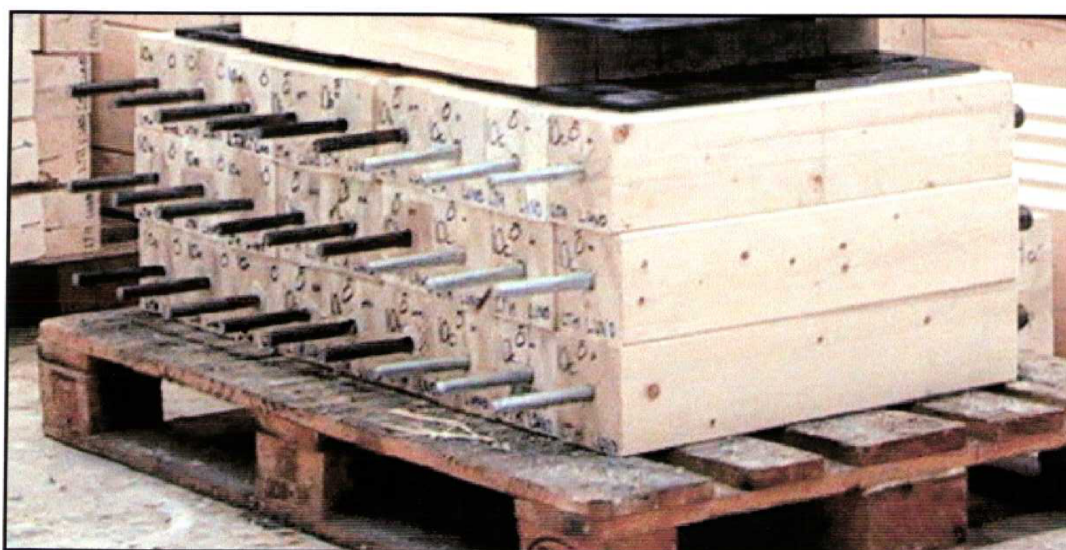
Figur 9. Förvaring av inlimmade stänger.

- Limmet fick härda över natt, sedan lades de vågrätt för förvaring, se *figur 9*.

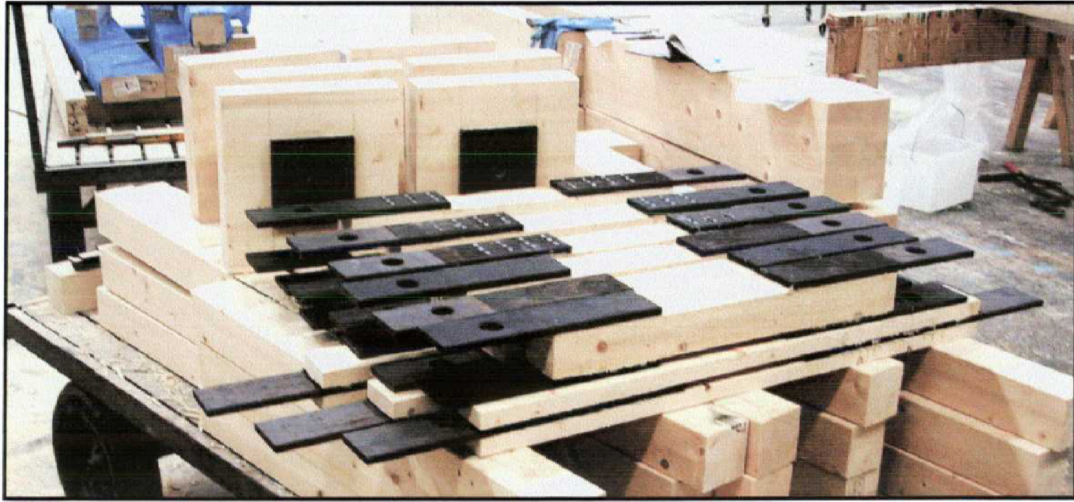
Figur 10. Förvaring av provkroppar från serie 11-14.

På- och inlimmade dragplattor samt pålimmade förankringsplattor: (Provkroppar serie 11-14)

- Se tillvägagångssätt för *Fogar med gummiduk*.
- Vulkningen av gummit mot stålet utfördes av Metso Minerals, Skellefteå.
