Wear mechanisms of uncoated and coated cemented carbide tools in machining lead-free silicon brass

Bushlya, Volodymyr; Johansson, Daniel; Lenrick, Filip; Ståhl, Jan Eric; Schultheiss, Fredrik

Published in:
Wear

2017

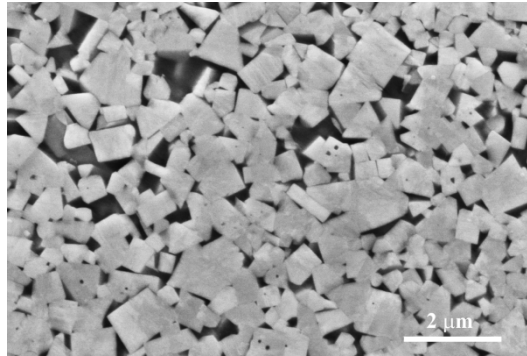
Fig. 2. SEM of microstructure of H10F cemented carbide grade.

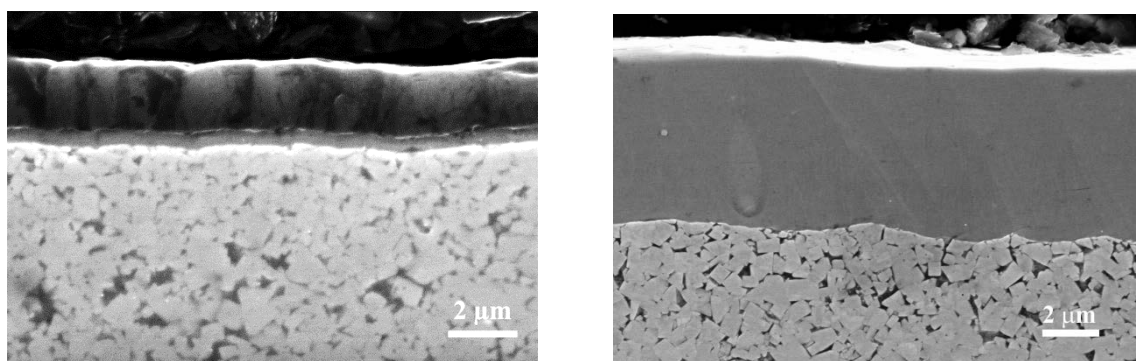
Fig. 3. SEM image of (a) a-C:H diamond like carbon and (b) (Ti,V,Zr,Hf,Nb,Ta)N coatings.

Two coatings were additionally applied on the H10F cemented carbide substrate in order to improve the machinability of CuZn21Si3P silicon brass and wear resistance of tooling during machining. Commercial multi-layered diamond like carbon (DLC) coating which consists of $\text{Cr}/\text{Cr}_x\text{C}_y$ and a-C:H (amorphous hydrogenated carbon) layers (Fig. 3.a) was used, as it possesses high hardness ($H \approx 30$ GPa) [23] and low friction in machining brass alloys [19]. Thickness of the DLC coating was 2 μm . TiN nitride coating were also shown to exhibit low friction in brass machining, yet low hardness of TiN coating resulted in poor performance [19]. High hardness ($H = 34$ GPa) experimental single layer nitride (Ti,V,Zr,Hf,Nb,Ta)N coating was also tested. The coating was deposited by vacuum-arc evaporation of a Ti-V-Zr-Hf-Nb-Ta high entropy alloy target [24]. The thickness of this nitride coating was 4 μm (Fig. 3.b).

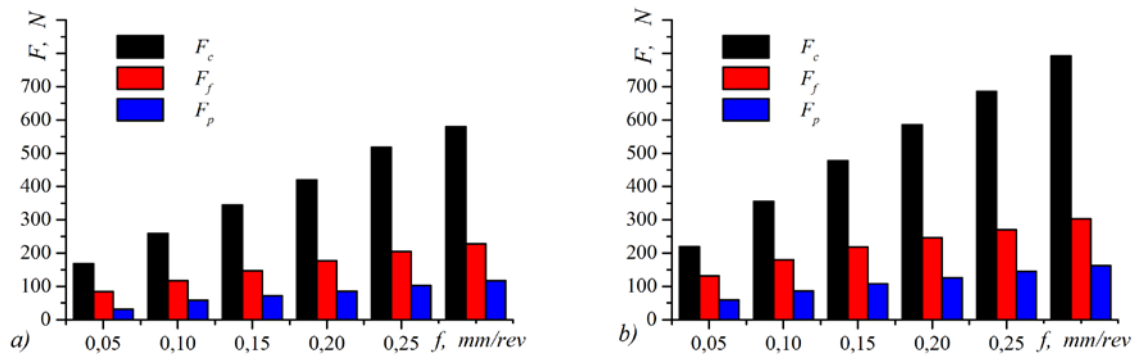
Fig. 4. Cutting forces when machining (a) CuZn39Pb3 and (b) CuZn21Si3P brass ($v_c = 400$ m/min, $a_p = 2.5$ mm).

Fig. 4 shows the obtained cutting forces when machining CuZn39Pb3 free-machining and CuZn21Si3P lead-free brass. On average, 35 to 40 % higher cutting forces were observed when machining CuZn21Si3P silicon brass, compared to CuZn39Pb3, which closely correlates to the tensile strength data for both brass grades (Table 2). The energy consumed in the cutting process therefore is by approx. 40% higher for lead-free brass machining, implying higher cutting temperatures and accelerated tool wear. Nobel et al. [9] indeed have shown that near-surface tool temperature is twice higher for lead-free CuZn21Si3P brass, as opposed to CuZn39Pb3 grade.

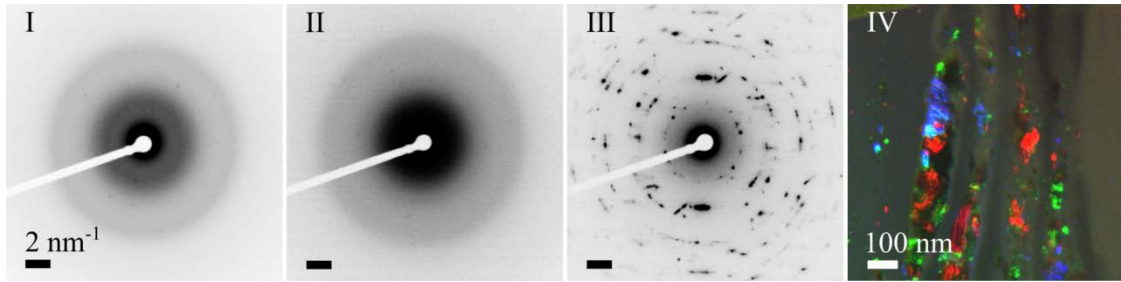
Fig. 12 Crystal structures of the TPL. (a)-(c) SAEDs from the three circular areas marked in Fig. 11.b. Region I is amorphous N-rich phase, region II is amorphous O-rich phase and region III is crystalline zinkblende ZnS. (d) Three superimposed false color DFTEM images from region IV showing the laminar structure of crystalline ZnS and N-rich amorphous phase.

Five major layers are identifiable in the STEM HAADF image of the TPL (Fig. 11.a). Among them, two thick (200-500 nm) layers have higher oxygen content (seen as dark grey in Fig. 11.a) and three thinner (50-150 nm) layer of laminar structure (seen as middle grey in grey in Fig. 11.a). Each of the thinner layers consists of alternating lamellae of ZnS and nitrogen enriched ceramic which can be as thin as 100 nm (Fig. 12.d). ZnS was identified to be crystalline with cubic zinkblende structure (Sphalerite) while both nitrogen rich and oxygen rich layers to be amorphous, as seen in Fig. 12. Both types of amorphous ceramic layers are from Si-Al-O-N system.

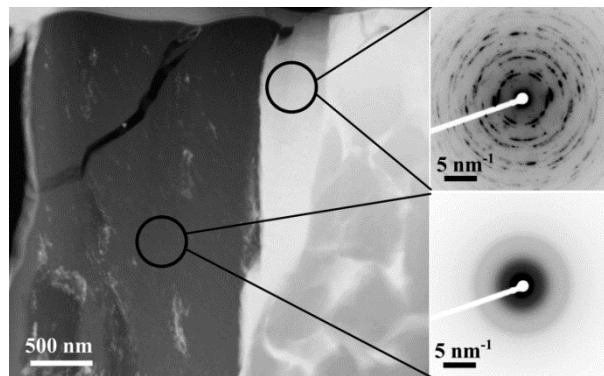
Fig. 14. (a) STEM HAADF image of FIB lamella and (inverted contrast) SAED pattern from (b) (Ti,V,Zr,Hf,Nb,Ta)N coating and (c) β -SiAlON.

TEM data from the lamella extracted from the region I in Fig. 13.c is shown in Fig 14. In the STEM HAADF image (Fig. 14.a) the cemented carbide is seen on the right, the nitrogen rich region on the left and the remains of the (Ti,V,Zr,Hf,Nb,Ta)N coating in the middle. Compositional EDX data for nitrogen rich phase presented in Table 3 show that Si to N ratio corresponds to silicon nitride (Si_3N_4), for which simultaneous equivalent substitution of Al-O for Si-N is additionally observed. Such compositional case directly corresponds to β -SiAlON phase [28]. The original nitride coating is completely removed in certain regions, as seen in the lower part of Fig.14.a. Brass fragments, which have been encapsulated in the β -SiAlON, are seen as bright regions in the otherwise smooth TPL. According to selected area electron diffraction (SAED), the original nitride coating is crystalline (Fig. 14.b) while β -SiAlON is fully amorphous (Fig. 14.c). It is worth noting that the total thickness of TPL closely follows the thickness of the original coating (Fig. 3.b). It can be assumed that the source of N for the formation of stoichiometric β -SiAlON is the nitrogen from the consumed (Ti,V,Zr,Hf,Nb,Ta)N coating. Absence of nitrogen in the original coating, in the case of DLC, resulted in significant N lack in the nitrogen rich TPL layer.

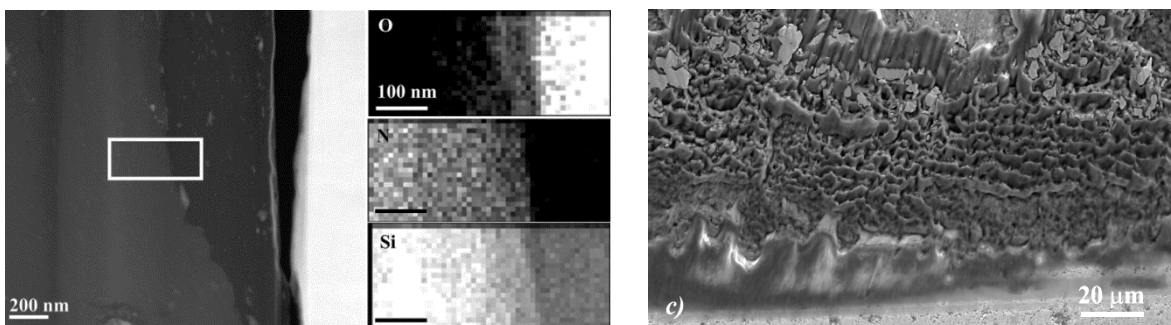
Fig. 16. (a) STEM HAADF image of transition area between β -SiAlON and SiO_2 , and (b) corresponding EDX maps (O $K\alpha$, N $K\alpha$, Si $K\alpha$). (c) SEM image of TPL morphology.

β -SiAlON layer of the TPL is either grown on SiO_2 layer or was deposited in the course of machining. Fig. 16.c shows that TPL is located in the sliding too-chip zone, while the coating was completely removed in the sticking zone. It is also seen that the TPL has an irregular wavy morphology. Chemical reactions leading to the formation of the above tool protection layers are, in part, enabled by the presence of oxidizing atmosphere in the sticking contact zone. Such reactions can occur on both the tool and chip surfaces. Additionally, the chip which slides across the tool rake can redistribute these reaction products over the entire contact zone. In this way β -SiAlON forming closer to the cutting edge can be deposited onto the SiO_2 layer located further away from the edge-line. A detailed study of the interface between β -SiAlON and SiO_2 layers revealed that separation between the phases is not sharp, but contains a transition area. In Fig. 16.a a higher magnification EDX mapping is presented and a sharp step-wise variation of composition between β -SiAlON and SiO_2 , which was identified as oxygen rich amorphous phase (Table 3), is seen.

Table 3 shows that the oxygen rich phase has a transitional composition between the two phases. This points to the transformation of SiO₂ into the oxygen rich phase which occurs in contact with the top layer of β-SiAlON. A small TPL deposit found on the worn uncoated cemented carbide tool is compositionally similar to the transitional layer observed in Fig. 16.b.
