Wear mechanisms of uncoated and coated cemented carbide tools in machining lead-free silicon brass

Bushlya, Volodymyr; Johansson, Daniel; Lenrick, Filip; Ståhl, Jan Eric; Schultheiss, Fredrik

Published in:
Wear

2017

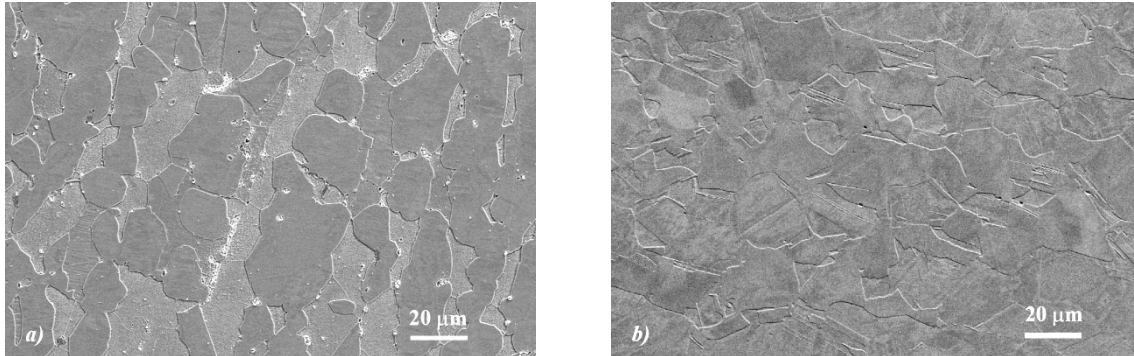
Fig. 1. SEM of microstructure of Pb-brass and Si-brass

The machining tests were conducted for CuZn39Pb3 free-machining brass containing 3.3 wt.% of lead and CuZn21Si3P lead-free brass containing 3 wt.% silicon, as shown in Table 1. Scanning electron microscope (SEM) images showing the typical microstructure for the two investigated materials can be found in Figure 1. Both brasses are dual-phase where CuZn39Pb3 contains roughly 70% α -phase and 30% β -phase, CuZn21Si3P contains roughly 60% α -phase and 40% κ -phase. Ductile α -phase (fcc) introduces machinability issues, both by adhering to the tool materials and by limiting chip breakage and handling [19]. Presence of lead in CuZn39Pb3 alleviates the problems because its low melting temperature (327.5 °C) which introduces a lubricating effect on the tool-chip interface and facilitates separation of individual chip segments into needle chips [9, 16].

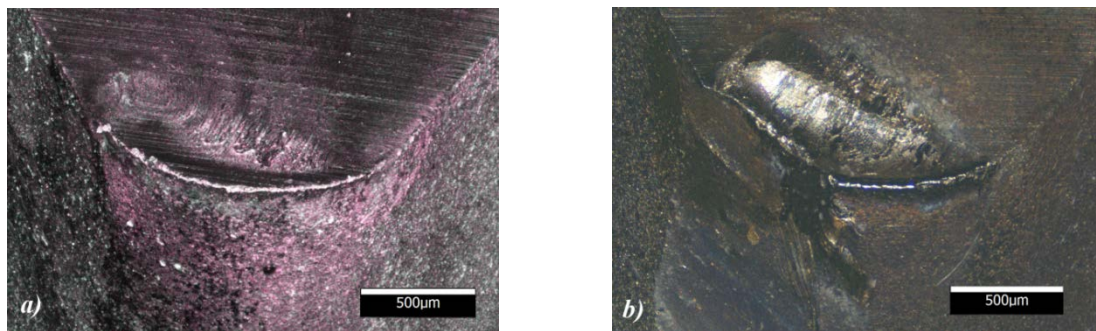
Fig. 5. Optical images of worn uncoated tools after machining (a) CuZn39Pb3 (160 min) and (b) CuZn21Si3P (142 min) brass.

Higher cutting temperature and higher workpiece hardness in case of CuZn21Si3P brass is expected to lead to accelerated tool wear. Fig. 5 shows optical images of rake and flank surfaces of uncoated tools used in machining both brass grades. Fig. 5.b illustrates that uncoated cemented carbide, used in machining lead-free brass for 142 minutes, has undergone severe crater which resulted in a positive rake angle, i.e. weaker tool geometry, and associated tool fracture. The maximum depth of the crater is $KT = 163$ μm . Machining of CuZn39Pb3 for 160 minutes, under identical cutting conditions, did not lead to detectable tool damage (Fig. 5.a).

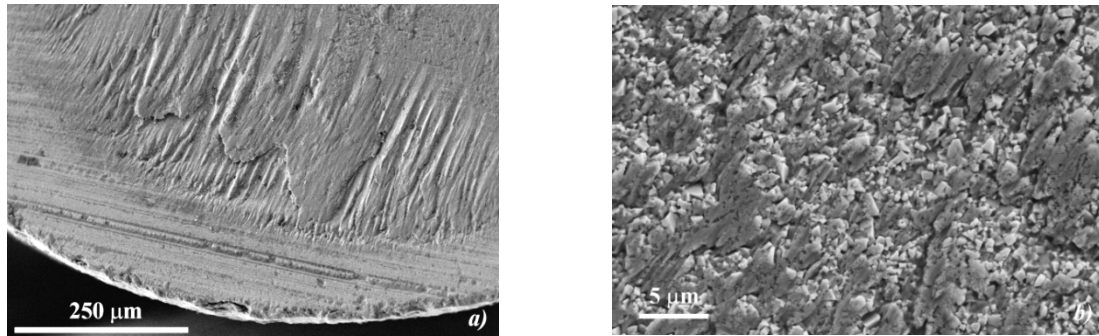
Fig. 6. SEM images of rake surface of worn uncoated tools after machining (a) CuZn39Pb3 and (b) CuZn21Si3P brass.

Fig. 6 shows higher resolution SEM images of the rake surfaces of both tools. Grinding marks from tool sharpening visible in the vicinity of edge-line (Fig. 6.a) illustrate that a minimal tool wear on the rake was sustained when machining CuZn39Pb3 brass. It also shows that solid layer of adhered workpiece material covers the central part of the contact zone. SEM of the rake of uncoated tool used for machining CuZn21Si3P (Fig. 6.b), on the opposite, shows that adhered workpiece materials is evenly distributed across the crater. It also demonstrates that tungsten carbide grains have sharp morphology that is typical for adhesive wear by grain pluck-out, rather than smoothed WC appearance expected for abrasive wear by hard κ -phase.

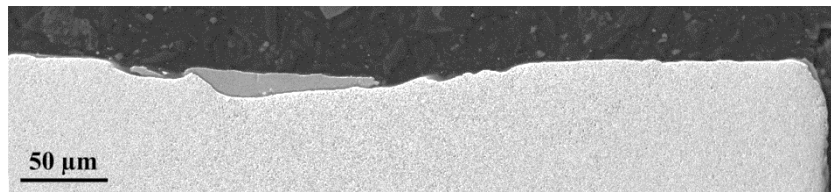
Fig. 7 Cross-sectional SEM image of worn uncoated tool after machining CuZn39Pb3 free-machining brass.

Both worn tools were sectioned with precision diamond saw, ground and polished in order to obtain a deeper insight into the wear mechanisms governing tool deterioration. Fig. 7, depicting the cross-section of the tool used for CuZn39Pb3 machining, shows formation of flank wear $VB = 34 \mu\text{m}$ on the tool clearance and formation of the crater having depth $KT = 22 \mu\text{m}$ that is hidden by the adhered brass layer. Tungsten carbide grains in the crater have smoothed appearance. Energy Dispersive X-ray (EDX) analysis did not provide additional information.

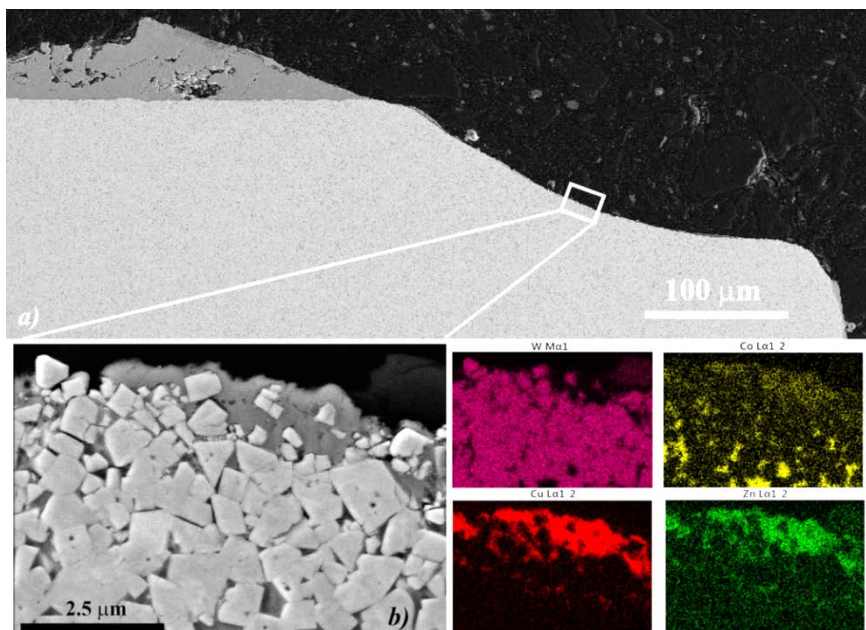
Fig. 8 Cross-section on Si-brass (a). SEM/EDX of Co diffusion (VB)

Cross-section (Fig. 8.a) of the crater on the tool for CuZn21Si3P machining have shown formation of zinc oxide deposit outside the tool-chip contact zone and evidence of the diffusional wear of the cemented carbide tool. Fig. 8.b shows that cobalt depletion occurs in the near-surface layer (approx. 3 μm) on the crater. EDX elemental maps indicate loss of cobalt binder via diffusion into the chips and minor cross-diffusion of copper and zinc. Loss of the binder in the cemented carbide is also shown to be accompanied by removal of WC grains. Therefore the earlier found (Fig. 6.b) adhesive pluck-out of tungsten carbide has another nature and is driven by diffusional loss of binder, followed by fracture and removal of non-bound WC grains.

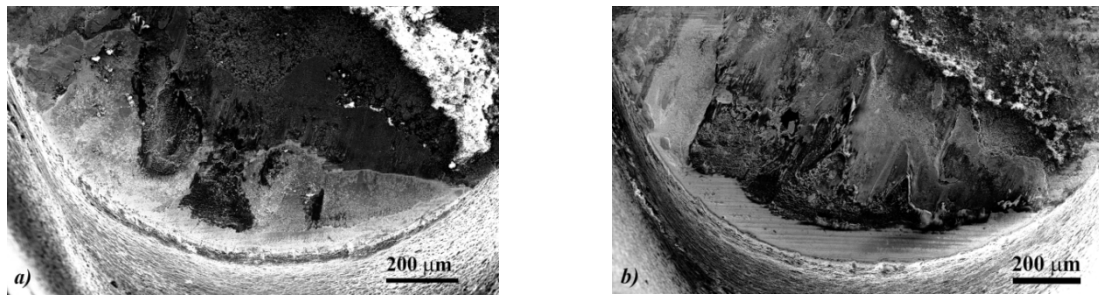
Fig. 9. SEM overview of the worn (a) DLC and (b) (Ti,V,Zr,Nb,Hf,Ta)N coated tools (145 min).

Fig. 9.a shows that the major part of the DLC coating has been delaminated during machining and initial signs of crater development are present. The maximum depth of the crater is 53 μm . It also shows that up to 30% of the tool-chip contact area is covered by a layer or deposit. More detailed inspection of the area indicates that this layer in the central part of the tool is deposited directly on the non-delaminated sector of DLC coating, while the layers in other regions are deposited on the already formed crater surfaces. Similar deposit of much smaller dimensions (50 μm by 20 μm) was also found in the crater of uncoated tool. The 50 μm to 100 μm wide band along the edge-line also does not have DLC coating, yet no crater formation is observed, leaving the intact plateau of the original cemented carbide substrate. Fig. 9.b shows that an identical band devoid of the coating exists in the case of (Ti,V,Zr,Nb,Hf,Ta)N coating. The rest of the tool-chip contact zone is completely covered by a layer or deposit. It also shows that the tool did not suffer from crater wear, and even the grinding marks are visible in the plateau region. This indicates that the formed deposit on the rake surface acts as a tool protection layer (TPL) by blocking the diffusion of Co binder and abrasive wear.

Cross-section of the (Ti,V,Zr,Hf,Nb,Ta)N coated tool (Fig. 13.a) has confirmed previous observation (Fig. 9.b) that the near-edge region is devoid of coating, while the rest of tool-chip contact area is completely covered by the deposit. EDX analysis has shown that diffusion of cobalt binder from the cemented carbide substrate was fully blocked by the formed TPL. This prevented cratering which is found to be the main wear mechanism in all other cases. Thickness of the TPL on the tool rake varies between 3 μm to 5 μm . TPL was found to consist of a single layer (Fig. 13.b) on the majority of tool-chip contact area, on the contrary to the deposit formed on DLC coated tool. A smaller fraction of the area at the far end of the tool-chip contact was covered by the TPL consisting of two layers, as shown in Fig. 13.c. Two FIM lamellae have been extracted from both regions of interest (region I and region II) as subjected to detailed TEM analysis, in order to gain understanding of the TPL formation in the case of (Ti,V,Zr,Hf,Nb,Ta)N coating. The positions of the lift-outs are shown on Fig. 13.b-c.

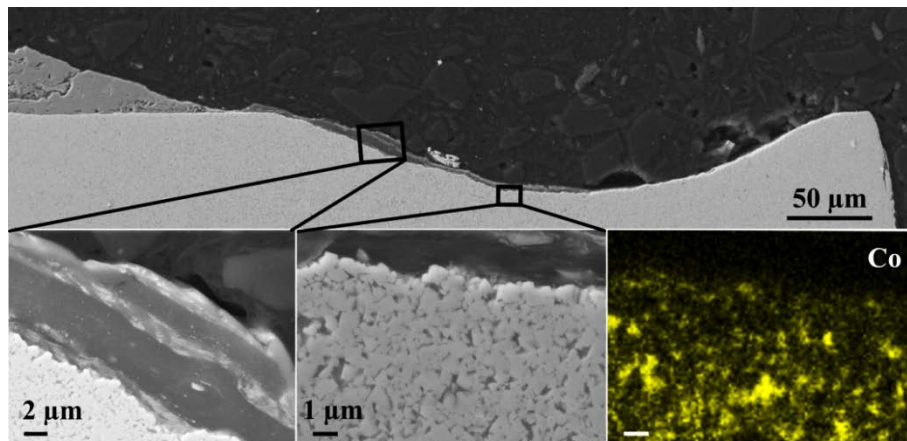
Fig. 10 (a) SEM overview of the crater in the DLC tool. (b) SEM image of the region where a FIB lamella was extracted. (c) SEM image and EDX Co K α map of a near-surface region in the crater.

Both coated tools were sectioned with the diamond saw and polished similarly to the uncoated cemented carbide tools. The cross-section on the DLC tool was carried out through the tool protection layer located in the crater (Fig. 10.a). More than half of the crater, further from the edge-line, is covered by TPL, which has thickness of 3 μm to 10 μm . Tool protection layer extends even beyond the tool-chip contact zone. As with the uncoated insert, the primary wear mechanism is Co diffusion which is shown by the reduced levels of Co close to the surface seen in Fig. 10.c. The figure however shows that Co was not completely removed or replaced by Cu and Zn, as is the case of uncoated tool, which gives an evidence of protective action of TPL. Flank wear $VB = 56 \mu\text{m}$ on the tool clearance is also present, apart from the crater.

To gain a deeper understanding of the composition of this tool protection layer and mechanisms of its formation a cross-sectional FIB lamella for TEM analysis was extracted from the crater of the worn DCL insert. The lamella was extracted at right angle to the surface of cemented carbide in the region shown in Fig. 10.b.

The N-rich and O-rich amorphous phases are presumably acting as diffusion barriers, blocking the migration of Co binder from the cemented carbide tool. Delamination of the TPL is, however, highly probable due to presence of ZnS which is characterized by low hardness and high brittleness [27]. Such TPL detachment from the rake surface (Fig. 9.a) can explain crater formation and reduced level of cobalt in the crater region (Fig. 10.c).

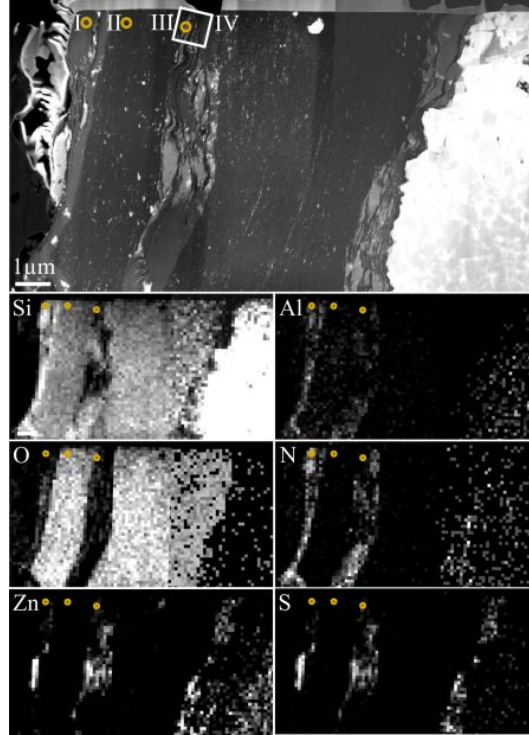
Fig. 11. (a) STEM HAADF image of the lamella extracted from the crater in the DLC insert with regions for SAED and DFTEM marked. (b) EDX maps (Si K α , Al K α , O K α , N K α , Zn K α , S K α) with regions for SAED marked.

Five major layers are identifiable in the STEM HAADF image of the TPL (Fig. 11.a). Among them, two thick (200-500 nm) layers have higher oxygen content (seen as dark grey in Fig. 11.a) and three thinner (50-150 nm) layer of laminar structure (seen as middle grey in grey in Fig. 11.a). Each of the thinner layers consists of alternating lamellae of ZnS and nitrogen enriched ceramic which can be as thin as 100 nm (Fig. 12.d). ZnS was identified to be crystalline with cubic zinkblende structure (Sphalerite) while both nitrogen rich and oxygen rich layers to be amorphous, as seen in Fig. 12. Both types of amorphous ceramic layers are from Si-Al-O-N system.

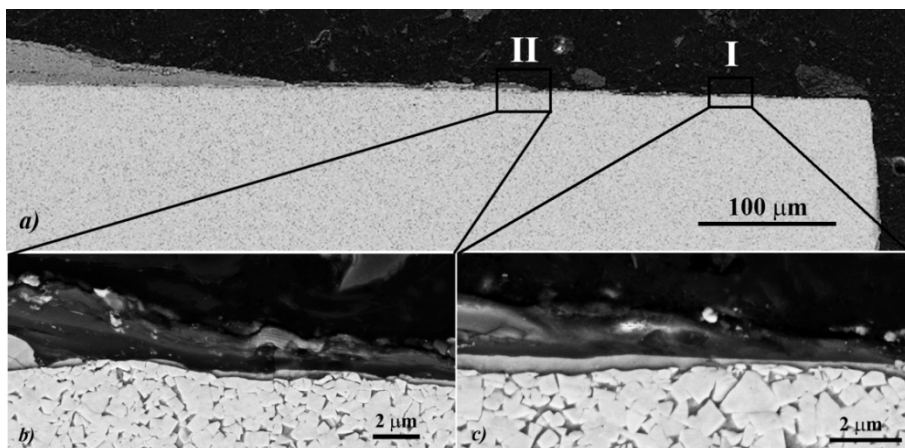
Fig. 13. (a) SEM overview of the cross-section of (Ti,V,Zr,Hf,Nb,Ta)N coated tool including SEM images of FIB lamella lift-out regions (b) at the end of tool-chip contact, and (c) near the cutting edge.

TEM data from the lamella extracted from the region I in Fig. 13.c is shown in Fig 14. In the STEM HAADF image (Fig. 14.a) the cemented carbide is seen on the right, the nitrogen rich region on the left and the remains of the (Ti,V,Zr,Hf,Nb,Ta)N coating in the middle. Compositional EDX data for nitrogen rich phase presented in Table 3 show that Si to N ratio corresponds to silicon nitride (Si_3N_4), for which simultaneous equivalent substitution of Al-O for Si-N is additionally observed. Such compositional case directly corresponds to β -SiAlON phase [28]. The original nitride coating is completely removed in certain regions, as seen in the lower part of Fig.14.a. Brass fragments, which have been encapsulated in the β -SiAlON, are seen as bright regions in the otherwise smooth TPL. According to selected area electron diffraction (SAED), the original nitride coating is crystalline (Fig. 14.b) while β -SiAlON is fully amorphous (Fig. 14.c). It is worth noting that the total thickness of TPL closely follows the thickness of the original coating (Fig. 3.b). It can be assumed that the source of N for the formation of stoichiometric β -SiAlON is the nitrogen from the consumed (Ti,V,Zr,Hf,Nb,Ta)N coating. Absence of nitrogen in the original coating, in the case of DLC, resulted in significant N lack in the nitrogen rich TPL layer.

TEM data from the lamella extracted from the region II (Fig. 13.a-b) is shown in Fig 15. In the STEM HAADF image (Fig. 15.a) four regions can be identified, from right to left: cemented carbide, (Ti,V,Zr,Hf,Nb,Ta)N coating, silicon oxide, and nitrogen rich phase on the leftmost side. Thickness of the remaining original nitride coating (1 μm to 1.5 μm) is significantly higher than in region I located closer to cutting edge. Table 3 shows that silicon oxide (SiO_2) layer is additionally doped with aluminum, while no traces of nitrogen are found. Nitrogen rich phase is identical to one in Fig 14. and represents β -SiAlON. Similarly to the sample from region I (Fig. 14) SAED patterns (not shown here) conclude that the original nitride coating is crystalline and β -SiAlON is amorphous. Additionally, SAED shows that SiO_2 layer is also amorphous.

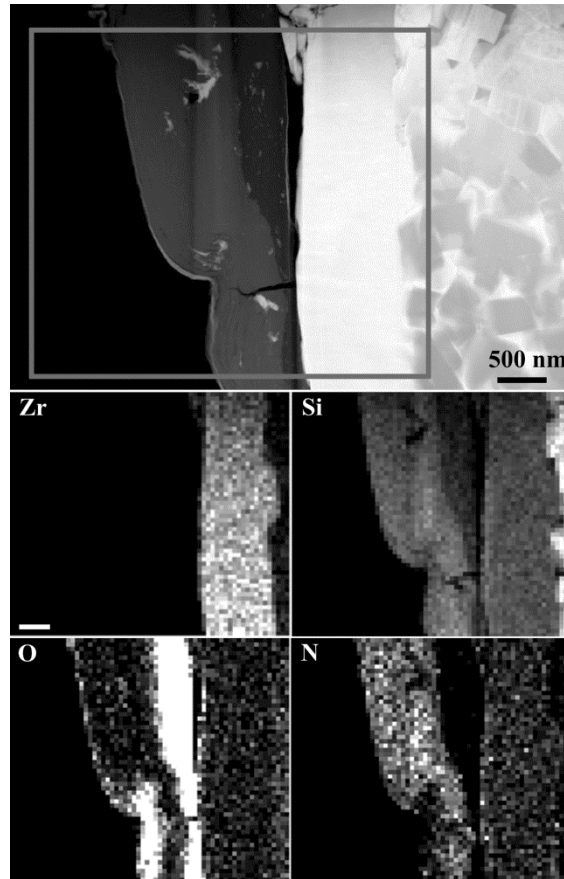
Fig. 15. (a) STEM HAADF image of FIB lamella from region II. (b) corresponding EDX maps Zr K α , Si K α , O K α , N K α .
