## CHLORIDE CONCENTRATION IN PRELOADED

## **COMPACT TENSION CONCRETE SPECIMENS**

Manouchehr Hassanzadeh

Rapport TVBM-7067

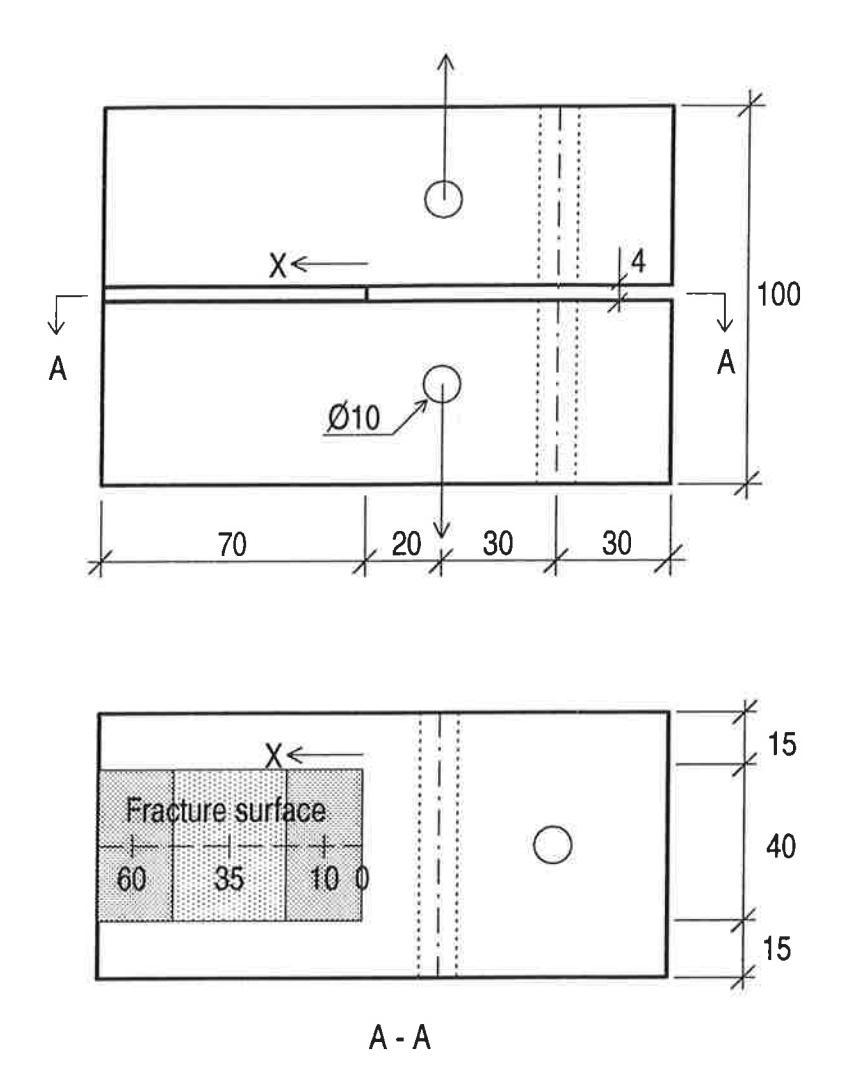
The CT specimens are made of notched prisms with the edge dimensions 150, 100 and 70 mm. The notches are imposed on the same plane from three different directions; see Fig. 1. The remaining uncut part of the specimen, viz. the fracture surface, is  $70 \times 40 \text{ mm}^2$ . The arrows on the figure show the position and the direction of the loads applied during the mechanical testing.

Fig. 1. Geometry of the compact tension specimen.

All specimens were painted with epoxy prior to sea water storage. All sides of the specimens were painted. Furthermore, besides the notch tip at x=0, see Fig. 1, all other notch tips were also painted. However, the epoxy treatment of the notch tips was not effective due to the tightness of the notches.

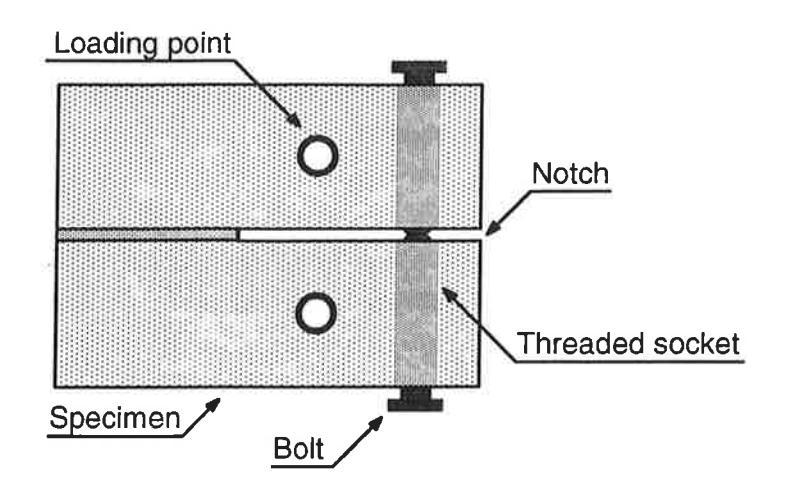
The second group is loaded to a certain level of their strength at 28 days of age and thereafter are subjected to stress relaxation during storage in sea water. Fig. 2 shows schematically the arrangement used for stress relaxation tests. As the figure illustrates, two unconnected threaded sockets are embedded in the specimen, located on both sides of the notch plane. The sockets contain bolts which can be screwed towards each other.

The load is applied to the specimen by a testing machine in displacement control. When the required load level is approached, the displacement is held constant while the bolts are screwed towards each other until they make contact and a small change in load is observed. Thereafter the specimen is unloaded, removed from the testing machine and stored in sea water. Since the bolts are in contact with each other, the specimen cannot be unloaded totally. Thus, residual stresses will arise within the specimen. The magnitude of the residual stresses depends upon the initial load imposed by the testing machine, and on the relaxation of the specimen which occurs during the storage in sea water.

Fig. 2. Arrangement for stress relaxation tests.

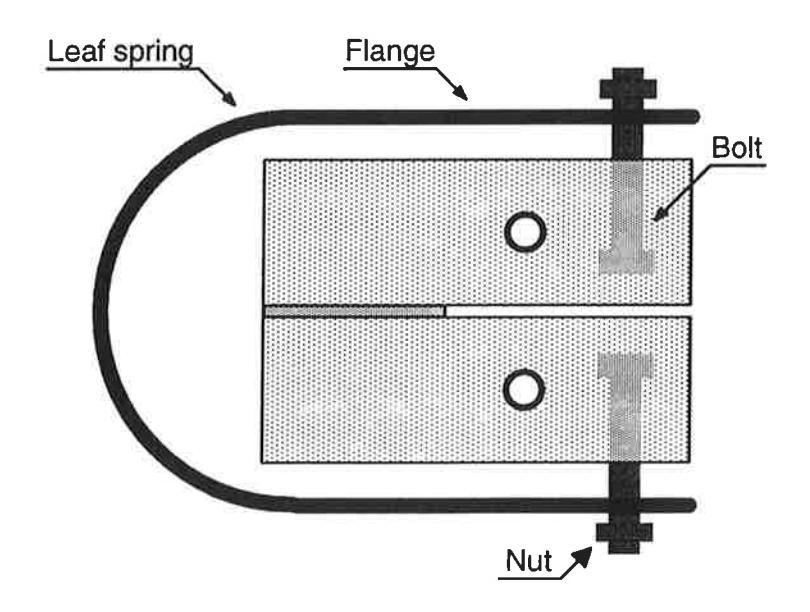
The third group of specimens was subjected to an approximately constant load, viz. a load corresponding to 60% of the specimens' strength, during the storage in sea water. The loading arrangement is illustrated in Fig. 3.

Fig. 3. Specimen subjected to constant load during storage in sea water.

As is illustrated, two bolts are embedded in the specimen on both sides of the notch plane. The bolts pass through holes on the flanges of the leaf spring. The load is imposed by compressing the flanges towards each other by an external load, fastening the nuts, and then removing the external load. Since the nuts oppose the reversed movements of the flanges, tensile load will be applied to the specimen through the bolts. The magnitude of the tensile load applied to the specimen will be somewhat lower than the initial external compressive load. The difference is caused by the displacement which occurs in the specimen. However, since the stiffness of the leaf spring (130 N/mm calculated for load - displacement at the holes) and the displacement of the specimen (approximately 0.4 mm when separation of the specimen into two pieces occurs) are low, the difference between the external and the final load imposed on the specimen is negligible.

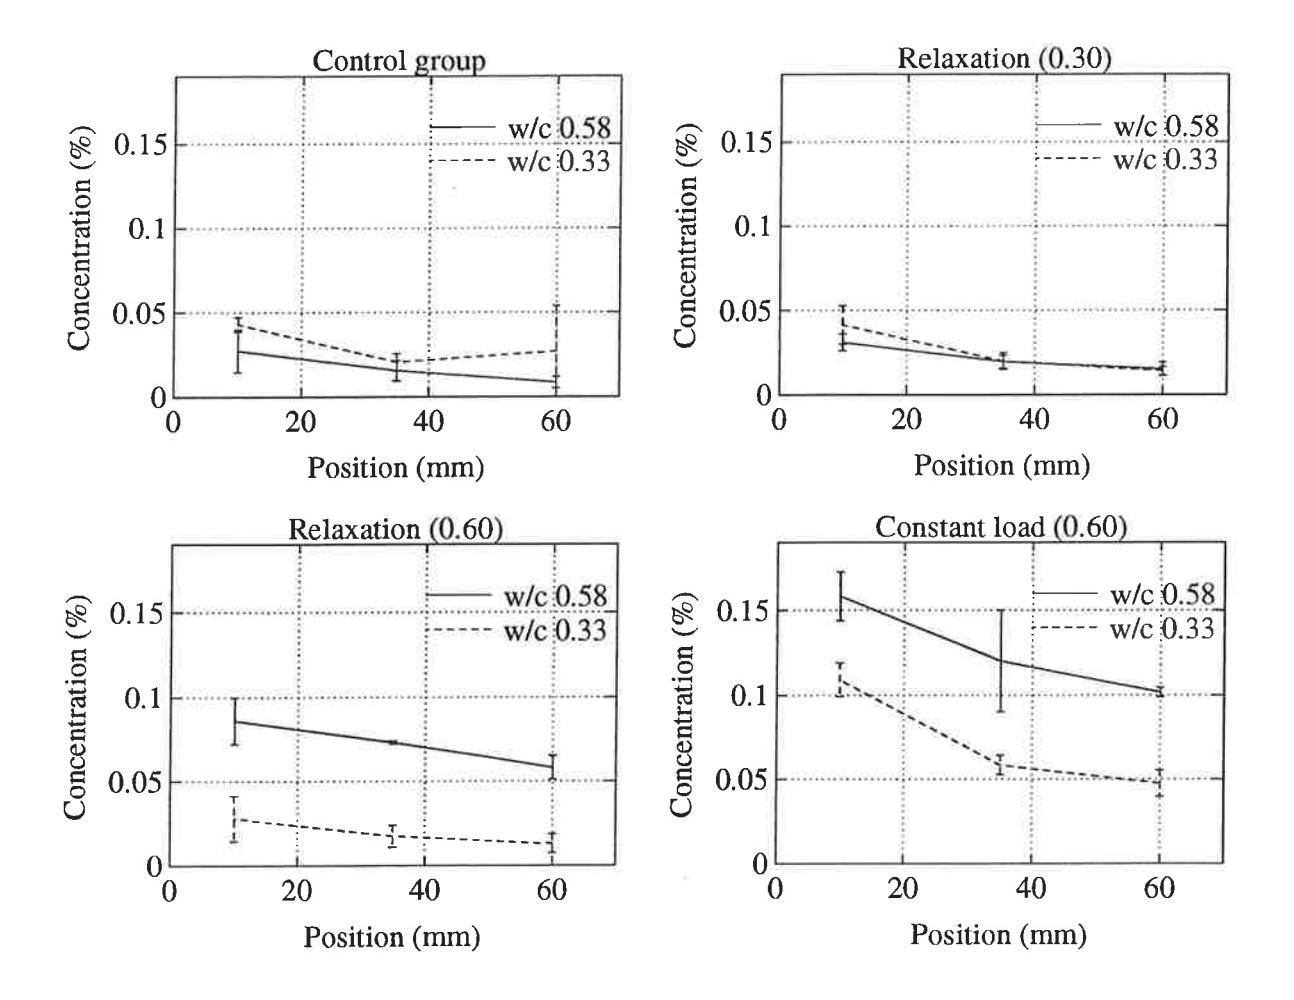
Fig. 4. Chloride concentration after two months of storage in sea water.

The results of the control group demonstrate that the painting of the notch tips by epoxy did not give the protection which was expected. The Chloride ingress has occurred from all notch tips. However, the Chloride ingress from the notch tip which was not painted at all (x=0) is higher than the notch tips treated by epoxy; compare the positions x=10 mm and x=60 mm.

Comparison between results of the control group and results of the relaxation tests indicates that there is no significant increase of Chloride ingress due to the presence of residual stresses at notch tip. However, in contrast with the relaxation tests, the ingress of the Chloride is significantly increased in the case of constant load tests. The reason for the observed phenomenon is not known. However, the following explanations are somewhat realistic.

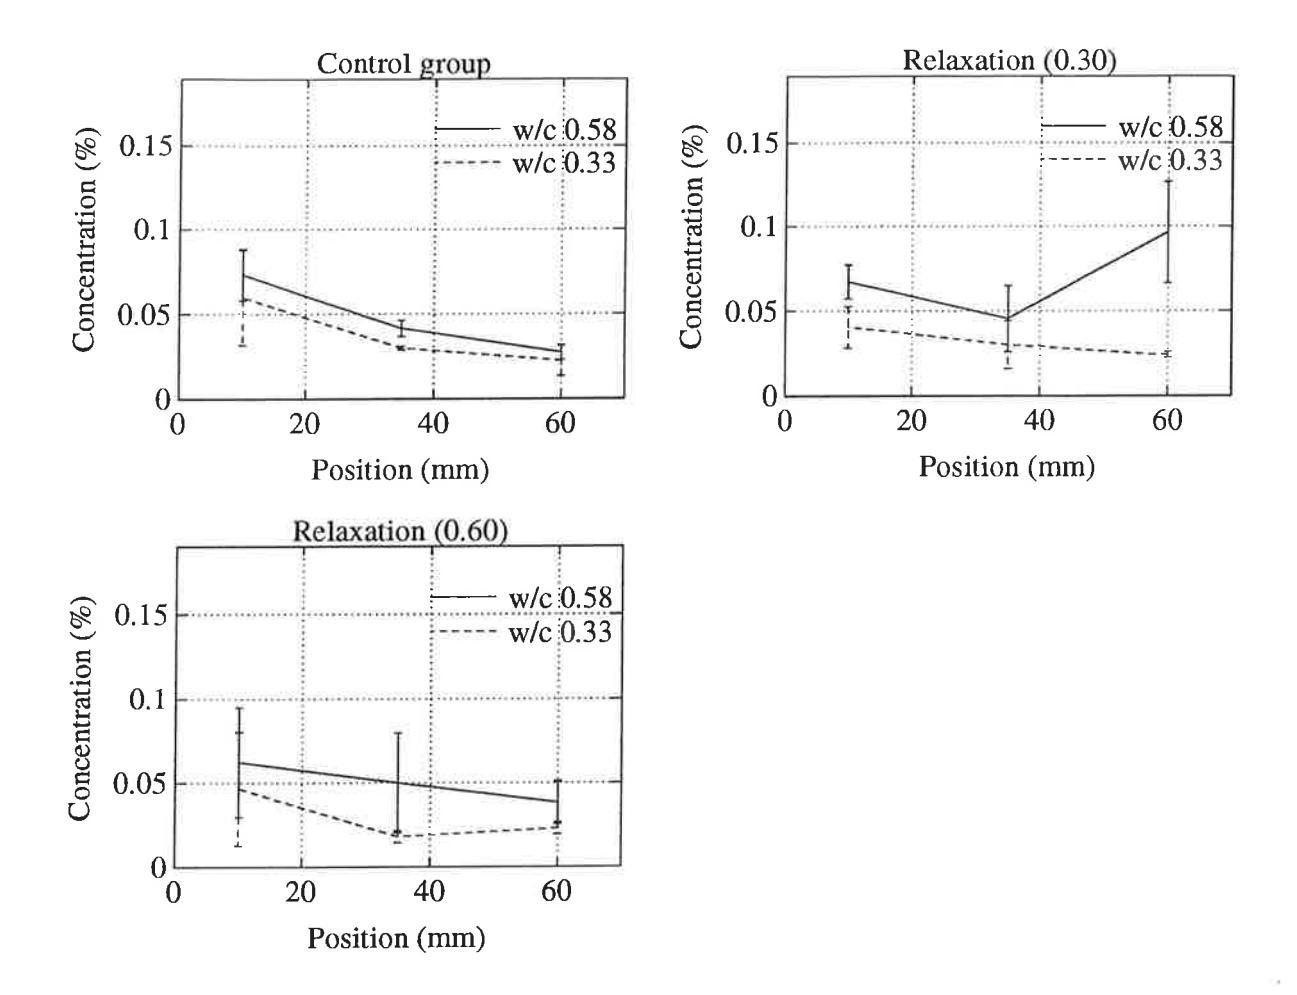
Fig. 5. Chloride concentration after four months of storage in sea water.

In relaxation tests, the stress concentrations at notch tips decrease and the self-healing process of concrete closes the micro cracks which may have occurred due to the stress concentration at the notch tips. In the case of constant load tests, however, creep occurs, which in spite of self-healing of concrete gives rise to continuous formation of new micro cracks.

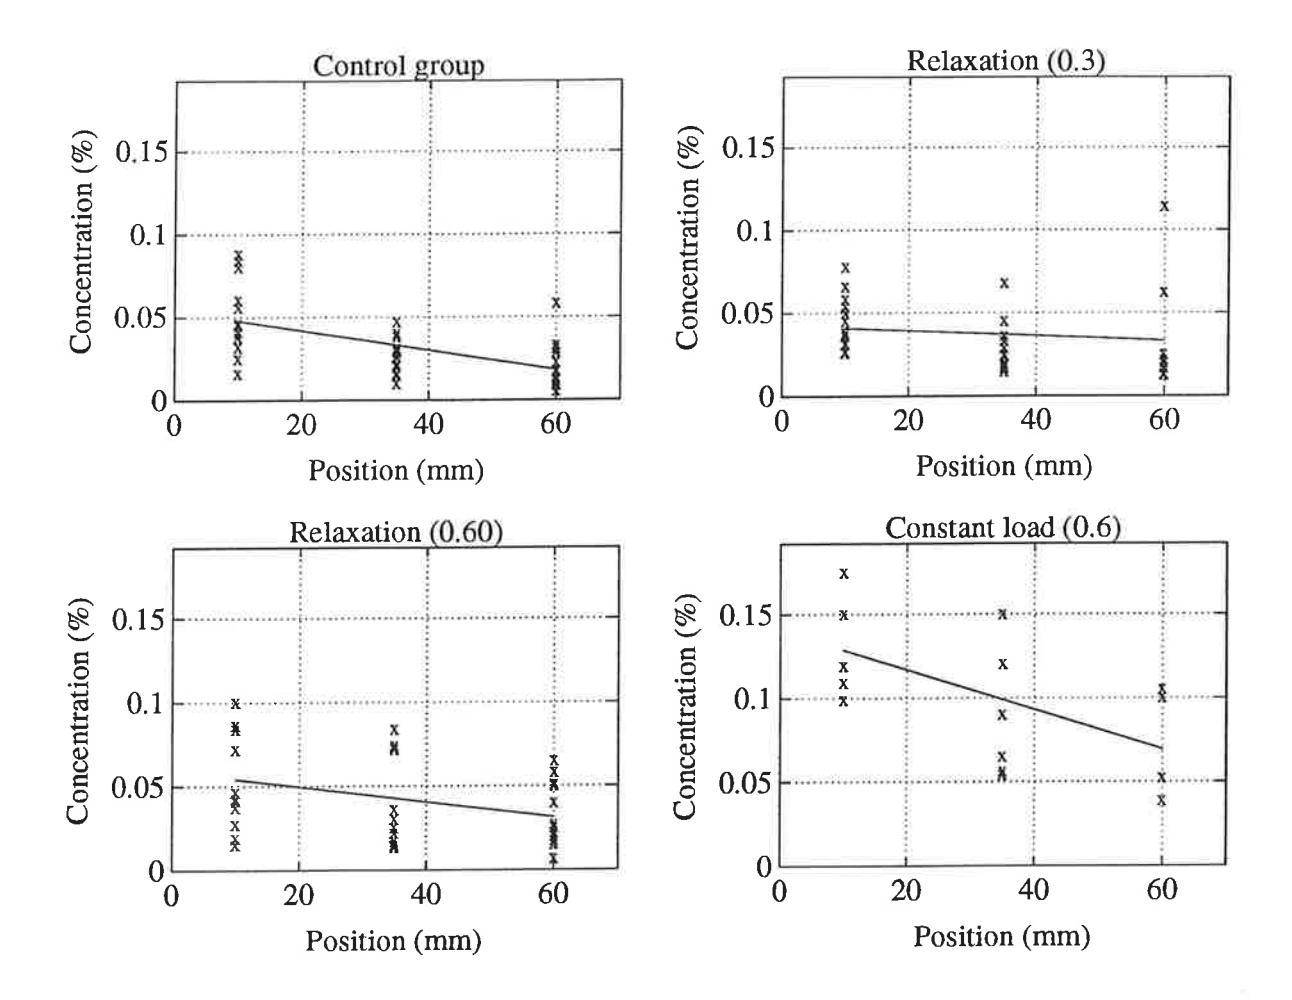
In order to more closely examine the significant differences between control group, relaxation and constant load tests, a straight lines are fitted to the test results by means of the Least Square Method. The possible influences of the concrete quality and storage time on Chloride ingress into specimens have been neglected; see Fig. 6. The figure shows that there is no significant difference between Chloride ingress in control specimens and in the specimens of the relaxation tests. Furthermore, the figure shows that the Chloride ingress increases significantly in the case of the specimens subjected to constant load.

Fig. 6. Influence of stress on chloride ingress.
