Sediment Sampling and Analysis in Rönne å at Ängelholm

Inamdeen, Fainaz; Larson, Magnus

2021

Water Resources Engineering Report 3243 ISSN 1101-9824

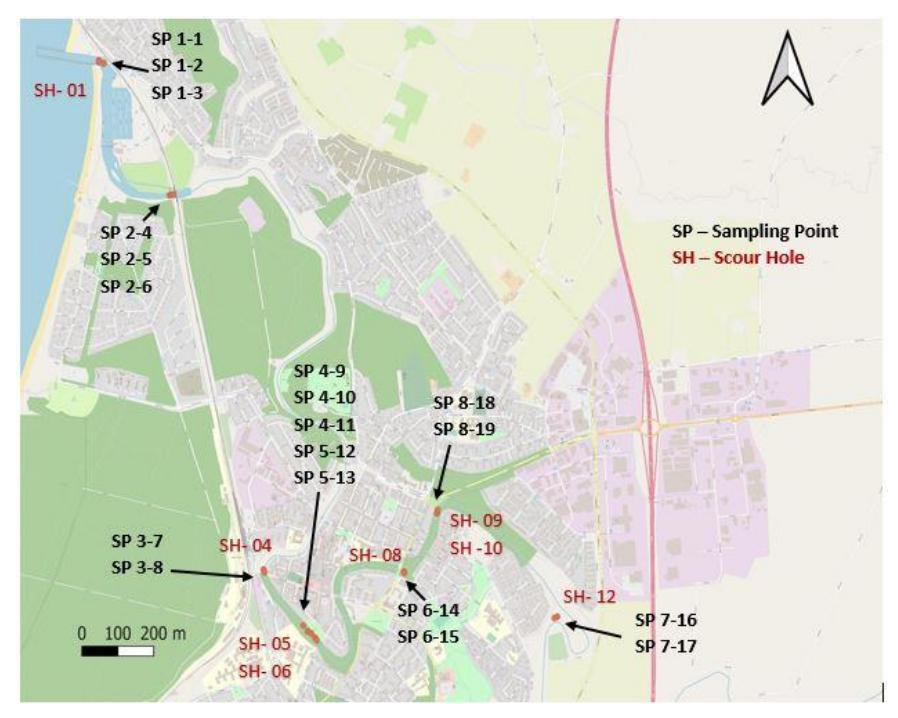
Figure 1. Overview map of the sample locations. SH denotes major scour holes identified in Inamdeen (2020) that were the basis for selecting sample locations.

There were 19 locations selected for sediment sampling by considering observed major bottom scour holes in the 12-km long stretch of Rönne å at Ängelholm. An overview map of the sample locations is shown in figure 1, whereas detailed pictures and bathymetric conditions are provided in figures 2-9. Further details on the locations are summarized in table 1, showing the coordinates for the sampling points in the SWEREF99 TM system and remarks on the conditions at the sampling sites together with a motivation for the sampling.

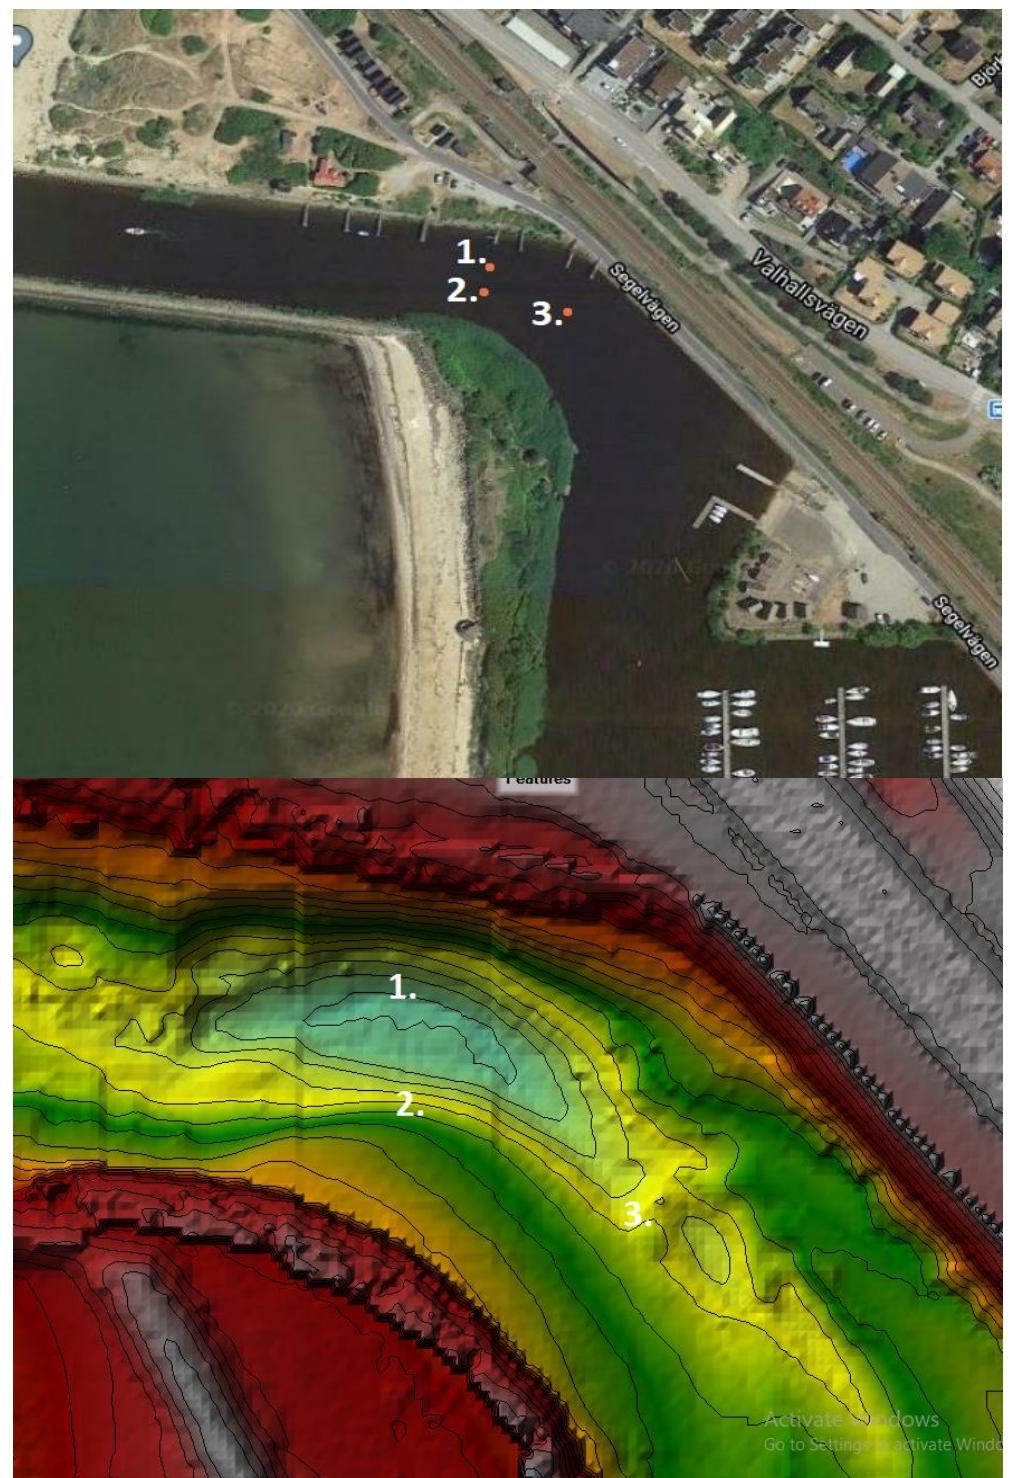
Location 1: KP 0 + 425 m

Figure 2. Location 1 with sample points 1 to 3

The sample 1-2 was taken adjacent to a bend scour hole (2.0 m deeper than the normal river bottom), near the river outlet to Skälderviken. This location represents an inner curve of a bend where sedimentation normally takes place (see figure 2). The sample textural group may be characterized as slightly gravelly sand.

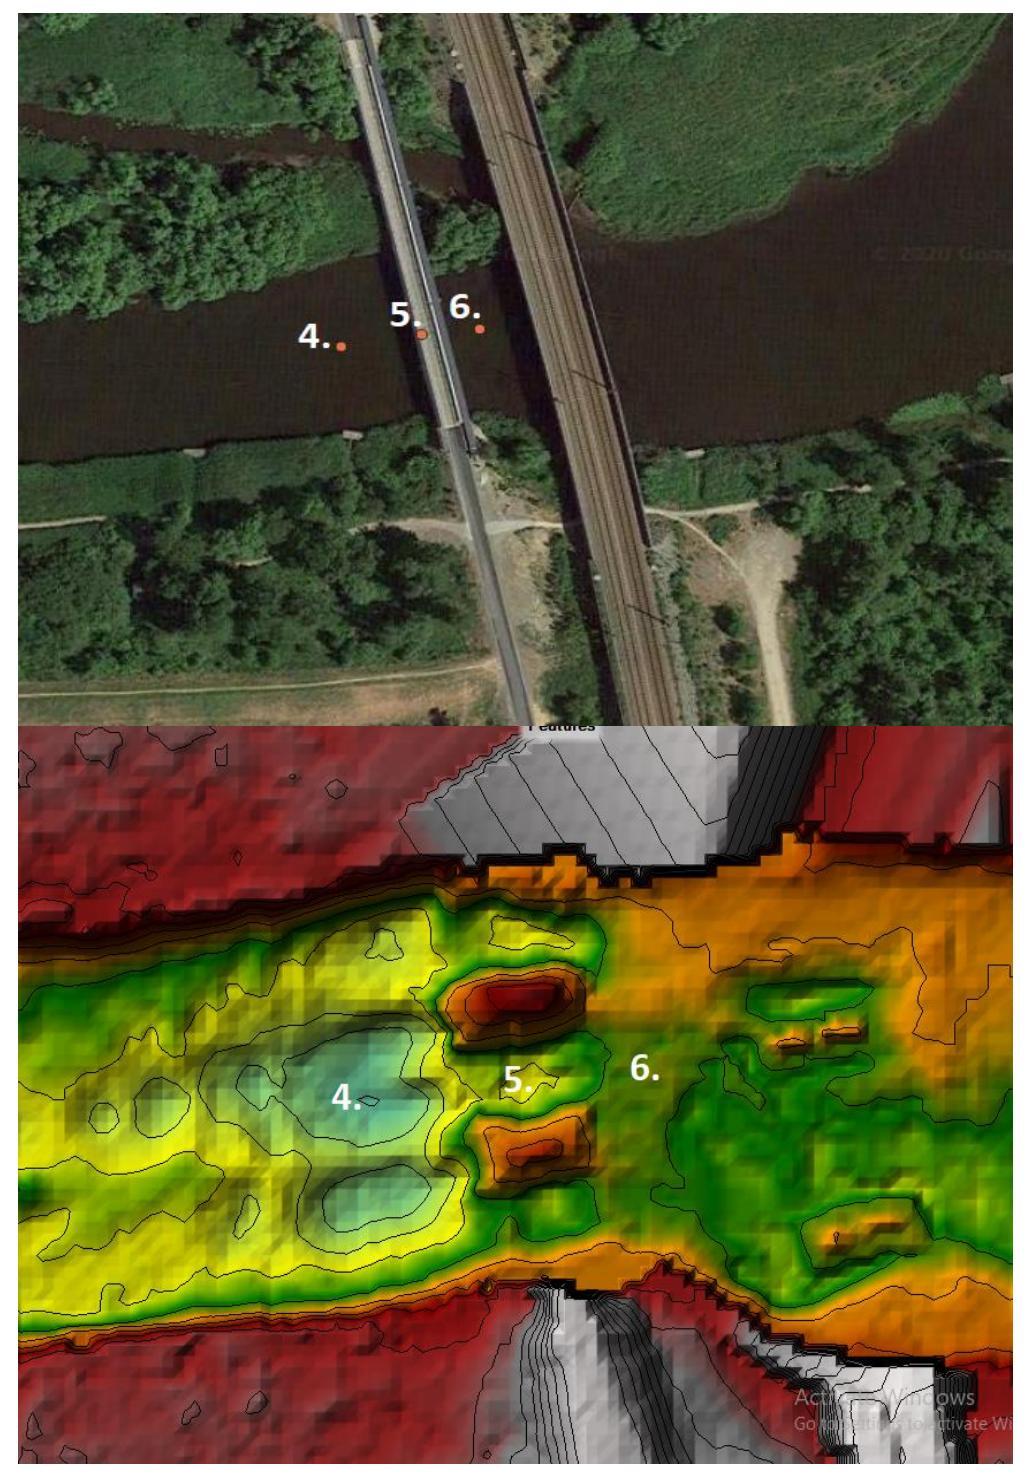
Location 2: KP 1 + 575 m

Figure 3. Location 2 with sample points 4 to 6

ANALYST & DATE: Fainaz Inamdeen, 25/11/2020 TEXTURAL GROUP: Slightly Gravelly Sand The sample 2-6 was taken from the approach section to Flygarebron (upstream) and downstream of the Skälderviken bron (see figure 3). The sample contained larger rock pieces suggesting an armored or hard bottom. The sample analysis was performed by visually means due to the sample characteristics and the quantity of material obtained.

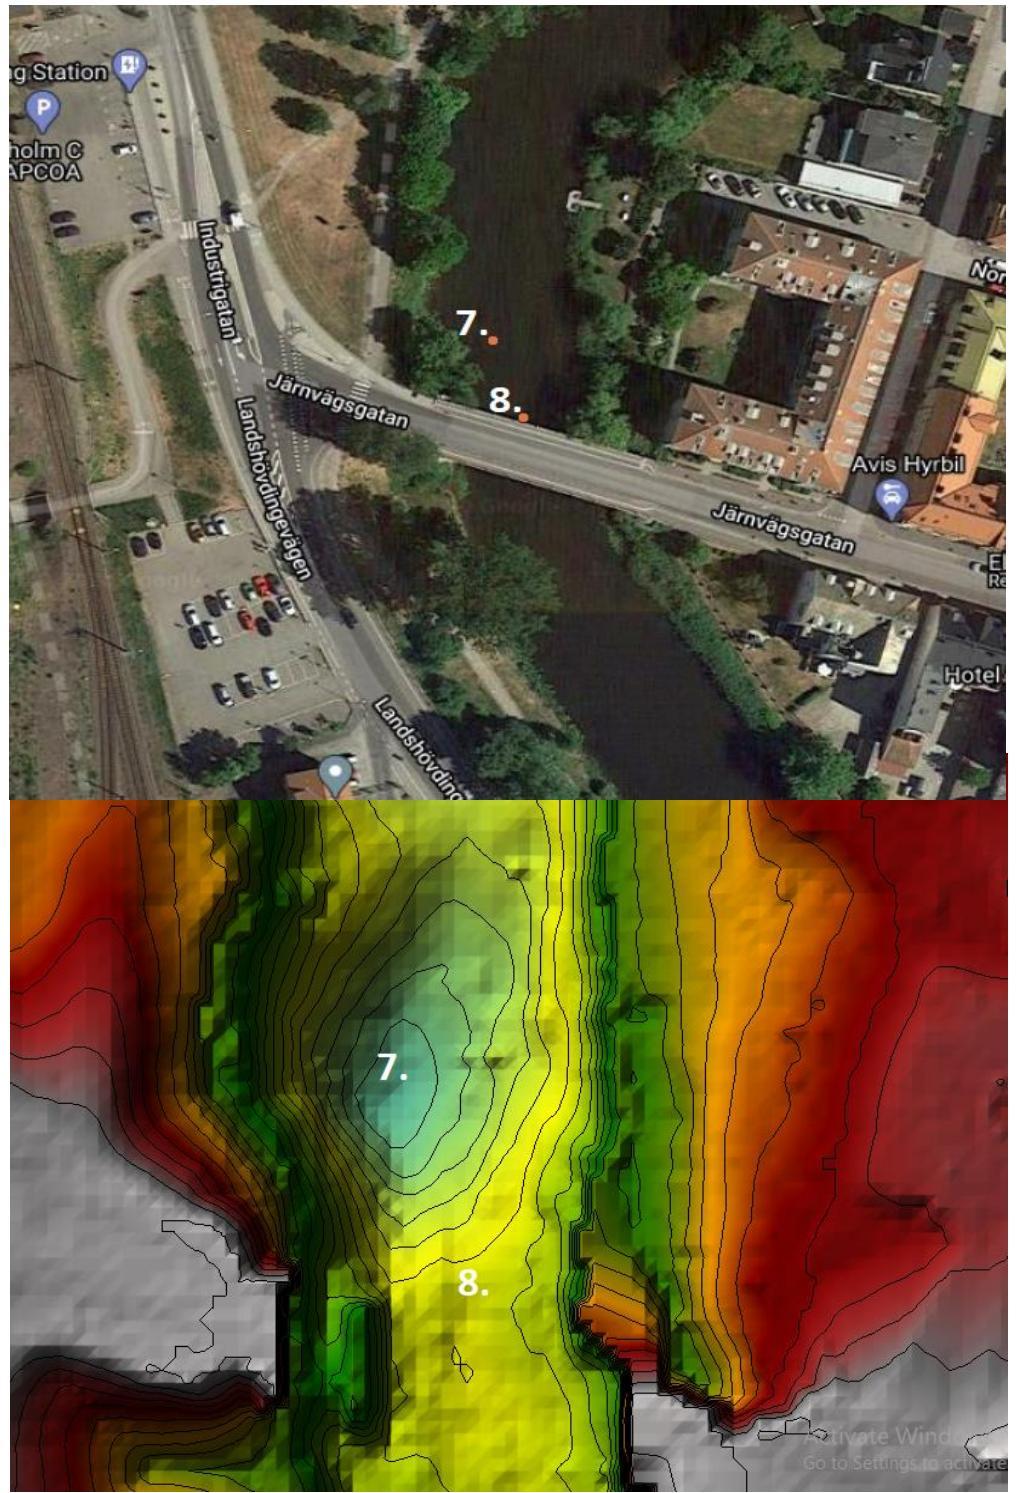
Location 3: KP 5 + 600 m

Figure 4. Location 3 with sample points 7 and 8

The sample 3-7 was taken from the center part of a scour hole near Järnvägsbron (see figure 4). The sample contained mussels and were not subjected to sieve analysis. The sample textural group is characterized as gravel.

The sample 3-8 was taken upstream of a scour hole (2.0 m deeper than the normal river bottom), downstream Järnvägsbron (see figure 4). The sample contained larger rock pieces, which suggested hard bottom. The sample analysis was performed visually because of the sample characteristics and obtained quantity of material.

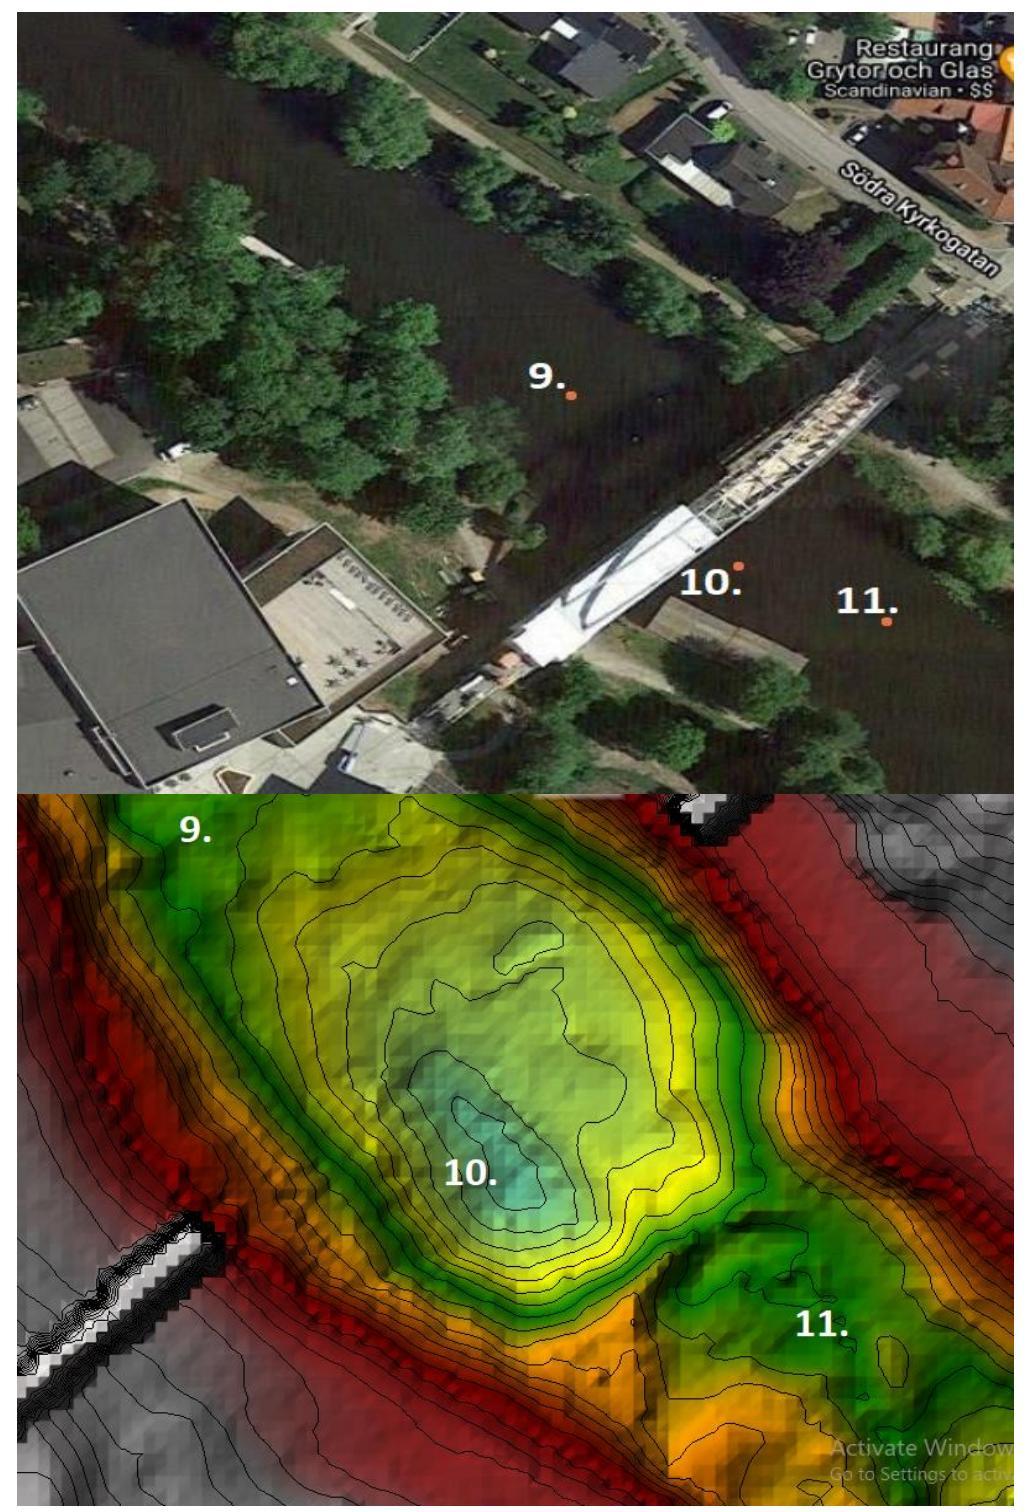
Location 4 : KP 6 + 025 m

Figure 5. Location 4 with sample points 9 to 11

The sample 4-9 was taken in the downstream part of a scour hole (3.5 m deeper than the normal river bottom), near Tullportsbron (see figure 5). The sample textural group is characterized as gravelly sand. The sample was mixed with lots of mussels, as seen in pictures below.

The sample 4-10 was taken from center part of a scour hole (3.5 m deeper than the normal river bottom), under Tullportsbron (see figure 5). The sample textural group is characterized as sandy gravel.

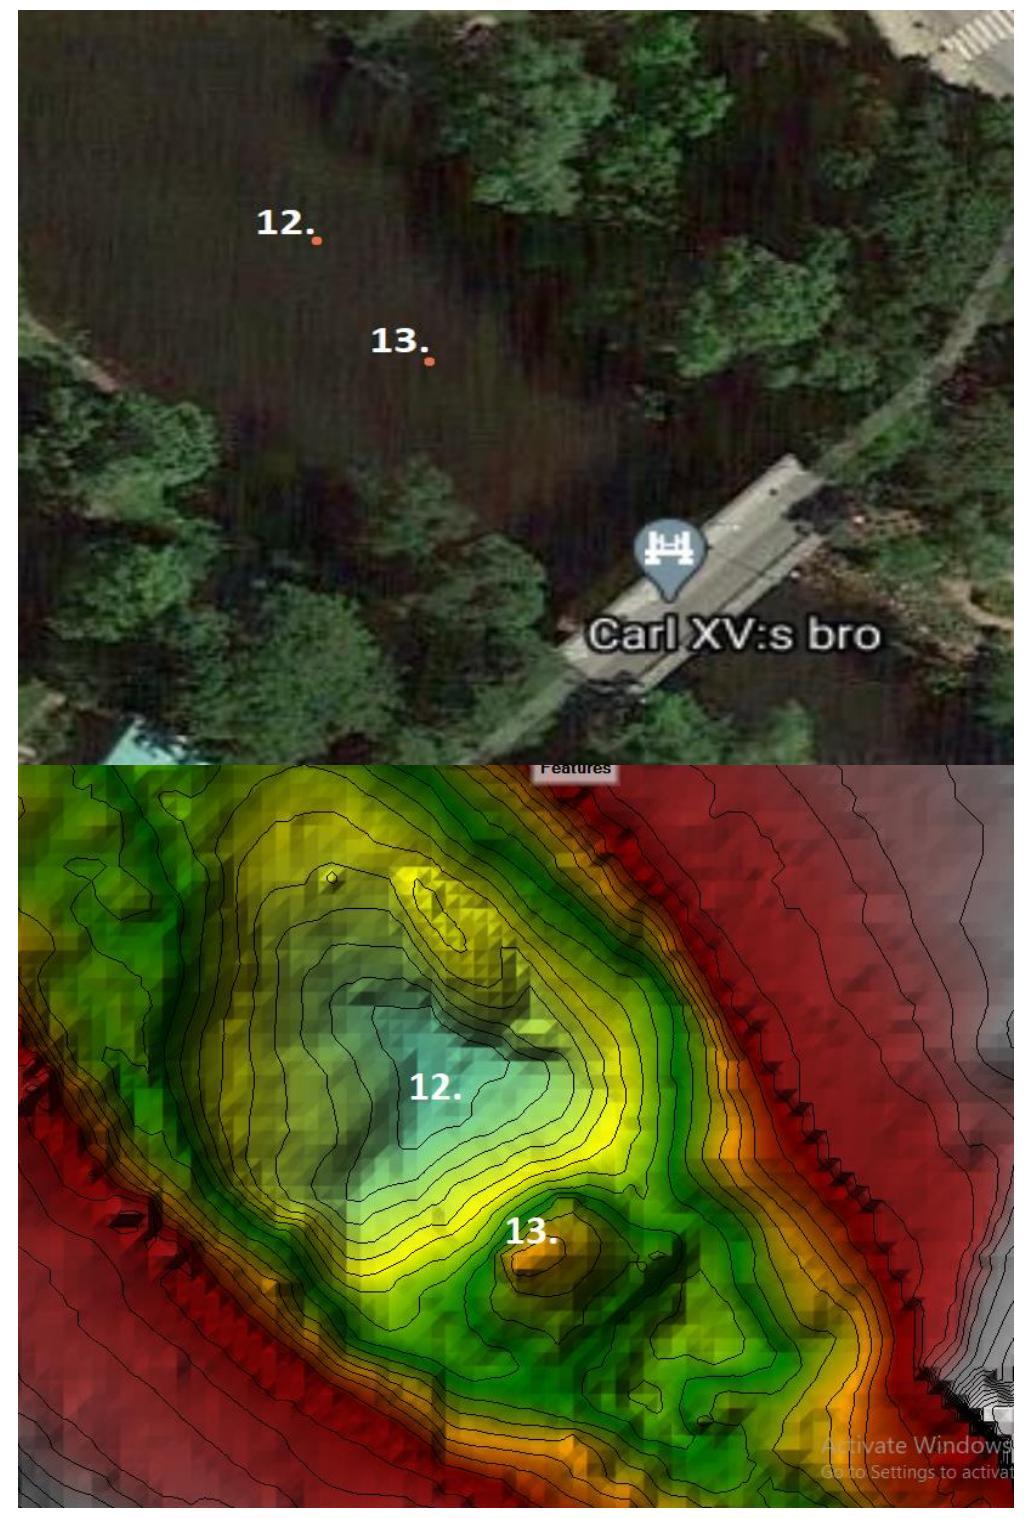
Location 5 : KP 6 + 175 m

Figure 6. Location 5 with sample points 12 and 13

The sample 5-12 was taken from the center part of a scour hole (3.5 m deeper than the normal river bottom), near Carl XV bridge (see figure 6). The sample analysis was performed visually due to the sample characteristics and sample quantity. The sample suggests that the particular bottom is hard and contains larger rock particles.

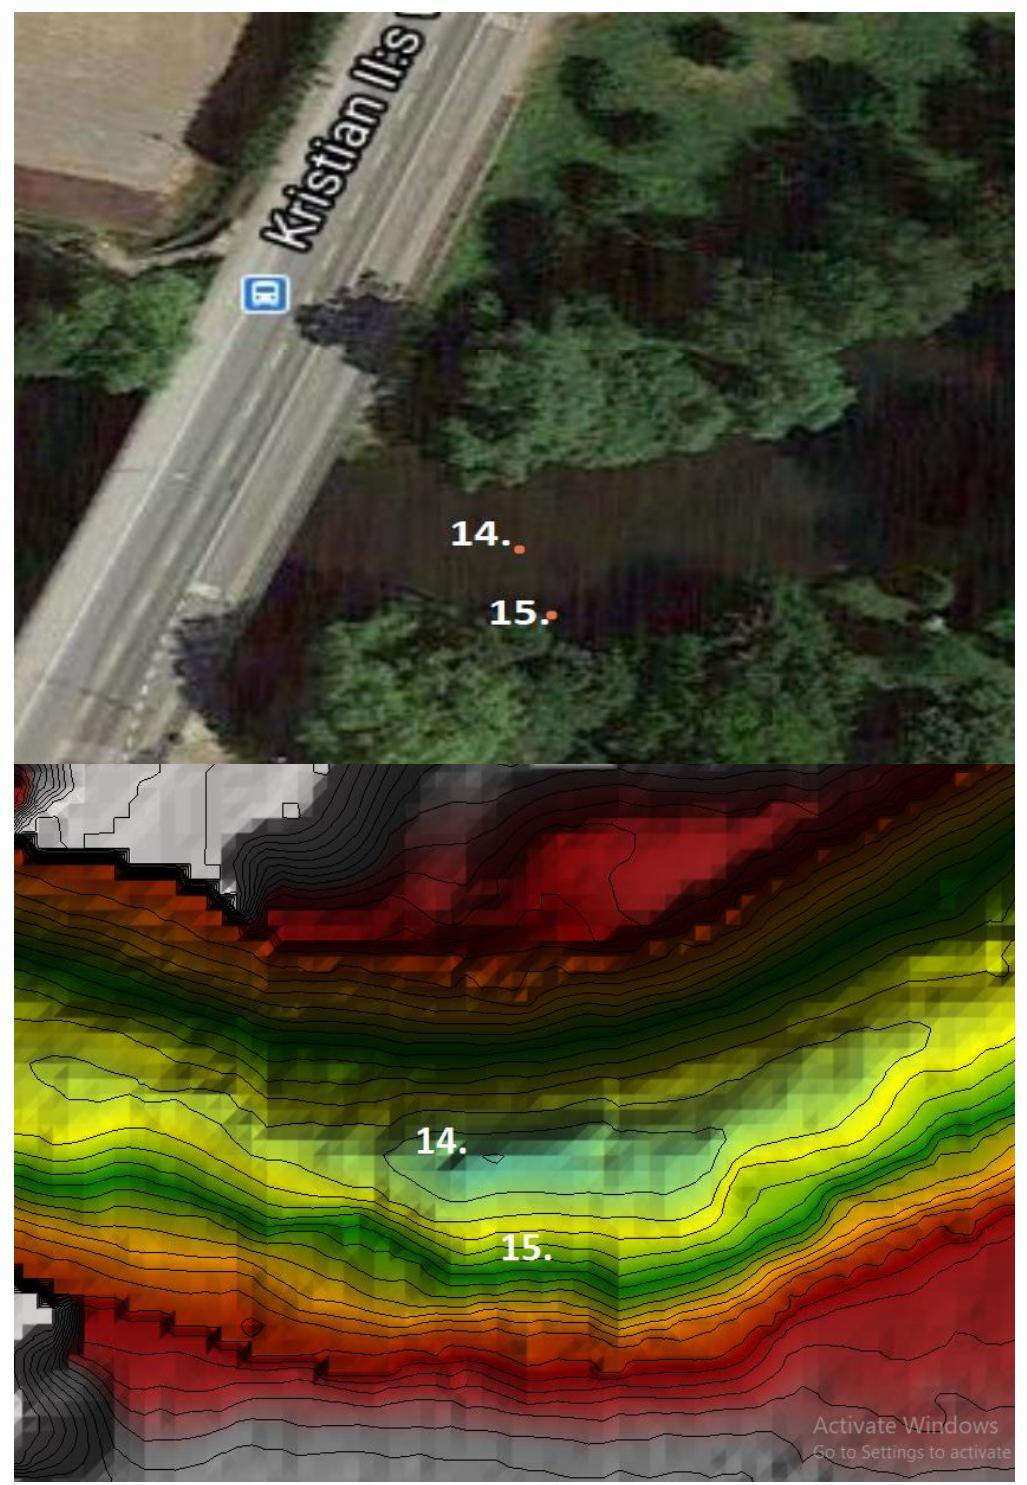
Location 6 : KP 7 + 400 m

Figure 7. Location 6 with sample points 14 and 15

The sample 6-14 was taken from the center part of a scour hole (1.5 m deeper than the normal river bottom), downstream to Kristian II bron (see figure 7). The sample textural group is characterized as sandy gravel.

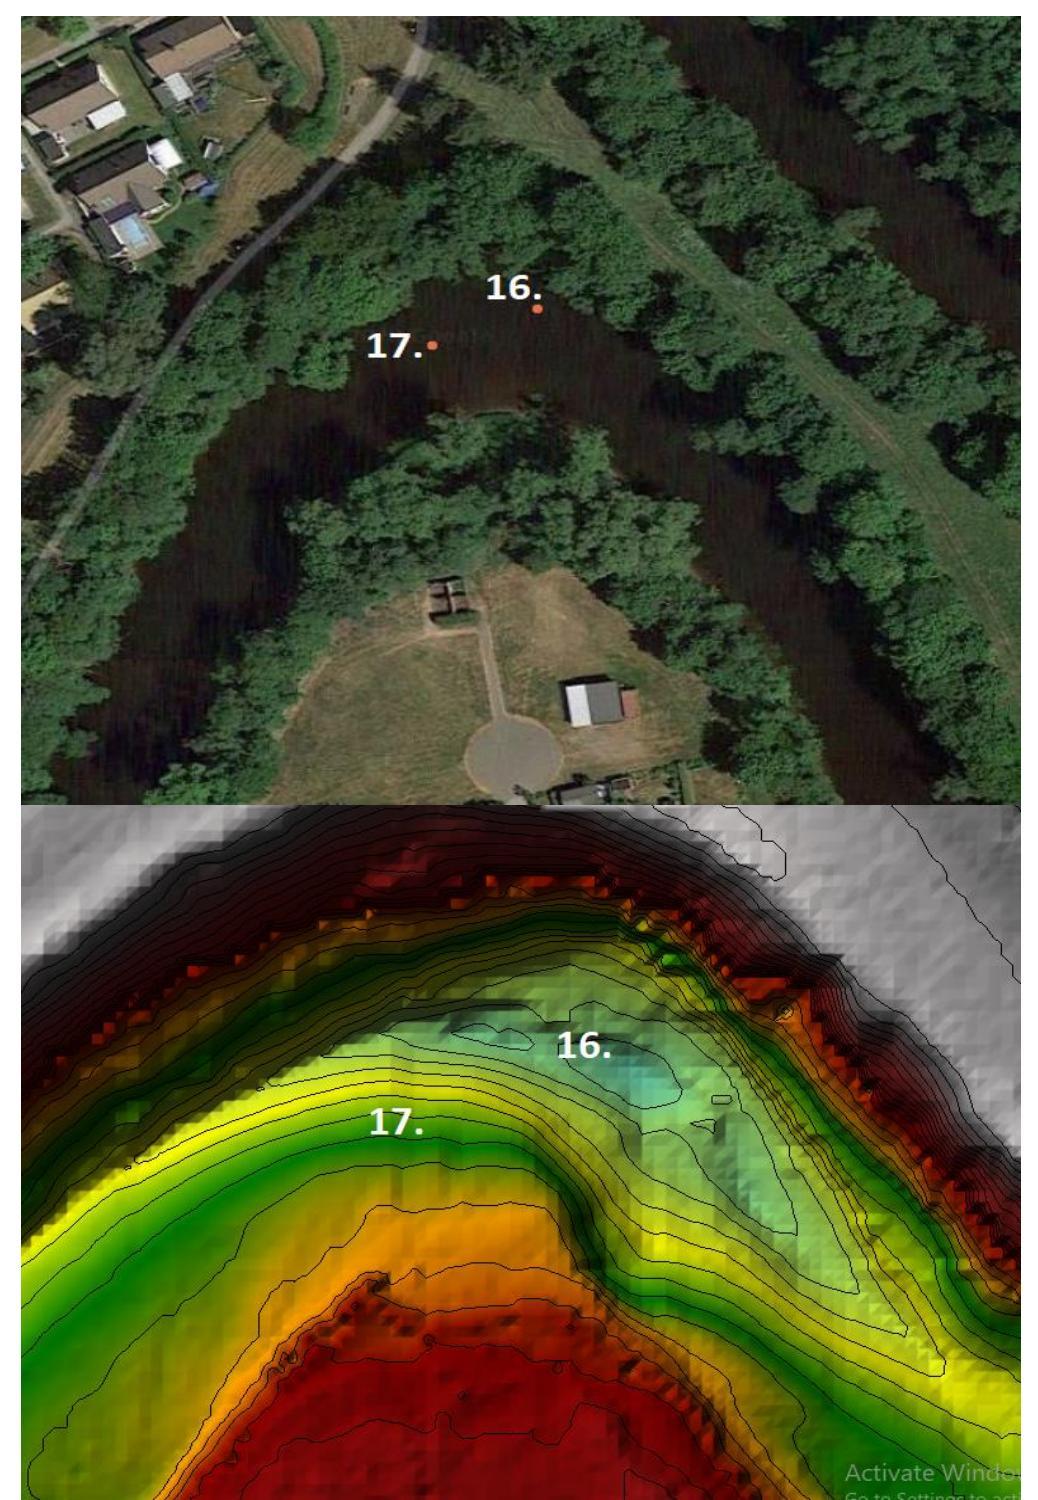
Location 7 : KP 9 + 650 m

Figure 8. Location 7 with sample points 16 and 17

The sample 7-17 was taken from the upstream part of a scour hole and near a sharp river bend where a riffle feature can be expected (see figure 8). The sample textural group is characterized as slightly gravelly sand.

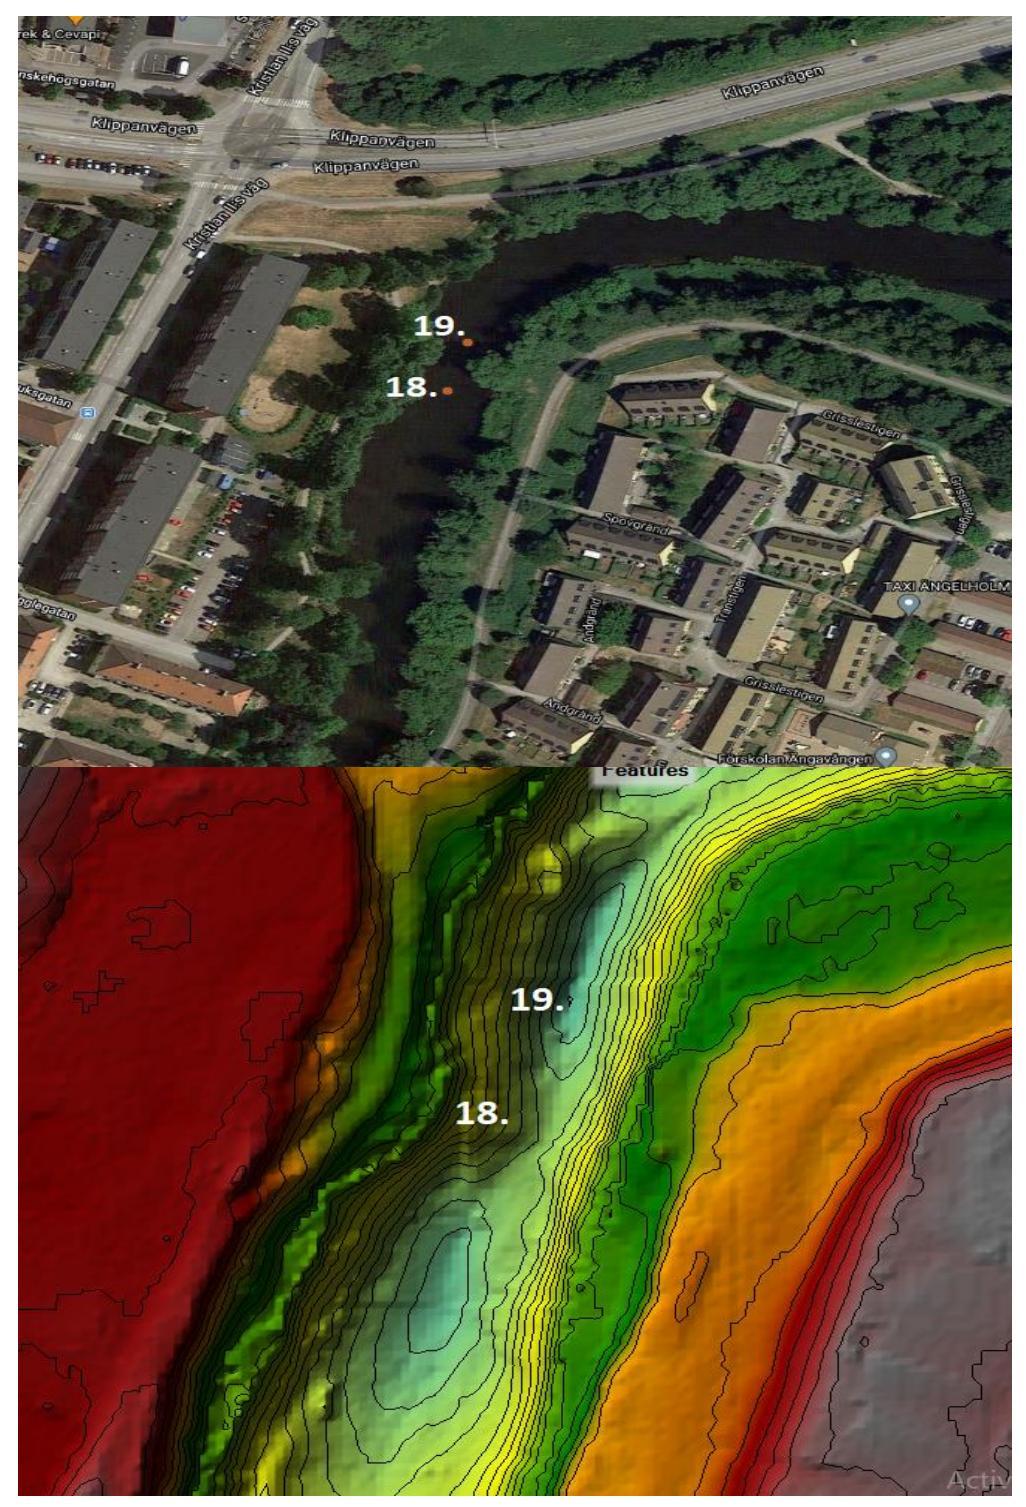
Location 8 : KP 7 + 850 m

Figure 9. Location 8 with sample points 18 and 19

The sample 8-18 was taken from the upstream part of a scour hole and near a river bend (see figure 9). Hard bottom features were expected before the sample was taken because of the formation of surrounding scour hole and adjacent river bathymetry. The sample analysis was performed visually due to lack of a sufficient sample quantity. The sample suggests that the particular bottom is hard and formed by claystone or siltstone.

The sample 8-19 was taken from center part of a scour hole (1.3 m deeper than the normal river bottom), near a river bend (see figure 9). The sample analysis was performed visually due to the sample characteristics. The sample suggests that the particular bottom is hard and layered by claystone or siltstone. Some eroding features are indicated at the top surface of the hard bottom.

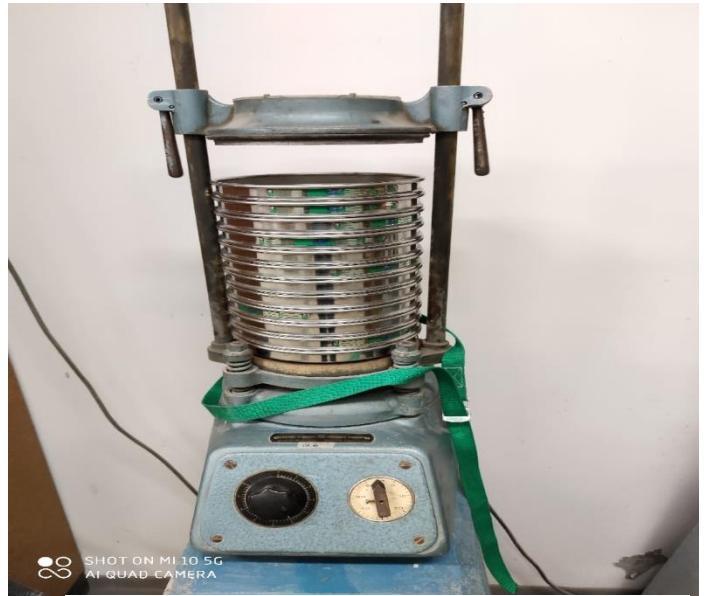
The sampling analysis was conducted in the laboratory of Building Materials in the Department of Building and Environmental Technology at Lund University. Initially, all the samples were dried at room temperature for several days. Then the samples were qualitatively checked and clustered for visual analysis; then grain size analysis were carried out based on sample quantity and initial characteristics. This report covers the results from the particle size sieve analysis as well as the visual analysis. The finer (clay particle) sediment samples should be analyzed through sedimentation techniques, yet to be performed, see section 4. For the particle sieve analysis, ASTM standard sieves from 32 mm to 0.063 mm were used and the testing procedure was adopted with reference to ASTM D 422 standard. There were six samples subjected to particle size analysis. The particle size distribution and associated statistical analysis were performed using GRADISTAT (2021).

Figure 10. Sieve set with sieve shaker

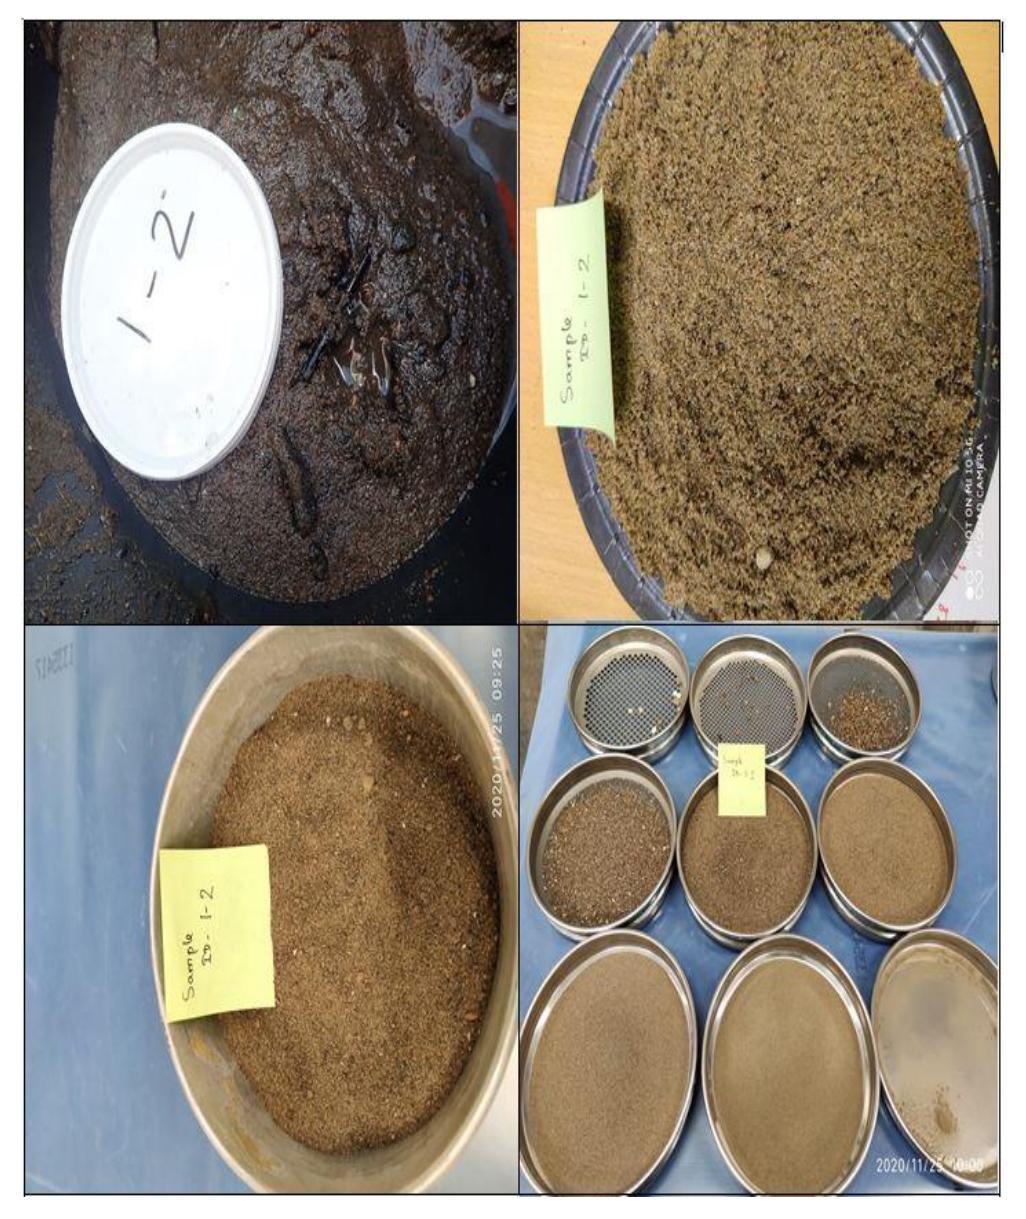
Figure 11. Sample 1-2 during the analysis process

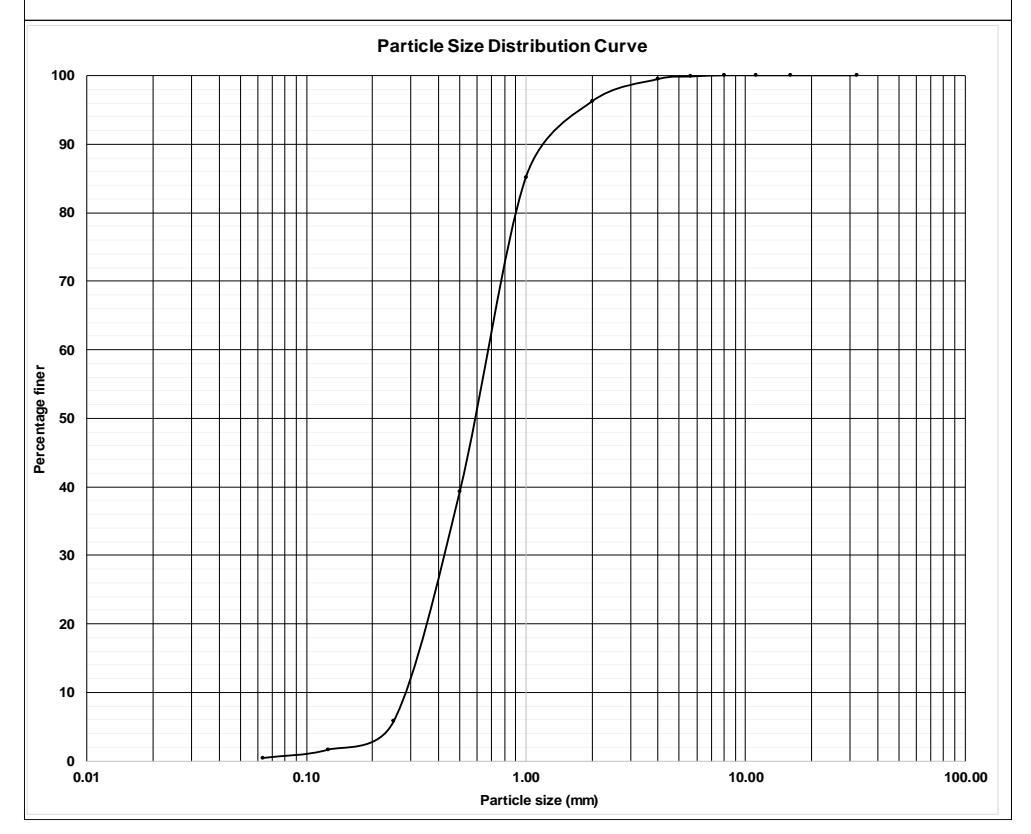
SAMPLE TYPE: Unimodal, Moderately Sorted

SEDIMENT NAME: Slightly Very Fine Gravelly Coarse Sand

mm	ф
MODE 1:	0.75	0.500
MODE 2:		
MODE 3:		
D ₁₀ :	0.27	-0.443
MEDIAN or D ₅₀ :	0.59	0.765
D ₉₀ :	1.36	1.872
(D ₉₀ / D ₁₀):	4.98	-4.224
(D ₉₀ - D ₁₀):	1.09	2.315
(D ₇₅ / D ₂₅):	2.30	6.481
(D ₇₅ - D ₂₅):	0.49	1.205

GRAIN SIZE DISTRIBUTION				
GRAVEL: 3.8%	COARSE SAND: 45.9%			
SAND: 95.8%	6 MEDIUM SAND: 33.5%			
MUD: 0.4%	FINE SAND: 4.1%			
	V FINE SAND: 1.2%			
V COARSE GRAVEL: 0.0%	V COARSE SILT: 0.1%			
COARSE GRAVEL: 0.0%	COARSE SILT: 0.1%			
MEDIUM GRAVEL: 0.0%	MEDIUM SILT: 0.1%			
FINE GRAVEL: 0.5%	FINE SILT: 0.1%			
V FINE GRAVEL: 3.3%	V FINE SILT: 0.1%			
V COARSE SAND: 11.19	6 CLAY: 0.1%

Figure 12. Sample 1-2 sieve analysis results

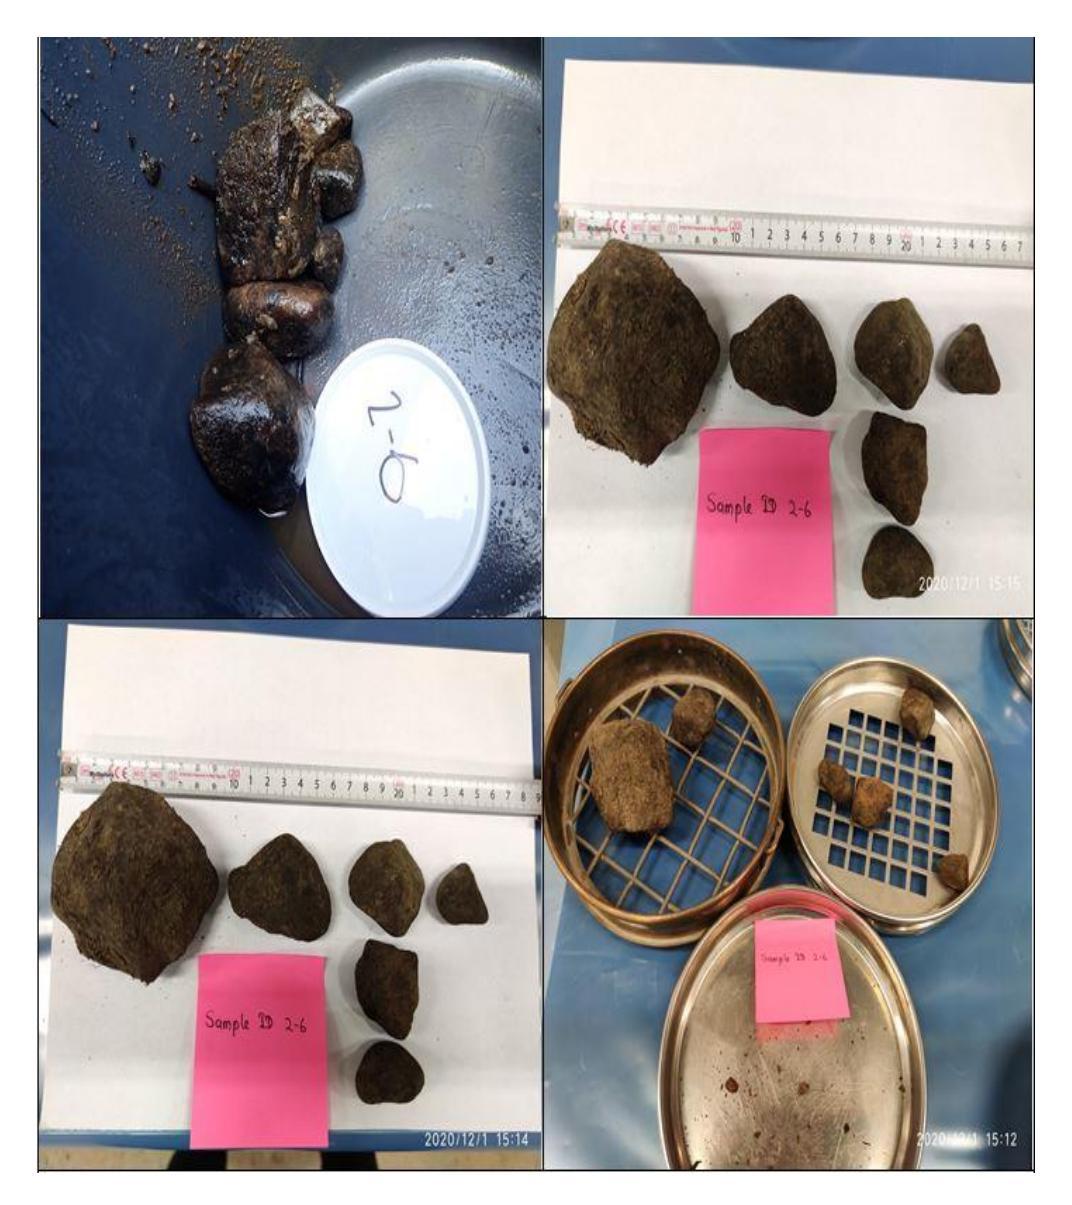
Figure 13. Sample 2-6 during the analysis process

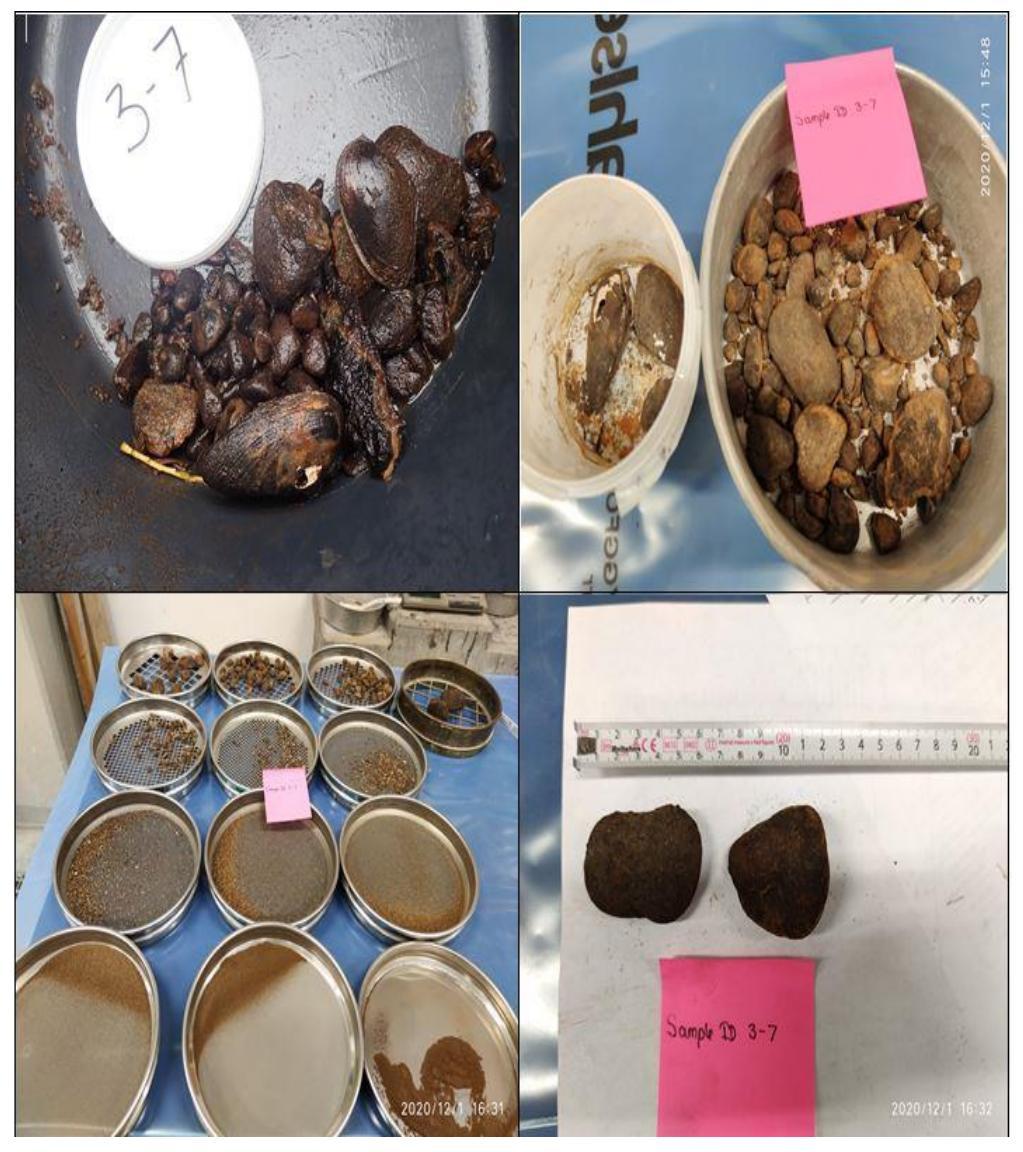
Figure 14. Sample 3-7 during the analysis process

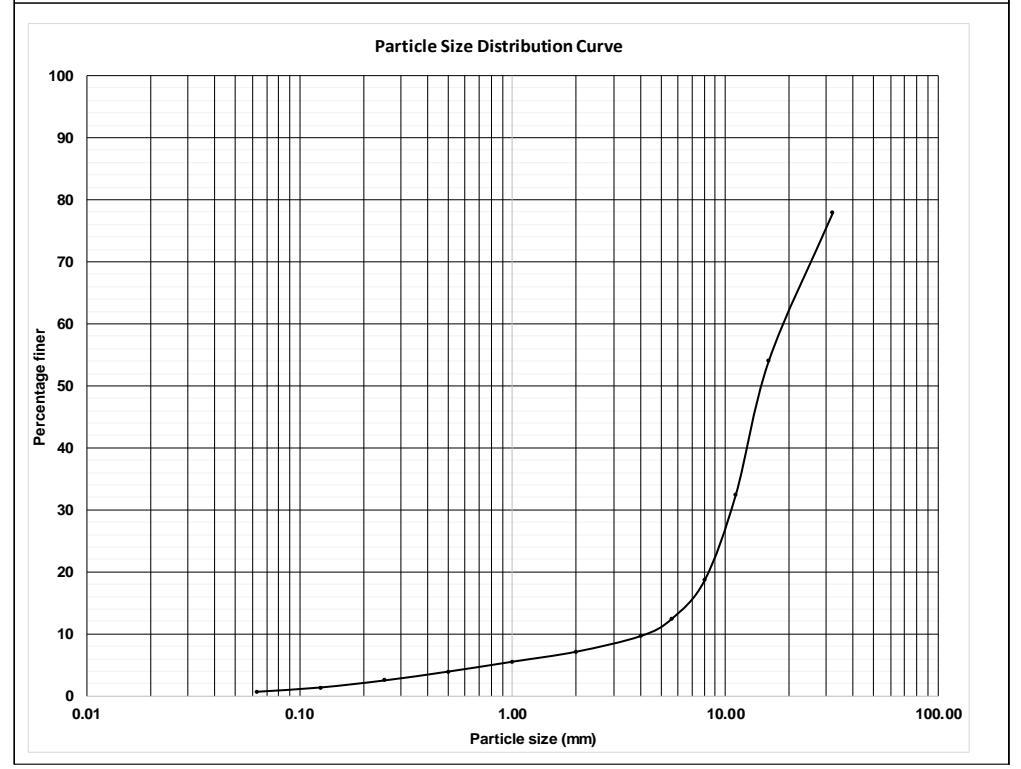
SAMPLE TYPE: Unimodal, Well Sorted

SEDIMENT NAME: Coarse Gravel

mm	φ
MODE 1:	13.60	-3.743
MODE 2:		
MODE 3:		
D ₁₀ :	4.18	-5.831
MEDIAN or D ₅₀ :	14.96	-3.904
D ₉₀ :	56.92	-2.062
(D ₉₀ / D ₁₀):	13.63	0.354
(D ₉₀ - D ₁₀):	52.74	3.769
(D ₇₅ / D ₂₅):	3.15	0.661
(D ₇₅ - D ₂₅):	20.03	1.653

GRAIN SIZE DISTRIB	UTION
GRAVEL: 92.9%	COARSE SAND: 1.6%
SAND: 6.5%	MEDIUM SAND: 1.4%
MUD: 0.7%	FINE SAND: 1.1%
	V FINE SAND: 0.7%
V COARSE GRAVEL: 0.0%	V COARSE SILT: 0.1%
COARSE GRAVEL: 45.9%	COARSE SILT: 0.1%
MEDIUM GRAVEL: 35.4%	MEDIUM SILT: 0.1%
FINE GRAVEL: 9.0%	FINE SILT: 0.1%
V FINE GRAVEL: 2.5%	V FINE SILT: 0.1%
V COARSE SAND: 1.6%	CLAY: 0.1%

Figure 15. Sample 3-7 sieve analysis results

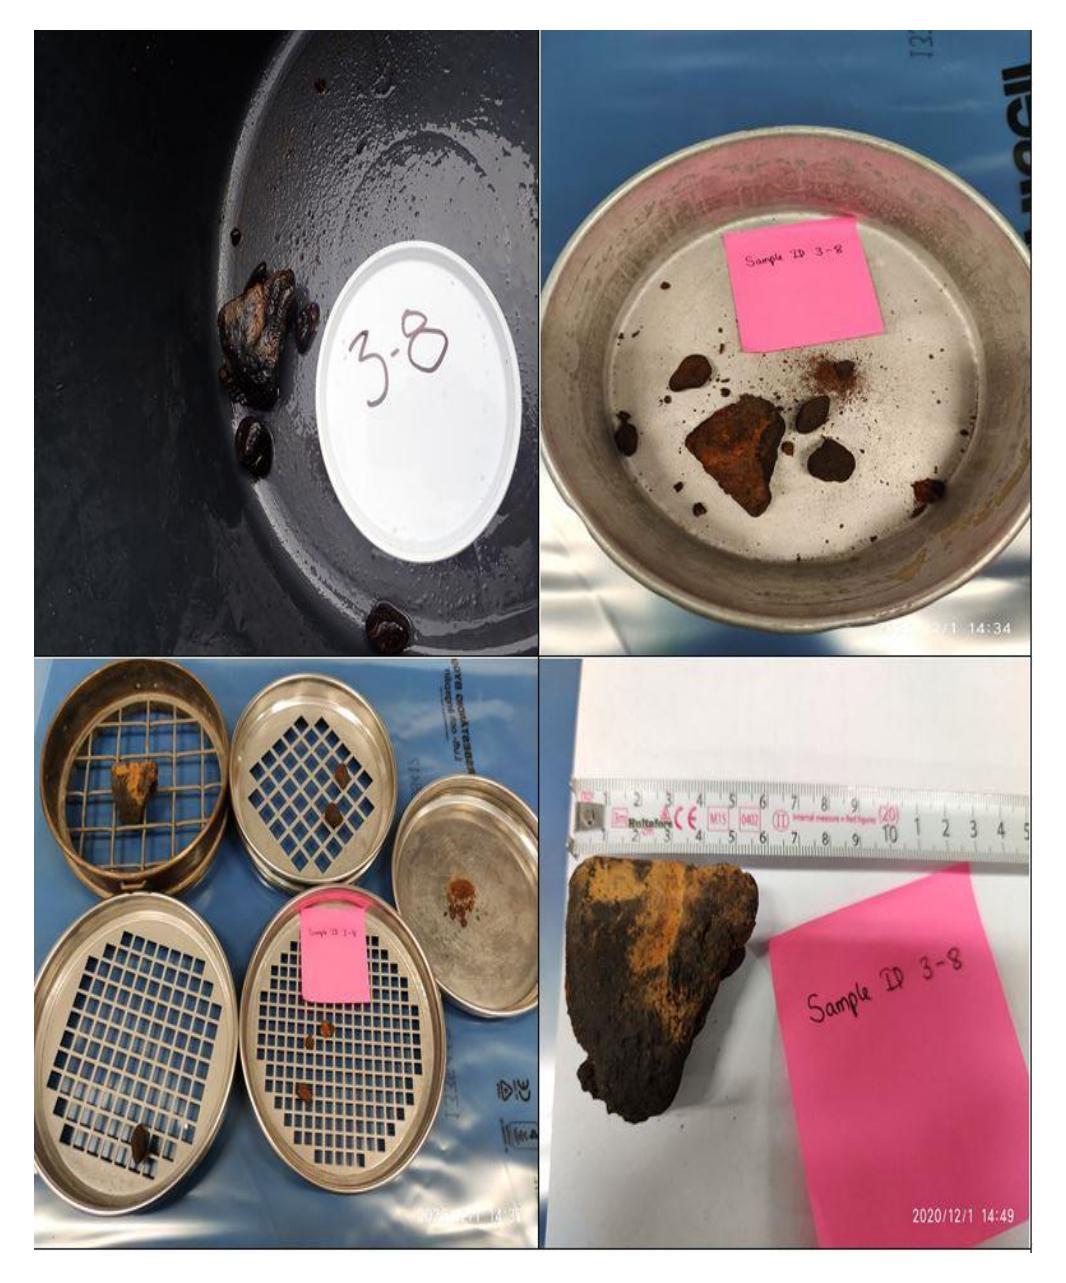
Figure 16. Sample 3-8 during the analysis process
