Sediment Sampling and Analysis in Rönne å at Ängelholm

Inamdeen, Fainaz; Larson, Magnus

2021

Water Resources Engineering Report 3243 ISSN 1101-9824

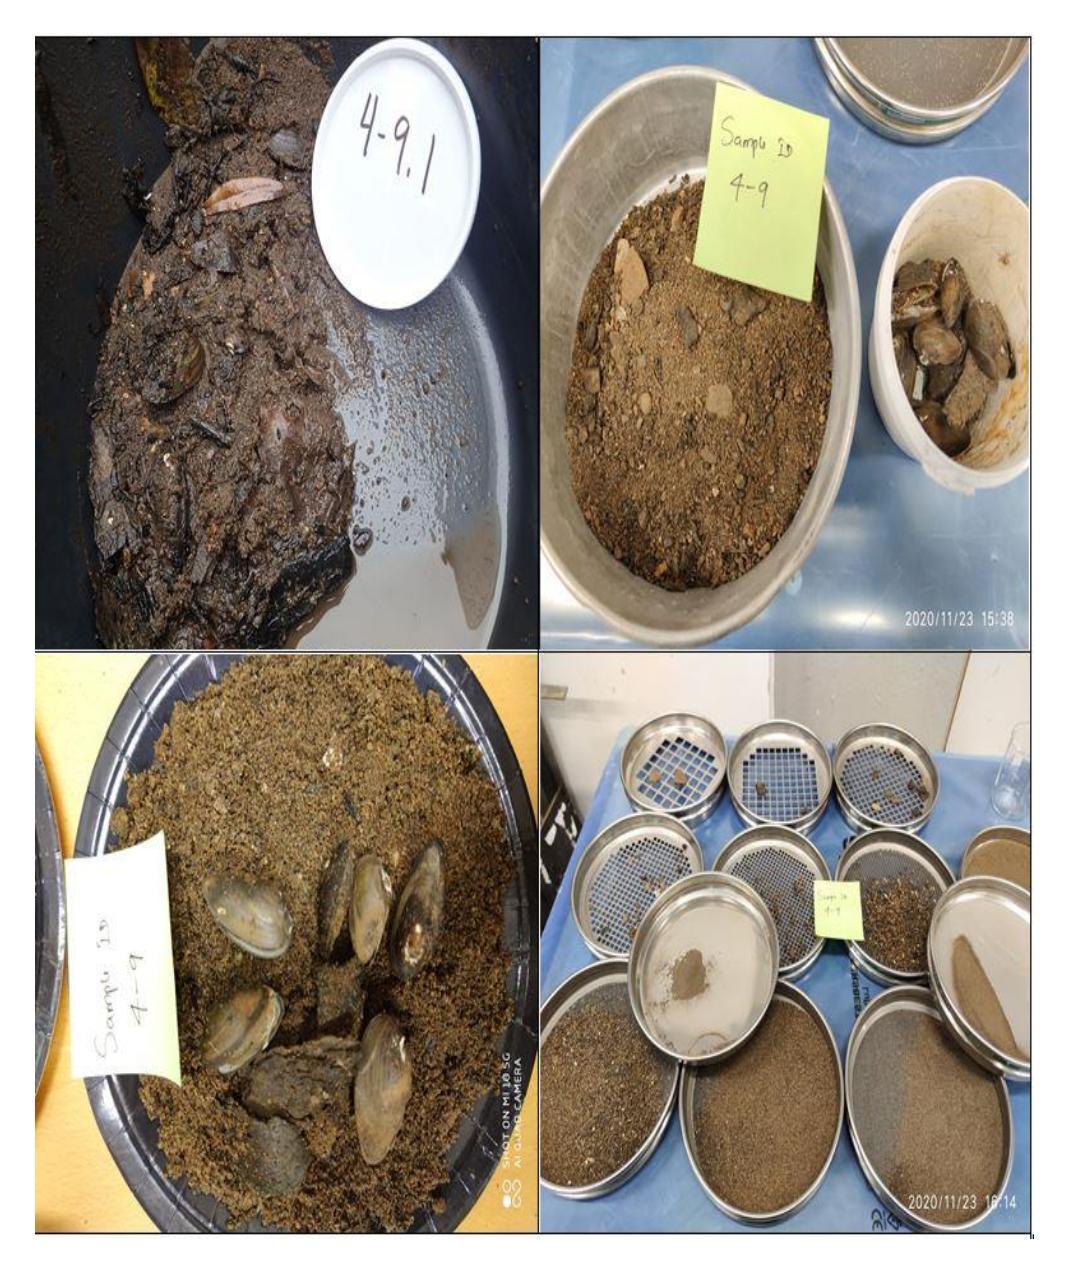
The sample 4-9 was taken in the downstream part of a scour hole (3.5 m deeper than the normal river bottom), near Tullportsbron (see figure 5). The sample textural group is characterized as gravelly sand. The sample was mixed with lots of mussels, as seen in pictures below.

Figure 17. Sample 4-9 during the analysis process

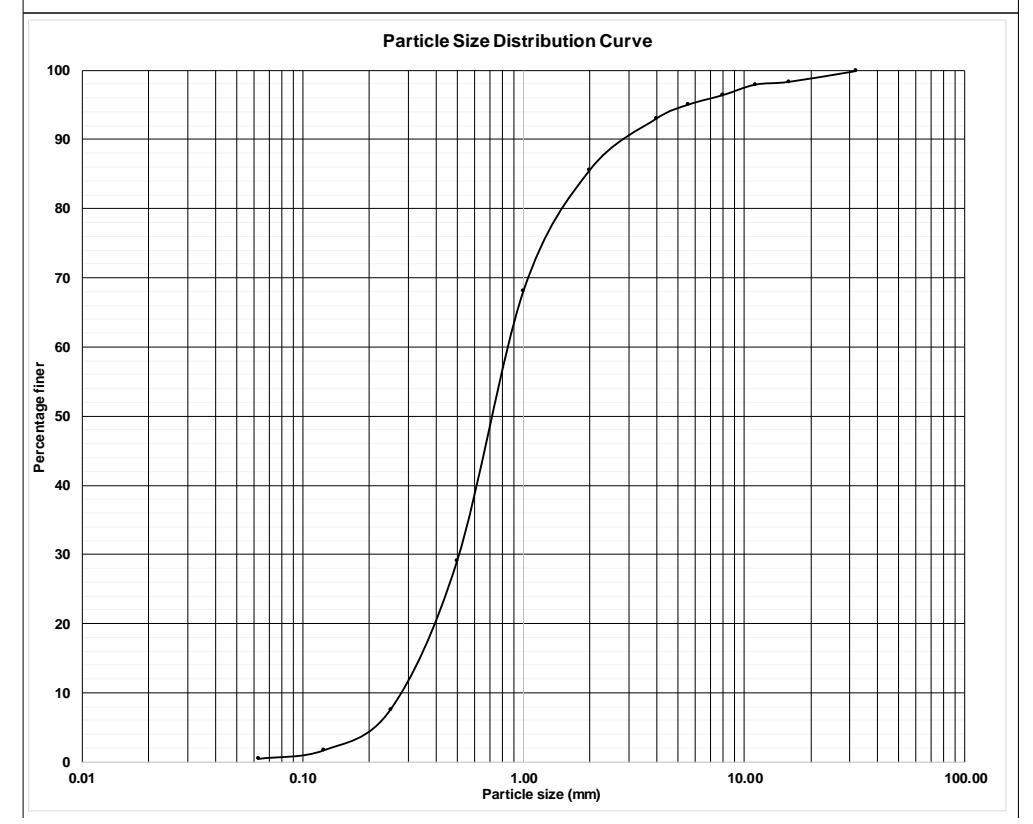
SAMPLE TYPE: Unimodal, Poorly Sorted

SEDIMENT NAME: Very Fine Gravelly Coarse Sand

mm	¢
MODE 1:	0.75	0.500
MODE 2:		
MODE 3:		
D ₁₀ :	0.27	-1.579
MEDIAN or D ₅₀ :	0.72	0.465
D ₉₀ :	2.99	1.888
(D ₉₀ / D ₁₀):	11.06	-1.196
(D ₉₀ - D ₁₀):	2.72	3.468
(D ₇₅ / D ₂₅):	2.99	-3.054
(D ₇₅ - D ₂₅):	0.87	1.579

GRAIN SIZE DISTRIBUTION				
GRAVEL: 14.3%	COARSE SAND: 39.1%			
SAND: 85.2%	MEDIUM SAND: 21.5%			
MUD: 0.5%	FINE SAND: 5.9%			
	V FINE SAND: 1.3%			
V COARSE GRAVEL: 0.0%	V COARSE SILT: 0.1%			
COARSE GRAVEL: 1.6%	COARSE SILT: 0.1%			
MEDIUM GRAVEL: 1.9%	MEDIUM SILT: 0.1%			
FINE GRAVEL: 3.4%	FINE SILT: 0.1%			
V FINE GRAVEL: 7.4%	V FINE SILT: 0.1%			
V COARSE SAND: 17.5%	CLAY: 0.1%

Figure 18. Sample 4-9 sieve analysis results

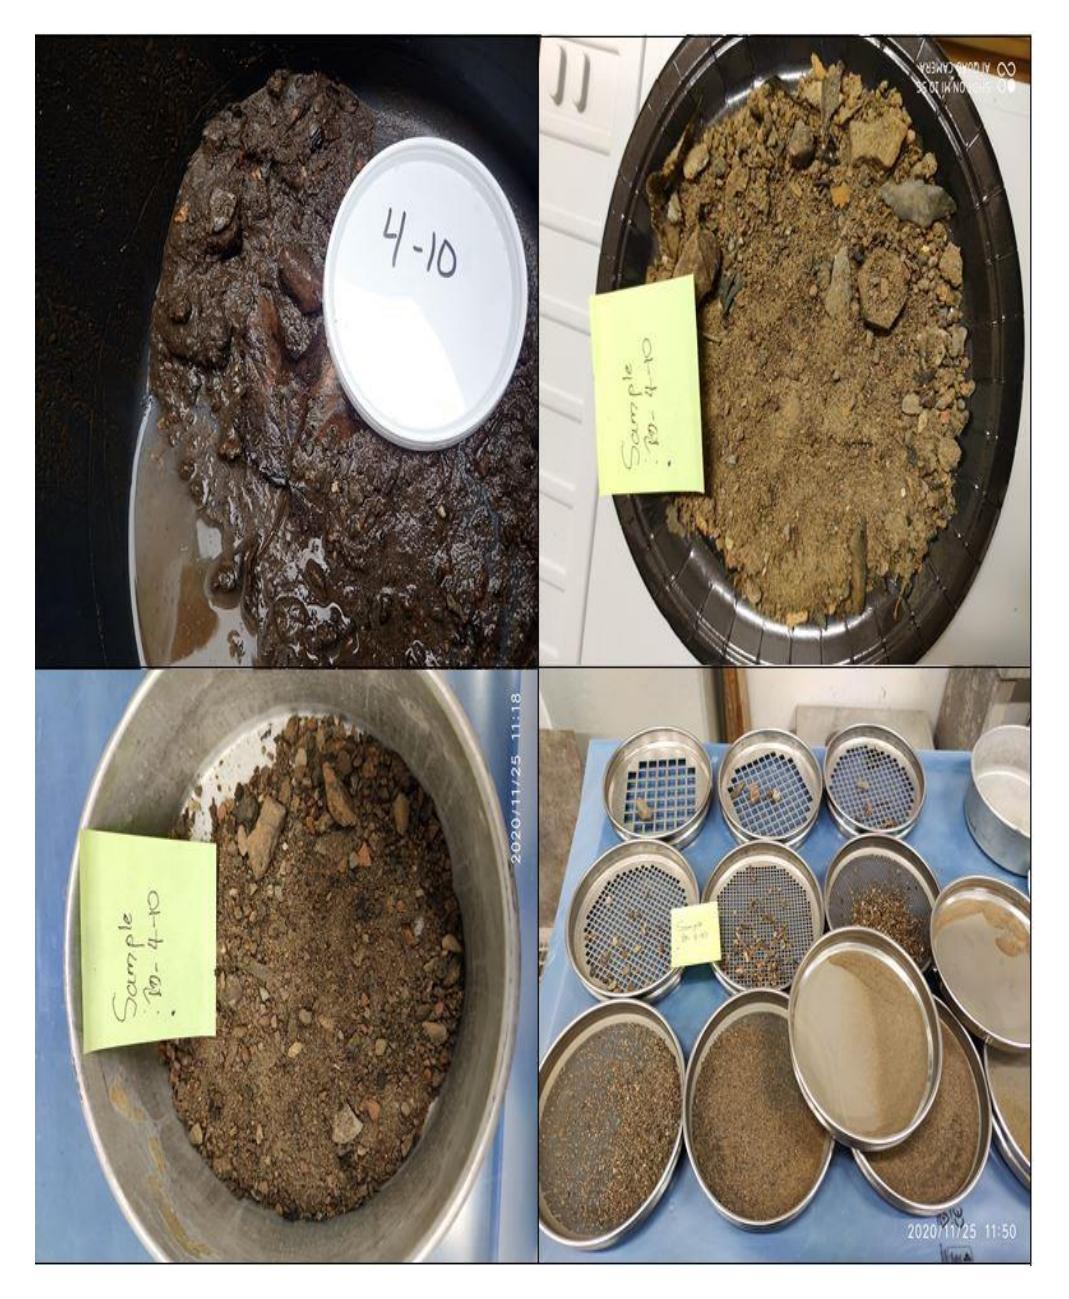
The sample 4-10 was taken from center part of a scour hole (3.5 m deeper than the normal river bottom), under Tullportsbron (see figure 5). The sample textural group is characterized as sandy gravel.

Figure 19. Sample 4-10 during the analysis process

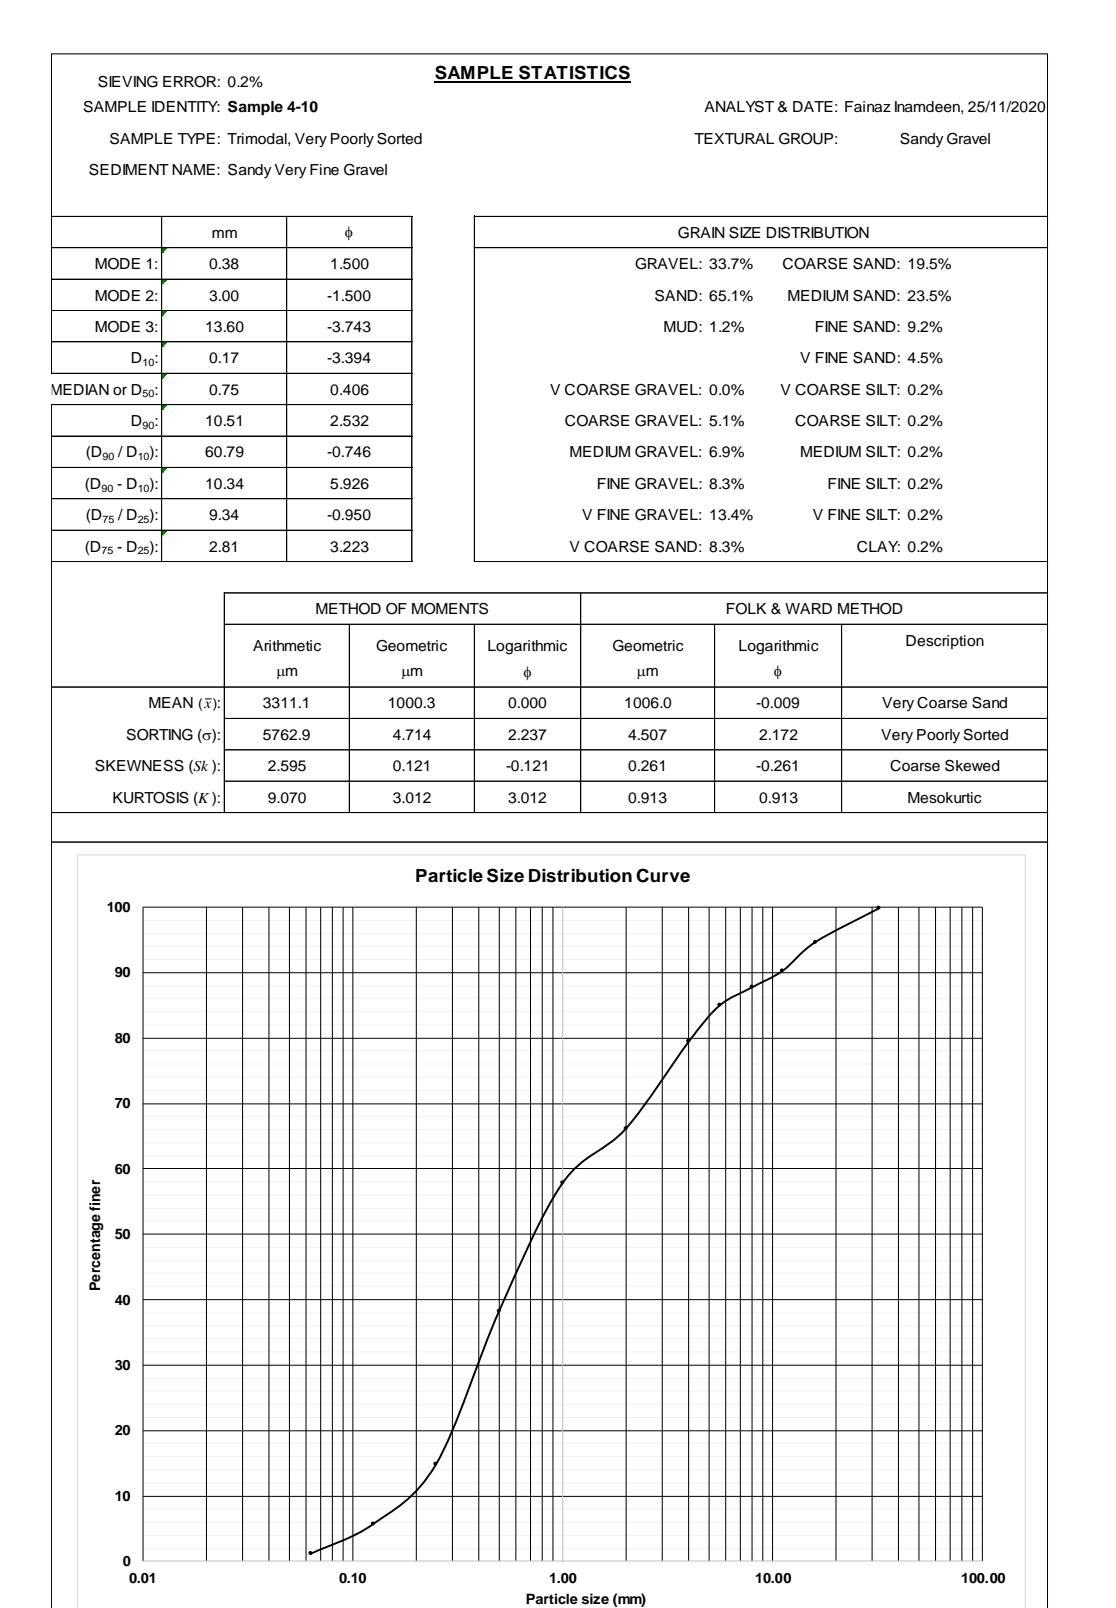
Figure 20. Sample 4-10 sieve analysis results

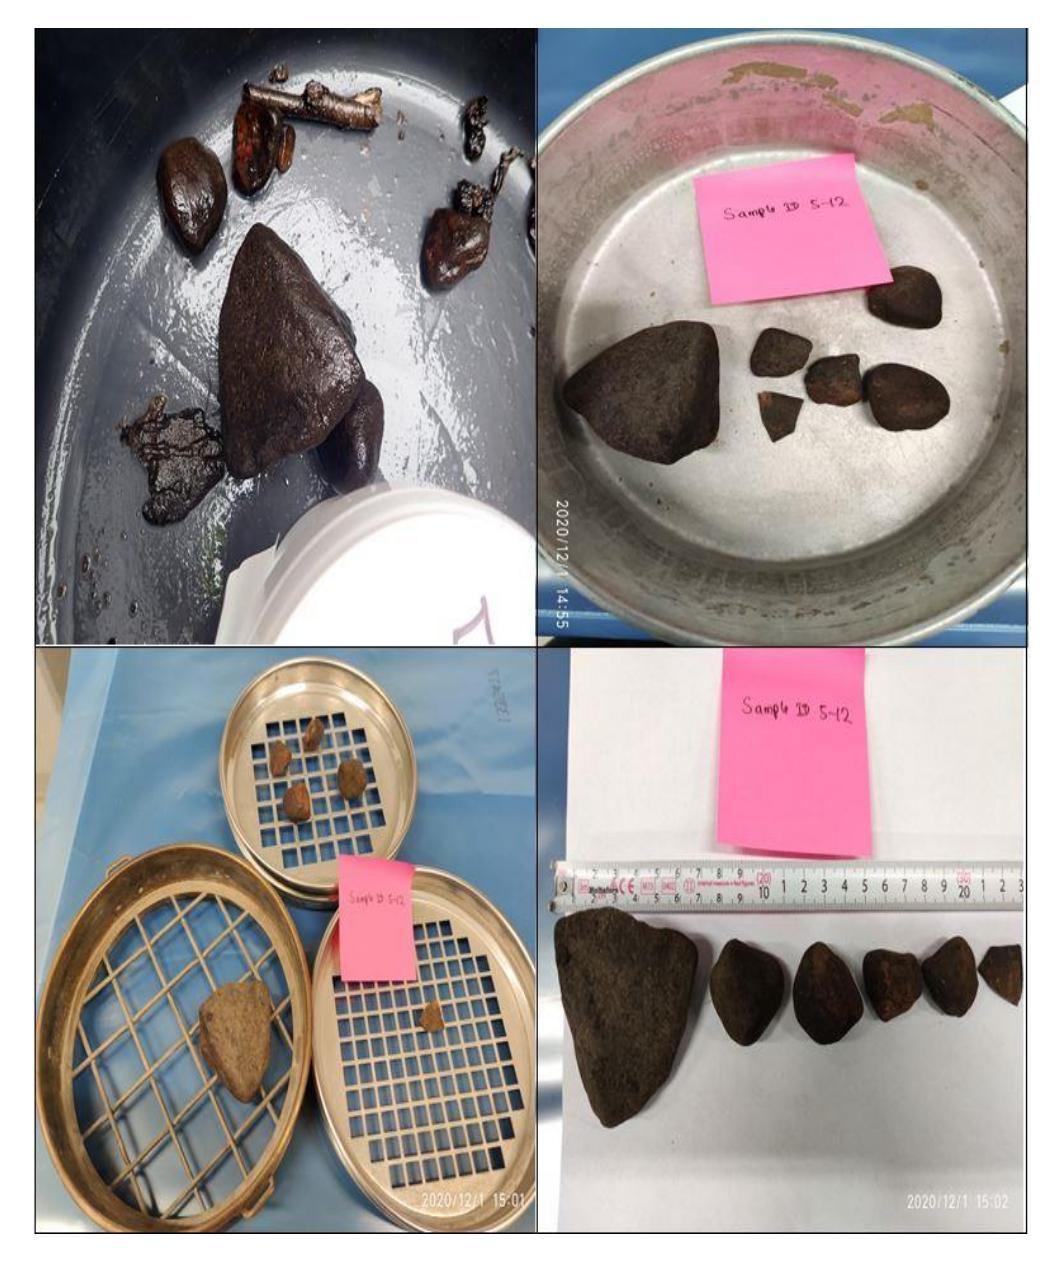
The sample 5-12 was taken from the center part of a scour hole (3.5 m deeper than the normal river bottom), near Carl XV bridge (see figure 6). The sample analysis was performed visually due to the sample characteristics and sample quantity. The sample suggests that the particular bottom is hard and contains larger rock particles.

Figure 21. Sample 5-12 during the analysis process

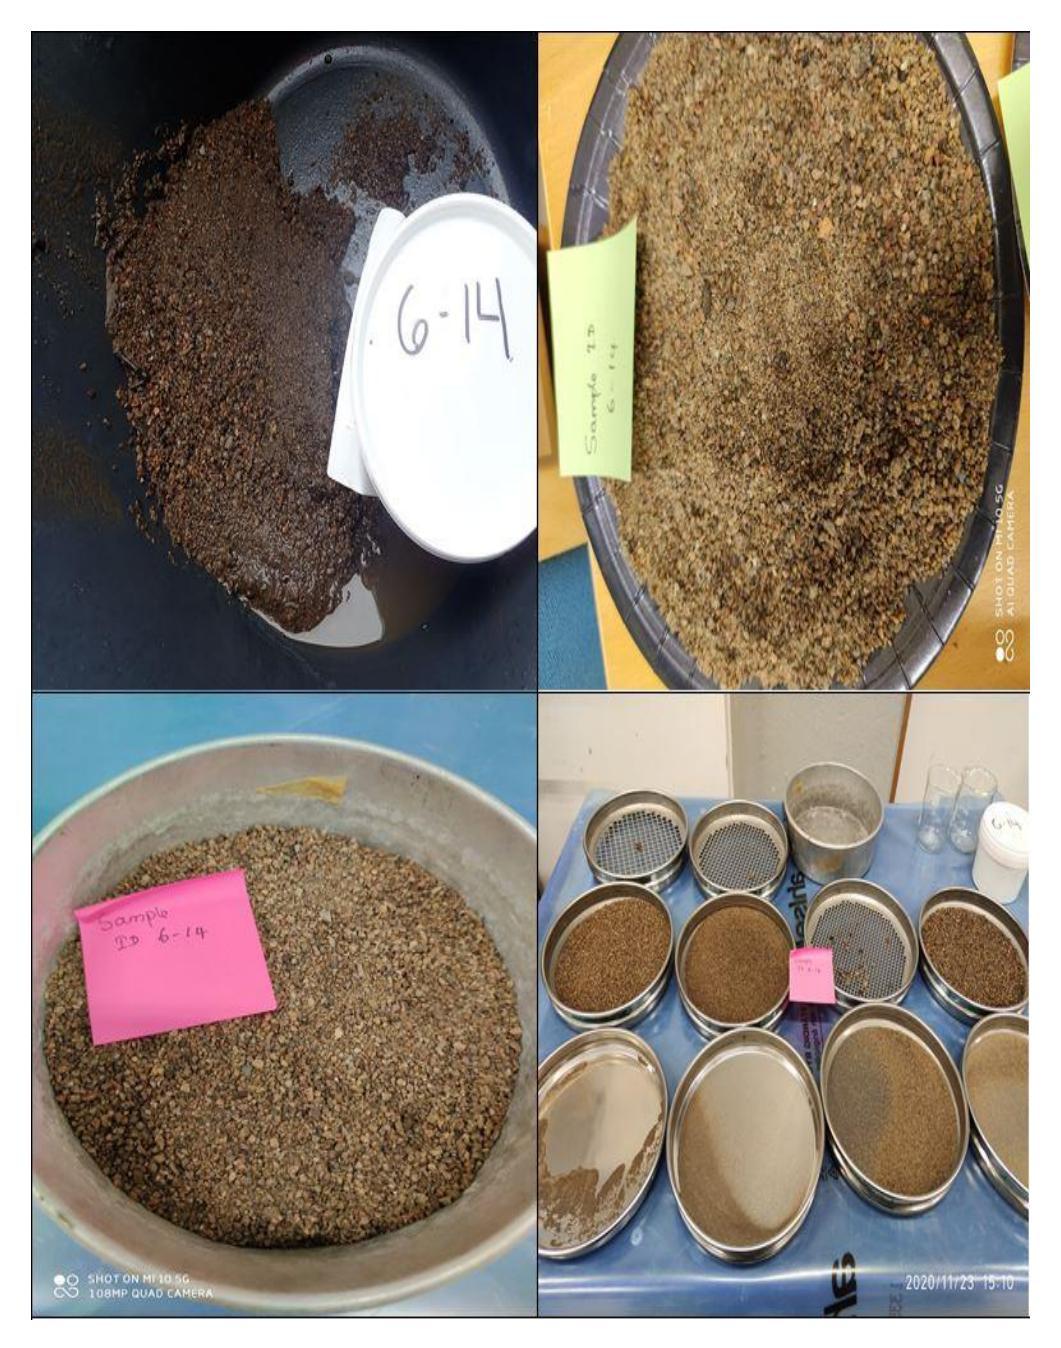
The sample 6-14 was taken from the center part of a scour hole (1.5 m deeper than the normal river bottom), downstream to Kristian II bron (see figure 7). The sample textural group is characterized as sandy gravel.

Figure 22. Sample 6-14 during the analysis process

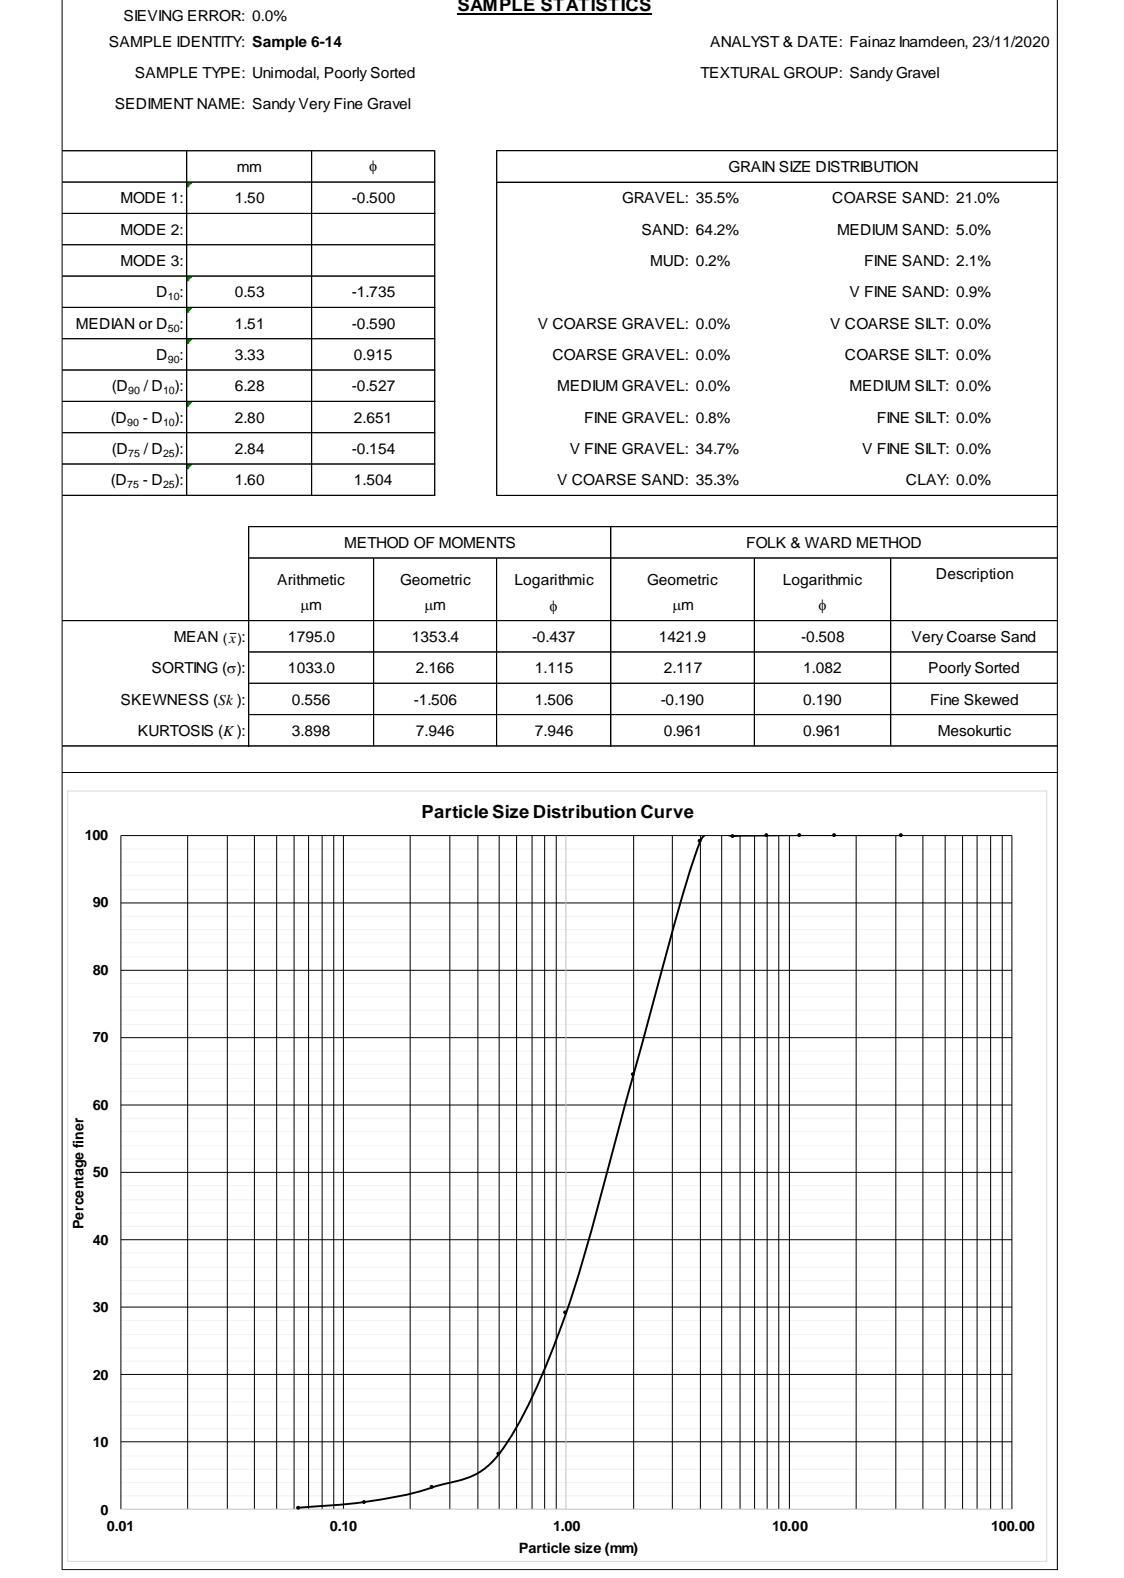
Figure 23. Sample 6-14 sieve analysis results

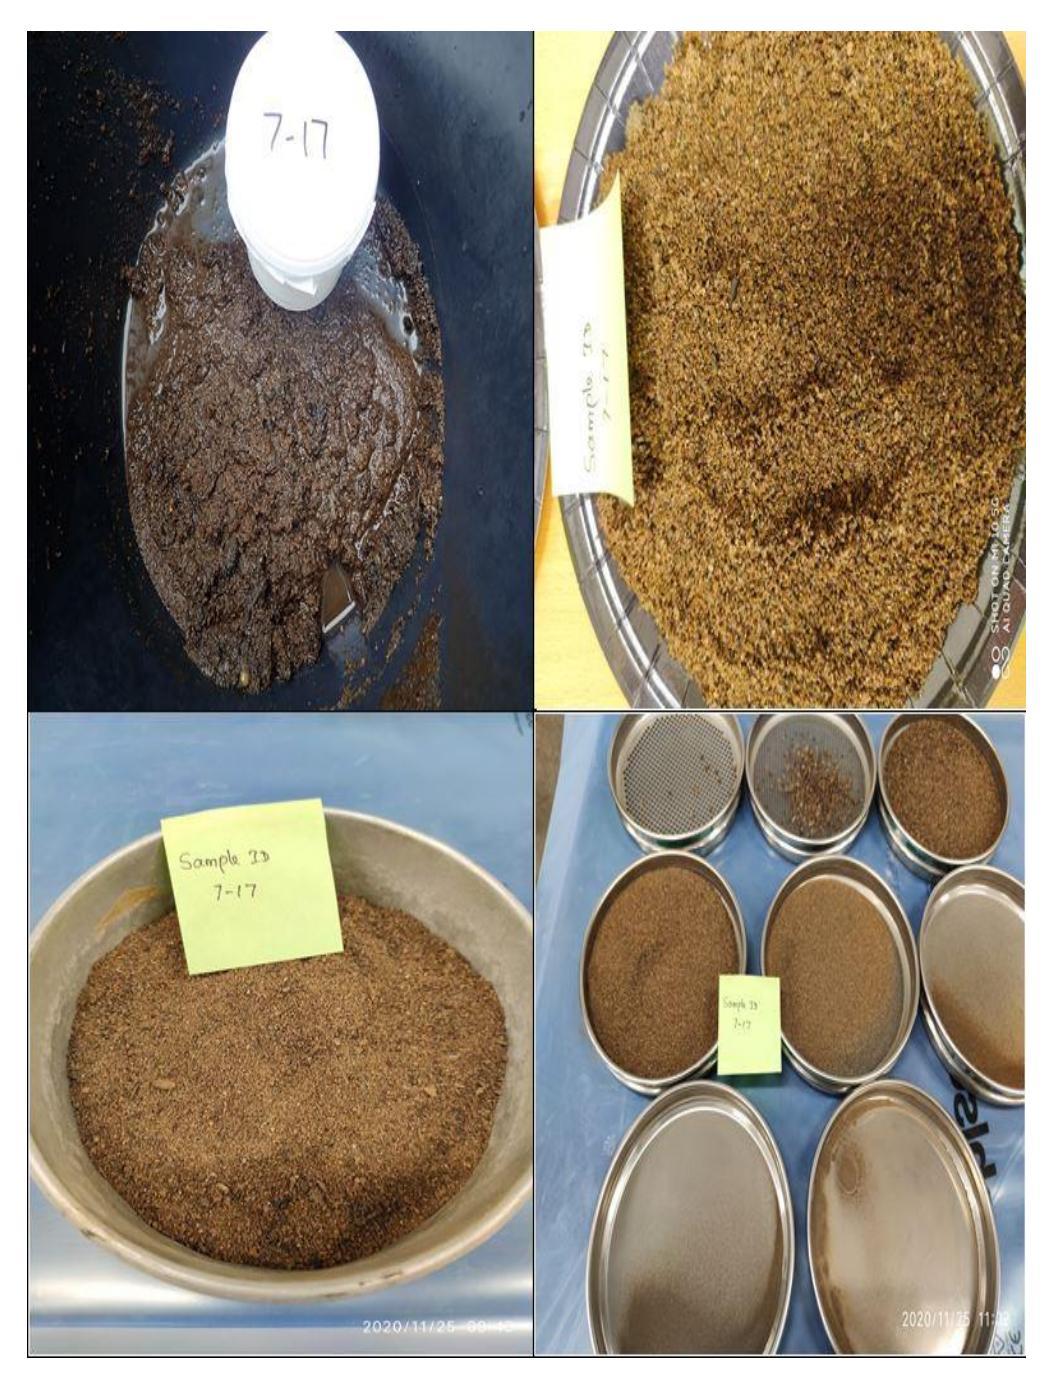
The sample 7-17 was taken from the upstream part of a scour hole and near a sharp river bend where a riffle feature can be expected (see figure 8). The sample textural group is characterized as slightly gravelly sand.

Figure 24. Sample 7-17 during the analysis process

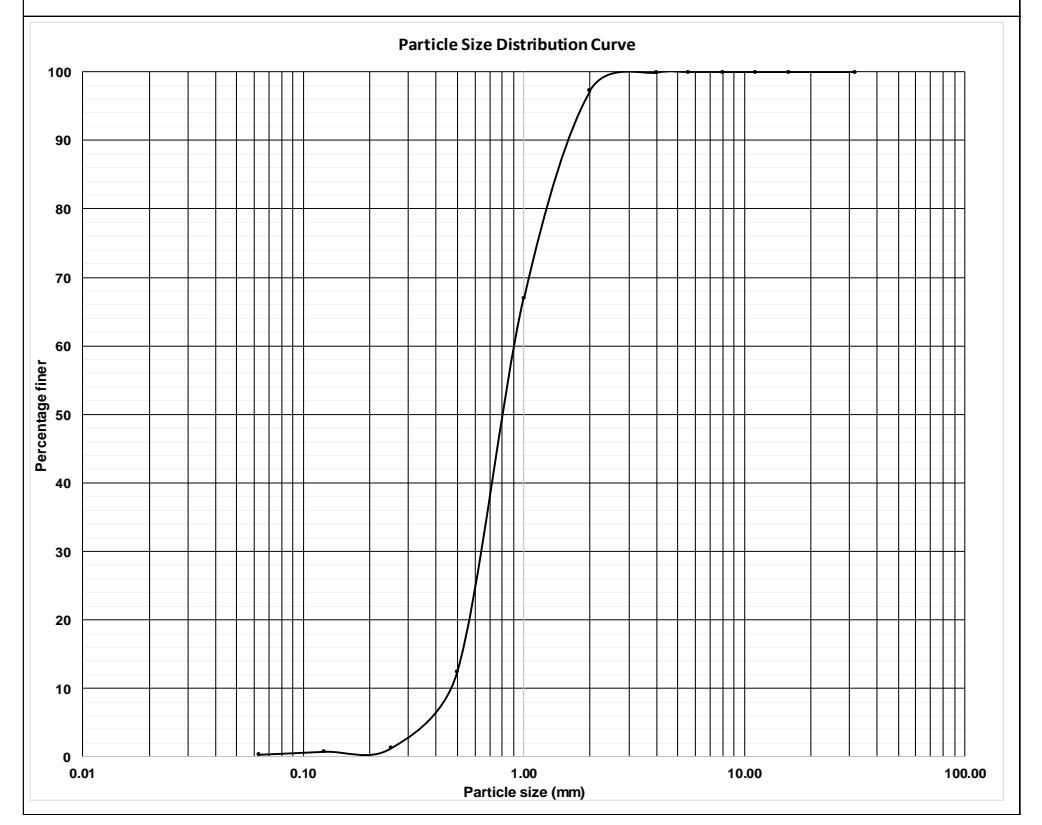
SAMPLE TYPE: Unimodal, Moderately Sorted

SEDIMENT NAME: Slightly Very Fine Gravelly Coarse Sand

mm	f
MODE 1:	0.75	0.500
MODE 2:		
MODE 3:		
D ₁₀ :	0.43	-0.759
MEDIAN or D ₅₀ :	0.81	0.312
D ₉₀ :	1.69	1.214
(D ₉₀ / D ₁₀):	3.93	-1.600
(D ₉₀ - D ₁₀):	1.26	1.973
(D ₇₅ / D ₂₅):	2.05	-2.925
(D ₇₅ - D ₂₅):	0.61	1.032

GRAIN SIZE DISTRIBUTION				
GRAVEL:	2.7%	COARSE SAND:	54.7%	
SAND:	97.0%	MEDIUM SAND:	11.1%	
MUD:	0.3%	FINE SAND:	0.5%	
		V FINE SAND:	0.4%	
V COARSE GRAVEL:	0.0%	V COARSE SILT:	0.1%	
COARSE GRAVEL:	0.0%	COARSE SILT:	0.1%	
MEDIUM GRAVEL:	0.0%	MEDIUM SILT:	0.1%	
FINE GRAVEL:	0.1%	FINE SILT:	0.1%	
V FINE GRAVEL:	2.6%	V FINE SILT:	0.1%	
V COARSE SAND:	30.3%	CLAY:	0.1%

Figure 25. Sample 7-17 sieve analysis results

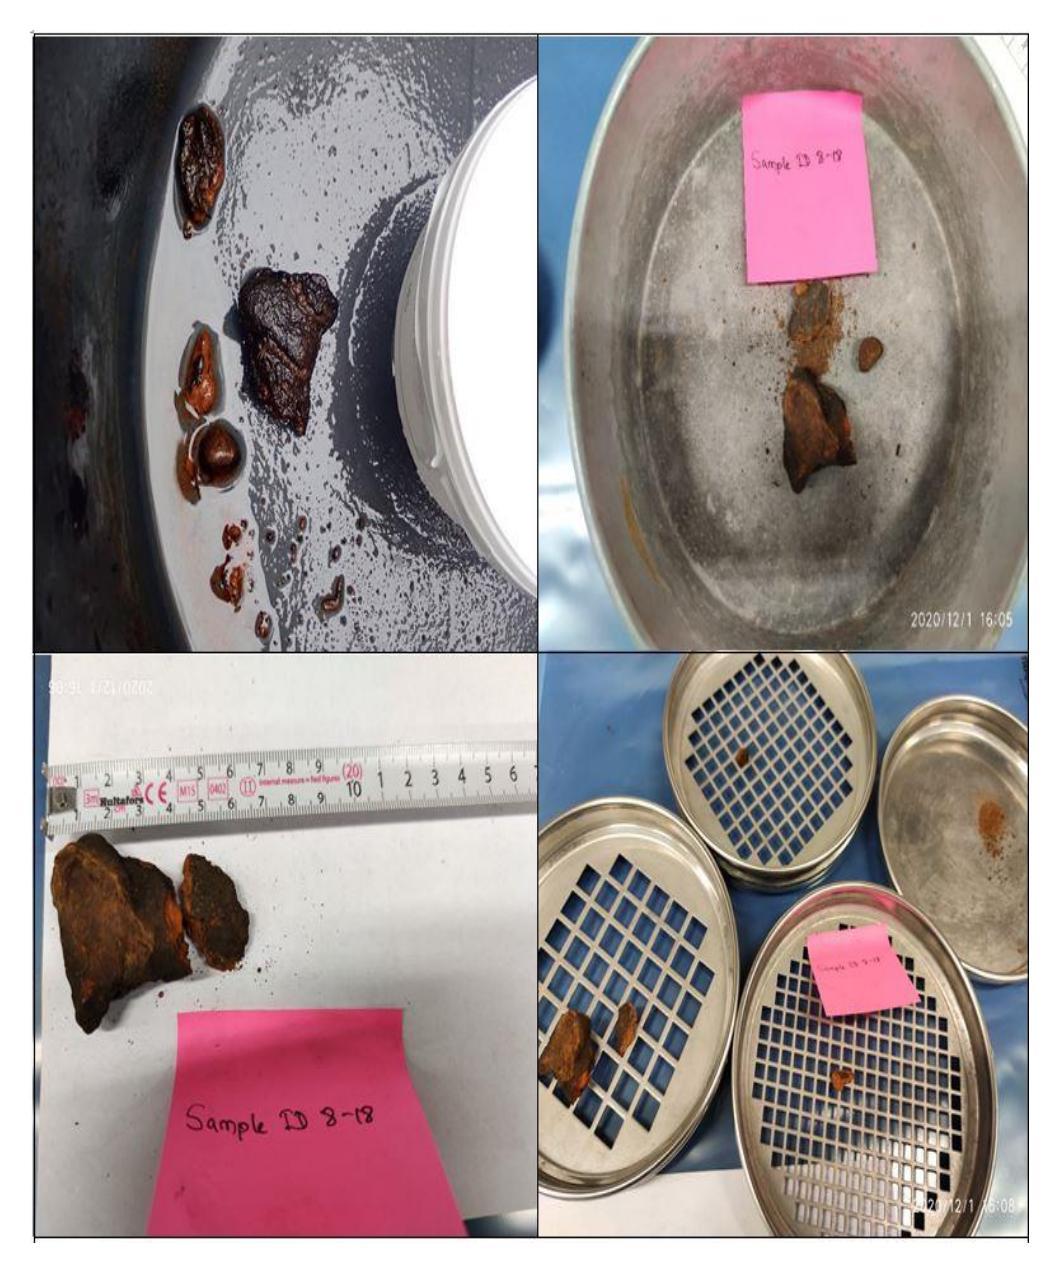
The sample 8-18 was taken from the upstream part of a scour hole and near a river bend (see figure 9). Hard bottom features were expected before the sample was taken because of the formation of surrounding scour hole and adjacent river bathymetry. The sample analysis was performed visually due to lack of a sufficient sample quantity. The sample suggests that the particular bottom is hard and formed by claystone or siltstone.

Figure 26. Sample 8-18 during the analysis process

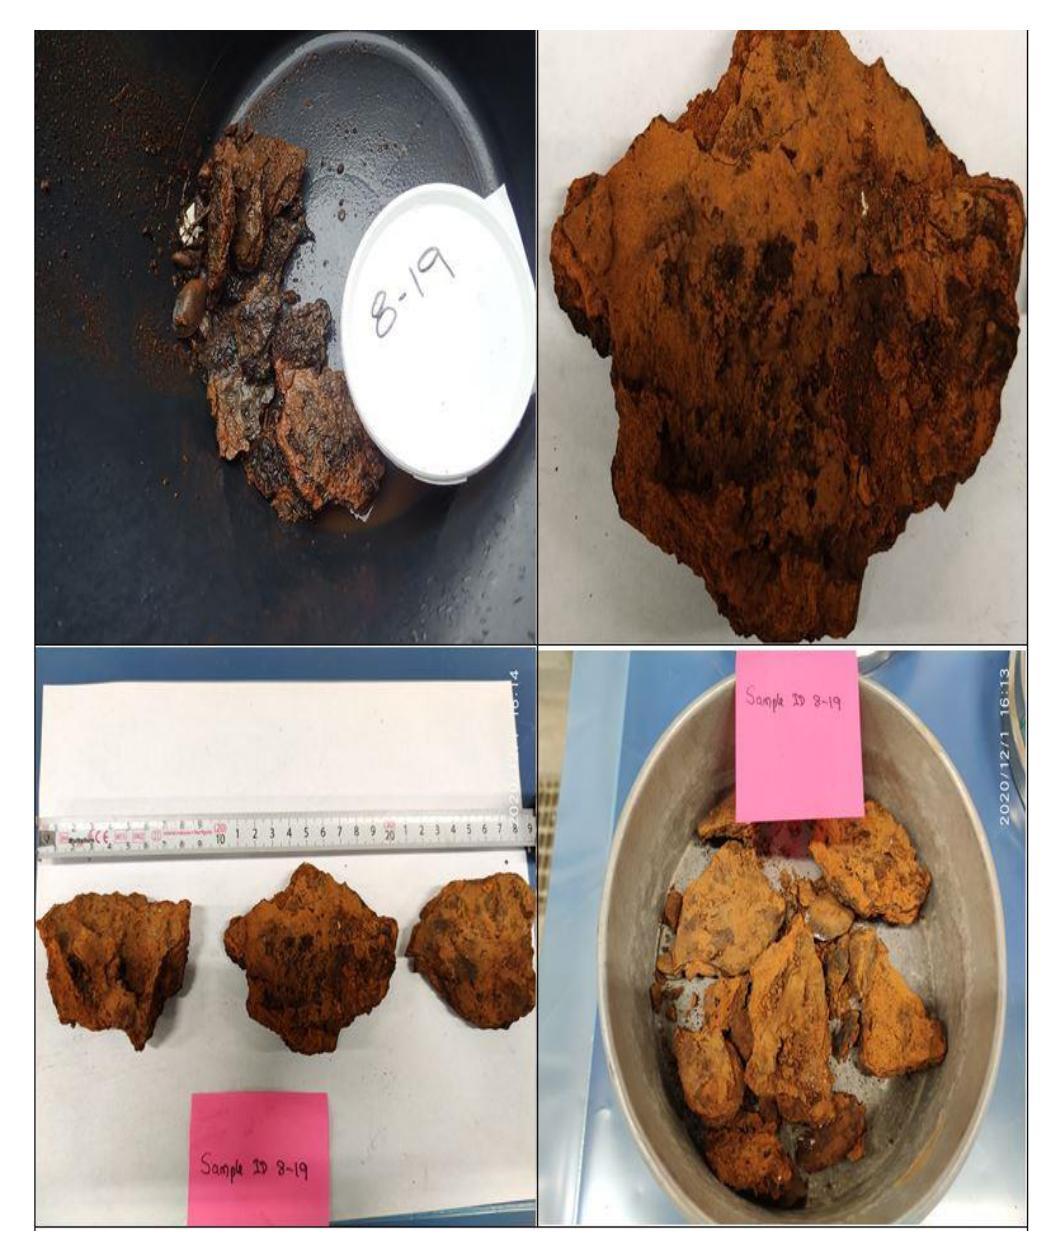
The sample 8-19 was taken from center part of a scour hole (1.3 m deeper than the normal river bottom), near a river bend (see figure 9). The sample analysis was performed visually due to the sample characteristics. The sample suggests that the particular bottom is hard and layered by claystone or siltstone. Some eroding features are indicated at the top surface of the hard bottom.

Figure 27. Sample 8-19 during the analysis process

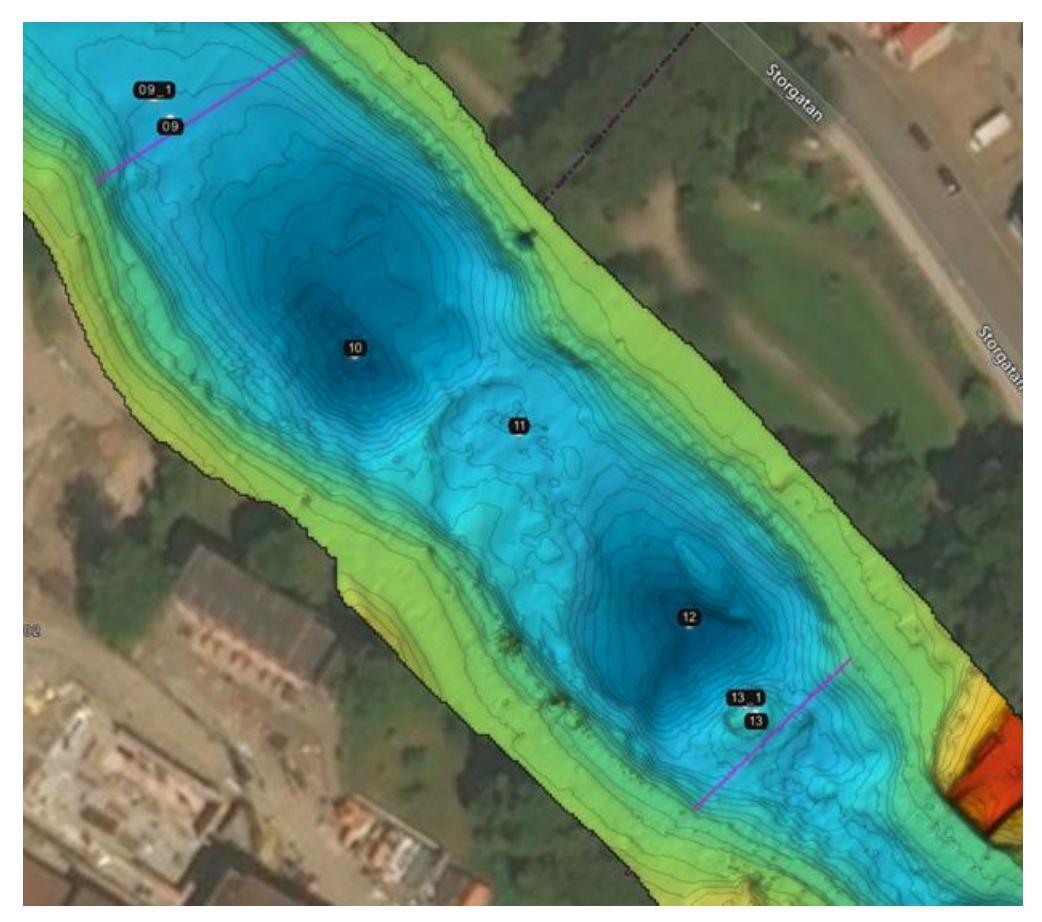
Figure A1. The changed sample locations due to crossing infrastructure (e.g., pipe or cable crossing) over the river as marked. The sampling location was changed with regard to the LTH suggested sampling points as a measure to keep a safe distance to the infrastructure (courtesy Carl Karlsson, MarCon Teknik AB).

The locations of sampling points 4-9 and 5-13 (notation: location followed by sample point number; *i.e.*, 4-9 means location 4 and sample point 9) were altered by the sampling contractor MTE due to the possible presence of pipes or cable lines passing across the pre-defined locations given in the table 1.
