## Tracing a Sacred Building Tradition. Wooden Churches, Carpenters and Founders in Maramures until the Turn of the 18th Century

Alexandru, Babos

2004

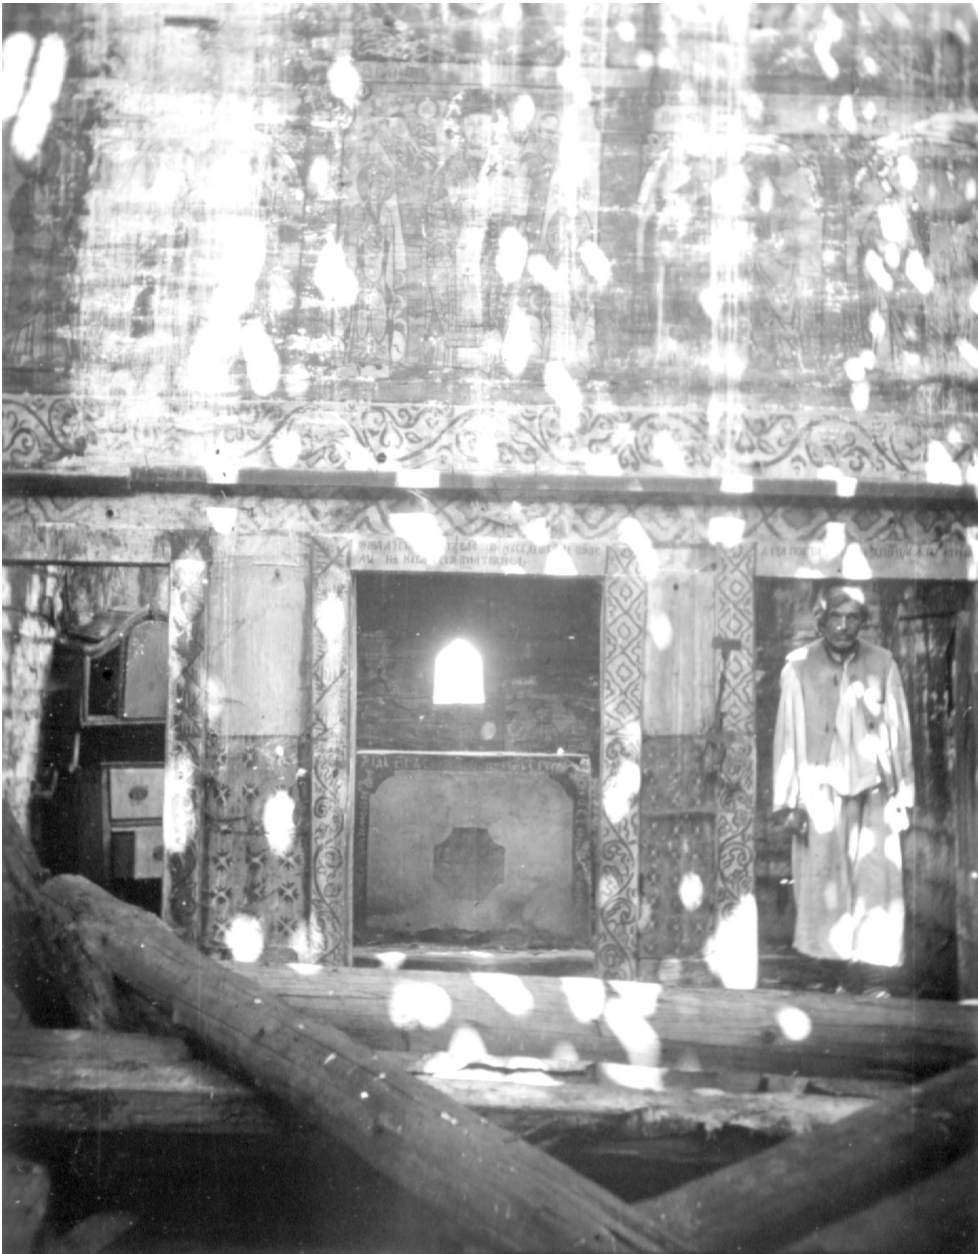
**8 Berbești.** Photo by Atanasie Popa, July 1932, just before its demolition (MIT, Arhiva CMIT, C3:4778). The picture was taken from inside the nave looking towards the sanctuary. The spots of light on the iconostasis and the timbers lying on the floor indicate the roof was in a poor state and the vault had fallen in.

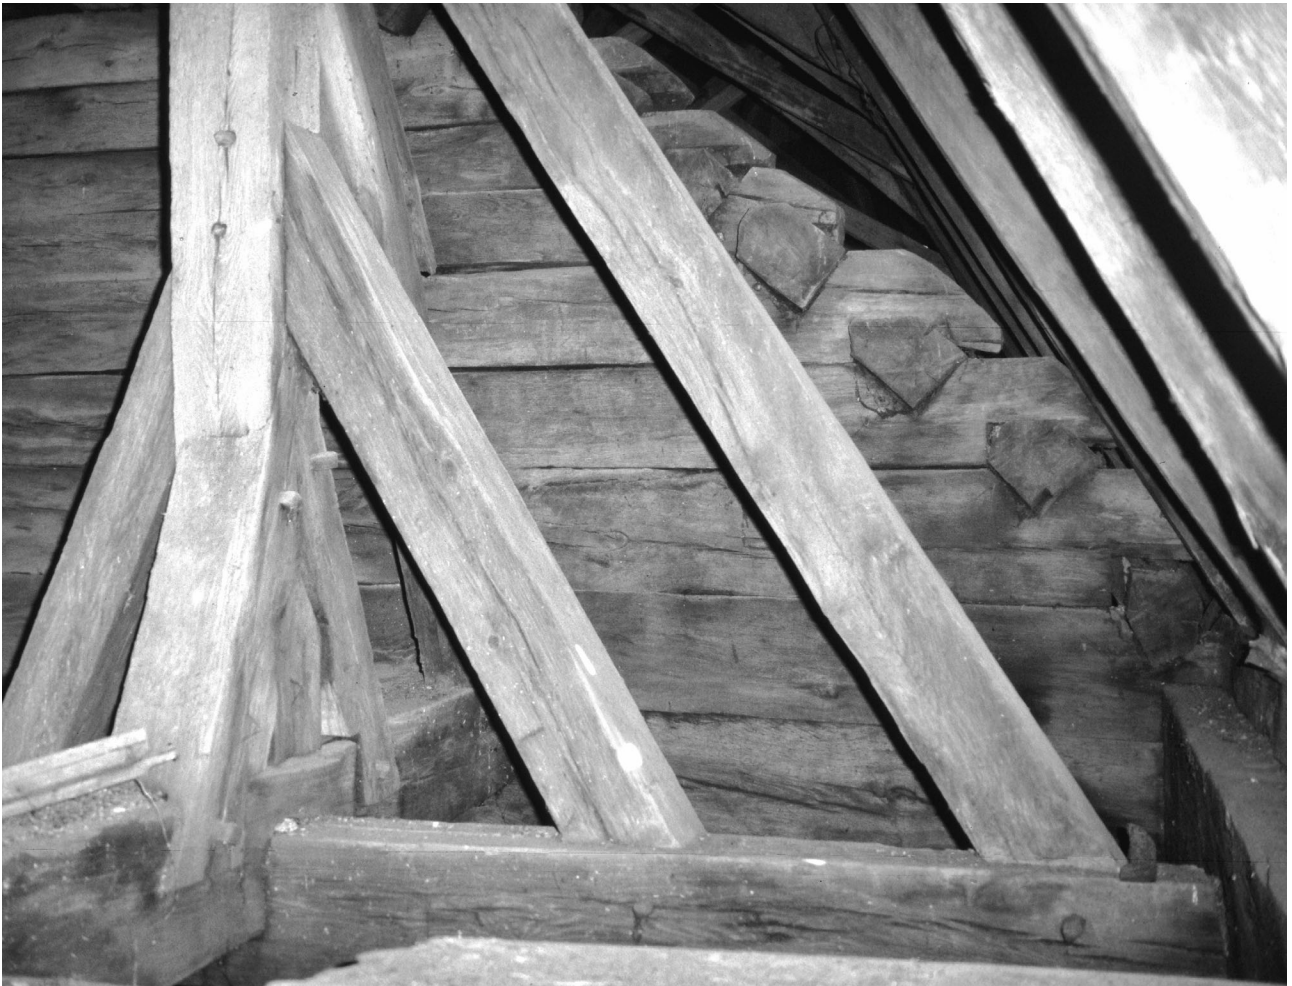
**127** *Apșa din Jos*. The anchoring of the south-eastern upright in the massive transoms of the base. The transoms were interlocked with the lateral walls while the log fabric was still in construction assuring a stable connection between them. Photo: October 2000.

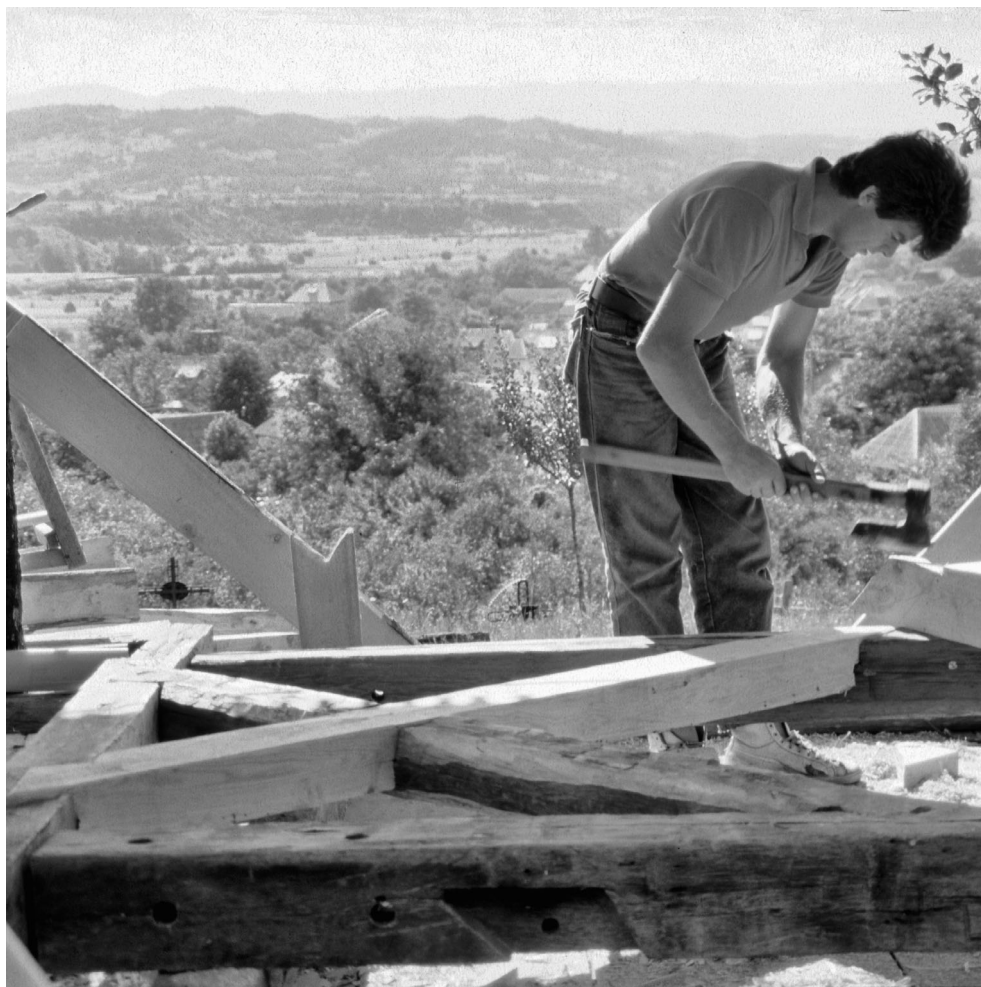
**132 Bârsana.** The work with a tower frame required a plane place where the pieces were cut and marked to be reassembled above the church. Here a carpenter cut a new cross brace for the tower of the former monastery church of Bârsana during the last repairs. Photo: July 1997.

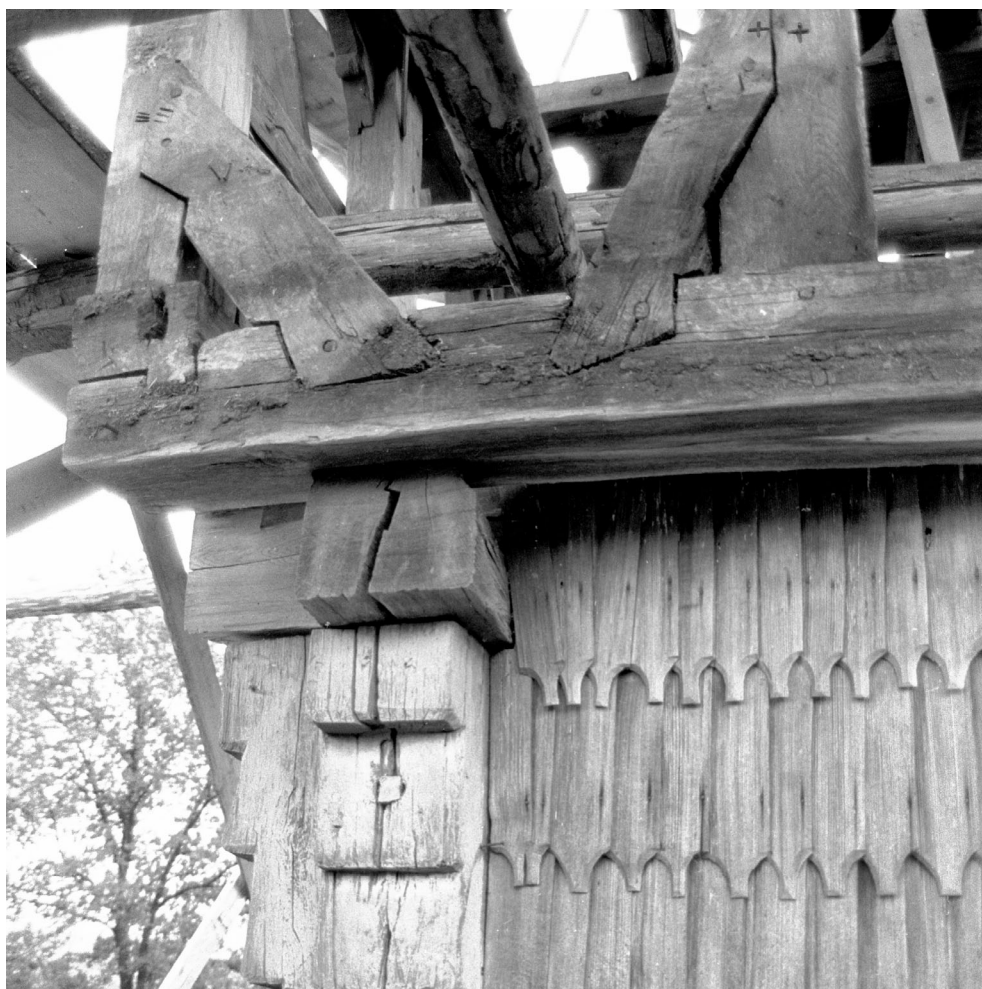
**133** *Desești*. During the repairs from 1996, the hidden parts of the tower were exposed revealing numerous assembly marks of great variety. Here there can be observed the graphic signs “+” and “III” on both the gallery posts and their respective downward angle ties. Unfortunately, some of them were lost with the replacement of some original pieces and some due to the “cleaning” of the surface with an axe without any thought for their historical value. Photo: June 1996.
