Cleaning of ultra-high temperature milk fouling -Structural and compositionl changes

Hagsten, C. (2016). *Cleaning of ultra-high temperature milk fouling -Structural and compositionl changes*. [Doctoral Thesis (compilation), Physical Chemistry]. Department of Chemistry, Lund University.

Structural and compositional changes

DOCTORAL DISSERTATION

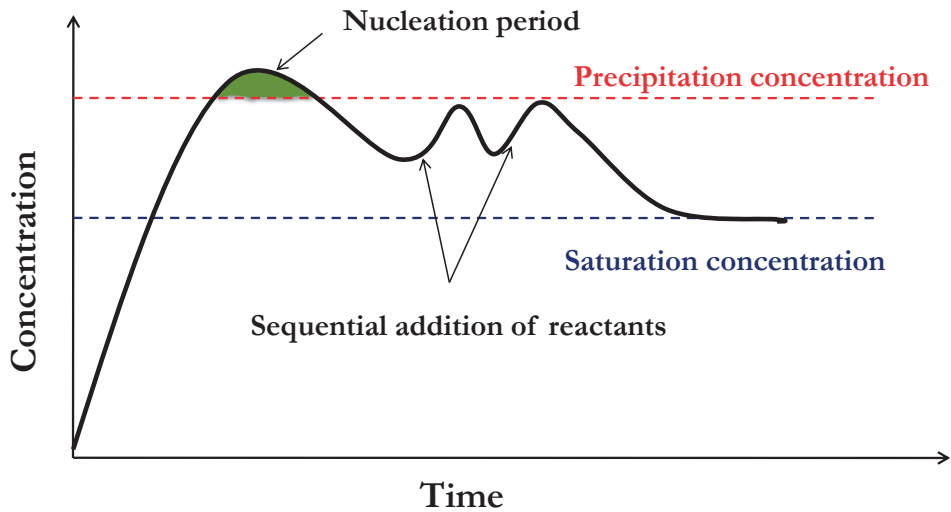
Figure 2 The nucleation process of calcium phosphate. The precipitation of calcium phosphate clusters starts when the ion concentration exceeds the precipitation concentration limit. At calcium phosphate concentrations between the saturation level and the precipitation level, no new clusters are formed, although the existing clusters increase in size. The figure is adapted from [43].

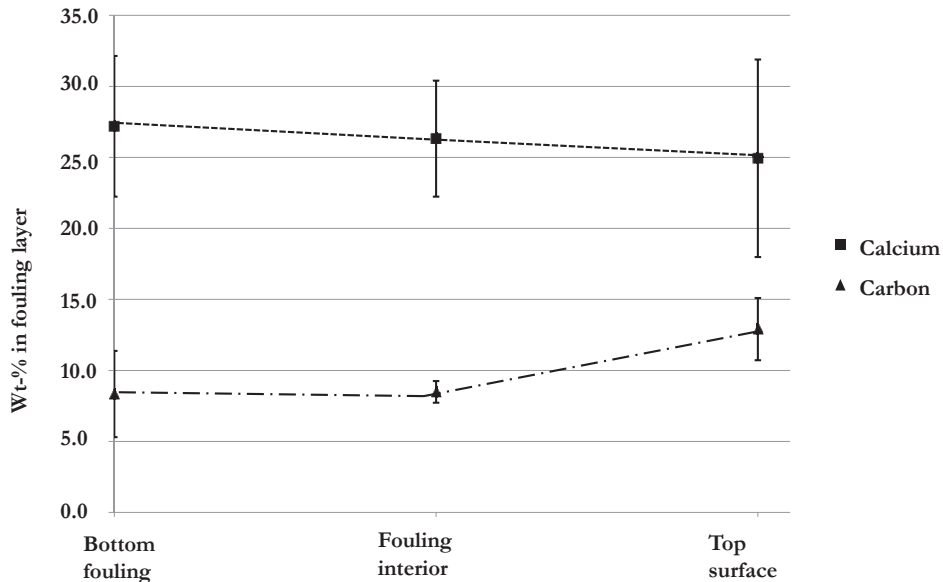
Figure 9 The results of the EDX measurements categorized according to the three subsections of the fouling layer: the first 50 μm closest to the metal surface; the interior of the fouling layer; and the outermost part of the fouling surface, towards the fluid. The top line (- -) indicates the calcium concentration and the bottom line (-.-) indicates the carbon content.

From the EDX measurements, it can be concluded that there is no significant spatial variation of the calcium component (Figure 9). This concurs with the structural images of the fouling layer, showing them to be composed of spherical aggregates. The spherical structures are observed all the way from the lower part of the fouling, close to the metal surface, to the upper part close to the bulk flow. However, closest to the metal surface, the aggregates appear to be sintered. This may be a consequence of the long heat-processing times used during production, although it may also reflect that part of the structure is nucleated at the surface. The aggregates range in size from approximately 5 μm to 20 μm , and since they are expected to contain a high concentration of calcium phosphate together with a smaller amount of an organic component, the presence of casein micelles or caseins cannot be excluded.

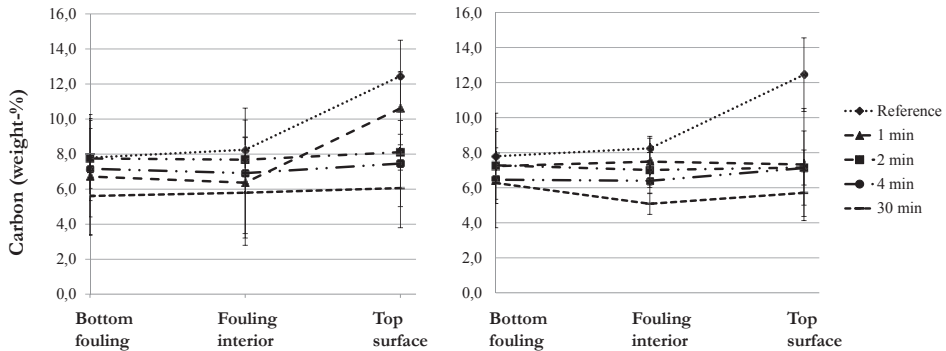
Figure 20 Results of the EDX measurements showing the changes in composition during cleaning in the cross-section of the fouling layer. The cleaning was performed for 0, 1, 2, 4 and 30 minutes in 1.5 wt% NaOH at a fluid velocity of 1.6 m/s. In the left panel, the experiment was performed at 100°C, and in the right panel, it was performed at 120°C.

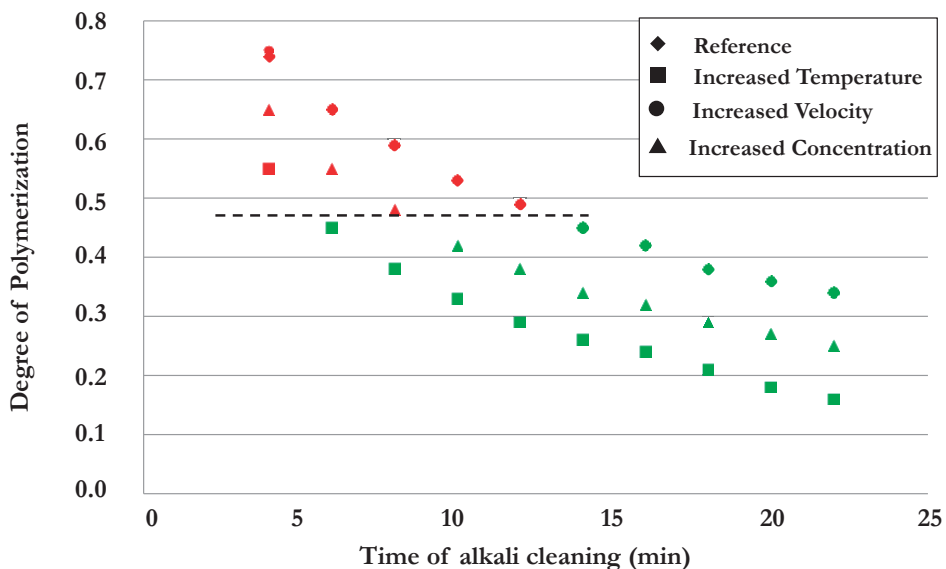
Figure 27 Modeled data for the change in degree of polymerization (DP) with alkali cleaning time. The reference protocol (100°C, 1.5% NaOH and flow velocity of 1.6 m/s) is compared to cases that use increased velocity (3 m/s), increased concentration of NaOH (3 wt%), and increased temperature (120°C). The shift from inefficient (red) to efficient (green) cleaning is adapted from experimental studies. At a DP of approximately 0.45, the end-result of the cleaning after the acid step will be a clean surface, whereas above this line the protein network will be strong enough to hinder its removal.

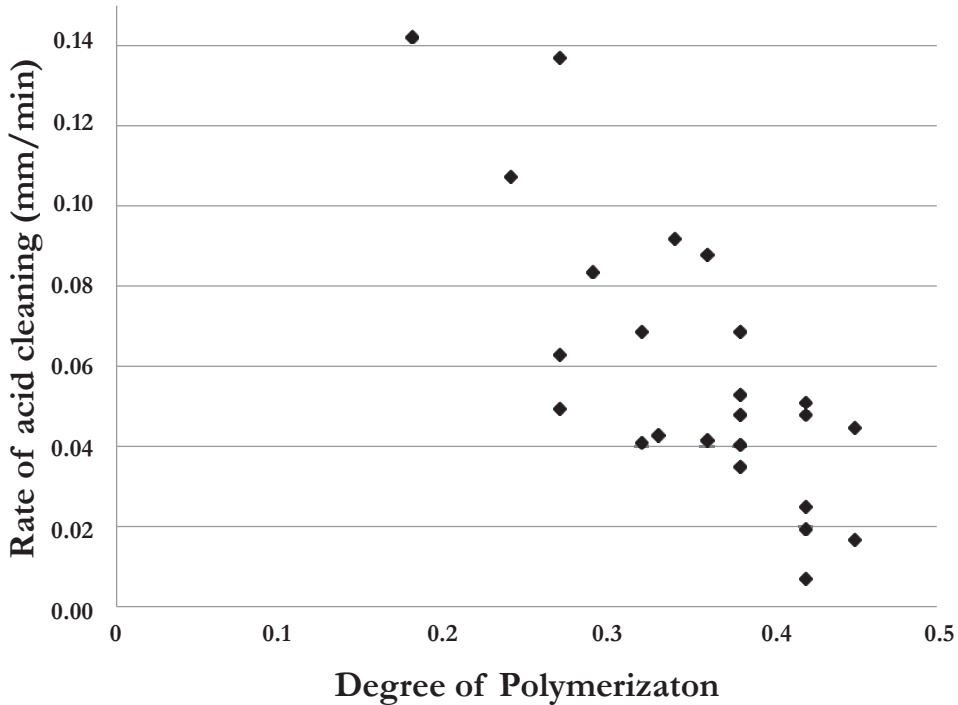
Figure 28 Experimental results on the acid cleaning rate (during efficient cleaning programs) in relation to the modeled data for degree of polymerization (DP). The decreasing DP has a positive effect on the rate of acid cleaning.
