## Using the resistivity method for leakage detection in a blind test at the Rossvatn embankment dam test facility in Norway

Sjodahl, P.; Dahlin, Torleif; Johansson, S.

*Published in:*  
Bulletin of Engineering Geology and the Environment

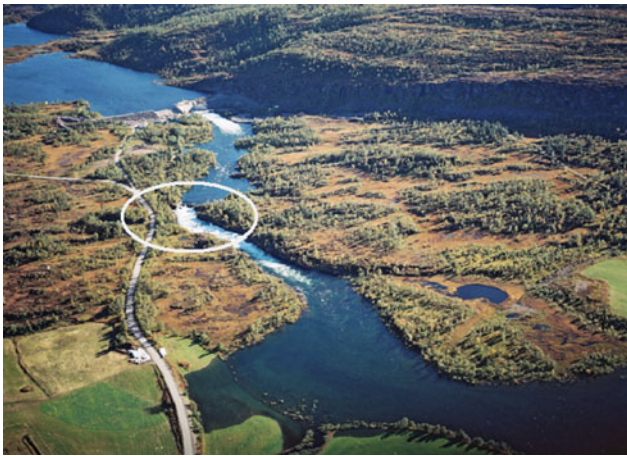
**Fig. 1** Aerial photograph of the location of the embankment test facility in Røssåga river. In the *upper left part* is the Røssvatn reservoir impounded by the Røssvassdammen dam (from Høeg et al. 2004)

The embankment dam test site is located in Norway, around 60 km south of the town of Mo i Rana and close to the large Røssvatn reservoir (Fig. 1). Beginning in 2001, a series of stability and breaching tests has been carried out at this unique test site. Numerous dams some 5–6 m in height and approximately 40 m in length have been built using different materials and designs and then forced to failure. All the tests were thoroughly documented in order to increase understanding of the stability of embankment dams and to analyse real dam failure scenarios (Høeg et al. 2004).

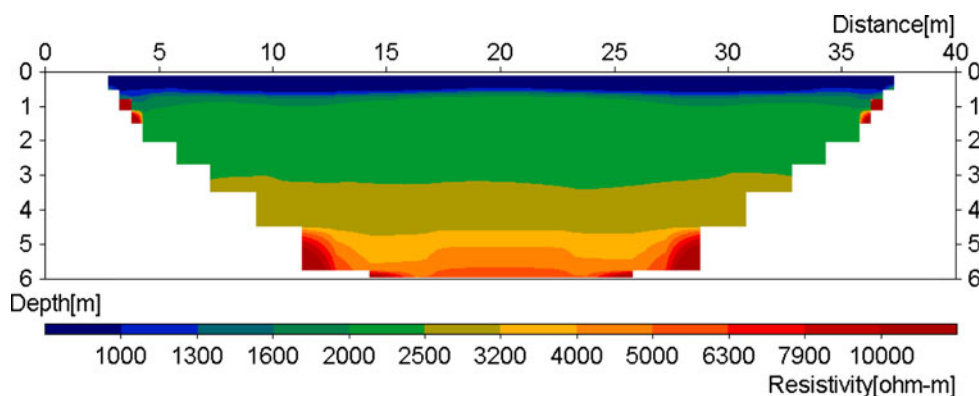
**Fig. 3** Inverted model for the “healthy” dam with no defects (mean residual 2.5%)

First, simulations were made for a stable dam with no defects. 2D inversion was carried out on the 3D forward model output data. At this stage the geometrical rules for 2D inversion were violated, which leads to distorted depths and erroneous absolute resistivity values. However, to date this is the only feasible way to invert apparent resistivity data from embankment geometries. As can be seen from the 2D inverted dam model (Fig. 3), resistivities increase with depth even though the core is assumed to have a constant resistivity with depth. This is explained by the fact that at greater depths a larger earth volume is involved for the current flow and hence the effect from the embankment slopes and the high-resistivity downstream fill will increase.

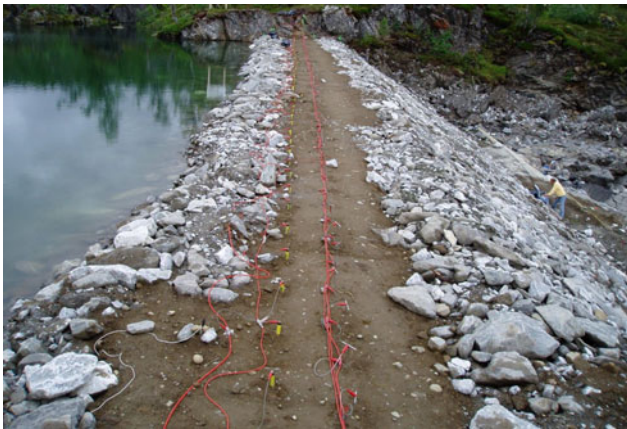
**Fig. 7** Electrode layout along the dam crest at the Rössvatn test embankment dam, with non-polarising Cu-CuSO<sub>4</sub> electrodes for SP monitoring to the *left* and stainless steel electrodes for resistivity and IP monitoring to the *right*
