# DURABILITY AND AGEING OF SEALANTS

PER GUNNAR BURSTRÖM

REPORT TVBM-3003  
LUND SWEDEN 1977

THIS REPORT REFERS TO PROJECT NUMBER 730221-4 FROM  
THE SWEDISH COUNCIL FOR BUILDING RESEARCH TO THE  
DIVISION OF BUILDING MATERIALS AT THE LUND INSTITUTE  
OF TECHNOLOGY

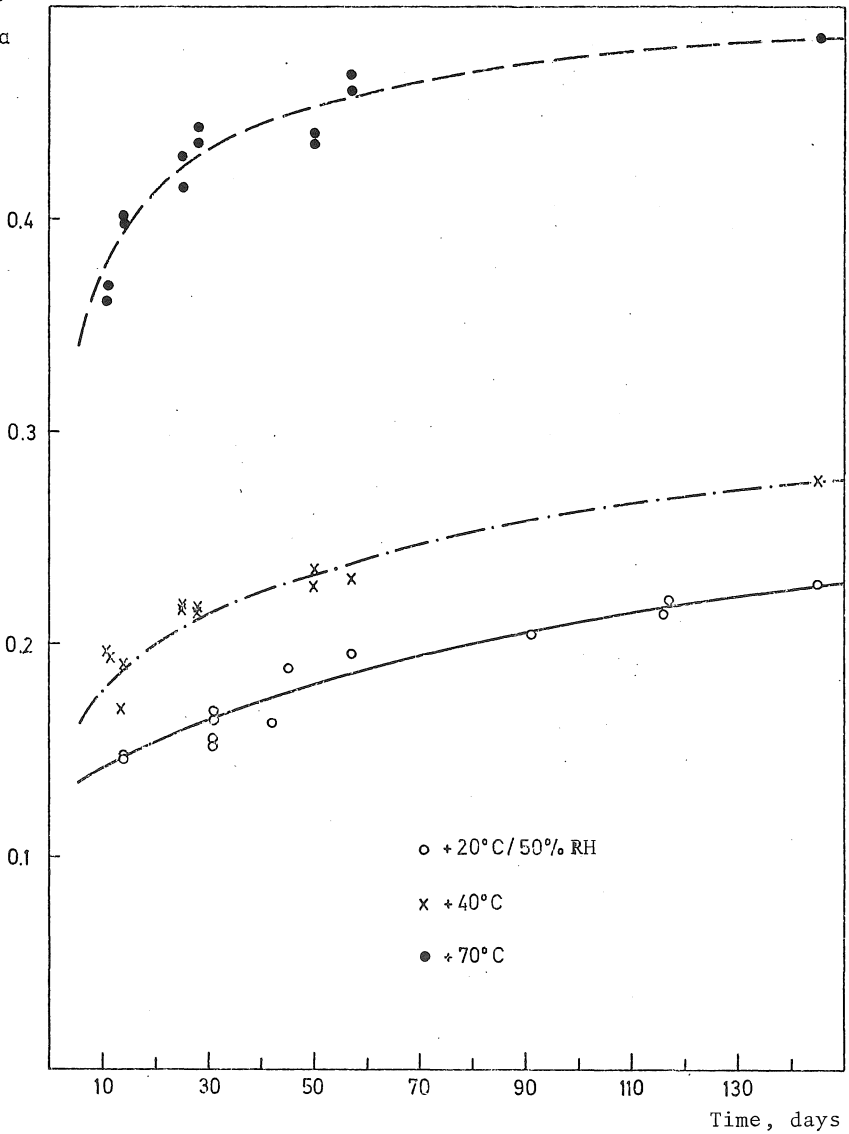
FIG 1 Stress at 50% tension ( $= \sigma_{50}$ ) for "Material No 3" as a function of storage time at different temperatures.

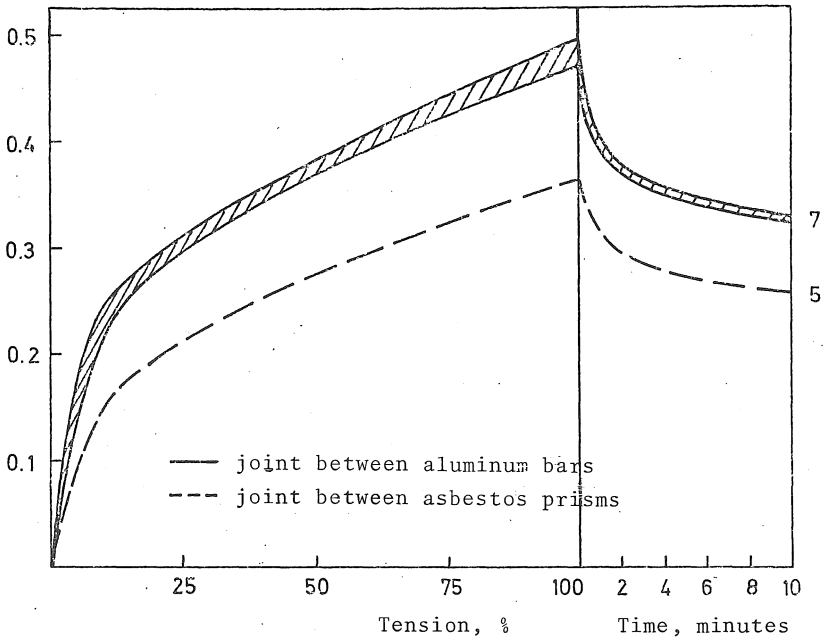
FIG 2 Stress-strain curves for "Material No 3" after varying time of outdoor exposure.  
Deformation speed: 1.5 mm/min  
Testing temperature: +2°C

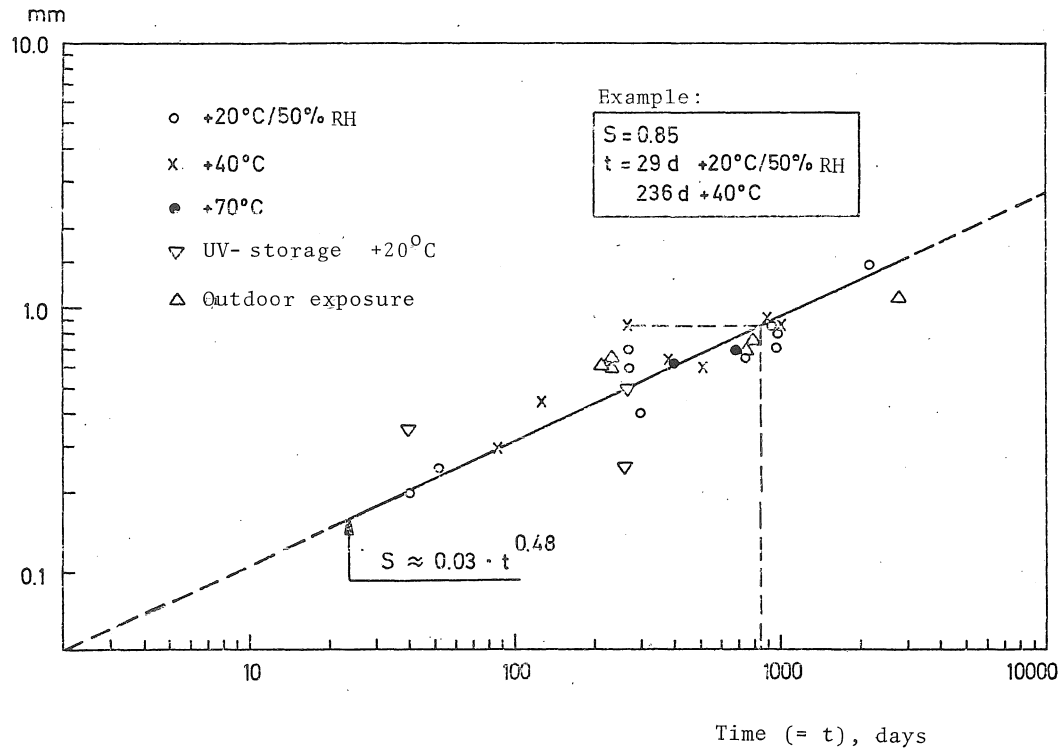
FIG 3 Skin thickness as a function of storage time at +20°C/50% RH for "Material No 8". Computing of equivalent storing time at +20°C/50% RH for material stored at +40°C and +70°C.

For the oleo resinous based sealant, whose ability to fulfill its sealing function depends to a great extent on the characteristics of the skin (toughness and growth rate), the investigation has shown a good correlation between the growth rate of the skin in a climate of  $20^{\circ}\text{C}/50\%$  relative humidity and in an outdoor climate (Fig. 3). By comparing the skin growth rate at  $+70^{\circ}\text{C}$  with the curve in Fig. 3 it is found that the heat ageing increases the rate with a factor about 22.

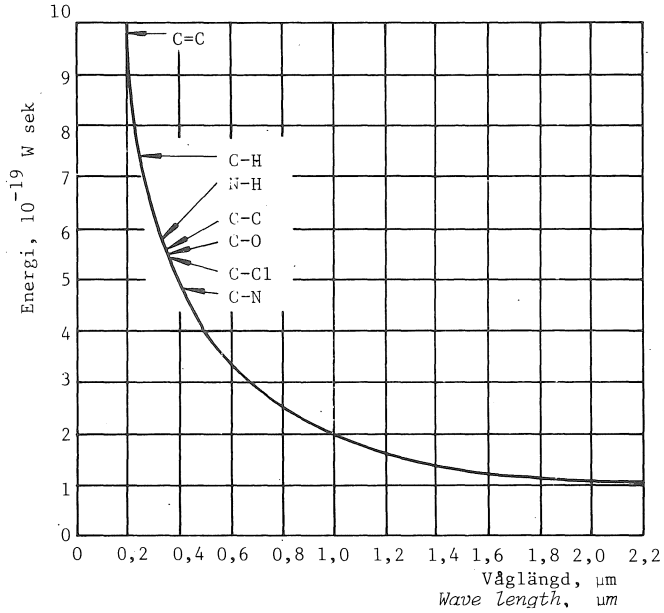
FIG 1 Energi per foton och dissociationsenergi per bindning Gjelsvik (1975)

*Energy per photon and dissociation energy per binding.*

It has been known for a long time that the short-wave part of the solar spectrum (UV and X-ray radiation) creates photo-chemical reactions in organic materials. Fig 1 shows the energy per photon in sunlight as a function of the wavelength. The dissociation energy per binding for some of the most frequently used bindings in organic materials is also shown in the Fig. It can be seen that it is a chain of binding types which can be broken by the UV light.

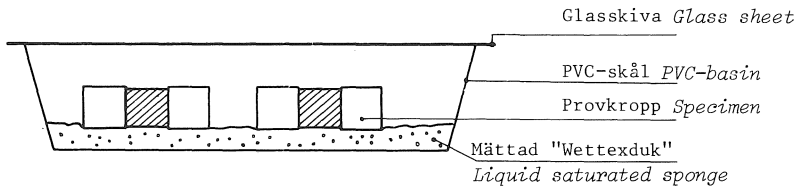
FIG 2 Fukt- respektive alkalilagring av provkroppar.

The effect of humidity has been studied by storing the specimens on a sponge saturated with de-ionized water (pH~4.0) (see Fig 2). The storage temperature was +20°C. This procedure could, for example, be similar to when a back-up material for some reason or other becomes saturated by water.

The influence of humidity and alkali was studied by storing the specimens on a sponge saturated with different media (see Fig 2). In this case "humidity" means de-ionized water with pH approx 4. The alkali solution used was a saturated  $\text{Ca(OH)}_2$  solution diluted to pH approx 11.0. This level can be considered to be the same as the alkalinity when water is poured onto a concrete surface.

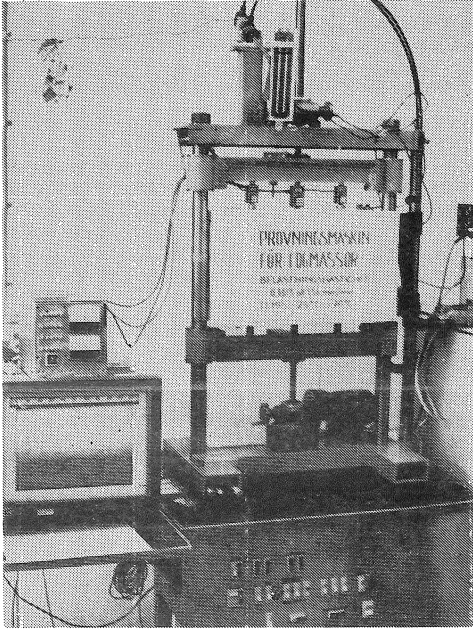
FIG 5a Provningsapparat för fogmassor. Klimatkammaren stängd. Deformationshastighet 0.001 - 1.5 mm/min, drag/tryck. Provnings temperatur  $-25^{\circ}\text{C}$  -  $+70^{\circ}\text{C}$ .

*Testing equipment for sealants. Climate chamber closed. Deformation speed 0.001 - 1.5 mm/min, tension/compression. Testing temperature  $-25^{\circ}\text{C}$  -  $+70^{\circ}\text{C}$ .*

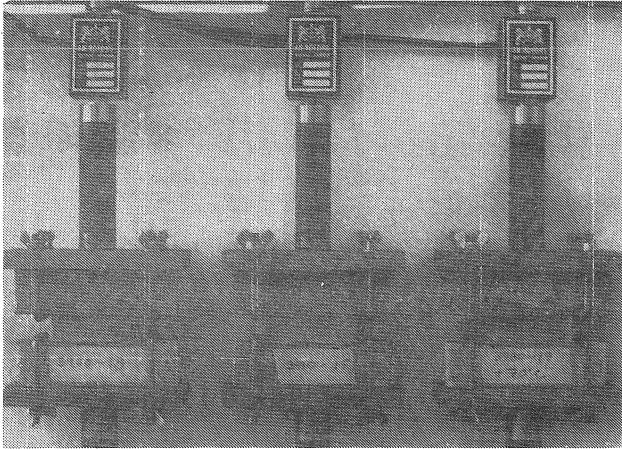
FIG 5b Provningsapparat för fogmassor. Inspänning av provkroppar och celler för kraftmätning.

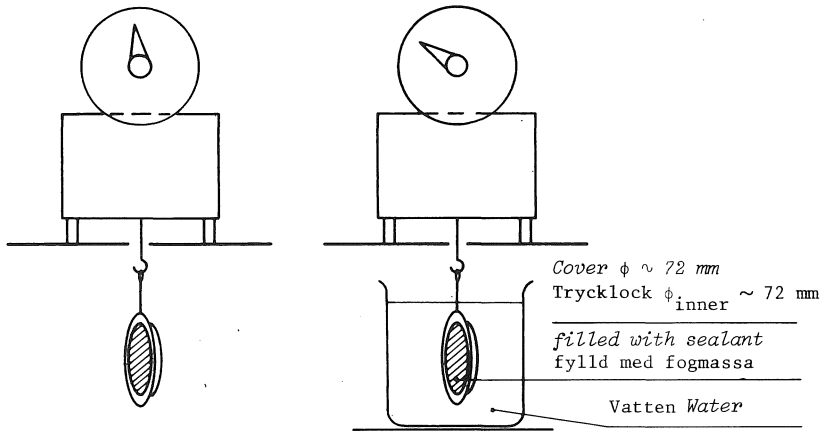
FIG 6 Metodik för bestämning av viktninskning och krympning.  
*Measuring of weight loss and shrinkage.*

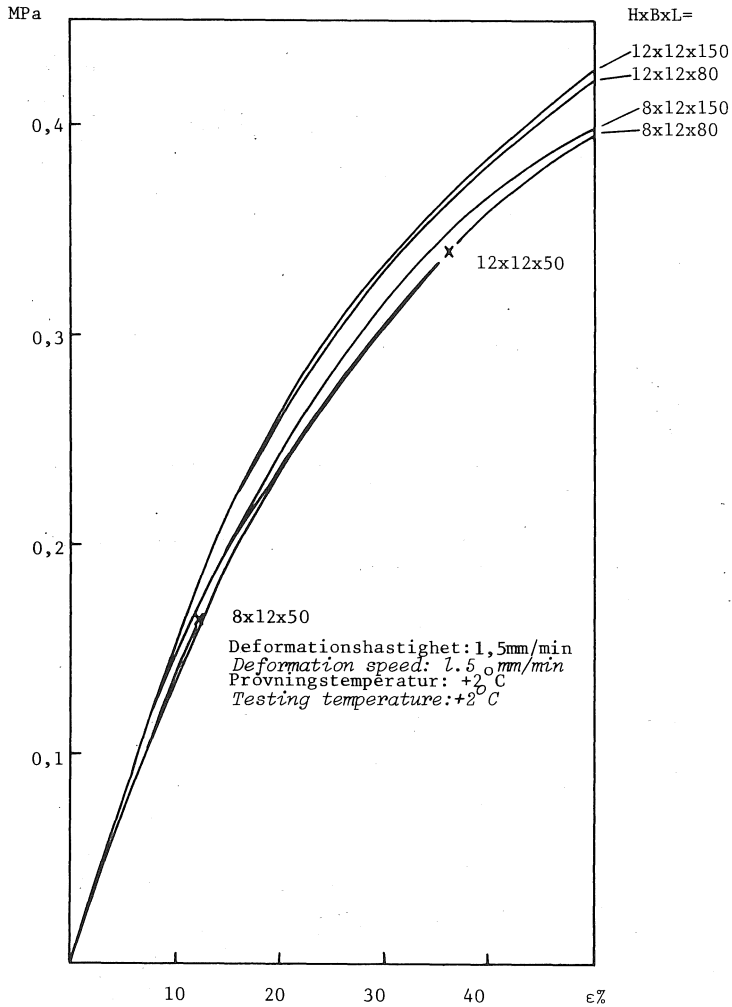
FIG 7 Arbetskurvas beroende av provkroppsdimensionen för en silikonbaserad fogmassa.

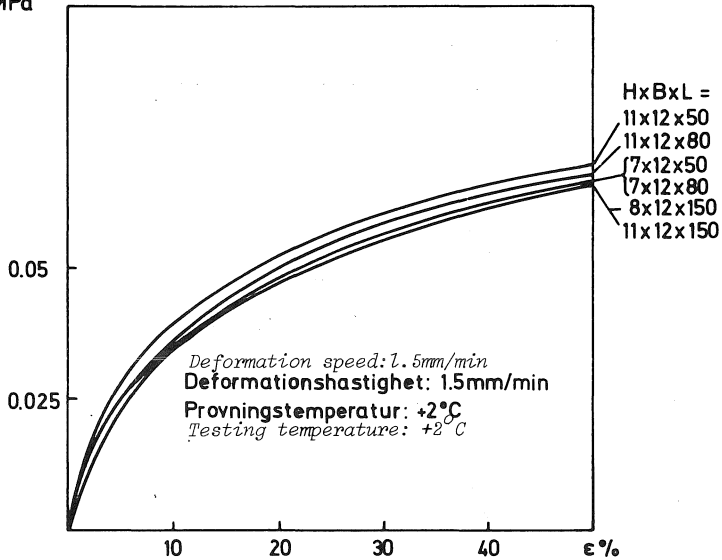
FIG 8 Arbetskurvas beroende av provkroppsdimensionen för en polysulfidbaserad fogmassa.

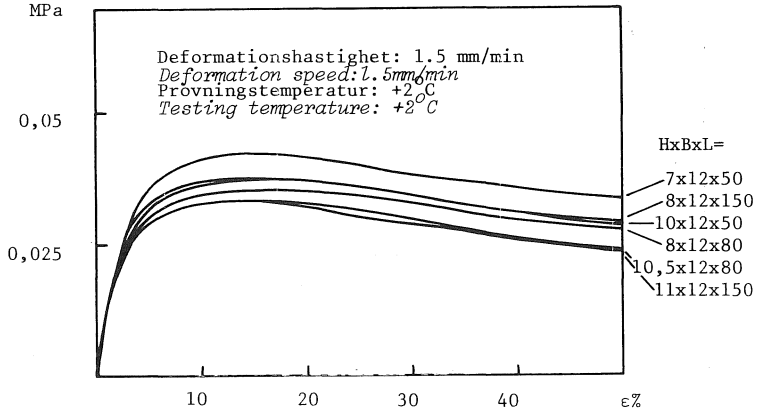
FIG 9 Arbetskurvas beroende av provkroppsdimensionen för en akrylatbaserad fogmassa.

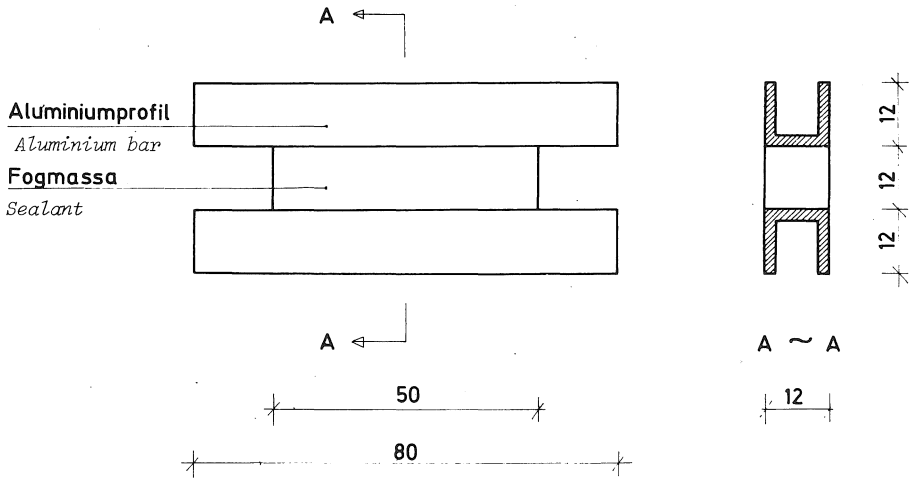
FIG 10 Provkropparnas utformning.  
*The specimens dimensions.*

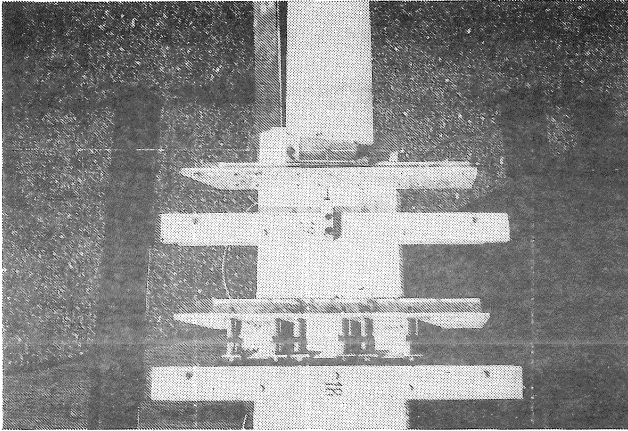
FIG 12 Utomhusexponering av provkroppar. Detalj av provkroppsfästning och lägesgivare.

*Outdoor exposition of specimens. Detail of specimen fixation and deformation gauge.*

Thermo couples were placed on the construction, which is located in a north-south direction. Inside the aerated concrete there are also three gauges for registering the relative humidity. An inductive deformation gauge was also placed on the aerated concrete in order to register the maximum difference in movement. The number of hours of sunshine were registered by a so called photoelement. All measured values were registered on a 12-channel point recorder.

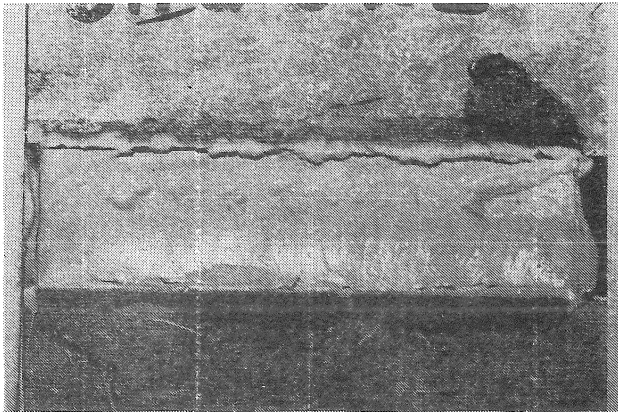
FIG 13 Yta av värmeåldrad lösningsmedelsbaserad akrylatfogmassa. Sprick- och blåsbildning p g a snabb bortgång av lösningsmedel.

*Specimen surface of a heataged acrylic based (solvent release) sealant. Forming of cracks and bubbles due to a rapid release of solvents.*

Storage at an increased temperature, +40°C and +70°C, started after the specimens had been stored at +20°C/50% RH for 7 or 21 days. Some undesirable effects can occur if the hot storage is started too early. This is shown in Figs 13-14, which show a solvent based acrylic sealant. In this case hot storage at +70°C was started after 7 days. The remaining solvent has evaporated from the material with blisters as a result. Consequently the rapid shrinkage also caused adhesion cracking on large surfaces. These after effects need not necessarily occur in sealants during natural ageing.

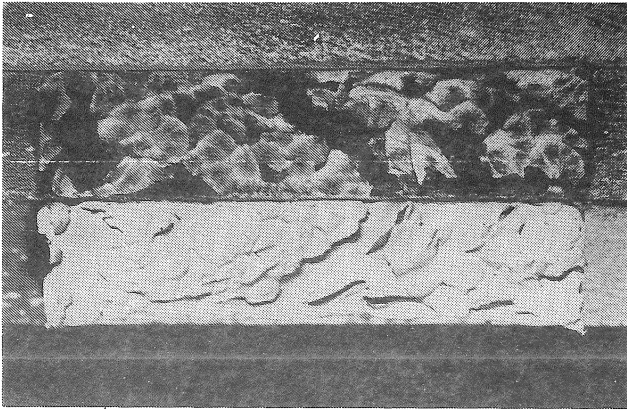
FIG 14 Brottyta av värmeåldrad lösningsmedelsbaserad akrylatfogmassa enligt fig 13.

*Fracture surface of a heataged acrylic based (solvent release) sealant according to fig 13.*

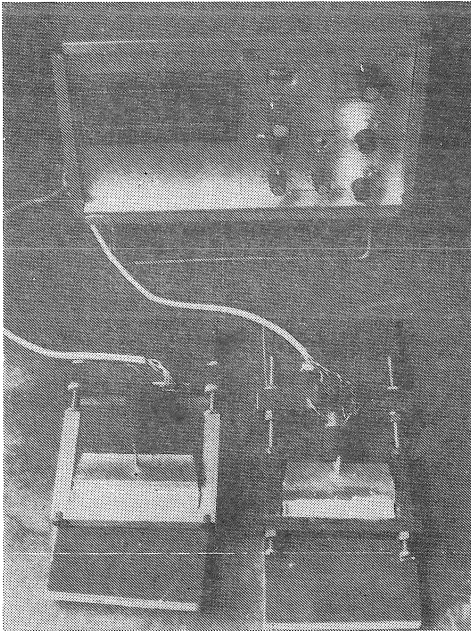
FIG 15 Utrustning för mätning av krympspänningar i fogmassor.

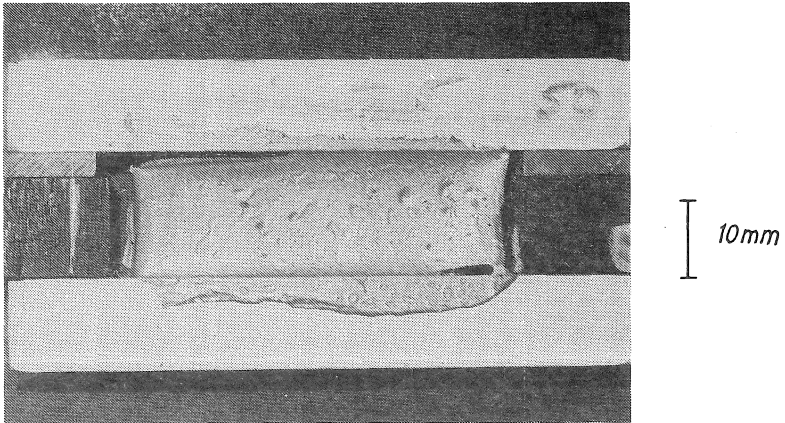
FIG 16 Adhensionsbrott vid ozonprovning av "Material 2", 25% töjning.

*Failure of adhesion at testing of ozone resistance for "Material No 2", extended to 25%.*

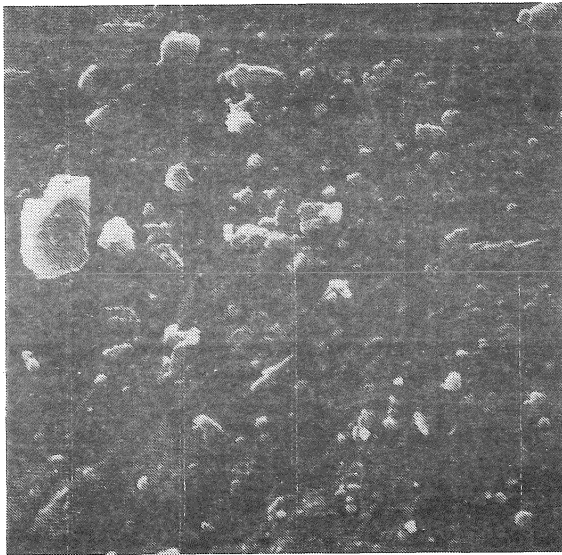
FIG 17 SEM-bild av ytan av en polysulfidbaserad fogmassa lagrad i +20°C/50% RF. Förstoring: 600x. Foto: Zoologiska institutionen, Lunds universitet.

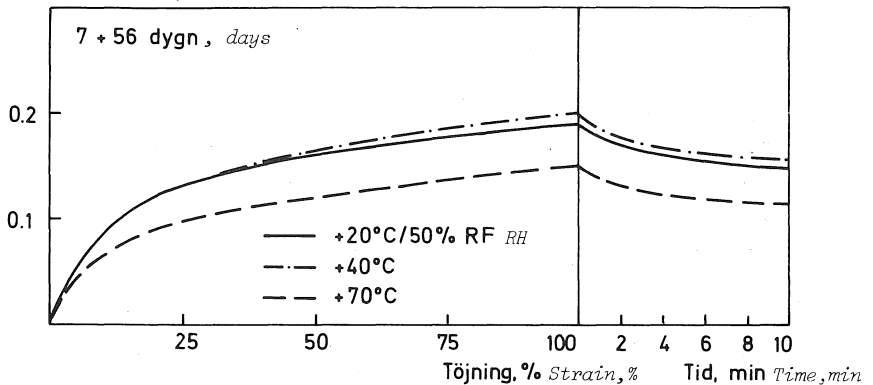
FIG 19 Arbetskurvor för "Material 1" värmeåldrat i olika temperaturer. Deformationshastighet: 1.5 mm/min. Provningsstemperatur: +2°C.

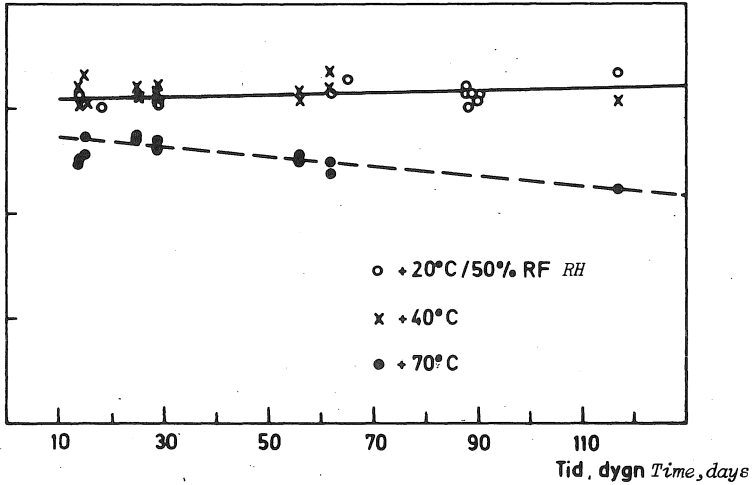
FIG 20 Dragspänning vid 50% töjning ( $=\sigma_{50}$ ) för "Material 1" som funktion av lagringstid i olika temperaturer. Initiallagring: 7 dygn i +20°C/50% RH.

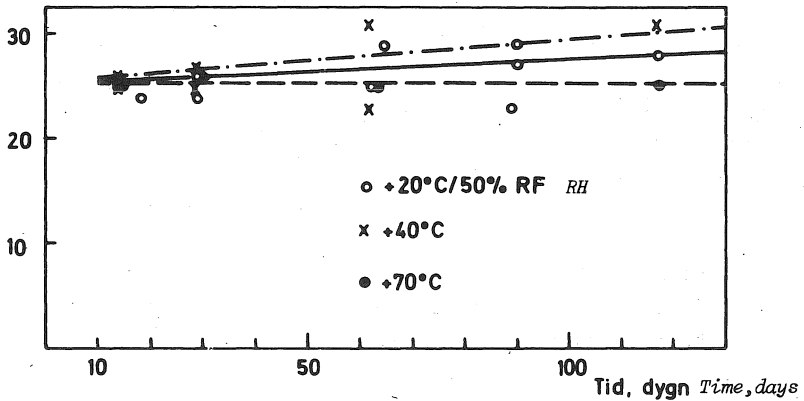
FIG 21 Härdhet i  $^{\circ}$ Shore A för "Material 1" som funktion av lagringstid i olika temperaturer. Initiallagring: 7 dygn i +20°C/50% RH.

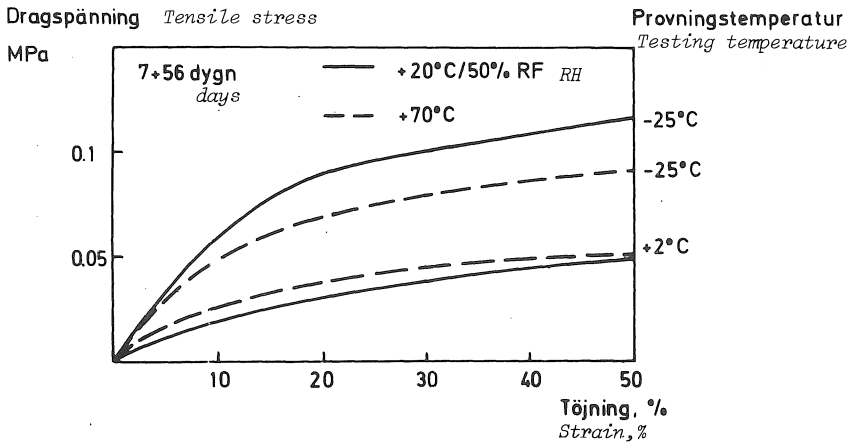
FIG 22 Arbetskurvor för "Material 1" efter värmelagring i olika klimat. Deformationshastighet: 0.001 mm/min.

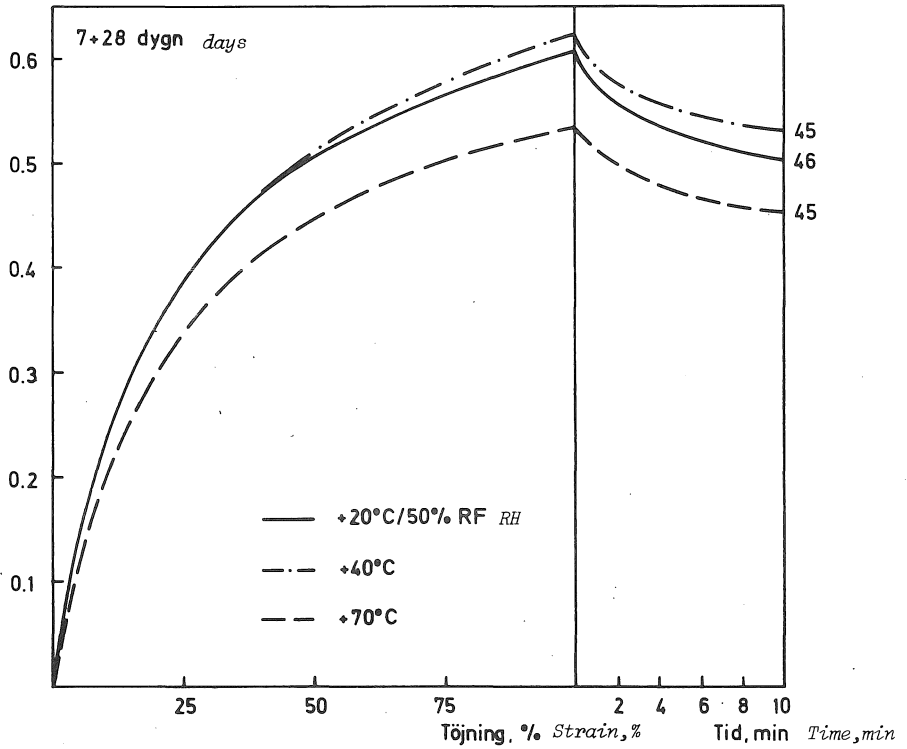
FIG 23 Arbetskurvor för "Material 2" värmeåldrat i olika temperaturer. Deformationshastighet: 1.5 mm/min. Provnings temperatur: +20°C.

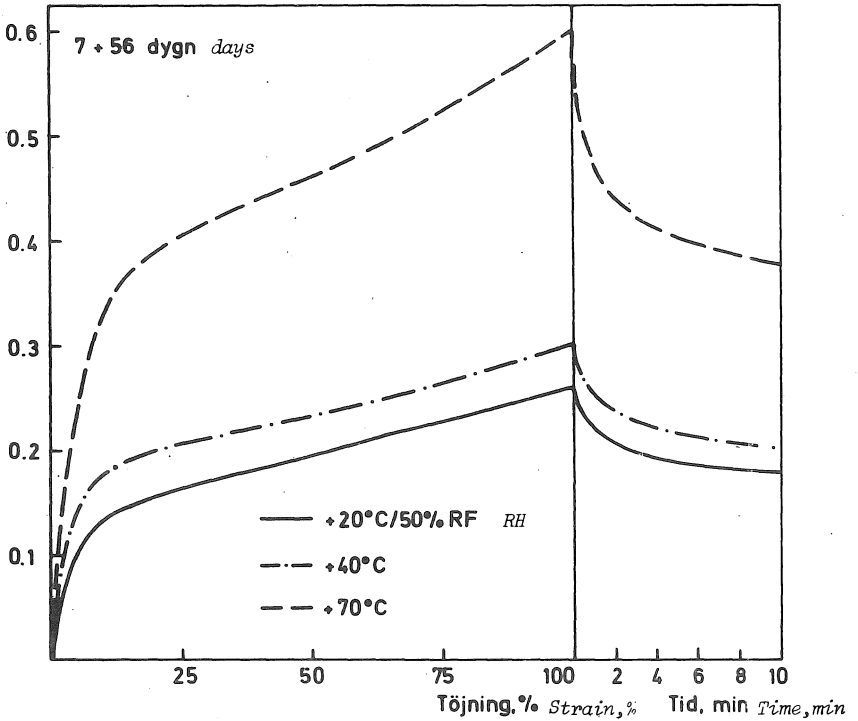
FIG 24 Arbetskurvor för "Material 3" värmeåldrat i olika temperaturer. Deformationshastighet: 1.5 mm/min. Provningsstemperatur: +2°C.

This material, a one-component polyurethane sealant, shows a great increase in hardness when exposed to heat ageing. The stress-strain curves can be seen in Fig. 24. The increase in hardness is to some extent dependent on the heat ageing having accelerated the rather slow curing mechanism at the normal climate of 20/50. This can be seen in Fig. 25 where the stress at 50% elongation is noted as a function of the storage time in different climates.

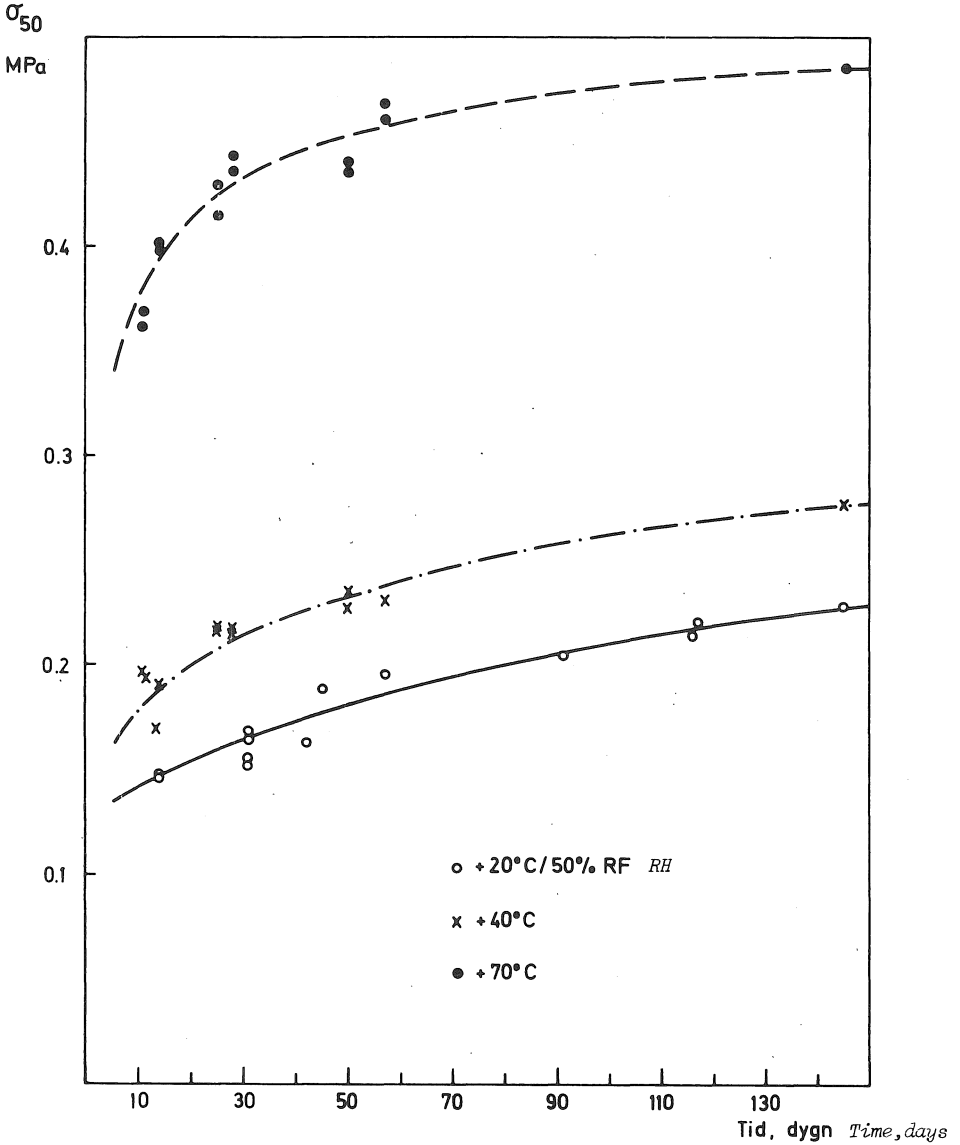
FIG 25 Dragspänning vid 50% töjning ( $= \sigma_{50}$ ) för "Material 3" som funktion av lagringstid i olika temperaturer. Initiallagring: 7 dygn i +20°C/50% RF.

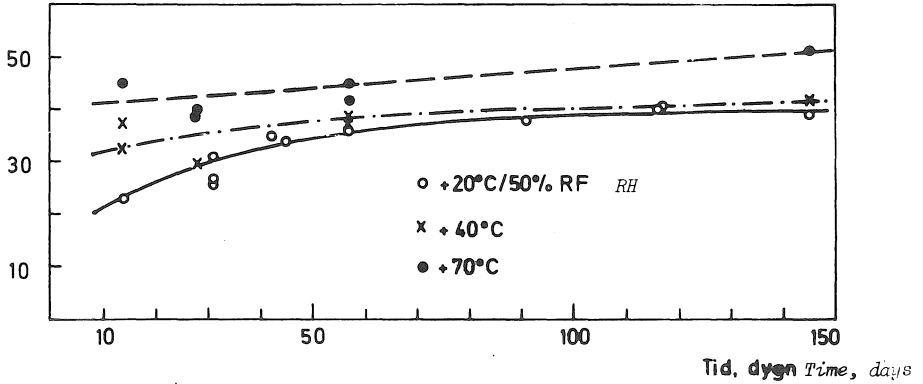
FIG 26 Hårdhet i °Shore A för "Material 3" som funktion av lagringstid i olika temperaturer. Initiallagring: 7 dygn i +20°C/50% RF.

Roughly the same tendency can be observed in Fig. 26. The hardness in °Shore A is considerably greater than the value stated by the manufacturer ( $25 \pm 5$ ).

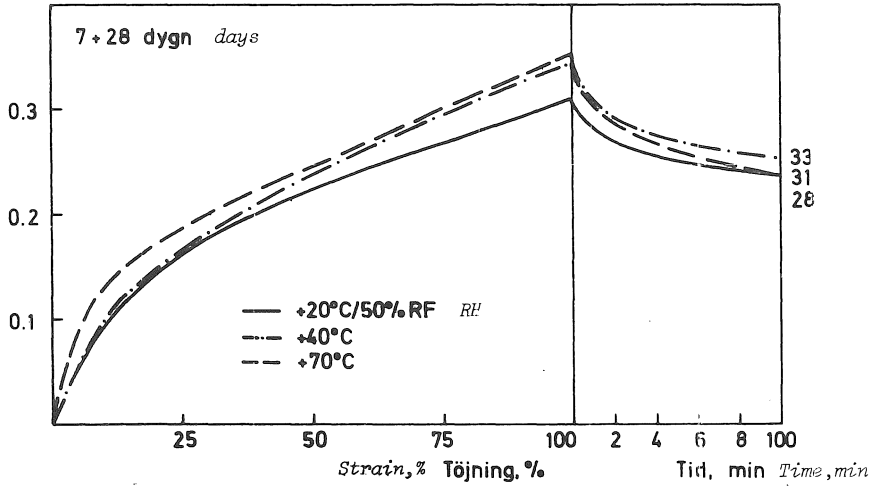
FIG 28 Arbetskurvor för "Material 4" värmeåldrat i olika temperaturer. Deformationshastighet: 1.5 mm/min. Provningsstemperatur: +2°C.

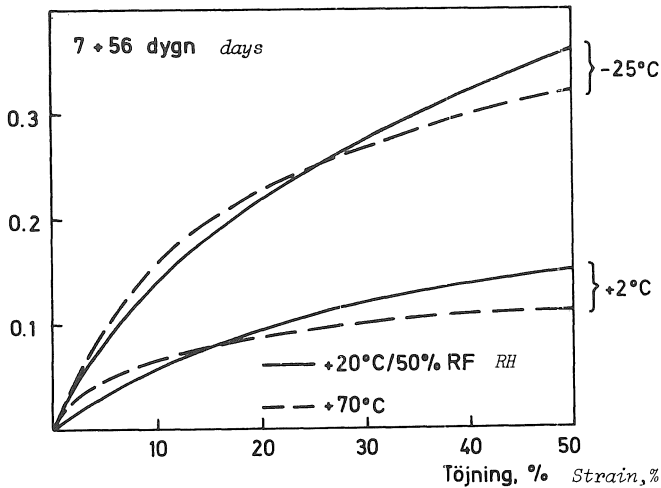
FIG 29 Arbetskurvor för "Material 4" efter värmeåldring i olika klimat. Deformationshastighet: 0.001 mm/min.

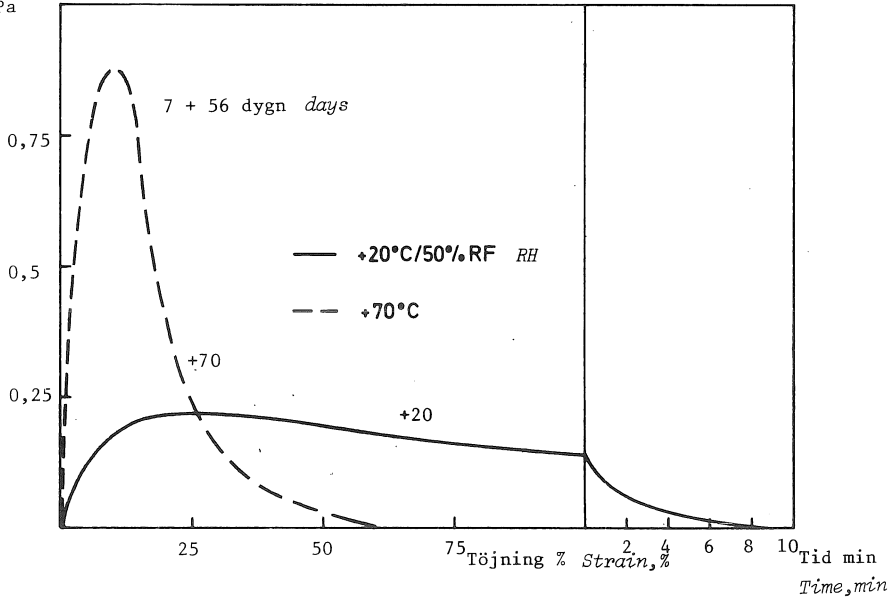
FIG 30 Arbetskurvor för "Material 5" värmeåldrat i olika temperaturer. Deformationshastighet: 1.5 mm/min. Provningsstemperatur: +2°C.

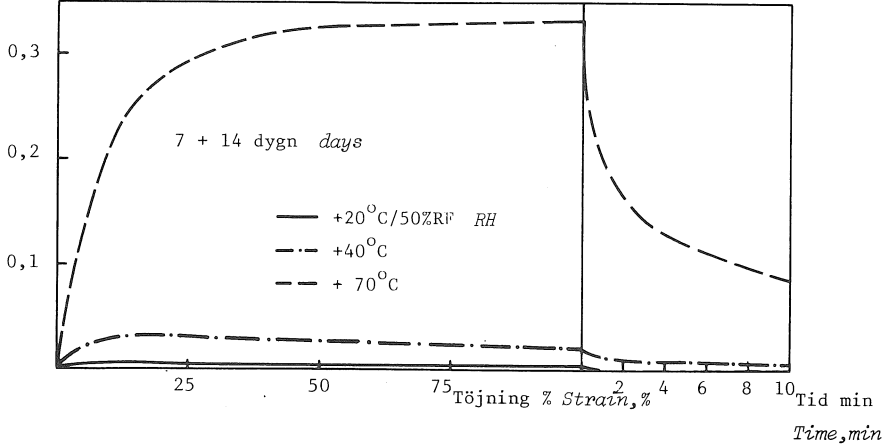
FIG 31 Arbetskurvor för "Material 6" värmeåldrat i olika temperaturer. Deformationshastighet: 1.5 mm/min. Provningsstemperatur: +2°C.

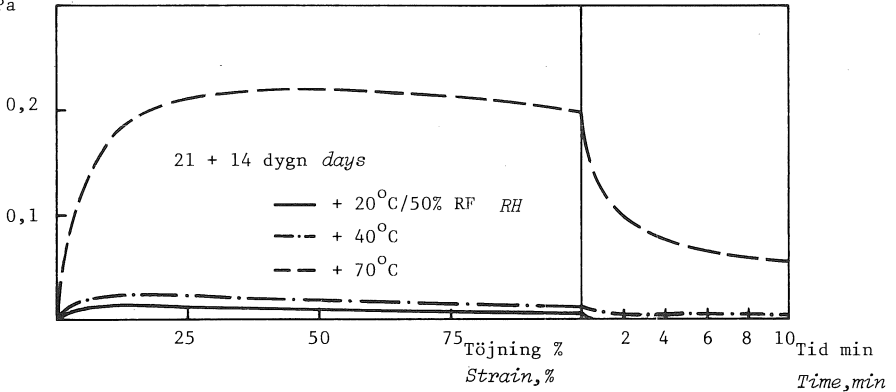
FIG 32 Arbetskurvor för "Material 6" värmeåldrat i olika temperaturer. Deformationshastighet: 1.5 mm/min. Provningsstemperatur: +2°C.

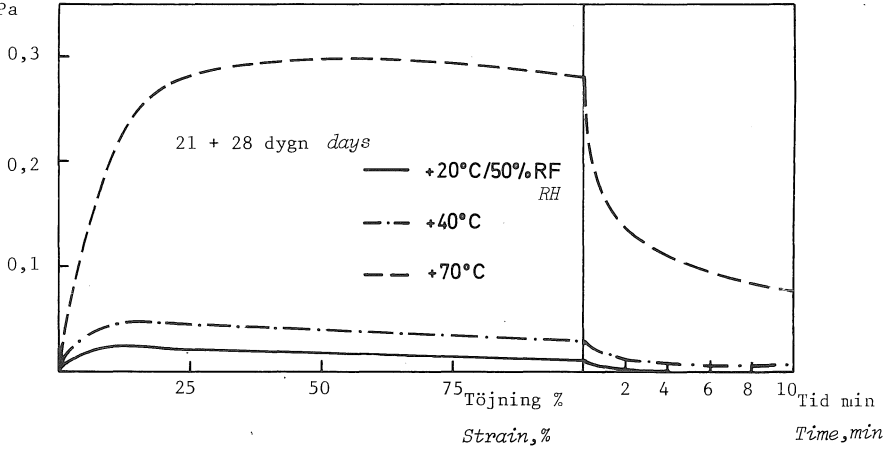
FIG 33 Arbetskurvor för "Material 6" värmeåldrat i olika temperaturer. Deformationshastighet: 1.5 mm/min. Provnings temperatur: +2°C.

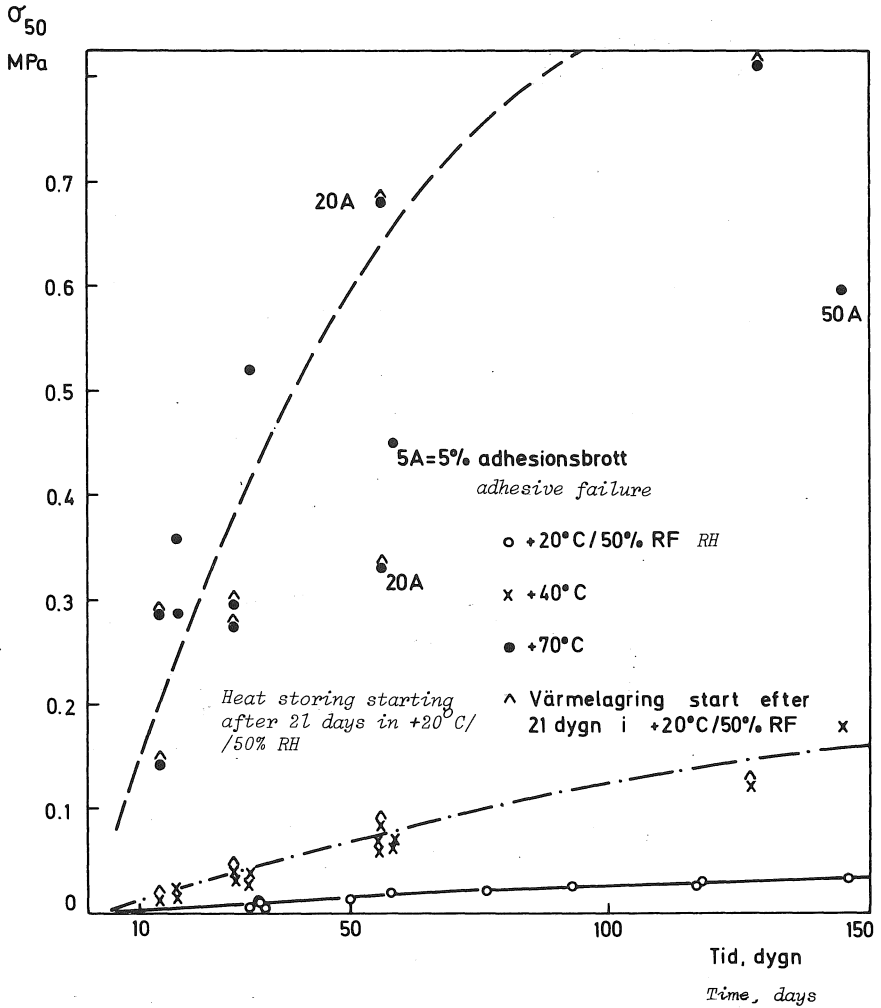
FIG 34 Dragspänning vid 50% töjning ( $= \sigma_{50}$ ) för "Material 6" som funktion av lagringstid i olika temperaturer. Initiallagring: 7 dygn i +20°C/50% RF.

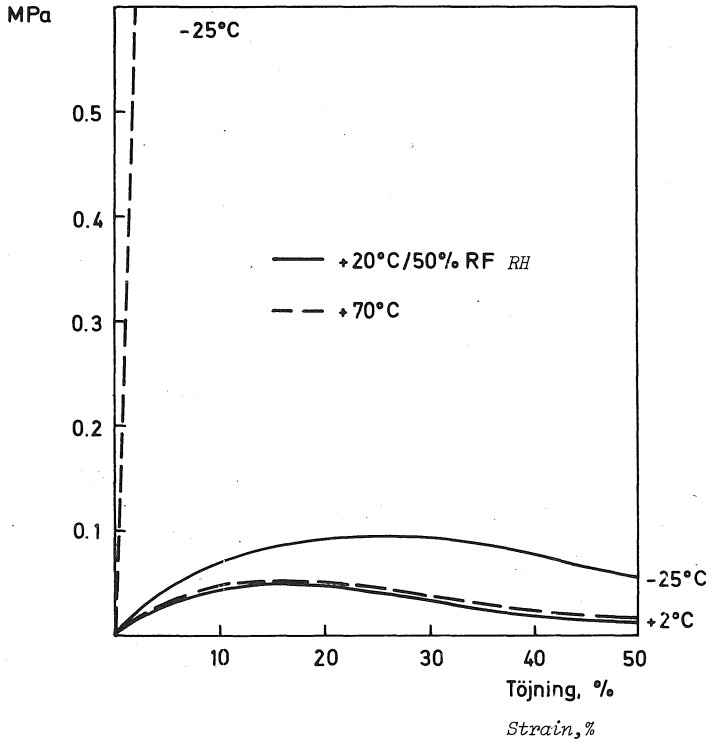
FIG 35 Arbetskurvor för "Material 6" efter värmeåldring i olika klimat. Deformationshastighet: 0.001 mm/min.

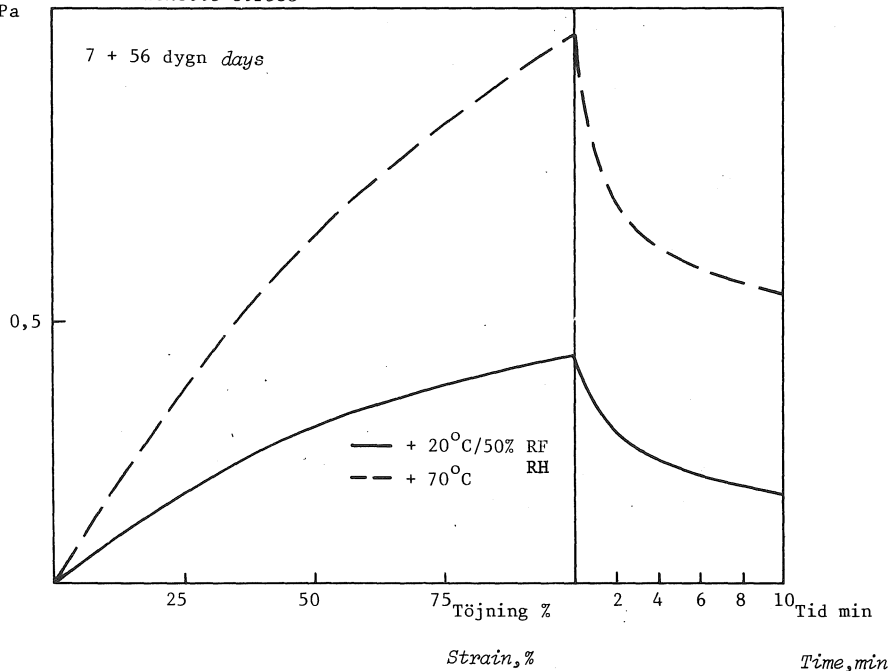
FIG 36 Arbetskurvor för "Material 7" åldrat i olika temperaturer. Deformationshastighet: 1.5 mm/min. Provningsstemperatur: +2°C.

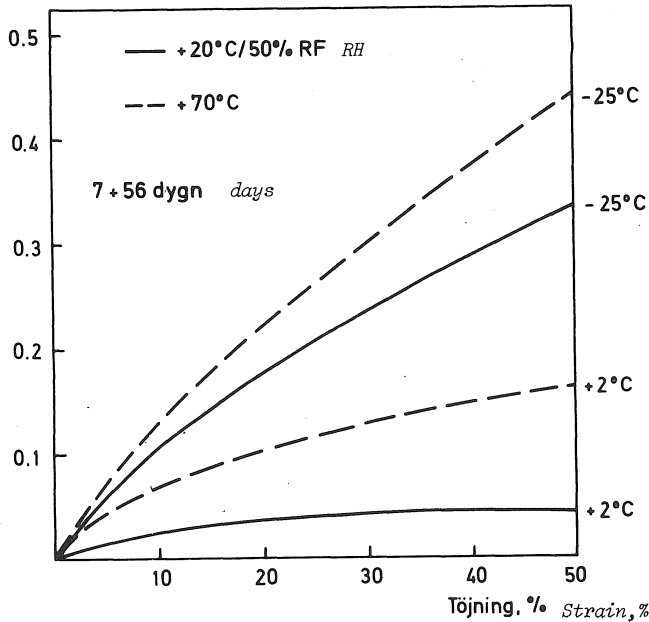
FIG 37 Arbetskurvor för "Material 7" åldrat i olika temperaturer. Deformationshastighet: 0.001 mm/min.

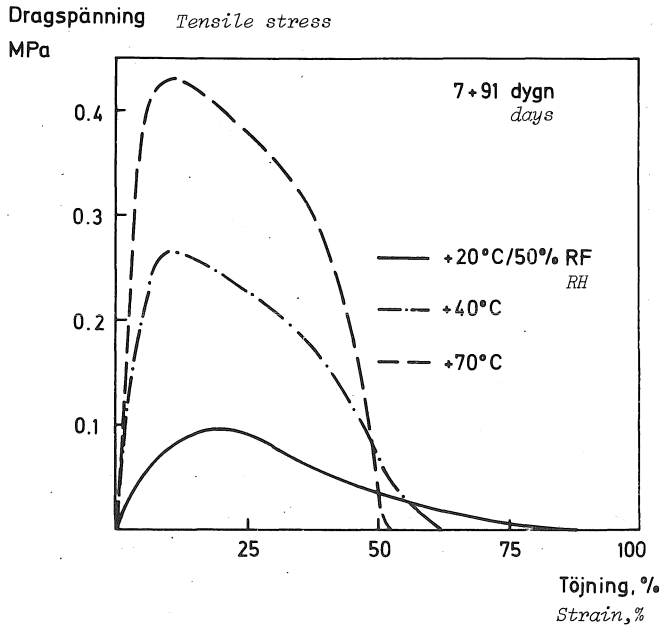
FIG 39 Arbetskurvor för "Material 8" värmeåldrat i olika temperaturer. Deformationshastighet: 1.5 mm/min. Provningsstemperatur: +2°C.

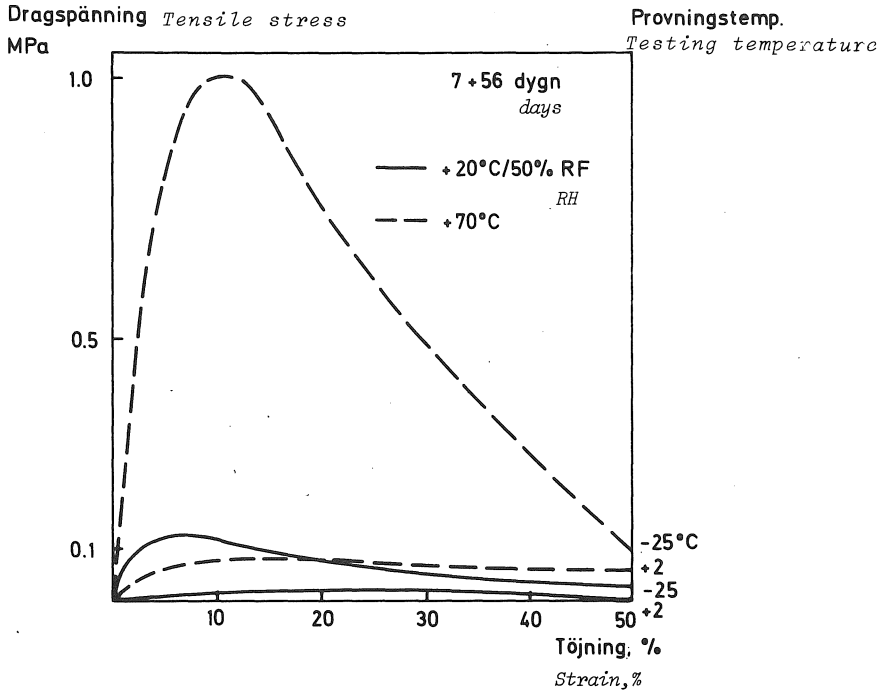
FIG 40 Arbetskurvor för "Material 8" efter värme-  
åldring. Deformationshastighet: 0.001 mm/min.

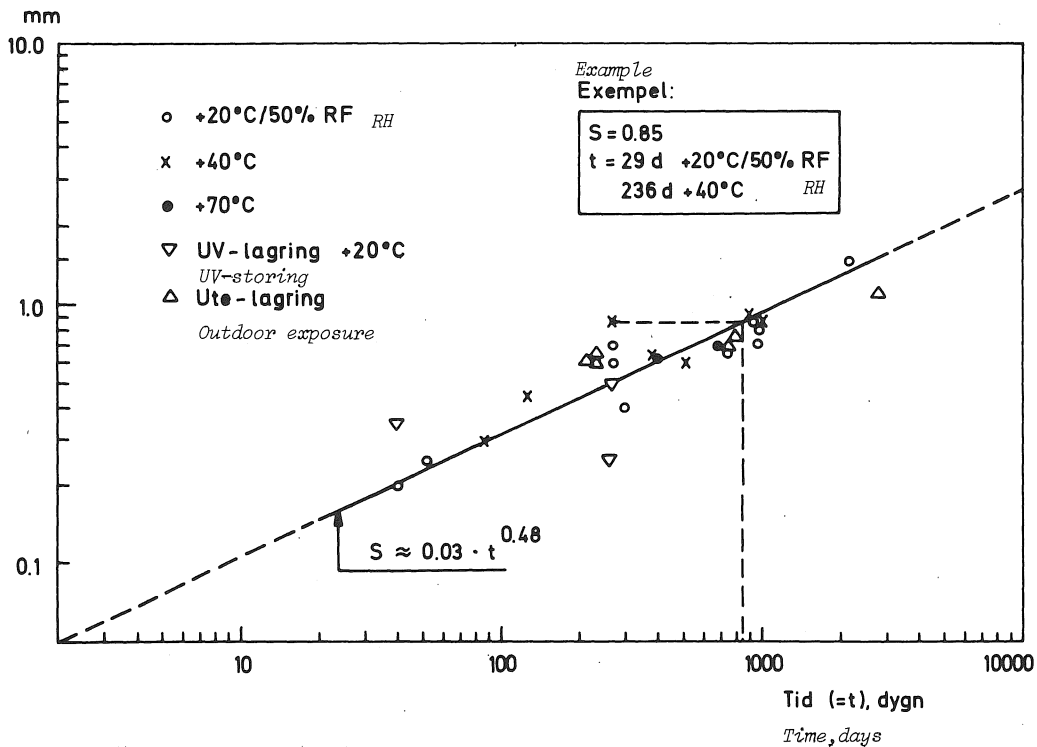
FIG 41 Skinntjockleken som funktion av lagringstiden i +20°C/50% RF för "Material 8". Beräkning av ekvivalent lagringstid i +20°C/50% RF för material lagrat i +40°C eller +70°C.

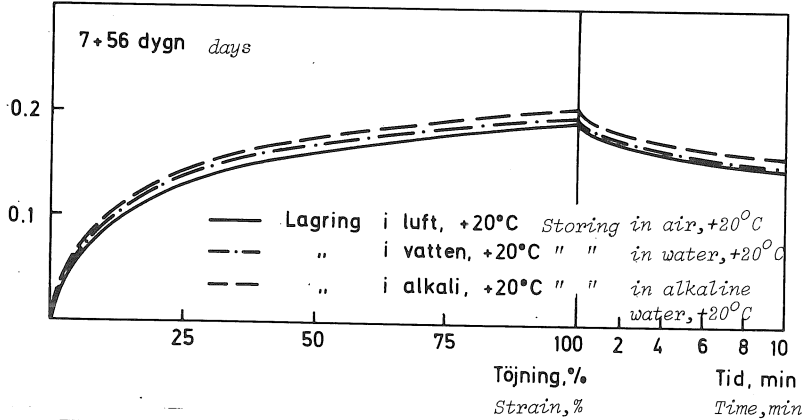
FIG 42 Arbetskurvor för "Material 1" efter lagring i luft, vatten och alkali. Deformationshastighet: 1.5 mm/min. Provningsstemperatur: +20°C.

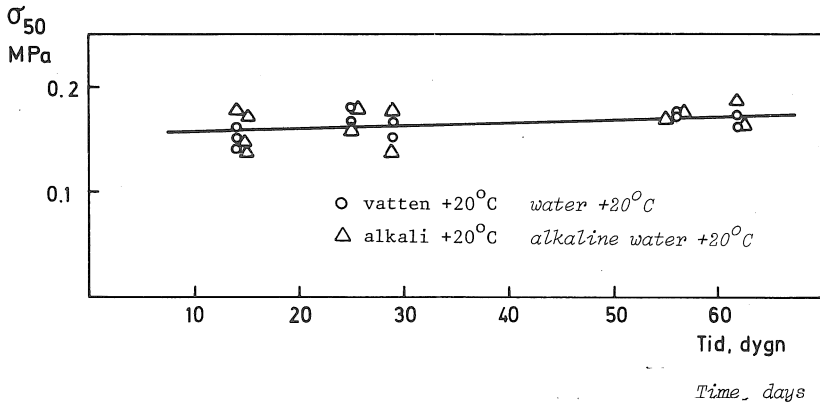
FIG 43 Dragspänning vid 50% töjning ( $= \sigma_{50}$ ) för "Material 1" som funktion av lagringstid i vatten och alkali. Initiallagring: 7 dygn i +20°C/50% RF.

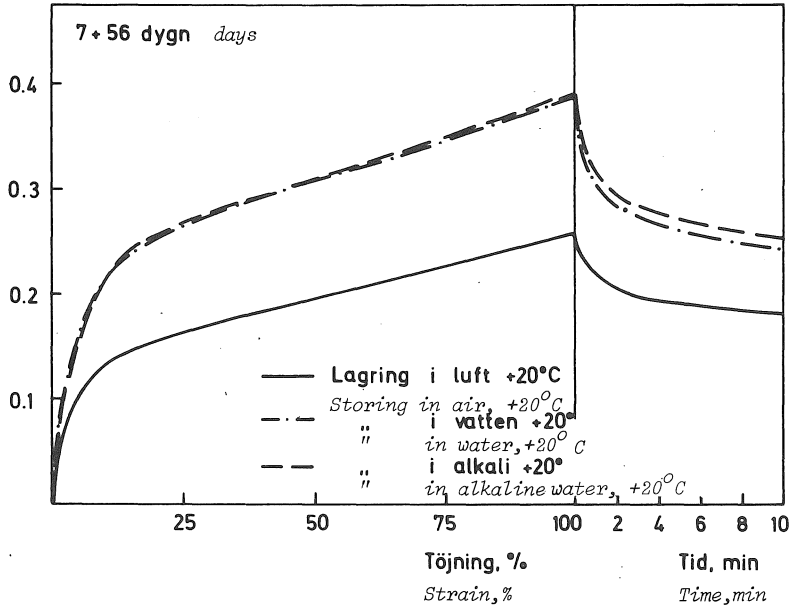
FIG 44 Arbetskurvor för "Material 3" efter lagring i luft, vatten och alkali. Deformationshastighet: 1.5 mm/min. Provningsstemperatur: +2°C.

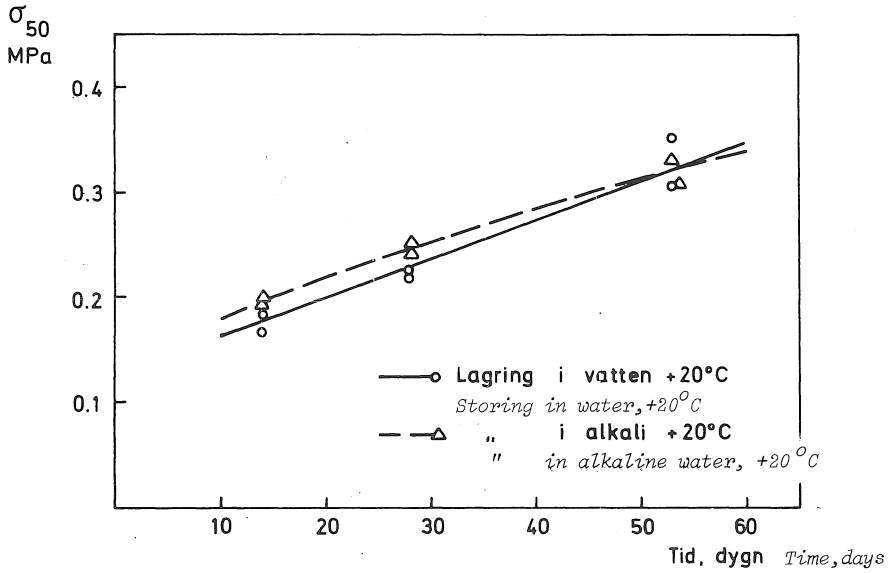
FIG 45 Dragspänning vid 50% töjning ( $= \sigma_{50}$ ) för "Material 3" som funktion av lagringstid i vatten och alkali. Initiallagring: 7 dygn i +20°C/50% RF.  
 Stress at 50% tension ( $= \sigma_{50}$ ) for "Material No 3" as a function of storing time in water and alkaline water. Initial storing: 7 days at +20°C/50% RH.

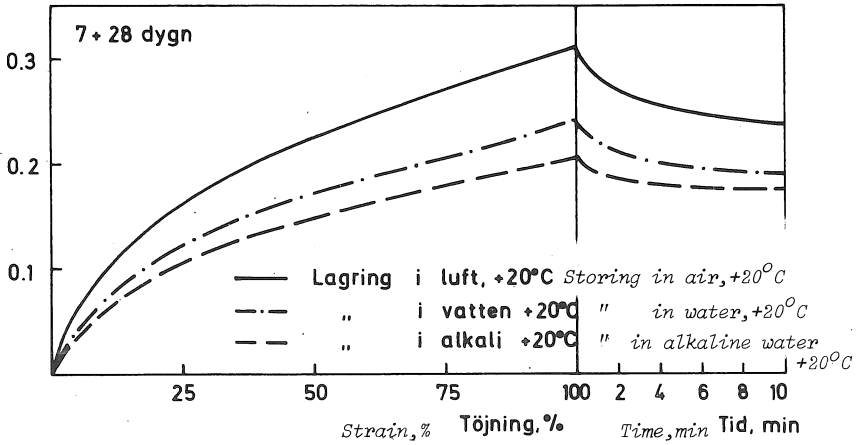
FIG 46 Arbetskurvor för "Material 4" efter lagring i luft, vatten och alkali. Deformationshastighet: 1.5 mm/min. Provningsstemperatur: +2°C.
