# DURABILITY AND AGEING OF SEALANTS

PER GUNNAR BURSTRÖM

REPORT TVBM-3003  
LUND SWEDEN 1977

THIS REPORT REFERS TO PROJECT NUMBER 730221-4 FROM  
THE SWEDISH COUNCIL FOR BUILDING RESEARCH TO THE  
DIVISION OF BUILDING MATERIALS AT THE LUND INSTITUTE  
OF TECHNOLOGY

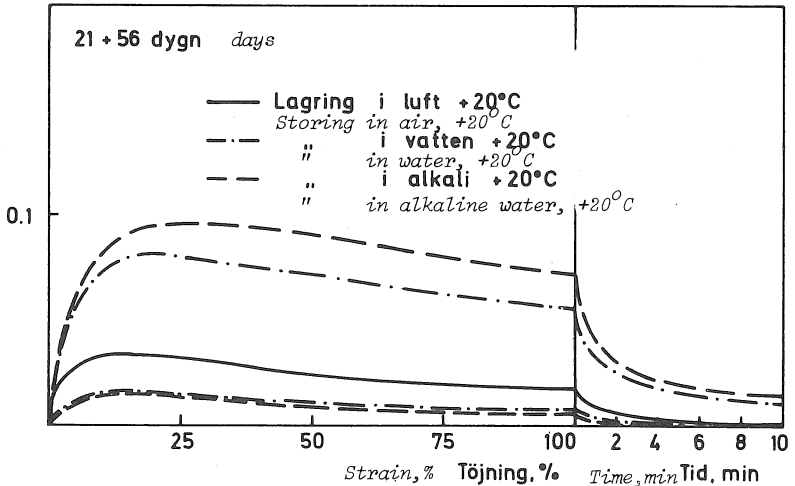
FIG 47 Arbetskurvor för "Material 6" efter lagring i luft, vatten och alkali. Deformationshastighet: 1.5 mm/min. Provningsstemperatur: +2°C.

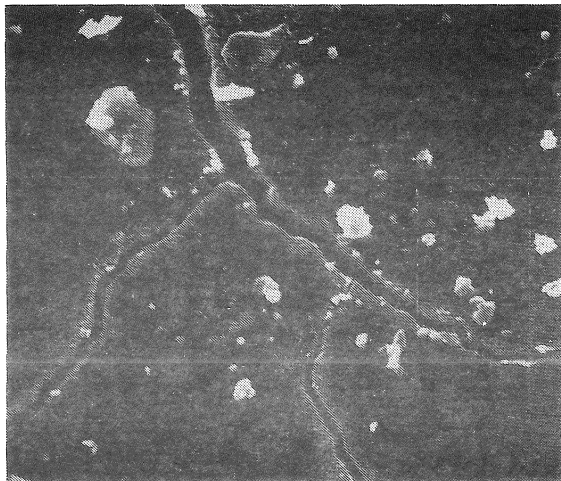
FIG 48 Yta av polysulfidbaserad fogmassa UV-bestrålad 21 dygn. Förstoring: 600x. Foto: Zoologiska institutionen, Lunds universitet.

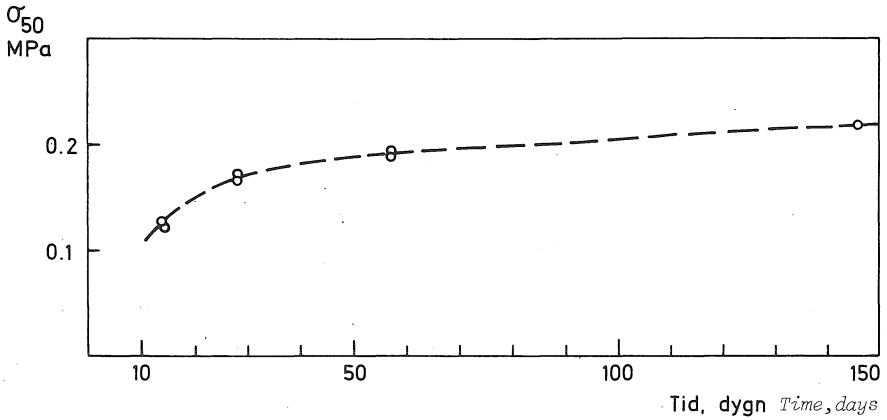
FIG 52 Dragspänning vid 50% töjning ( $= \sigma_{50}$ ) för "Material 3" som funktion av lagringstid i UV-ljus. Initiallagring: 7 dygn i  $+20^{\circ}\text{C}/50\%$  RF.

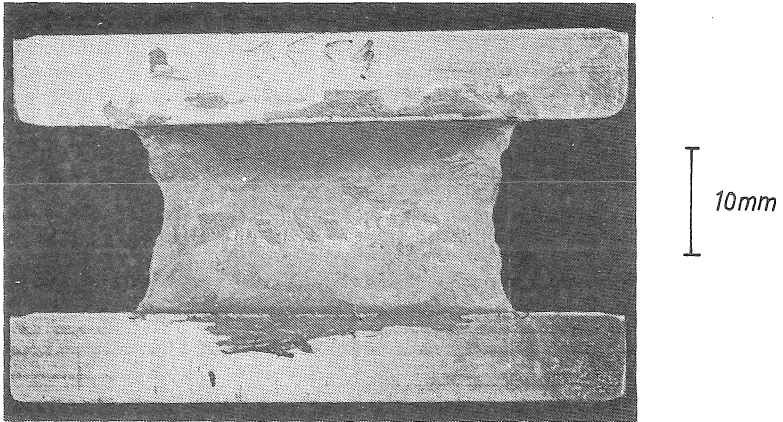
FIG 53 Sprickbildning i ythud som bildats vid UV-lagring av "Material 6".

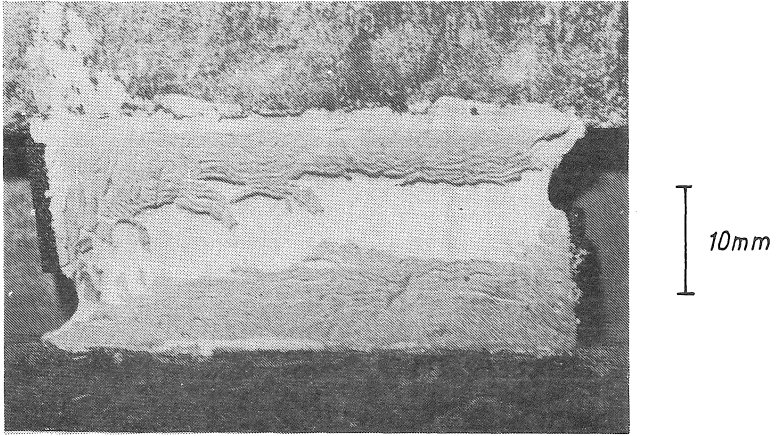
FIG 54 Sprickbildning i ythud som bildats vid UV-lagring av "Material 8".

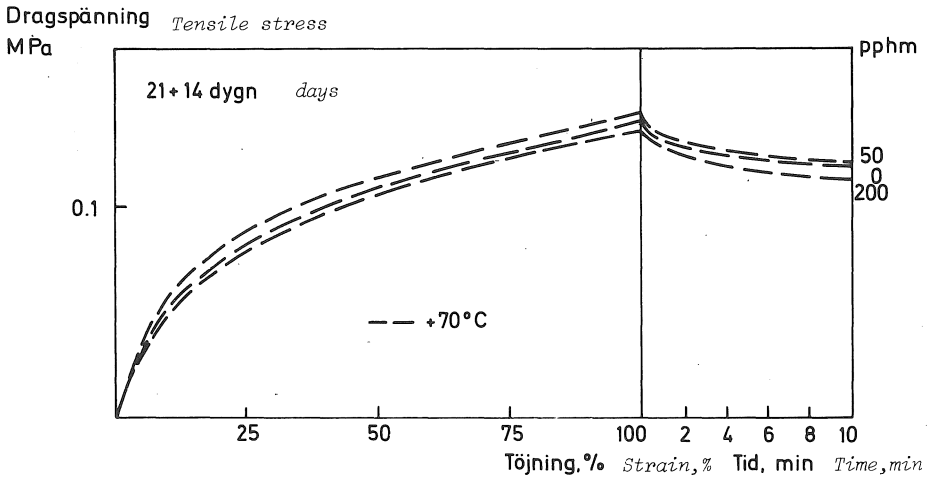
FIG 55 Arbetskurvor för "Material 1" efter lagring vid 25% töjning och varierande ozonhalt. Deformationshastighet: 1.5 mm/min. Provningstemperatur: +2°C.

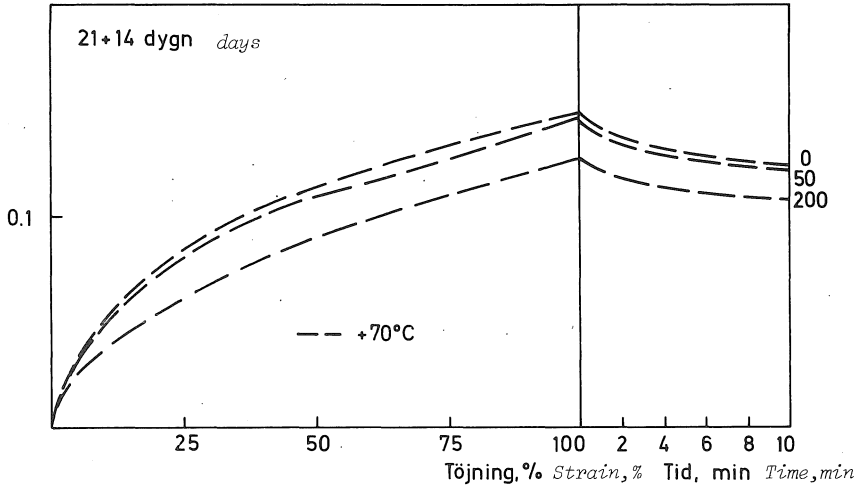
FIG 56 Arbetskurvor för "Material 1" efter lagring vid 50% töjning och varierande ozonhalt. Deformationshastighet: 1.5 mm/min. Provningsstemperatur: +2°C.

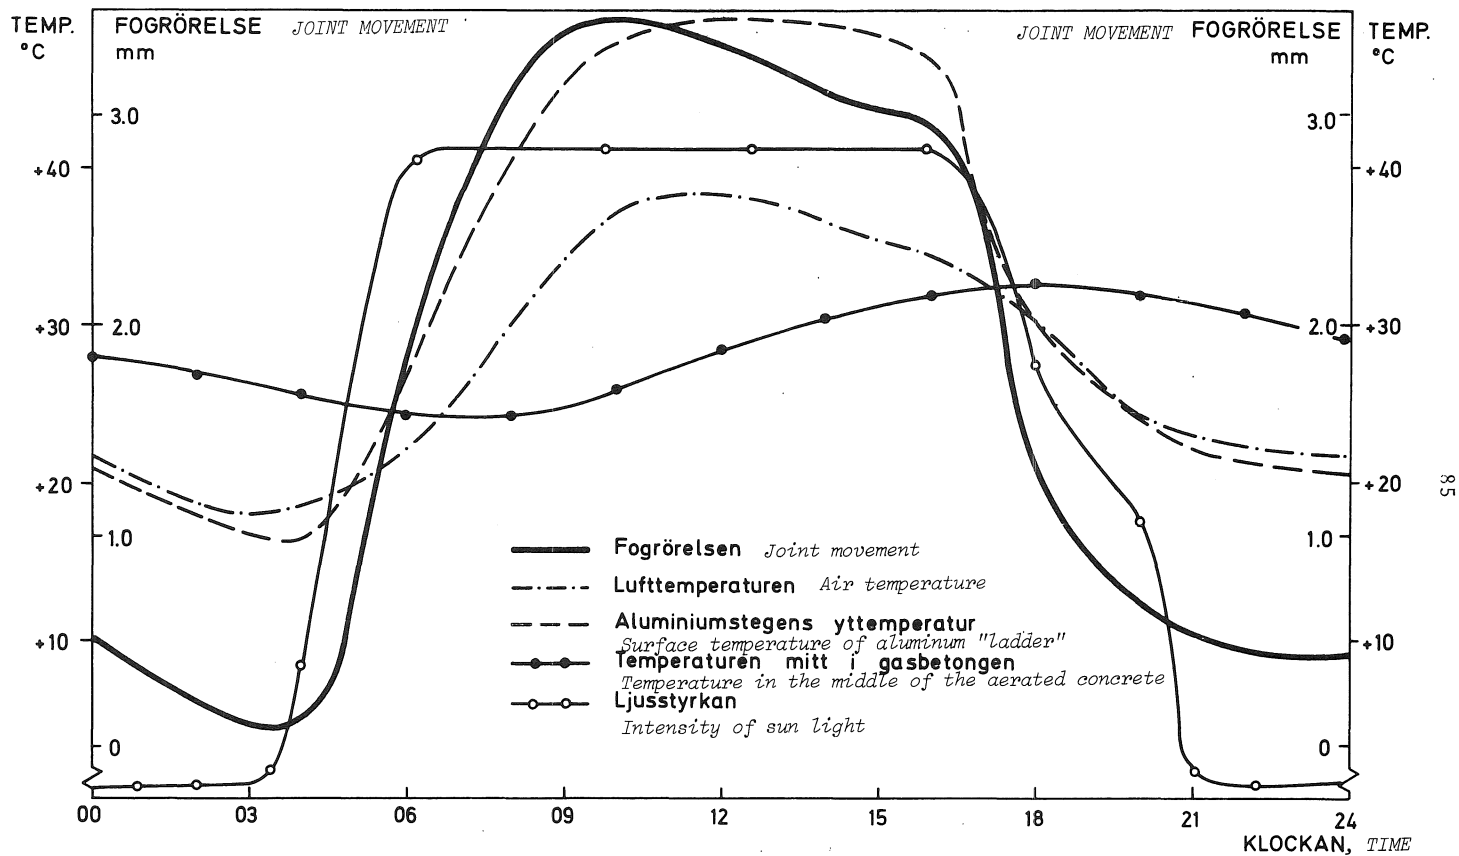
FIG 60 Exempel på ett dygn (750809) med stora uppmätta temperaturvariationer och därmed sammanhängande fogrörelser i utomhusutrustning för exponering av provkroppar.

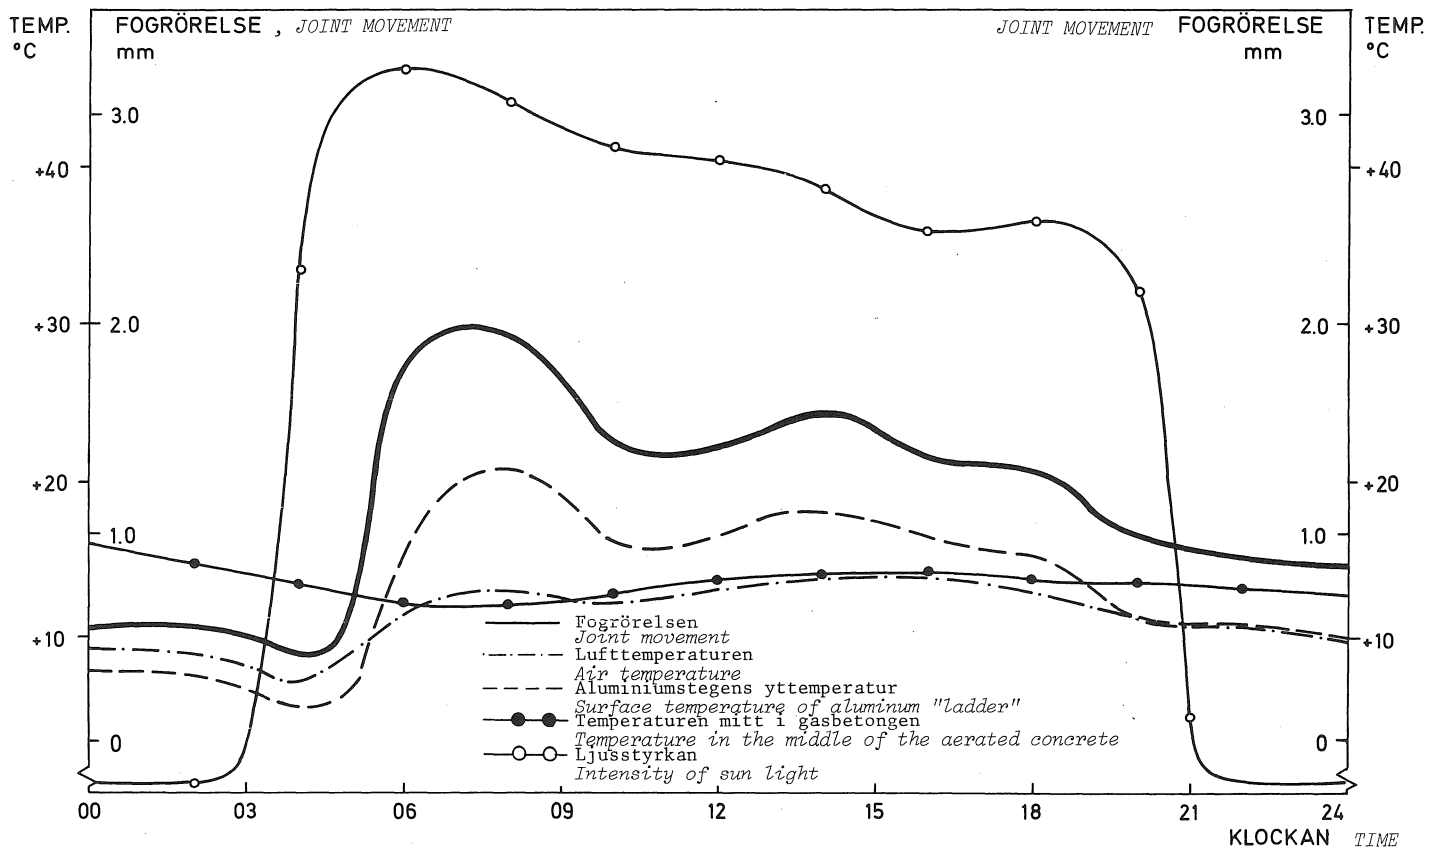
FIG 61 Exempel på ett dygn (760605) med små uppmätta temperaturvariationer i utomhusutrustning för exponering av provkroppar.

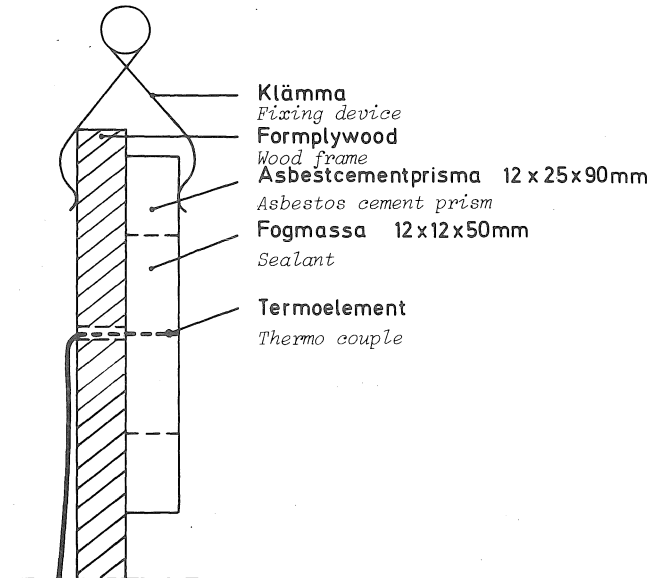
FIG 65 Mätning av temperaturer i olikfärgade fogmassor vid utomhusexponering.

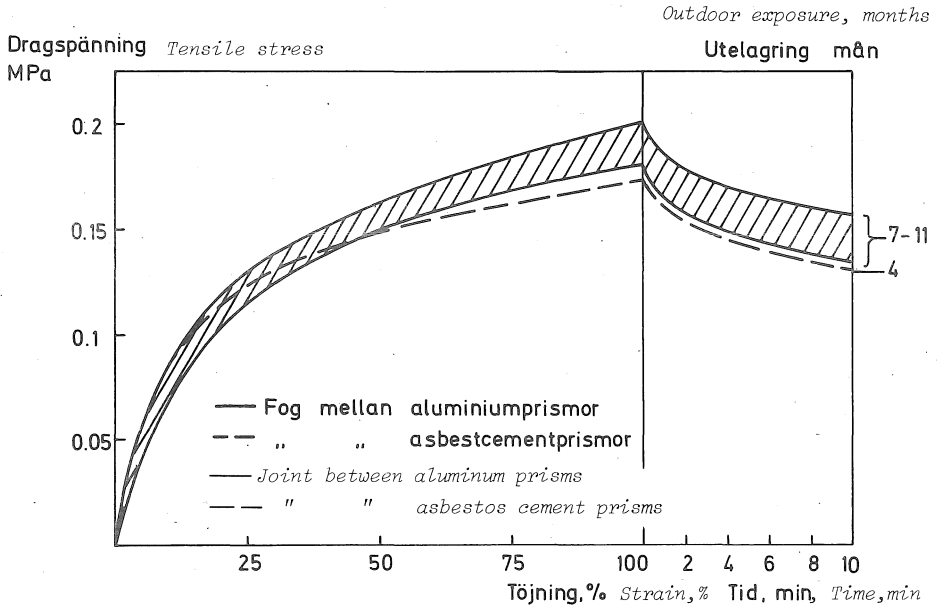
FIG 66 Arbetskurvor för "Material 1" efter olika lång tids utomhusexponering. Deformationshastighet: 1.5 mm/min. Provningsstemperatur: +2°C.

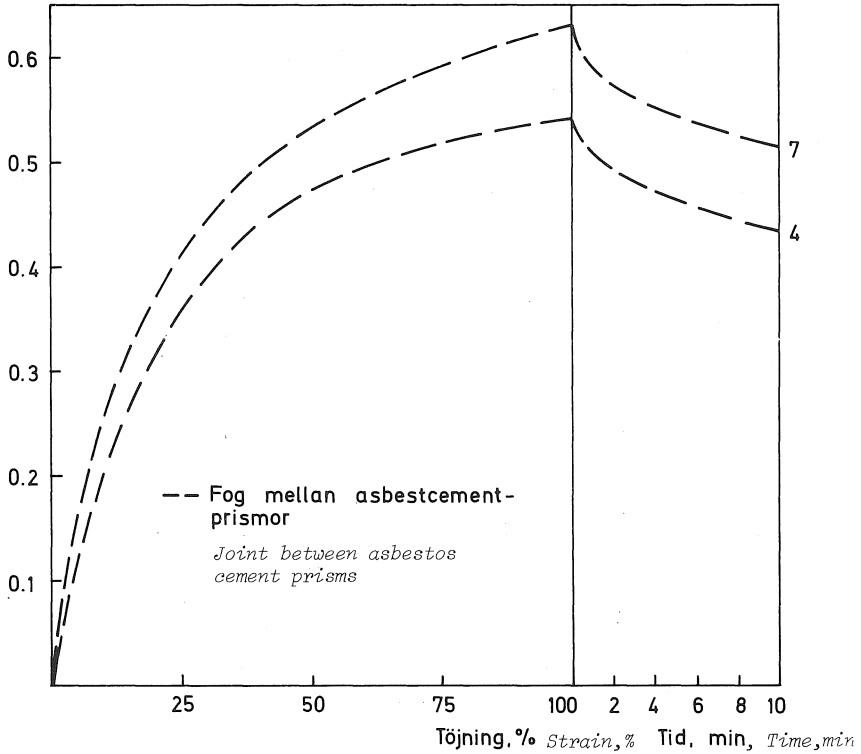
FIG 67 Arbetskurvor för "Material 2" efter olika lång tids utomhusexponering. Deformationshastighet: 1.5 mm/min. Provnings temperatur: +2°C.

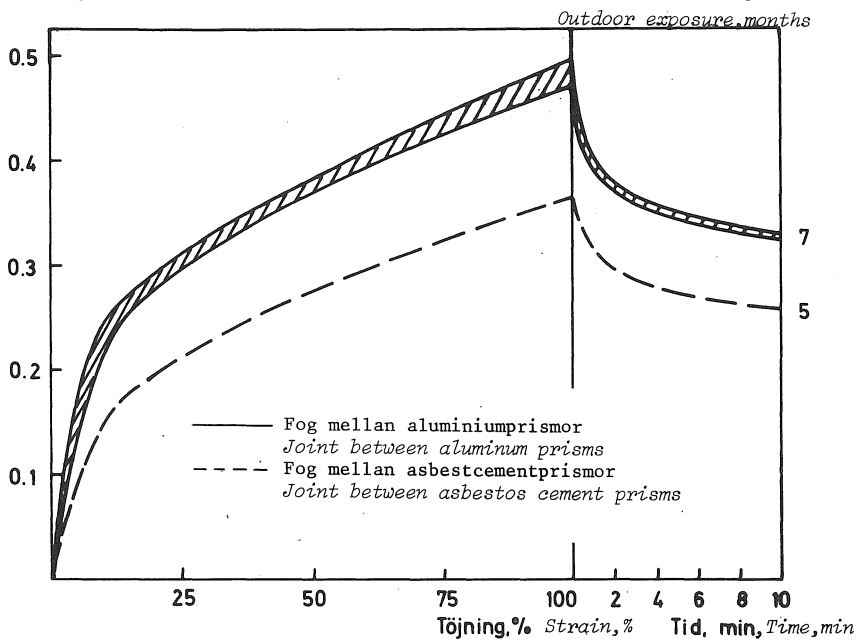
FIG 68 Arbetskurvor för "Material 3" efter olika lång tids utomhusexponering. Deformationshastighet: 1.5 mm/min. Provningsstemperatur: +2°C.

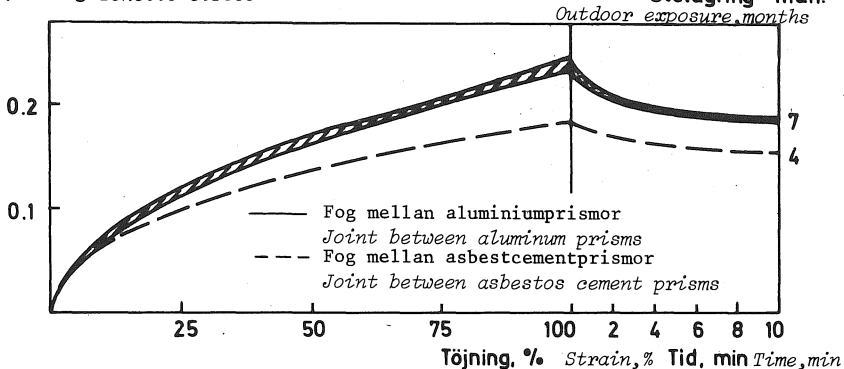
FIG 69 Arbetskurvor för "Material 4" efter olika lång tids utomhusexponering. Deformationshastighet: 1.5 mm/min. Provningsstemperatur: +2°C.

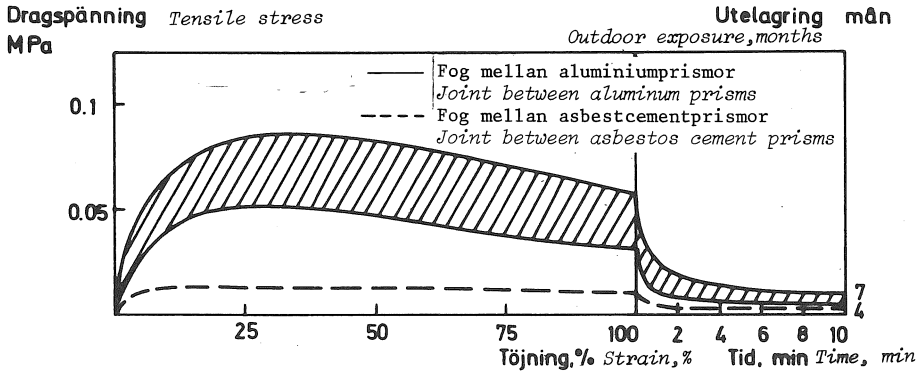
FIG 70 Arbetskurvor för "Material 5" efter olika lång tids utomhusexponering. Deformationshastighet: 1.5 mm/min. Provingstemperatur: +2°C.

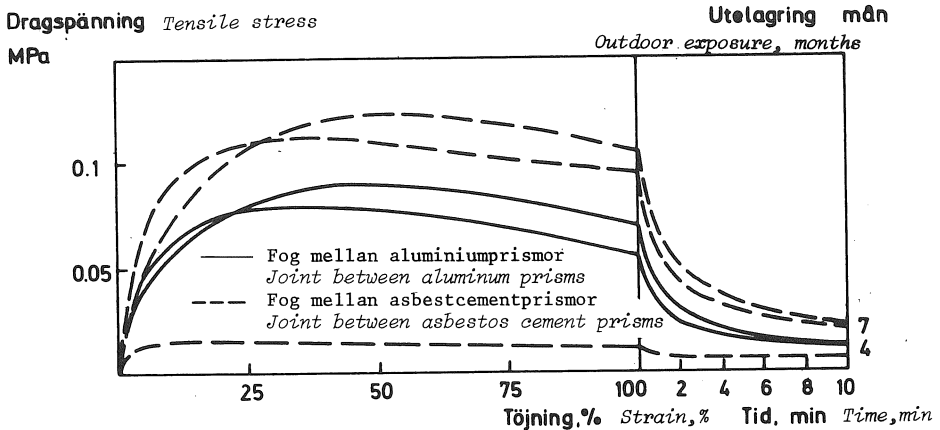
FIG 71 Arbetskurvor för "Material 6" efter olika lång tids utomhusexponering. Deformationshastighet: 1.5 mm/min. Provingstemperatur: +2°C.

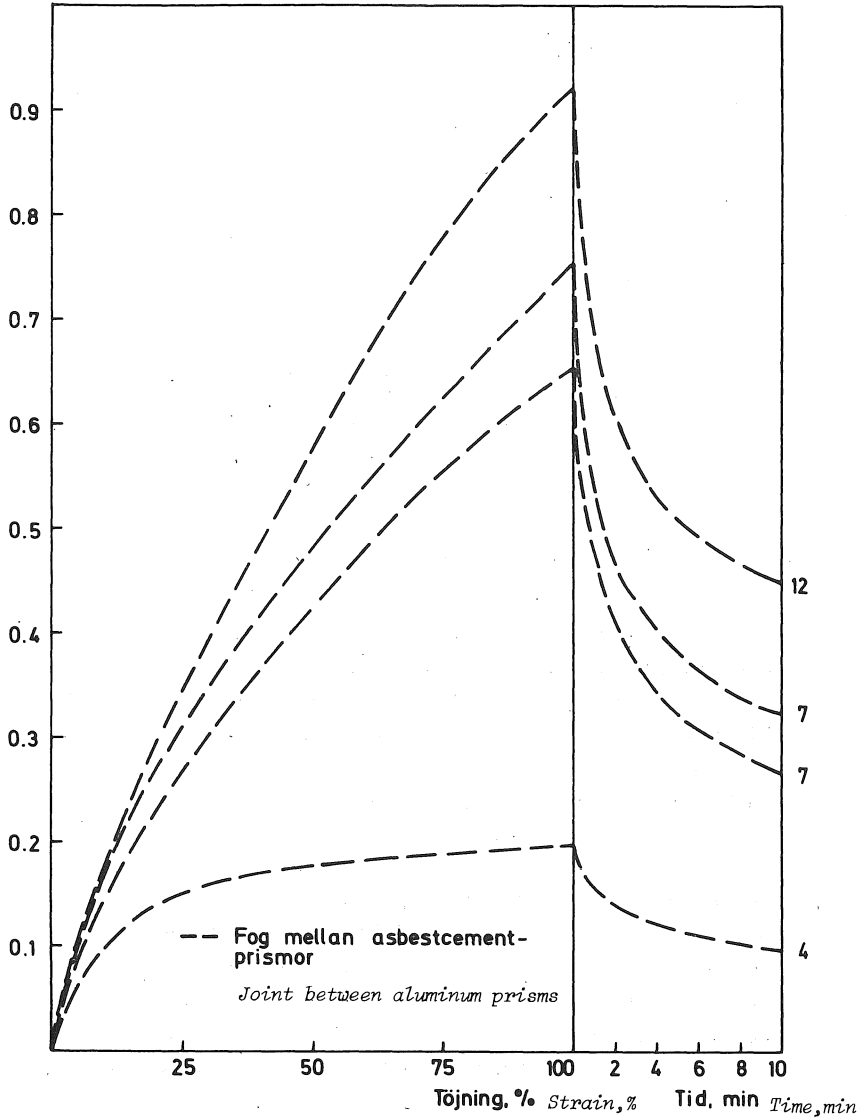
FIG 72 Arbetskurvor för "Material 7" efter olika lång tids utomhusexponering. Deformationshastighet: 1.5 mm/min. Provningsstemperatur: +2°C.

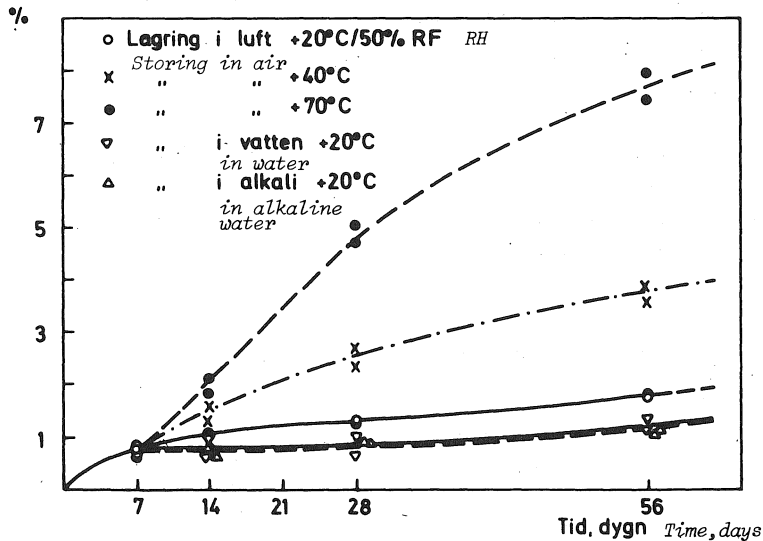
FIG 74 Volymminskning (krympning) som funktion av lagringstid i olika klimat för "Material 1".

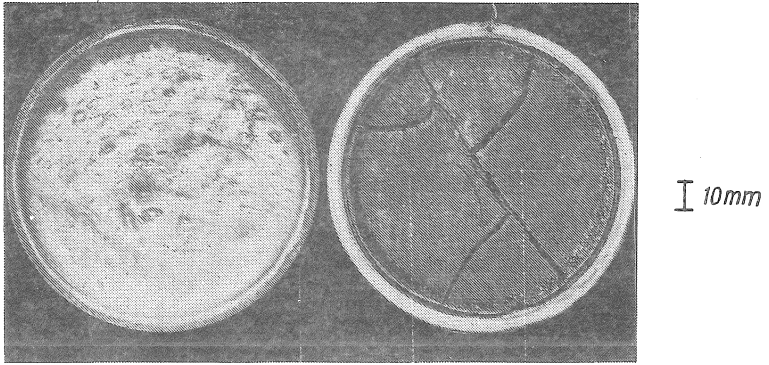
FIG 75 Bestämning av vikt- och volymminskning för två olika polysulfidbaserade fogmassor vid lagring i +70°C. Vänster provkropp är "Material 1", den högra av annat fabrikat.

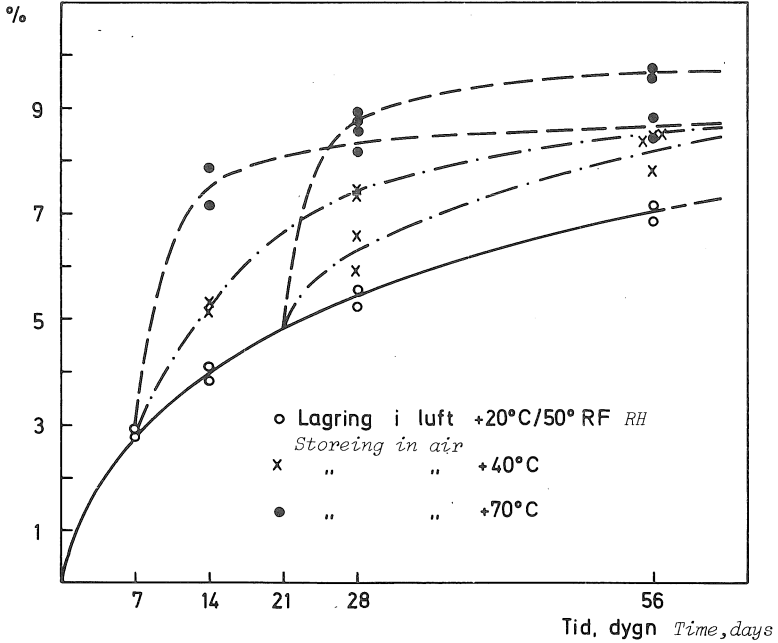
FIG 76 Volymminskning (krympning) som funktion av lagringstid i olika klimat för "Material 3".

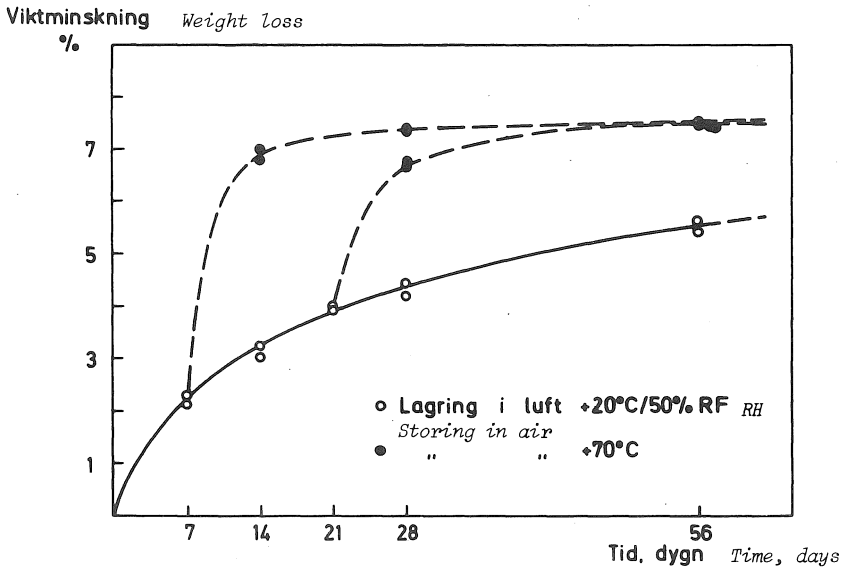
FIG 77 Viktminskning som funktion av lagringstid i olika klimat för "Material 3".

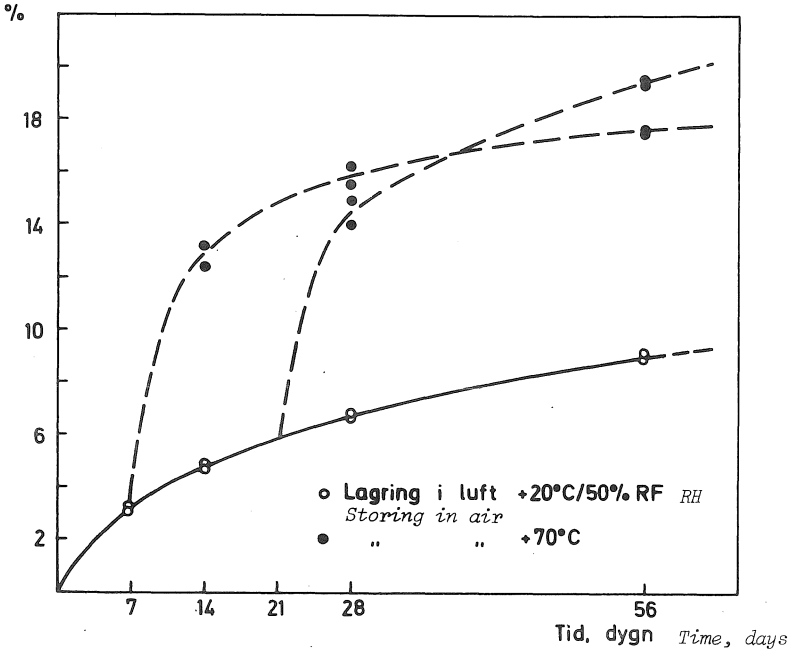
FIG 78 Volymminskning (krympning) som funktion av lagringstid i olika klimat för "Material 6".

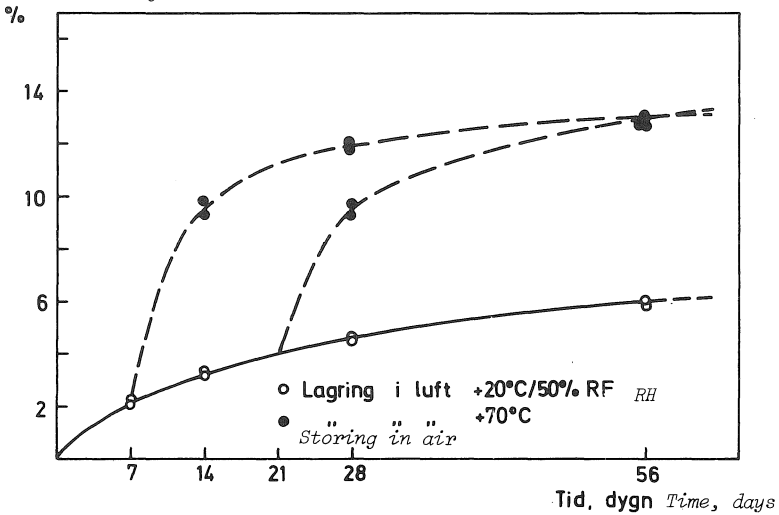
FIG 79 Viktninskning som funktion av lagringstid i olika klimat för "Material 6".
