Dense resistivity and induced polarization profiling for a landfill restoration project at Harlov, Southern Sweden

Published in:
Waste Management & Research

A resistivity and time-domain induced polarization (IP) survey was conducted at a landfill site under restoration at Härlöv in Southern Sweden. The covering of the landfill had begun some years ago, without keeping precise records of the work done, as is usual in such procedures. The survey was conducted in two steps, on two adjacent areas. First, a number of geoelectrical sections were made on a partly covered area that had been investigated earlier by auger drilling, in order to assist restoration. Then, a second area that should have received its final cover was imaged, and some defects in the cover could be detected and repaired. The resistivity and time-domain IP results were consistent with the results of the geotechnical drillings, and they enabled quasi-continuous mapping along the profiles. Three-dimensional visualization showed the overall consistency of the two-dimensional lines, and helped to generate a global view of the site. In spite of some ambiguities, cover and waste could be distinguished in most cases. In

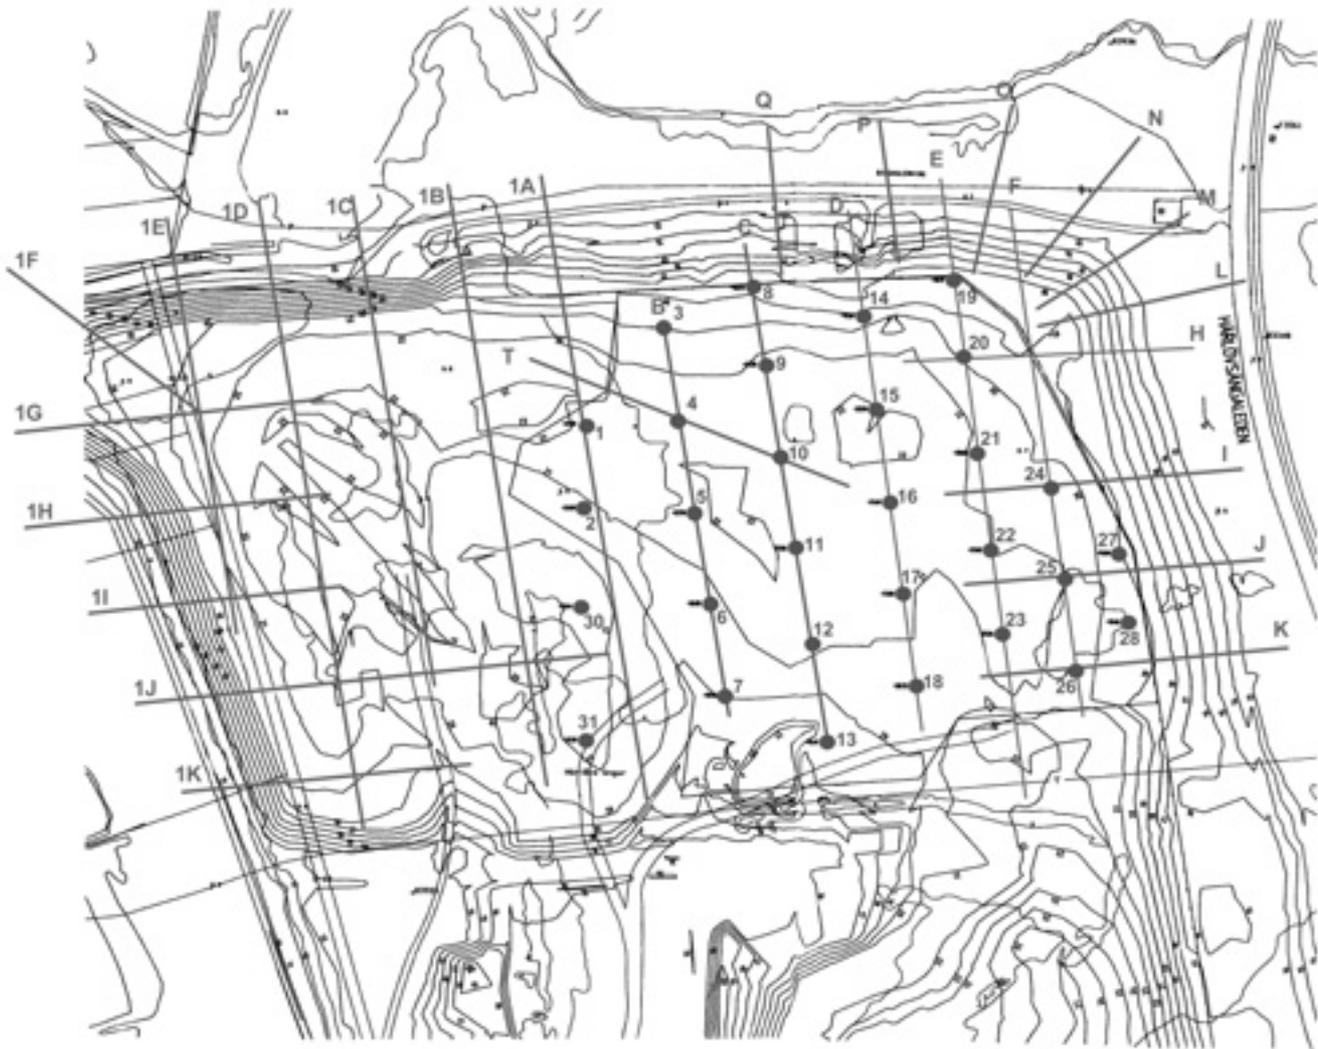
Fig. 1: Map over the investigated part of Härlöv waste site with locations of auger drillings and resistivity lines.

The geoelectrical field study at Härlöv was conducted in two steps. First, a 90 000 m² area was covered by ten resistivity sections (B, C, D, E, F, H, I, J, K, T), as shown in Figure 1, and IP was measured on five of them. This survey took place during spring 2002. Six complementary IP and resistivity sections (L to Q) were added on the north-east corner of the area in autumn 2002. This zone had been investigated through geotechnical auger drillings placed on a 50-m grid and the geophysical results could be compared with the borings. The aim was to determine what kind and thickness of material was needed to cover the area.

A second survey was conducted in the area immediately adjacent to the west, which was covered by eleven resistivity and IP sections (1A to 1K, see Figure 1) in autumn 2002. The aim was to ensure that the covering material was sufficiently dense and thick to comply with the new regulations.

The 31 shallow auger drillings were made through the cover in a 50-m grid covering the eastern part of the studied area (Figure 1). They reached the waste at 0.5 to 2 m depth. The cover materials found were classified according to the geotechnical standards, and were very diverse, comprising clay, clay till, mould, sludge, sand, gravel, bricks, lime and gypsum, which also can be expected to have very different hydraulic conductivities.

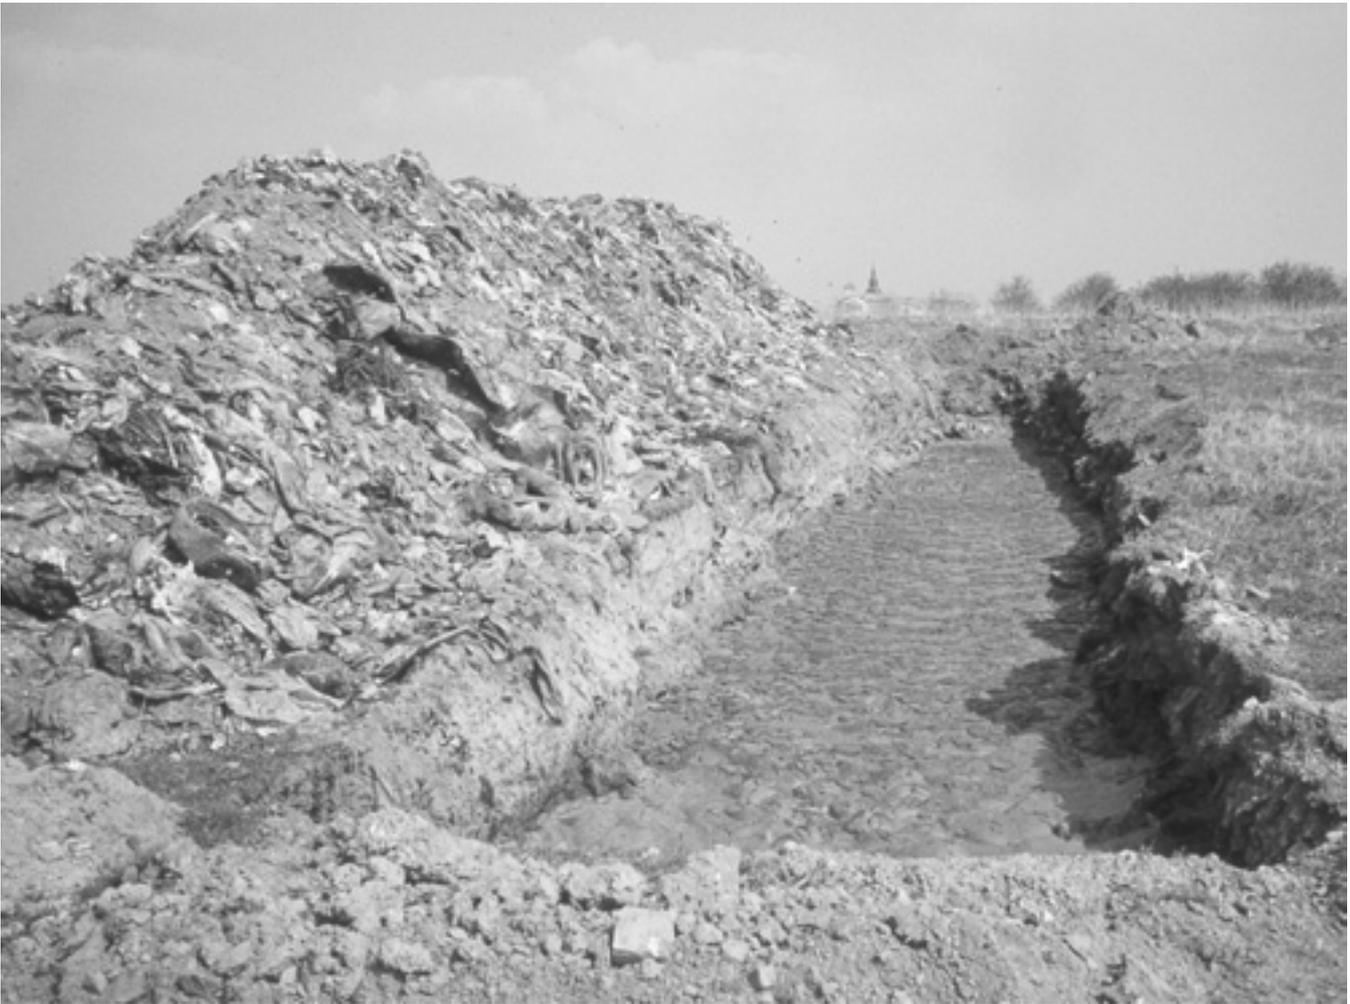
Fig. 2: View of excavated waste material in a trench.

No distinction was made between different kinds of waste. It is assumed that in the major part of the landfill it is similar to that photographed in Figure 2, which is mostly mixed materials with a lot of organic matter and plastic bags, and diverse disseminated objects. Trenches such as the one that was photographed were opened during the course of the survey and they rapidly filled with liquid mud to a depth of around 1 m.

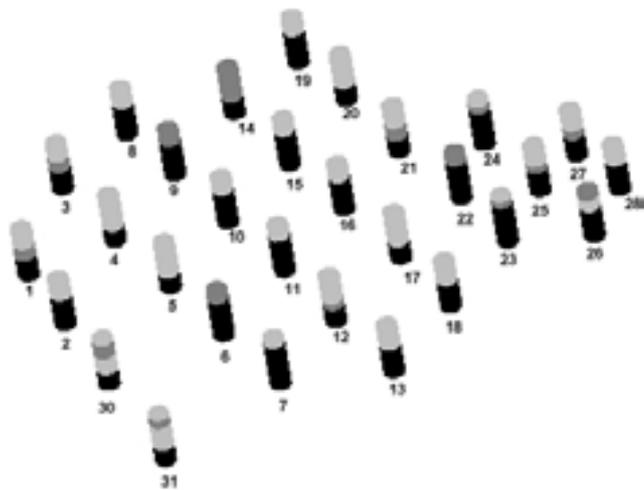
Fig. 3: Result of auger drilling investigation, view from SW. Legend: dark grey, clay; black, waste; light grey, other materials, often mixed (sand, gravel, clay till, lime, mould, sludge, bricks). Vertical enlargement: $\times 10$.

The distribution of the various materials found is summarized in Figure 3. The cover was very inhomogeneous,

and it was in general not possible to correlate two neighbouring points with certainty. Clay or other impermeable

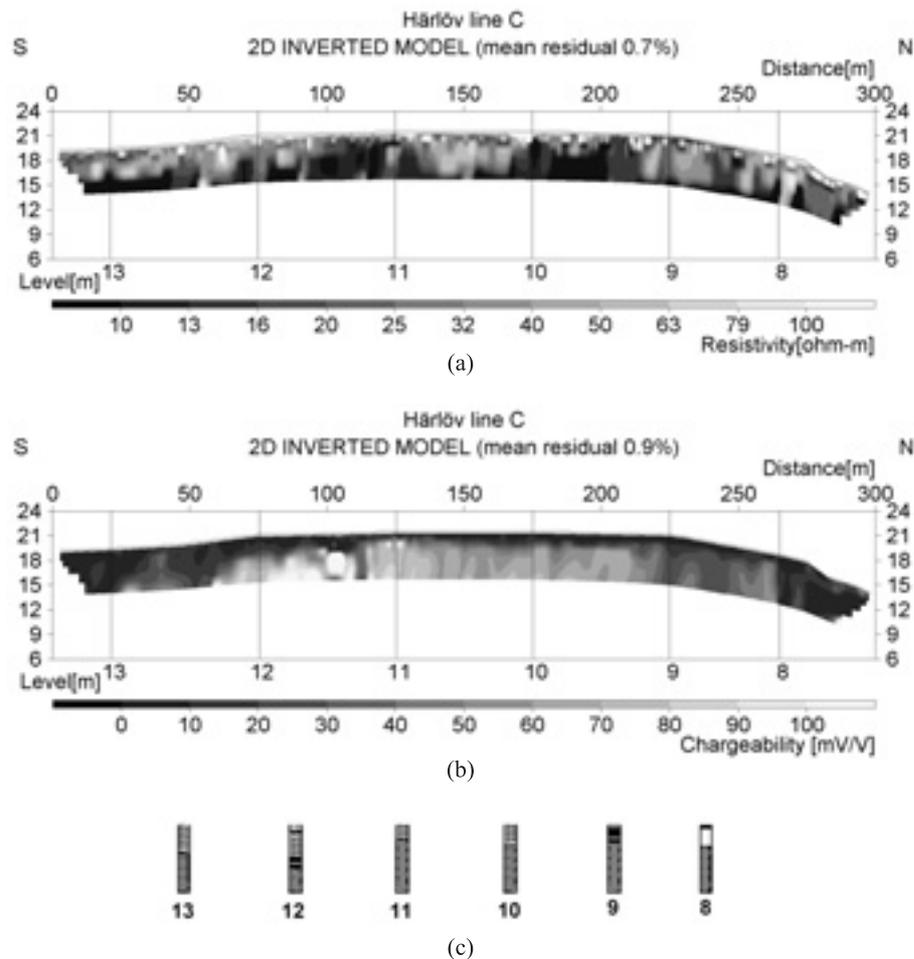
Fig. 4: (a) Inverted resistivity section for line C (Wenner array); (b) inverted chargeability section for line C (Wenner array, 20 to 120 ms); (c) profile of auger drilling documentation for line C. Legend: white with large pattern, clay fill and sand; black, clay; white, lime; grey with finer pattern, waste. The represented logs are 3 m deep.

Six geotechnical auger drillings were placed on line C, and this line was the most favourable for comparison between geotechnical and geoelectrical data (Figure 4a–c).

At a first glance it is not easy to correlate the two kinds of information. As on the other lines, essentially two kinds of material can be distinguished on the resistivity section: a superficial, resistive and very inhomogeneous layer and a deeper conductive material. The first layer only partially follows the thickness of the cover as was found by the drillings: it seems thicker at points 12 and 13 than at boring 10, which was confirmed by the borings. This correlation does not work for positions 11 and 9, unless one looks into more detail and distinguishes two sub-layers in the resistive material, separated by a very thin conductive one. This intermediate conductive layer correlates with clay at location 9 but not at location 11, where no clay was found. It seems however likely that this intermediate thin conductive layer is caused by clay.

Looking at the inverted IP section (Figure 4b), chargeable material is found at depth, whereas very little IP effect is visible in the uppermost layer. The high chargeability values seem to correlate well with the distribution of the waste, especially at locations 11, 10, 9 and 12. Small discrepancies appear at locations 8 and 13, but they could be due to lateral

Using both resistivity and chargeability results, a material with high chargeability ($> 30 \text{ mV V}^{-1}$) and low resistivity can be identified as waste. A material with higher resistivity ($> 10 \Omega \text{ m}$) and low chargeability can be classified as covering soil material, probably medium grained to coarse grained. In between materials with higher resistivity and intermediate chargeability can be found; those can probably be identified as waste also, but of another composition. A part of the cover is made of low resistivity material with very weak chargeability, and this is probably clay.

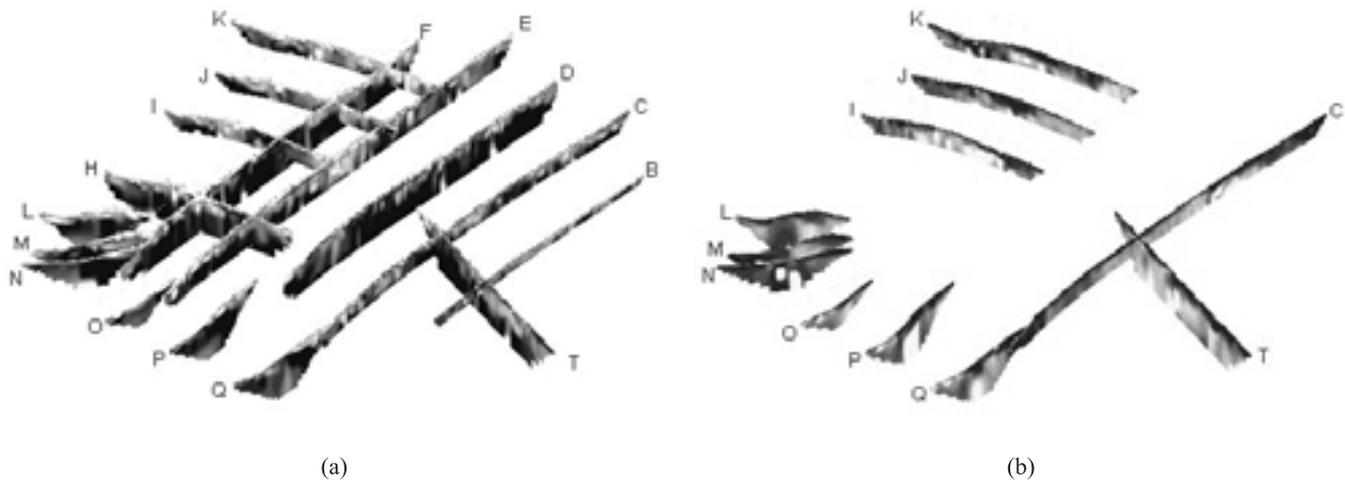
Fig. 5: (a) Three-dimensional view of survey 1 results: interpreted resistivity (from NW); (b) three-dimensional view of survey 1 results: interpreted chargeability (20–120 ms).

It can be seen that most intersecting sections agree well (Figure 5a for the resistivity sections and Figure 5b for the chargeability sections), although all of them have been interpreted using a two-dimensional assumption of the structure of the ground. The bottom of the landfill cannot be identified, which should be found around level 0, on any of the inverted sections. This may be due to insufficient depth of investigation, but other likely explanations are that the geoelectrical contrast with the natural soil is too weak, or that conductive water has leaked from the landfill into the soil and thus wholly or partially removed the natural electrical contrast.

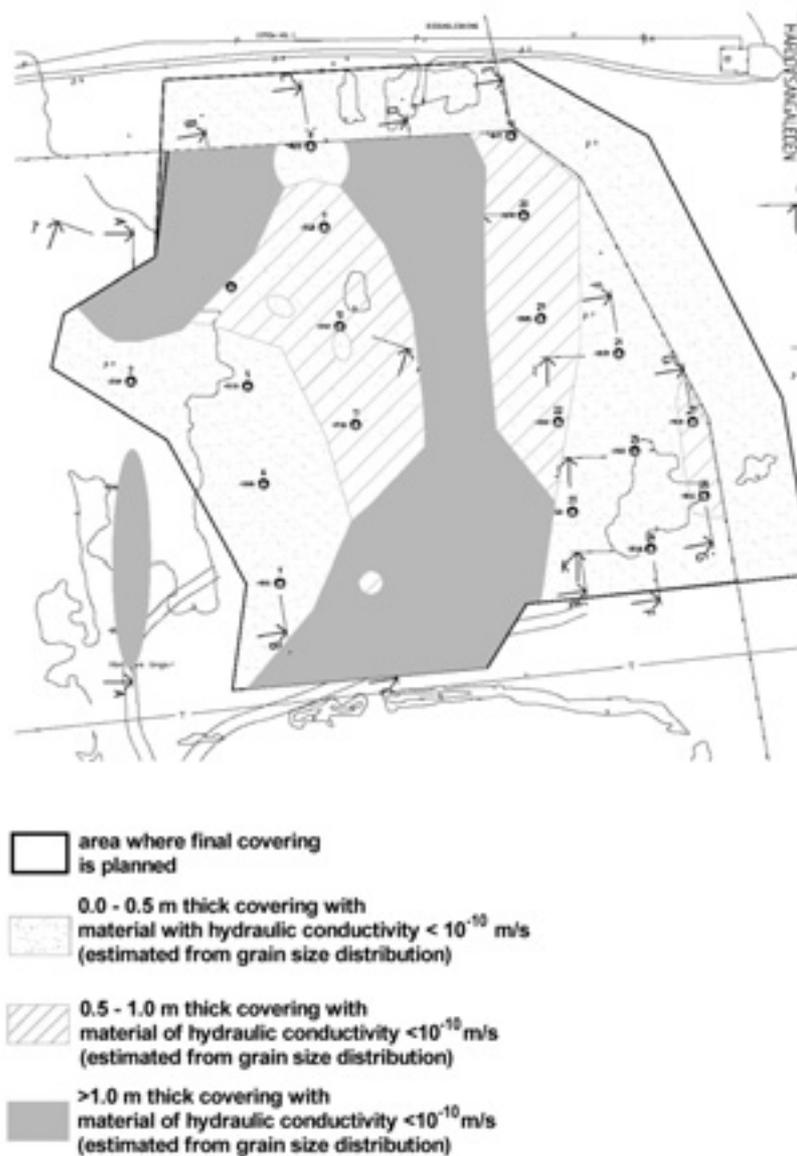
Fig. 6: Revised plan for continuing reclamation work.

The cover on the edges of the eastern part of the landfill was judged more satisfactory and a reduced thickness of complementary cover was required there (less than 0.5 m), as around the southern part of line B. An intermediate thickness (0.5–1 m) of complementary material was required otherwise. The produced plan for the continuation of the reclamation work is shown in Figure 6.

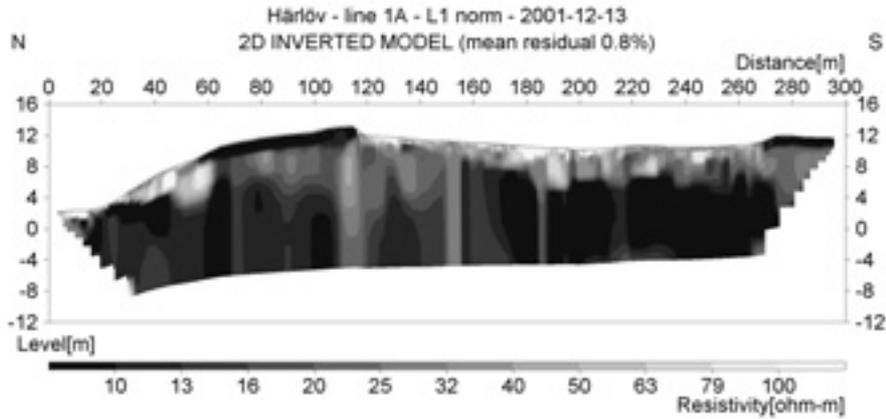
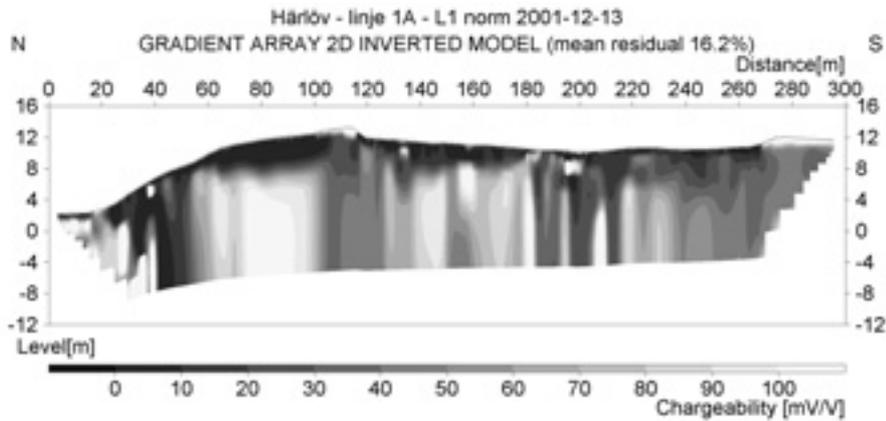
Fig. 7: Inverted resistivity section for line 1A (gradient array); (b) inverted chargeability section for line 1A (gradient array, 10–110 ms).

Line 1A can be used as an example (Figure 7a and b). On the interpreted sections, it can be seen that the first conductive layer – the clayey cover – is not continuous. It is clearly absent between x -coordinates 118 and 270 m, as well as between x -coordinates 0 and 50 m. The more resistive and very inhomogeneous

geneous superficial layer found between $x = 118$ m and $x = 270$ m is most probably composed of coarser materials. It has weak and mixed chargeability. The clayey cover is not chargeable. At depth, resistive material can be either waste or coarse soil materials. Material with high chargeability is probably waste. Boring 1 was situated on line 1A at around 121 m, boring 2 was very close to it at around 155 m and borings 30 and 31 were still rather close at 203 and 266 m, respectively. The clay layer seems to appear on the resistivity section around boring 1 but it is not clear on the IP section. It does not appear at the location of boring 2, as it does not exist there. Borings 30 and 31 might be located too far from the line to draw certain conclusions, but it seems that the waste was located deeper towards the southern end of profile 1A. Between 120 and 260 m the waste is covered by mainly non-clayey material, as is apparent on the geoelectrical sections and con-

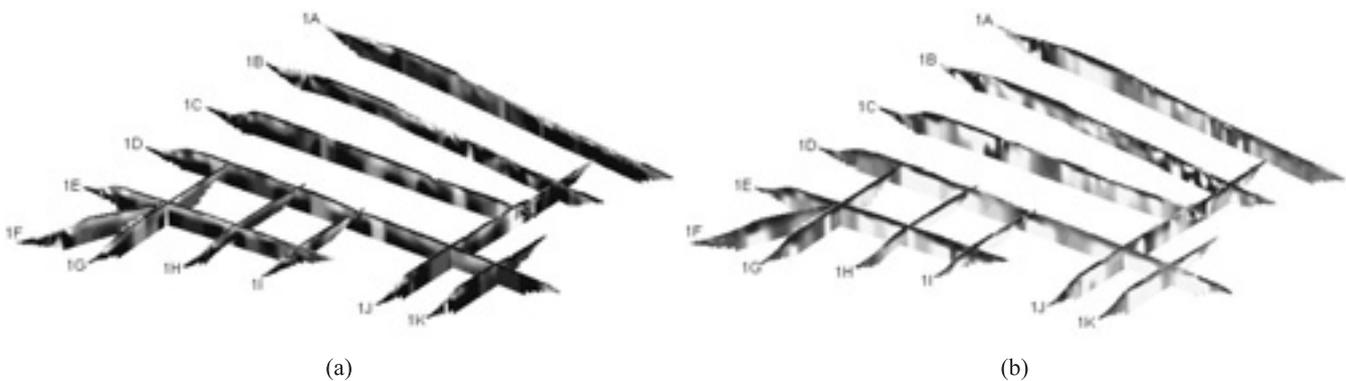
Fig. 8: (a) Three-dimensional view of survey 2 results: interpreted resistivity sections. (b) three-dimensional view of survey 2 results: interpreted chargeability sections (10–110 ms).

The intersecting sections here are also very consistent (Figure 8a for the resistivity sections, and Figure 8b for the chargeability). The superficial clayey cover can be easily followed everywhere, except where it is missing, in the middle of lines 1A and 1B, at the end of line 1E and on the slopes. Resistivity gives clear enough results here for detecting possible infiltration windows in the landfill that were not covered by clay.
