LEAKING ROOFS IN TUNISIA

Erik Johansson Farhad Kalantari

The report is based on a master thesis by Erik Johansson and Farhad Kalantari presented at the division of Building Materials at L.N.T.H. in 1989.

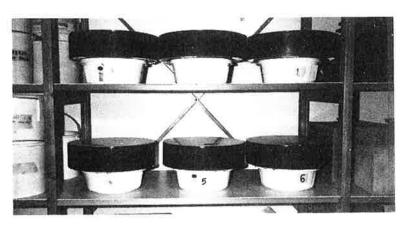
Fig. 1. Tubes containing the specimens (black) on bowls containing a bed of wet salt (white).

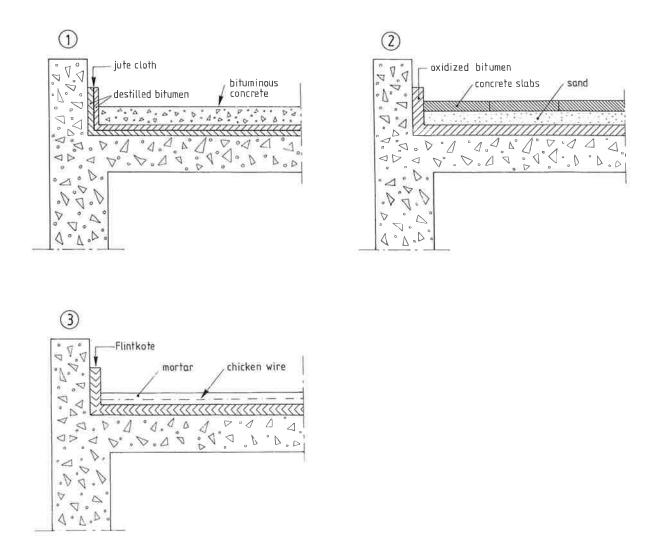
Fig. 2. Three proposals for roof structures.

We have suggested three roof structures all containing a bituminous membrane as well as a *protective layer* on top of it, as shown in fig. 2. Three sorts of bitumen - distilled and oxidized bitumen and also bituminous emulsion - have been used as well as three types of protective layers.

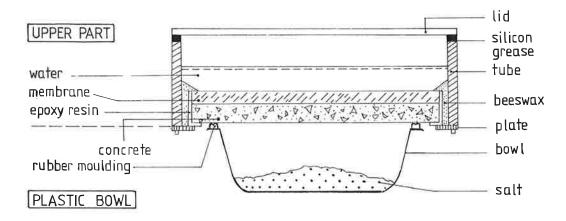
Fig. 3. The measuring method.

The method, which is shown in fig. 3, consists of a tube into which a model of a roof structure is put. Afterwards, water is poured on top of it and the flow of water through the roof structure is measured. In order to accelerate the water flow through the roof materials and to have a constant climate for all specimens, the upper part of the experimental arrangement (the model of the roof together with the plastic tube) is put on top of a plastic bowl containing a salt with a low relative humidity of 33%. Thus, the climate just under the specimen is held at a constantly low relative humidity of 33% whereas it is, of course, 100% R.H. on top of the specimen.

Each specimen of the roof structure (a 20 mm thick concrete slab plus a bituminous membrane and a protective layer) is made circular having a diameter of 30 cm. Now the edge of each specimen as well as the part of the bottom surface that is outside the plastic bowl is covered with epoxy resin. This is done in order to prevent the water from penetrating along the edge of the specimen and to make sure that all water leaking through the specimen eventually will reach the salt bed in the plastic bowl.

Each specimen is then put into a plastic tube of polyethylene. The opening between the wall of the tube and the specimen is tightened by a mixture of beeswax (75%) and paraffin (25%). The measuring process starts by pouring water into the tube on top of the specimen and immediately after putting a lid on top of the tube. The joint between the tube and the lid is tightened by silicon grease.

The weighing is made every second day. Between weighings, the upper part is always resting on top of the bowl with the bed of wet salt. The weight of the upper part as well as the weight of the plastic bowl is measured. The upper part loses its weight from day to day whereas the weight of the plastic bowl increases with about the same amount. The velocity of the weight reduction for the upper part is a measure of the flow of water leaking through each roof model being tested.

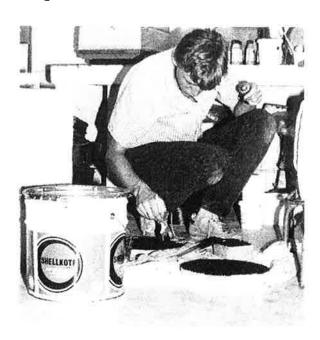
Fig. 6. Painting the bituminous emulsion in proposal 3.

In the third proposal the waterproof membrane of the bituminous emulsion Flint-kote was produced by painting the bitumen on the slab. The procedure was repeated, once the first coat had got dry, but now painting perpendicular to the first direction. This product was very convenient to use, especially as no heating was needed.

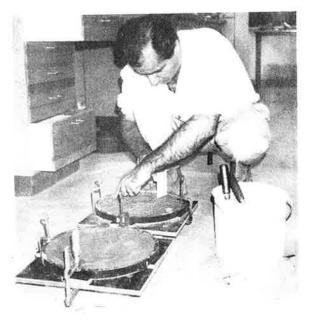
Fig. 7. Protective layer of mortar reinforced with chicken wire.

The protective layer of mortar, reinforced with chicken wire, was then applied on top of the Flintkote.

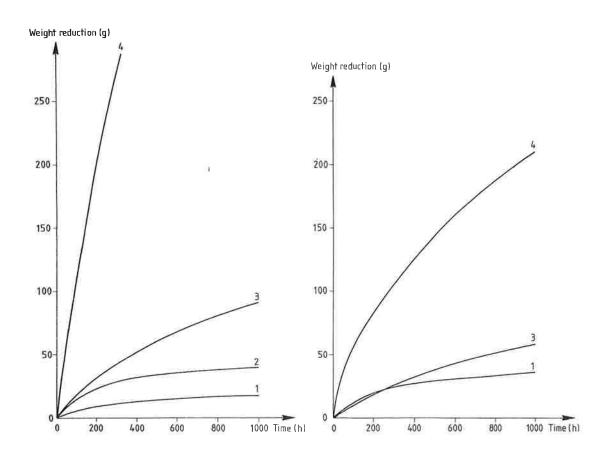
The results, see fig. 10, from both E.N.I.T. and L.N.T.H. clearly show that a water-proof membrane on top of normal concrete improves the watertightness. The differences between the results from E.N.I.T. and L.N.T.H. come from the fact that a more watertight concrete was used in Tunis. From the tests in Tunis, the result from proposal 2 is missing since oxidized bitumen was not obtainable for the tests made at E.N.I.T..

Fig. 10. Results from L.N.T.H. (left) and E.N.I.T. (right). 1, 2, 3, = proposals 1, 2, 3, whereas 4 = concrete without membrane.

The most watertight roofing membrane proved to be that of proposal 1. Proposal 2 came second whereas the most "water leaking" suggestion was number 3.

When watching the curves from the results one can wonder why the water flow through the specimens decreases in course of time. The reason ought to be that the concrete slabs were only two weeks old when the tests started. Then the hydration was far from complete, which made the concrete more watertight as time went on. Also the drying up was not ready after only a fortnight.

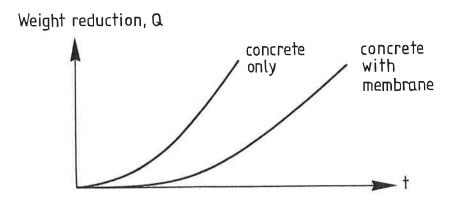
When the effects due to hydration and drying up have been made neglectible, the curves will probably have the shapes shown in fig. 11. The first part of the curve shows that when the water above the specimen passes the membrane it will take some time until the pores of the concrete slab get filled with water. Once the pores are filled with water a steady state will begin as in the latter part of the curve.

Fig. 11. The presumed shapes of the curves.

Preparing the concrete slabs as described above should make it possible to calculate the diffusion coefficient of the roofing membranes. It is then necessary to have dummies made of only concrete as comparison to the specimens made of concrete slab and membrane. The slope of the steady state parts of the curves in fig. 11 will be proportional to the diffusion coefficient, which can be calculated with the formula
