Investigation of shallow leakage zones in a small embankment dam using repeated resistivity measurements in Internal erosion in embankment dams and their foundations

Investigation of shallow leakage zones in a small embankment dam using repeated resistivity measurements

keywords: seepage, detection, resistivity, embankment dam

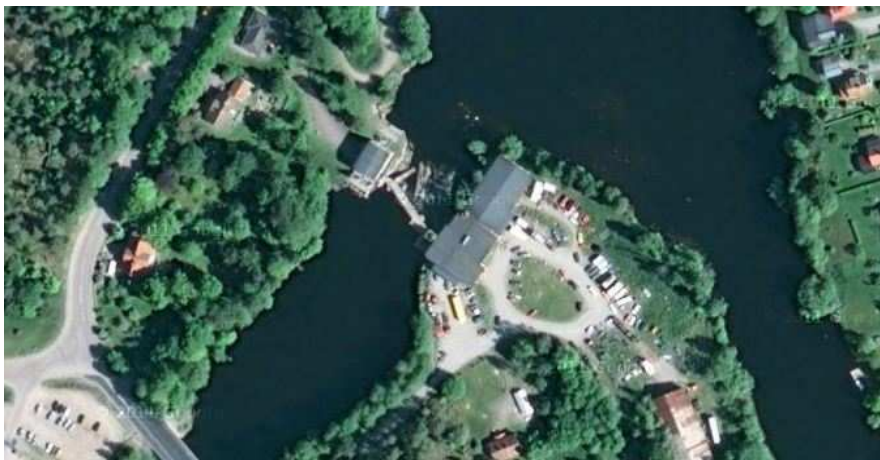
Fig. 1 Plan view over from left to right: the power plant, spillways, workshop building and embankment dam (from Google maps).

The plant is situated in central Sweden. It consists of a power plant, a concrete dam with gates, a workshop building and an embankment dam (Fig. 1). The embankment dam is less than 100 meters long and less than 10 m high.
